Assessment of Damage Accumulation in Thermal Barrier Coatings Using a Fluorescent Dye Infiltration Technique

B. Barber, E. Jordan, M. Gell, and A. Geary

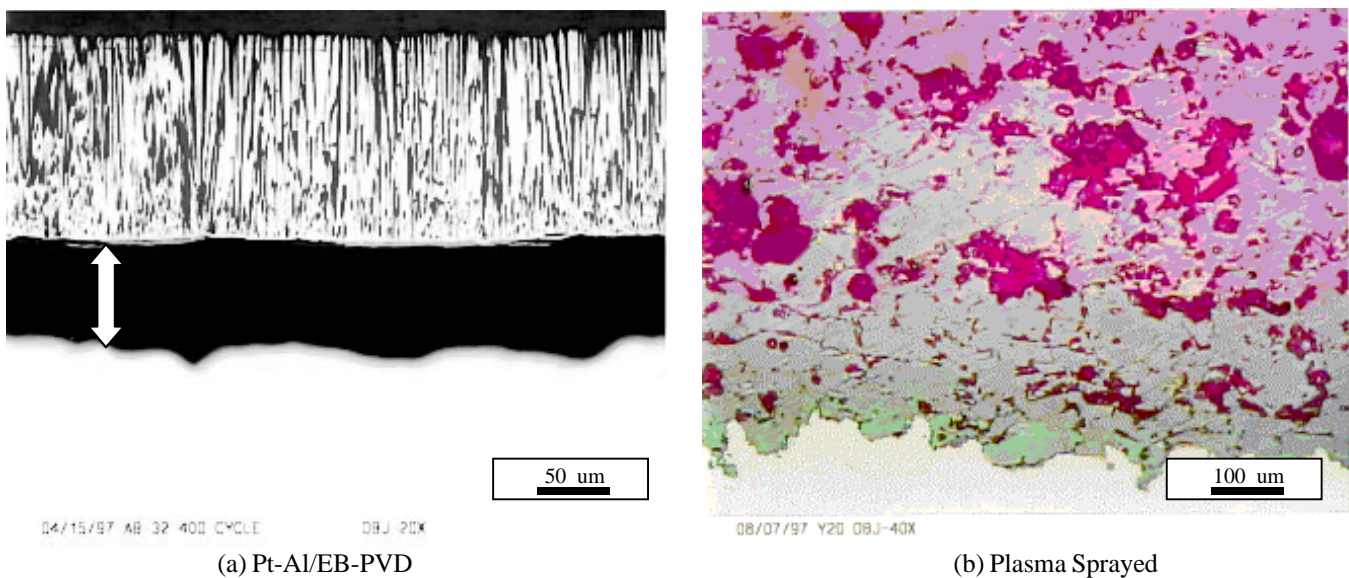
The effectiveness of this technique is illustrated in Fig. 2, which shows a sectioned view of an EB-PVD coating and a plasma sprayed sample vacuum impregnated with the rhodamine-B dye (ACROS Organics, Pittsburgh, Pennsylvania). The dye is shown to penetrate throughout the porous ceramic to the bond coat interface. In the EB-PVD sample (Fig. 2a) the dye penetrates down the parallel ceramic columns. The large dark

void between the arrows results from the ceramic debonding from the substrate and is clearly shown as an artifact introduced during sample preparation because the lower surface is devoid of the red dye. In the plasma sprayed sample, in Fig. 2(b), the voids filled with the fluorescent epoxy are surface connected processing voids present before sectioning and metallographic preparation. For both EB-PVD and plasma sprayed TBCs, the intentionally produced processing defects are shown by the dye to be interconnected from the external surface of the ceramic to the thermally grown oxide (TGO).

Fig. 2 Vacuum impregnated EB-PVD and plasma sprayed sample with rhodamine dye
