Stress corrosion cracking fracture mechanisms in rock bolts

E. GAMBOA, A. ATRENS

Division of Materials, The University of Queensland, Brisbane, QLD 4072, Australia

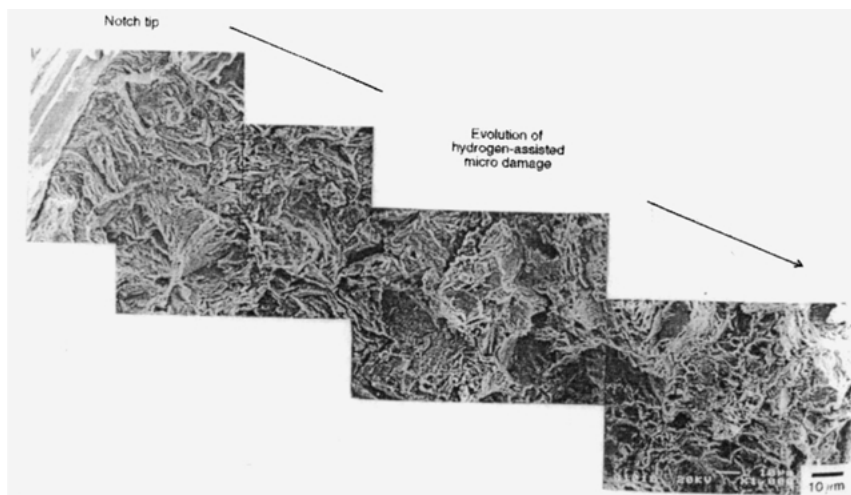
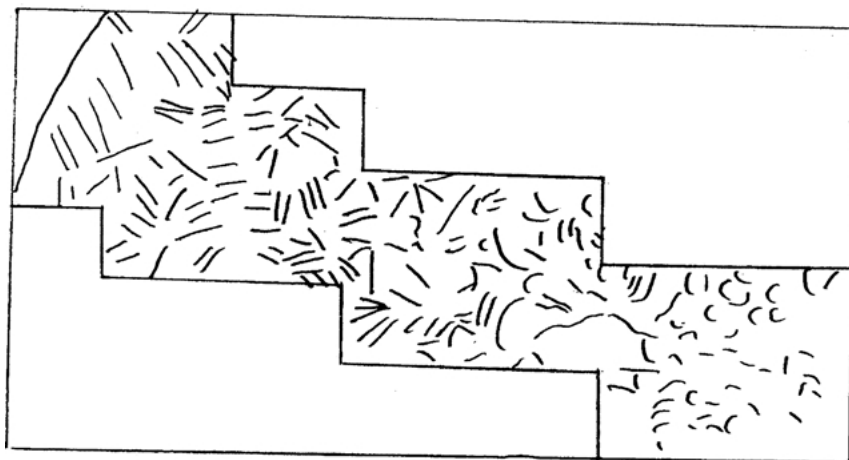
Figure 3 TTS region overview.

(a) Picture taken by Toribio and Vasseur of evolution of hydrogen assisted micro damage. [4]

(b) Schematic view showing TTS ridge orientation

the direction of damage propagation. Such orientation was lost further into the sample. Fig. 3 shows such orientation. Close to the surface the deep ridges tended to point towards the free surface, but as the distance from the free surface increases, the orientation became random. Toribio [4] suggested that this fracture surface was formed by hydrogen diffused into the metal and assisting fracture by embrittling the material.
