## Investigation of blade failure in a gas turbine<sup>†</sup>

Yeon-Sun Choi<sup>1,\*</sup> and Kyu-Hwa Lee<sup>2</sup>

### Abstract

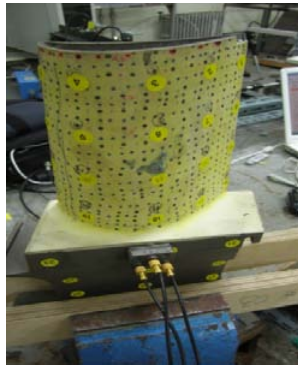
To find the natural frequencies of the blade, an impact test for the blade was performed at the fixed boundary condition as shown in Fig. 7. The fixed condition was established using a vice. The frequencies were calculated using SAMCEF software. A comparison of the natural frequencies is given in Table 1 which shows that there are good agreements except for the second mode between the experimental results and the numerical simulation. This is why the experimentally determined shape of the second mode came from the lateral motion

Fig. 7. Modal test for fixed boundary condition of a blade.

of the fixed blade because the vice could not fully constrain the lateral motion.
