Damages of hot-pressed boron carbide during solid target boronization in Uragan-3M torsatron

Abstract

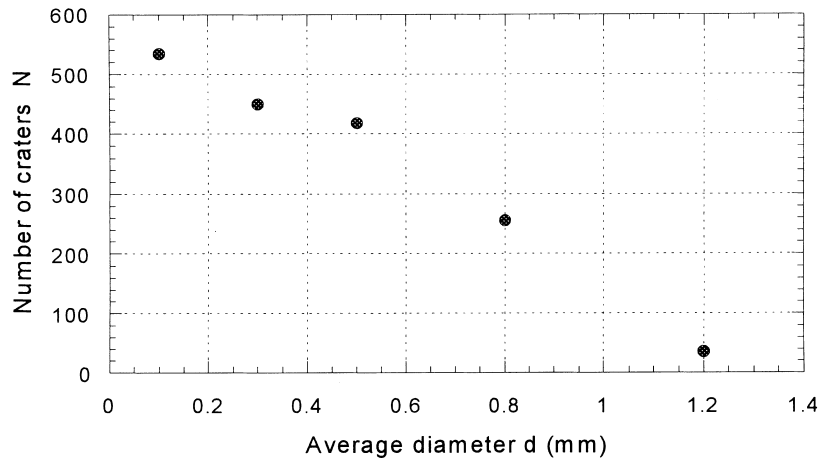
The most damaged are those plate edges which were located during the experiment at the nearest distance from the plasma axis (Fig. 2(a)). There are observed not only craters but also partially melted spallings. In contrast, there are only craters on the sample surface located far away from the plasma axis (Fig. 2(c)). The total number of craters (without spallings) on the sample surface as a function of their average diameters is presented in Fig. 3. As it is seen, the size of the majority of craters ranges between 0.1 and 0.5 mm. Smaller sizes of craters than those observed in work [2] can be explained by a difference in boron carbide surface temperatures during the tests. Fig. 4 shows the crater density distribution on the damaged surface. The decrease of the crater density value at the nearest dis-

tances from the plasma column axis is explained by appearing the numerous spallings which demolish the craters.

Fig. 3. Total number of craters N on the damaged surface of B_4C -plate versus their average diameter d .

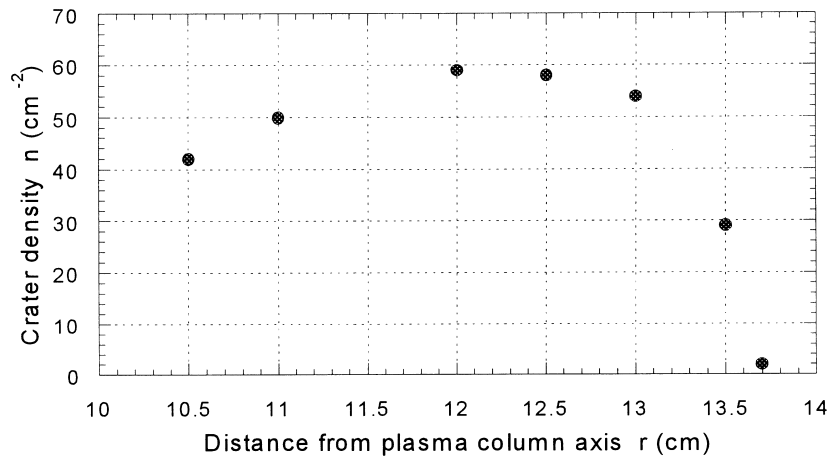
Fig. 4. Crater density n on the damaged surface versus distance r from the plasma column axis.
