Rupture analysis of CuCrZr plasma facing component during a loss of flow accident in Tore-Supra

Abstract

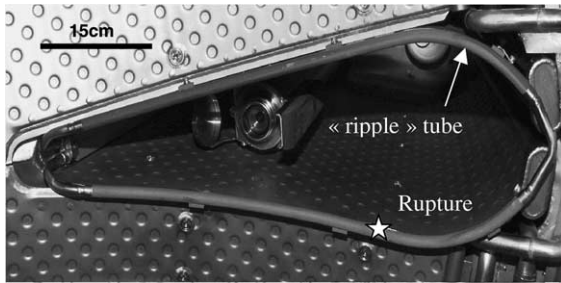
Fig. 1. View of the ripple protection installed in Tore Supra.

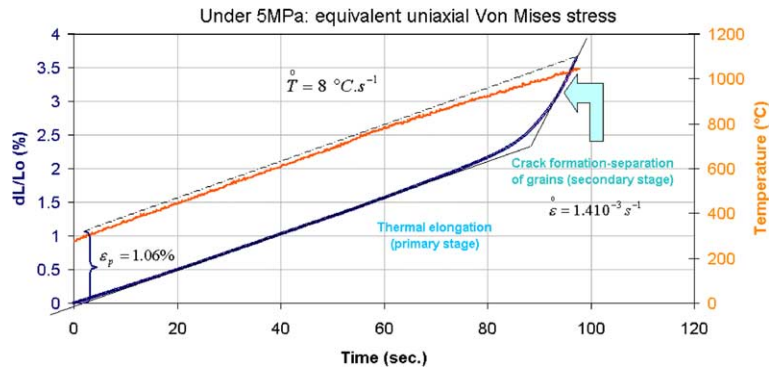
To determine from which dynamic cycle heating a change of the deformation mechanism appeared, technological tests in extreme conditions were carried out in air in uniaxial constant load on cylindrical specimens with 6 mm diameter and 30 mm gauge length. Elongation of sample during the test was measured by LVDT gauge linked on adapters of the specimen. The specimens have been locally heated by mean of induction heating power supply (5 kW; 300 kHz). Induction heating takes place when alternating current produced by the power supply is caused to flow through an inductor, which is placed around specimen. Because of the high conductivity of copper alloy many steps have been used to optimise the specimen geometry. The temperature was controlled and monitored by thermocouple type K fixed in the middle of specimen length. Under permanent strength, a fast cycle heating have been carried out until the rupture of sample. To take into account biaxial in-service stresses an equivalent uniaxial Von-Mises stress was used. A typical temperature–deformation–time curve is shown in Fig. 6, the dynamic cycle heating and the results of the analysis were delicate to discern. In the deformation curve, two evolutions of elongation are measured. First, there is thermal elongation, which is due to the vacancy diffusion at grain boundaries taking place during heating. Second, there is a plastic elongation probably due to crack formation followed by extension caused by crack separation of grains. Afterwards on the basis of scratch displacements it is difficult to account for the formation of these widened grooves otherwise than grain boundary sliding accommodated by slip [5]. In this case, the nucleation rate of microvoids and grain boundary sliding could be controlled by simple linear model. As shown Fig. 7, local plastic strain rate during secondary stage versus dynamic cycle heating indicate a linear deformation mechanism. On the same graphic the curve of plastic strain strongly decreases from 4.5% to 1%. Based on the extrapolation of these results, a strain rate value of about 10⁻² s⁻¹ at 40 °C s⁻¹ has been selected to characterise the copper alloy tensile test under accidental conditions. Thermomechanical tests indicated that the fracture temperature at 0.9T_m is almost independent of

Fig. 6. Typical temperature–deformation–time curve.

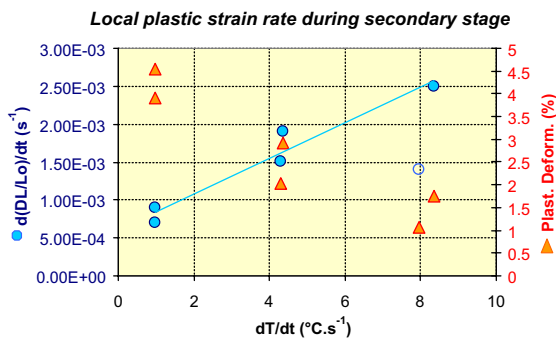
Fig. 7. Strain rate versus dynamic cycle heating.

heating rates. It is noted that for all specimens, metallographic analysis showed an intergranular rupture surface morphology with a low reduction of area (up to 3%).
