## Post irradiation examination of thermal reactor fuels

### ABSTRACT

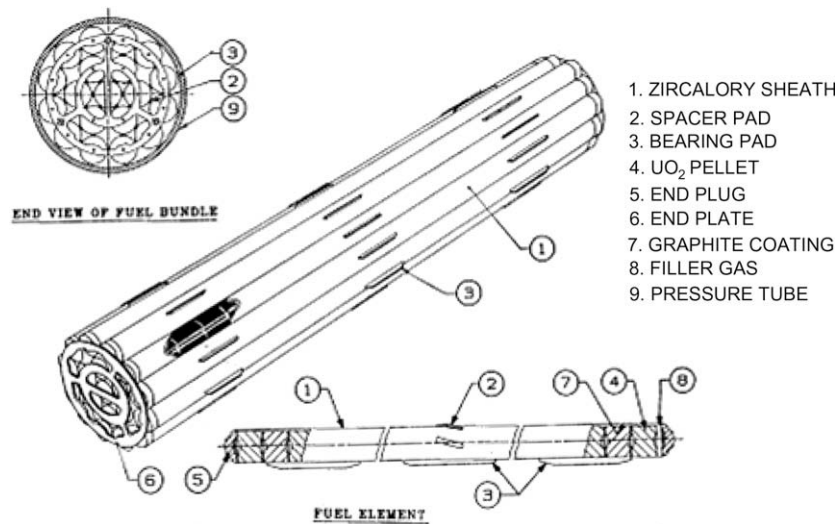
Fig. 2. Details of 19-pin PHWR fuel bundle.

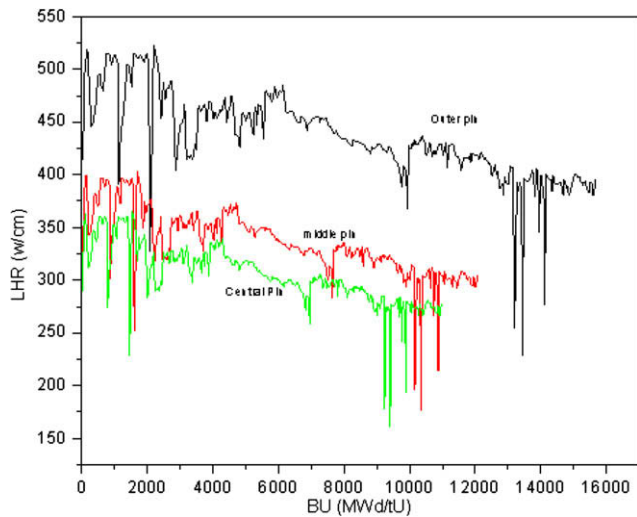
Results from one of the two high burnup fuels are discussed in this paper. The bundle was of the standard 19-element design with natural UO<sub>2</sub> fuel, clad in Zircaloy-2 (Fig. 2). The linear power ratings of the fuel pins in the outer ring, in the intermediate ring and the central fuel pin of the bundle are given as a function of burnup in Fig. 3. The fuel bundle examined in this study had attained an average burnup of 15000 MWd/tU, which is more than twice the designed discharge burnup of 7000 MWd/tU. The burnup in the peak rated fuel pins of outer ring, intermediate ring and the central pin were 15460 MWd/tU, 13120 MWd/tU and 12390 MWd/tU, respectively. Visual examination and leak testing showed

Fig. 3. Power history of fuel pins in bundle 56504.

that all the 19 fuel pins of the bundle were intact, demonstrating that PHWR fuel pins can operate up to such high burn ups, without failure, under normal operating conditions.

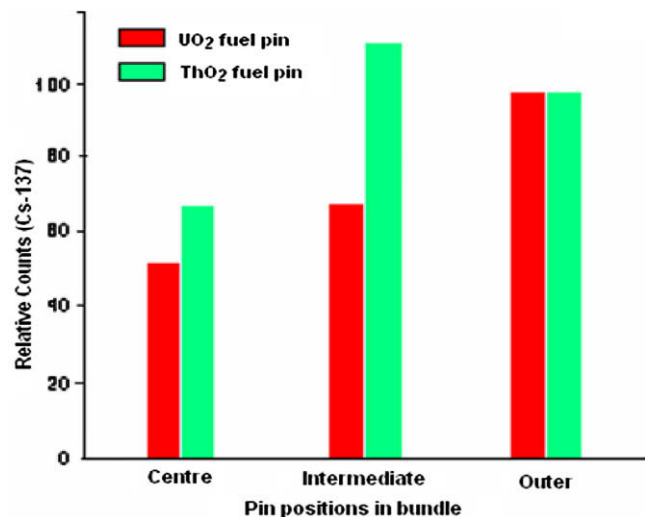
The  $\text{ThO}_2$  fuel bundle irradiated in KAPS to a burnup of 11000  $\text{MWd/t(Th)}$  did not show any defect or aberration, as revealed by the results from leak test and visual examination of the individual pins after dismantling the bundle. Puncture tests carried out on the individual pins did not indicate any fission gas release. However, the gamma scanning carried out on the central fuel pin and the pins from the intermediate and the outer rings revealed distinctive difference in the relative counts of  $\text{Cs}^{137}$  between 19-element  $\text{UO}_2$  bundle and the  $\text{ThO}_2$  bundle, as shown in Fig. 15(a–b). In the case of  $\text{UO}_2$  bundle the relative count of  $\text{Cs}^{137}$  monotonically increased from the central pin to the outer pin. However, in  $\text{ThO}_2$  bundle maximum count of  $\text{Cs}^{137}$  was noticed

Fig. 15. Relative  $\text{Cs}^{137}$  distribution between the centre, middle and outer pins in  $\text{UO}_2$  fuel and in  $\text{ThO}_2$  fuel.
