## Microstructural analysis of MTR fuel plates damaged by a coolant flow blockage

A. Leenaers\*, F. Joppen, S. Van den Berghe

SCK•CEN, Nuclear Materials Science Institute, Boeretang 200, B-2400 Mol, Belgium

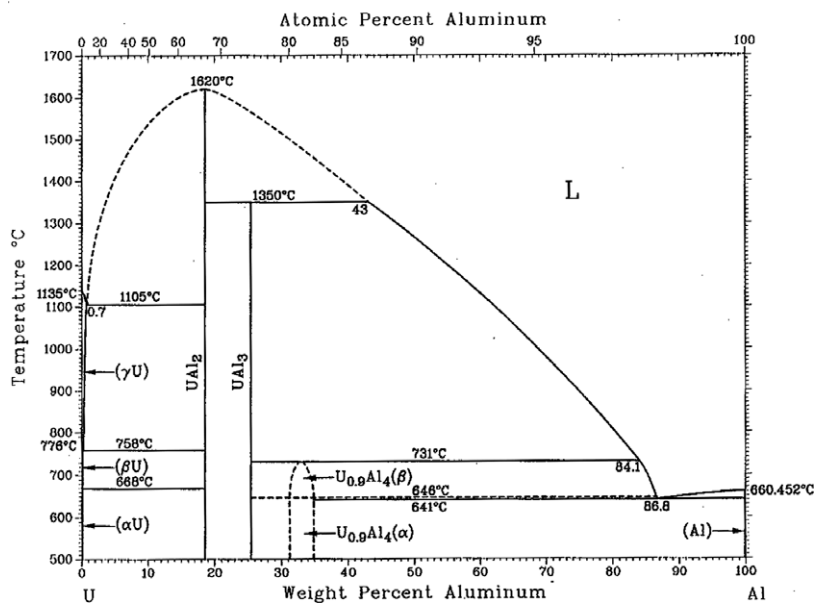
Fig. 9. Binary U–Al diagram [16].

Based on this information, the observed microstructure and the binary diagram (Fig. 9), it is possible to indicate the local temperatures in the different zones and samples.

More towards the center of the fuel plate,  $UAl_3$  dendrites are seen. At the extremities of these dendrites, eutectic droplets are observed (gray particles in Fig. 8e). These observations and the assumption that the average composition of the melt is around 72–75 wt% Al (supported by EDX and image analysis), indicate from the binary diagram (Fig. 9) that the temperature in this location must have reached at least 900–950 °C.
