The Erosion of a Cobalt-Chromium Alloy by Liquid Impact [and Discussion]

IX. The erosion of a cobalt–chromium alloy by liquid impact

BY J. B. MARRIOTT AND G. ROWDEN

The English Electric Co., Whetstone, nr Leicester

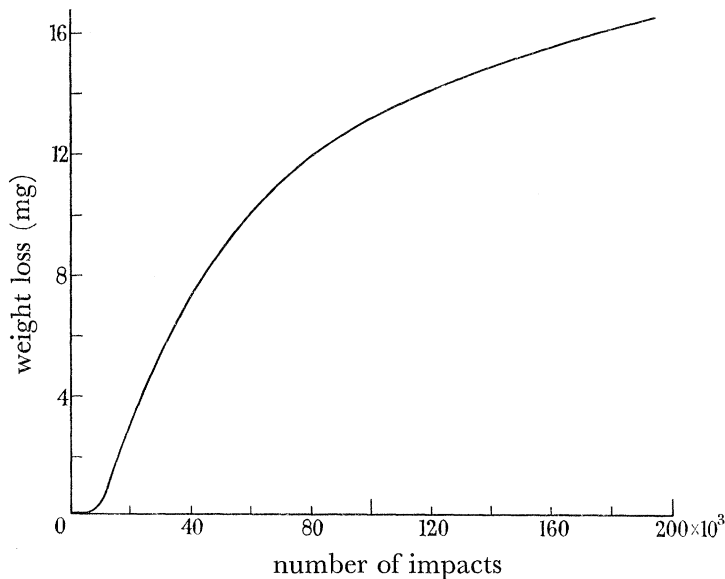
FIGURE 4. Typical erosion curve for Stellite 6.

During the test the specimens are removed periodically for examination and weighing. A graph can then be produced relating weight loss (reciprocal of erosion resistance) to number of impacts (running time). Testing is generally carried out at 1400 ft./s for a period of 200 000 impacts; a typical curve is shown in figure 4.

In order to study the effect of water jet impact loading on the surface of the material it was necessary to examine specimens which had not suffered extensive damage. This means that the specimens were in the ‘incubation period’ of figure 4, during which the weight loss is insignificant. Tests for this purpose were carried out at 1400 ft./s for exposures of 5000 to 12000 impacts. A wider range of exposures was also covered at 1030 ft./s to examine the changes in greater detail. The amount of damage after 70000 impacts at 1030 ft./s appeared to be similar to that found after 10000 impacts at 1400 ft./s.

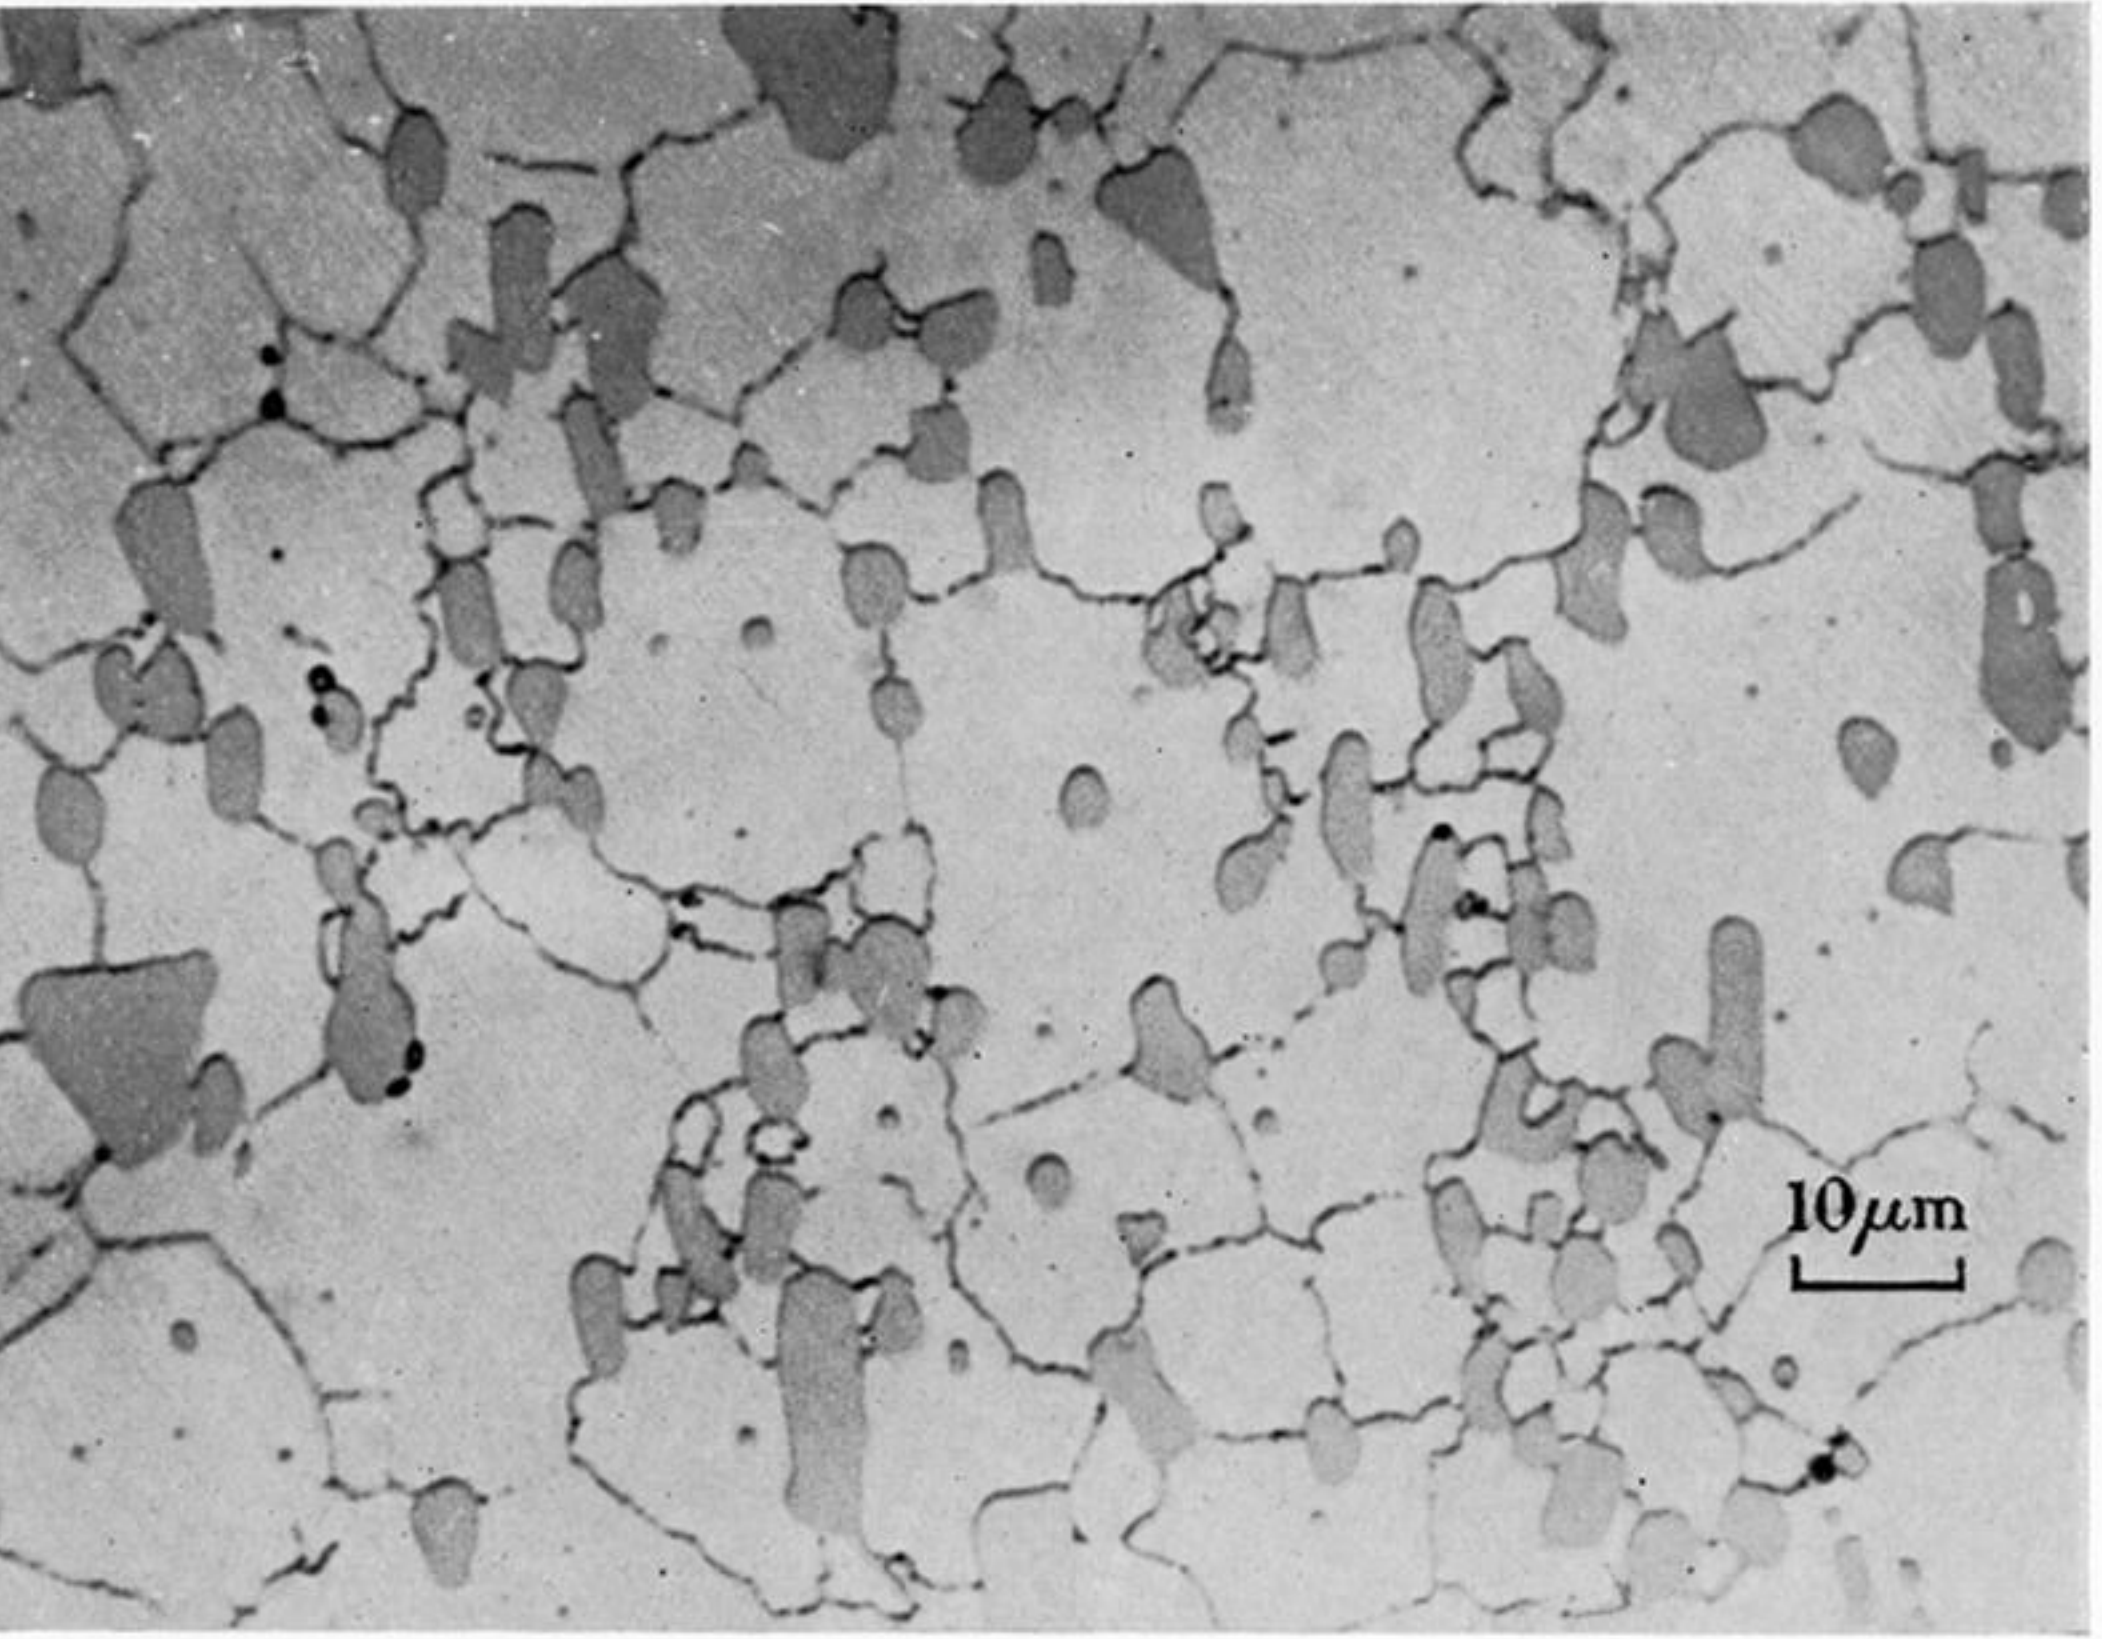
The overall erosion resistance of both forms is very similar but since the latter has a more uniform distribution of carbides (figure 6, plate 25), better homogeneity, and no shrinkage porosity, it was thought to be more suitable for a detailed metallographic study. The typical chemical analysis of both alloys is given in table 1.

The wrought alloy has an equiaxed fine grained structure in which elongated carbides, mainly WC and Cr_7C_3 , are present in a single phase matrix (figure 6, plate 25). Examination of the surface prior to test shows a dispersion of carbides approx. $7 \mu\text{m}$ diameter in the matrix (figure 7 (a)).

FIGURE 6. Typical structure Haynes alloy 6B (etched).
