XLI. *An Account of the Effects of Lightning in St. Bride's Church, Fleet-street, on the 18th of June 1764: In a Letter to Mr. Benjamin Wilson, F. R. S. from Edward Delaval Esq; F. R. S.*

Read June 28, 1764. **T**HE inclosed is an account of the effects of the lightning on the steeple and spire of St. Bride's church, with drawings [TAB. XIV. XV.] which very accurately express the parts damaged by it.

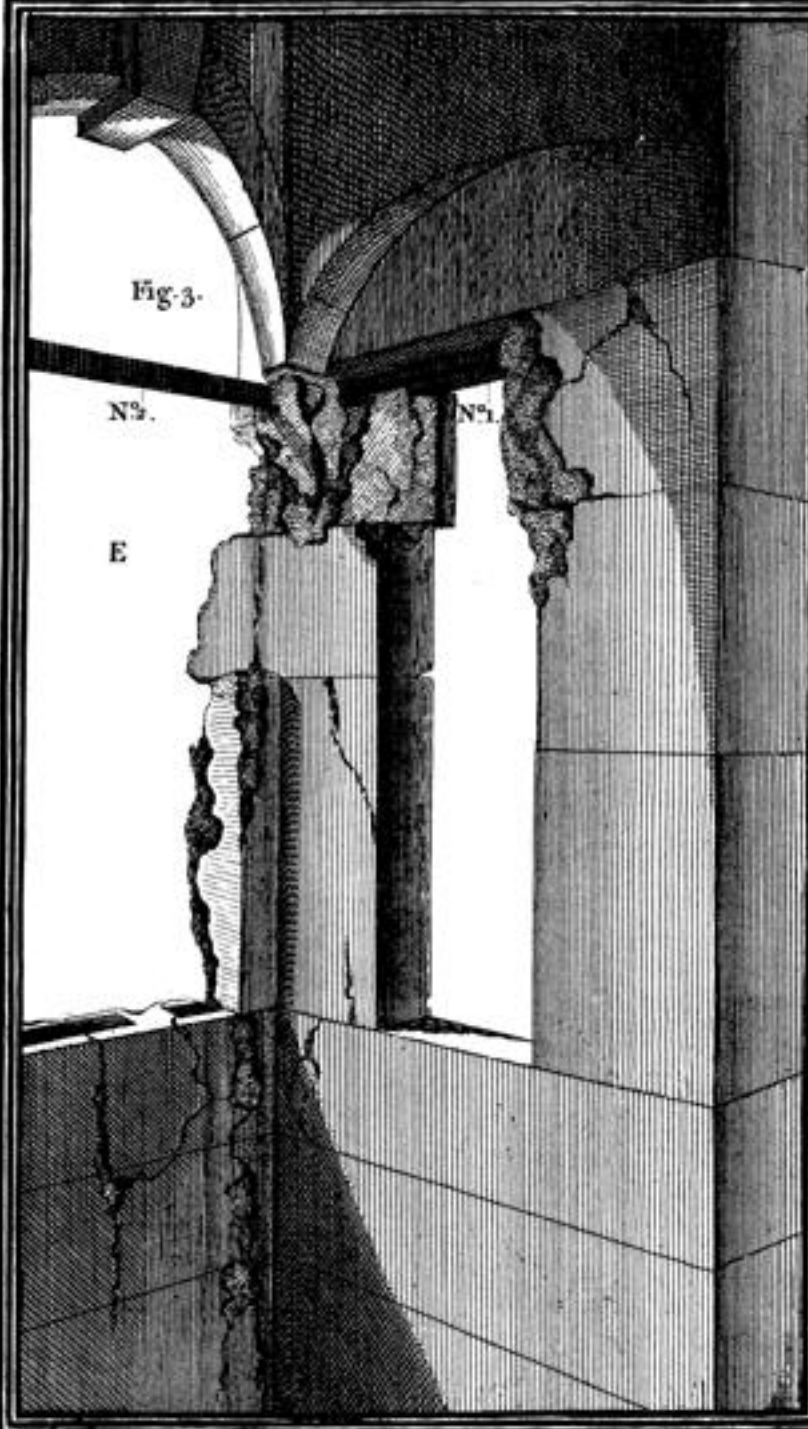
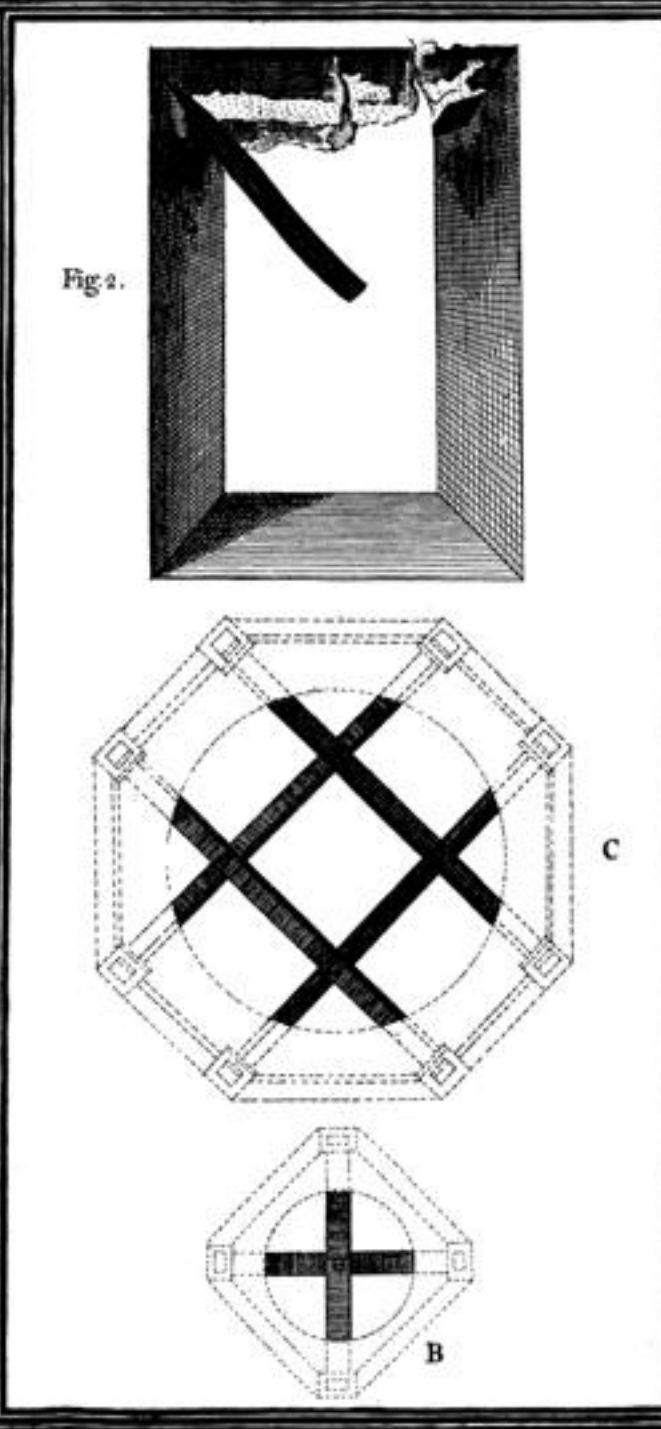
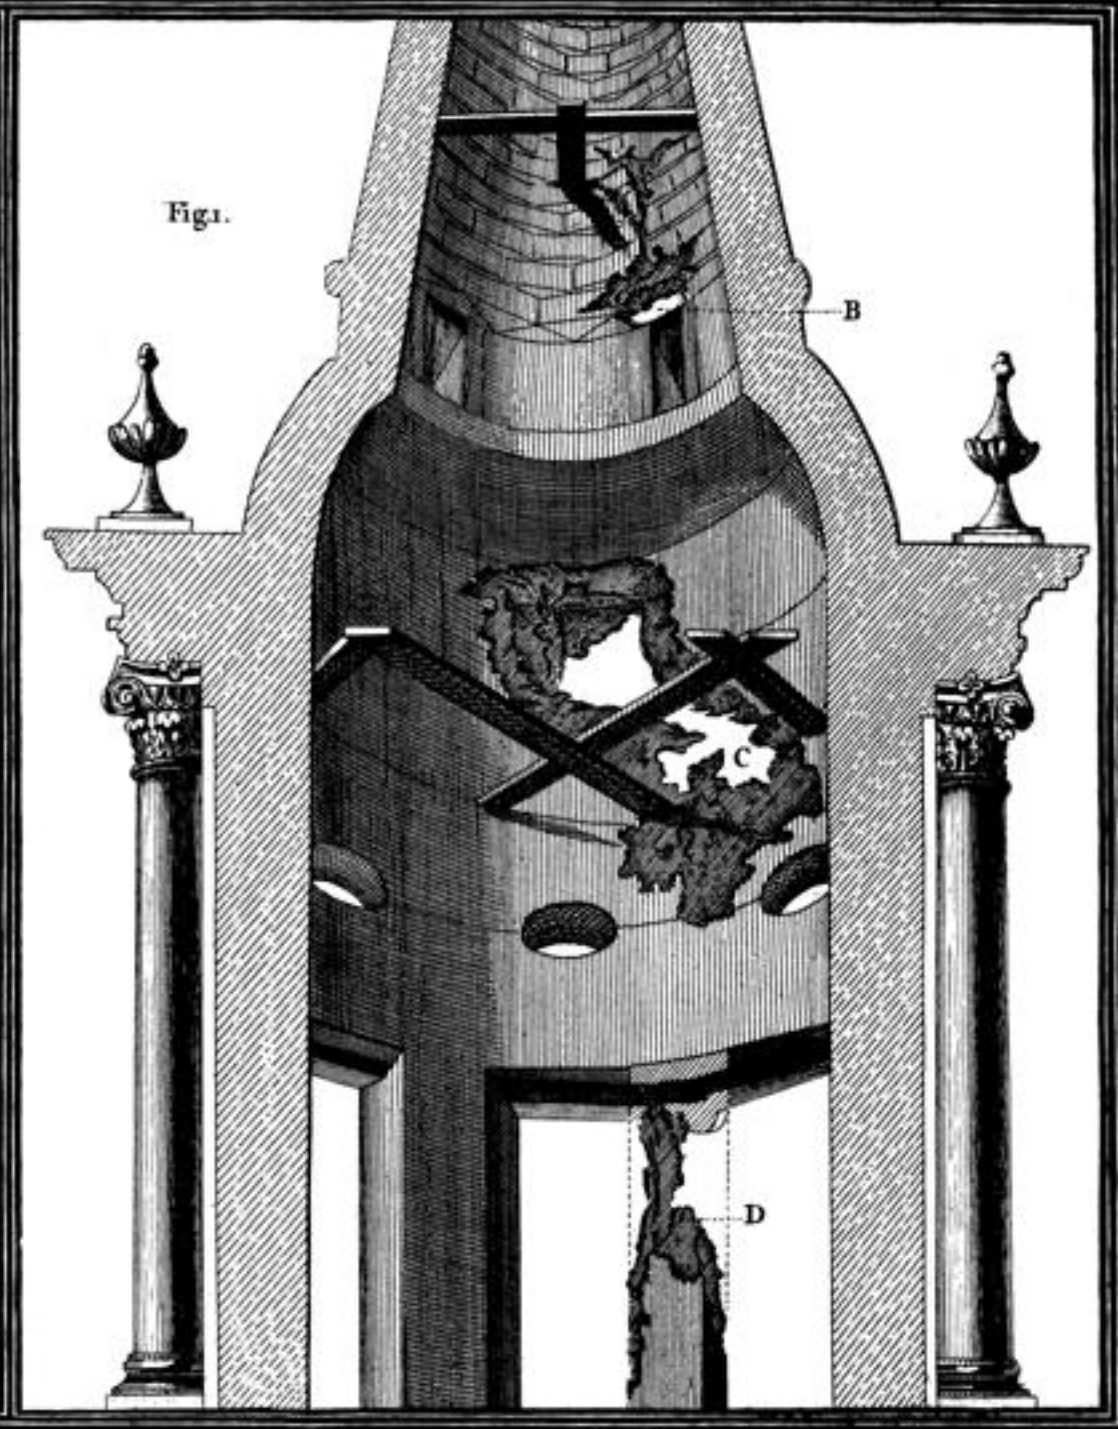
At this place the first marks of it are seen: at H the top of the copper cross, which is the highest part of the building, the gilding is by the explosion partly torn off and partly discoloured, so as to differ remarkably from the rest of the cross where the gilding is very well preserved. Some small pieces of solder are melted; and all this part appears as if it had been exposed to the fire.

At each of the angles of the metal, the stone on which it rested is cracked, which probably was occasioned by the lightning issuing with greater freedom from those parts, than from the flat surface.

The next stroke is about four feet below: at this place four iron bars lie horizontally across the spire, and are tied together by chain bars which are inclosed in the stonework: where the end of one of the cross bars is inserted in the stone, the lightning has burst open the hole described at C, and, when the same is viewed at the outside, a great part of the cornice appears to be broken off.

At D, where the two iron bars serving to support the top of the windows meet and are joined together, the lightning accumulated in them has broken off the pier by which they were inclosed.

At F, the next arch lying immediately under the last mentioned one, an iron was inclosed in the stone in the same manner as the bar at N°. 1. The stone is torn off from this iron exactly in the same manner as at N°. 1: but the damage has not reached much further than the stone which was contiguous to and covered this bar. At the bottom of this arch the fill stone, which covered some cramps of iron, is torn off from it's place.

At G, the next arch under this, the force of the lightning seems to have been much diminished, a small part of one stone only being broken.

From the wall at the West side of the South window of the belfry some stones are thrown down: one chalky stone in particular is reduced into an impalpable powder, and the wall under the West window is almost covered with the powder: this stroke seems to have been directed towards the bells one of which is very near the place damaged: the bells have not been examined; nor can they, as I am informed, without danger of shaking the spire by their motion.

In every part that is damaged, the lightning has acted as an elastic fluid, endeavouring to expand itself where it was accumulated in the metal: and the effects are exactly similar to those which would have been produced by gun-powder pent up in the same places, and exploded. Amongst many other stones thrown to a considerable distance by these explosions, one weighing above seventy pounds was removed fifty yards Eastward from the steeple, where it fell through the roof of a house.

From several observations which I made on this occasion, such a communication seems necessary in buildings of this form. The iron bars, which were fixed in the stonework of the East arches were struck by the lightning, while those in the arches fronting them on the West side of the same story remained untouched by it. So that I do not apprehend, that a conductor communicating with the West arches only, would have preserved the opposite ones from the damage which they have suffered.

I think, a conductor of metal less than six or eight inches in breadth, and a quarter of an inch in thickness (or an equal quantity of metal in any other form that may be found more convenient) cannot with safety be depended on, where buildings are exposed to the reception of so great a quantity of lightning. These are the only points in which I have ventured to differ from Dr. Franklyn.
