XXII. *Proceedings relative to the Accident by Lightning at Heckingham.*

Report of the Committee.

PURSUANT to your resolution, appointing us a committee to examine the House of Industry at Heckingham in Norfolk, which had been struck by lightning although it was armed with conductors, we arrived there on the 21st of January. Seven months had then elapsed since the accident, yet we had the satisfaction to learn, that no material changes had been made in the conductors or the building in that period; some laths that had been burnt, some bricks and pantiles which had been damaged or thrown down, were replaced; but we found means to procure distinct information of those repairs from the workmen who had been employed to execute them. In order to communicate a clear idea of the accident, it will be necessary to premise a general account of the building; then to represent the manner in which the conductors were applied; and, lastly, to describe the stroke of lightning, with its effects.

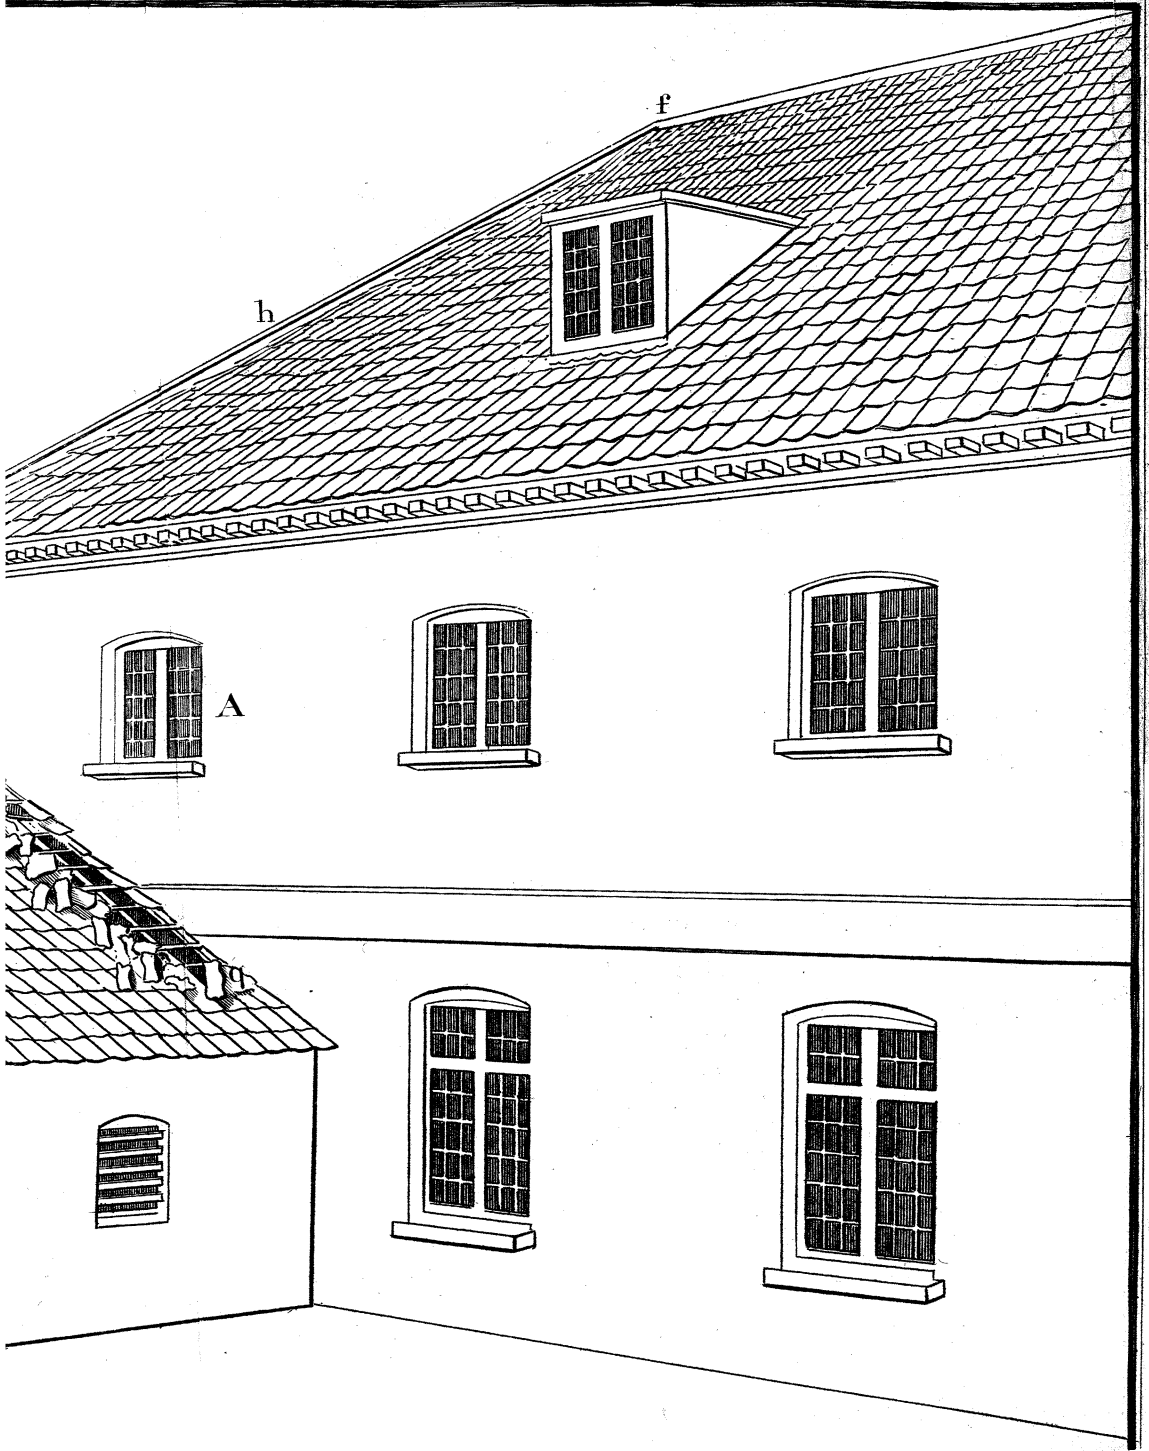
Fig. II.

As both extremities of the hip, therefore, were, in some degree at least, affected by the lightning, we proceeded to ascertain their distances from the nearest conductor, which was that affixed to the chimney E (fig. 2. and 4.). Having determined the necessary measures, and calculated the hypotenuse, the distance from the point of the conductor to the beginning of the lead on the top of the hip (*e*, fig. 4.) came out 42 feet and a quarter; thence to the bend where we found the marks of fusion (from *e* to *f*, fig. 4.) was five or six inches more; and as the hip measured about 27 feet in length, the distance from the conductor to the bottom of the hip (*g*, fig. 4.) may be called 69 feet. From the top or bottom of the hip, to the nearest part of the conductor as it ran downward, the distances were not a foot less than these measures. We then took down the uppermost rod of the conductor, and carefully examined it, especially at the point, and at the hook and screws by which it had been joined to the second rod; but could no where discover the least mark of fusion or other injury. At the bottom of this conductor, however, where, having joined that from the chimney

*SOUTH WEST VIEW of the EAST WING and part of the CENTER RANGE
shewing the junction of the two Conductors that were nearest the Stable Lean-to.*
