# Adhesive Bonding to Galvanized Steel

## II. Substrate Chemistry, Morphology and Bond Failure Analysis

ROBERT T. FOISTER

*General Motors Research Laboratories, Warren, Michigan 48090-9055, U.S.A.*

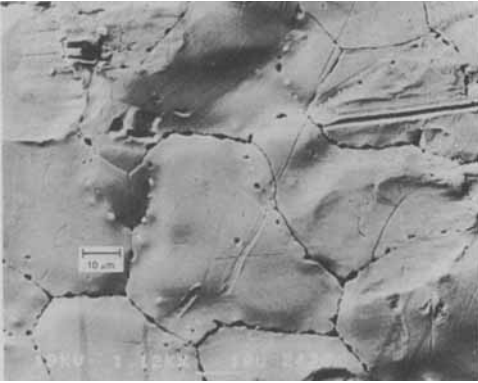
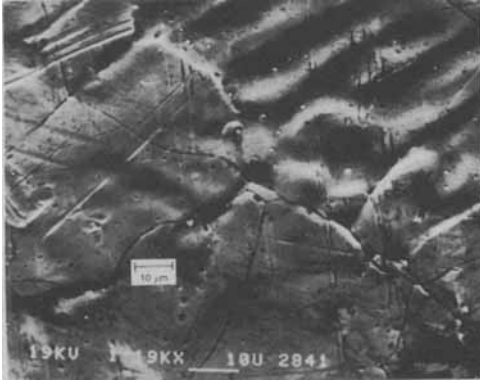
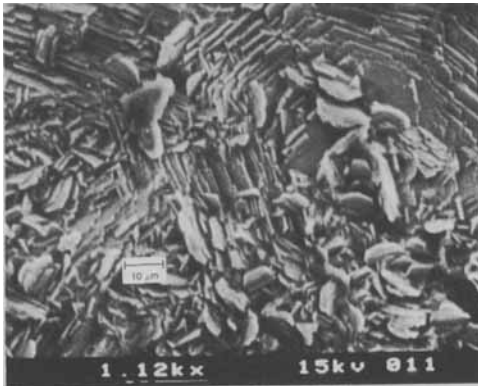
**FIGURE 1** Surface morphologies of bonding substrates.

In distinct contrast, the electroplated coatings are characterized by oxides whose major component is Zn, present in crystal form (Figure 1C). Table IV lists Zn at a relative atomic percent of about sixty for the three electroplated surfaces, while the highest corresponding value for a hot-dipped surface is forty-one ("Ultra-smooth A"), with the other hot-dipped samples showing less than thirty-five percent Zn. In all cases, the hot-dipped surfaces showed amounts of Al and/or Ca, Mg, or Pb comparable to the amount of Zn.

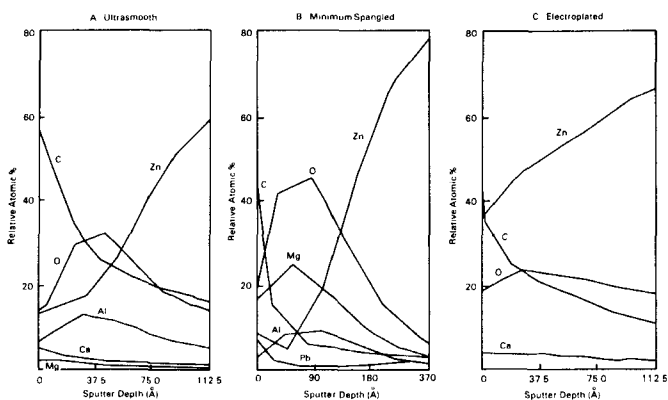
FIGURE 2 Auger depth profiles of bonding substrates.

Ca, and Mg in the surface, but Zn is still the major constituent. In contrast Figure 2B indicates that the minimum spangled substrate contains Mg as a major constituent, followed by Zn, Al, and Pb. Although in both cases the relative atomic percent of Zn in the hot-dipped coating increases with sputter depth, the actual bonding surface is chemically heterogeneous. Finally, and in contrast, the surface of the electroplated substrate (Figure 2C) contains primarily Zn, with small amounts of Ca.

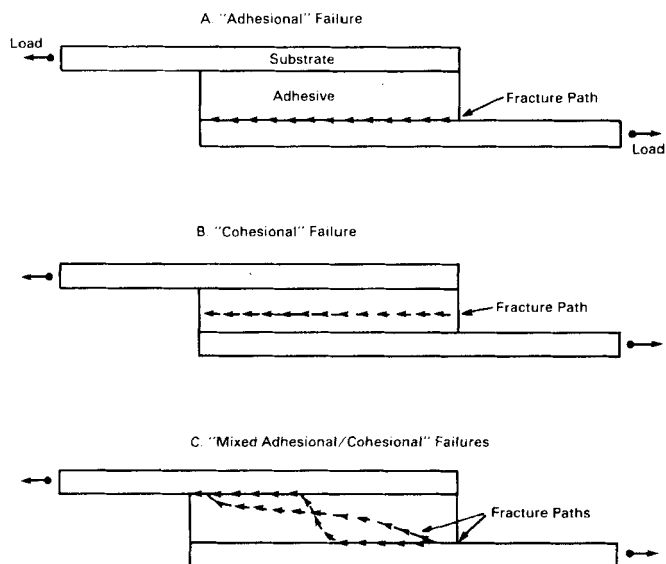
FIGURE 3 Schematic illustration of fracture paths producing (a) adhesional, (b) cohesional, and (c) mixed adhesional/cohesional failures in lap shear samples.

Figure 3 illustrates, in schematic form, the terminology for adhesional, cohesional and mixed adhesional/cohesional failures. Within the mixed adhesional/cohesional category, a crack may propagate initially at the adhesive/substrate interface, but may be diverted into the adhesive after it has travelled some distance along its initial path. Various degrees of mixed failure result from different distances of initial propagation, as shown in Figure 3C.

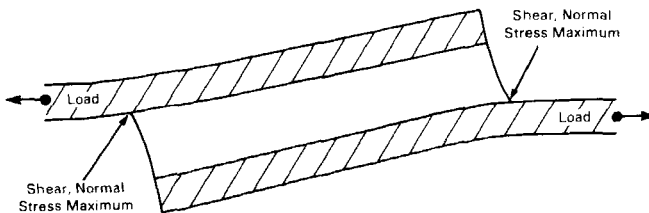
It is well known and documented<sup>9</sup> that considerable normal stresses, with resulting rotation of the bonded area, can occur in stressed single lap shear joints. The magnitude of these normal stresses depends primarily on substrate stiffness. It is essential to keep in mind the actual nature of the stress distribution in the single lap shear configuration when attempting to correlate strengths and failure modes. Figure 4 illustrates schematically the essential features of this stress distribution. These are (1) normal (or “peel”) stress distributions accompanying bond rotation, and (2) normal and shear stress concentrations at the indicated bond edges. Recalling Figure 3C, which illustrates a mixed adhesional/cohesion-al failure mode, these areas of shear and normal stress concentration will act as likely initiation sites for bond failure.

FIGURE 4 Schematic of lap shear sample exhibiting rotation (bending) and associated normal stress concentrations.

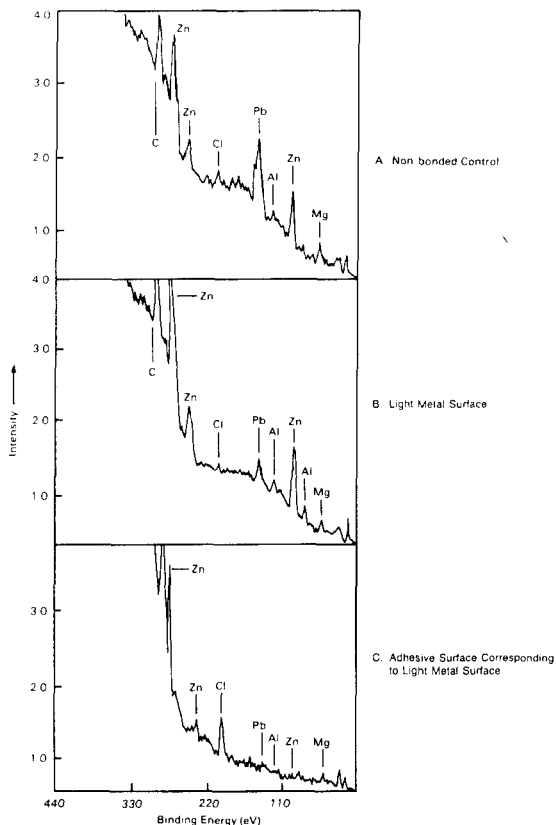
It is immediately obvious from Figures 18 and 19 that both “adhesive” areas contain residual Zn, so that the fracture path has included portions of the galvanized surface. However, Figures 18 and 19 also indicate that the fracture is much nearer the oxide/adhesive interface for the “light” area, than the “dark” area. Note that the intensities of Zn, Pb, Al and Mg peaks for the metal side of the light area (Figure 18B) more closely approximate those for the control surface (Figure 18A) than do those for the metal side of the dark area (Figure 19B). In fact, the adhesive side of the dark area (Figure 19C) more closely resembles the control non-bonded surface (compare Figure 18C, where there is little evidence of metals other than Zn). Table VI, which gives a breakdown of

FIGURE 18 ESCA spectra for determination of EA2/ultrasmooth galvanized failure locus: "light" adhesive area.

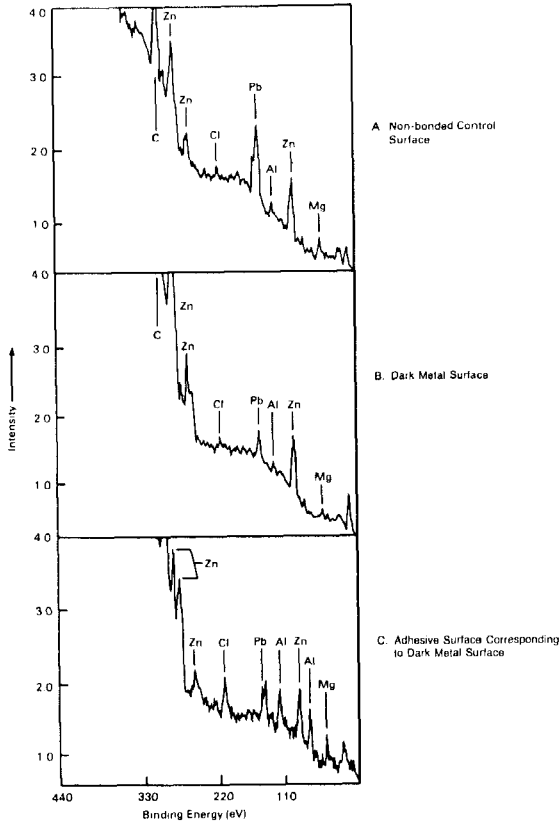
FIGURE 19 ESCA spectra for determination of EA2/ultrasmooth galvanized failure locus: "dark" adhesive area.

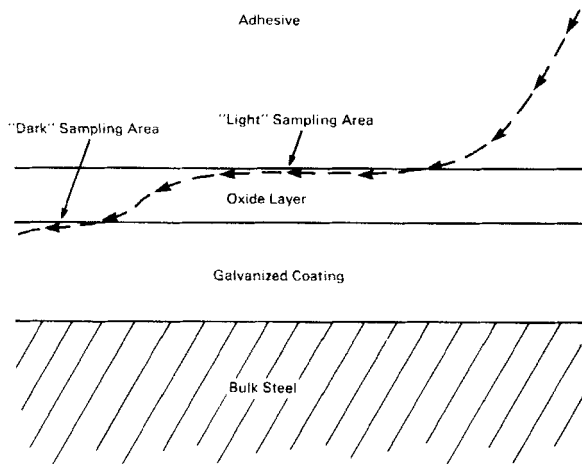
Based on the ESCA analysis, Figure 20 shows the probable locus of failure for the EA2/ultrasmooth sample. The path obviously included significant portions of the oxide layer before being diverted

into the adhesive. This accords with the conclusions reached by Commerçon and Wightman.<sup>11</sup> It is therefore obvious that the mechanical strength of the galvanized surface can influence bond integrity. Similar conclusions have been reached for other systems.<sup>2</sup>

FIGURE 20 Schematic interpretation of failure locus from ESCA spectra. Arrows denote failure path.

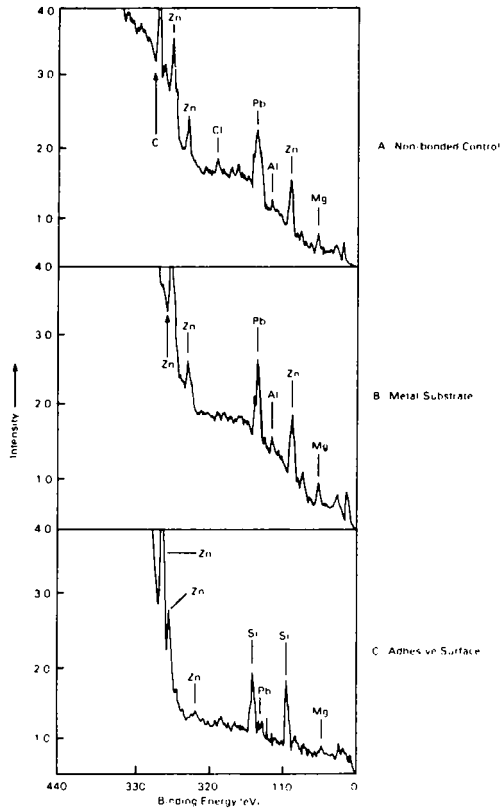
Figure 21 confirms that again the locus of bond failure has included the substrate oxide layer, since the spectrum for the adhesive portion (Figure 21C) contains peaks for Zn, as well as Pb and Mg. The Si peaks in Figure 21C are most likely due to filler in the adhesive.

Thus the lower strengths for the two-part epoxy (EA2) (~6400 kPa) as well as the higher strengths for the one-part epoxy (H1989) (~15,100 kPa) both reflect failure initiation in the oxide region. In the case of EA2, however, the stress in the bond was

FIGURE 21 ESCA spectra for determination of H1989/ultrasmooth galvanized failure locus.
