To cite this Article Hemminger, Carol S.(1994) 'Interfacial Chemistry of an Aluminum-to-EPDM Rubber Bonding System', *The Journal of Adhesion*, 47: 1, 51 – 64

Interfacial Chemistry of an Aluminum-to-EPDM Rubber Bonding System*

CAROL S. HEMMINGER**

The Aerospace Corporation El Segundo, California 90245, USA

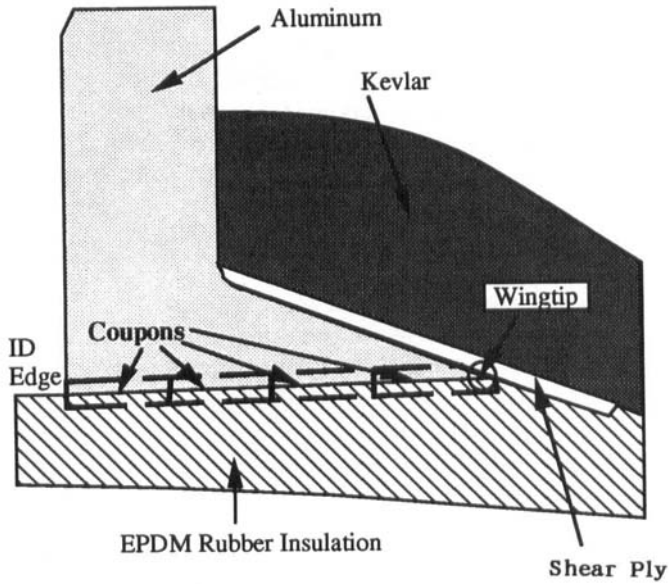
FIGURE 1 Schematic of polar boss slice, showing coupons for temperature-stress rupture.

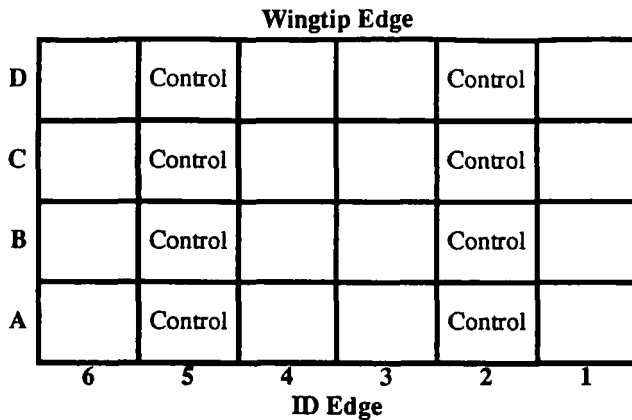
Six adjacent radial strips from the forward polar boss of motor case 2 (chosen for minimal bondline corrosion) were cut into a total of 24 coupons for the high-humidity test. Coupons were designated by column (strips 1 through 6) and row (A through D) notation, as seen schematically in Figure 2. The second and fifth radial strips were designated as the controls. The other 16 coupons were exposed to 100% relative humidity (RH) at 80° to 85°C. The coupons were placed on a stainless steel mesh on top of the ceramic tray in a glass desiccator. The bottom of the desiccator served as a reservoir for water. The sealed desiccator was placed in a temperature-controlled oven. Samples were removed after 1, 2, 4, 8, 14, 23, 32, 63, and 99 days by opening the oven, then the desiccator. The temperature in the furnace restabilized in about 30 min after

FIGURE 2 Schematic of forward polar boss test coupons from SRM case 2. Coupons were designated by column and row notation. The second and fifth radial strips were designated as the controls.
