THE USE AND EXTENDED LIFETIMES OF MICROFURNACES FOR THERMOGRAVIMETRY. PART II. REPAIR OF BROKEN FURNACE STEMS

C.M. EARNEST and DWIGHT KINZER

Department of Chemistry, Berry College, Mt. Berry Station, Rome, Georgia 30149 (U.S.A.)

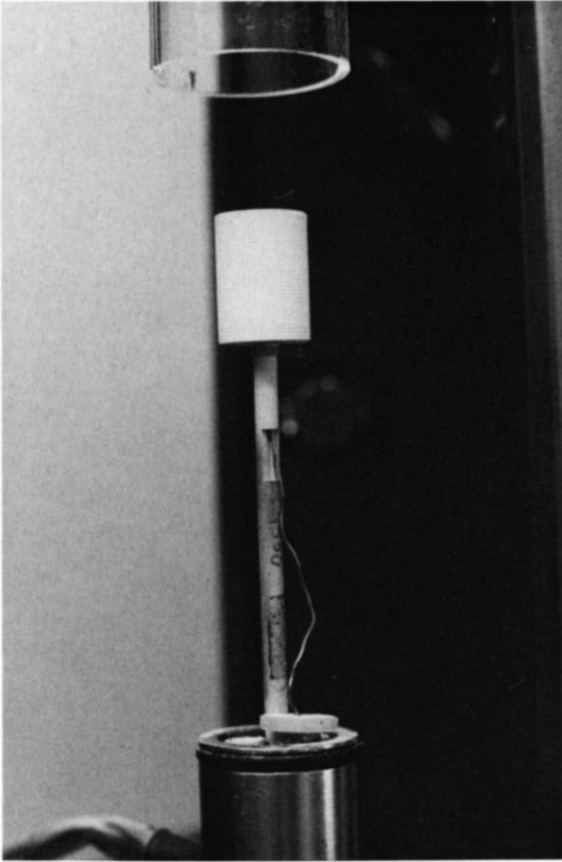
Fig. 3. TG microfurnace and TG furnace tube (above furnace) after execution of the separation procedure.

Some operators prefer to simply remove the furnace tube by giving it an upward pull while the furnace is in the "down" position. This can be achieved if the O-ring at the base of the furnace tube is sufficiently loose (this condition is often achieved by removing and stretching the O-ring) to allow the forced separation of the Pyrex tube from the furnace-support assembly. Unfortunately, on initial installation, the O-ring is meant to be vacuum tight and, hence, is strongly held by the furnace-support assembly. In many cases, when sufficient force is applied, the furnace tube is finally pulled away in something less than a completely vertical manner. This can cause the furnace tube to intersect the stand-up microfurnace, usually resulting in damage to the furnace stem. This is the most frequent cause of furnace-stem fracture or dislocation but some operators have managed to achieve the same result when using the previous method recommended by the user's manual [2]. Once the supporting mullite stem is damaged and the furnace does not stand upright in a near vertical manner, the sample pan and stirrup cannot be positioned into the small furnace by a vertical wire. Hence, the microfurnace, even though it will still operate properly as a heating device, is rendered useless for the purpose of performing thermogravimetry.
