*TB 1-1520-210-30-01

DEPARTMENT OF THE ARMY TECHNICAL BULLETIN

MANDATORY RECURRING INSPECTION OF TAIL BOOM VERTICAL FIN SPAR ASSEMBLY FOR ALL UH-1 SERIES AIRCRAFT

Headquarters, Department of the Army, Washington, D. C.
4 November 2005

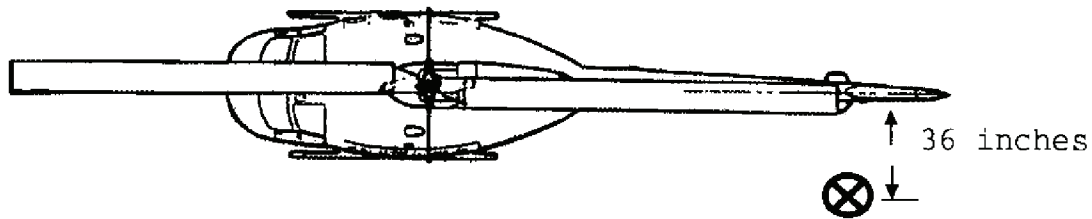
Figure 5: X-ray Tube Head Position

Tubehead Position for Exposure #1 and #2

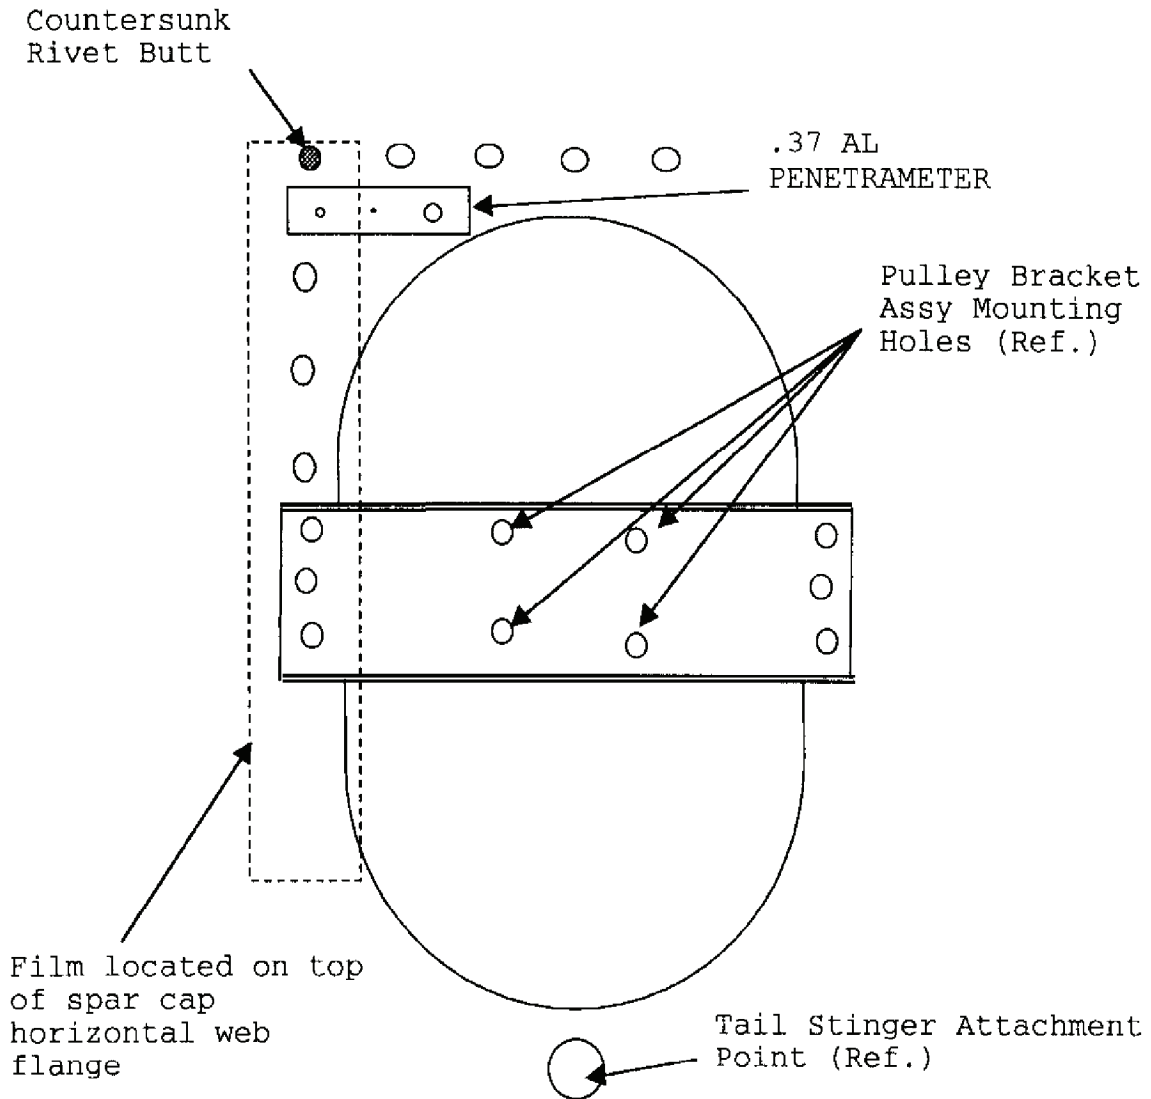
Figure 7: Radiographic Exposure #3

View looking forward at canted bulkhead through inspection panels, Item 124, Figure 16, TM 55-1520-210-23-P1

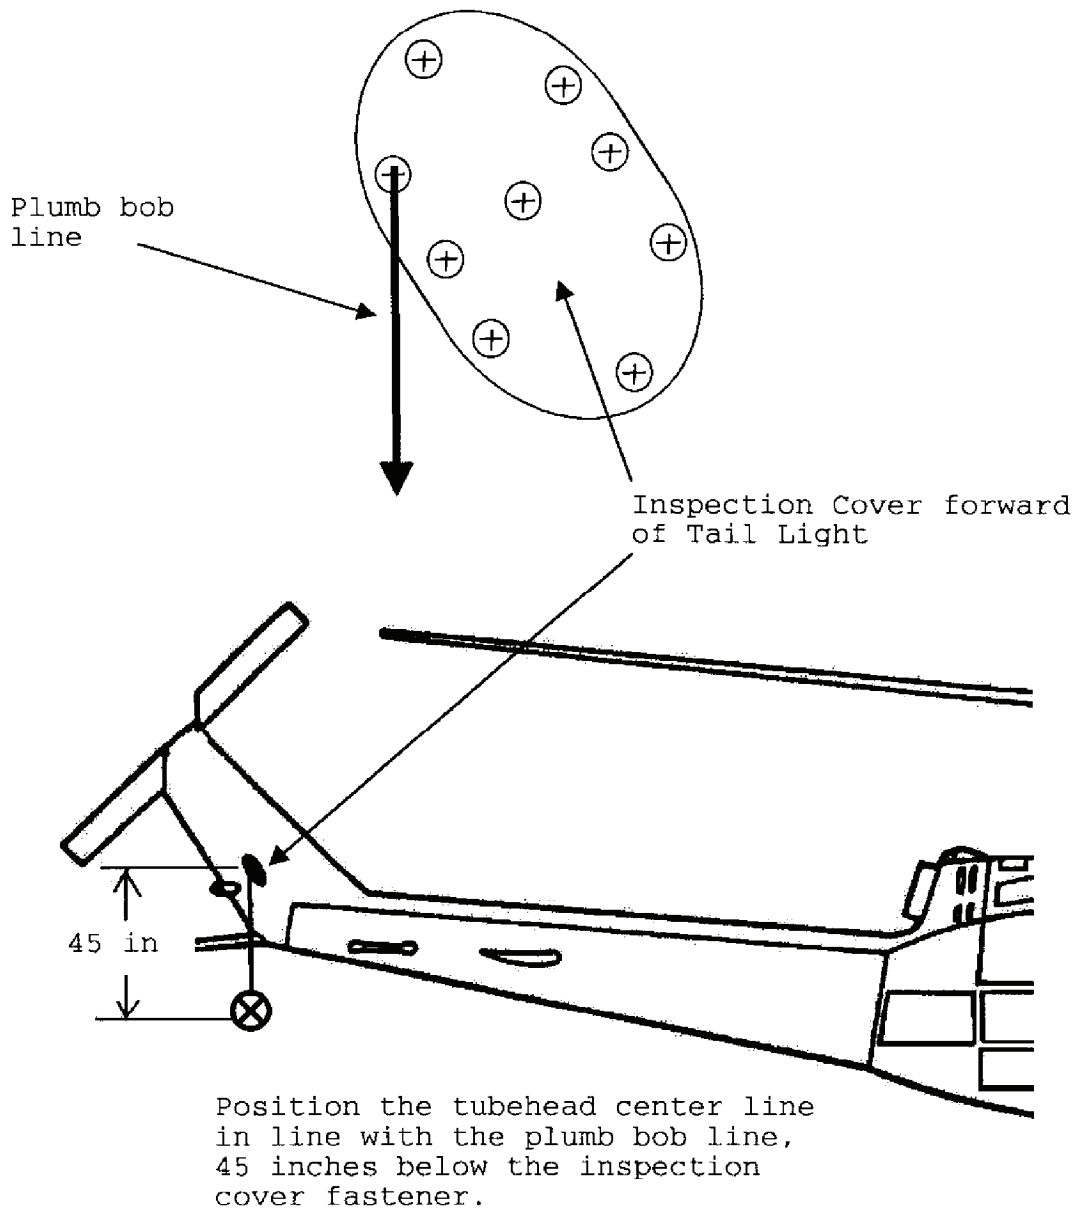
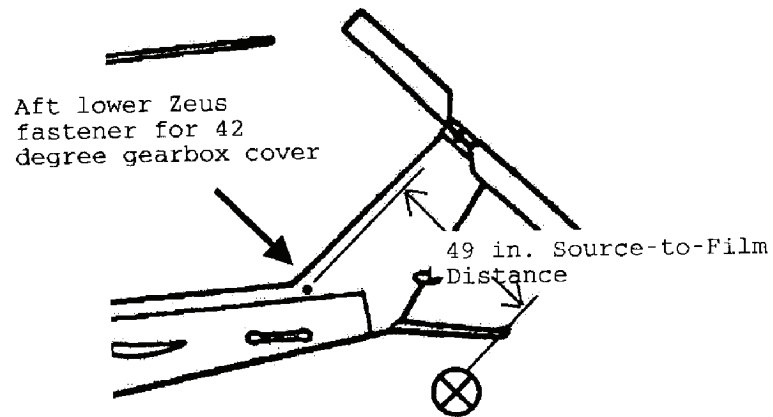
Figure 8a: X-ray Tube Head Position for Exposure #3

Positioning the tube head in line with the plumb bob achieves a 49 inch source-to-film distance, measured from the 42 degree gearbox cover aft, left hand, lower Zeus fastener receptacle to the center of the x-ray tube head.
