OCAMA AIRMUNITIONS LETTER
NO. 136-11-56C

SUBJECT: Advance Explosive Ordnance Disposal Technical Information

SUMMARY OF NUCLEAR WEAPONS INCIDENTS (AF FORM 1058) AND
RELATED PROBLEMS JUNE 1960

2. This summary includes the incident at McGuire AFB, New Jersey, on 7 June 1960. This incident will hereafter be referred to as NWI-60-1.

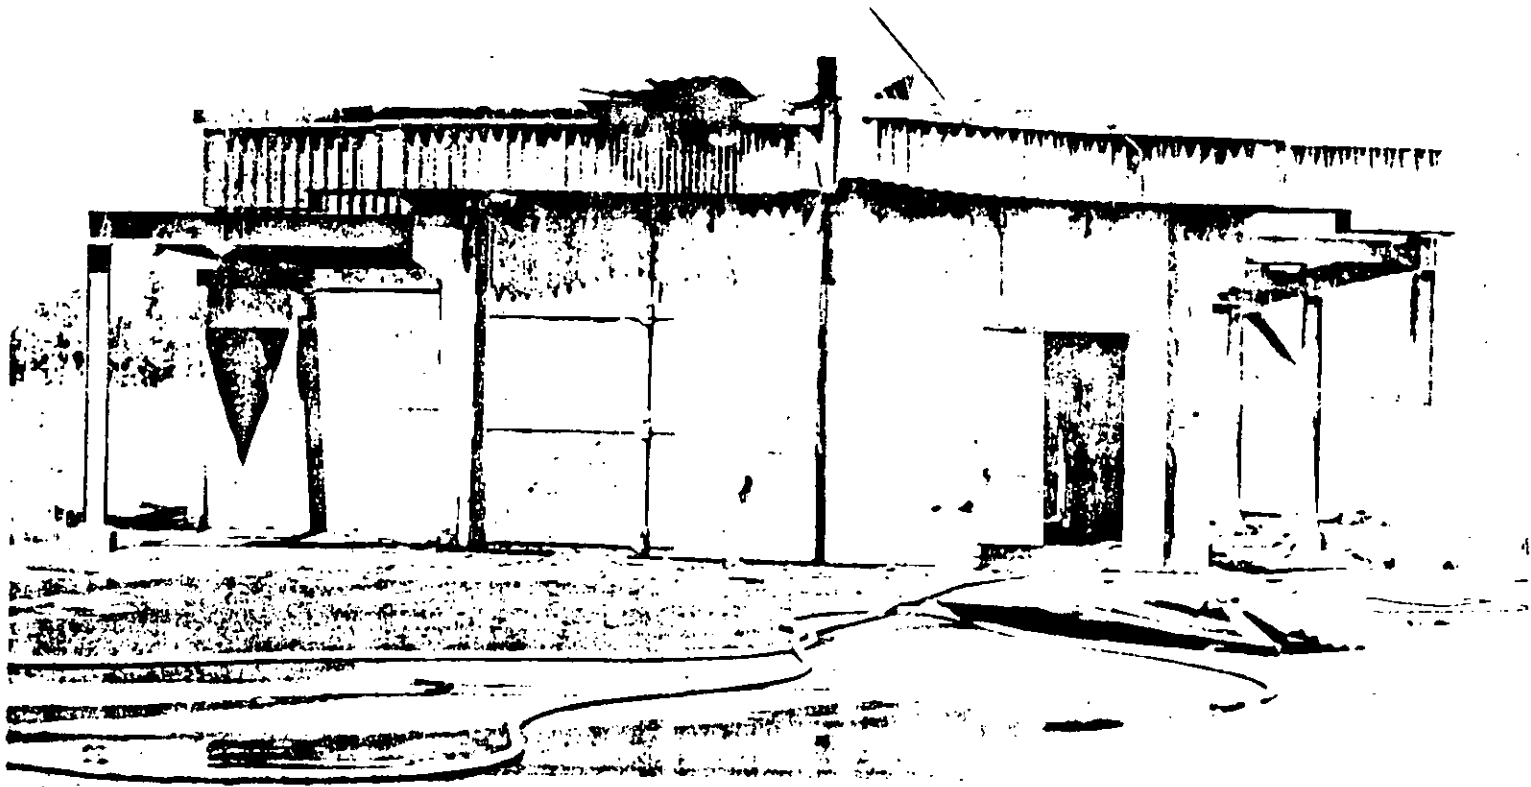
(9) Note Figures 3, 4, 5, 6, 7, 8, 9, 10, 11, 12, 13, 14, 15, 16, 17, 18, 19, 20, 21, 22 for extent of damage incurred at this incident.
