**AIRCRAFT
ACCIDENT INVESTIGATION BOARD
REPORT**

**US ARMY UH-60
BLACK HAWK HELICOPTERS
87-26000 AND 88-26060**

TECHNICAL REPORT F-15 MAINTENANCE

Aircraft Evaluated: F-15C, Tail Number 79-0025

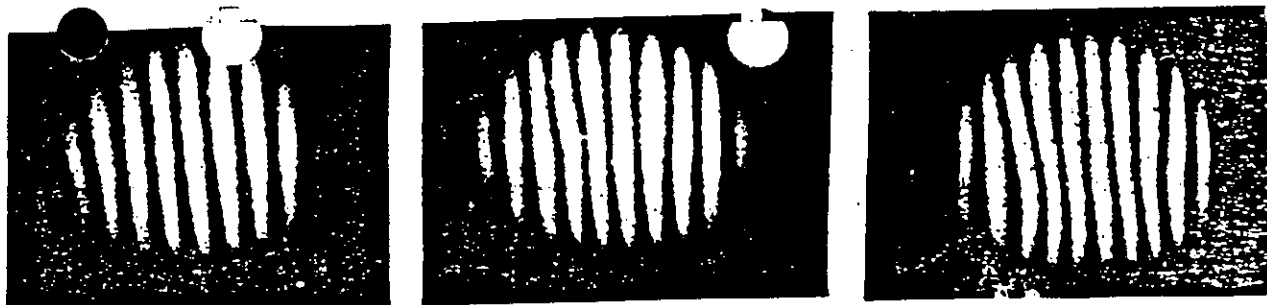
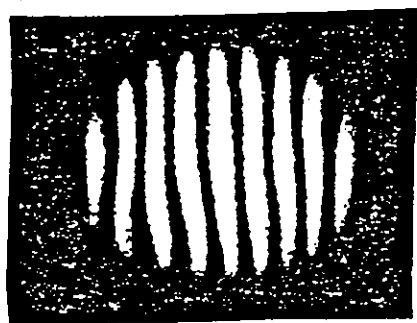
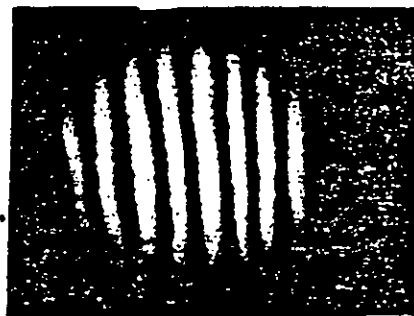
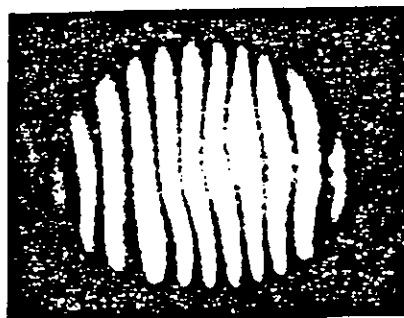
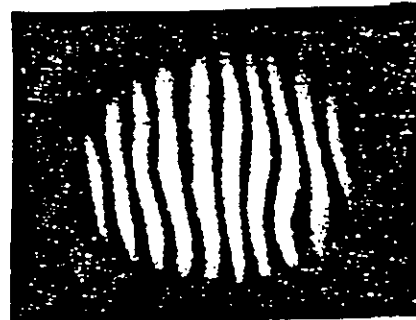
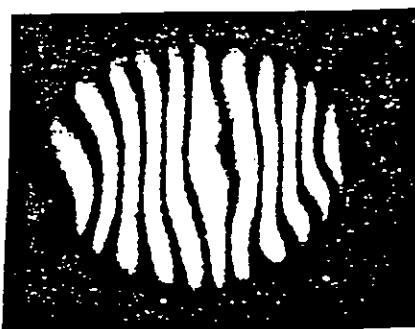
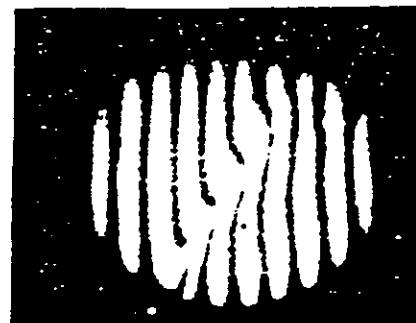
Figure 7. Examples of acceptable (1-5) and unacceptable (6-9) shearing interferometric optical distortion patterns as stated in MIL-V-43511C.

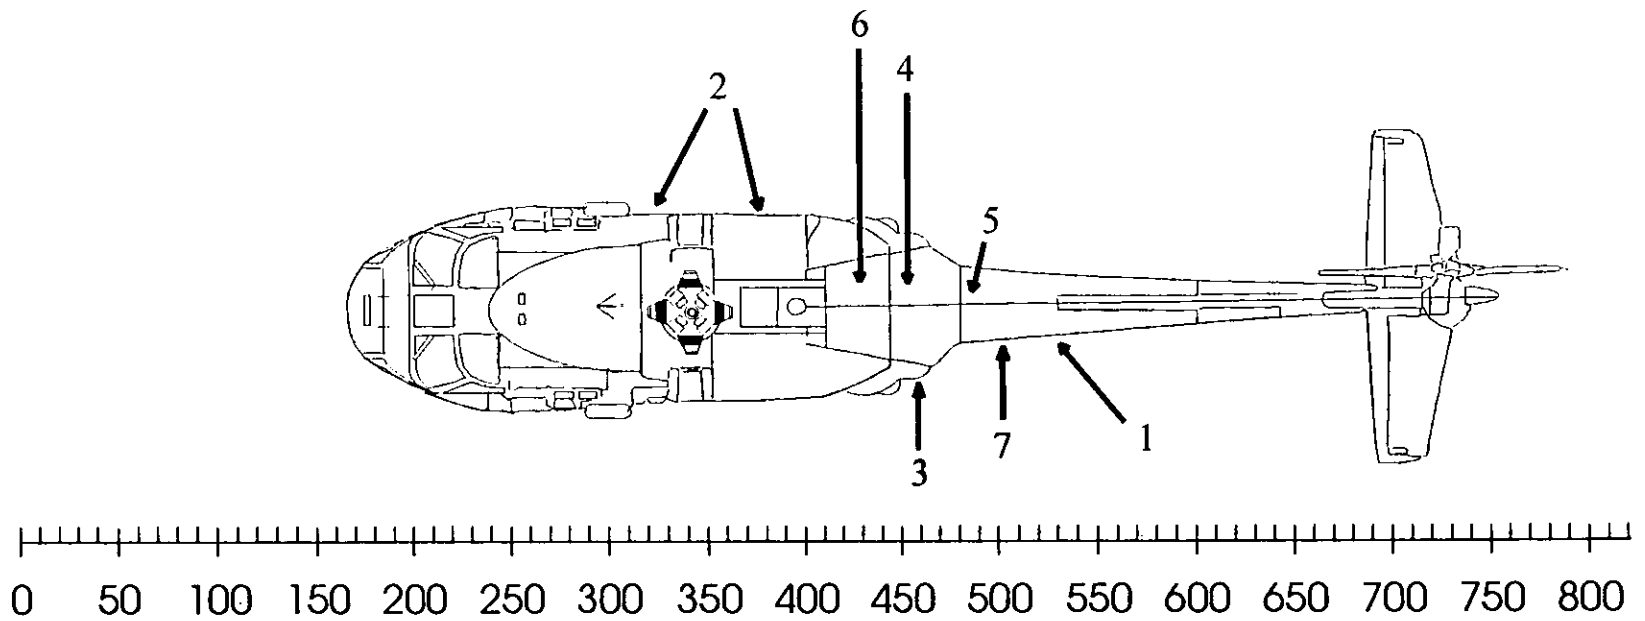
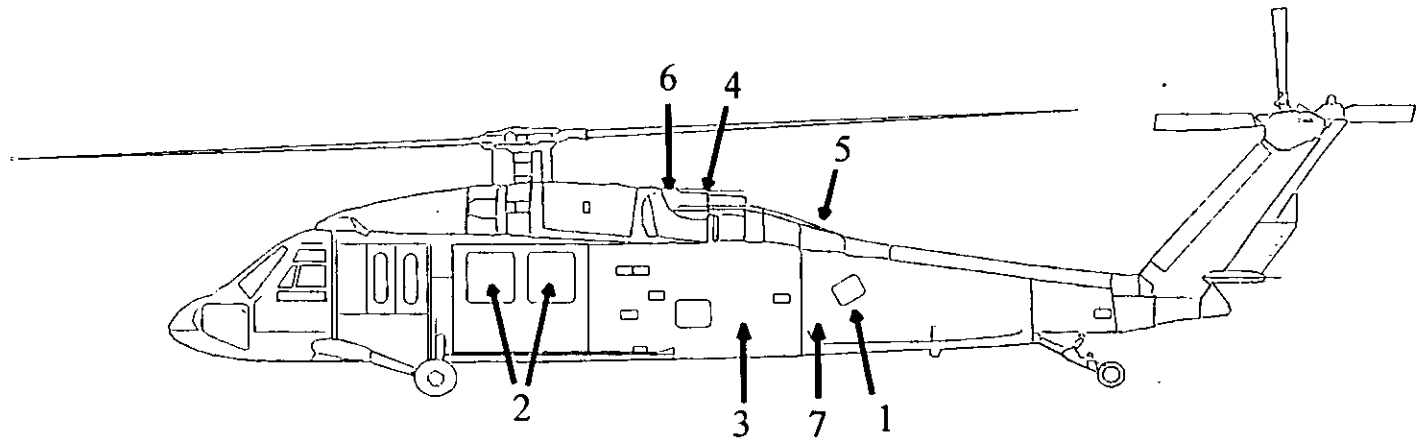
DIAGRAM 5

**AIRCRAFT COMPONENT LOCATIONS
TAIL NO. 87-26000**

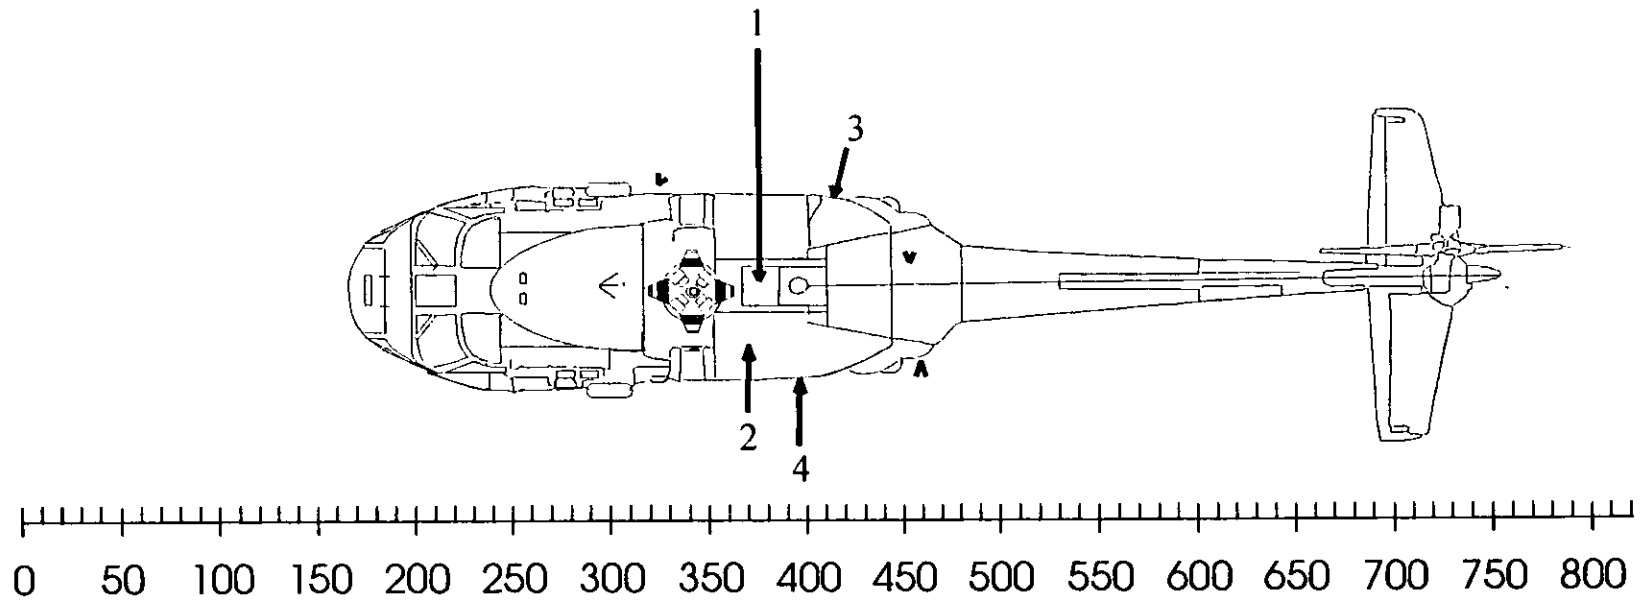
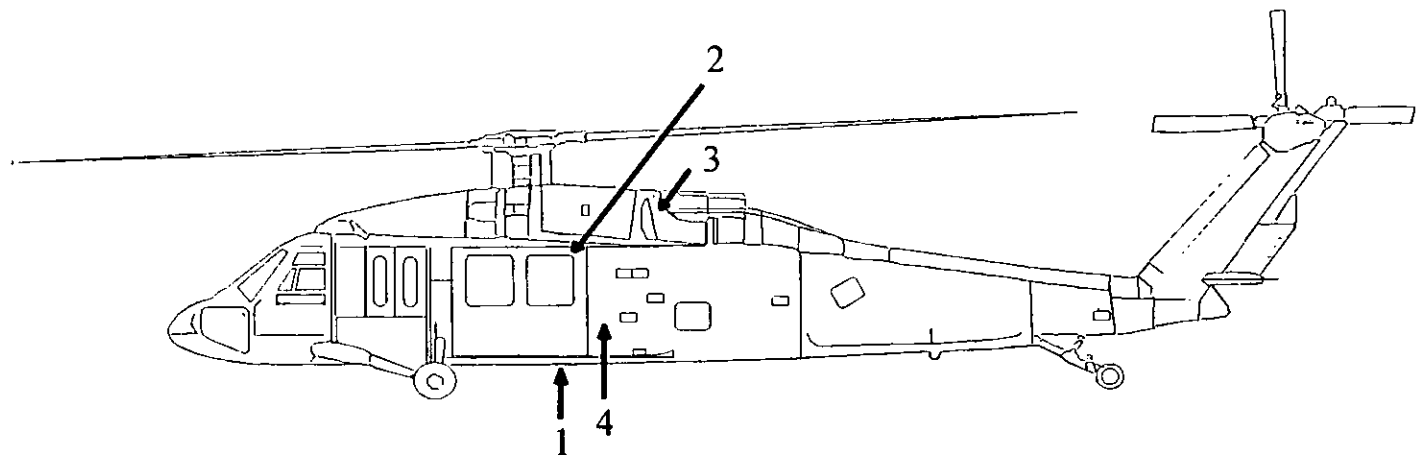
DIAGRAM 9

**AIRCRAFT COMPONENT LOCATIONS
TAIL NO. 87-26060**
