**AIRCRAFT
ACCIDENT INVESTIGATION BOARD
REPORT**

**US ARMY UH-60
BLACK HAWK HELICOPTERS
87-26000 AND 88-26060**

TECHNICAL REPORT F-15 MAINTENANCE

Aircraft Evaluated: F-15C, Tail Number 79-0025

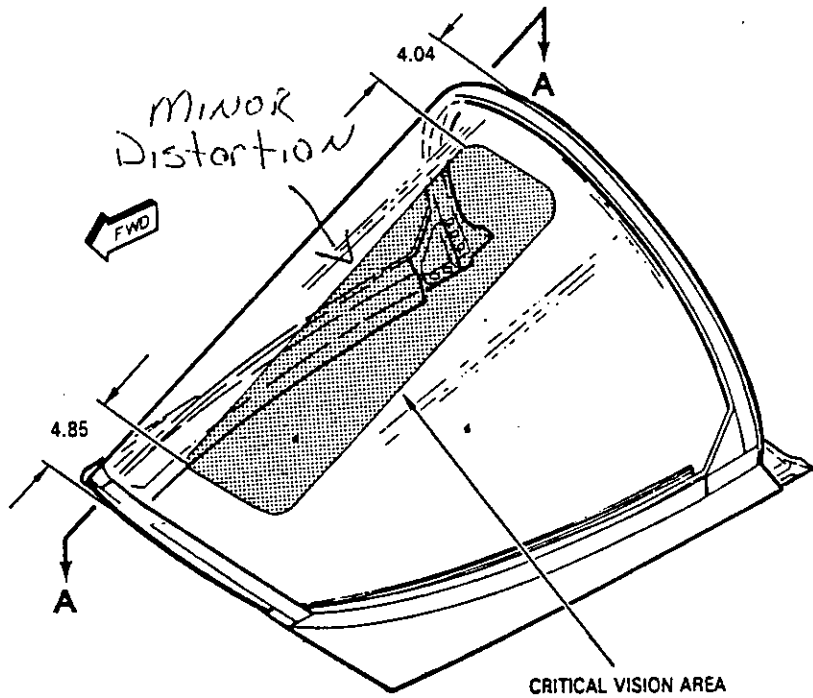
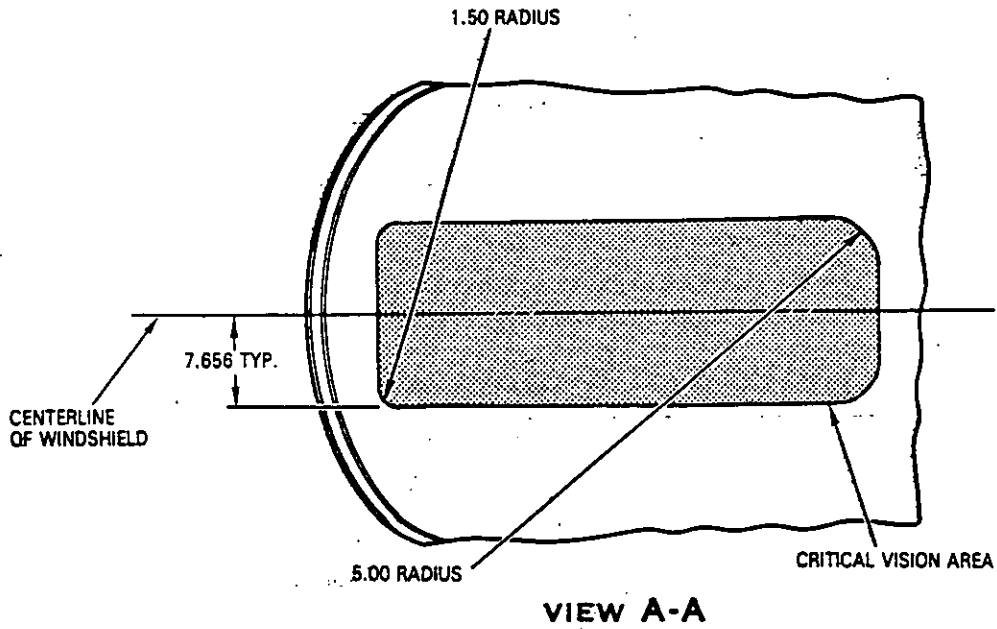
Figure 4-6B. Acrylic Transparency Rework Diagram, 68A350016

On my evaluation of A/C 9025 I found a scratch approximately 4 inches long at the 11 o'clock position on the windshield, near the windshield arch (Atch 3). Through visual inspection I found no distortion, and therefore there is no visual distortions. I then inspected the canopy, I found a few scratches that look like they may have come from a pilots helmet, but determined that they would be out of the pilots view area, and there was not any distortion.

I then inspected A/C 4025. Upon inspection I found a small distortion in the windshield at about 12:10 position. This was about half way down the windshield in the critical view area (Atch 4). I was not sure if it was a distortion or not so I examined the canopy and found the same thing I found on A/C 9025, and that was a few scratches but no distortions. I then went back and looked at the windshield again to make sure the distortion was still there and it was still there. Upon further inspection I determined that it was a small area not an area where a pilot would be able to focus in on for a long period of time.

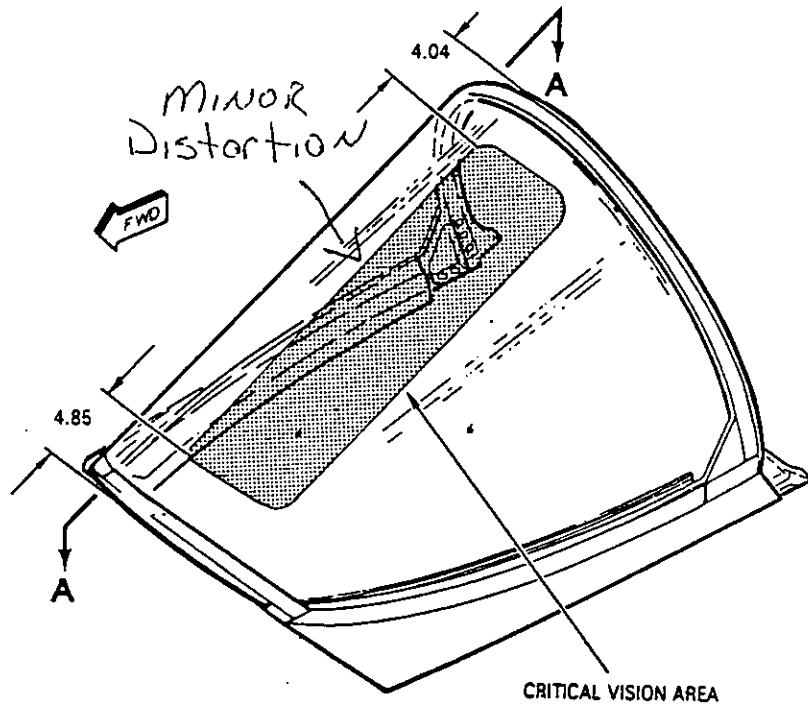
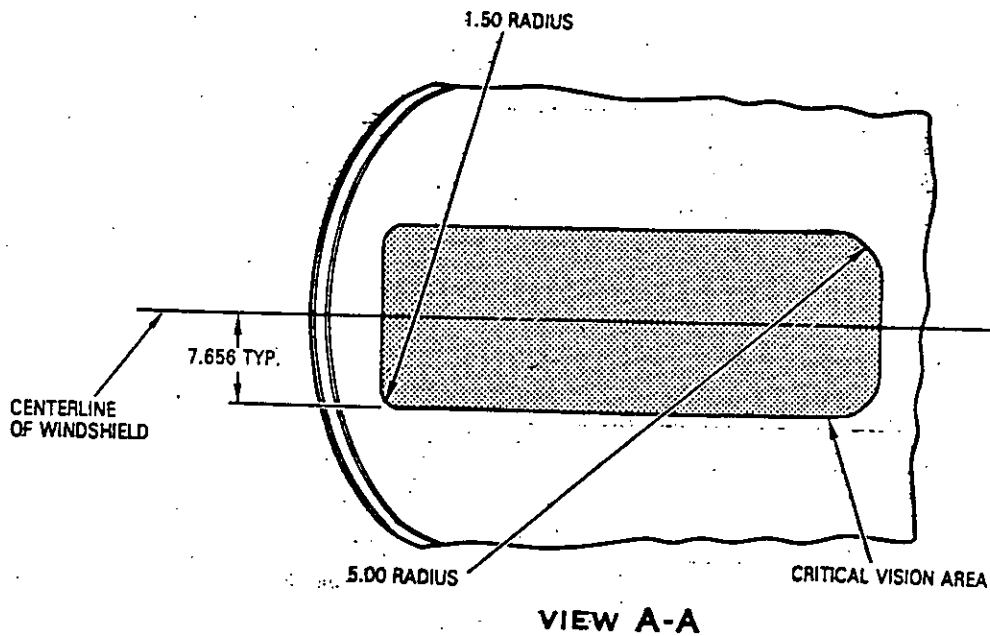
Figure 4-6B. Acrylic Transparency Rework Diagram, 68A350016

Overall I found that both A/C's canopy's and windshield's were in very good condition. The canopy and windscreen are within limits IAW T.O. 1F-15C-3-4 on both aircraft.
