**Serious Accident Investigation
Factual Report**

**Freeman Reservoir Fatality
Bureau of Land Management
Northwest Colorado Fire Management Unit
Little Snake Field Office
Craig, Colorado
June 26, 2009**

ACCIDENT INVESTIGATION FACTUAL REPORT

Accident: Freeman Reservoir Tree Falling Fatality
Location: Little Snake Field Office, Craig, Colorado
Date: June 26, 2009

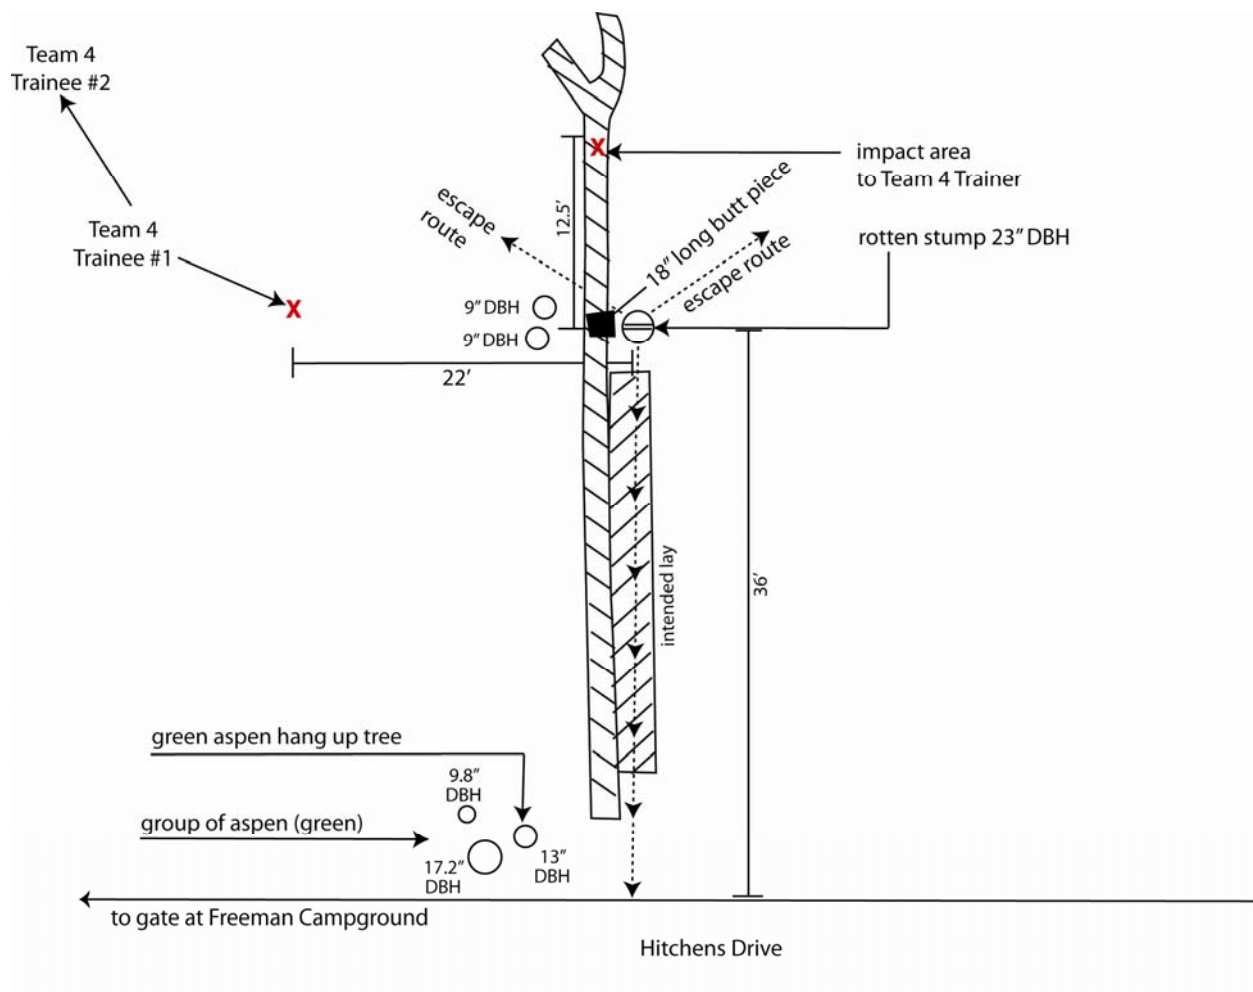
Illustration B3: Overhead View of Accident Site Post Accident (Not to Scale)

The upper portion of the tree strikes Team 4 Trainer in the back of the head and back, driving him to the ground, and coming to rest on top of him.

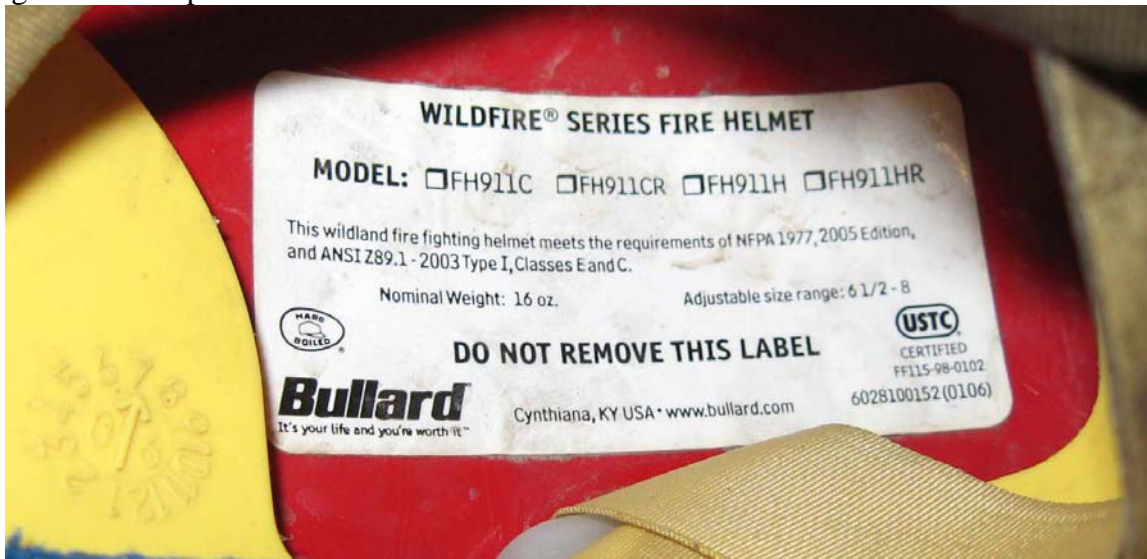
Figure 1 – Compliance Label

Manufacturer: Bullard, Model FH911C with Bullard Sure Lock® Suspension
Date of Manufacture: Hardhat - May, 2006; Suspension – July, 2006
Compliance: USTC certified to NFPA 1977-2005 and ANSI Z89.1-2003 Type I, Classes E & C (Figure 1)
