General Electric LM2500 Gas Turbine

LM2500 SAC Borescope Inspection UNIT TM40

CUST – DOWANS

ENGINE SERIAL NUMBER:
481-364

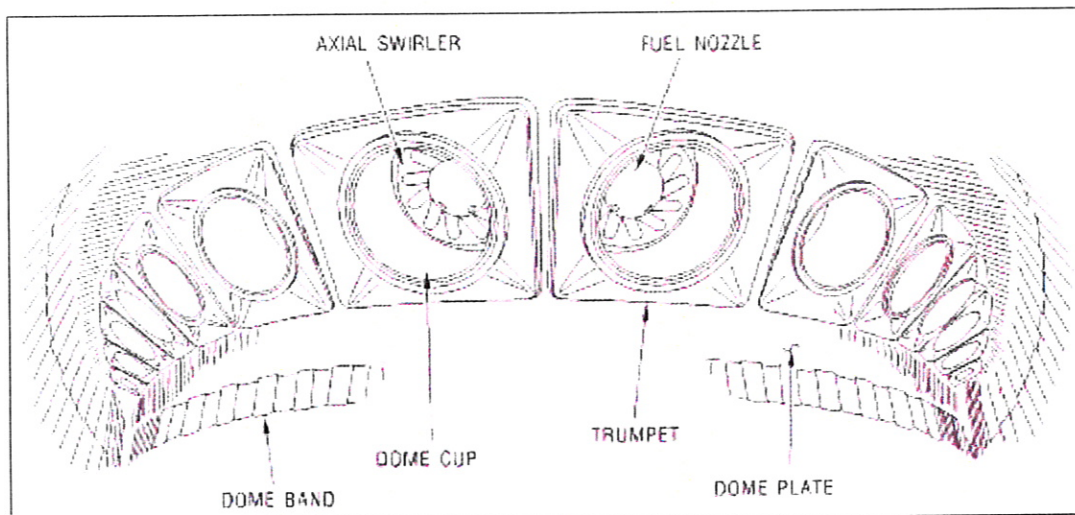
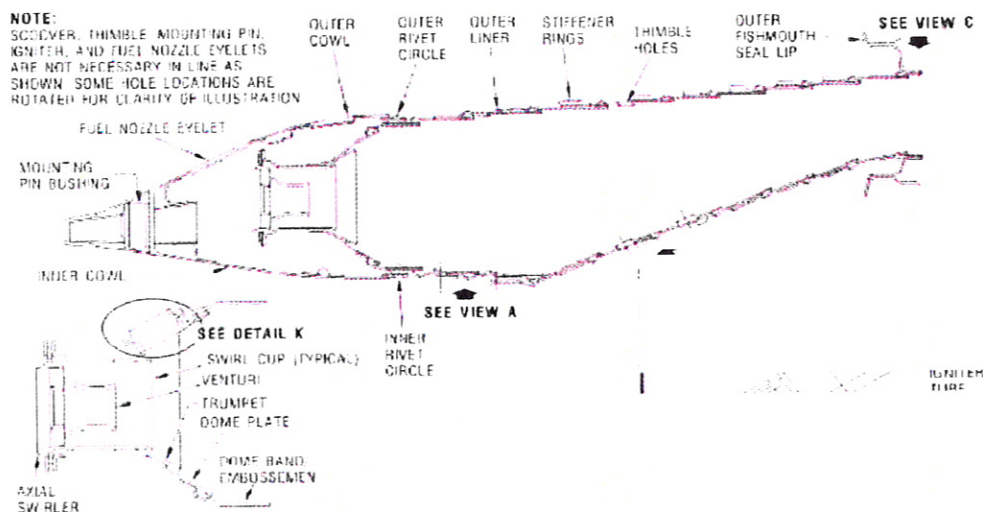
GEK 937310 Inspection References:

Component	Condition
All Combustor Surfaces	<ul style="list-style-type: none"> General condition acceptable.
Dome Band/Dome Plate	<ul style="list-style-type: none"> Minor thermal barrier coating loss/degradation-acceptable
Riveted Joints	<ul style="list-style-type: none"> No defects found
Trumpet and swirler cups	<ul style="list-style-type: none"> Minor thermal barrier coating loss/degradation-acceptable.
Dome Assembly	<ul style="list-style-type: none"> No defects found
Igniter Ferrule	<ul style="list-style-type: none"> No defects found
Combustor Cowl	<ul style="list-style-type: none"> No defect found
Inner and Outer Liner	<ul style="list-style-type: none"> Circumferential crack found at inner liner (approx 1"), acceptable in accordance with GEK 97310 Vol. 1 Table 5-5 inspection 7.
Fuel nozzle	<ul style="list-style-type: none"> 3 fuel nozzles removed for visual inspection and re - installed, S/N PHCGP878, S/N PHCGP770, S/N PHCGP889. Spray orifices unacceptable for liquid fuel use.
