LA-13638

A Review of Criticality Accidents

2000 Revision

Issued: May 2000

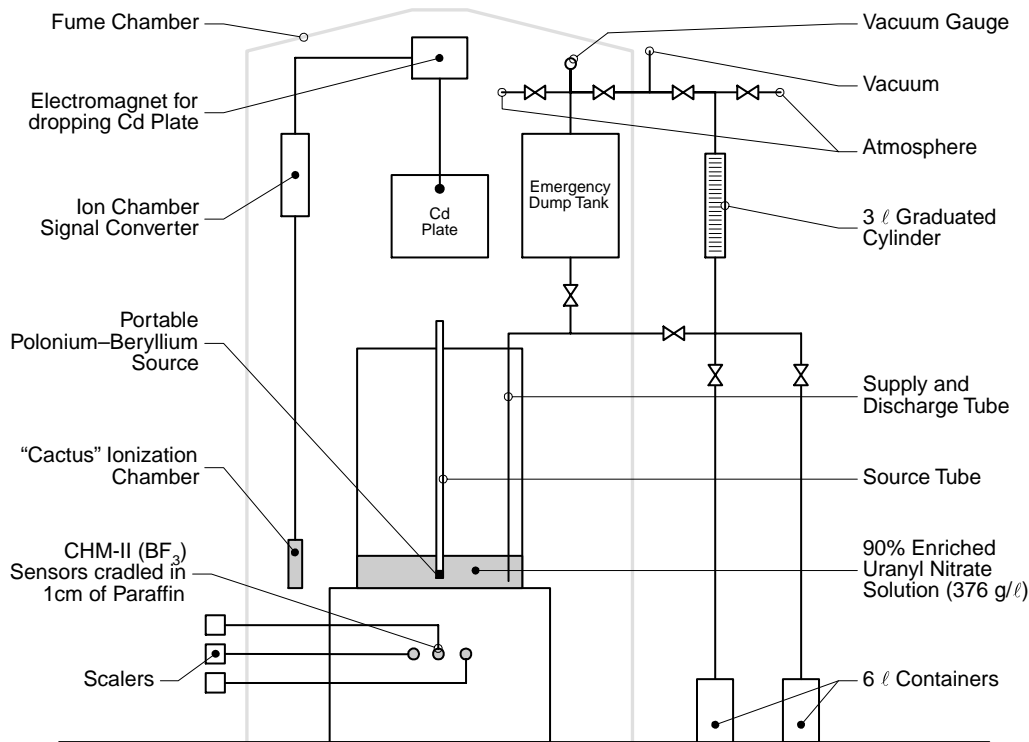
Figure 8. Layout of the experimental equipment.

The small critical experiment setup, shown in Figure 8, was located in a separate room in the main process building. It had only been in operation for two months at the time of the accident. During measurements, the critical experimenters worked at a control

0.8 m above the concrete floor and at least 1.5 m from any walls. Thus it was without appreciable reflection, approximating many in-plant situations. The vessel capacity was in excess of 400 ℓ, permitting critical states to be measured over a wide range of conditions. A central guide tube accommodated a neutron source, and the leakage neutron flux was monitored with a BF₃ proportional counter located beneath the tank. Approach-to-critical measurements employed the standard inverse multiplication technique.

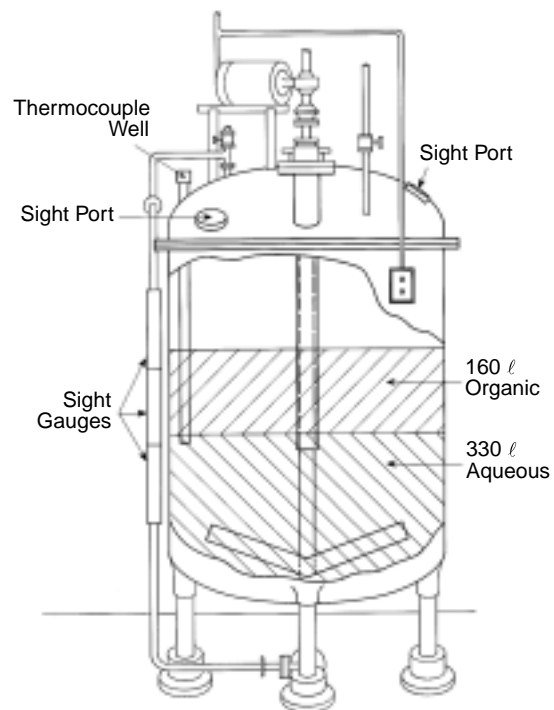
Figure 11. Configuration of solutions (aqueous and organic) in the vessel before the accident.

mixing of the layers. The average plutonium content in the fully mixed solution was 6.8 g/ℓ, a value less than the limiting critical concentration for an infinite homogeneous metal-water system.

From these time intervals and the estimate that initially the system was 5 \$ subcritical, the reactivity insertion rate would have been about 5 \$/s. Using coefficients appropriate for the solution, this insertion rate leads to a spike yield of 2.2×10^{17} fissions with the spike completed in 1.65 seconds, that is, 0.45 seconds after prompt criticality was reached. To obtain the observed yield (1.5×10^{17} fissions) in a single spike, the reactivity insertion rate would have to be reduced to about 2 \$/s. Because this is inconsistent with the time involved (about 3 seconds before complete mixing), the only alternative is to assume that the rate was somewhat less than 5 \$/s and that the excursion was terminated in about 3 seconds by the stirring action. One can surmise that the initial action was thickening of the upper layer at the same time reflection was added by the aqueous liquid. This was followed almost immediately by distortion into a less critical, vortex-like shape by the action of the stirring blades and then permanent shutdown due to a uniform concentration of less than 7 g/ℓ.

The entire plutonium process area had been reviewed by the Laboratory's Nuclear Criticality Safety Committee about a month before the accident. Plans were underway to replace the large-volume process vessels with a bank of more favorable geometry, limited diameter pipe sections (6 inches in diameter by 10 feet long each). Administrative controls that had been used successfully for more than 7 years were considered acceptable for the additional six to eight months that would be required to obtain and install the improved equipment.

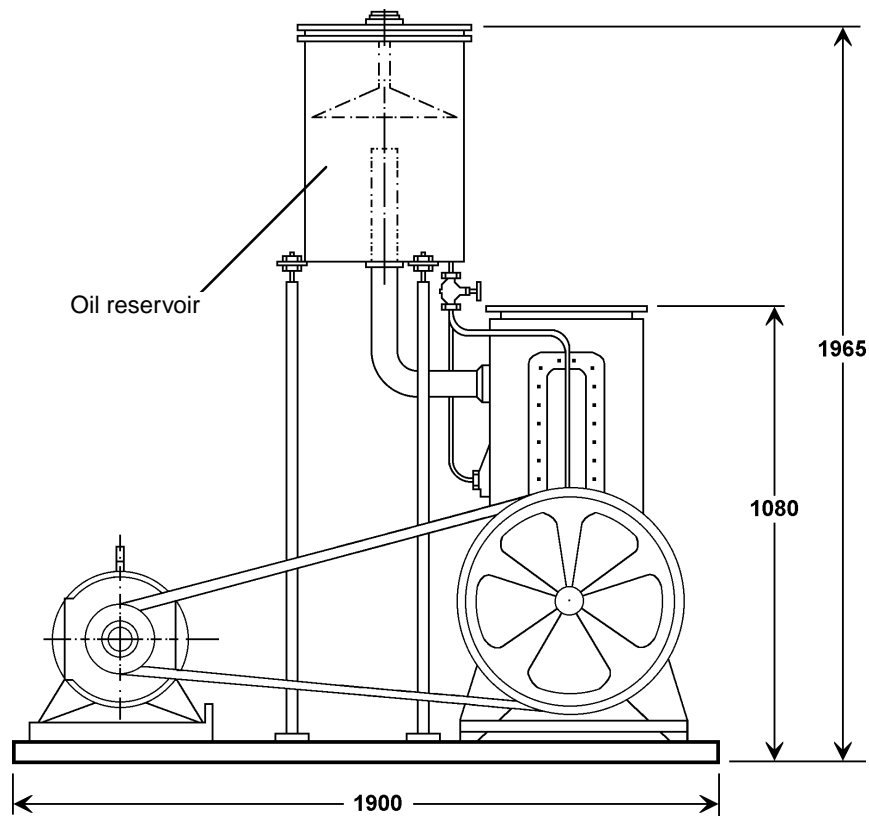
Figure 15. Vacuum pump diagram showing oil reservoir (Dimensions are in mm).

On 1 July 1961, equipment breakdowns at the liquid nitrogen production facility decreased its output by 50%, greatly reducing the available supply to the enrichment facility. The following day, operating procedures were changed to require that the 5 main cylinders be charged with liquid nitrogen manually. Furthermore, and in violation of procedures, the cooling of the 3 intermediate cylinders was discontinued entirely. These events and actions resulted in a large increase in the rate and amount of UF_6 passing through the holding vessels and accumulating in the vacuum pump oil.

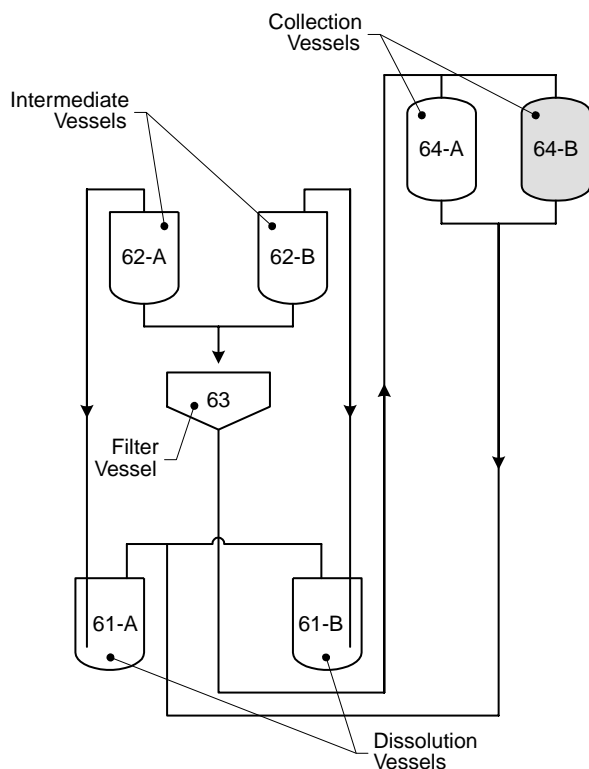
Figure 18. Process vessels and material flow diagram.

Using the erroneous work orders, an operator loaded 2 kg of precipitate from one container and 5 kg from another into dissolution vessel 61-A, believing the total uranium content to be 126 g when it was actually about 1,260 g. Because of a shift change, a different operator completed the dissolution process. The solution was then filtered and transferred to collection vessel 64-A, where a sample was taken to determine the concentration. Later during that same shift, the operator asked for the sample results by telephone. While this normally would have led to the discovery of the original recording error, the laboratory erroneously reported the results for a vessel other than 64-A. By an unfortunate coincidence, this other vessel contained solution with a uranium concentration 10 times lower than that in 64-A, thus reinforcing the operator's expectations.

The supervisor for the second shift, relying on this erroneous information, decided to recycle this supposedly low concentration solution to dissolve the next batch of dry precipitate. This next batch, still subject to the original recording error, contained ~1,255 g of uranium, about the same as that of the preceding batch. The dry precipitate was loaded into dissolution vessel 61-A and then the solution from collection

vessel 64-A was added. The dissolution vessel thus had over 2,500 g of uranium, an amount close to the unreflected critical mass for this diameter vessel. The solution was then filtered in 10 ℓ batches and transferred to the larger diameter collection vessel 64-B. In the course of this filtering/transfer operation, the solution exceeded the critical height in 64-B, and the first excursion occurred at 18:10 on 30 January 1963. The criticality alarm system sounded and all personnel evacuated. The γ -ray detectors were set to activate at 110 mR/h. Several of the personnel were directed to undergo medical assessment.

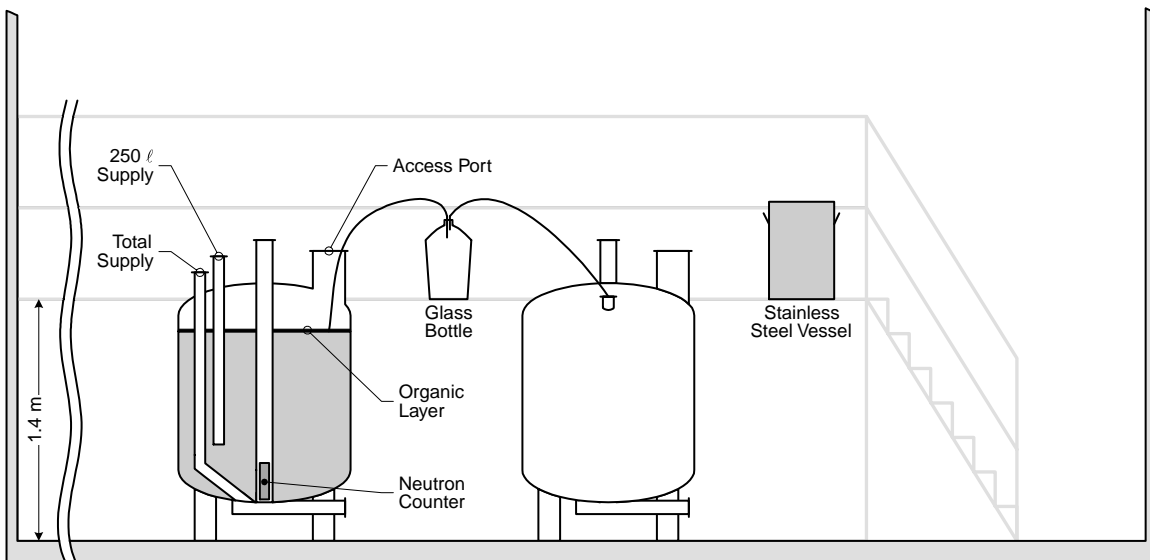
Figure 24. Elevation view of the tanks involved in the accident.

Figures 23 and 24 show plan and elevation views of these tanks, and the other vessels involved in the accident by their location in the basement room. Each tank had an operating volume of 800 ℓ. Each was equipped with neutron detectors located near the bottom to monitor the plutonium concentration and to detect any sediment accumulation.

On 10 December, the 19:00 shift supervisor instructed an operator to sample the contents of tank 2 before transferring it to recovery operations. Since the sampling device was out of order, the sample was taken by lowering a glass vial on a thin line through one of the upper level sensor ports [Figure 24]. The results of the analysis indicated that the plutonium concentration was ~0.6 g/ℓ. Since the total volume of solution in the tank was ~800 liters, the total plutonium mass was ~480 g, which exceeded the criticality safety mass limit of 400 g. According to regulations, the shift supervisor then ordered that two additional confirmatory samples be taken.

The temporary arrangement of equipment used to remove the organic solution from tank 2 is shown in Figures 23 and 24. Two reinforced rubber hoses, 1.2 m in length and 13 mm in internal diameter, were fixed into the neck of a 20 ℓ glass bottle (usually used for chemical reagents) with a cloth plug. One hose was connected to the vacuum line on tank 1 and the other was lowered into tank 2 through its access port. If the 20 ℓ bottle became full, it was decided that the contents would be poured into a 60 ℓ vessel usually used for the collection of very low concentration wastes before reprocessing. The bottle and vessel were placed on the platform above tanks 1 and 2. The use of these types of temporary, improvised, setups as well as the use of unfavorable geometry vessels were strictly prohibited by existing regulations.

operator was again able to fill the bottle, this time to nearly 20 ℓ. Having disconnected the bottle from the hoses, the operator then poured its contents in the 60 ℓ vessel for a second time. After almost all of the solution had been poured out of the bottle, the operator saw a flash of light and felt a pulse of heat. Startled, the operator dropped the bottle, ran down the stairs and from the room. The bottle, which had only a small amount of solution remaining, broke, splashing the remaining contents around the base of the 60 ℓ vessel.

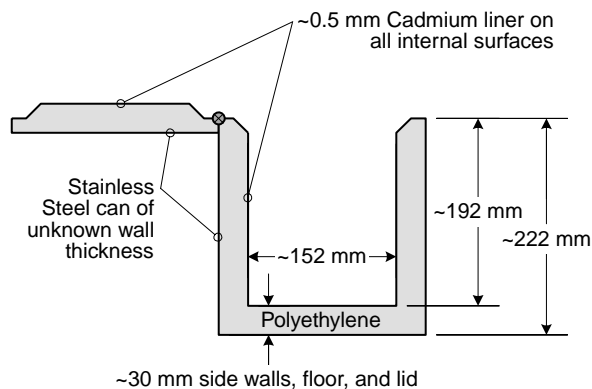
Figure 28. Storage container.

Transfer and temporary storage of the ingots within the gloveboxes was accomplished using cylindrical storage containers designed specifically for this purpose. The containers were lined with a 0.5 mm thick cadmium layer and had a 30 mm thick shell of polyethylene encased in a stainless steel sleeve (Figure 28). The design decreased the neutron interaction for a planar array to such a degree that it was not necessary to control the number or storage arrangement of the containers within any of the gloveboxes.

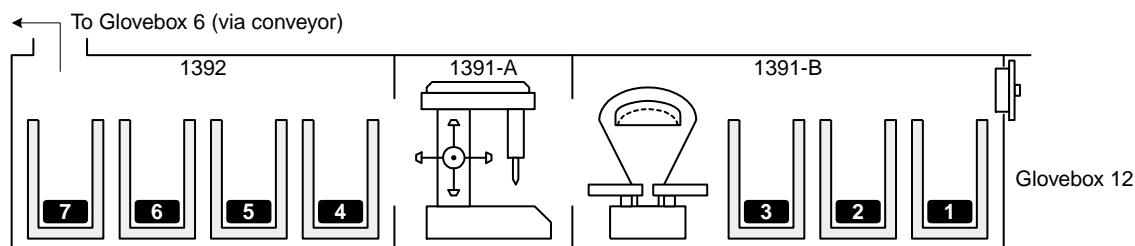
Figure 29. A simplified layout of Glovebox 13.

Glovebox 13, where the criticality accident took place, consisted of three workstations, (1391-A, 1391-B, and 1392, see Figure 29) and was connected to gloveboxes 12 and 6 by a pass-through port and conveyor, respectively. All of the ingots produced at the plant passed through this glovebox operation. For these particular workstations, the administrative limit for the containers was even stricter, allowing only one ingot regardless of its mass. Workstation 1391-A was used for extracting drill samples (up to 0.1 g) for chemical analysis of the impurities. The ingots were weighed in workstation 1391-B, where the samples were also temporarily stored. Workstation 1392 was used for measuring the dimensions of the ingots. Within the workstations the ingots were removed and returned to their original containers one at a time. The workstations were equipped with pass-through ports in the connecting walls, gloveports, and 50 mm thick leaded glass windows. The front of the workstation had a 30 mm thick lead shield to reduce the γ -radiation from the plutonium.

At the beginning of the shift on 13 December 1978, three containers were in workstation 1391-B, and four containers were in workstation 1392, each with one ingot. The ingots are numbered sequentially in Figure 29 for the purpose of the discussion that follows. Although the containers are depicted as being linearly arranged, in actuality the containers holding ingots 4 and 5 were behind those with ingots 6 and 7, making visual inspection of the contents more difficult

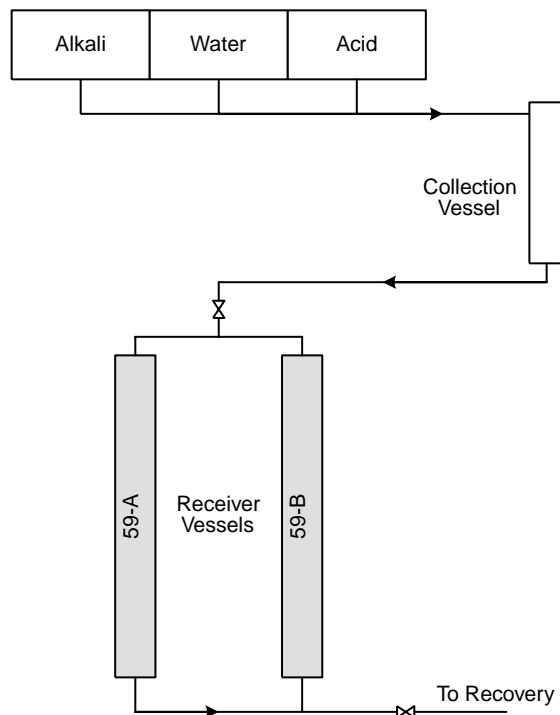
Figure 32. Major components of the chemical-etching process.

This accident occurred in Building 17 where highly enriched U(90) fuel rods were fabricated from UO_2 and aluminum, using the powder metallurgy method. The final process prior to placing a rod into its aluminum cladding was chemical etching. The objective of this operation was to remove microscopic defects on the rod surfaces to ensure tight contact between the rod and its cladding. The major components of the process equipment are shown in Figure 32.

The etching process involved consecutively immersing a batch of rods into three separate vessels filled with sodium hydroxide (alkali), water, and nitric acid, respectively. As a result of a chemical reaction with the sodium hydroxide, some of the aluminum particles on the surface of the rods formed the precipitates, NaAlO_3 and $\text{Al}(\text{OH})_3$. The etching process leached a small fraction of the uranium dioxide from the rods which was also deposited on the bottom of the alkali vessel. The rods were then washed in the second vessel with water to remove as much alkali as possible. In the final vessel of nitric acid, any traces of alkali were neutralized and the rods were etched to their final size by dissolving UO_2 particles from their surfaces.

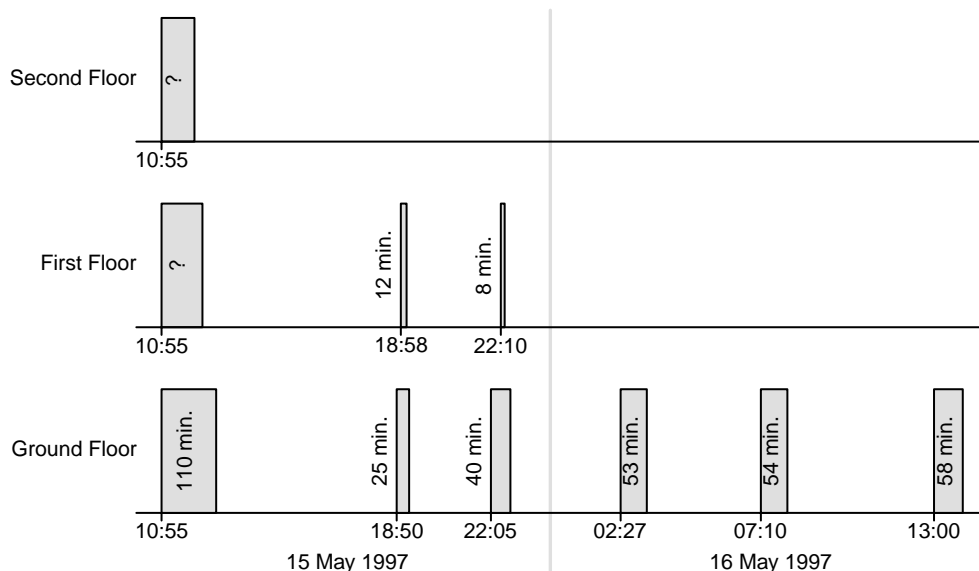
Figure 33. Sequence of alarms and duration that the radiation levels exceeded the alarm level (36 mR/h).

samples of the UO_2 particles taken on 20 May. The detectors were located at 12 monitoring stations. However, during the excursions, at most only three of the monitoring stations alarmed, indicating very low peak power for each excursion. These three stations were located on the ground, first, and second floors directly above one another. From the central control room, health physicists documented the sequence of excursions, the response of the detectors, and the length of time that the detector alarm threshold (36 mR/h) was exceeded (Figure 33).

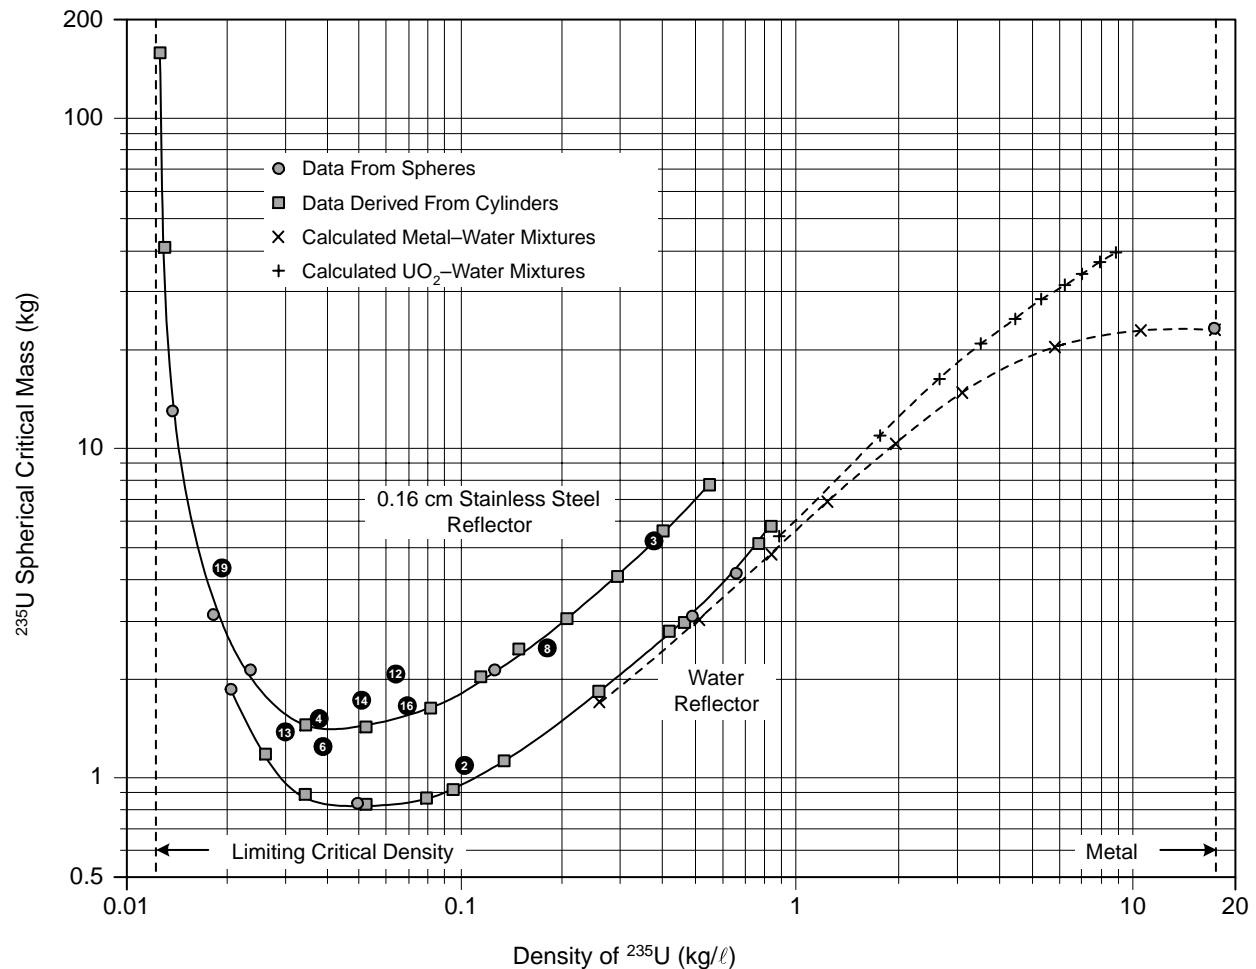
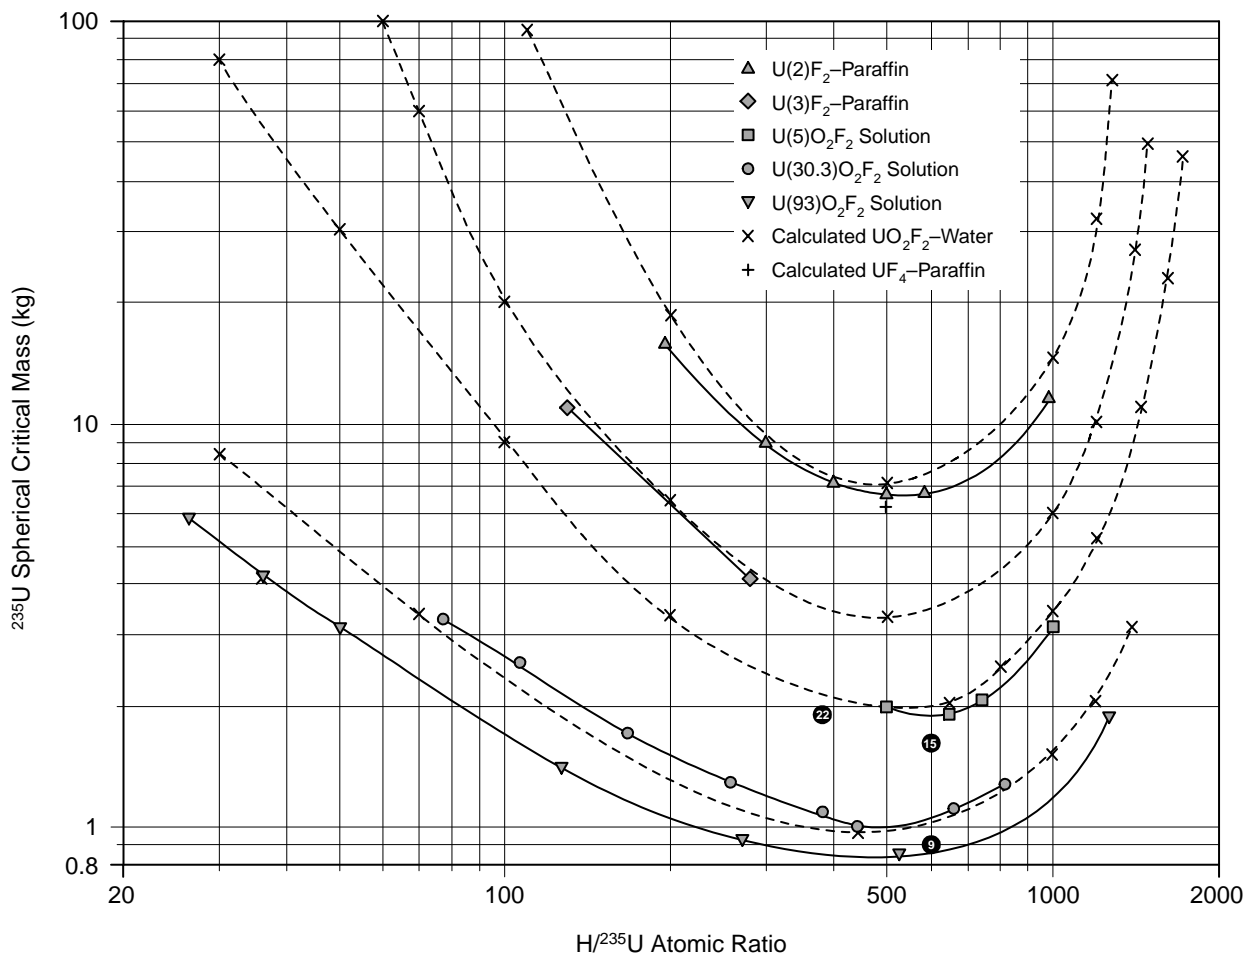
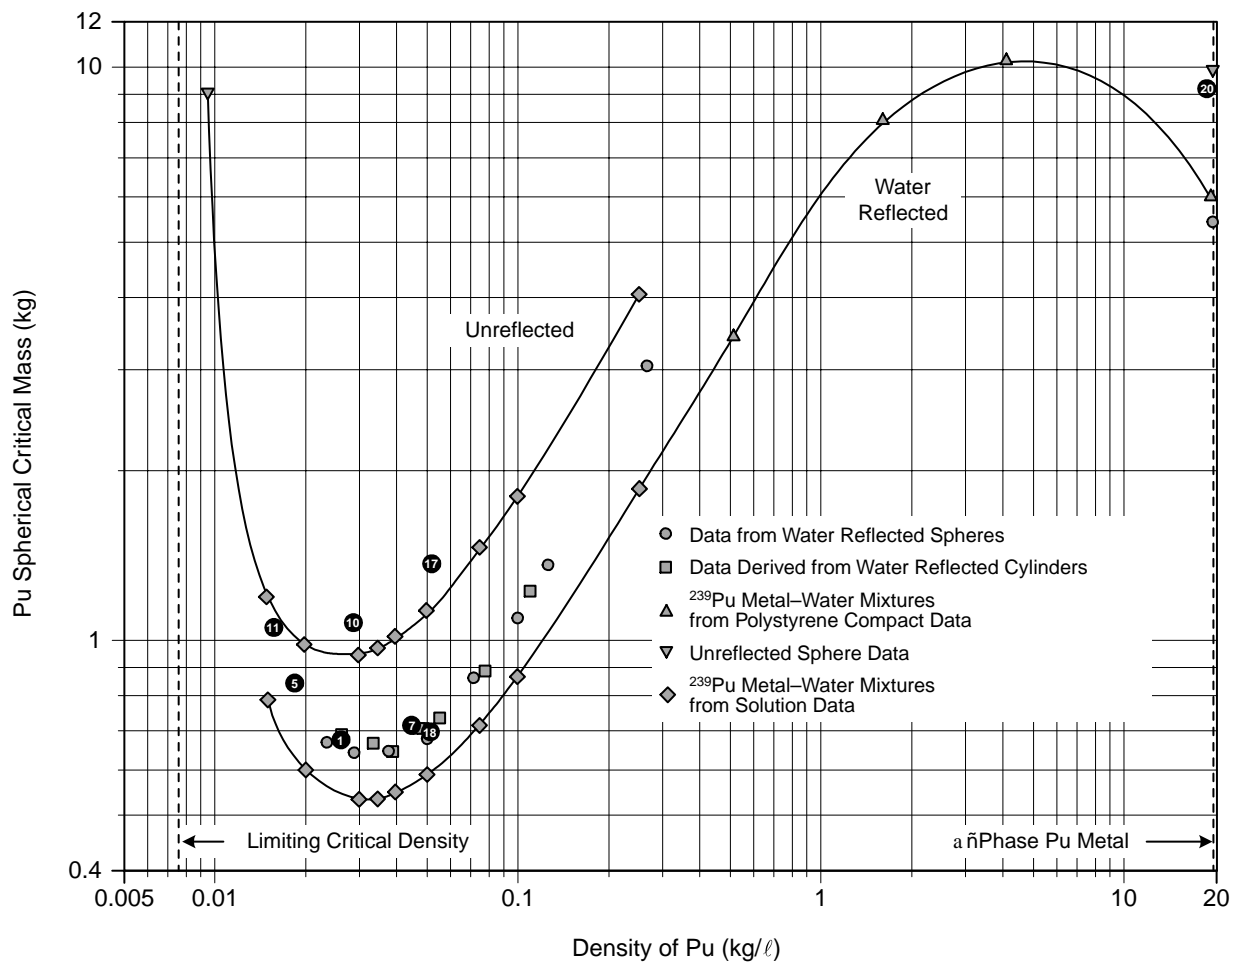
Figures 37, 38, and 39 are selected and adapted from Los Alamos report LA-10860.³⁴ These three figures include points corresponding to fissile density (or atom ratio) and the estimated spherical critical mass for the twenty-one accident re-constructions in Table 9. Figure 38 includes curves for systems with uranium enrichment corresponding

to 2.0, 3.0, 5.0, 30.3, and 93.0. Accidents 9, 15, and 22 are superimposed on this figure. Since the curves in Figure 38 are for water reflected systems, these points have been adjusted downward since the actual accidents were relatively unreflected.

Considering the effects of partial reflection and inherent uncertainties in the estimates, it is judged that the position of 18 of the 21 points plotted in Figures 37, 38, and 39 are sufficient for establishing credible agreement between the reported accident conditions and known conditions for criticality. The estimates for accidents 1, 7, and 9 appear to be somewhat questionable in that more mass than reported in the accident would be required for criticality under the hypothesized unreflected accident conditions. However, accidents 1 and 7, would be in reasonable agreement if the partial reflection present during the accident were taken into account. It should be noted that for these two cases, the “missing” mass is no greater in magnitude than other accident reconstructions (notably, accidents 12, 14, and 17) in which the reported mass exceeds the known conditions for criticality. The discrepancy surrounding accident 9 is also consistent with the large reported uncertainty in the amount of mass present. No systematic features are distinguishable that differentiate the R.F., U.S., U.K., and Japanese accidents.
