investigation report

Plutonium Contamination

Incident

Wednesday, October 14, 1981

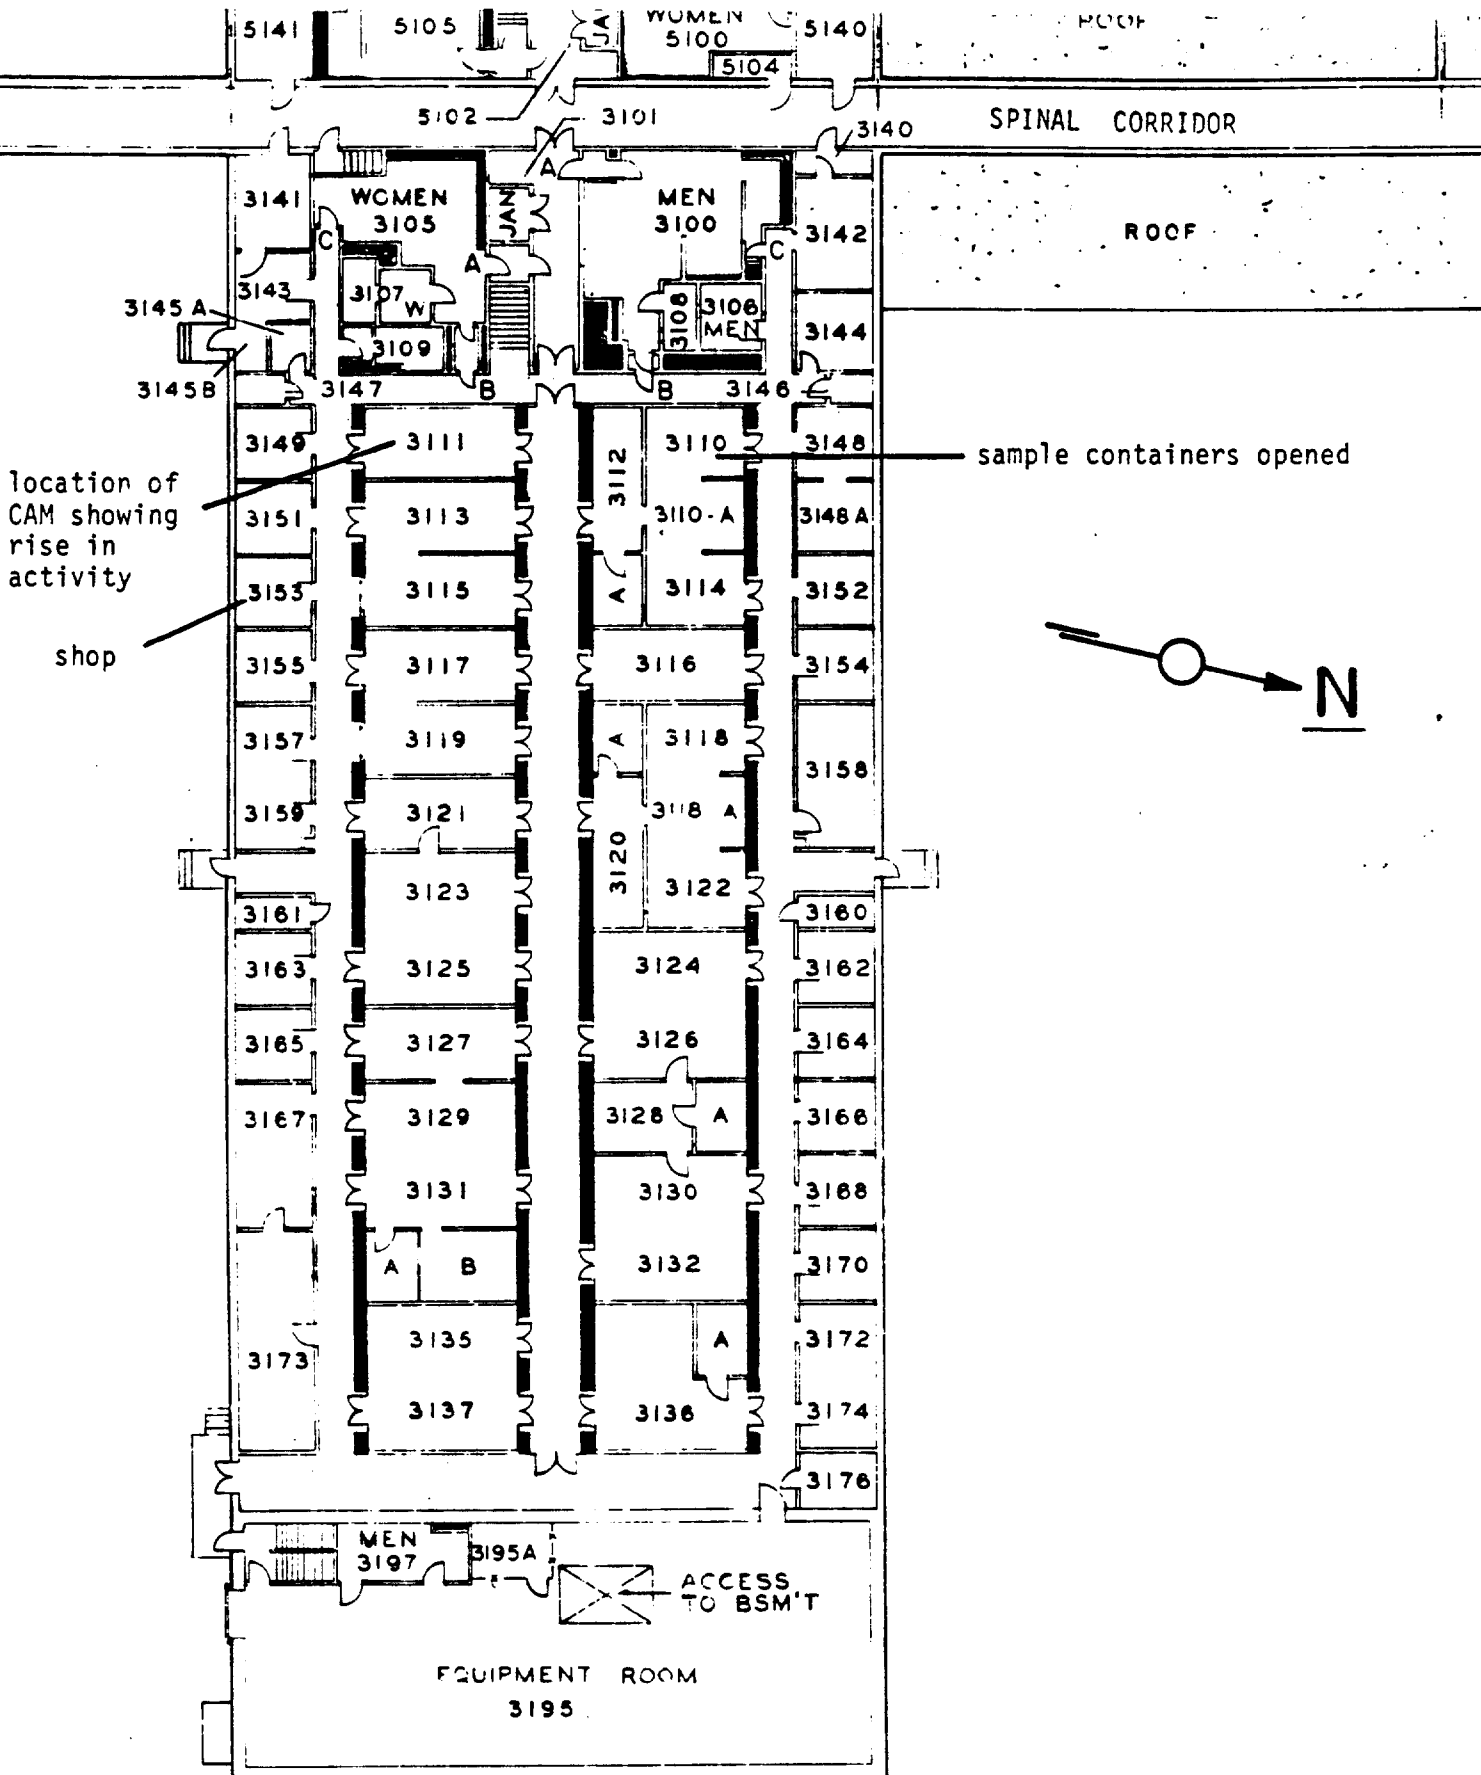
Figure 5. Layout of Wing 3.

The plutonium contamination incident described in this report occurred on the first floor of Wing 3, so pertinent features of this wing will be described in more detail. Normal access to the wing from outside the building may be described as follows. A worker or visitor will enter the security area surrounding the building at Security Station 321, which is on the street in front of the building. At this point he will show his badge to a Protective Force Inspector for access. He will then proceed to the building, go through the front door and into the lobby where a second Inspector, at Station 322, will examine his badge. Approximately 350 people who regularly work in the building and approximately 850 others who have occasional duties in the building are allowed access on the basis of information on their badges. Other individuals are logged in after being cleared for entry by one of a number of designated employees in the building. This same procedure is used for access via the rear door at the loading dock. Access to the interior of Wing 3 (see Figure 5) is by way of door A into one of the change rooms (3100 or 3105). These rooms are furnished with clothing lockers for regular employees, showers, and wash basins. Supplies of booties and smocks are available and workers or visitors are required to put on booties before proceeding by way of door B into the working area of the wing. Exit from the wing is the reverse of that described above except that a person enters the change room by way of door C after monitoring his hands and booties with a nearby instrument. Booties are removed upon entering the change room and

The working area in the Wing is approximately 18,000 square feet. The change rooms are not considered to be inside the Wing because they are not bootie areas. As shown in Figure 5, the various laboratory and office modules are arranged in four rows separated by three corridors. The two central rows are laboratories and the rows along the north and south walls are mainly offices but include some laboratories and a small shop (Room 3153). The basement and attic areas of Wing 3 will not be discussed.

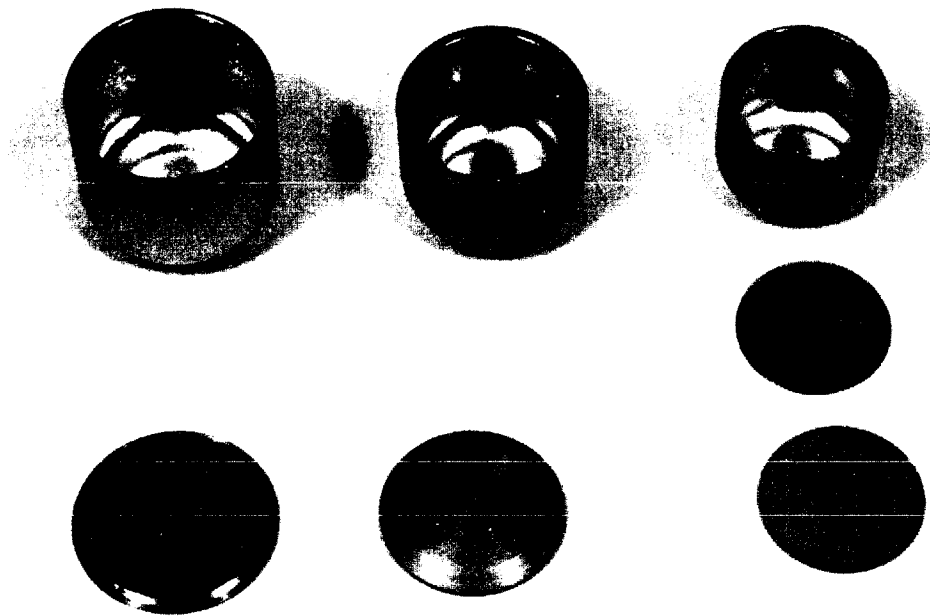
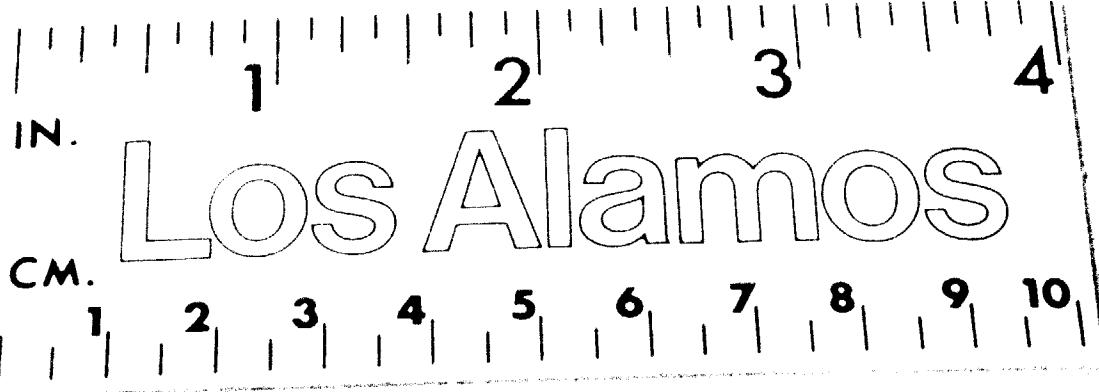
FIGURE 6. Heat Source Capsule Components.

shown in Figure 6. The inner and middle cups are made of an alloy of tantalum, tungsten, and hafnium, designated T111. The outer cup is made of Hastalloy C. The $^{238}\text{PuO}_2$ (53 - 500 micron size range) is put into the inner cup, covered with a shield, and the lid welded on. This, in turn, is placed into the next cup and its lid welded on, and so on, to form a triply sealed capsule.

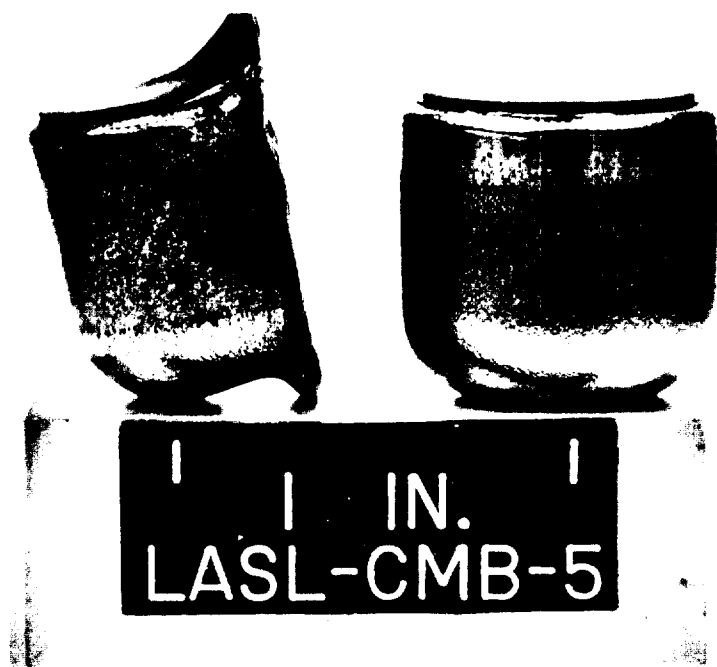
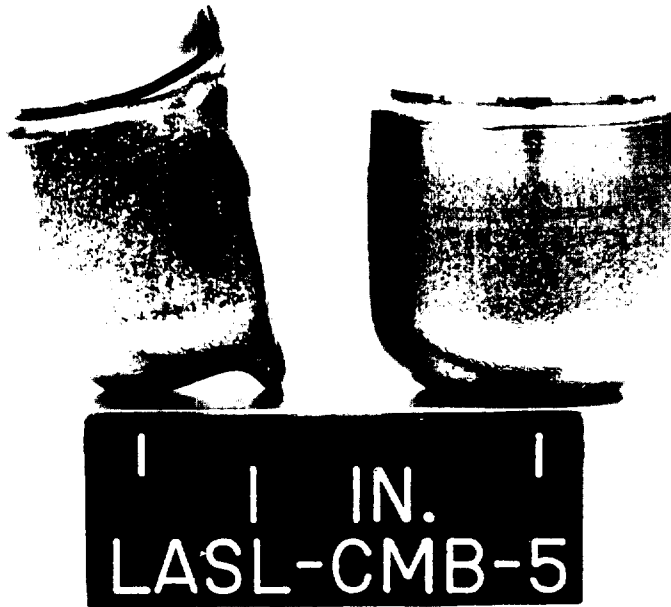
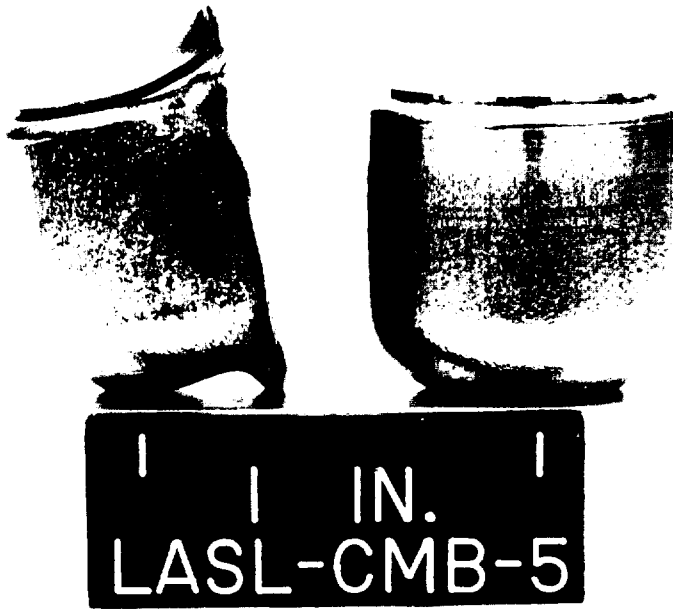
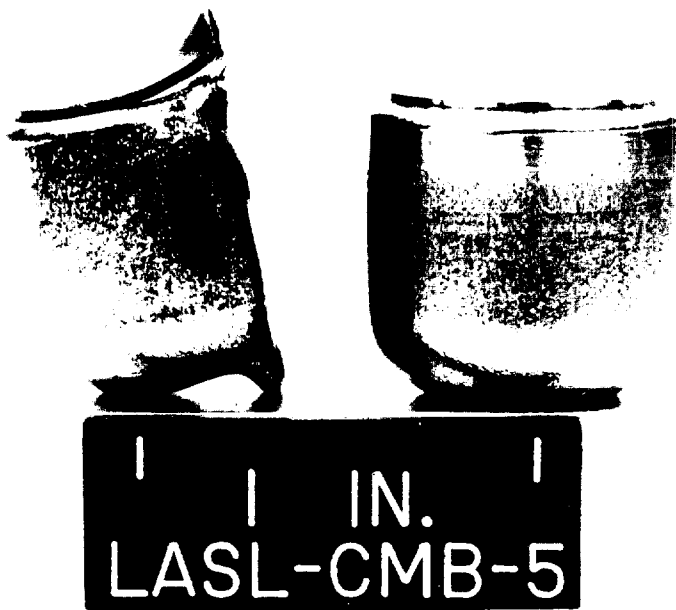
The right-hand side of Figure 7 shows an assembled heat source before impact, while the left-hand side of the figure shows the source after an impact test.

Fig 7 Appearance of heat source capsule before and after impact testing.

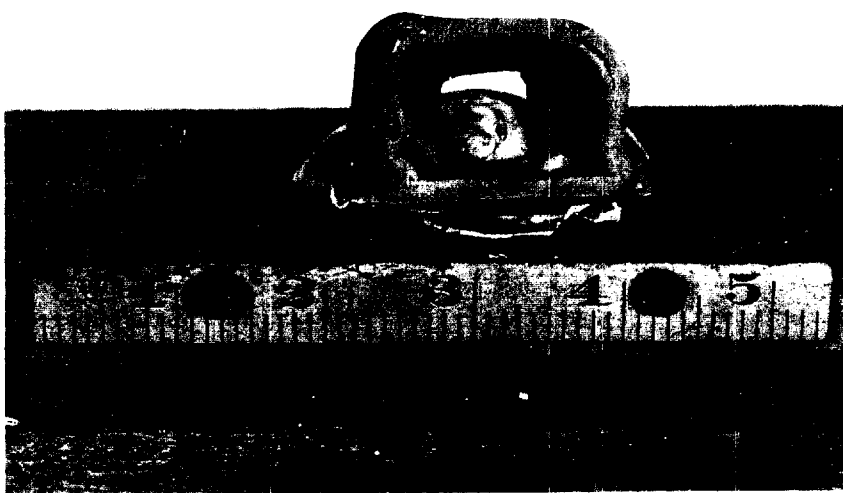
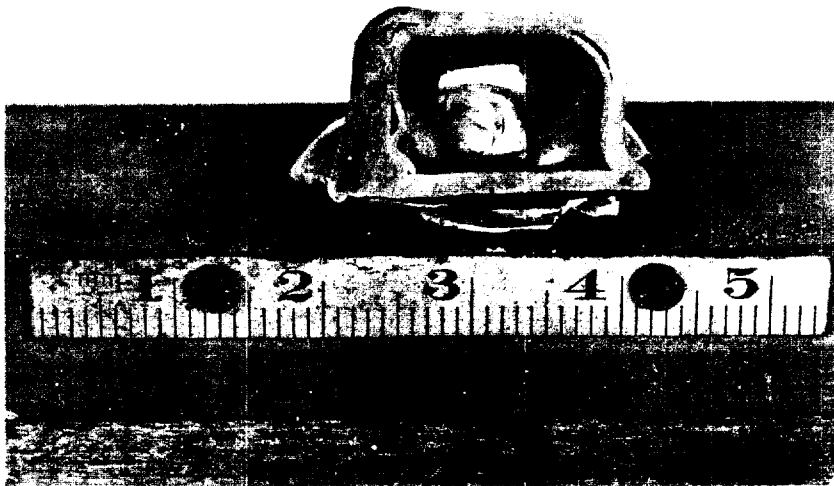
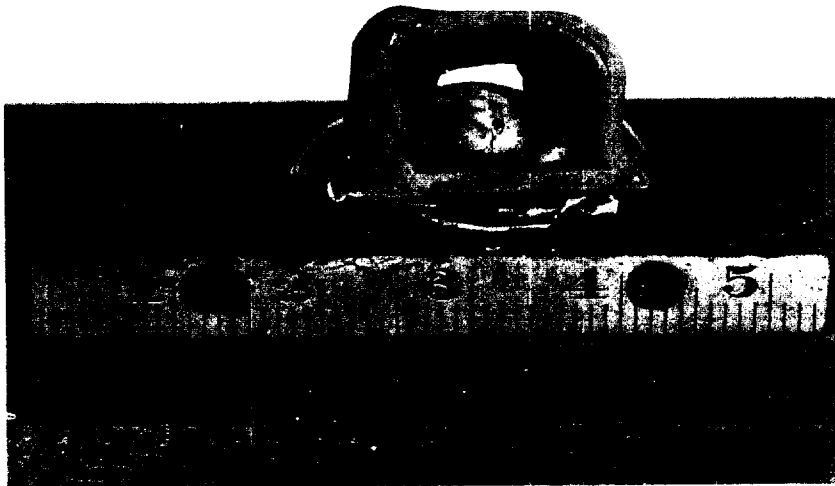
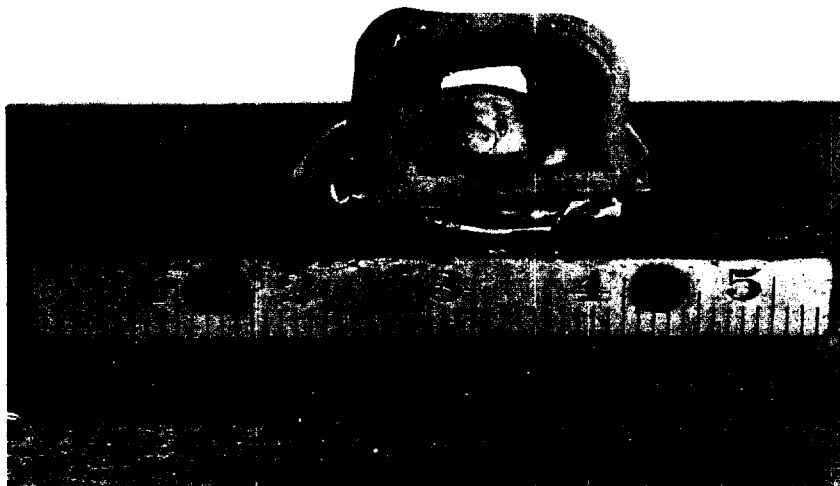
After impact, the source is placed in a glovebox and the outer cup is peeled off. The $^{238}\text{PuO}_2$ fuel is removed by way of a rectangular hole cut in the side of the capsule. The capsule is cleaned ultrasonically to remove most of the remaining fuel; it has been estimated that no more than about 2 mg typically remain. After impact, about 2% of the PuO_2 particles are found to pass through a 5 micron screen showing that impaction produces some pulverization of the oxide particles. After the fuel is removed, the capsule is sectioned as shown in Figure 8. Impact also causes folds and wrinkles in the liner cup and some of the fuel may remain embedded as shown in Figure 9. The capsule is further sectioned to provide samples of the welds and other regions for chemical analysis. The testing program began in December 1979, and by September 30, 1981, a total of 17 heat source capsules had been tested, giving rise to 160 separate analytical samples. An additional 10 weld-test samples, also contaminated with $^{238}\text{PuO}_2$, were submitted to CMB-1. In the capsule development stage of this program, 43 noncontaminated samples of the T111 alloy were prepared. The last set of these was submitted to CMB-1 on July 14, 1980.

Fig 8. Sectioned heat source capsule after ultrasonic cleaning
