AND8374/D

AMIS-30663 - Loss of 3.3 V Digital I/O Supply

APPLICATION NOTE

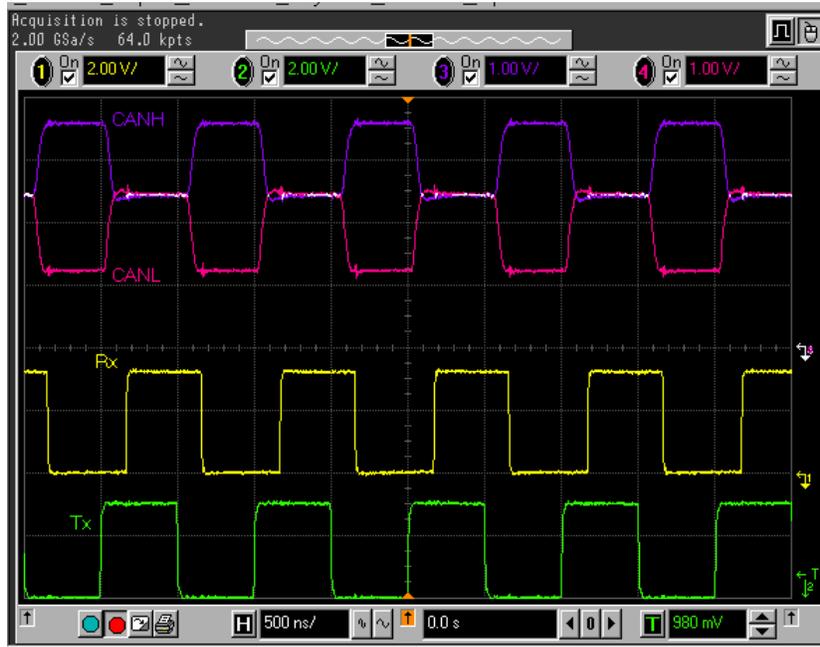
Figure 2. Normal Communication, S Closed V33 Present, Communication via TxD

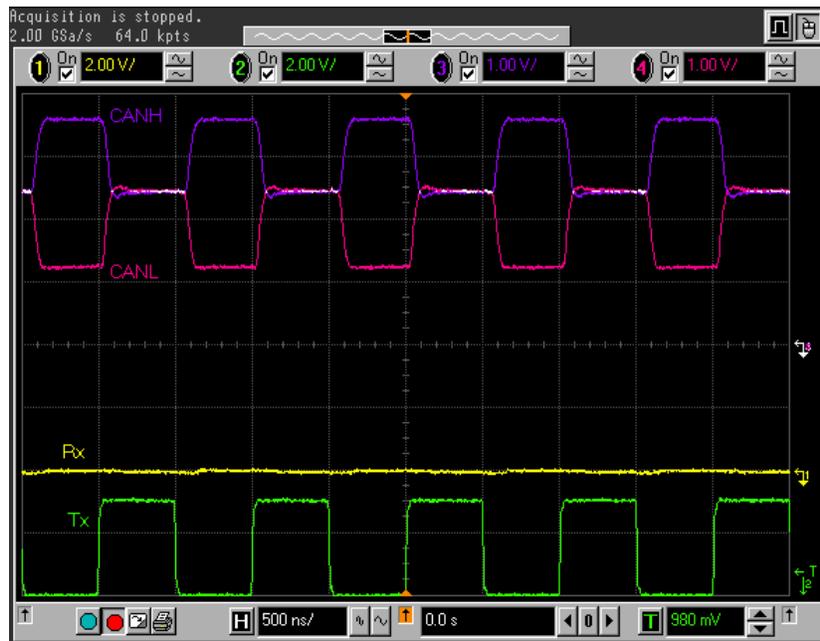
When the I/O supply of the transceiver is interrupted and the CAN controller is still supplied, there will still be a TxD transmission possible. RxD is a constant low (or dominant).

As a consequence, communication from the controller to the bus is still possible but communication from CAN−bus to controller is blocked (RxD = 0). See oscilloscope plots below.

Figure 3. S is Open, V33 is Lost for Transceiver Only, Transmission is Still Possible

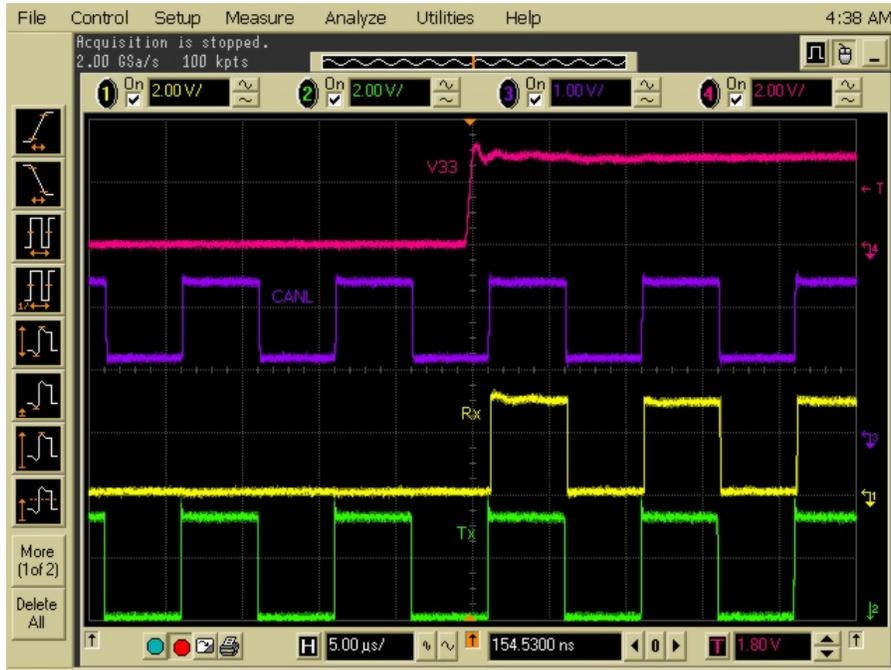
When the I/O supply of the transceiver is interrupted and the CAN controller is still supplied, there will still be a TxD transmission possible. Transients on the I/O supply will not have any influence on the communication on the bus, but enables the RxD driver.

**Figure 4. S is Closed → V33 Transient at Dominant State (TxD = 0)**

Figure 5. S is Close → V33 Transient at Recessive State (TxD = 1)

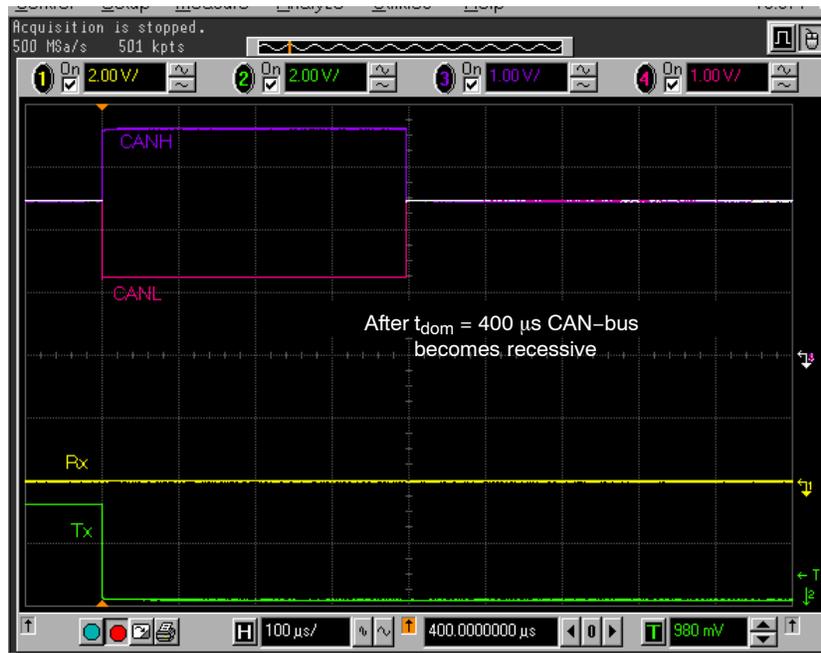
When the I/O supply of the transceiver is interrupted and the CAN controller is not supplied anymore, TxD transmission is possible. TxD will be 0 and the CAN bus becomes dominant. After the t_{dom} time−out (typically 450 μs) the CAN−bus becomes recessive. Further communication by other CAN nodes remains possible.

Figure 6. S = Open, V33 is Lost for Both Transceivers as Controller, After the Dominant Time−Out the CAN−Bus Becomes Recessive
