Service Bulletin #: SB11
Title: EX500 Satellite Communicator Software
Field Update

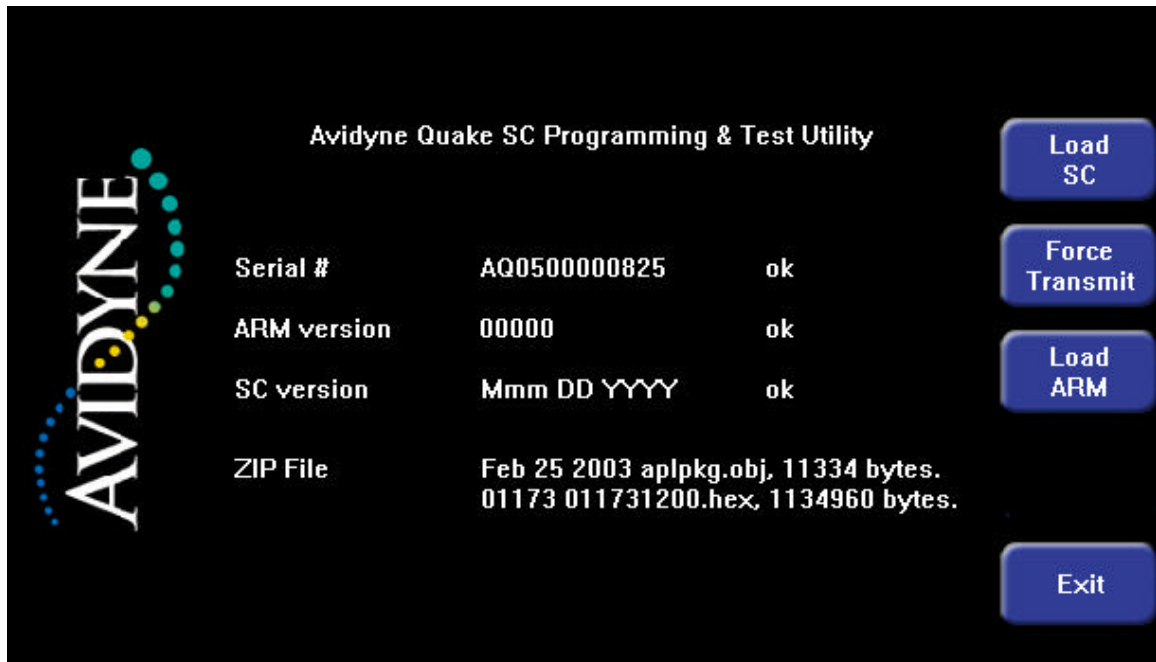
4. _____ Power-up the FlightMax EX500 with the Zip drive attached and disk 510-00085-000 inserted in the zip drive.
5. _____ Verify that after initialization, the following screen is displayed (ARM version may differ; SC version may differ or be dashed)

6. _____ Press the Load ARM button
7. _____ Verify that the loader proceeds through the following stages:
 - a. _____ Rebooting SC...
 - b. _____ Launching Loader...
 - c. _____ Loading ARM X% complete...
 - d. _____ Completed, waiting for result...
 - e. _____ Success, waiting for SC reboot...
 - f. _____ Screen returns to format shown above

8. ____ Verify ARM version and SC versions now match the following values.
 - a. ____ SC version matches date Feb 25 2003
 - b. ____ ARM version matches number 4213 if the SC number begins with "DQ" or matches 6273 if the SC number begins with "AQ".
9. ____ If the update procedure fails reattempt the process. If the procedure fails again, call Avidyne Technical Support at 1-888-723-7592
10. ____ Press Exit to close the loader and continue with EX500 start -up.

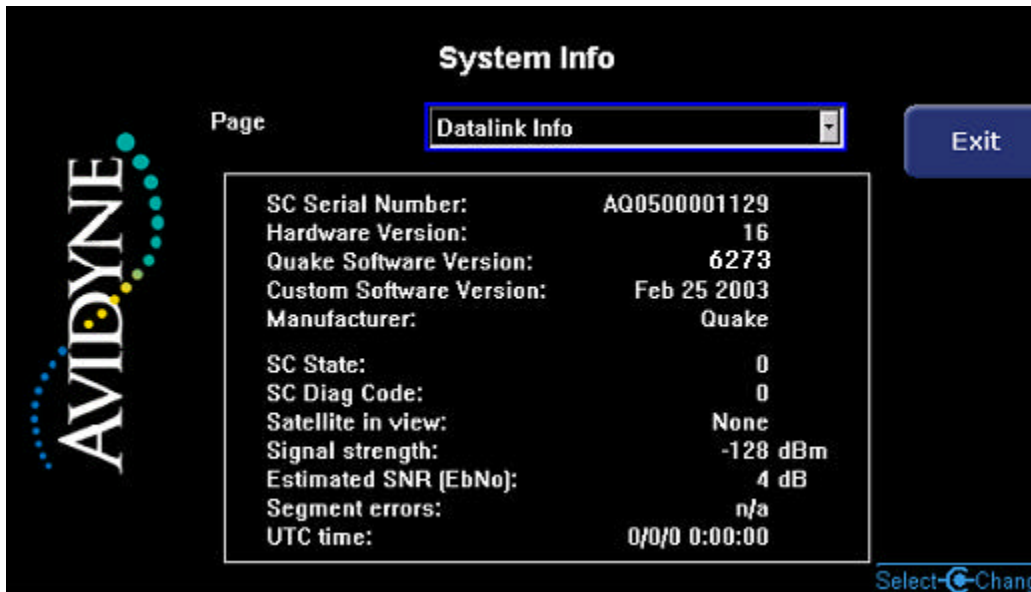
30. ____ Press the "System Info" button. The "Port Info" page will be displayed.
31. ____ Select "Datalink Info" with the change knob.
32. ____ Determine the Quake Software Version. Prior to accomplishment of this Service Bulletin, the Quake Software Version may be either "10162" or "1173." After completion of this Service Bulletin, verify that the Quake Software Version is:

- 4213 if the SC Serial Number begins with "DQ"
 - 6273 if the SC Serial Number begins with "AQ"
33. ____ Determine the Custom Software Version. Prior to accomplishment of this Service Bulletin, the Custom Software Version is "Nov 6 2002". After completion of this Service Bulletin, verify that the Custom Software version is "Feb. 25, 2003."
