Nokia Customer Care
6235/6235i/6236i (RM-60)
Mobile Terminals

Antenna Description and Troubleshooting

Issue 1 04/2005

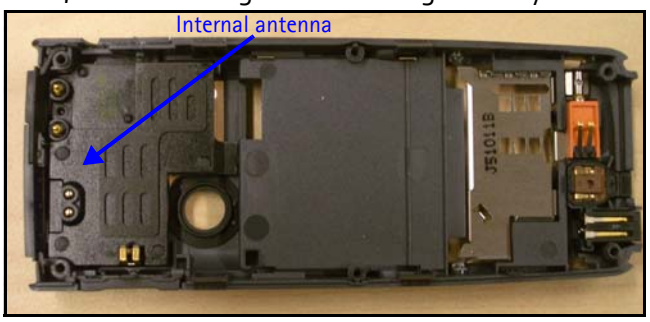
Figure 1: B-cover assembly

The internal antenna is assembled into the B-cover as shown in Figure 1. If no internal antenna is installed, the antenna gain will be degraded by more than 25 dB.

If the internal antenna is missing, install one. If the radiator looks obviously damaged, then replace the internal antenna.

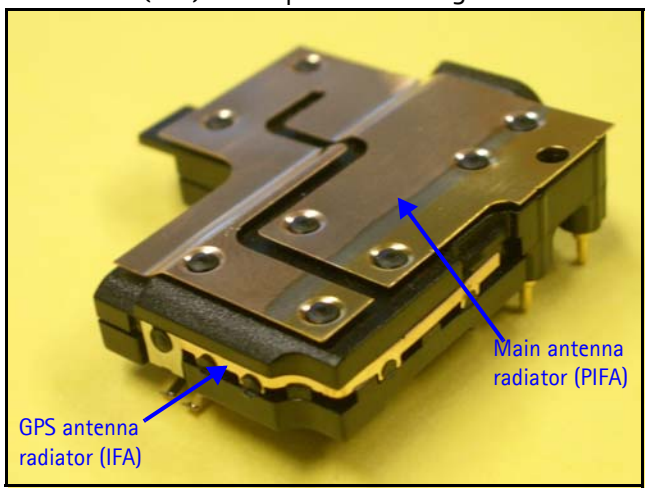
Figure 2: Internal antenna

The internal antenna includes a planar-inverted F antenna (PIFA) radiator and an inverted F antenna (IFA), which is the GPS antenna radiator, attached to a plastic carrier.

An integrated hands-free (IHF) mini speaker is integrated inside the plastic.

Note: The GPS antenna is only functional on models that support the GPS engine.

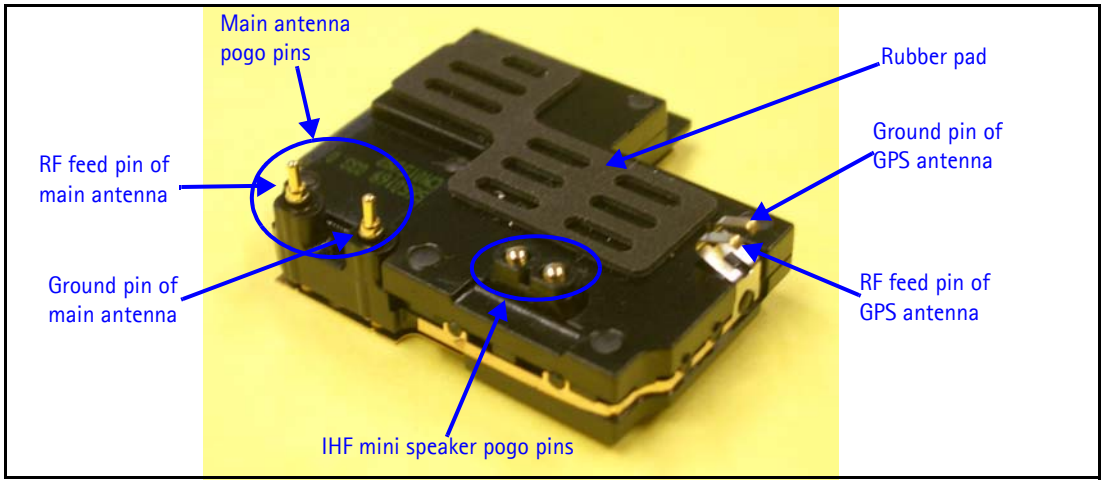
Figure 3: Back view (internal antenna)

The main antenna and the GPS antenna have pins (spring clips) that must properly touch the PWB. Positioning of these pogo pins is shown in Figure 3. Two pogo pins are inserted in the black plastic module.

- One end of the pogo pin touches the antenna; the other end touches the pad on the PWB. If either of them is missing or damaged (i.e. get stuck in the black plastic module or loses the inside spring force), the antenna will lose contact to the PWB. Then the antenna module must be replaced with a good one.
- If the main antenna's RF feed pin does not touch the PWB, the antenna gain degrades by more than 25 dB and the GPS antenna is detuned.
- If the ground pin of the main antenna does not touch the PWB, the antenna gain degrades about 5 to 10 dB and the GPS antenna is detuned.
- If the GPS antenna's RF feed pin does not touch the PWB, then the GPS antenna gain degrades by more than 20 dB.

- If the ground pin of the GPS antenna does not touch the PWB, the GPS antenna gain may degrade by more than 5 dB.
- If either the RF feed pin or ground pin are broken or bent such that either pin does not touch the PWB, then replace the internal antenna.
- If either the RF pin or ground pin springs appear damaged, then replace the internal antenna.
- If either of the IHF speaker pins is damaged or missing, the speaker will not connect to PWB. Then the antenna module must be replaced with the correct one.
- If the rubber pad on the antenna module is missing, then replace the antenna module with a properly assembled antenna module.

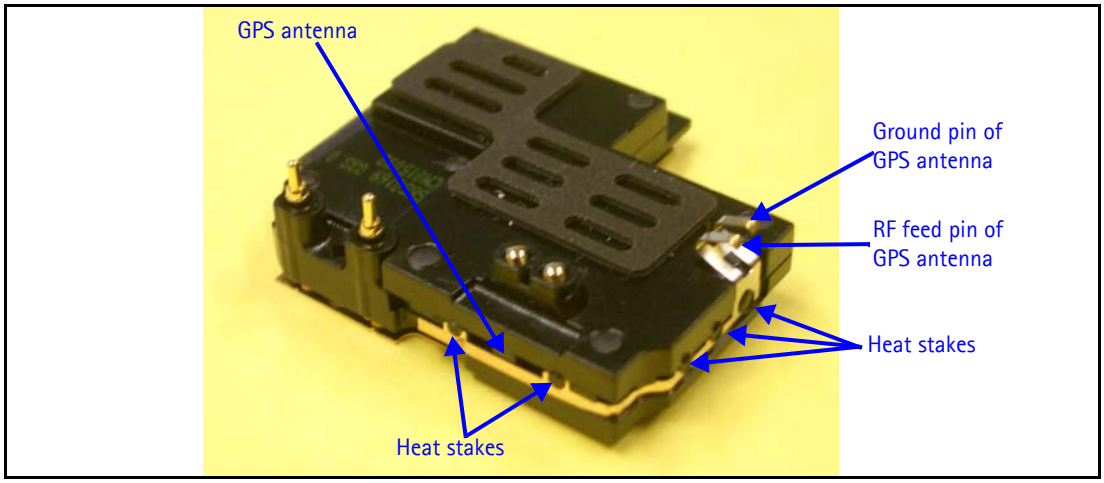
Figure 4: Back view (GPS antenna)

The GPS antenna is heat staked to the plastic.

If any of the following problems happen, the antenna should be replaced with a correct on GPS antenna is missing.

- GPS antenna looks obviously damaged.
- Any of the 5 heat stakes look damaged, the GPS antenna will be loose.
- Any of the 5 heat stakes are over heated and melt GPS antenna into plastic, antenna will look distorted and bent.
- Either of the GPS antenna feed or ground leg is broken, or bent such that either pin will not touch the PWB.

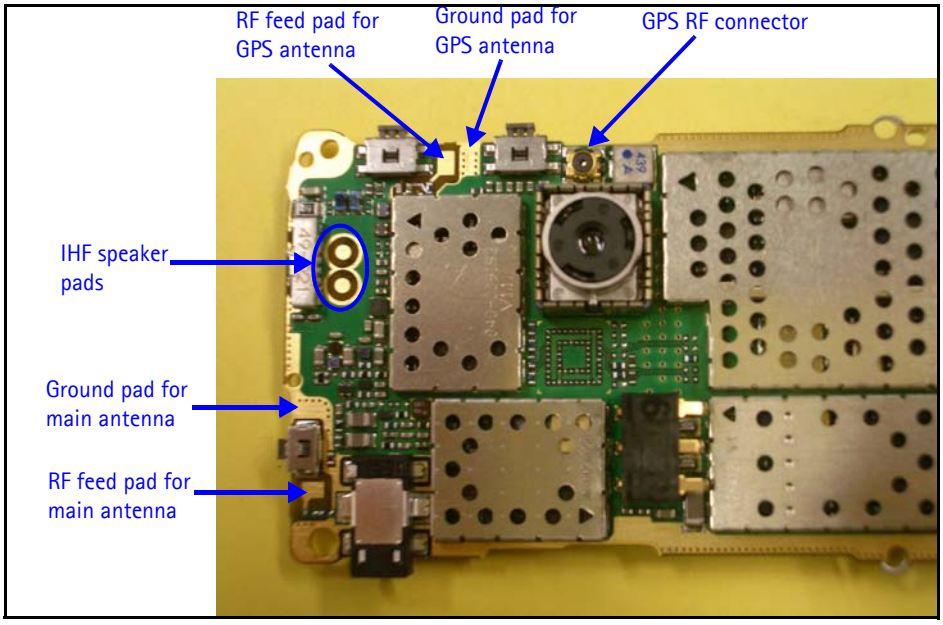
Figure 5: PWB layout of IHF speaker, RF feed, and ground pads

- If the main antenna feed pad is obstructed, removed or covered, then the internal antenna feed pogo pin will not touch the PWB and the antenna gain will degrade by more than 25 dB.

- If the main antenna ground pad is obstructed, removed or covered, then the ground pogo pin will not touch the PWB and the antenna gain will degrade more than 5 dB.

- If the GPS antenna feed pad is obstructed, removed or covered, then the GPS antenna feed leg will not touch the PWB.
- If the ground pad is obstructed, removed or covered, then the ground spring clip will not touch the PWB.

- If the IHF (Internal Hands Free) speaker pads are obstructed, removed or covered then the IHF speaker will not produce sound.
- If corrosion is present or the pads are missing, then the PWB and phone needs to be replaced.

- If corrosion is present or the pads are missing, then the PWB and phone needs to be replaced.
- If either pad is obstructed or covered, the pads should be cleared and cleaned.

- If either IHF speaker pad is obstructed or covered, the pad should be cleared and cleaned.

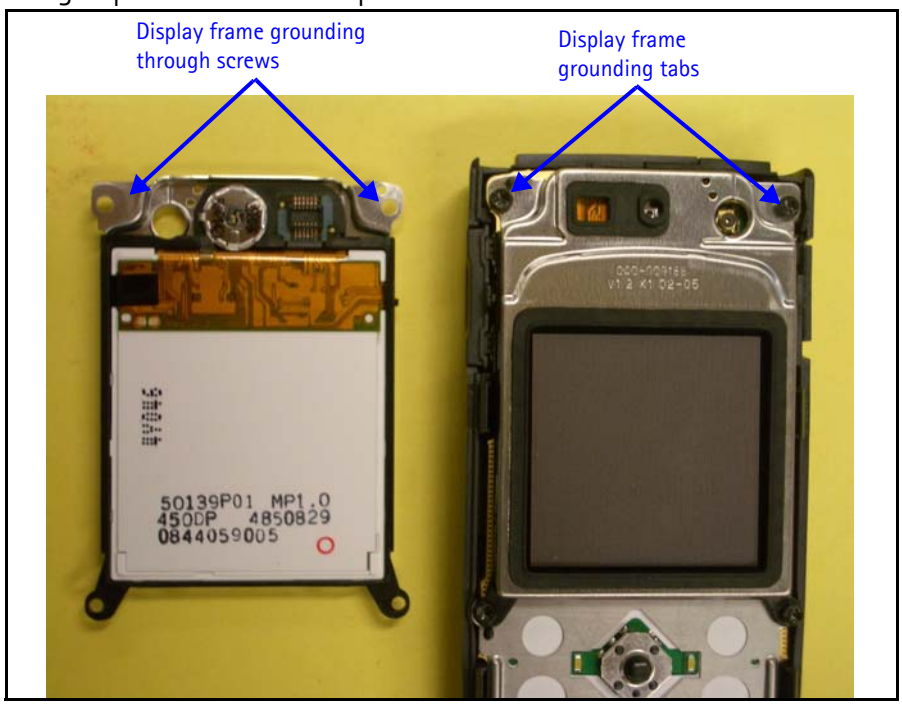
Figure 6: Display assembly ground points

The display frame is grounded to the PWB through two ground panels. The display frame grounding impacts the radiation performance of the mobile terminal.

- If the clips are not touching the PWB, or are corroded, obstructed, then the display frame should be replaced.
- If the screws are loose then tighten them.
- If the screws are missing, install new ones. Figure 6 shows the contact between the display frame ground clips and the PWB in greater detail.
- If any portion of the metal display frame is damaged, or if the metal display frame is not properly attached to the rest of the display assembly, then this display assembly must be replaced with a good one.
