FlightMax™ Entegra Primary Flight Display

Field Level Troubleshooting Guide

700-00006-XXX-() PFD

**P/N 600-00103-000
Rev Draft 00-F**

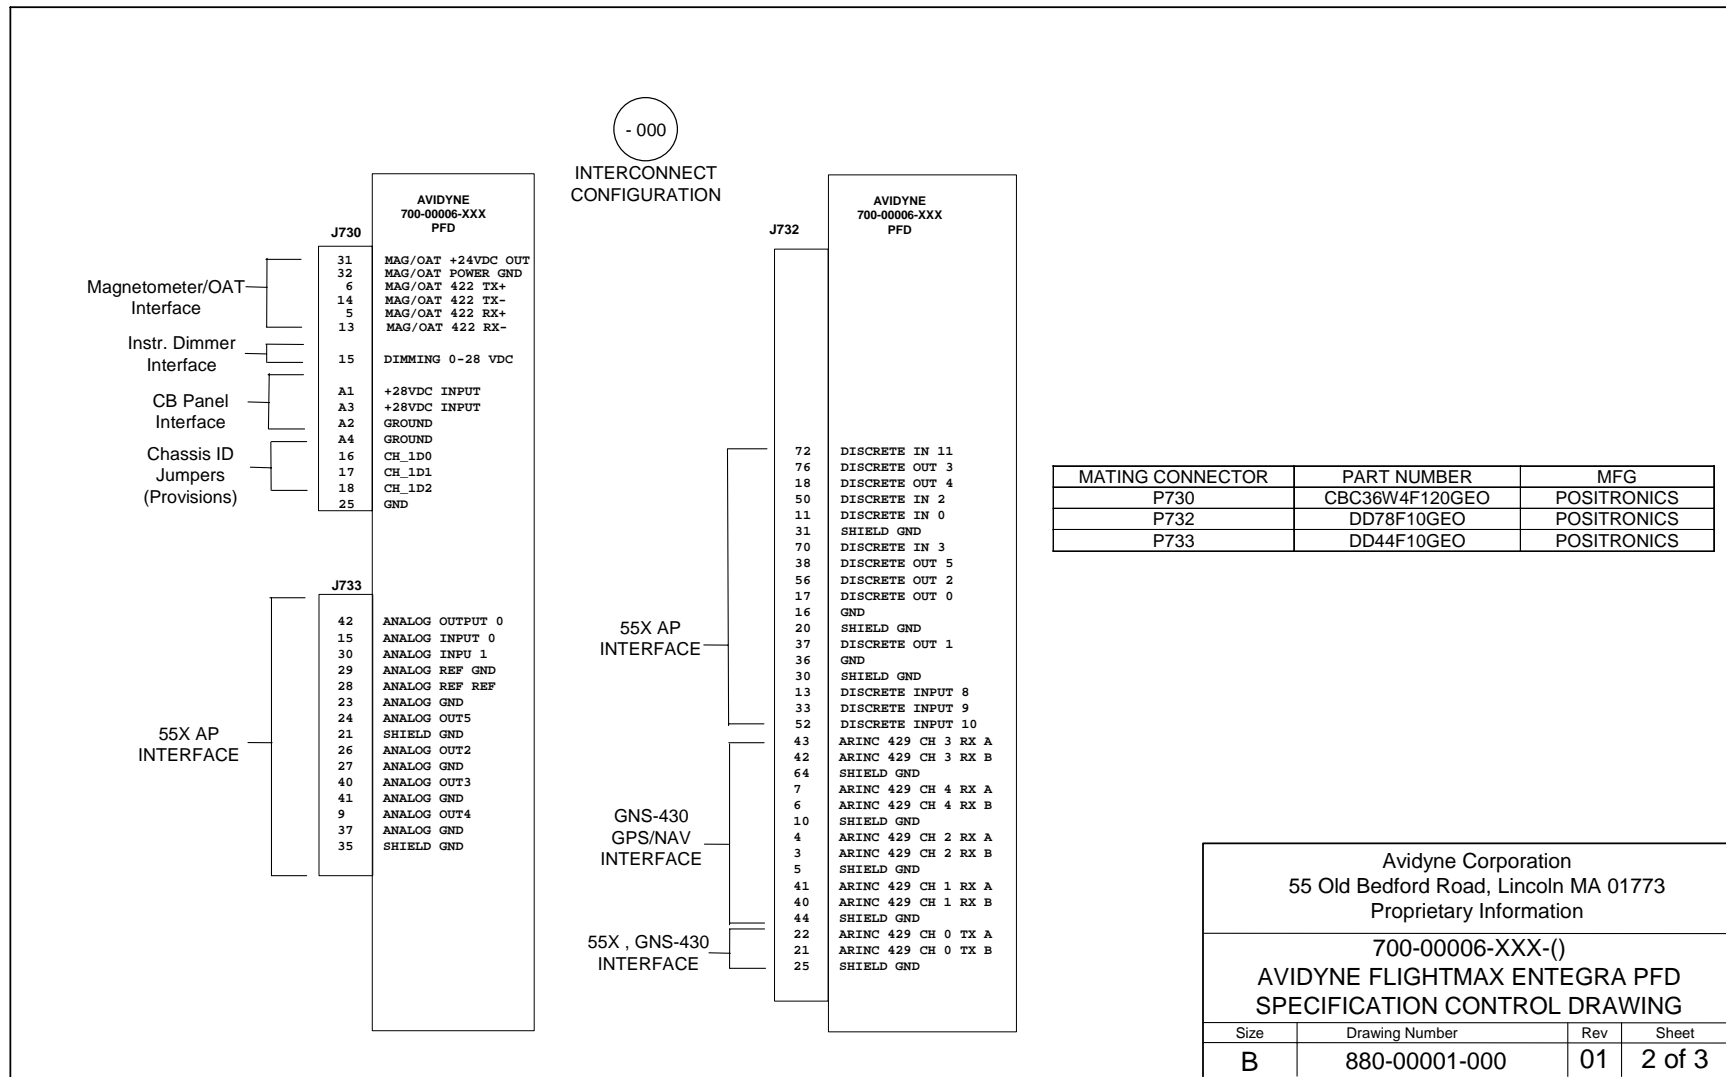
Avidyne Corporation 55 Old Bedford Road, Lincoln MA 01773 Proprietary Information			
700-00006-XXX-() AVIDYNE FLIGHTMAX ENTEGRA PFD SPECIFICATION CONTROL DRAWING			
Size	Drawing Number	Rev	Sheet
B	880-00001-000	01	1 of 3

Appendix D – Top Level PFD Specification
