TELEVISION TECHNICAL BULLETIN

MODELS 37AM12H 37AM23H 37AT25H

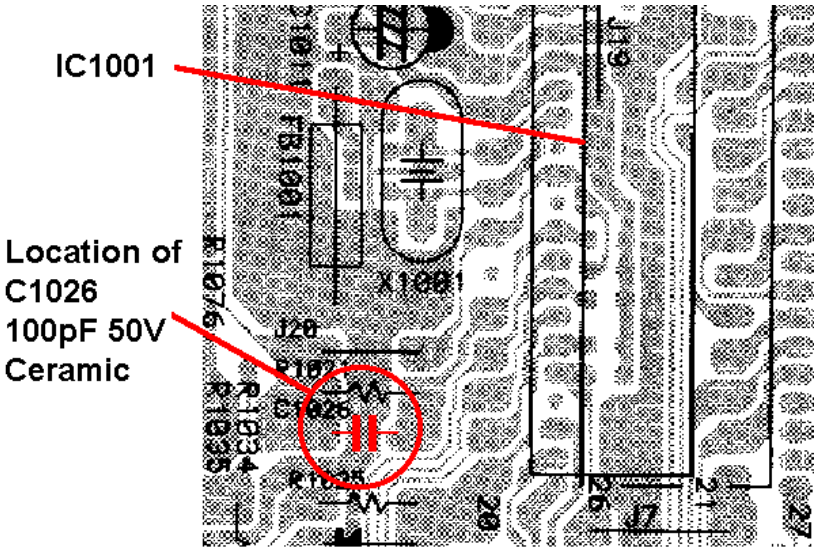
SYMPTOM Tuner drift.

CAUSE C1026 (VCO decoupling – microprocessor output).

ACTION Replace C1026
