COMMUNICATIONS

CHAPTER 23 COMMUNICATIONS

737-600/700/800/900 FAULT ISOLATION MANUAL

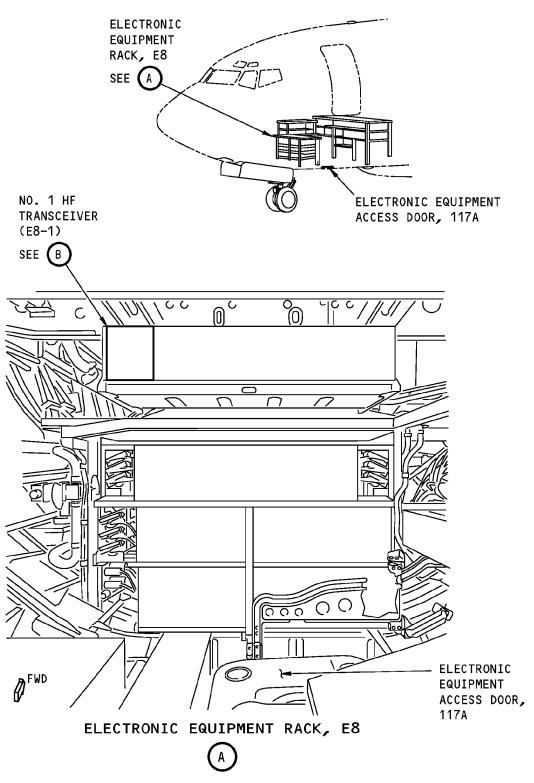
HF Transciever Installation Figure 201 / 23-11-00-990-830

HAP 038, 041-047, 049-054; HAP 037, 039, 040 POST SB 73723-1299

- (c) Make sure that these conditions occur:
 - 1) All three LEDs on the HF transceiver front panel turn red for one to three seconds.
 - 2) The LRU STATUS LED turns green and the KEY INTERLOCK and CONTROL FAIL LEDs stay red for one to three seconds.
 - 3) All three LEDs go off for one to seven seconds.
 - 4) The LRU STATUS LED comes on green for about 30 seconds and the KEY INTERLOCK and CONTROL FAIL LEDs stay off.

- (a) Push and hold the TEST switch on the HF transceiver front panel.
 - 1) Make sure that the LRU FAIL, COUPLER FAIL, and EXTERNAL INPUT FAIL lights come on and stay on.

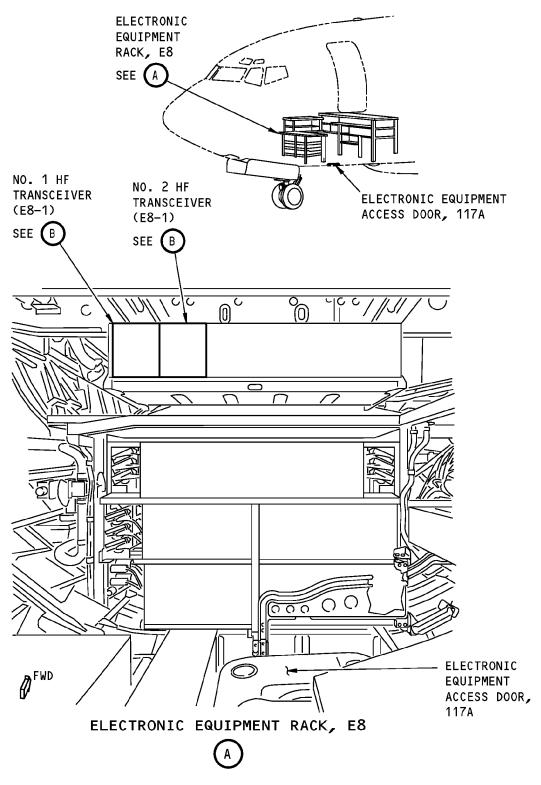
HF Transceiver Installation Figure 202 / 23-11-00-990-829

EFFECTIVITY
HAP 048
D633A103-HAP

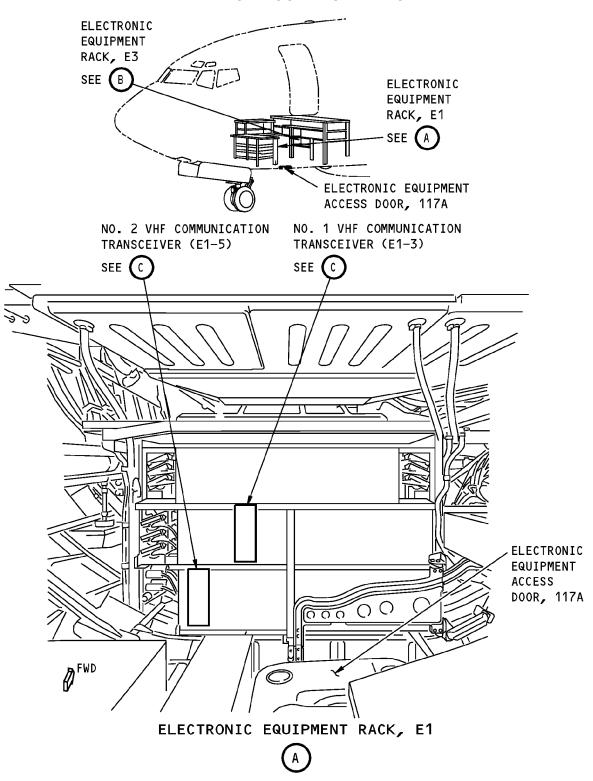
VHF Communication System Installation Figure 201 (Sheet 1 of 2)/ 23-12-00-990-803

NO. 3 VHF COMMUNICATION TRANSCEIVER (E3-3)

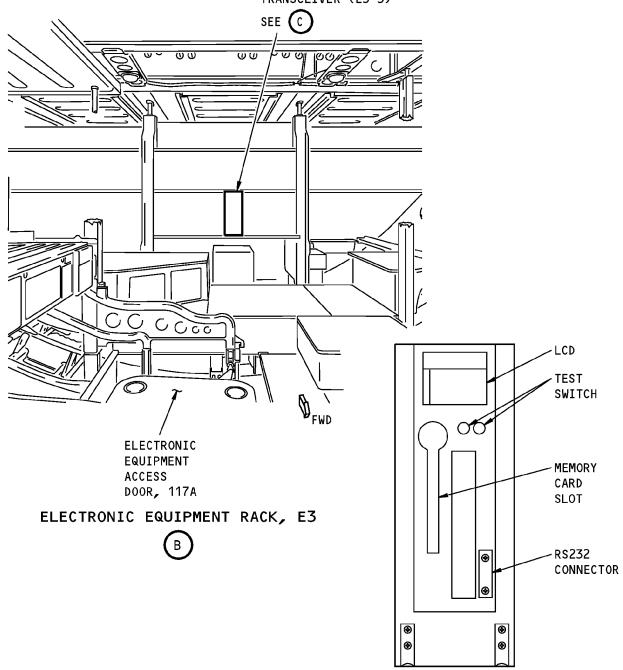
VHF Communication System Installation Figure 201 (Sheet 2 of 2)/ 23-12-00-990-803

VHF COMMUNICATION TRANSCEIVER

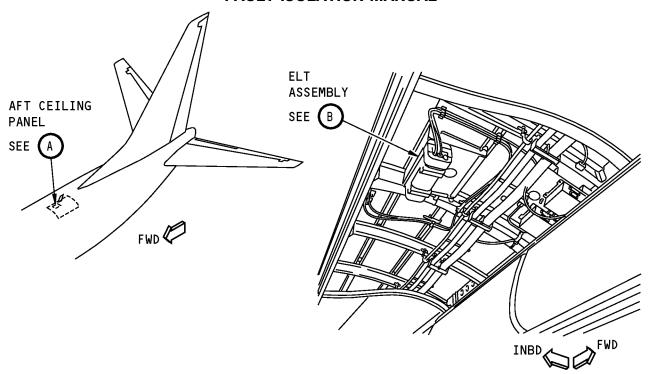
Emergency Locator Transmitter (ELT) Figure 201 (Sheet 1 of 2)/ 23-24-00-990-803

AFT CEILING PANEL (REMOVED)

- (1) Do the BITE procedure for the ELT as follows (Figure 201):
 - (a) On the ELT front panel, put the ON/OFF switch to ON for less than 15 seconds.
