Service Bulletin

Model: TA-AX311

No. 235

Subject: Incorrect Part Number: D957

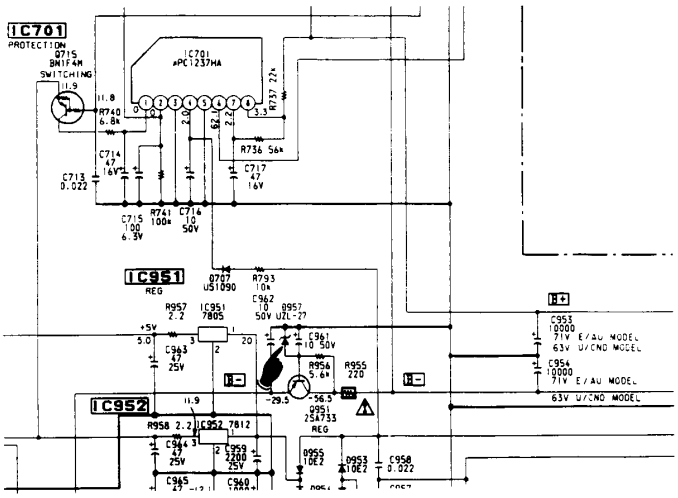
[AMP-R BOARD]

Symptom:
(**) The schematic diagram indicates a type UZL-27 for D957 and the parts list description indicates a type HZS30-1L.

Solution: The correct component type to be used as replacement for D957 is shown below:

REFERENCE	DESCRIPTION	PART NUMBER
D957	UZL-27H	8-719-002-48
