**737-600/700/800/900
AIRCRAFT MAINTENANCE MANUAL**

**CHAPTER 56
WINDOWS**

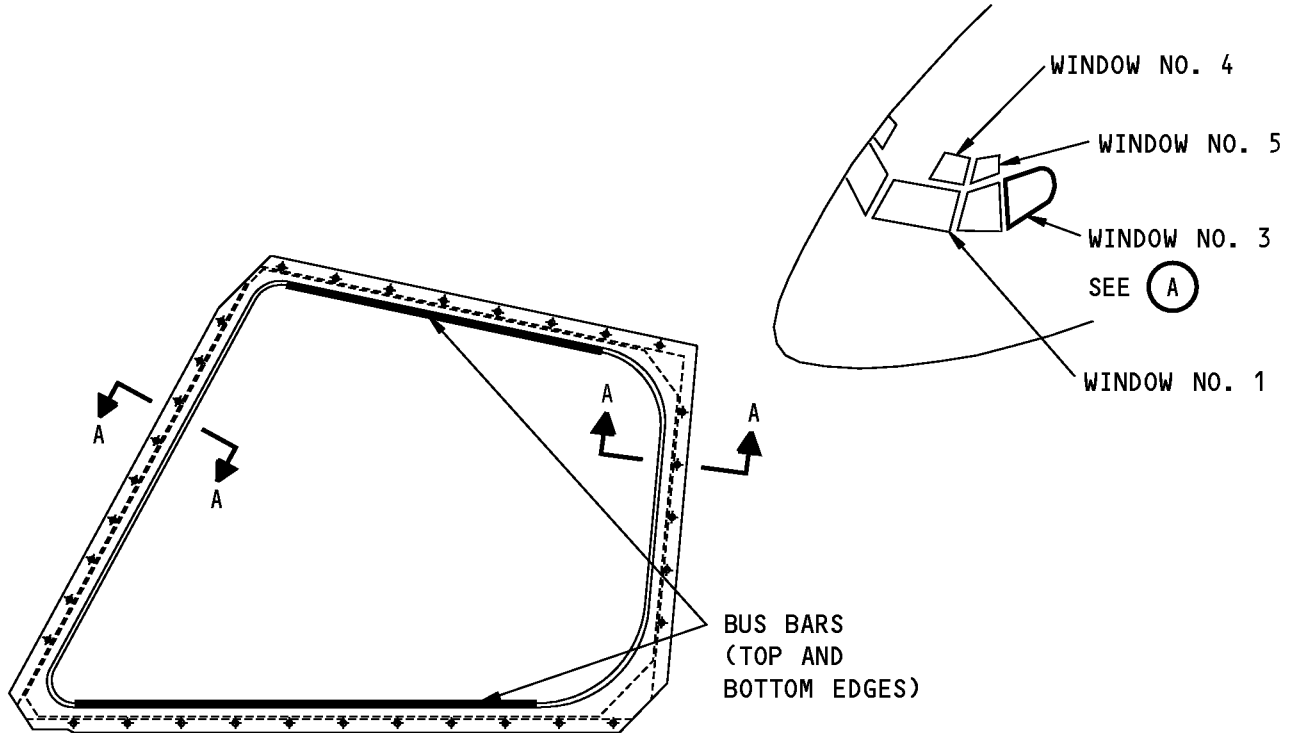
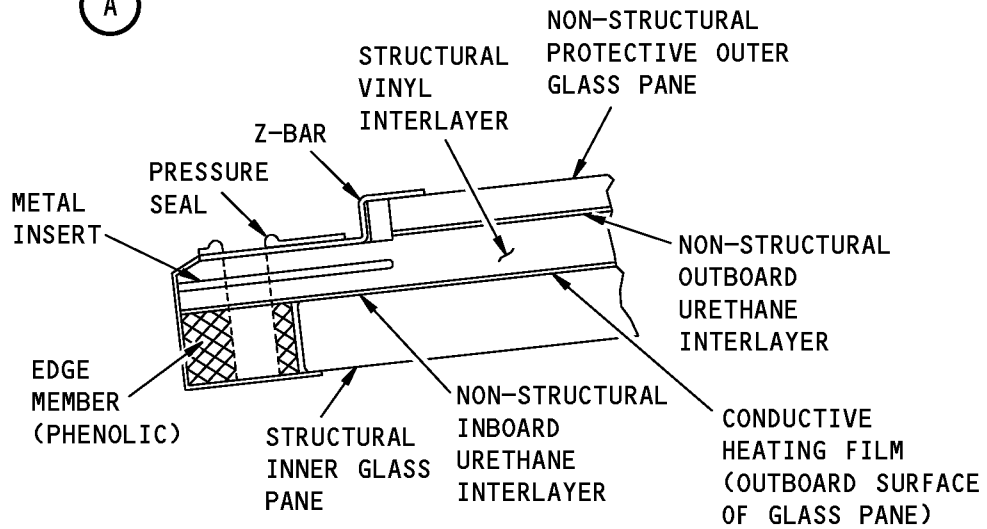
**Flight Compartment No. 3 Window – Cross Sections
Figure 602 (Sheet 1 of 2)/56-11-00-990-808**

**WINDOW NO. 3
(GLASS)
A-A**

(Figure 602)

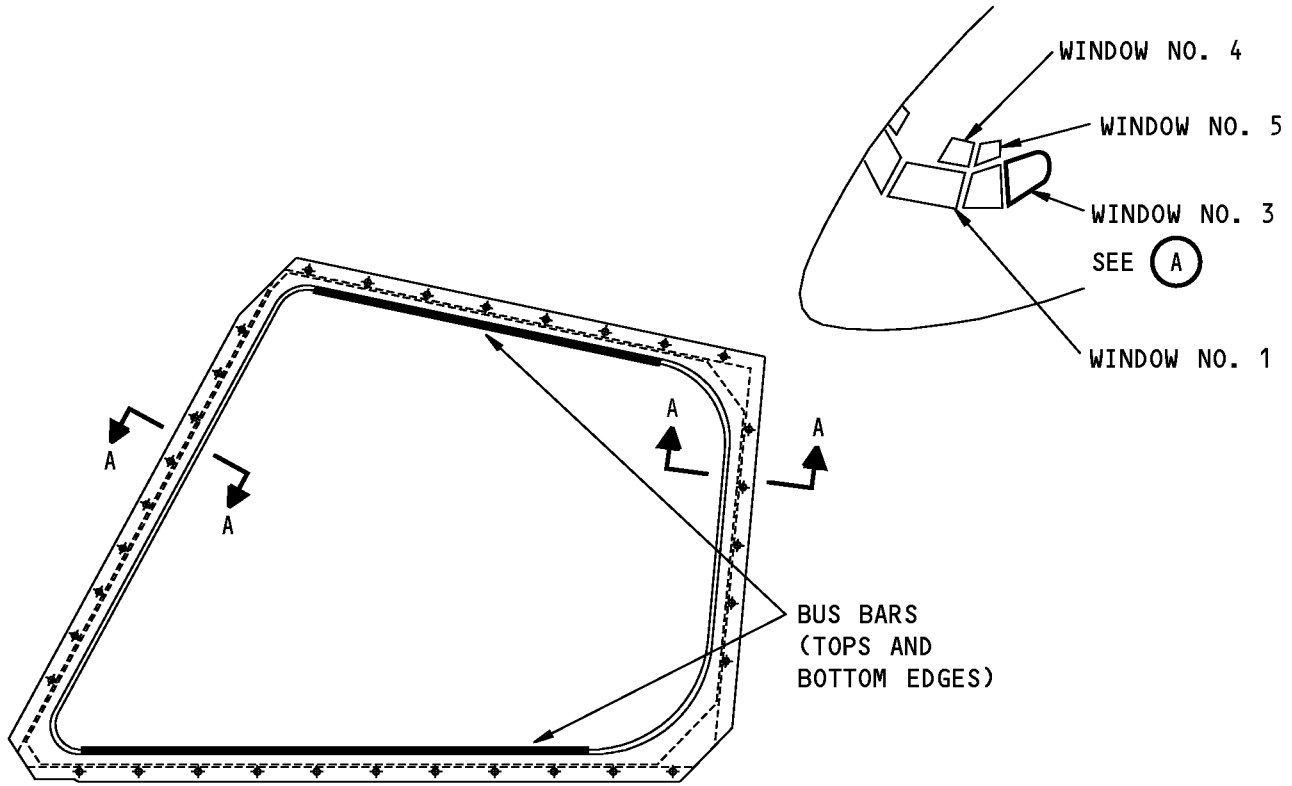
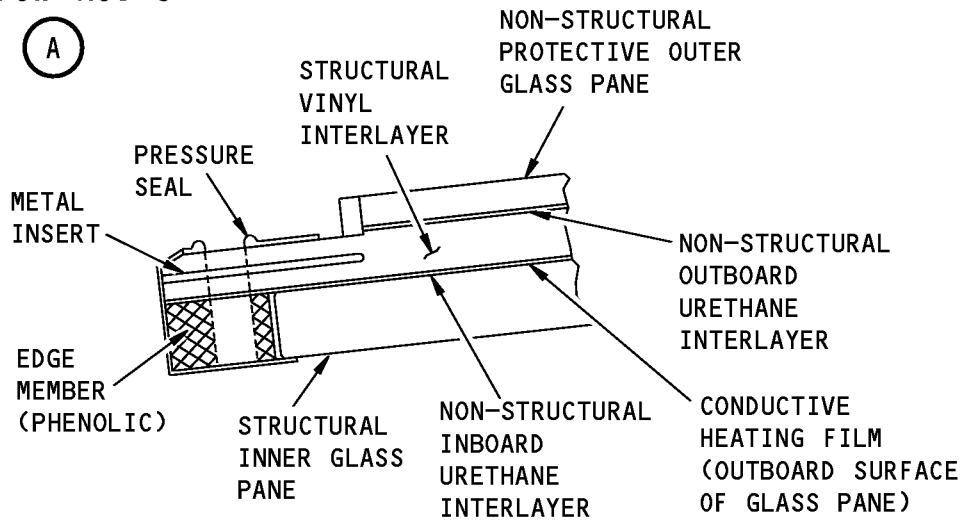
**Flight Compartment No. 3 Window – Cross Sections
Figure 602 (Sheet 2 of 2)/56-11-00-990-808**

WINDOW NO. 3
(GLASS)
A-A

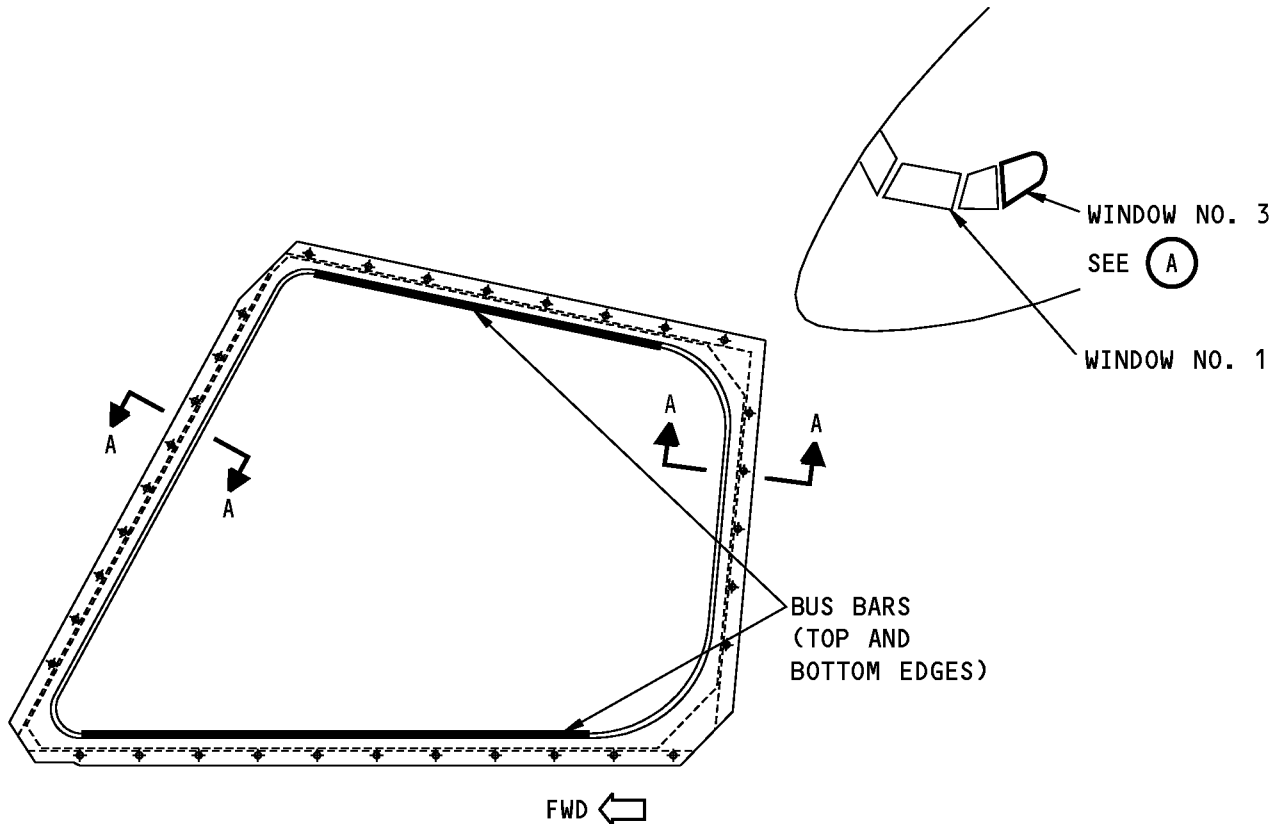
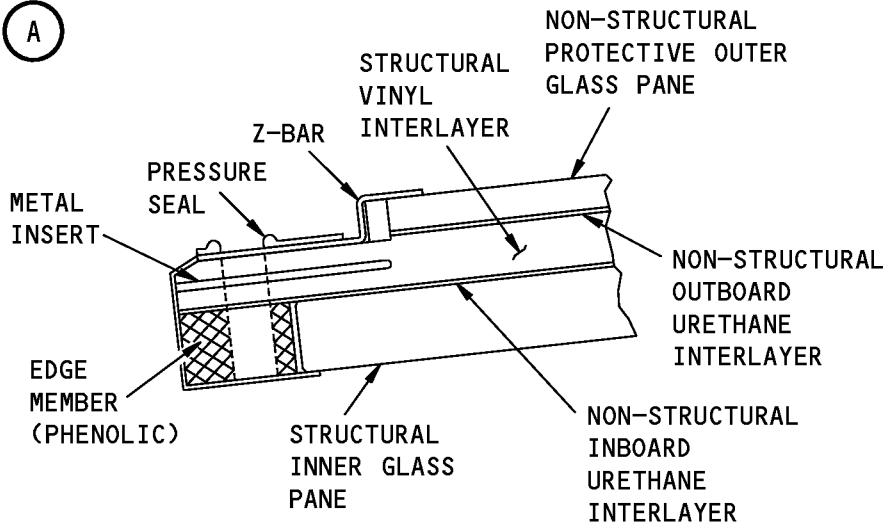
**Flight Compartment No. 3 Window – Cross Sections
Figure 603 (Sheet 1 of 2)/56-11-00-990-824**

WINDOW NO. 3
(GLASS)
A-A

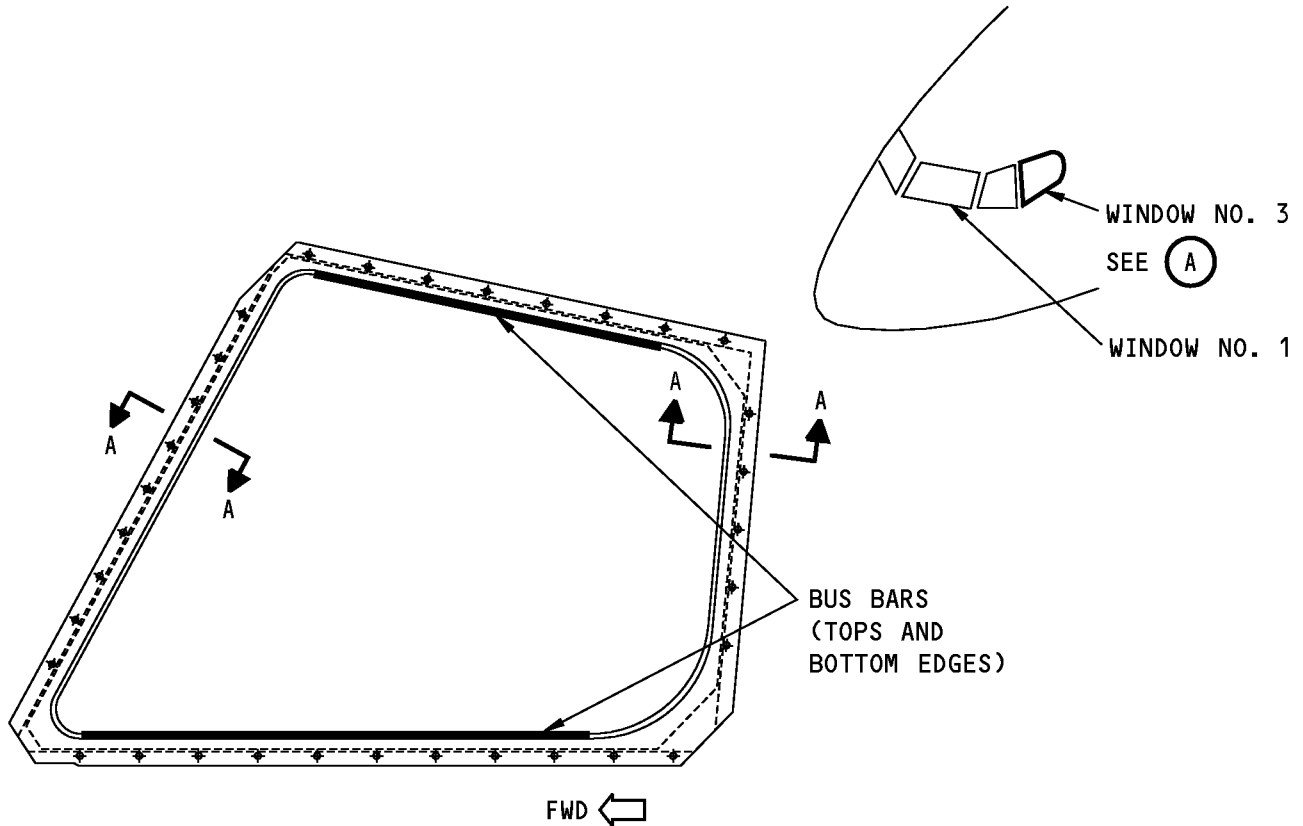
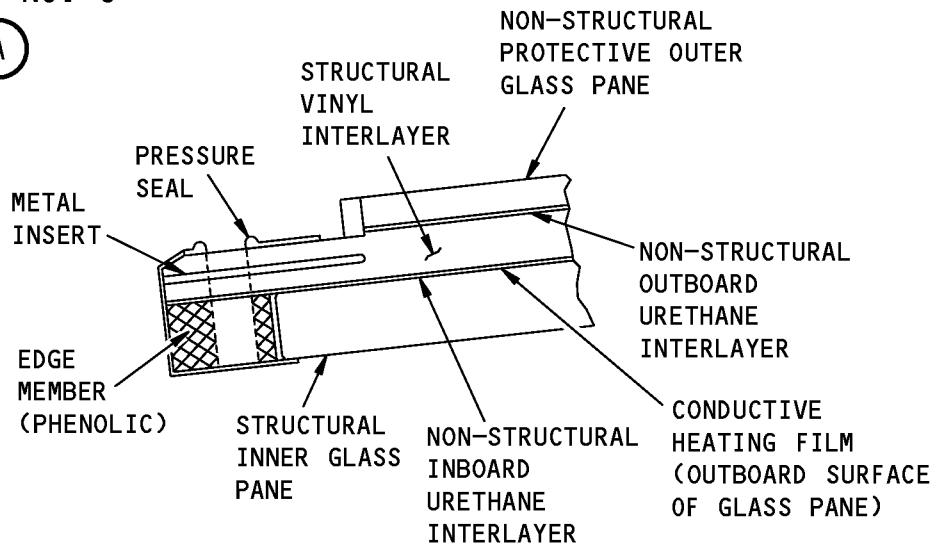
**Flight Compartment No. 3 Window – Cross Sections
Figure 603 (Sheet 2 of 2)/56-11-00-990-824**

WINDOW NO. 3

(GLASS)

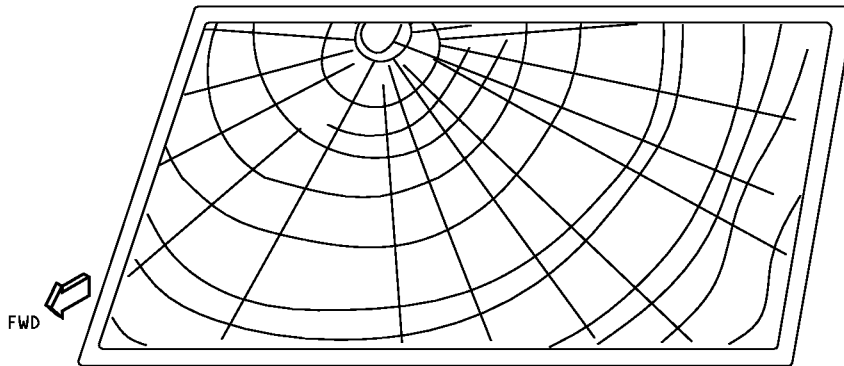
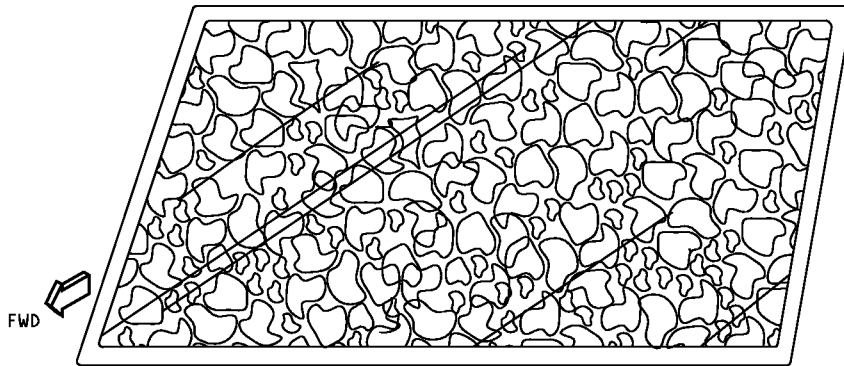
Glass Pane Cracks
Figure 604/56-11-00-990-812

GLASS PANE CRACKS
(NON-STRUCTURAL)

GLASS PANE CRACKS
(STRUCTURAL)

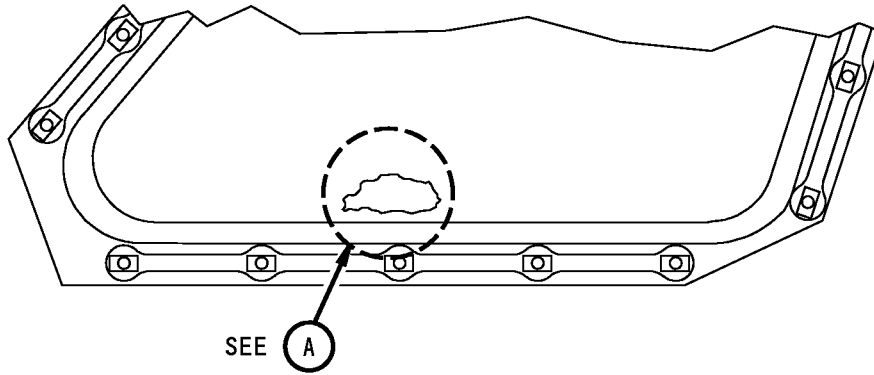
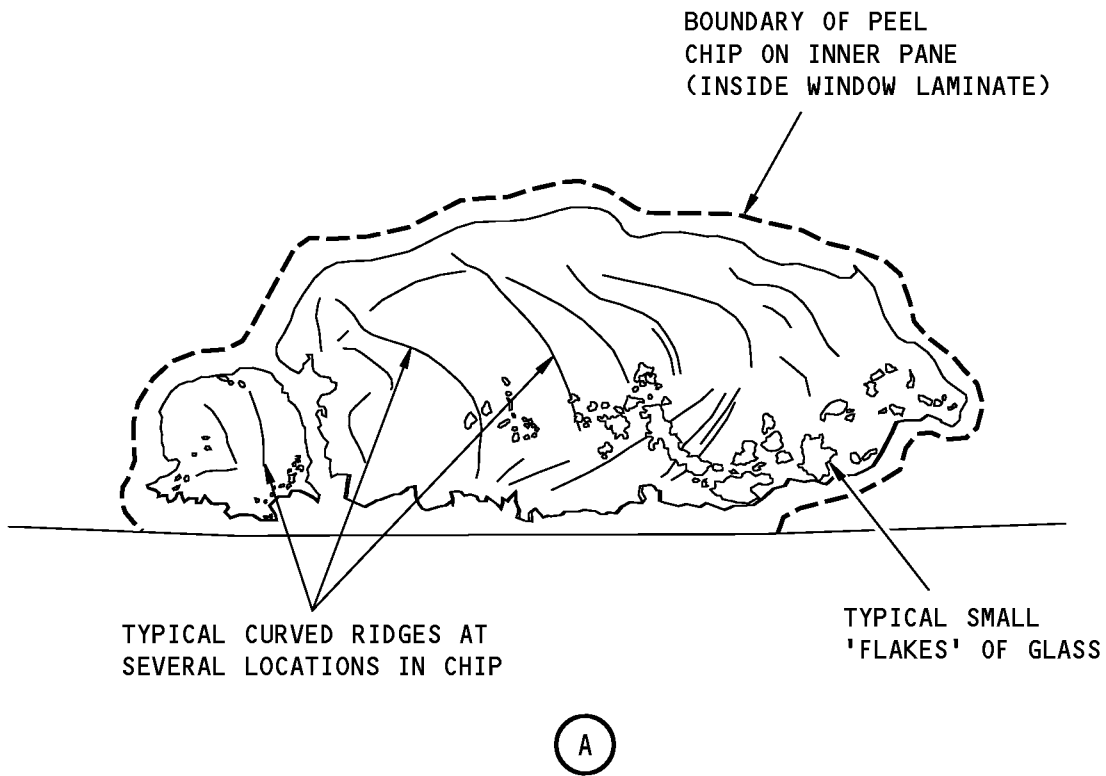
Peel Chip
Figure 606/56-11-00-990-816

(TYPICAL)

- 2) “V” shaped chips have the shape of a sharp narrow “V”. Depth of the chip is equal to or larger than the width.
- (b) Internal chips:
- 1) Peel Chips - Chips that occur on the internal surface of glass panes. Chipped areas have a curved, rough grained shape, and are easily seen in reflected light. The chipped area can have small glass flakes, usually white. The view through the window will distort through the rough surface of the chip. Usually the chips start very small but can continue to grow with the continued use of the airplane. (Example: Figure 606).

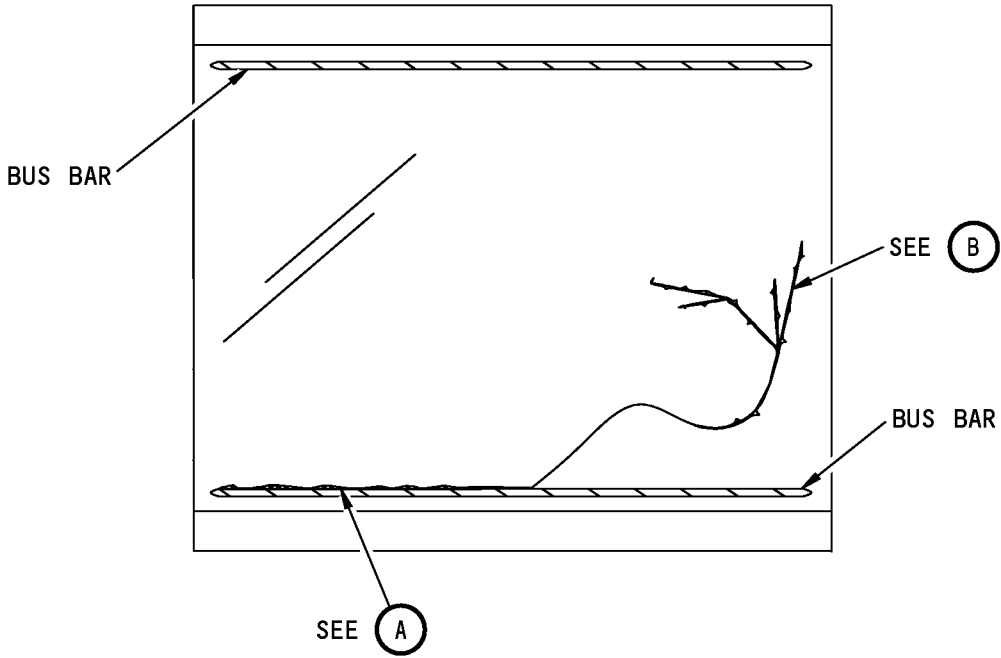
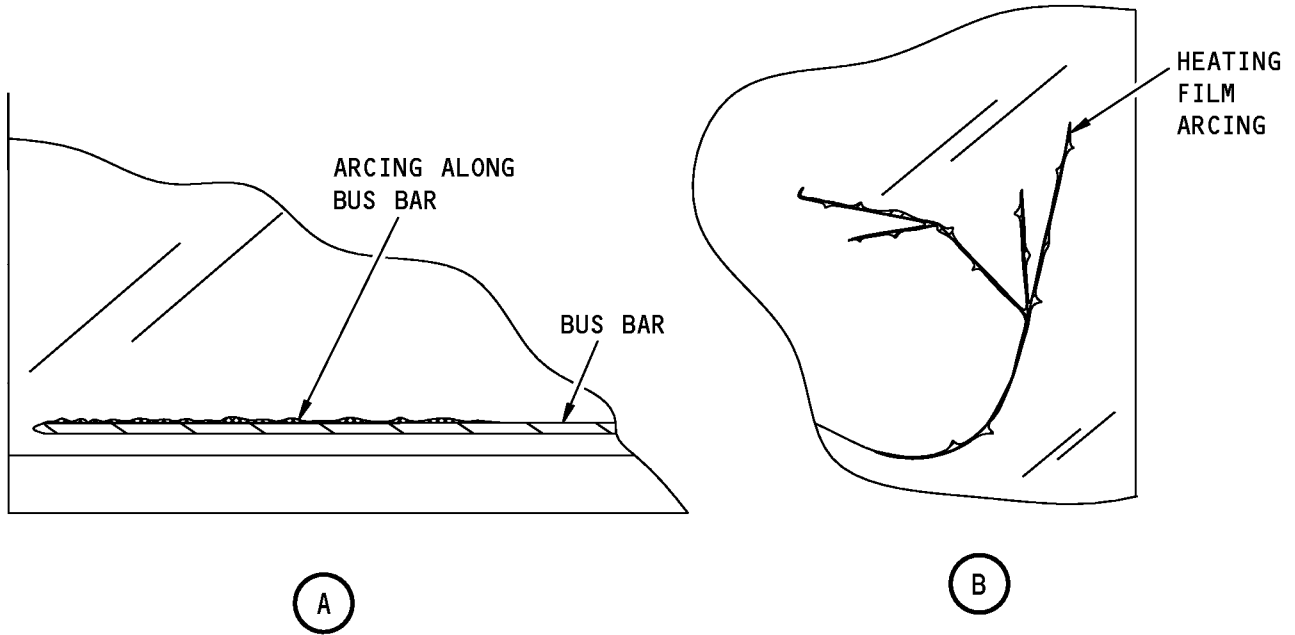
**Window Heat Arcing
Figure 607/56-11-00-990-817**

WINDOW HEAT ARCING

- (1) **Arcing:** An electrical arc is a discharge or short circuit across a discontinuity in a wire, bus bar, conductive heating film, or other internal window components. Arcs usually occur near the window bus bars, and are typically the result of moisture ingress. The heat from an arc can cause dark brown or black burn marks on the bus bar and in the interlayer or the fracture of a glass pane. It is also possible to see small bubbles in the interlayer at the location of an arc. Arcs in the heating film away from the bus bar can occur as a jagged line and is also known as a line arc (Example: Figure 607) (“lightning bolt pattern”).

- (3) Examine the windshield for arcing (Example: Figure 607):

(3) Examine the window for arcing (Example: Figure 607):

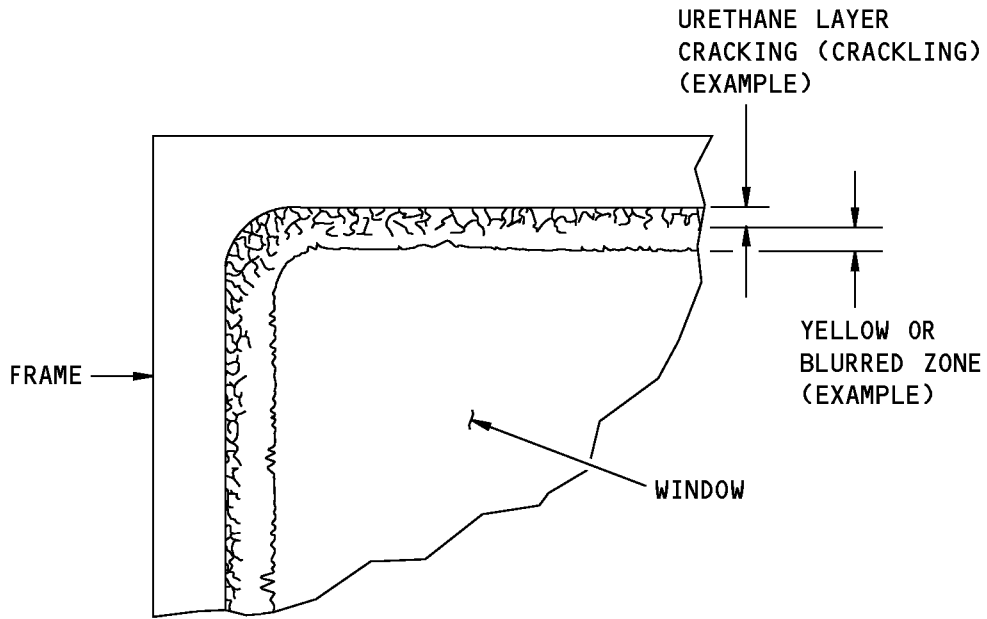
Urethane Interlayer Cracks
Figure 608/56-11-00-990-818

URETHANE INTERLAYER CRACKS

- (b) Interlayers:
- 1) Urethane – Cracks can occur in urethane interlayer around the outboard edge of the window and at bolt hole locations. The cracks are usually in a network that does not run parallel to the edges of the window and are usually in random directions (also referred to as crackling). Urethane interlayer cracks frequently occur with white or yellow discoloration. See also moisture ingress. (Examples: Figure 608).

- (6) Examine the window for cracks in the vinyl interlayer:
- (a) Examine the vinyl interlayer for cracks along the edges of the metal insert.
 - (b) Examine the vinyl interlayer for cracks that extend out from the bolt holes.
 - (c) Replace the window if you find cracks in the vinyl interlayer (Examples: Figure 610, Figure 608).

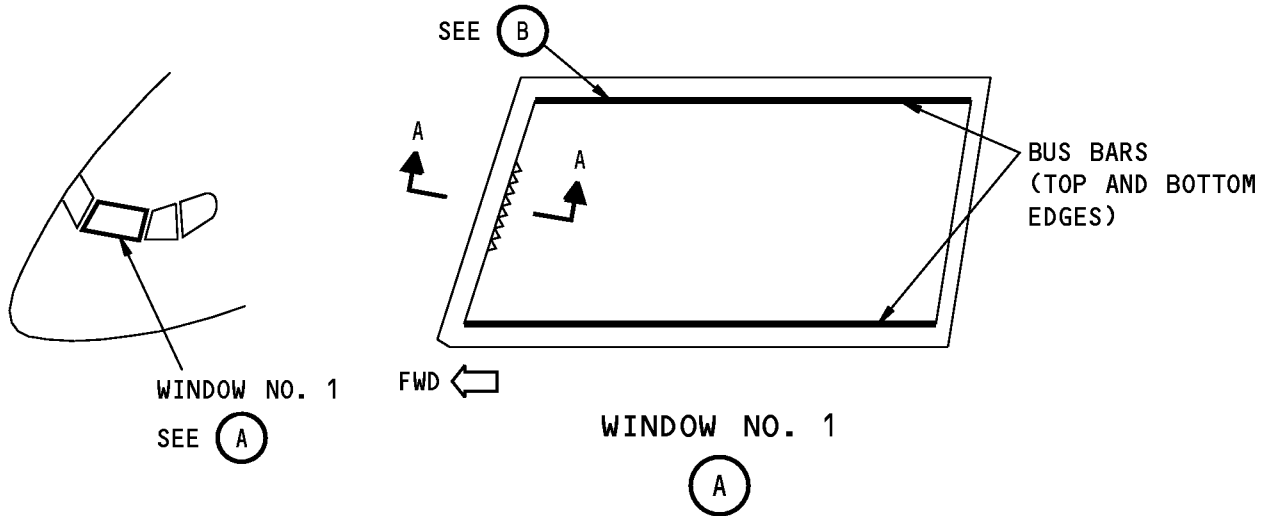
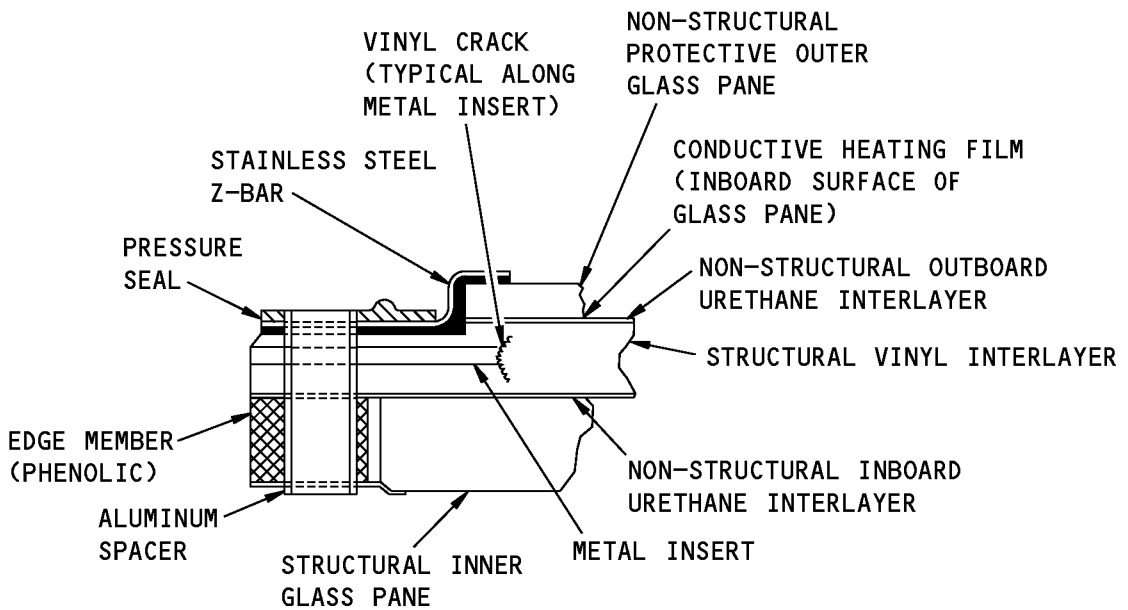
**Windshield Structural Vinyl Interlayer Cracks
Figure 609 (Sheet 1 of 2)/56-11-00-990-819**

WINDOW NO. 1 VINYL CRACK (TYPICAL) A-A

- 2) Vinyl – Cracks that can occur in the vinyl interlayer around the perimeter of the window and follow or extend from the edges of internal features, for example, the metal inserts, or bolt holes. The cracks usually appear as thick or broken lines perpendicular to the window panes. It is possible in some extreme conditions to see the vinyl interlayer as stretched or separated from the metal insert. (Examples: Figure 609).

- (a) Examine the vinyl interlayer for cracks along the edges of the metal insert.
- (b) Examine the vinyl interlayer for cracks that extend out from the bolt holes.
- (c) Replace the windshield if you find cracks in the vinyl interlayer (Examples: Figure 609).

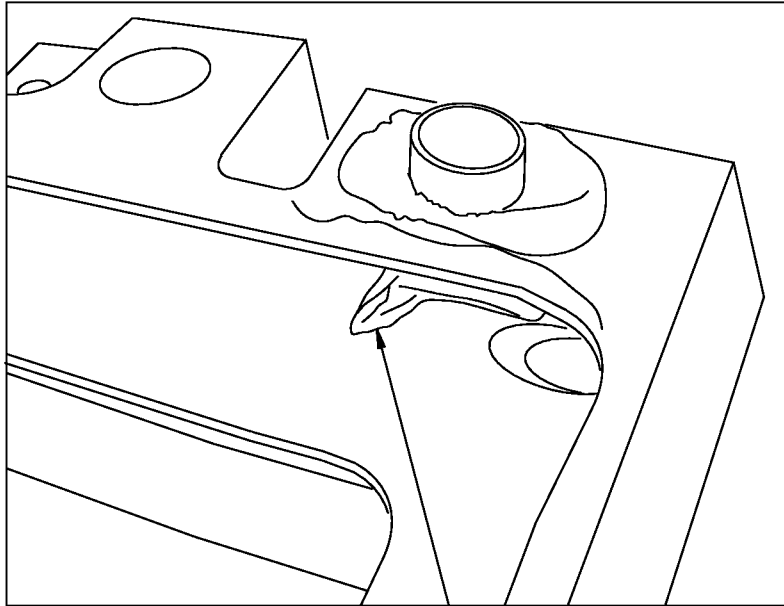
**Windshield Structural Vinyl Interlayer Cracks
Figure 609 (Sheet 2 of 2)/56-11-00-990-819**

VINYL CRACK
(EXTENDS FROM
BOLT HOLE)

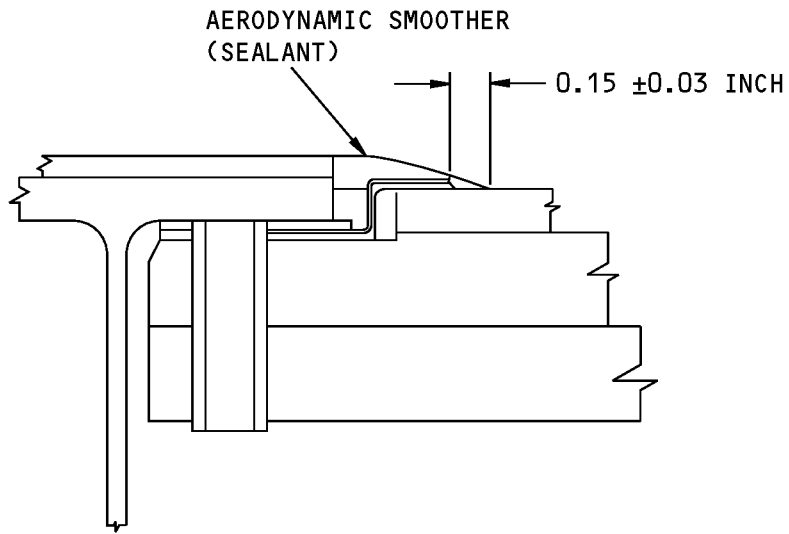
Aerodynamic Smoother Application
Figure 801 (Sheet 1 of 3)/56-11-00-990-801

SEALANT SHAPE - WINDOW NO. 1

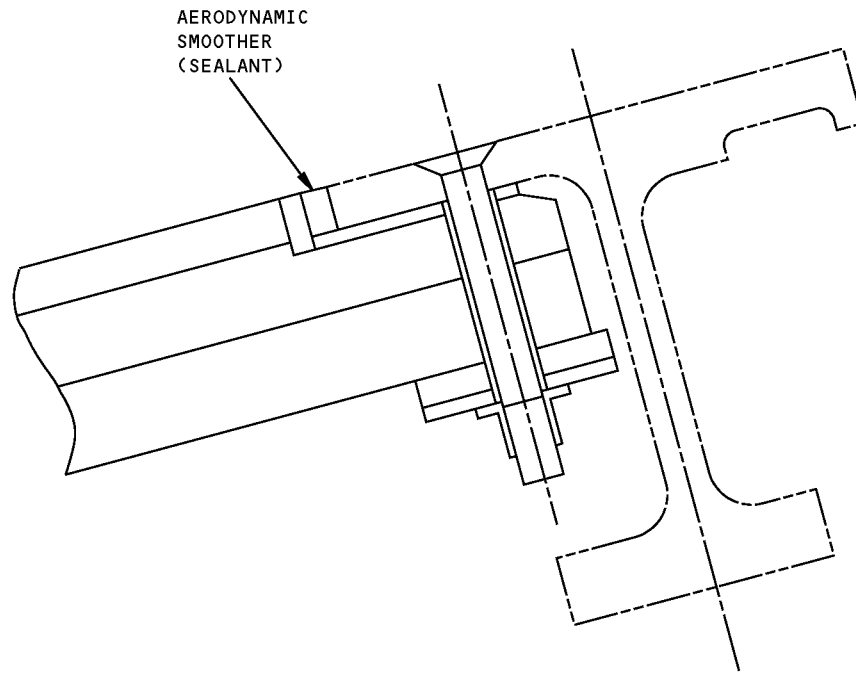
Aerodynamic Smoother Application
Figure 801 (Sheet 2 of 3)/56-11-00-990-801

SEALANT SHAPE - WINDOW NO. 3

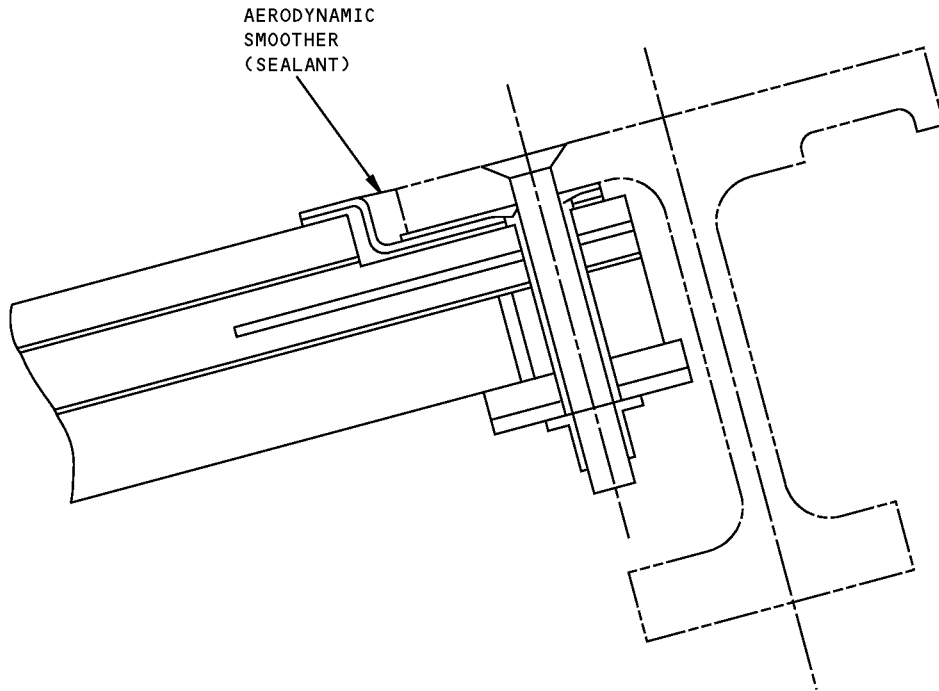
**Aerodynamic Smoother Application
Figure 801 (Sheet 3 of 3)/56-11-00-990-801**

SEALANT SHAPE – WINDOW NO. 3

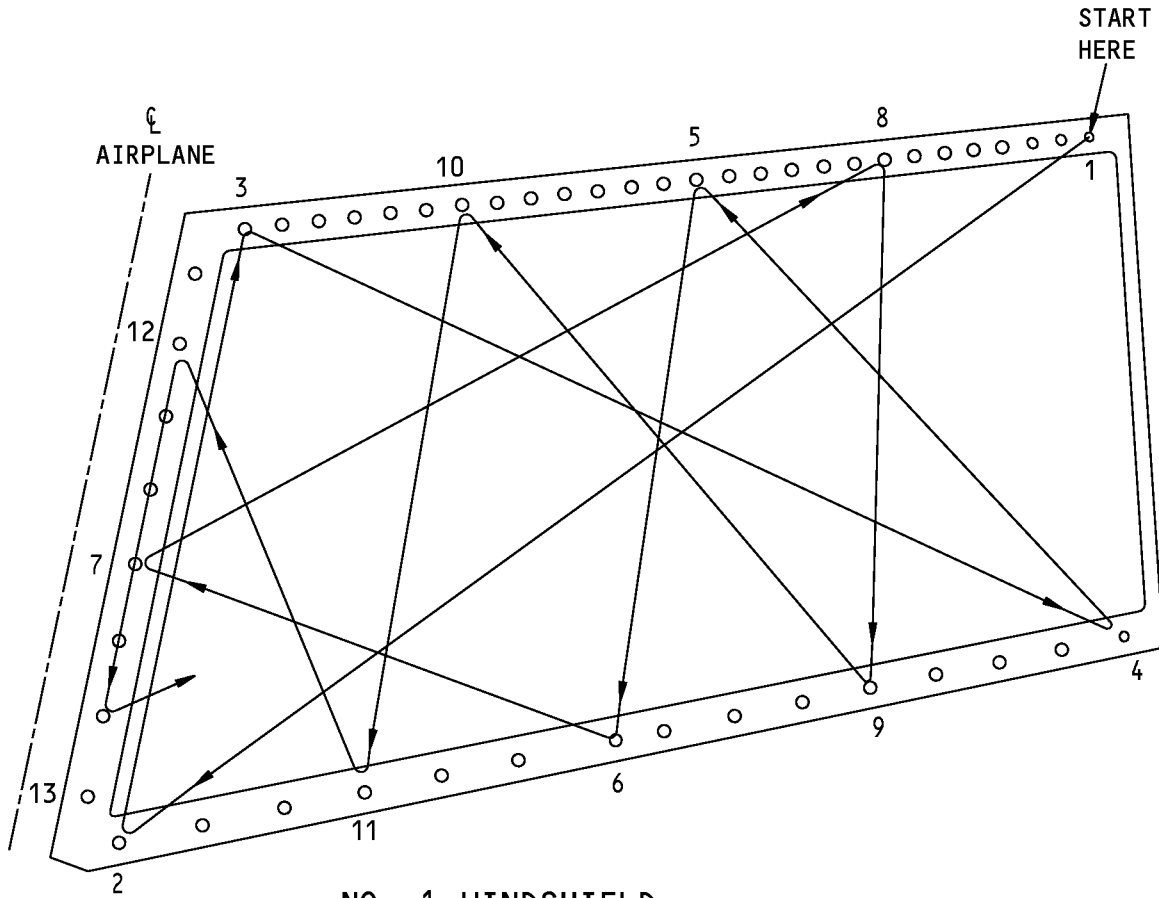
**NO. 1 WINDSHIELD
(VIEW FROM OUTSIDE)
(LEFT SIDE IS SHOWN, RIGHT SIDE IS OPPOSITE)**

NOTE: THIS IS AN EXAMPLE OF HOW YOU CAN TIGHTEN THE FASTENERS FOR THE WINDOW. ANY PATTERN THAT IS ALMOST THE SAME IS PERMITTED. FIRST ATTACH THE WINDOW AT AS MANY POINTS THAT ARE OPPOSITE ON THE WINDOW. DO THIS AS EARLY IN THE FASTENER TORQUE SEQUENCE AS POSSIBLE. CONTINUE IN THIS PATTERN. ALWAYS GO TO A FASTENER THAT IS IN THE MIDDLE OF TWO INSTALLED FASTENERS. YOU MUST GO TO A SIDE OTHER THAN THE SIDE ON WHICH A FASTENER WAS JUST TIGHTENED.

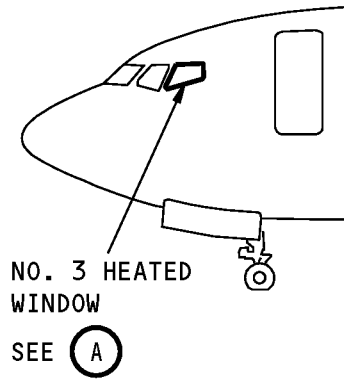
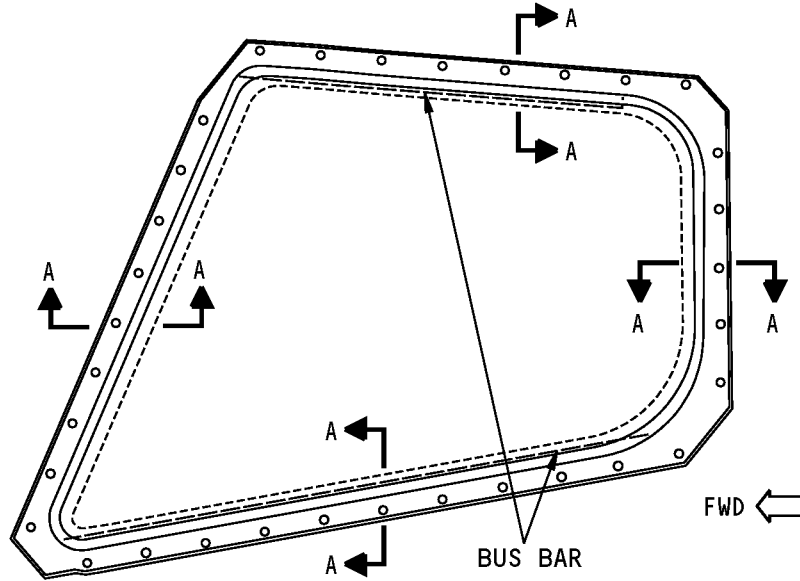
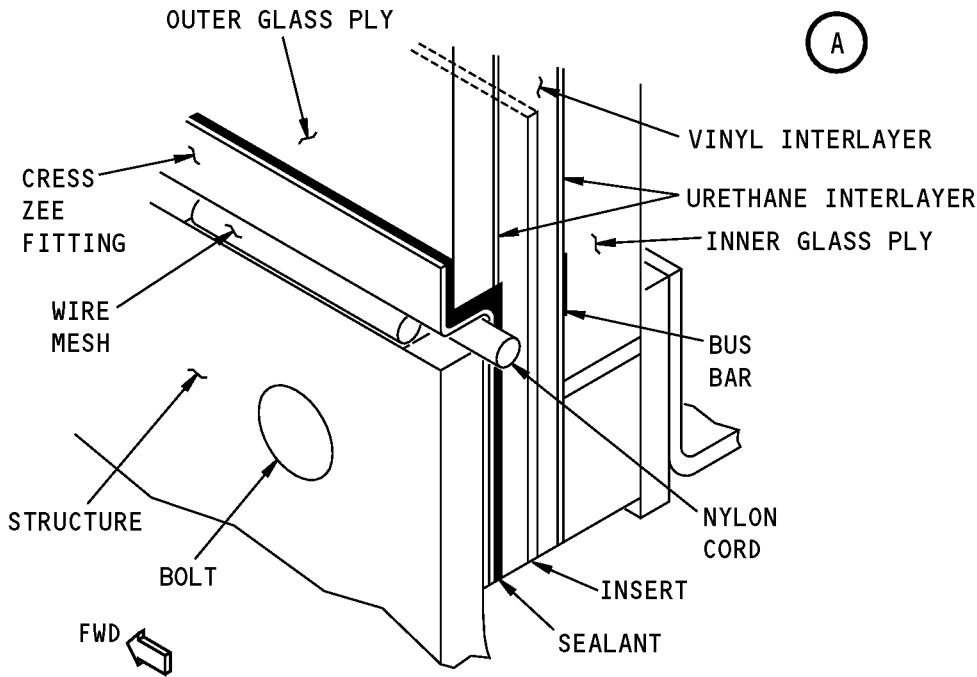
Wire Mesh Installation
Figure 402/56-11-21-990-806

NO. 3 HEATED WINDOW
(LEFT SIDE IS SHOWN,
RIGHT SIDE IS OPPOSITE)

WIRE MESH INSTALLATION
(EXAMPLE)
A-A

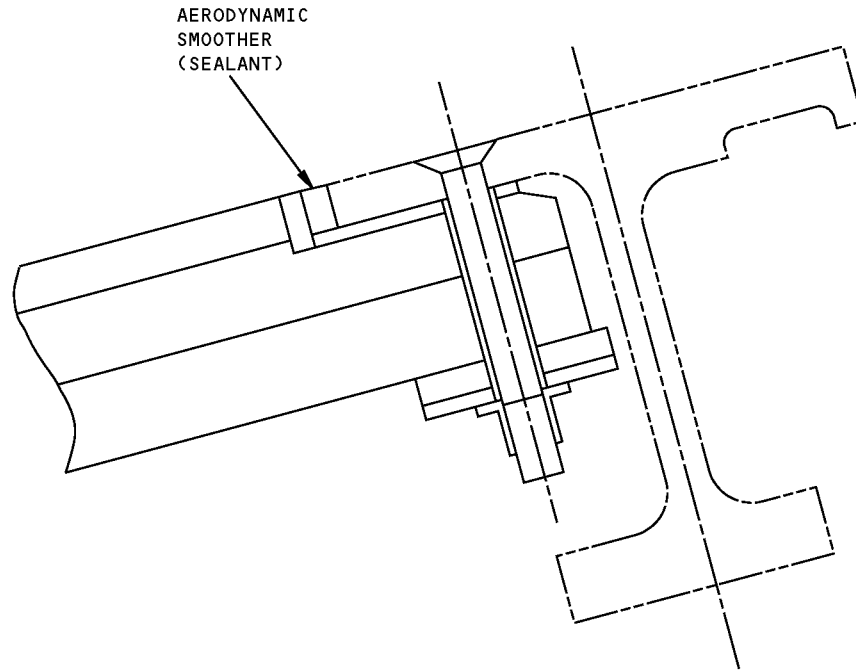
Aerodynamic Smoother Application
Figure 403 (Sheet 1 of 2)/56-11-21-990-811

SEALANT SHAPE - WINDOW NO. 3

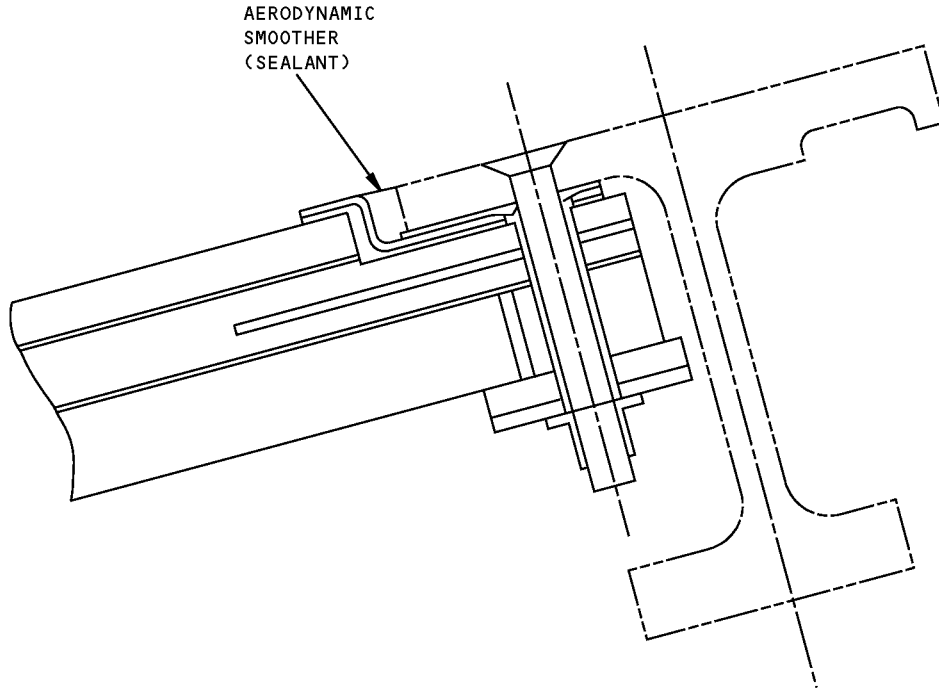
**Aerodynamic Smoother Application
Figure 403 (Sheet 2 of 2)/56-11-21-990-811**

SEALANT SHAPE – WINDOW NO. 3

- (1) The spacer that is on the window assembly will bend the aerodynamic sealant on the structure around the end of the spacer. Do not repair the sealant in this area on subsequent window installations.
- (2) In all other areas, repair any aerodynamic sealant that has damage.
- (3) The aerodynamic sealant must be flat within 0.00 ± 0.03 in. (0.000 ± 0.762 mm) around the entire edge of the window. To make sure a large repair will be flat, use a faceplate, with a surface identical to the window, and clamp or bolt it to the window frame. For small repairs, make the aerodynamic sealant smooth with a hand tool.

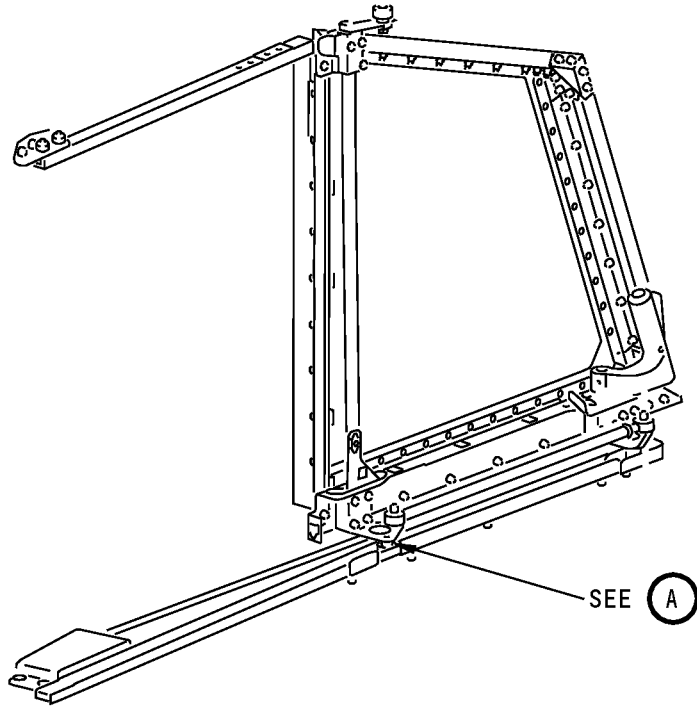
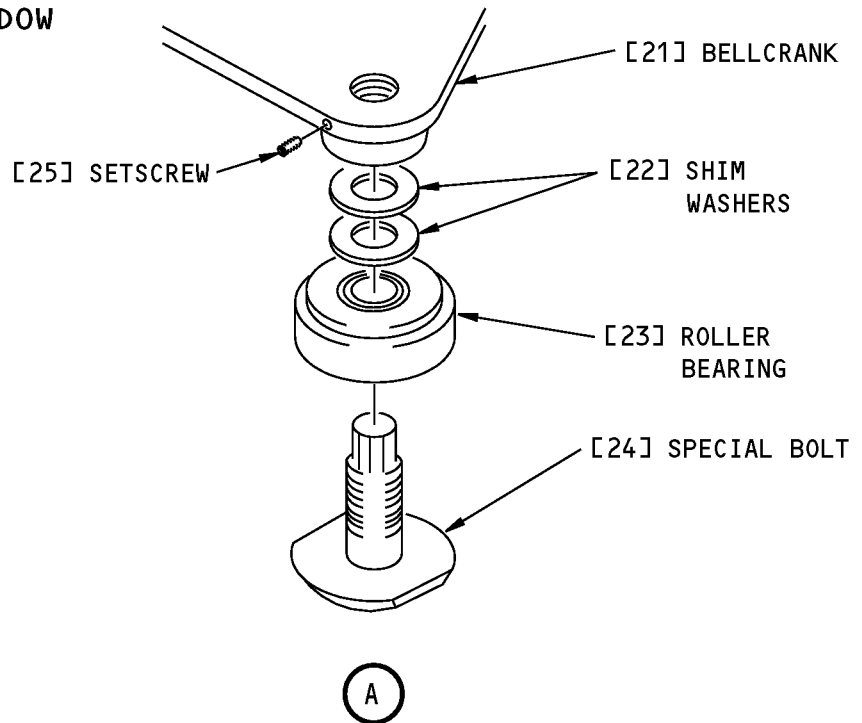
No. 2 Window Bearing Installation
Figure 202/56-12-11-990-802

LEFT NO. 2 WINDOW
(RIGHT NO. 2 WINDOW
IS EQUIVALENT)

(2) Remove the track roller bearing (Figure 202):

(3) Install the new track roller bearing (Figure 202):

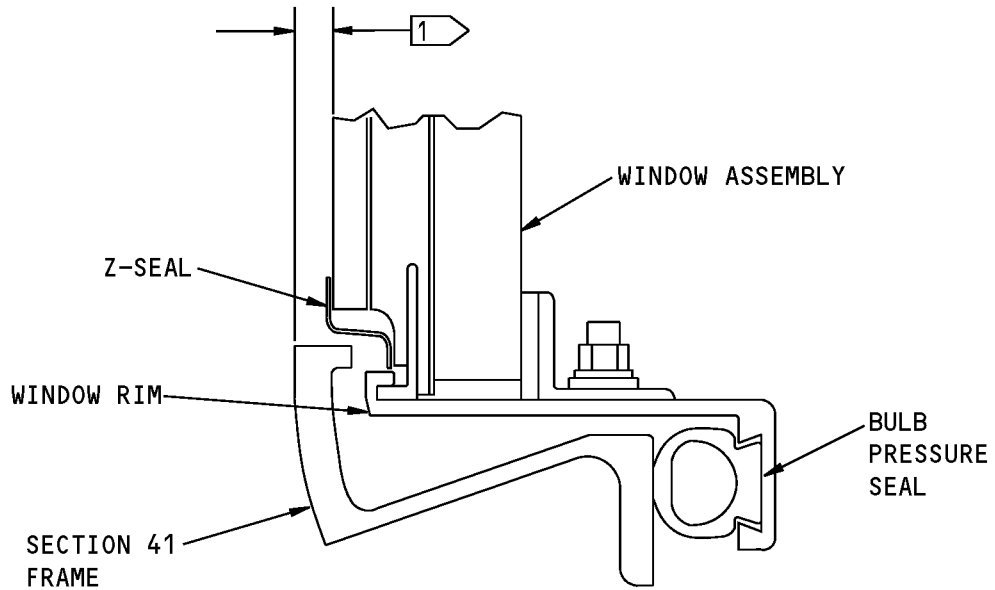
No. 2 Window Adjustment
Figure 501 (Sheet 2 of 5)/56-12-11-990-806

NOTE: WINDOW FAIR NOT PRESSURIZED:
 THE WINDOW RIM CAN RECLINE INWARD
 FROM THE INNER SURFACE OF FRAME
 SUPPORT FLANGE AS SHOWN.

- (9) Do a check of the flushness of the window assembly (Figure 501) (Section A-A):
- The flushness for the forward top corner must be $0.04 + 0.11 / -0.03$ in. ($1.02 + 2.80 / -0.77$ mm).
 - The flushness for the 3 other corners must be $0.04 + 0.06 / -0.03$ in. ($1.02 + 1.53 / -0.77$ mm).

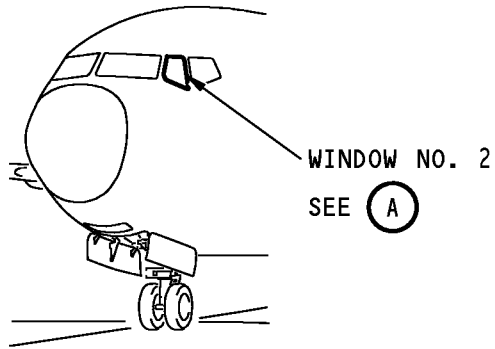
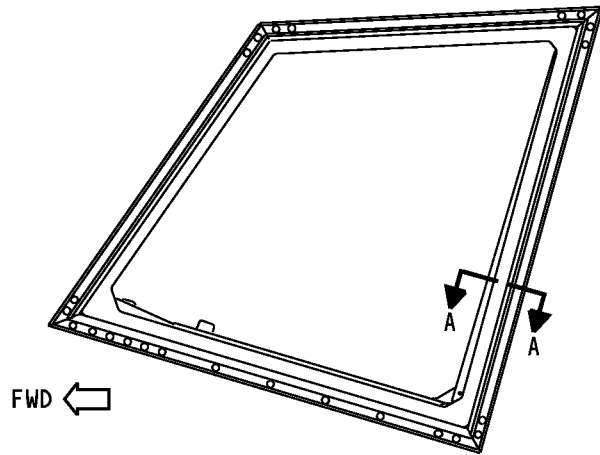
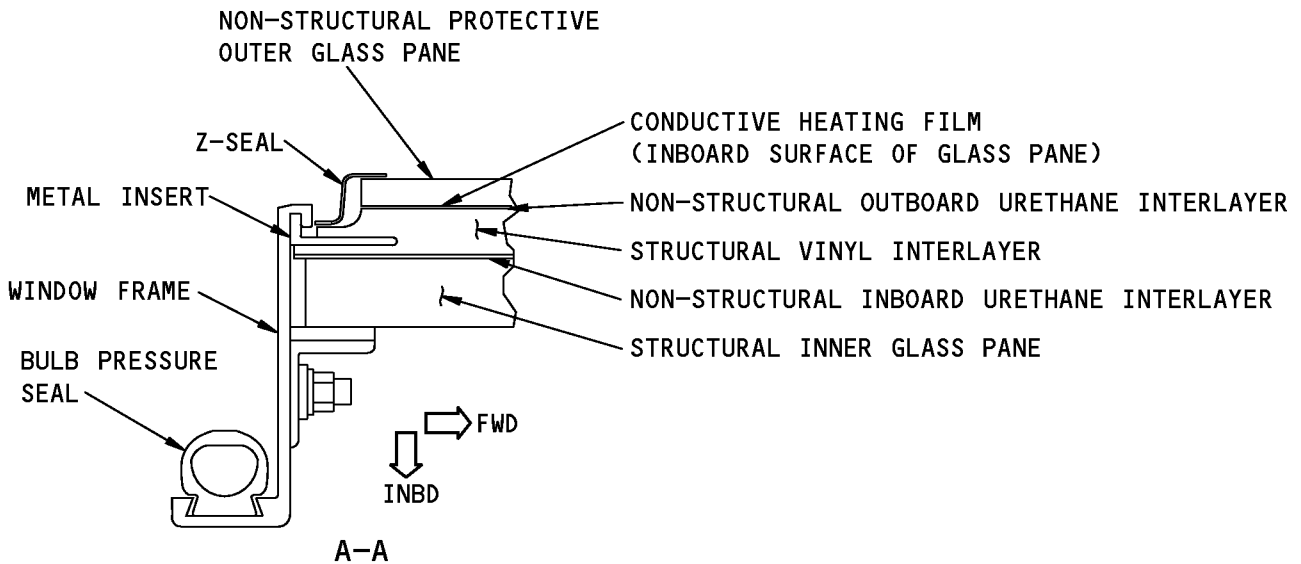
**Control Cabin Window Cross Sections
Figure 602/56-12-11-990-812**

WINDOW NO. 2

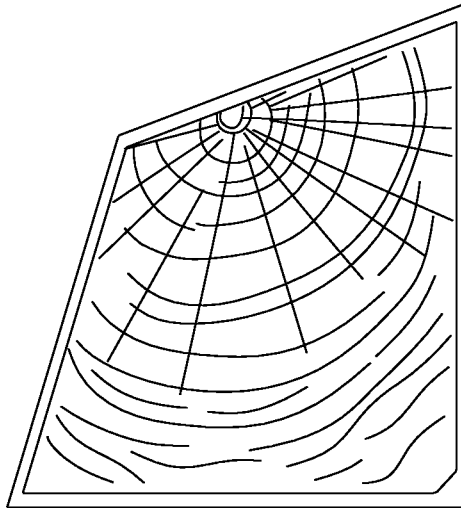
GLASS PANE CRACKS
(NON-STRUCTURAL)

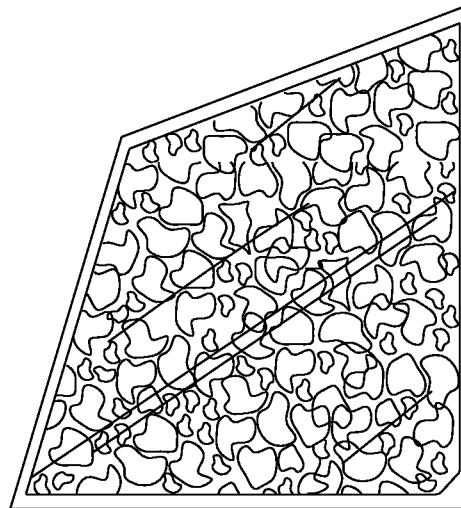
GLASS PANE CRACKS
(STRUCTURAL)

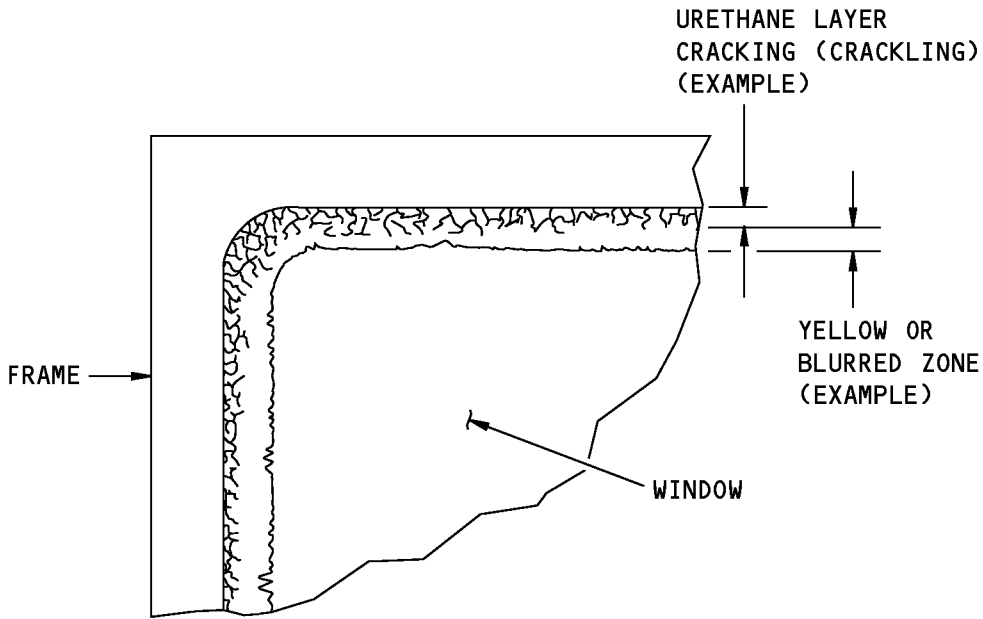
**Urethane Interlayer Cracks
Figure 606/56-12-11-990-817**

URETHANE INTERLAYER CRACKS

- (b) **Interlayers:**
 - 1) **Urethane –** Cracks can occur in urethane interlayer around the outboard edge of the window and at bolt hole locations. The cracks are usually in a network that does not run parallel to the edges of the window and are usually in random directions (also referred to as crackling). Urethane interlayer cracks frequently occur with white or yellow discoloration. See also moisture ingress. (Examples: Figure 606).
