**737-600/700/800/900
AIRCRAFT MAINTENANCE MANUAL**

**CHAPTER 56
WINDOWS**

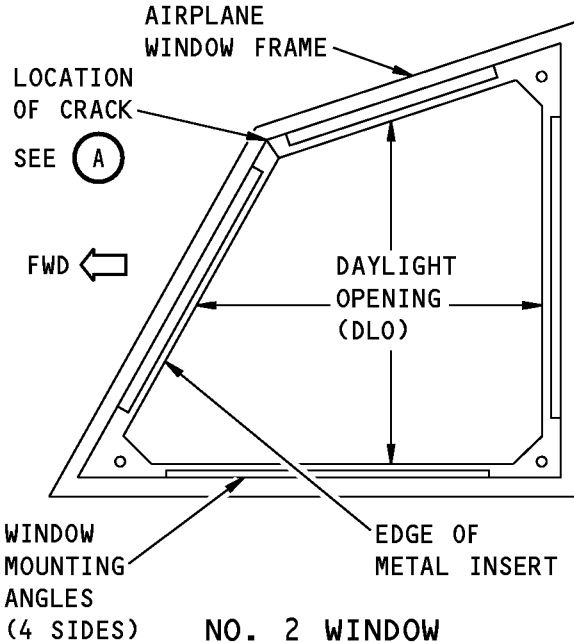
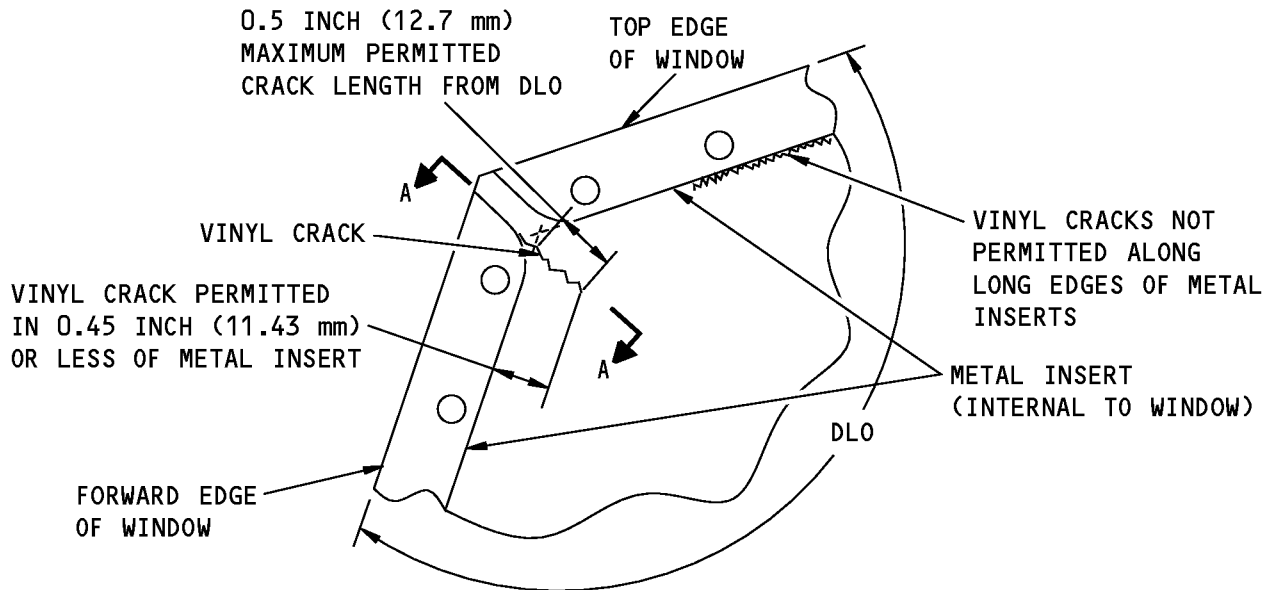
No. 2 Window Vinyl Interlayer Crack Limits
Figure 607 (Sheet 1 of 3)/56-12-11-990-810

NO. 2 WINDOW (RIGHT SIDE)
(VIEW IN THE OUTBOARD DIRECTION)

LOCATION OF CRACK (AIRPLANE WINDOW FRAME NOT SHOWN)

- 2) Vinyl – Cracks that can occur in the vinyl interlayer around the perimeter of the window and usually follow the edges of internal features, for example, the metal inserts, or bolt holes. The cracks are usually thick or broken lines perpendicular to the window panes. It is possible in some extreme conditions to see the vinyl interlayer as stretched or separated from the metal insert. (Examples: Figure 607).

- (a) Replace the window if you find cracks that follow the long edges of the metal insert.(Examples: Figure 607).

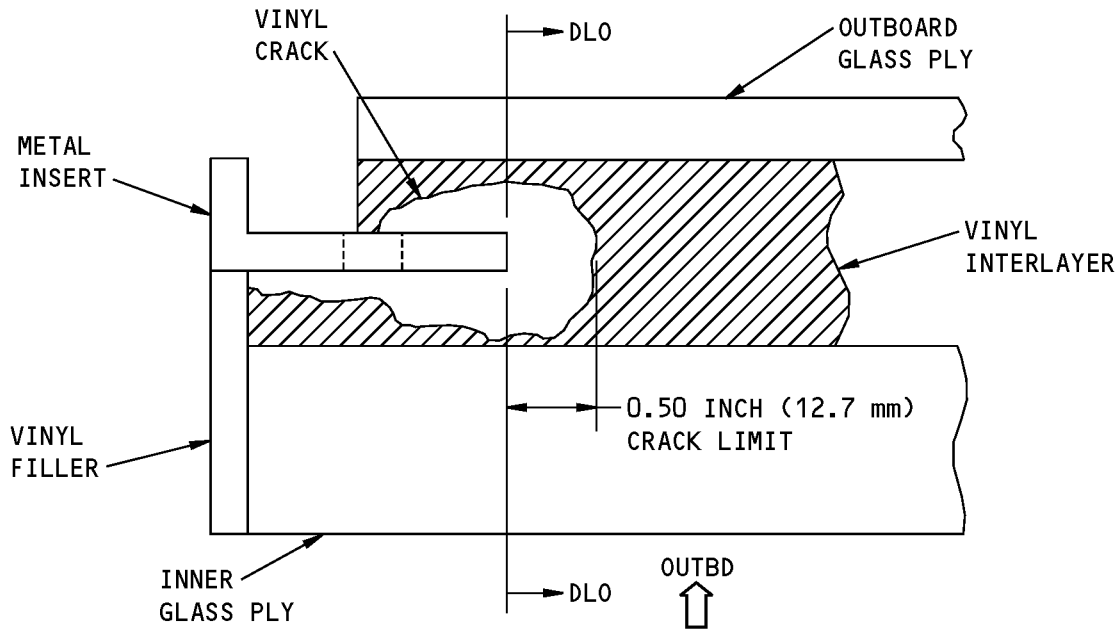
**No. 2 Window Vinyl Interlayer Crack Limits
Figure 607 (Sheet 2 of 3)/56-12-11-990-810**

(AIRPLANE WINDOW FRAME NOT SHOWN)
A-A

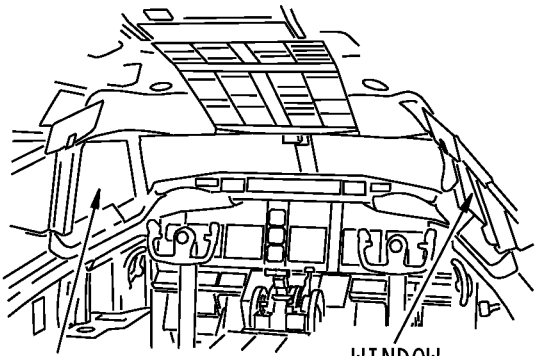
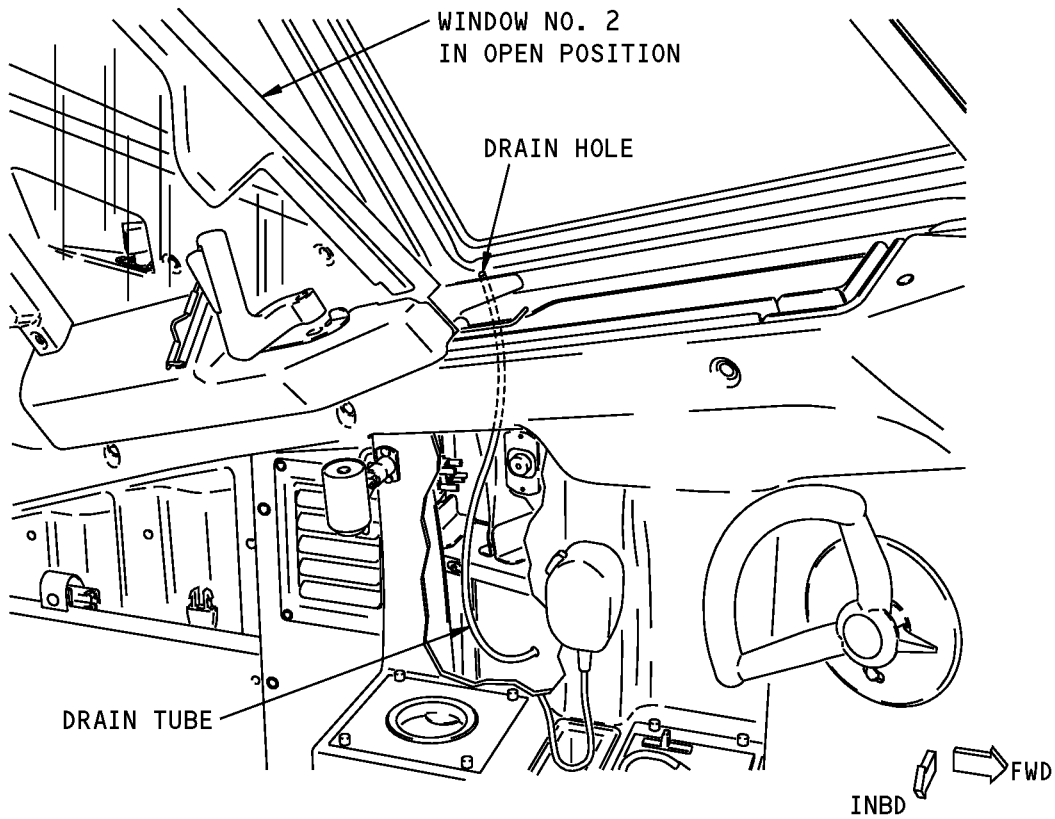
WINDOW
NO. 2

NOTE: LEFT SIDE IS SHOWN,
RIGHT SIDE IS OPPOSITE.

C. Perform a general visual check of the pilot's and co-pilot's no. 2 openable window sill drain for obvious damage, clogging, condition and security.

(a) Examine no. 2 openable window sill drain for obvious damage, condition and security.

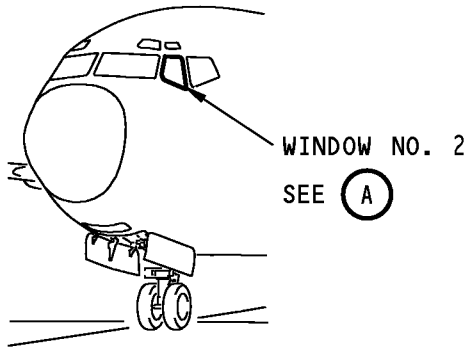
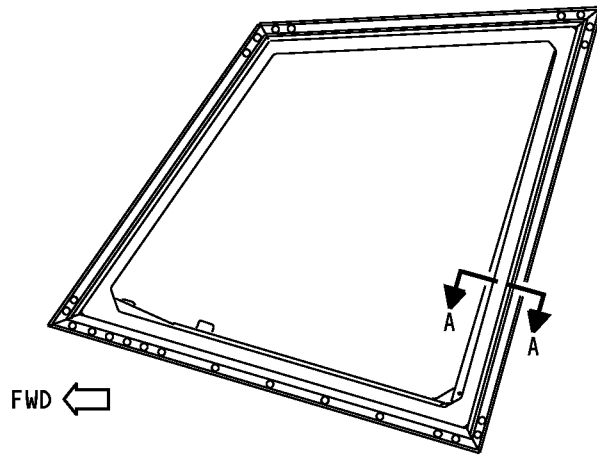
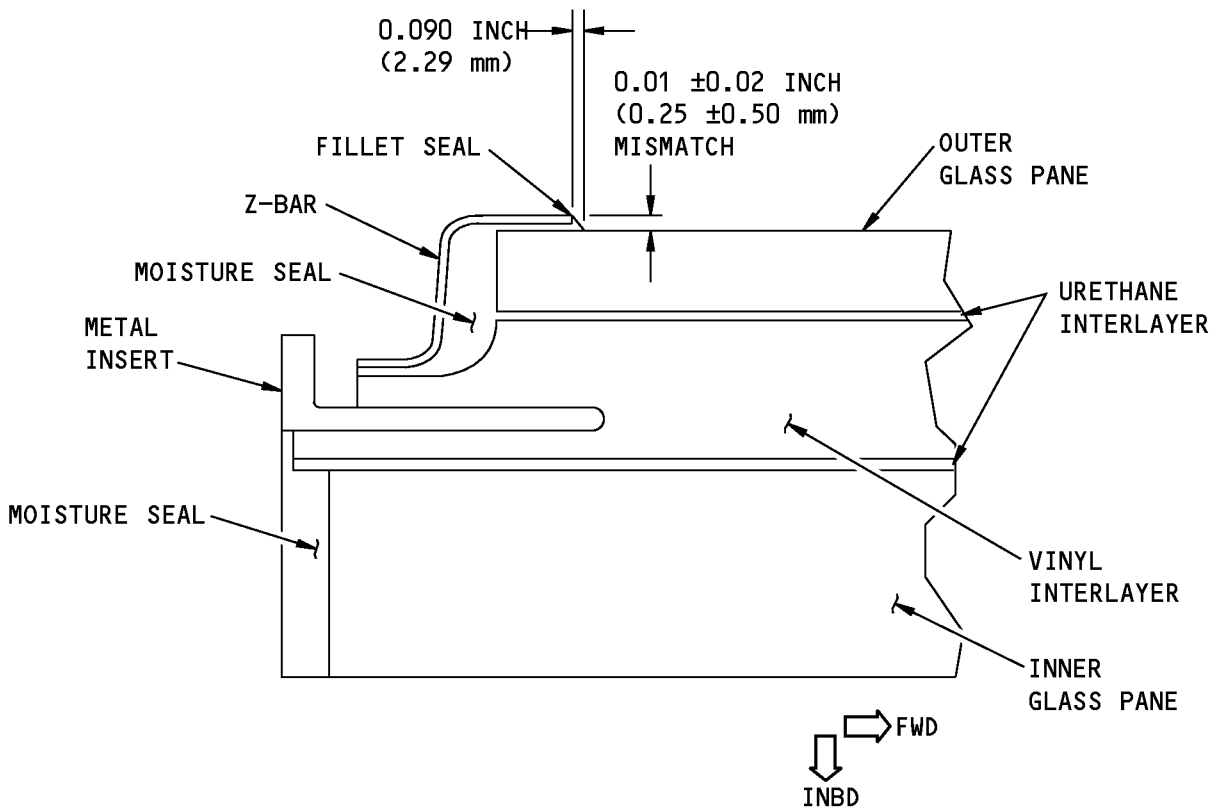
WINDOW NO. 2

A-A

(1) The repair of the fillet seal for the No. 2 openable window.

B. There is aerodynamic smoother (sealant) around the No. 2 windows. The aerodynamic smoother can erode and have cracks.

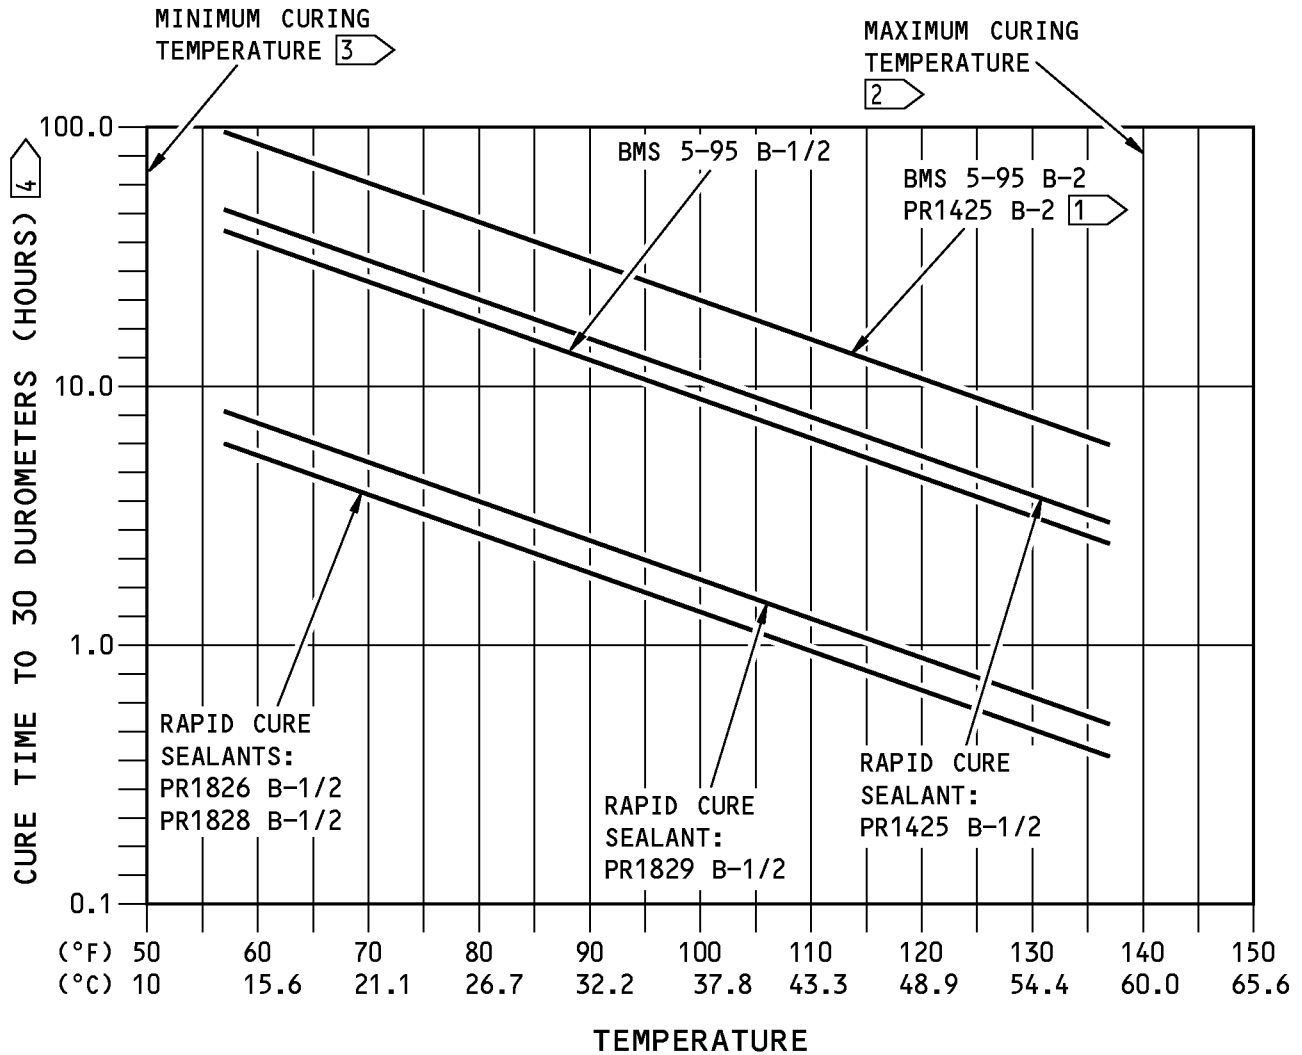
1 FOR SHOP HANDLING AND FLY AWAY

3 DO NOT CURE SEALANT BELOW 50°F (10°C)

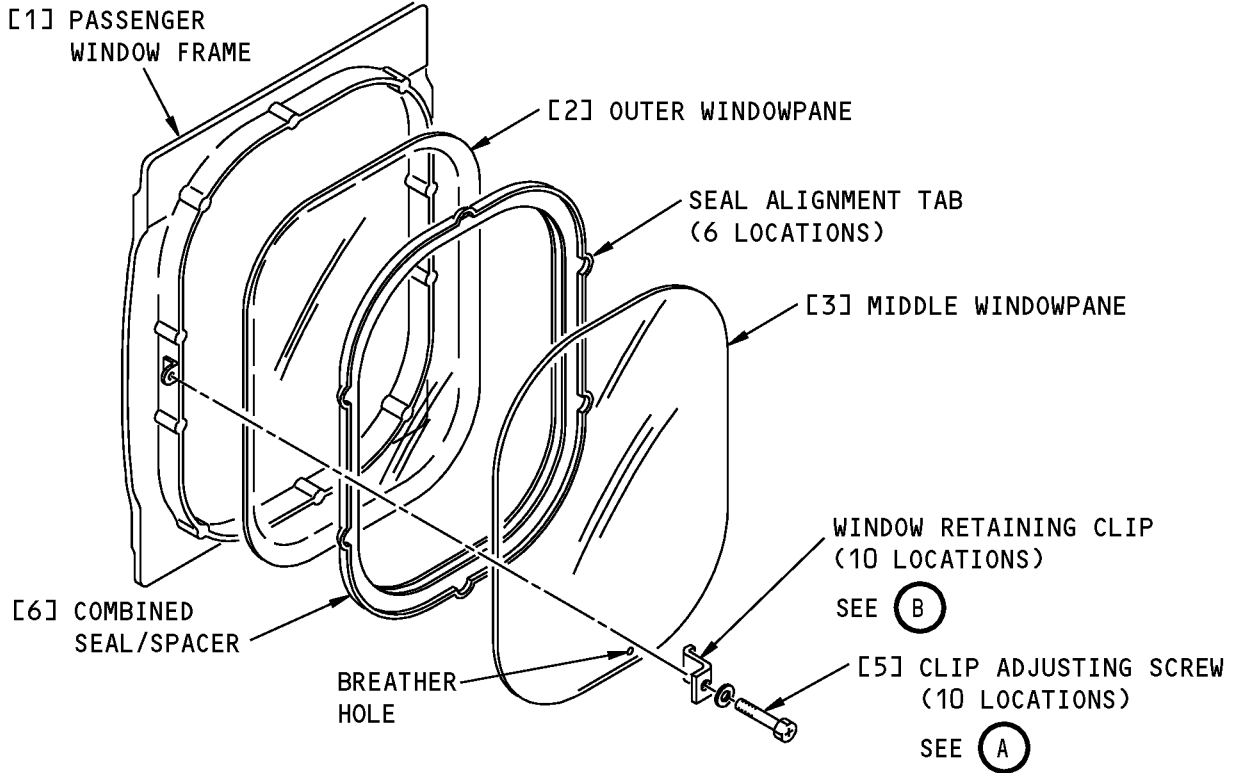
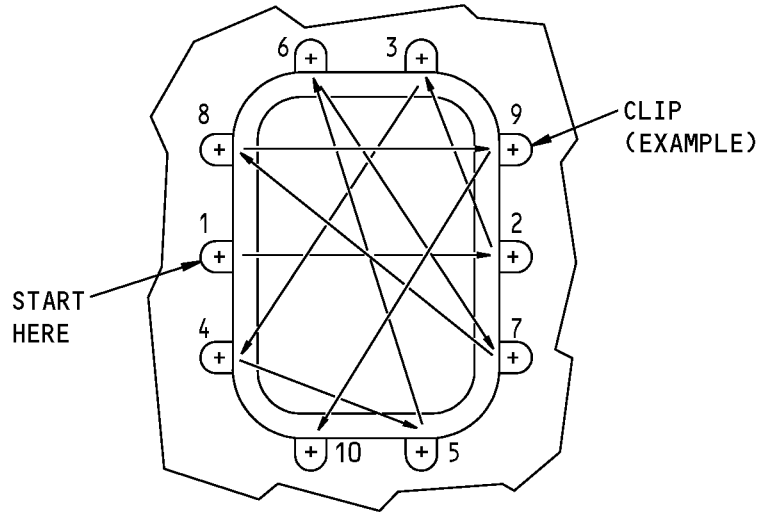
SEQUENCE DIAGRAM TO TIGHTEN THE SCREWS

➡ USE THIS DIAGRAM AS AN EXAMPLE ONLY. (A) 1 ➡
 ANY SIMILAR PATTERN TO TIGHTEN THE SCREWS IS SATISFACTORY.

- (a) Tighten the window clip adjustment screws [5] to 13.5 ± 1.5 in-lb (1.5 ± 0.2 N·m). Use a sequence equivalent to that shown in Figure 401 or Figure 402.
- (b) If the clips [4] are loose, increase the torque in 5.0 in-lb (0.6 N·m) increments to a maximum of 25.0 in-lb (2.8 N·m).

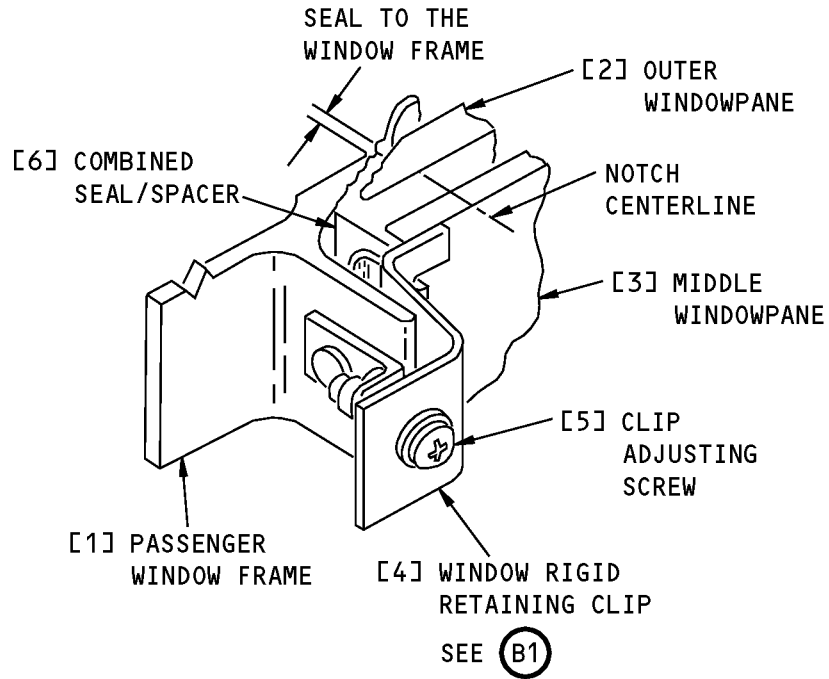
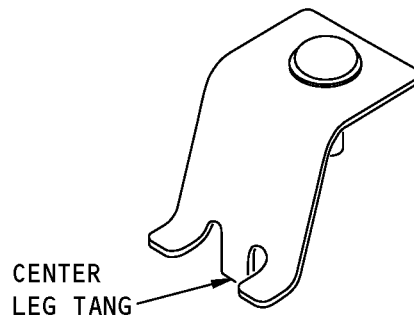
**Passenger Cabin Windows Installation
Figure 401 (Sheet 2 of 2)/56-21-00-990-804**

**WINDOW RIGID RETAINING CLIP
WITH CENTER LEG TANG IN FLANGE**

NOTE: For windows that use clip [7] without a center leg tang in the flange, the end of the spring clip can push against the seal [6] or against the edge of the middle pane [3]. The recommended position is against the seal.

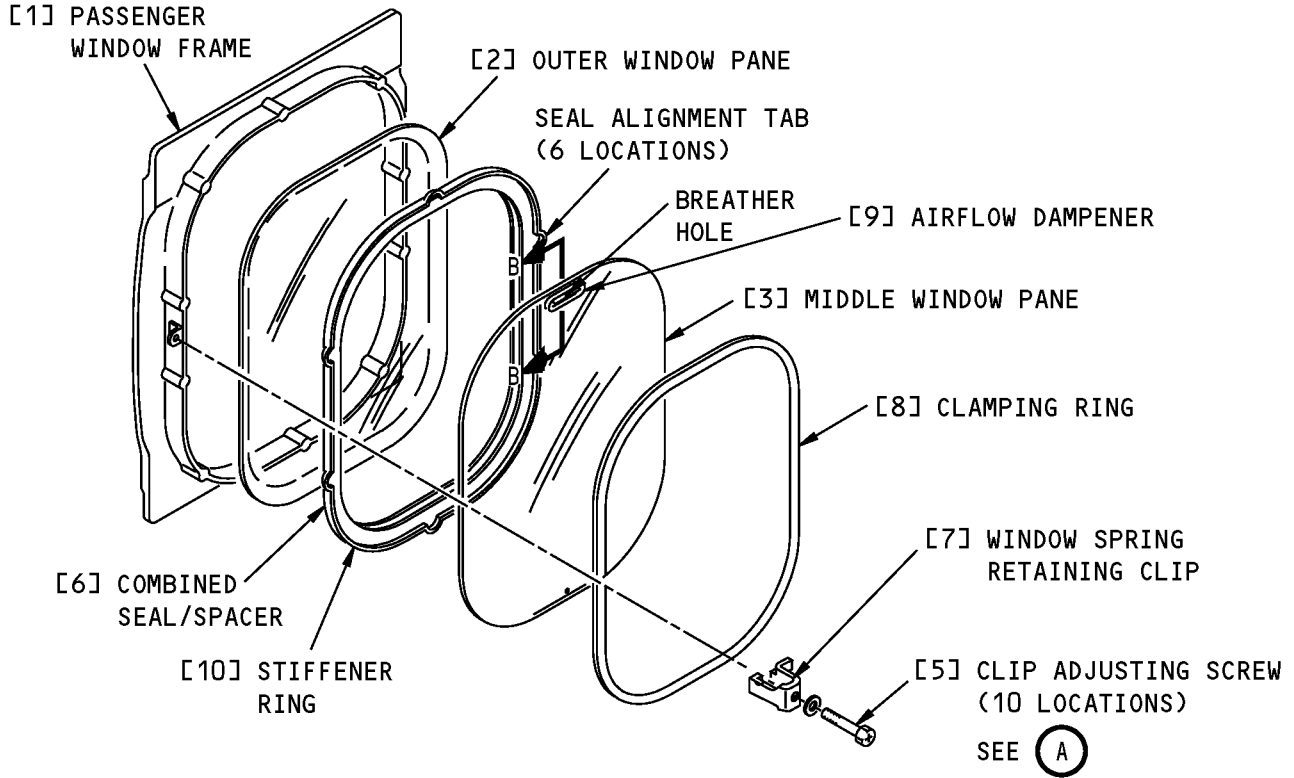
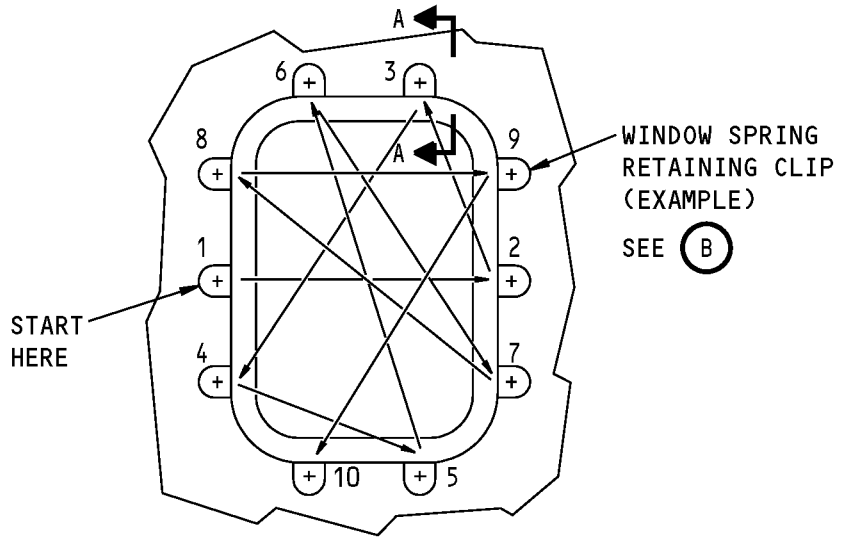
SEQUENCE DIAGRAM TO TIGHTEN THE SCREWS

1 USE THIS DIAGRAM AS AN EXAMPLE ONLY. ANY SIMILAR PATTERN TO TIGHTEN THE SCREWS IS SATISFACTORY.

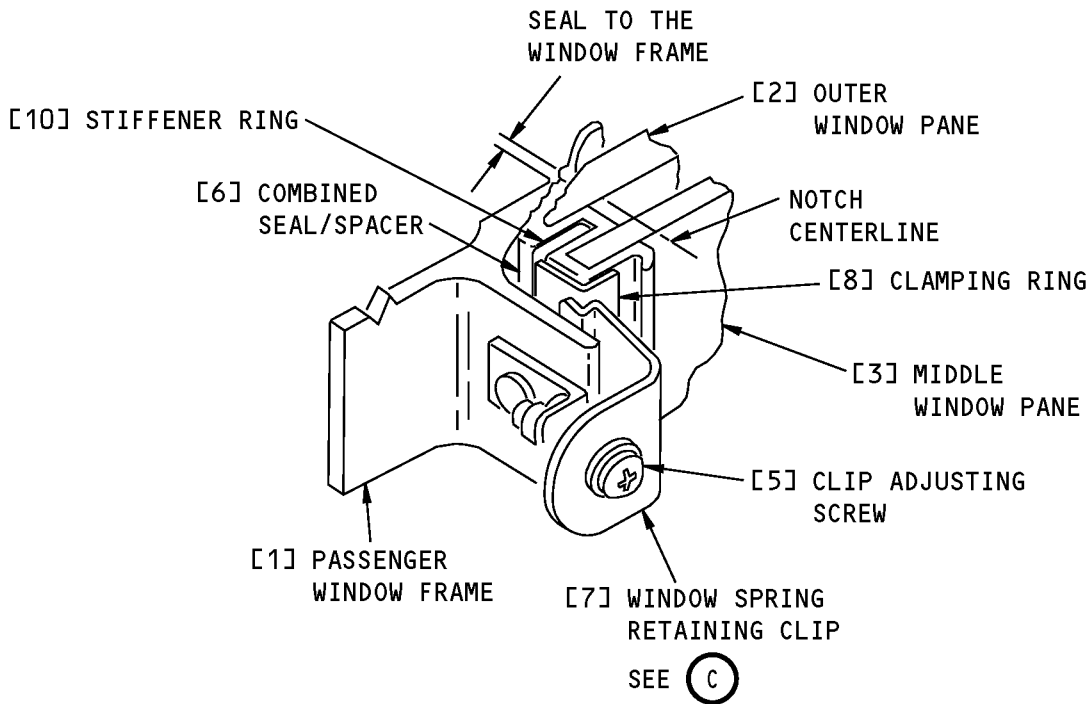
**WINDOW SPRING RETAINING CLIP
(AS INSTALLED)
(EXAMPLE)**

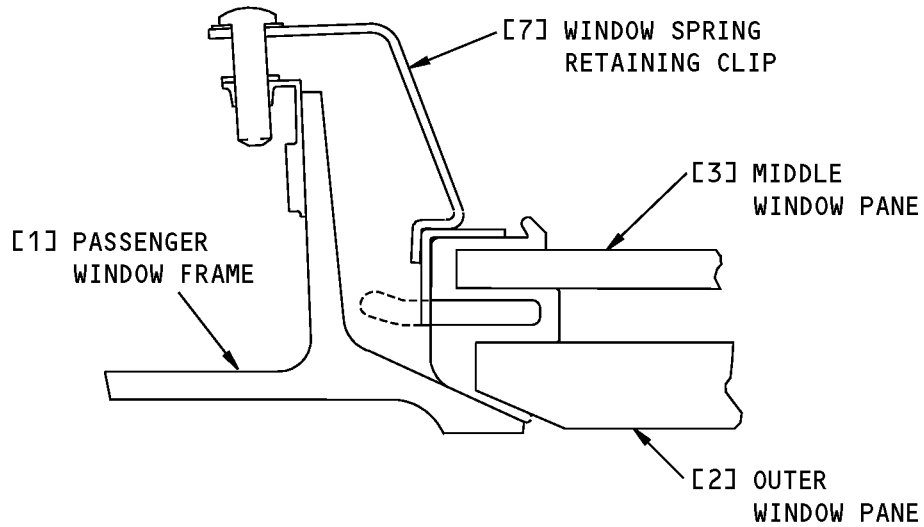
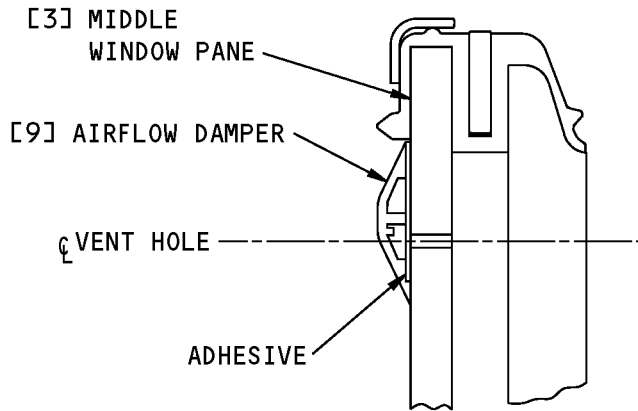
**WINDOW SPRING RETAINING CLIP
(TOP/BOTTOM OF WINDOW)
(EXAMPLE)**

WINDOW CLIPS AT TOP (2 LOCATIONS) AND BOTTOM OF WINDOW (2 LOCATIONS) ARE SLIGHTLY LONGER THAN CLIPS AT SIDES OF WINDOW AND USE A LONGER ADJUSTING SCREW.

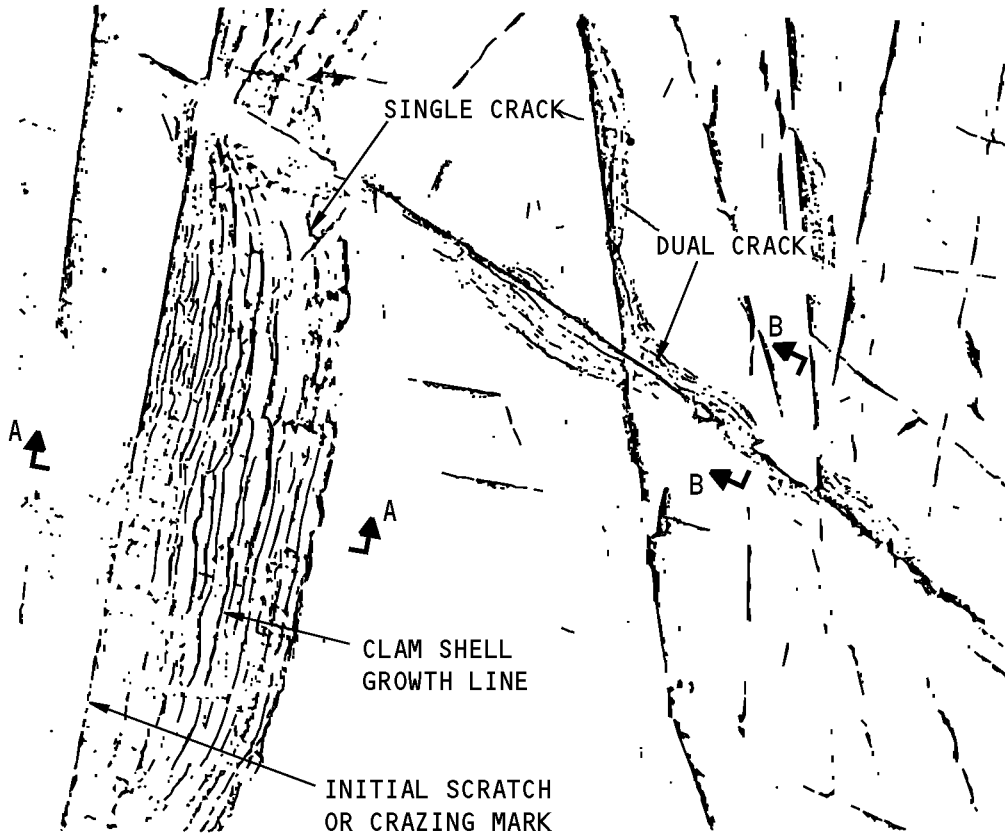
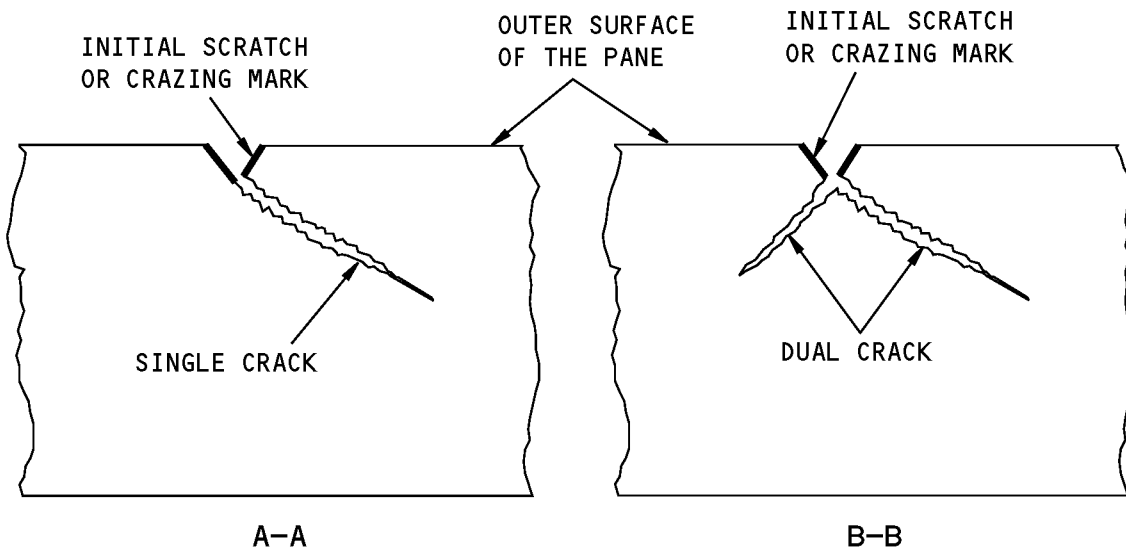
**WINDOW SURFACE
(EXAMPLE)**

**Example of Window Surface Cracks that Develop (Outer Pane Stretched Acrylic)
Figure 601/56-21-00-990-802**

- 1) A crack is a fissure that has a visible width and depth.
- 2) Cracks can start from a scratch or a crazeing mark Figure 601.
- 3) Cracks can be single or dual Figure 601.
- 4) Cracks in stretched acrylic plastic that occur in the direction of the applied force can become in-plane cracks.

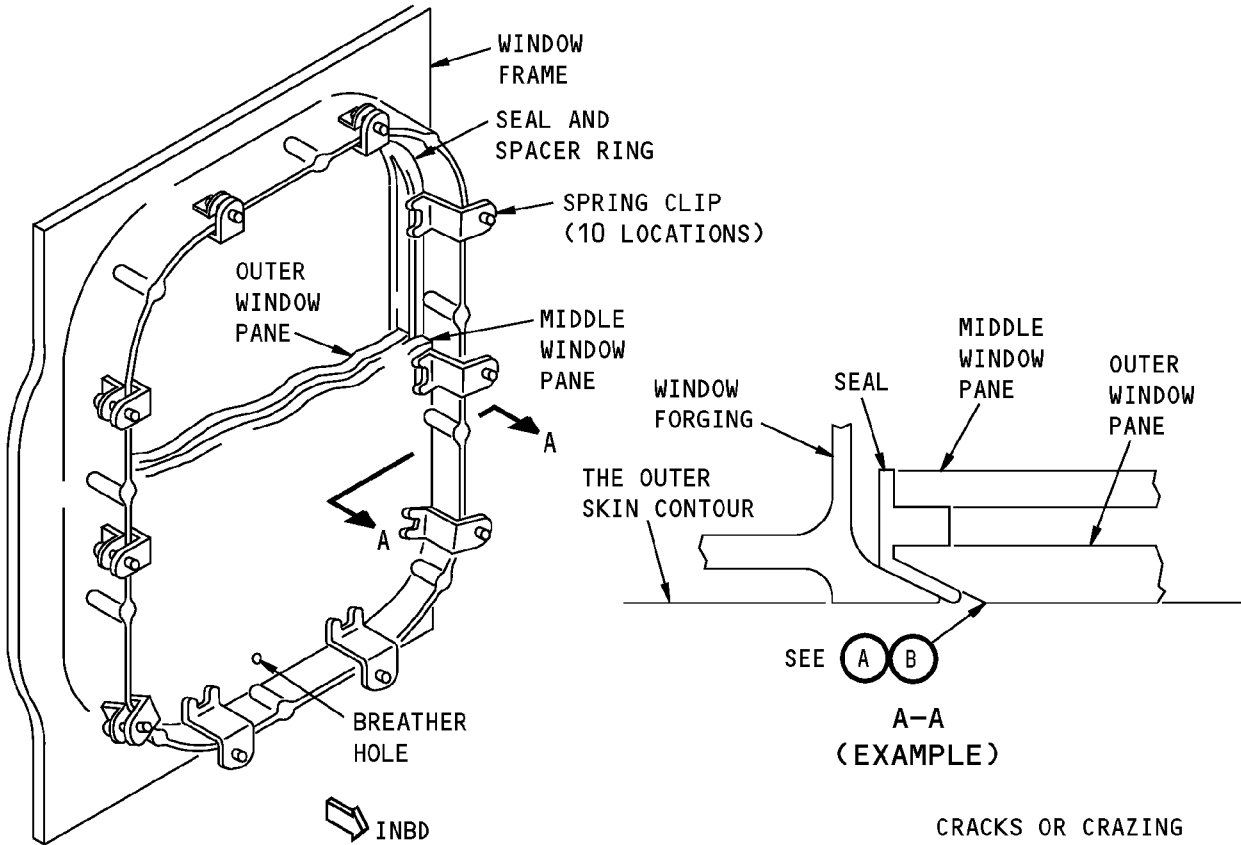
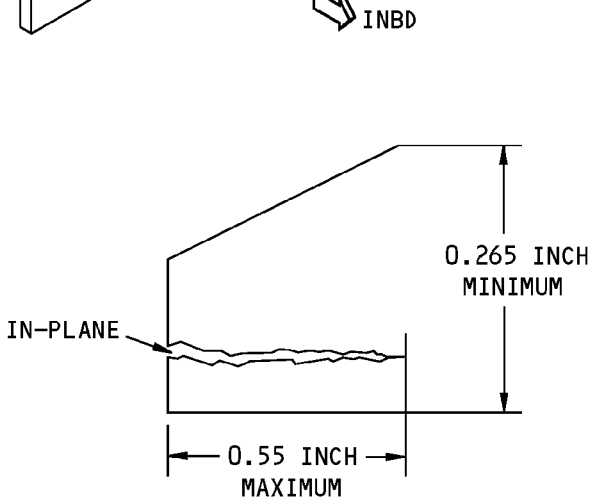
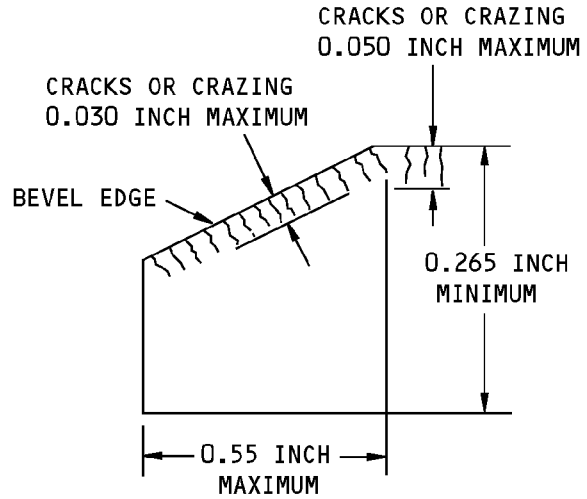
**DELAMINATION
(IN-PLANE CRACK)**

**OUTER WINDOW PANE
CRACK AND CRAZING LIMITS**

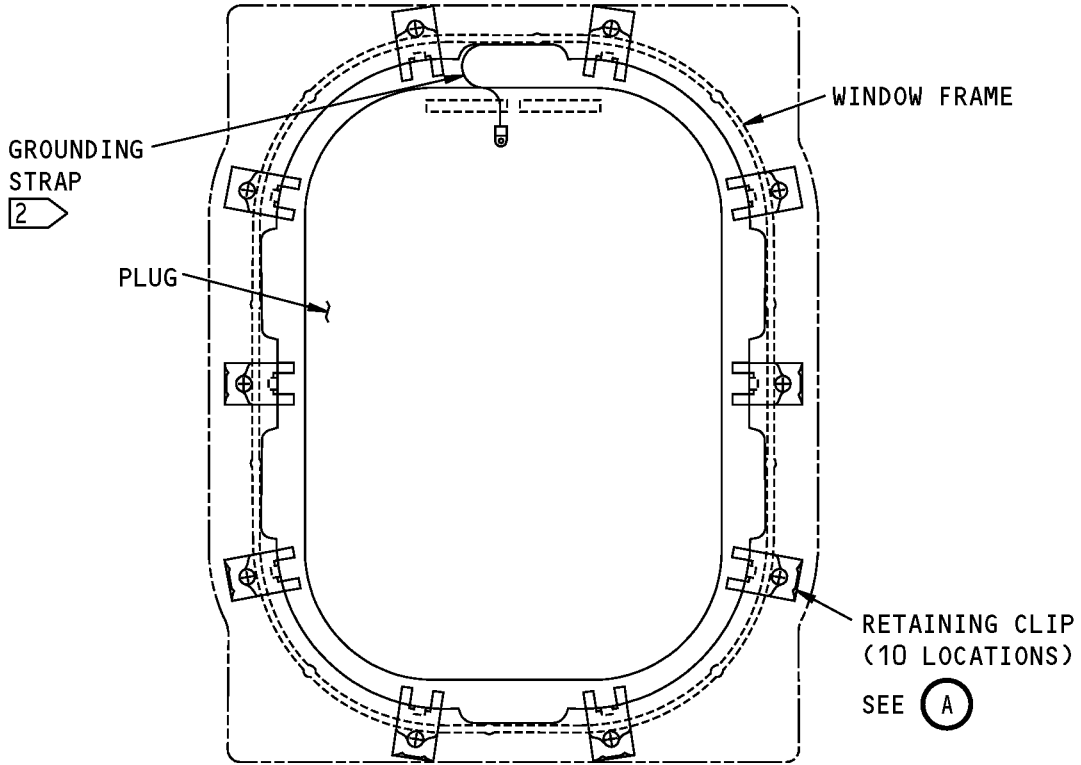
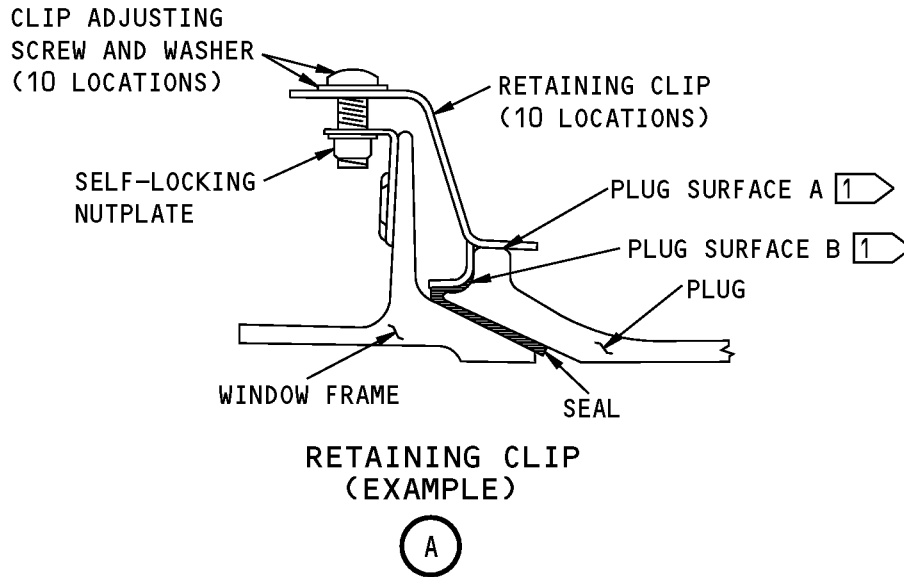
1 IF THE WINDOW RETAINING CLIP TOUCHES PLUG SURFACE B, A SPACE IS PERMITTED BETWEEN THE WINDOW RETAINING CLIP AND PLUG SURFACE A.

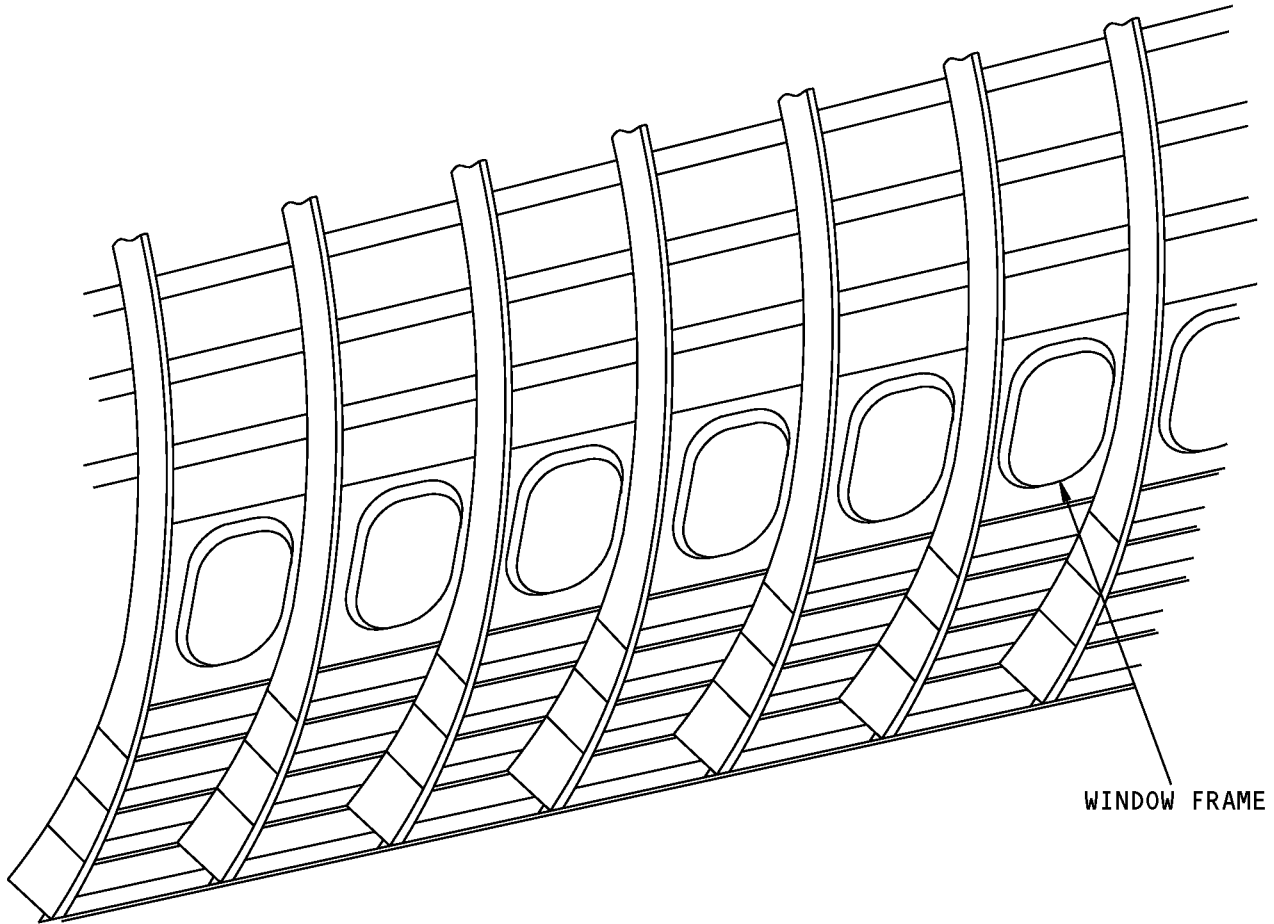
TYPICAL PASSENGER CABIN WINDOW AREA

**Passenger Cabin Window Frames
Figure 201/56-21-37-990-801**

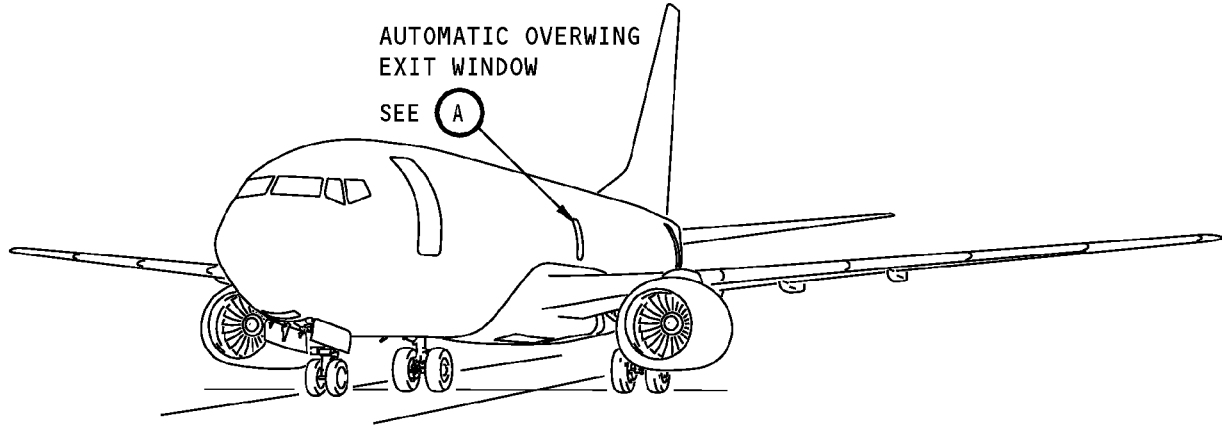
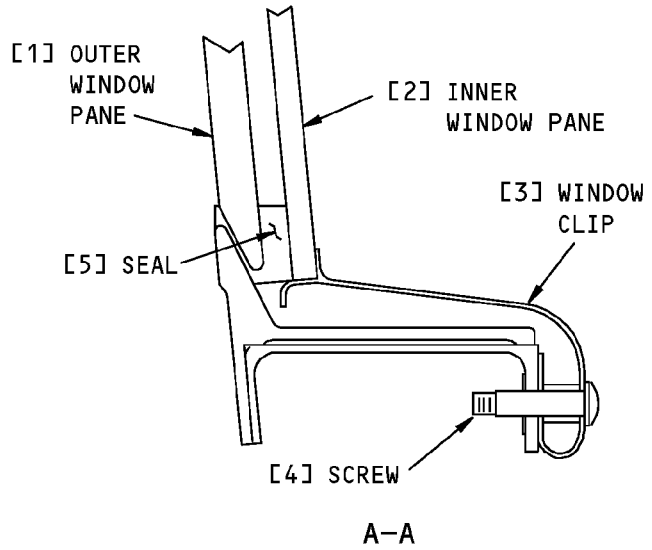
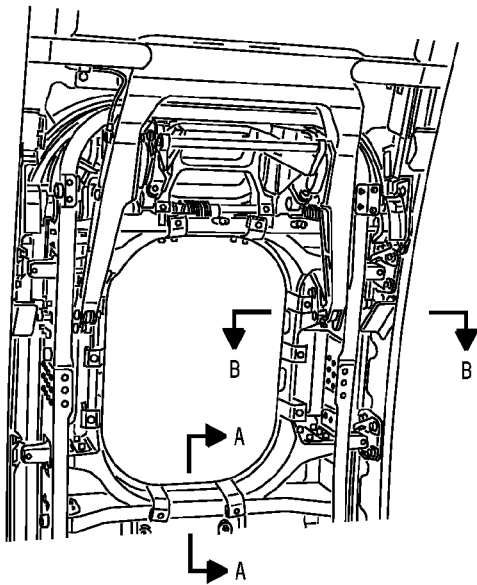
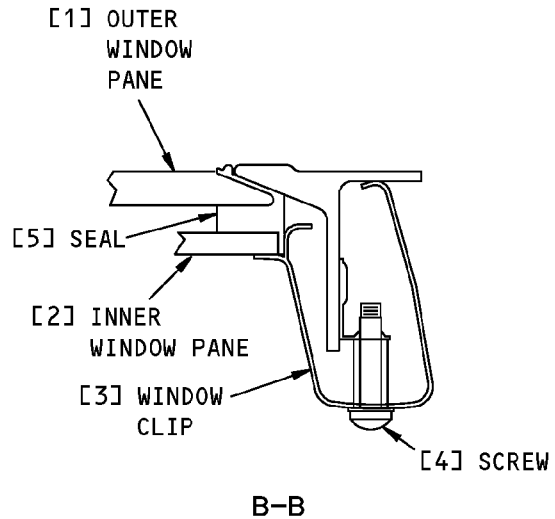
**AUTOMATIC OVERWING EXIT WINDOW
(EXAMPLE)**

**Automatic Overwing Exit Window Installation
Figure 401 (Sheet 1 of 2)/56-22-00-990-801**

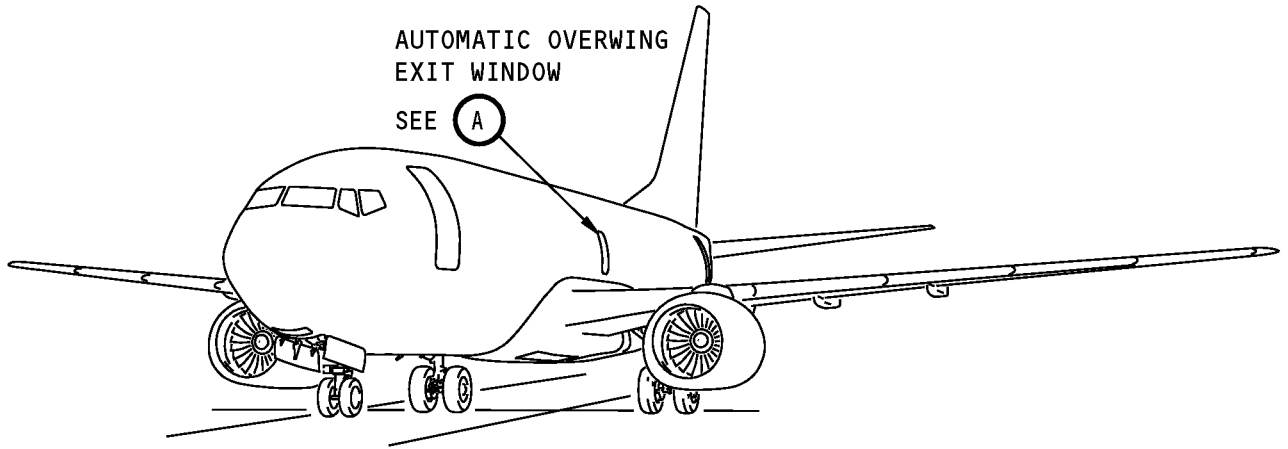
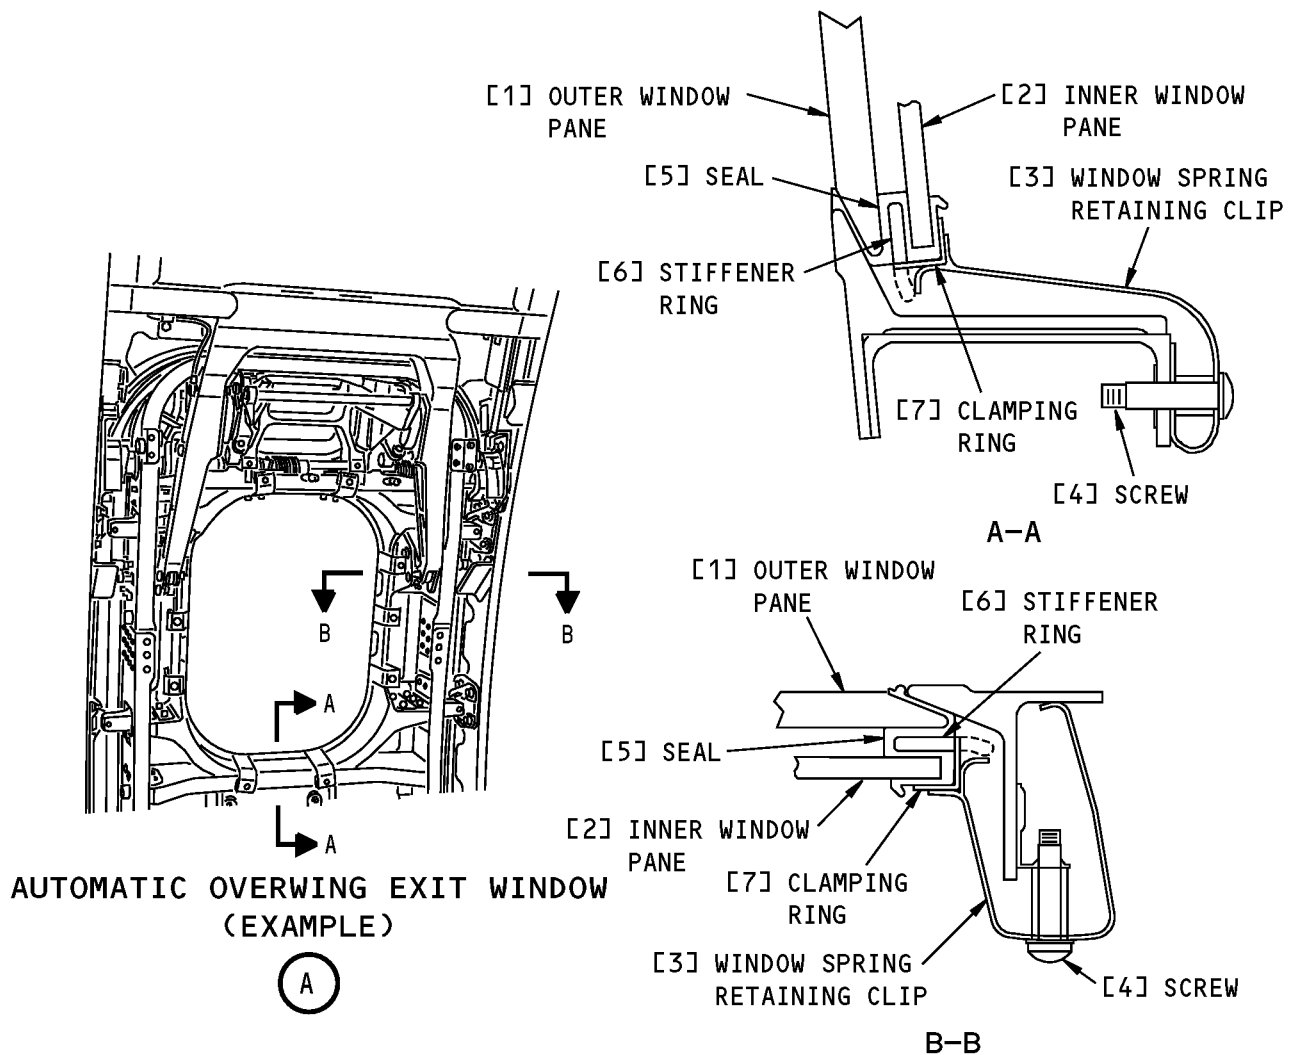
Automatic Overwing Exit Window Installation
Figure 401 (Sheet 2 of 2)/56-22-00-990-801

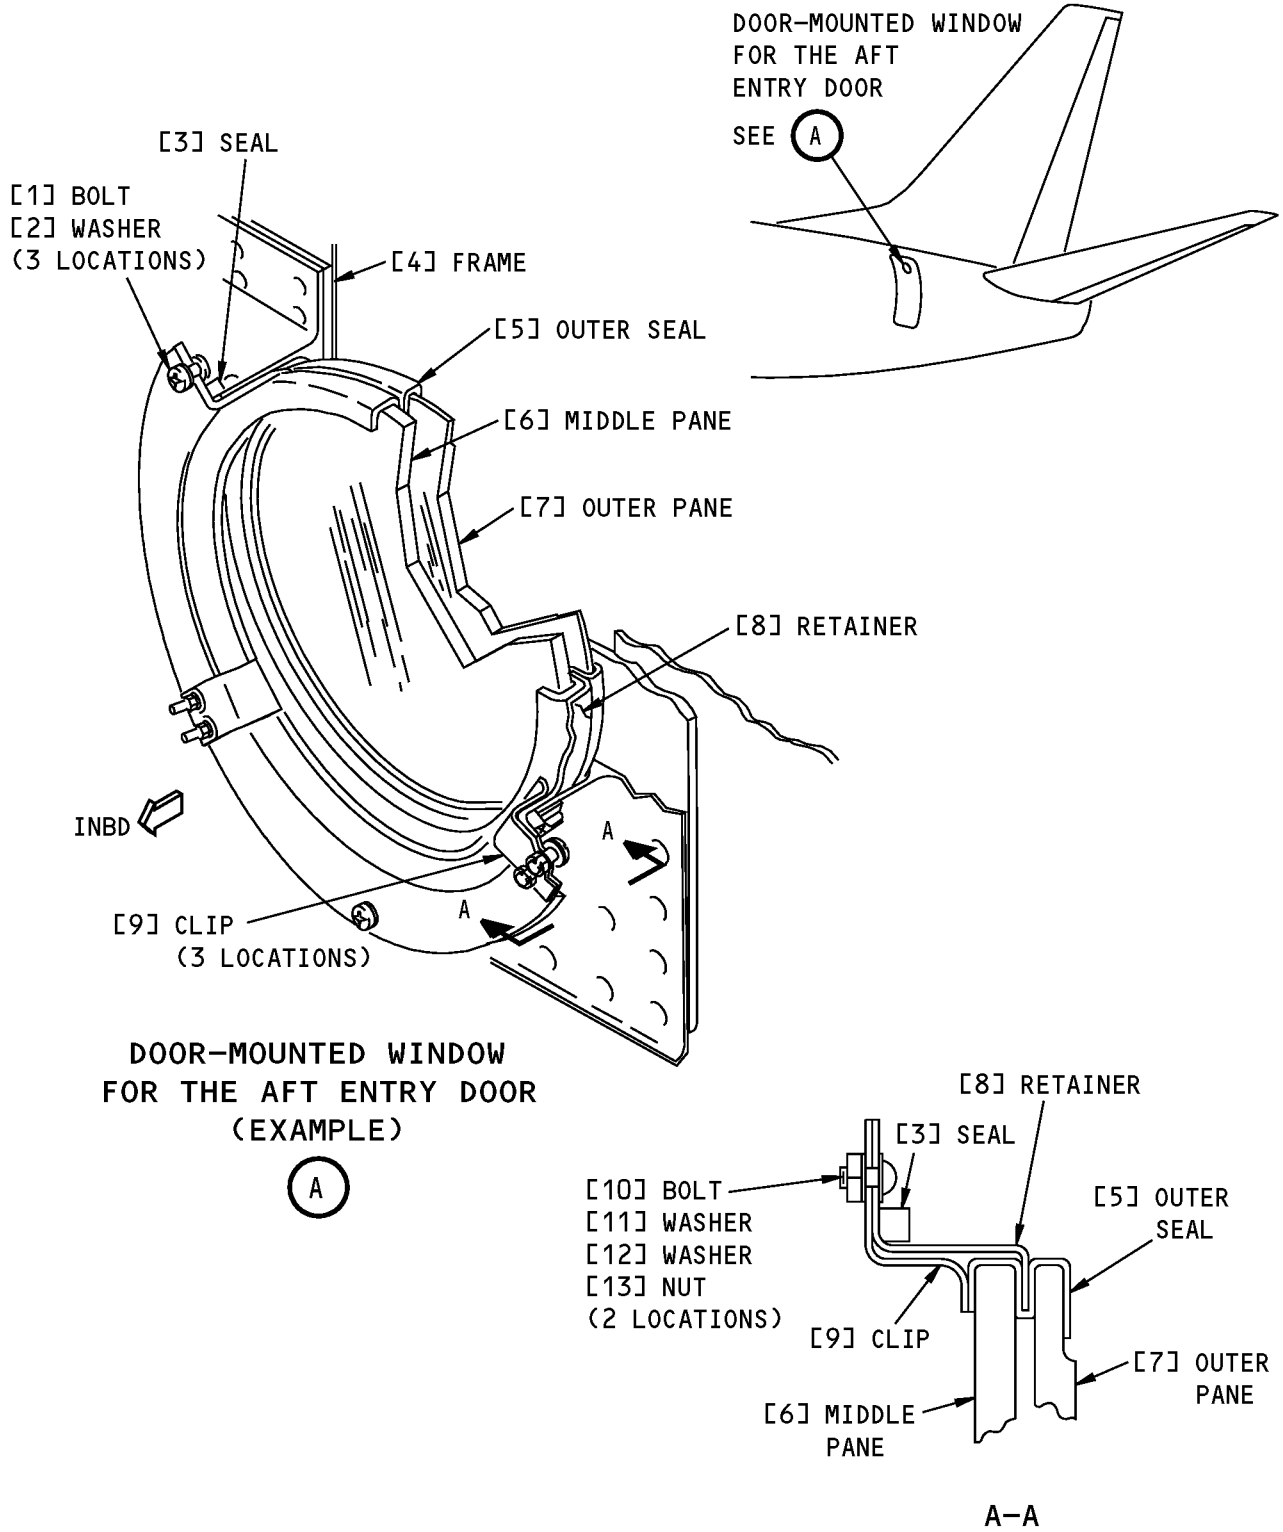
**DOOR-MOUNTED WINDOW
FOR THE AFT ENTRY DOOR
(EXAMPLE)**
