**737-600/700/800/900
AIRCRAFT MAINTENANCE MANUAL**

**CHAPTER 56
WINDOWS**

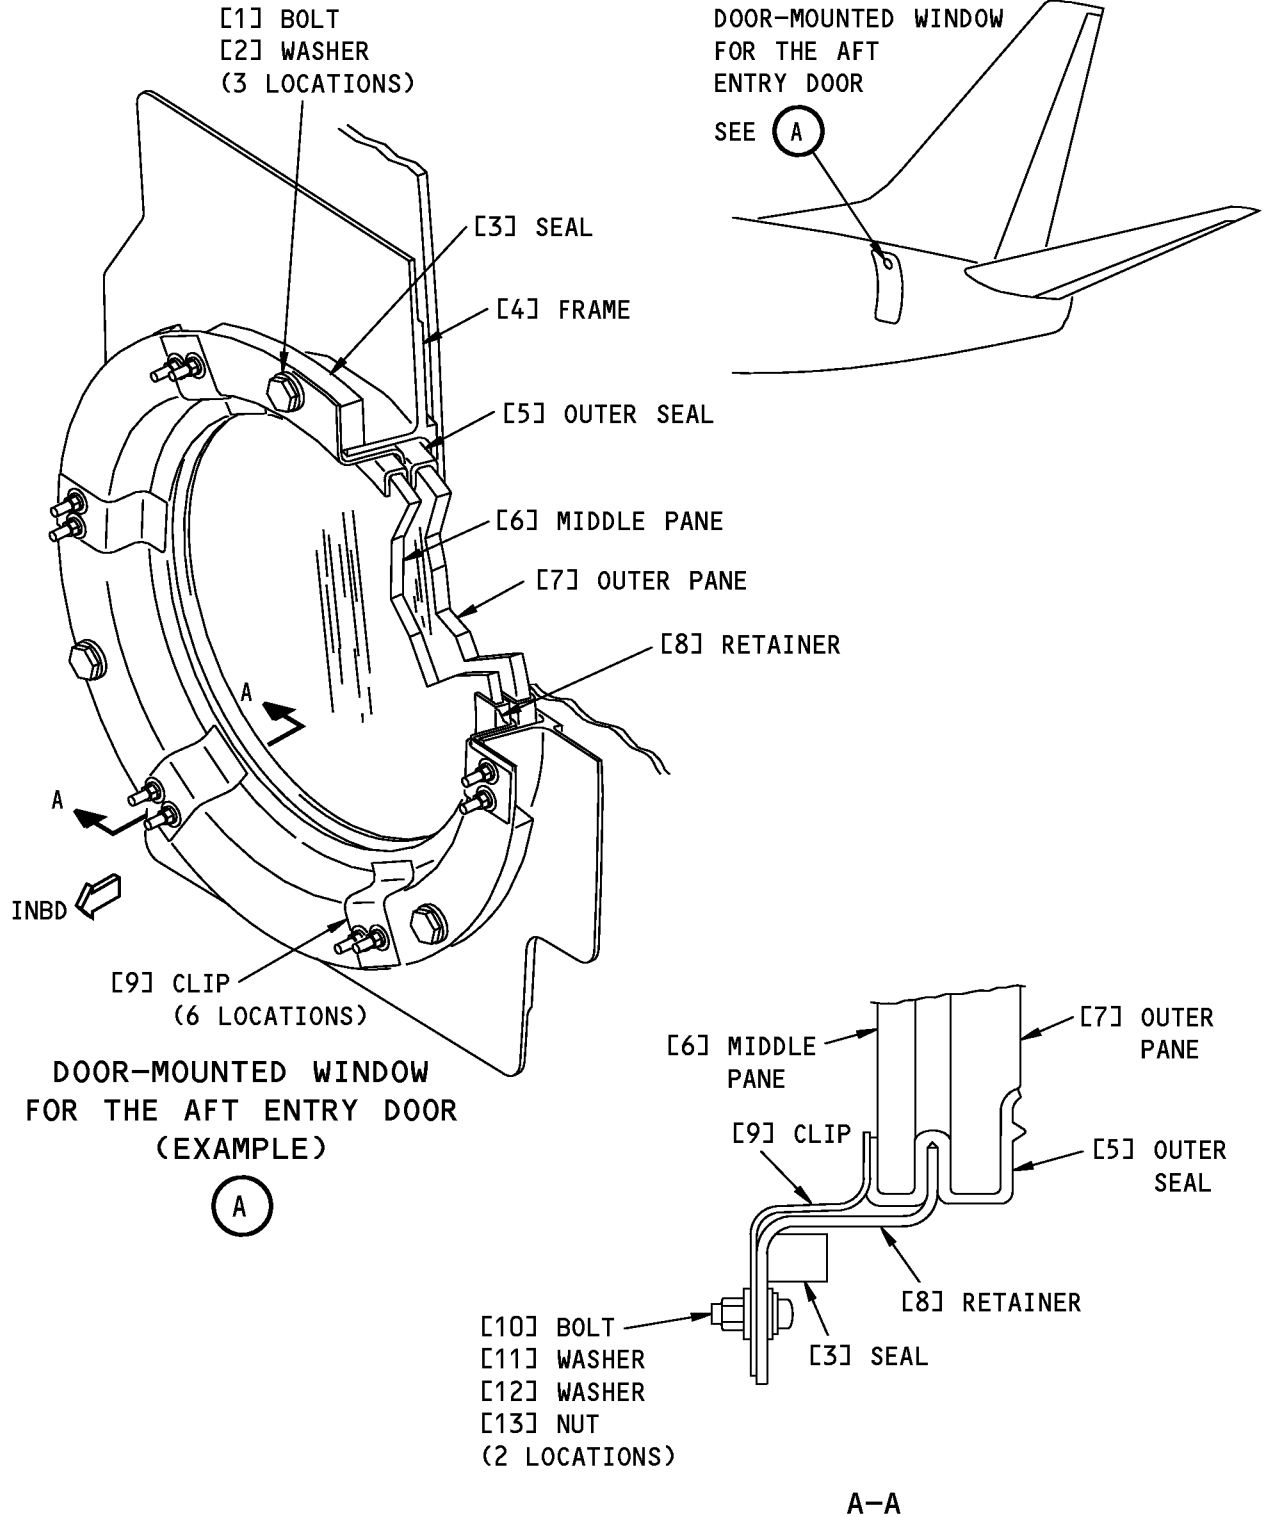
Door-mounted Window Installation
Figure 401 (Sheet 2 of 2)/56-31-00-990-801

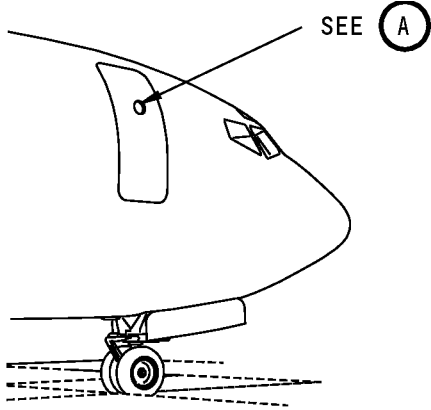
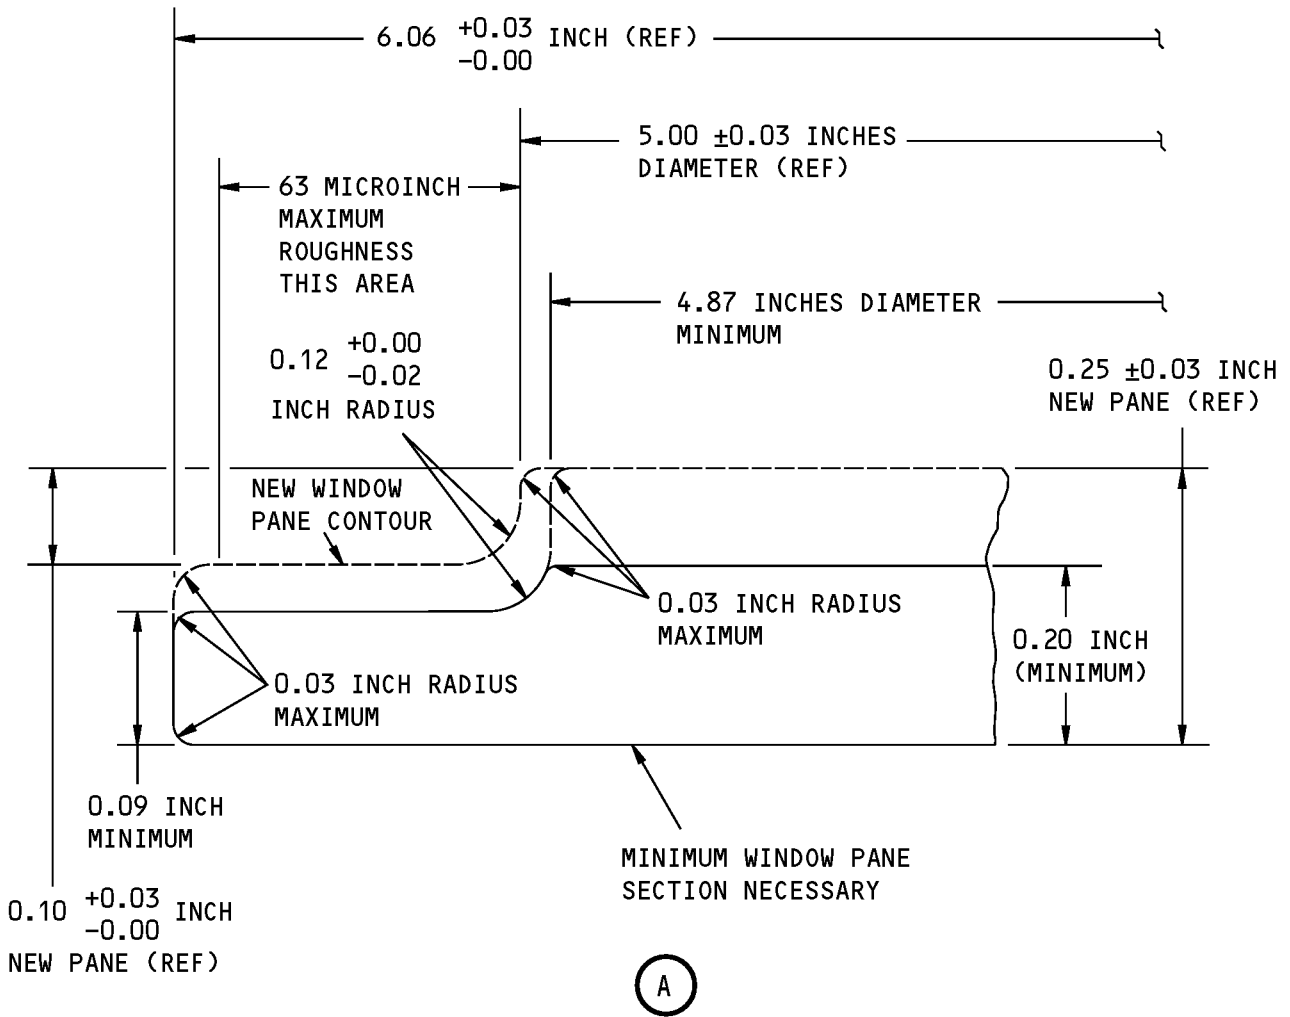
NOTE: ALL DIMENSIONS ARE FOR MINIMUM WINDOW THICKNESS.

**Entry and Galley Service Window Outer Panel Allowable Rework Limits
Figure 801 (Sheet 1 of 2)/56-31-00-990-803**

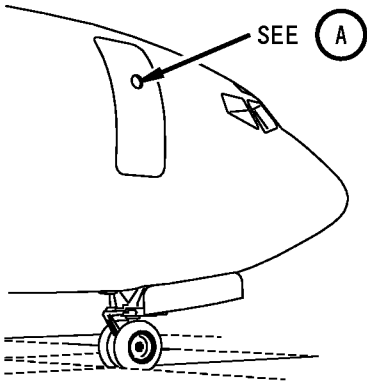
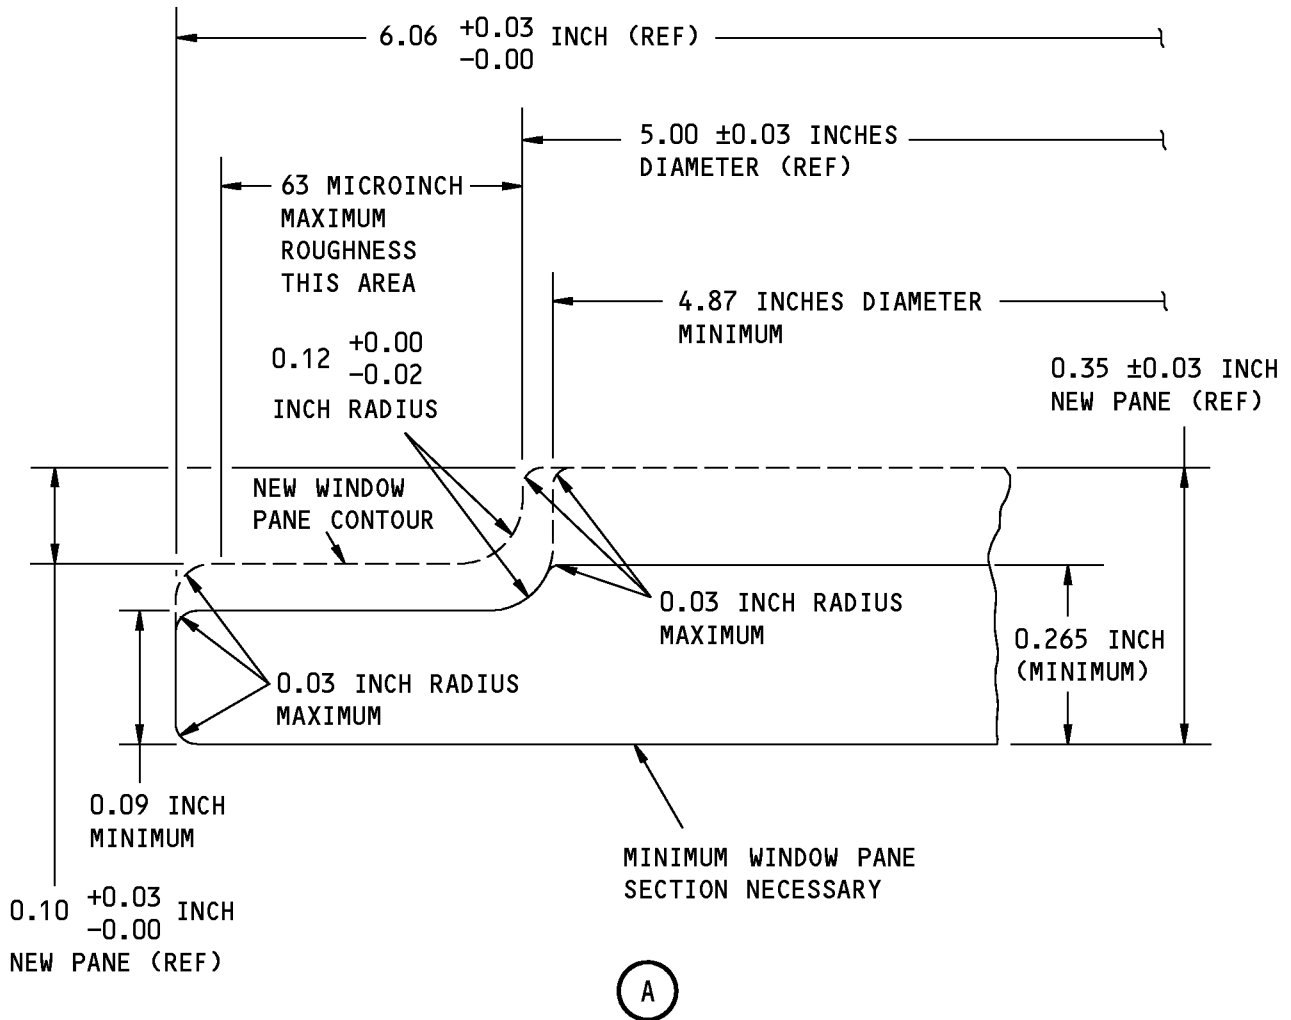
NOTE: ALL DIMENSIONS ARE FOR MINIMUM WINDOW THICKNESS.

**Entry and Galley Service Window Outer Panel Allowable Rework Limits
Figure 801 (Sheet 2 of 2)/56-31-00-990-803**
