CHAPTER 555

STABILIZERS

737-800 STRUCTURAL REPAIR MANUAL

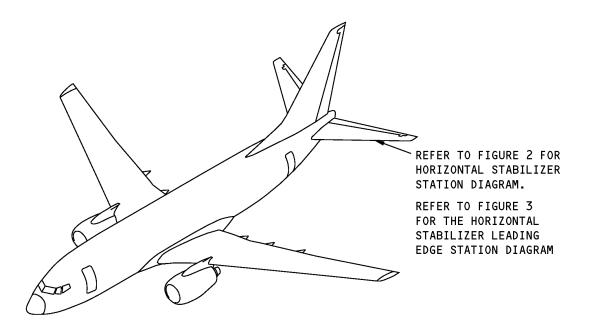
Horizontal Stabilizer Location Figure 1

IDENTIFICATION GENERAL - HORIZONTAL STABILIZER STATION DIAGRAM

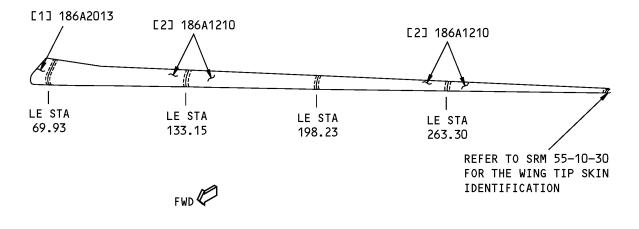
Horizontal Stabilizer Leading Edge Skin Identification Figure 2

IDENTIFICATION 1 - HORIZONTAL STABILIZER LEADING EDGE SKIN

LEFT SIDE IS SHOWN, RIGHT SIDE IS OPPOSITE UPPER SURFACE IS SHOWN

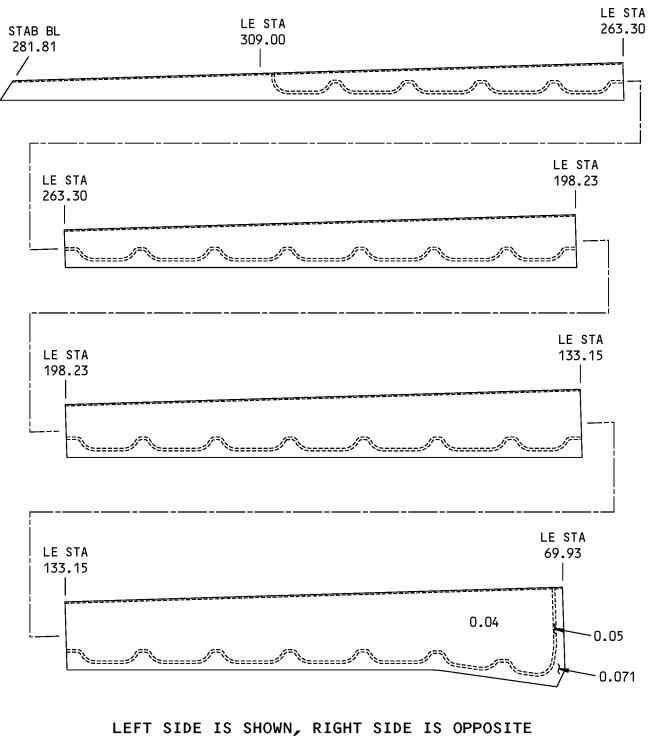
Chem-Milled Areas of Figure 2, Item [2] Figure 4

UPPER SURFACE IS SHOWN

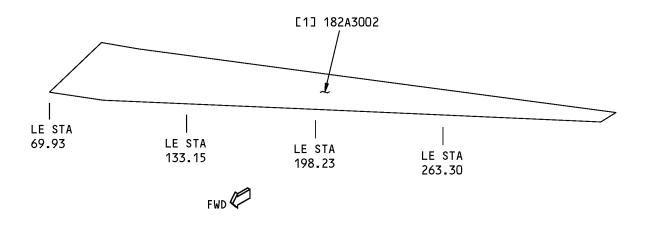
Horizontal Stabilizer Upper Inspar Skin Identification Figure 2

IDENTIFICATION 2 - HORIZONTAL STABILIZER UPPER INSPAR SKIN

LEFT SIDE IS SHOWN, RIGHT SIDE IS OPPOSITE UPPER SURFACE IS SHOWN

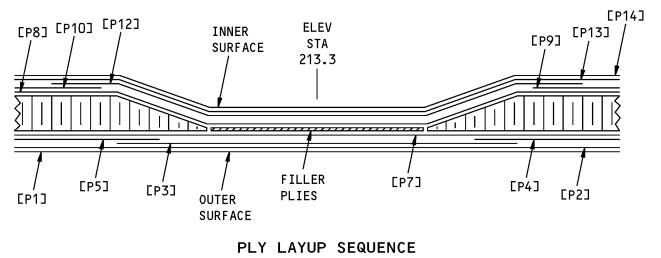
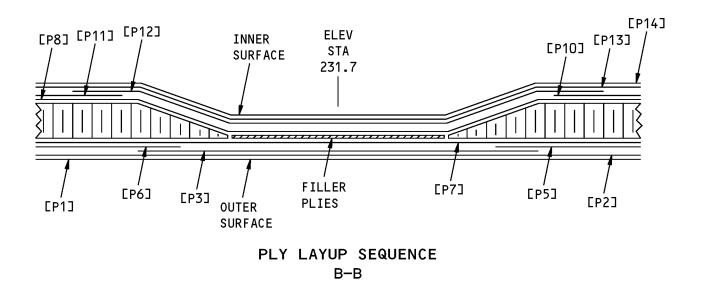
Ply Direction, Core Ribbon Direction, and Ply Sequence for the Upper Trailing Edge Panel, Figure 2, Item [3] Figure 5 (Sheet 2 of 2)

A-A

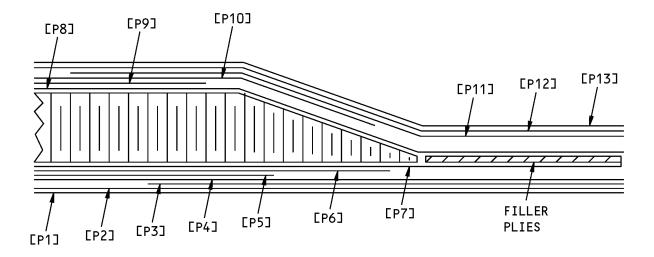
Ply Direction, Core Ribbon Direction, and Ply Sequence for the Upper Trailing Edge Panel, Figure 2, Item [4] Figure 6 (Sheet 2 of 2)

PLY LAYUP SEQUENCE A-A

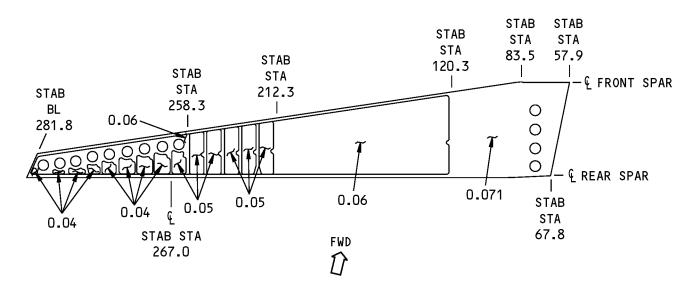
> Chem-Milled Areas of Figure 2, Item [1] Figure 3

LEFT SIDE IS SHOWN, RIGHT SIDE IS OPPOSITE UPPER SURFACE IS SHOWN

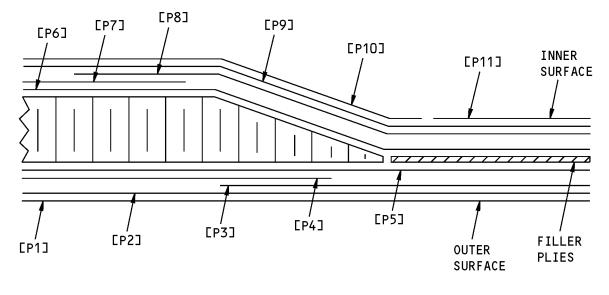
Ply Direction, Core Ribbon Direction, and Ply Sequence for the Upper Trailing Edge Panel, Figure 2, Item [4] Figure 6 (Sheet 2 of 2)

PLY LAYUP SEQUENCE A-A

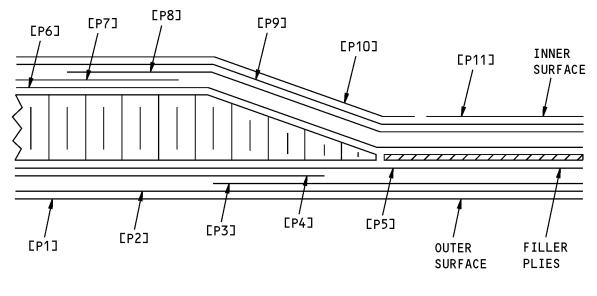
Ply Direction, Core Ribbon Direction, and Ply Sequence for the Upper Trailing Edge Panel, Figure 2, Item [5] Figure 7 (Sheet 2 of 2)

PLY LAYUP SEQUENCE A-A

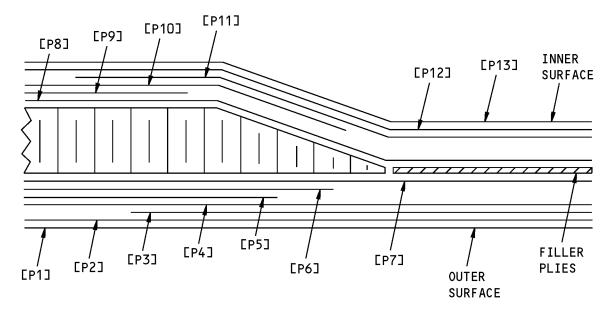
Ply Direction, Core Ribbon Direction, and Ply Sequence for the Upper Trailing Edge Panel, Figure 2, Item [7] Figure 9 (Sheet 2 of 2)

PLY LAYUP SEQUENCE

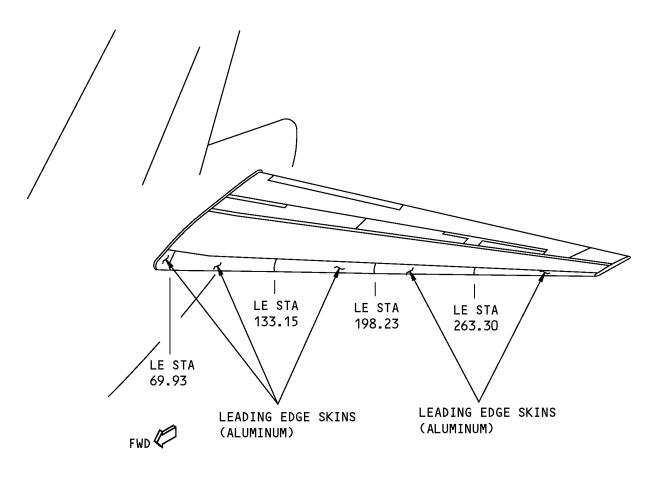
> Horizontal Stabilizer Leading Edge Skin Locations Figure 101 (Sheet 1 of 2)

LEFT SIDE IS SHOWN, RIGHT SIDE IS OPPOSITE UPPER SURFACE IS SHOWN

A. This subject gives the allowable damage limits for the horizontal stabilizer leading edge skins shown in Horizontal Stabilizer Leading Edge Skin Locations, Figure 101/ALLOWABLE DAMAGE 1.

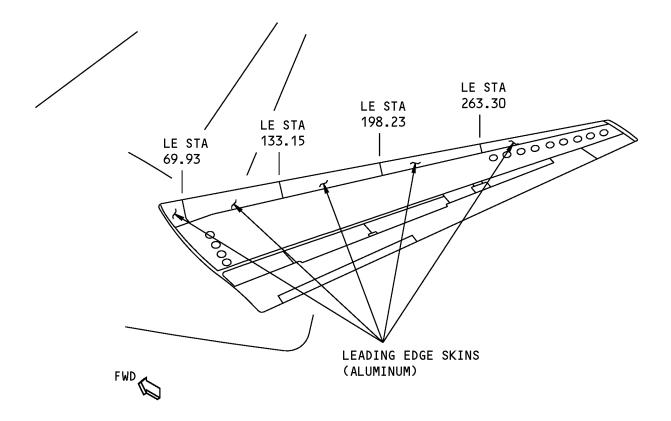
Horizontal Stabilizer Leading Edge Skin Locations Figure 101 (Sheet 2 of 2)

LEFT SIDE IS SHOWN, RIGHT SIDE IS OPPOSITE LOWER SURFACE IS SHOWN

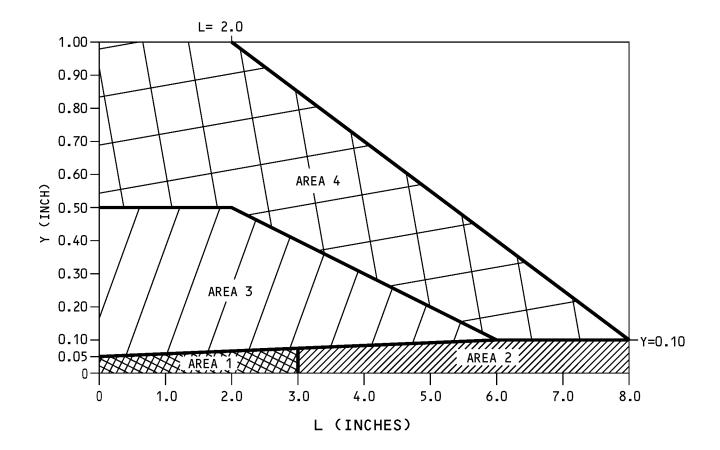
FOR AREA NUMBER	REFER TO ALLOWABLE DAMAGE PARAGRAPH
1	4. D. (3) (a)
2	4. D. (3) (b)
3	4. D. (3) (c)
4	4. D. (3) (d)

- (a) Refer to Definition of Dent Dimensions, Figure 103/ALLOWABLE DAMAGE 1 for the definitions of the dimensions for a dent.
 - (b) Refer to Allowable Damage Limits for Leading Edge Skin Dents, Figure 104/ALLOWABLE DAMAGE 1 for the relation of dent dimensions.

(Y) is more than o	r equal to 0.20 but less than 0.30 There must be 1 bay that is not damaged on each side of the damaged ba
	ecified Conditions:
(a)	Dents are permitted in Area 1 as shown in Allowable Damage Limits for Leading Ed Skin Dents, Figure 104/ALLOWABLE DAMAGE 1.
	 For dents that are more than the limits shown in Allowable Damage Limits, Figure 107/ALLOWABLE DAMAGE 1, fill the dents as given in 51-70-01.

(b)	Dents are permitted in Area 2 if you make an inspection of the damage after no more th 5000 flight hours. Refer to Allowable Damage Limits for Leading Edge Skin Dents, Figure 104/ALLOWABLE DAMAGE 1.
	NOTE : It is recommended that you remove or repair the damage after no more th 5000 flight hours or 18 months, that which occurs first.
	 For dents that are more than the limits shown in Allowable Damage Limits, Figu 107/ALLOWABLE DAMAGE 1, fill the dents as given in 51-70-01.

(C)	Dents are permitted in Area 3 as shown in Allowable Damage Limits for Leading Ed Skin Dents, Figure 104/ALLOWABLE DAMAGE 1 if you do the steps that follow:

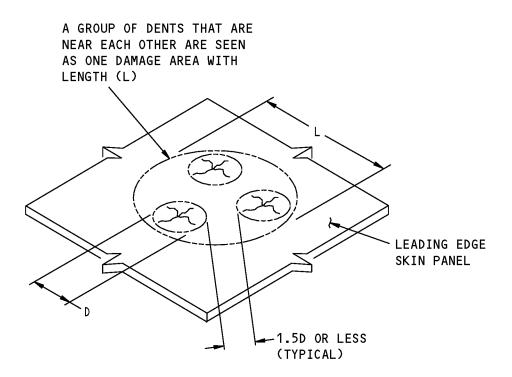
Damage Size and Spacing Limits for Adjacent Dents Figure 105

NOTE: D IS THE LARGEST LENGTH OF THE ADJACENT DENTS.

- (c) Refer to Damage Size and Spacing Limits for Adjacent Dents, Figure 105/ALLOWABLE DAMAGE 1 for the definition of the dimensions for adjacent dents.

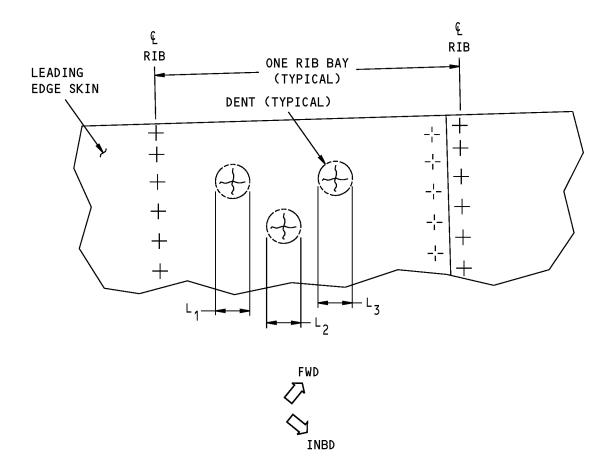
Equivalent Length of Dents When the Depth is Large Figure 106

- NOTE: IF THE DEPTH OF THE DENT IS 0.050 INCH OR MORE, THEN 1) ADD THE LENGTH OF EACH DENT TO GET THE EQUIVALENT LENGTH (L) OF THE DENTS. $L = L_1 + L_2 + L_3$
 - 2) AND APPLY THE ALLOWABLE DAMAGE LIMITS FOR ONE DENT.

- (d) Refer to Equivalent Length of Dents When the Depth is Large, Figure 106/ALLOWABLE DAMAGE 1 for the definition of the length if there is more than one dent in a bay.

- (2) Refer to Equivalent Length of Dents When the Depth is Large, Figure 106/ALLOWABLE DAMAGE 1 for the definition of the length if there is more than one dent in a bay.

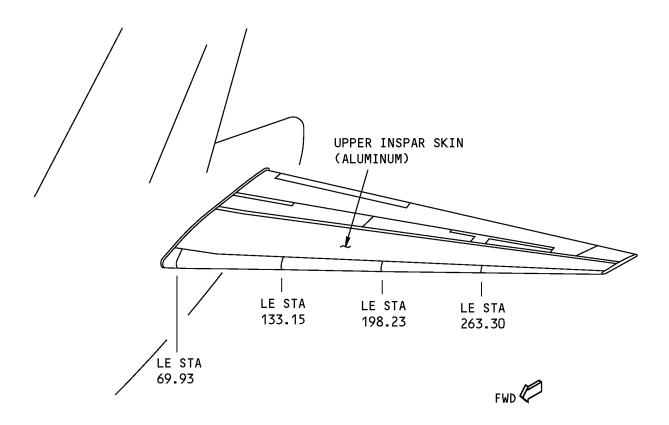
Horizontal Stabilizer Upper Inspar Skin Location Figure 101

LEFT SIDE IS SHOWN, RIGHT SIDE IS OPPOSITE UPPER SURFACE IS SHOWN

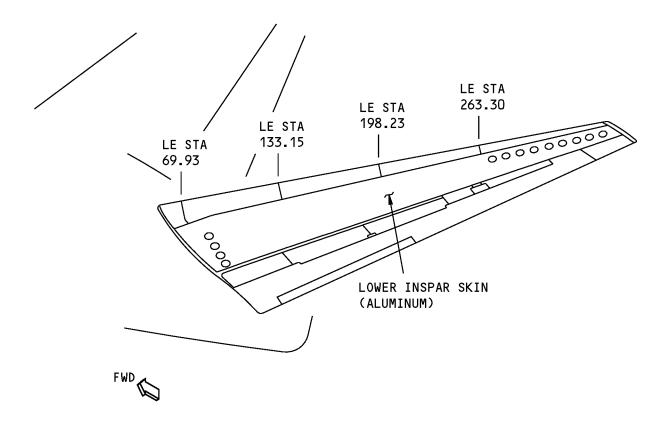
Horizontal Stabilizer Lower Inspar Skin Location Figure 102

LEFT SIDE IS SHOWN, RIGHT SIDE IS OPPOSITE LOWER SURFACE IS SHOWN

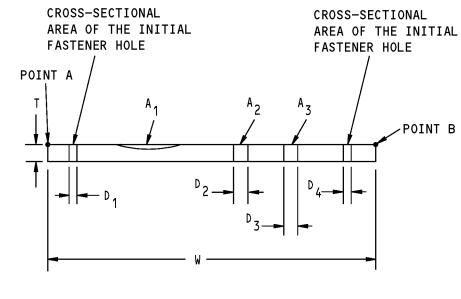
D_1 , D_4 = DIAMETERS OF THE INITIAL FASTENER HOLES D_2 , D_3 = DIAMETERS OF THE HOLES WHERE THERE IS DAMAGE W = WIDTH OF THE SKIN AT THE CROSS-SECTION BETWEEN POINTS A AND B T = THICKNESS OF THE SKIN AS GIVEN BY THE NOMINAL THICKNESS ON THE PRODUCTION DRAWING A₁ = INITIAL AREA OF THE SKIN = THE TOTAL CROSS-SECTIONAL AREA MINUS THE CROSS-SECTIONAL AREA OF THE INITIAL FASTENERS HOLES (AS MANUFACTURED BY BOEING) = WT - $D_1T - D_4T$ A₁ = CROSS-SECTIONAL AREA OF THE DAMAGE THAT IS REMOVED AT LOCATION 1 A₂ = CROSS-SECTIONAL AREA OF THE DAMAGE THAT IS REMOVED AT LOCATION 2 A₃ = CROSS-SECTIONAL AREA OF THE DAMAGE THAT IS REMOVED AT LOCATION 3 $\left(\frac{A_1 + A_2 + A_3}{A_1}\right)$ X 100 = PERCENT OF CROSS-SECTIONAL AREA REMOVED AS GIVEN IN TABLE 101

THE TOTAL CROSS-SECTIONAL AREA REMOVED IN ALL ZONES A-B (3.00 INCH (76.2 mm) ON EACH SIDE OF A LINE A-B) MUST NOT BE MORE THAN THE LIMITS GIVEN IN TABLE 101

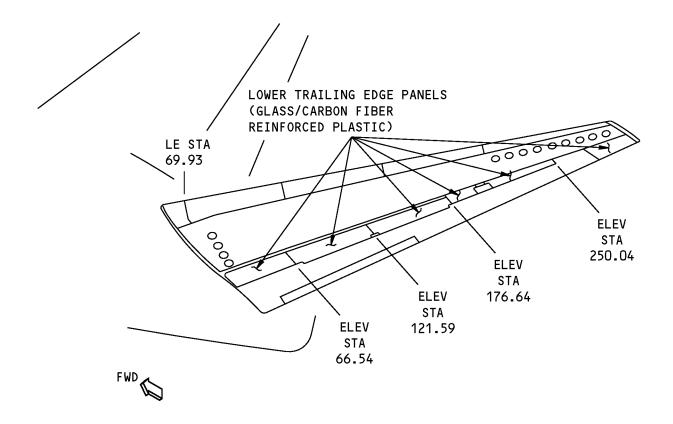
NOTE: REFER TO FIGURE 105 FOR THE DEFINITIONS OF THE ALLOWABLE DAMAGE ZONES.

LEFT SIDE IS SHOWN, RIGHT SIDE IS OPPOSITE LOWER SURFACE IS SHOWN

Horizontal stabilizer trailing edge panels shown in Horizontal Stabilizer Lower Trailing Edge Panel Locations, Figure 102/ALLOWABLE DAMAGE 3.

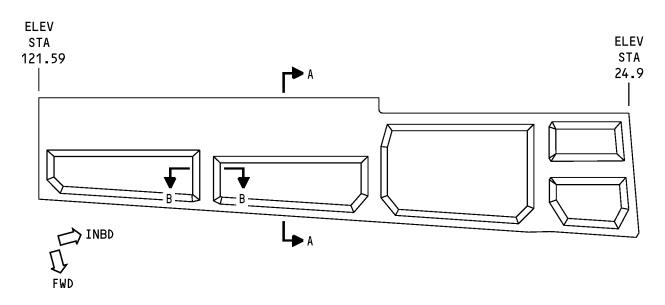
TYPICAL UPPER PANEL IS SHOWN, LOWER PANELS ARE THE SAME

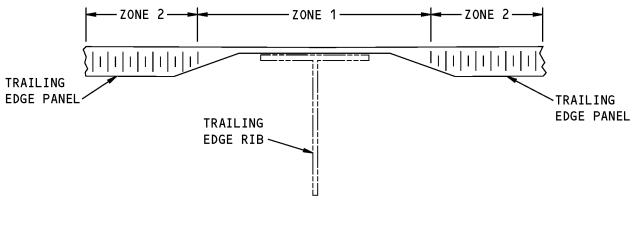
В-В

ZONE 1: SOLID LAMINATE AREA WITH FASTENERS, EDGE BAND ZONE 2: HONEYCOMB CORE AREA

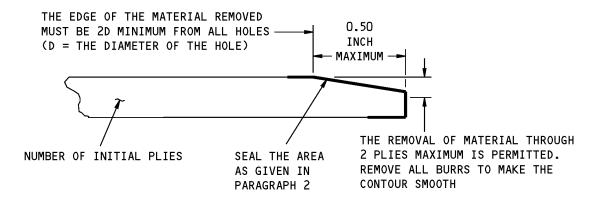
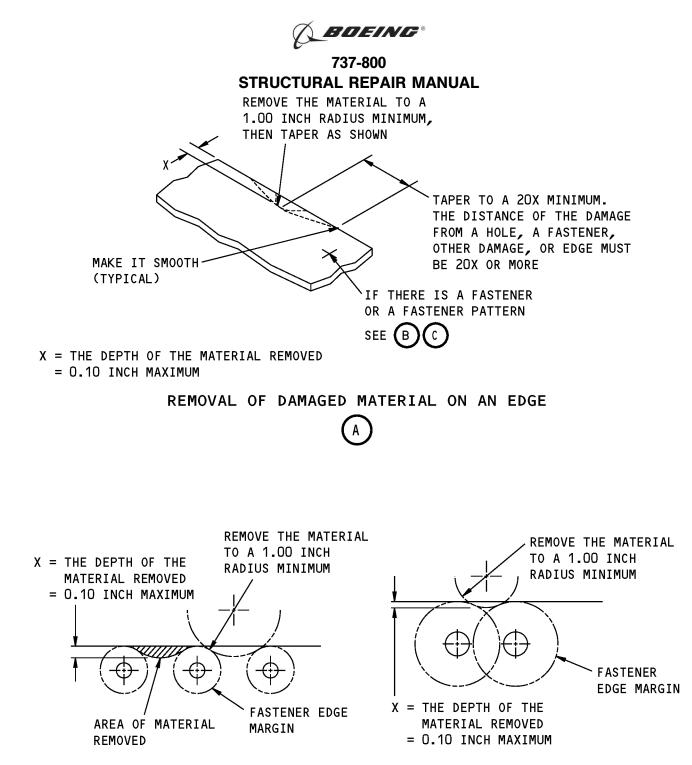
Edge Erosion Damage Removal Figure 106

REMOVAL OF DAMAGED MATERIAL AT EDGES WHERE THE FASTENER EDGE MARGINS DO NOT HAVE AN OVERLAP

REMOVAL OF DAMAGED MATERIAL AT EDGES WHERE THE FASTENER EDGE MARGINS HAVE AN OVERLAP

- (6) Edge Erosion is permitted as shown in Edge Erosion Damage Removal, Figure 106/ALLOWABLE DAMAGE 3 if:
 - (a) Not more than 10 percent of the edgeband for each side of panel is damaged

- (a) It is a maximum 0.10 inch in depth
 - (b) Not more than 10 percent of the edgeband for each side of panel is damaged
 - (c) It is removed as shown in Allowable Damage Limits, Figure 106/ALLOWABLE DAMAGE 3, Detail A

- (c) It is removed as shown in Allowable Damage Limits, Figure 106/ALLOWABLE DAMAGE 3, Detail A
- (d) It is sealed as given in Paragraph 2.

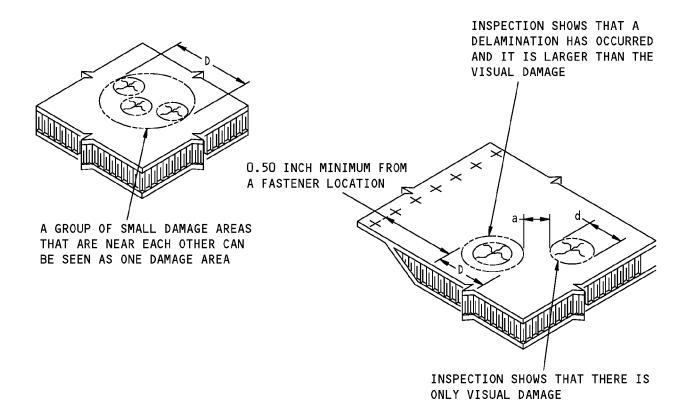
NOTE: TO FIND DELAMINATION YOU CAN USE NONDESTRUCTIVE INSPECTION PROCEDURES (REFER TO NDT PART 1, 51-01-02).

THE DIAMETER OF A DAMAGE AREA IS EITHER THE DIAMETER OF THE VISUAL DAMAGE OR THE DIAMETER OF THE DELAMINATION. USE THE DIAMETER OF THE LARGER DAMAGE.

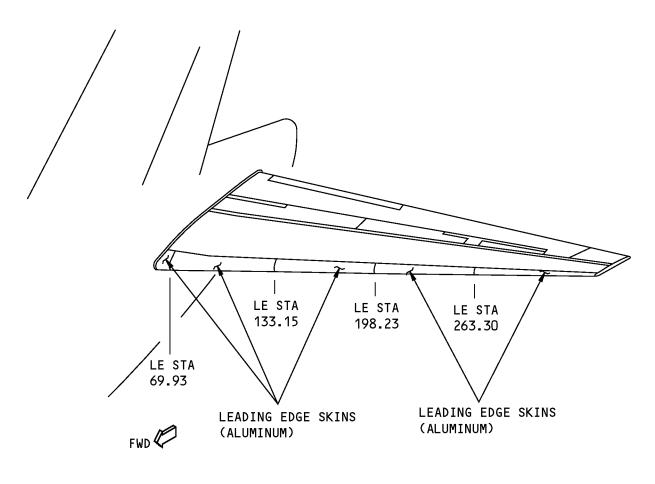
> Horizontal Stabilizer Leading Edge Skin Locations Figure 201

LEFT SIDE IS SHOWN, RIGHT SIDE IS OPPOSITE UPPER SURFACE IS SHOWN

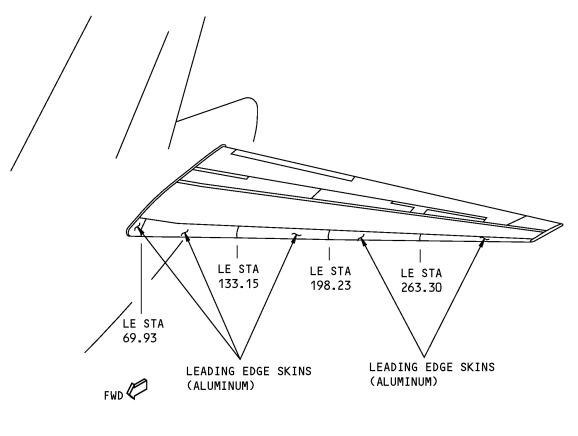
Horizontal Stabilizer Leading Edge Skin Locations Figure 201

LEFT SIDE IS SHOWN, RIGHT SIDE IS OPPOSITE UPPER SURFACE IS SHOWN

A. Repair 2 is applicable to damage to the horizontal stabilizer leading edge skins shown in Horizontal Stabilizer Leading Edge Skin Locations, Figure 201/REPAIR 2. Repair 2 is also applicable as a replacement repair for Repair 1.

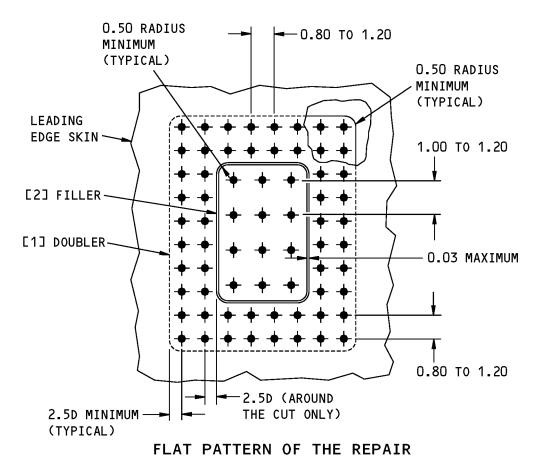
- ALL DIMENSIONS ARE IN INCHES
- (D) IS THE DIAMETER OF THE REPAIR FASTENER. USE (D) TO CALCULATE EDGE MARGINS.

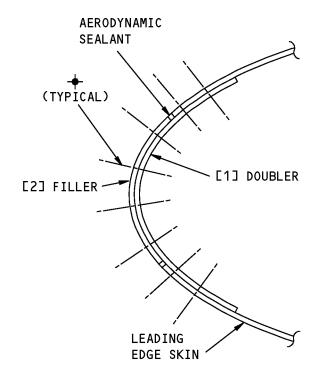
Horizontal Stabilizer Leading Edge Skin Flush Repair Figure 202 (Sheet 2 of 2)

SECTION THROUGH LEADING EDGE REPAIR

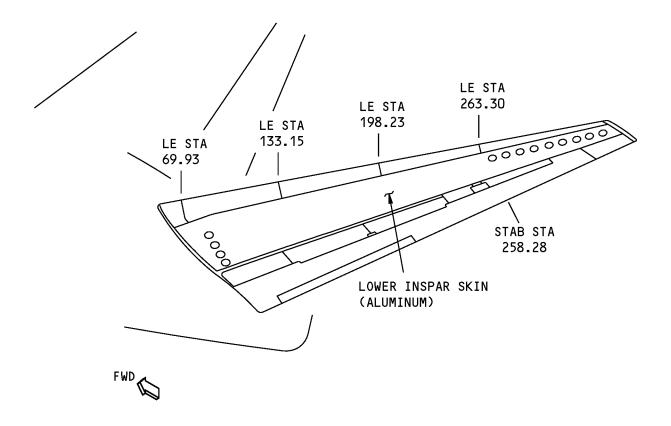
Horizontal Stabilizer Lower Inspar Skin Location Figure 202

LEFT SIDE IS SHOWN, RIGHT SIDE IS OPPOSITE LOWER SURFACE IS SHOWN

- A. Repair 4 is applicable to damage to the horizontal stabilizer inspar skins shown in Horizontal Stabilizer Upper Inspar Skin Location, Figure 201/REPAIR 4 and Horizontal Stabilizer Lower Inspar Skin Location, Figure 202/REPAIR 4.
 - (1) Repair 4 is also applicable as a replacement repair for Repair 3.

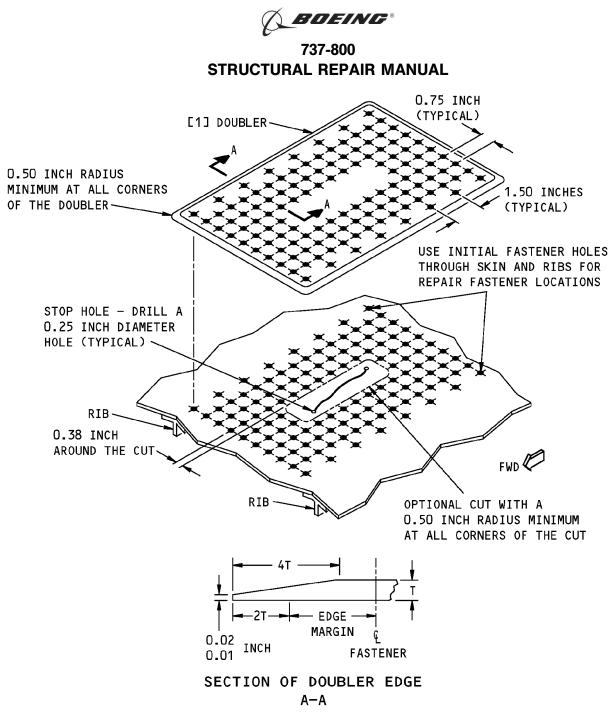
> Horizontal Stabilizer Inspar Skin External Repair Figure 203

- MAKE SURE THE REPAIR IS SYMMETRICAL AROUND THE DAMAGE.
- MAKE SURE THERE IS A MINIMUM OF FOUR ROWS OF REPAIR FASTENERS AROUND THE DAMAGE.

➡ REPAIR FASTENER LOCATION. INSTALL A BACR15CE6D SOLID RIVET. REFER TO SRM 51-40-00 THROUGH 51-40-08 FOR THE FASTENER DATA.

- A. Drill a stop hole at the ends of all skin cracks that do not end at fastener holes. Refer to Horizontal Stabilizer Inspar Skin External Repair, Figure 203/REPAIR 3 and SRM 51-10-02 for the procedures to drill a stop hole. For other damage, do what follows:
 - (1) Cut and remove the damaged part of the skin as shown in Horizontal Stabilizer Inspar Skin External Repair, Figure 203/REPAIR 3. Refer to 51-10-02 for the procedures to remove the damage.
 - (a) Make the cut in the shape of a rectangle with the longest sides parallel to the inspar ribs.
 - (b) Make the corner radii of the cut a minimum of 0.50 inch.
- B. Put the skin that is around the damage back to the initial contour.

- C. Make the part [1] doubler as shown in Horizontal Stabilizer Inspar Skin External Repair, Figure 203/REPAIR 3. Refer to Table 201/REPAIR 3 for the repair material.
 - (1) Make the contour of the part [1] doubler the same as the initial contour of the skin.

- D. Assemble the part [1] doubler as shown in Horizontal Stabilizer Inspar Skin External Repair, Figure 203/REPAIR 3.
- E. Drill the fastener holes.
- F. Countersink the fastener holes in the part [1] doubler.

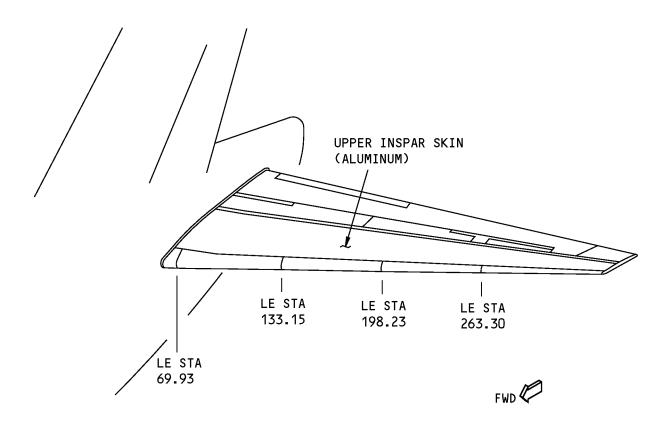
Horizontal Stabilizer Upper Inspar Skin Location Figure 201

LEFT SIDE IS SHOWN, RIGHT SIDE IS OPPOSITE UPPER SURFACE IS SHOWN

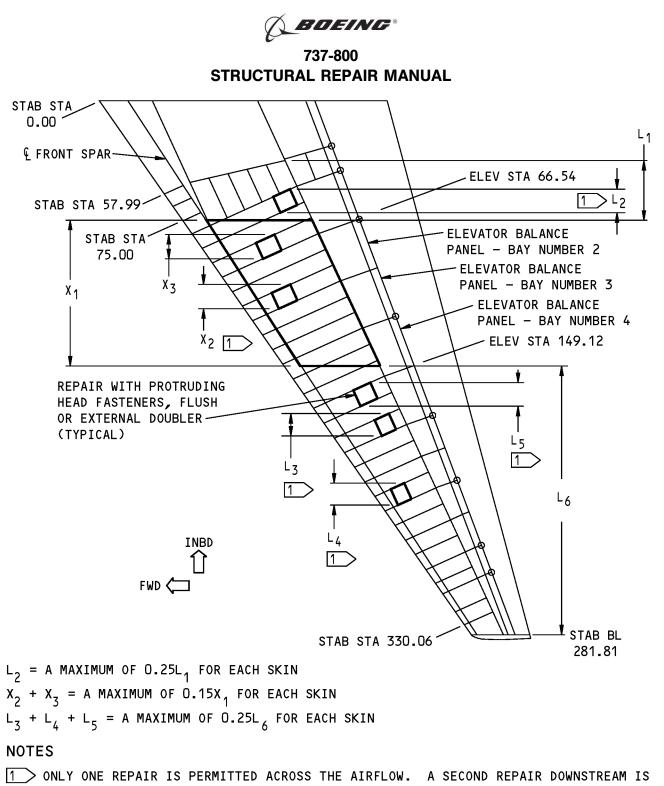
Horizontal Stabilizer Inspar Skins - Aerodynamic Limits of Repairs with Protruding Head Fasteners Figure 203

NOT PERMITTED.

LEFT SIDE IS SHOWN, RIGHT SIDE IS OPPOSITE

- C. Repairs with protruding head fasteners are permitted as shown in Horizontal Stabilizer Inspar Skins - Aerodynamic Limits of Repairs with Protruding Head Fasteners, Figure 203/REPAIR 4 and as follows:

- (1) For the area of each skin located in front of balance bays numbers 2, 3, and 4 (located between ELEV STA 66.54 and ELEV STA 149.12), repairs are permitted as follows:

- (a) The total outboard width across all repairs can not be more than 15 percent of the width of the airstream for each skin. The width of this airstream is the distance across the airstream measured in the outboard direction.

- (2) For the area of each skin not located in front of balance bays numbers 2, 3, and 4 repairs are permitted as follows:
 - (a) The total outboard width across all repairs can not be more than 25 percent of the width of the airstream for each skin. The width of this airstream is the distance across the airstream measured in the outboard direction. This width does not include the airstream in front of balance bays numbers 2, 3, and 4.

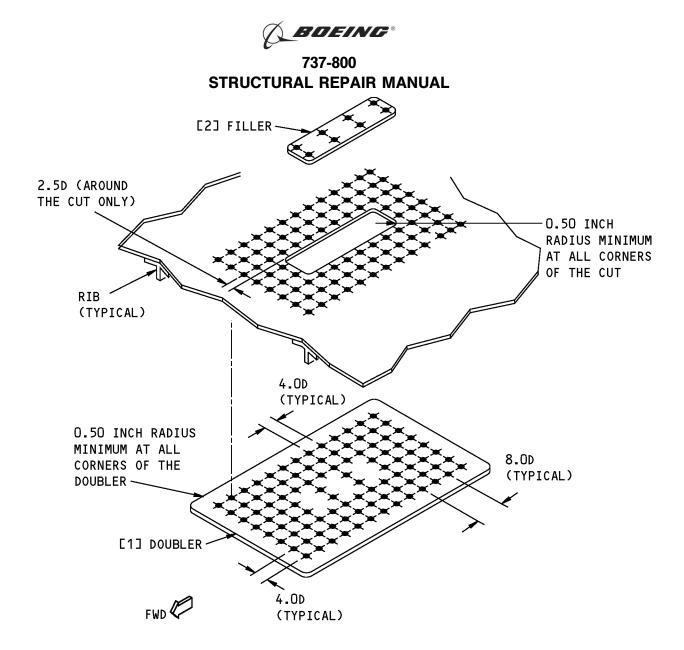
REPAIR FASTENER LOCATIONS - STABILIZER STATIONS 83.5 TO 92.7

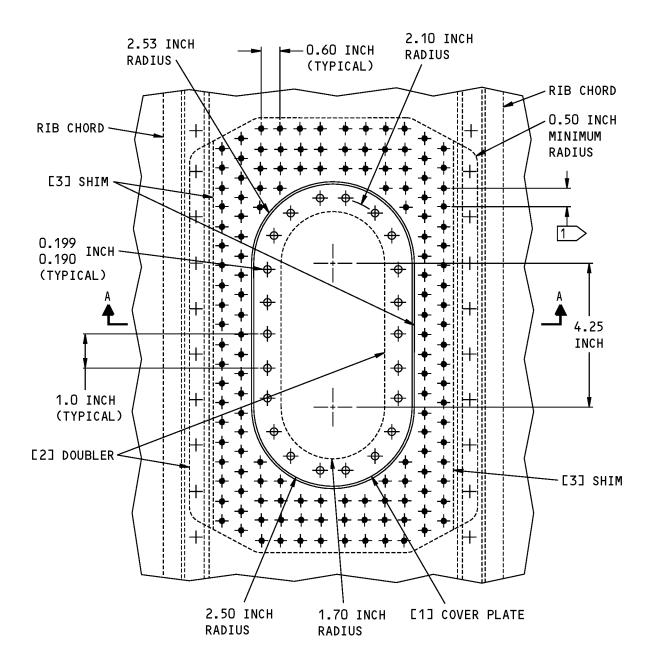
1 USE THE FASTENER SPACING AS FOLLOWS: - 0.65 INCH FOR STAB BL 83.5 TO STAB BL 258.0

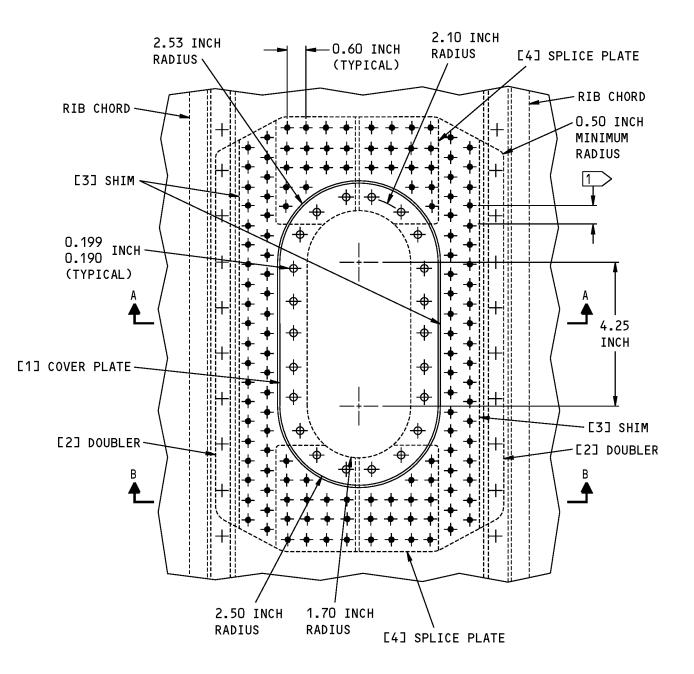
1 USE THE FASTENER SPACING AS FOLLOWS: - 0.65 INCH FOR STAB BL 83.5 TO STAB BL 258.0

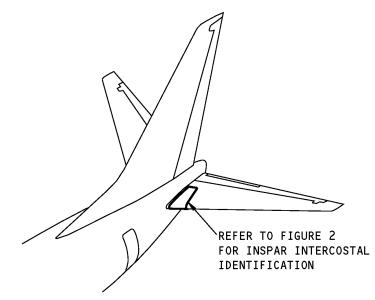
Horizontal Stabilizer Inspar Intercostal Location Figure 1

NOTE: REFER TO TABLE 1 FOR THE REFERENCE DRAWINGS.

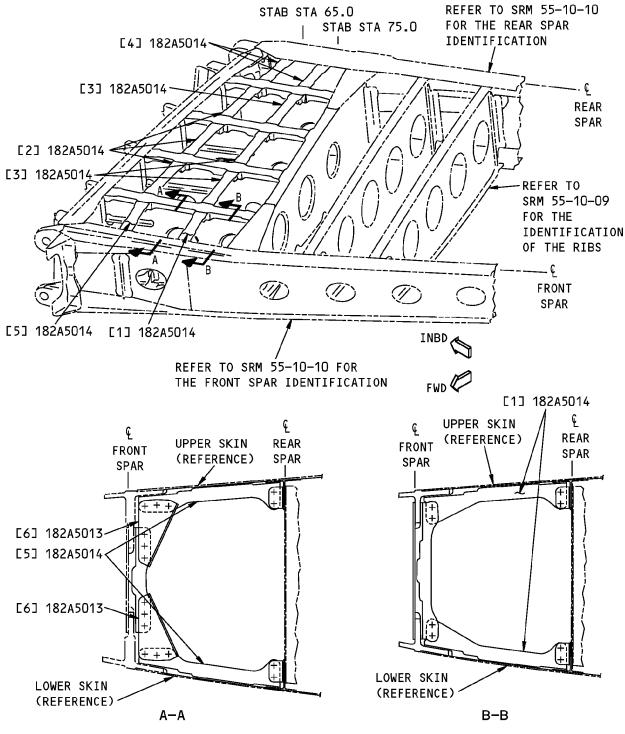
Horizontal Stabilizer Inspar Intercostal Identification Figure 2

NOTE: REFER TO TABLE 2 FOR THE LIST OF MATERIALS.

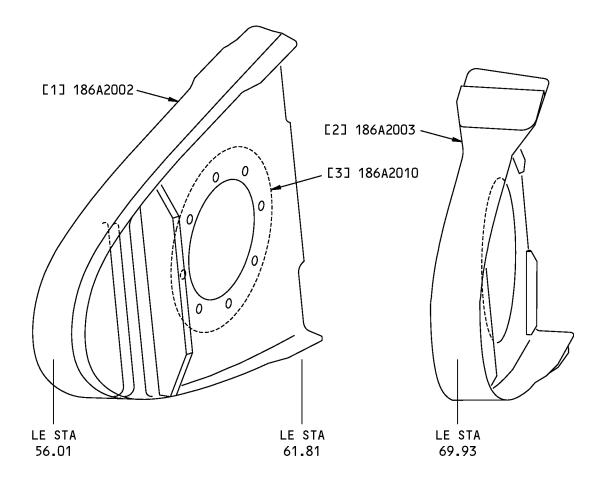
NOTE: REFER TO TABLE 3 FOR THE LIST OF MATERIALS.

FIXED HORIZONTAL STABILIZER LEADING EDGE RIB

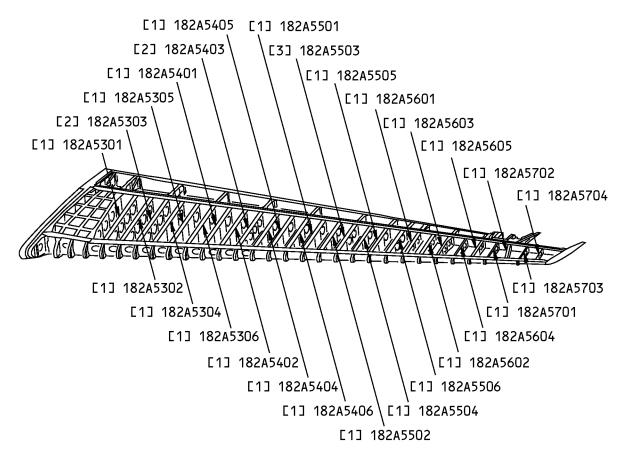
NOTE: REFER TO TABLE 5 FOR THE LIST OF MATERIALS.

INSPAR RIB ASSEMBLIES

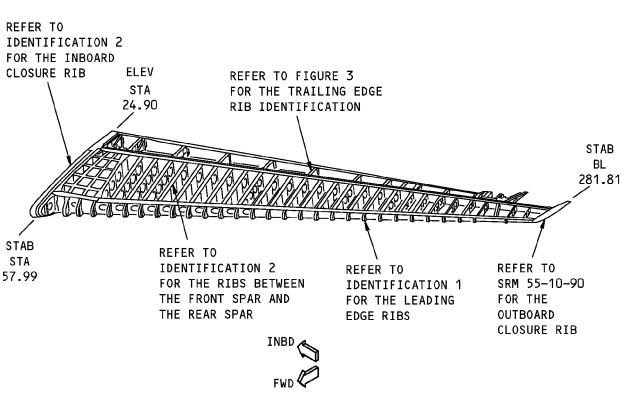
Horizontal Stabilizer Trailing Edge Rib Location Figure 2

LEFT SIDE IS SHOWN, RIGHT SIDE IS OPPOSITE

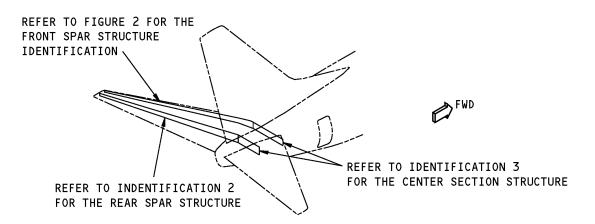
Horizontal Stabilizer Front Spar Structure Location Figure 1

NOTE: REFER TO TABLE 1 FOR THE REFERENCE DRAWINGS.

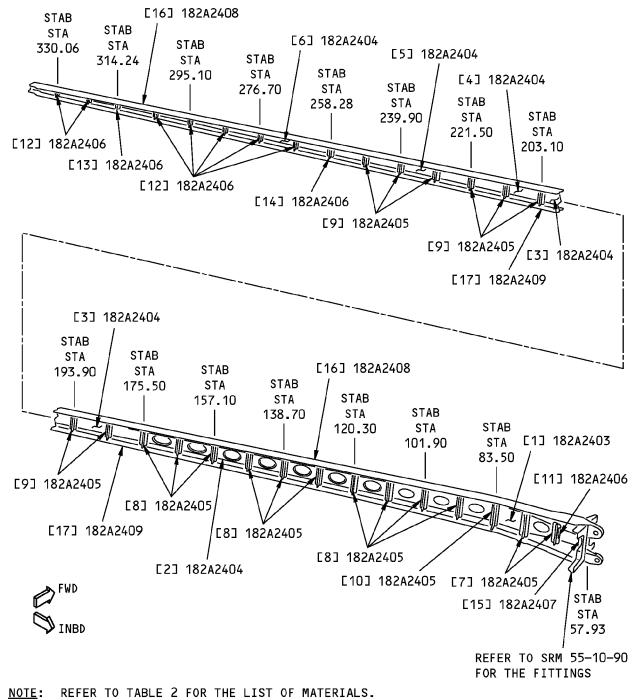
Horizontal Stabilizer Front Spar Structure Identification Figure 2

LEFT SIDE IS SHOWN, RIGHT SIDE IS OPPOSITE

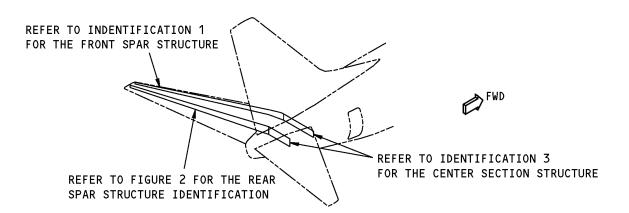
Horizontal Stabilizer Rear Spar Structure Location Figure 1

NOTE: REFER TO TABLE 1 FOR THE REFERENCE DRAWINGS.

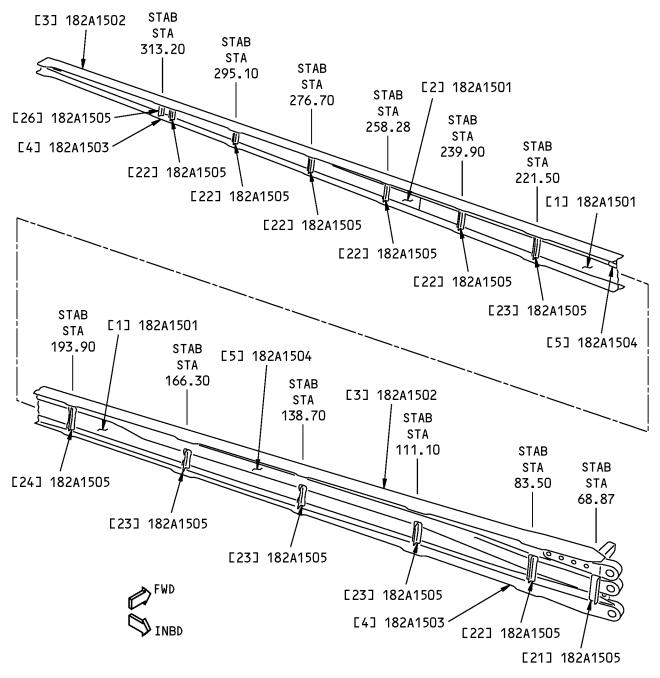
VIEW LOOKING FORWARD

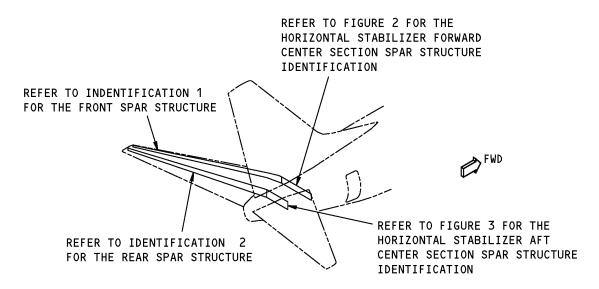
Horizontal Stabilizer Center Section Spar Structure Locations Figure 1

NOTE: REFER TO TABLE 1 FOR THE REFERENCE DRAWINGS.

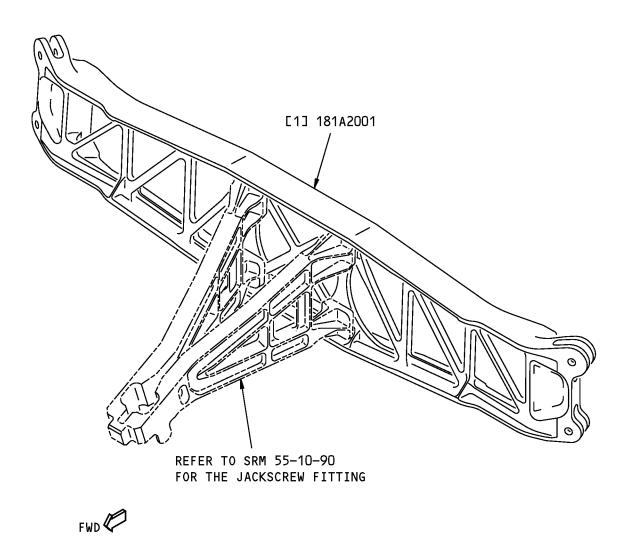
Horizontal Stabilizer Forward Center Section Spar Structure Identification Figure 2

NOTE: REFER TO TABLE 2 FOR THE LIST OF MATERIALS.

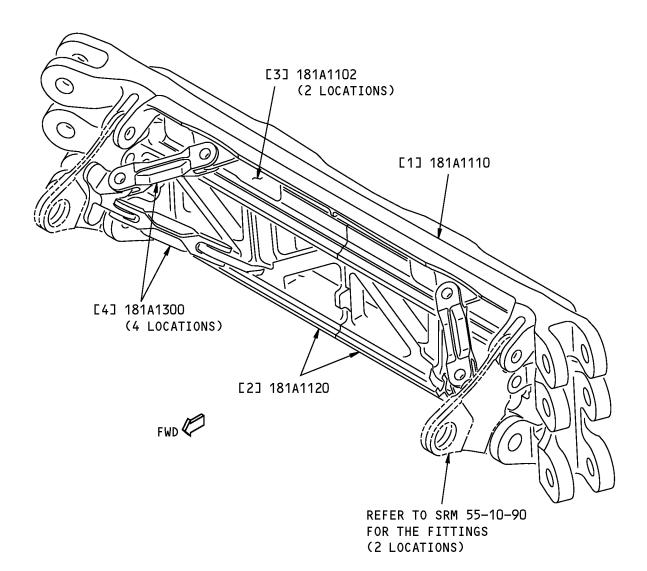
Horizontal Stabilizer Aft Center Section Spar Structure Identification Figure 3

NOTE: REFER TO TABLE 3 FOR THE LIST OF MATERIALS.

LIST OF MATERIALS FOR FIGURE 3				
ITEM	DESCRIPTION	T ^{*[1]}	MATERIAL	EFFECTIVITY
[1]	Rear Spar Fitting - Upper		Ti-6AI-4V titanium forging as given in BMS 7-247	
[2]	Rear Spar Fitting - Lower		7050-T74 forging as given in BMS 7-214	
[3]	Web-Splice	0.125 (3.18)	Ti-6AI-4V titanium sheet as given in MIL-T-9046, Code AB-1, in the annealed condition	
[4]	Upper and Lower Brace Fitting (LH and RH)		7050-T7451 plate as given in BMS 7-323, Type I

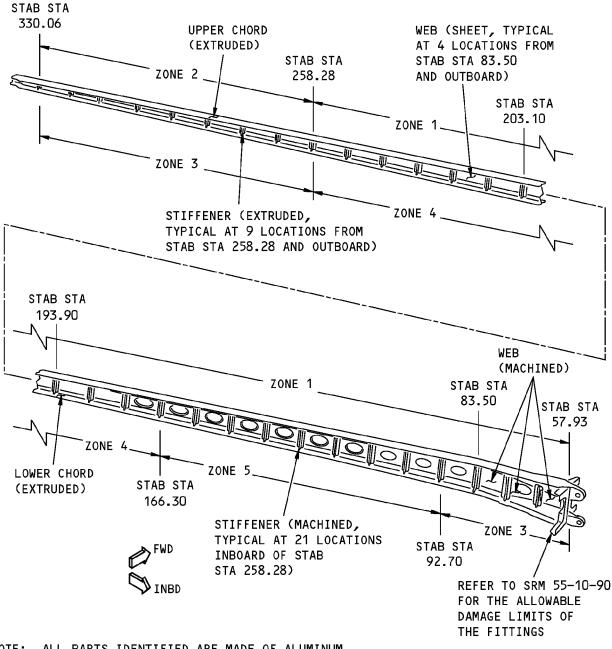
Horizontal Stabilizer Front Spar Structure and Allowable Damage Zones Figure 102

NOTE: ALL PARTS IDENTIFIED ARE MADE OF ALUMINUM.

LEFT SIDE IS SHOWN, RIGHT SIDE IS OPPOSITE

A. This subject gives the allowable damage limits for the horizontal stabilizer front spar shown in Horizontal Stabilizer Front Spar Location, Figure 101/ALLOWABLE DAMAGE 1 and Horizontal Stabilizer Front Spar Structure and Allowable Damage Zones, Figure 102/ALLOWABLE DAMAGE 1.

Table 101:					
PARAGE	APH REFEREN	CES FOR THE ALLOWABLE DAMAGE LIMITS			
TYPE OF STRUCTURE ZONE STABILIZER STATION PARAGRAPH					
Upper Chord	1	258.28 and inboard	4.A		
	2	258.28 and outboard	4.		
Lower Chord	3	92.70 and inboard 258.28 and outboard	4.C		
	4	258.28 to 166.30	4.D		
	5	166.30 to 92.70	4.E		
Webs		All	4.F		
Stiffeners		All	4.G

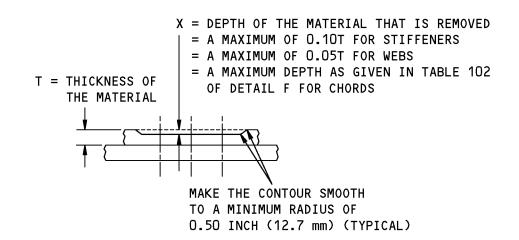
Allowable Damage Limits Figure 103 (Sheet 2 of 8)

REMOVE THE FASTENERS BEFORE THE DAMAGE IS REMOVED. INSTALL THE FASTENERS AFTER THE DAMAGE IS REMOVED

REMOVAL OF DAMAGE AROUND THE FASTENERS ON AN EDGE OR A SURFACE

- A. Upper Chord Zone 1
 - (1) Cracks:
 - (a) Remove the damage as shown in Allowable Damage Limits, Figure 103/ALLOWABLE DAMAGE 1, Details A, B, and C.
 - (2) Nicks, Gouges, Scratches and Corrosion:

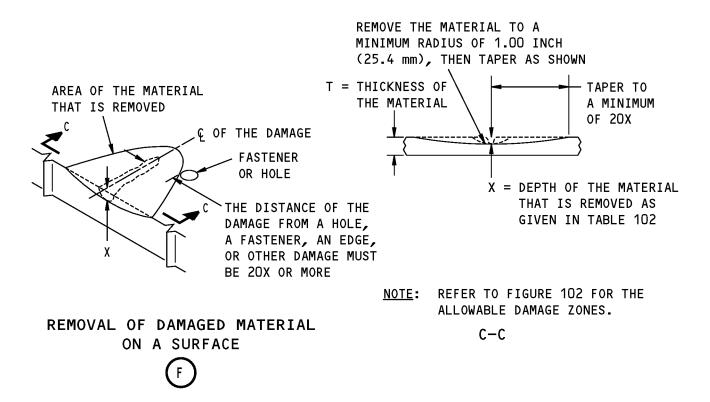
Allowable Damage Limits Figure 103 (Sheet 4 of 8)

DEPTH OF THE REMOVED MATERIAL				
TYPE OF STRUCTURE ZONE MAXIMUM PERCENT OF THE INITIAL THICK				
UPPER CHORD	1	10		
UPPER CHURD	2	10		
	3	10		
LOWER CHORD	4	NO DAMAGE PERMITTED		
	5	5		
WEB	-	15		
STIFFENERS	-	10

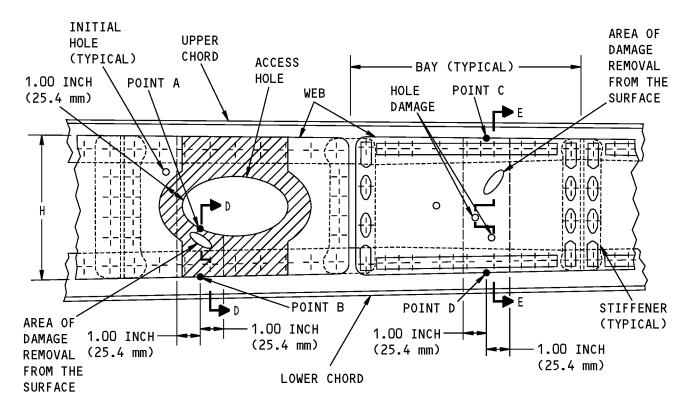
Allowable Damage Limits Figure 103 (Sheet 6 of 8)

H = HEIGHT OF THE WEB

ZONE A: NO HOLE DAMAGE PERMITTED

REMOVAL OF DAMAGED MATERIAL FROM A WEB

- (a) Remove the damage as shown in Allowable Damage Limits, Figure 103/ALLOWABLE DAMAGE 1, Details A, B, D, F, G, and I.
- (3) Dents are permitted as shown in Allowable Damage Limits, Figure 103/ALLOWABLE DAMAGE 1, Detail H.

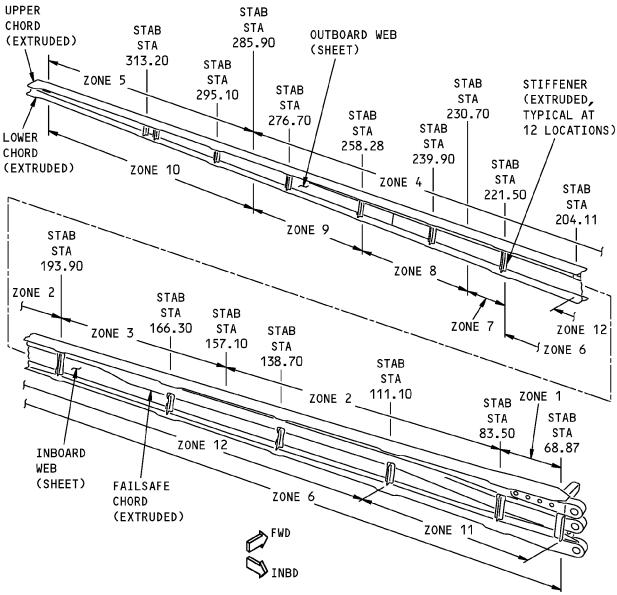
Horizontal Stabilizer Rear Spar Structure and Allowable Damage Zones Figure 102 (Sheet 1 of 2)

LEFT SIDE IS SHOWN, RIGHT SIDE IS OPPOSITE

- ALL PARTS IDENTIFIED ARE MADE OF ALUMINUM.
- ZONES 1, 2, 3, 4 AND 5 ARE APPLICABLE TO THE UPPER CHORD.
- ZONES 6,7,8,9, and 10 ARE APPLICABLE TO THE LOWER CHORD.
- ZONES 11 AND 12 ARE APPLICABLE TO THE FAILSAFE CHORD.

A. This subject gives the allowable damage limits for the horizontal stabilizer rear spar shown in Horizontal Stabilizer Rear Spar Location, Figure 101/ALLOWABLE DAMAGE 2 and Horizontal Stabilizer Rear Spar Structure and Allowable Damage Zones, Figure 102/ALLOWABLE DAMAGE 2.

PARAGRAPH REFERENCES FOR THE ALLOWABLE DAMAGE LIMITS				
TYPE OF STRUCTURE	ZONE	STABILIZER STATION	PARAGRAPH	
Upper Chord	1	68.87 thru 83.50	4.A	
	2	83.50 thru 157.10	4.A	
	3	157.10 thru 193.90	4.A	
	4	193.90 thru 285.90	4.A	
	5	285.90 and outboard	4.A	
Lower Chord	6	68.87 thru 221.50	4.B	
	7	221.50 thru 230.70	4.B	
	8	230.70 thru 258.28	4.B	
	9	258.28 thru 285.90	4.B	
	10	285.90 and outboard	4.B	
Failsafe Chord	11	68.87 thru 111.10	4.C	
	12	111.10 thru 204.11	4.C	
Webs		All	4.D	
Stiffeners, Fitting		All	4.E

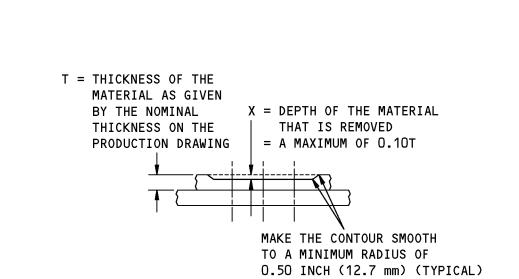
Allowable Damage Limits Figure 103 (Sheet 2 of 10)

REMOVAL OF DAMAGE AROUND THE FASTENERS ON AN EDGE OR A SURFACE

- A. Upper Chord Zones 1 thru 5
 - (1) Cracks:
 - (a) Remove the damage as shown in Allowable Damage Limits, Figure 103/ALLOWABLE DAMAGE 2, Details A, B, and C.

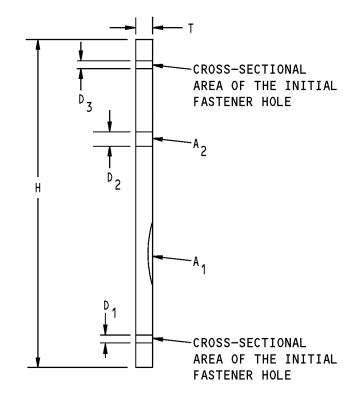
D_1 , D_3 = DIAMETERS OF THE INITIAL FASTENER HOLES D_2 = DIAMETER OF THE HOLE WHERE THERE IS DAMAGE H = HEIGHT OF THE WEB AT THE CROSS-SECTION T = THICKNESS OF THE WEB AS GIVEN BY THE NOMINAL THICKNESS ON THE PRODUCTION DRAWING A_1 = INITIAL AREA OF THE WEB = THE TOTAL CROSS-SECTIONAL AREA MINUS THE CROSS-SECTIONAL AREA OF THE INITIAL FASTENERS HOLES (AS MANUFACTURED BY BOEING) = HT - D_1 T - D_3 T A_1 = CROSS-SECTIONAL AREA OF THE DAMAGE THAT IS REMOVED AT LOCATION 1 A_2 = CROSS-SECTIONAL AREA OF THE DAMAGE THAT IS REMOVED AT LOCATION 2

$\begin{pmatrix} \frac{n_1 \cdot n_2}{A_1} \end{pmatrix}$ X 100 = PERCENT OF CROSS-SECTIONAL AREA REMOVED = A MAXIMUM OF 20 PERCENT

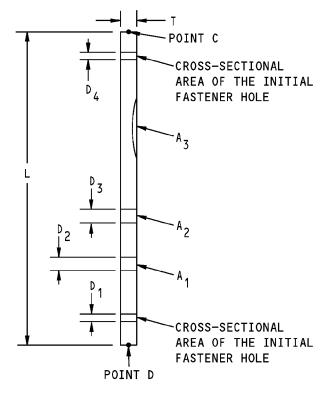
D_1 , D_4 = DIAMETERS OF THE INITIAL FASTENER HOLES D_2 , D_3 = DIAMETERS OF THE HOLES WHERE THERE IS DAMAGE L = LENGTH OF THE WEB AT THE CROSS-SECTION BETWEEN POINTS C AND D T = THICKNESS OF THE WEB AS GIVEN BY THE NOMINAL THICKNESS ON THE PRODUCTION DRAWING A_1 = INITIAL AREA OF THE WEB = THE TOTAL CROSS-SECTIONAL AREA MINUS THE CROSS-SECTIONAL AREA OF THE INITIAL FASTENERS HOLES (AS MANUFACTURED BY BOEING) = HT - D_1 T - D_4 T A_1 = CROSS-SECTIONAL AREA OF THE DAMAGE THAT IS REMOVED AT LOCATION 1 A_2 = CROSS-SECTIONAL AREA OF THE DAMAGE THAT IS REMOVED AT LOCATION 2 A_3 = CROSS-SECTIONAL AREA OF THE DAMAGE THAT IS REMOVED AT LOCATION 3 $\left(\frac{A_1 + A_2 + A_3}{A_1}\right) \times 100$ = PERCENT OF CROSS-SECTIONAL AREA REMOVED = A MAXIMUM OF 20 PERCENT THE TOTAL CROSS-SECTIONAL AREA REMOVED IN ALL ZONES C-D (1.00 INCH (25.4 mm) ON

EACH SIDE OF A LINE C-D) MUST NOT BE MORE THAN 20 PERCENT OF THE INITIAL AREA OF THE WEB

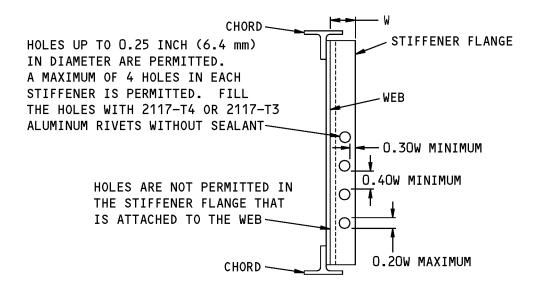
W = THE WIDTH OF THE STIFFENER FLANGE

HOLES THAT ARE PERMITTED TO REMOVE DAMAGED MATERIAL IN WEB STIFFENERS

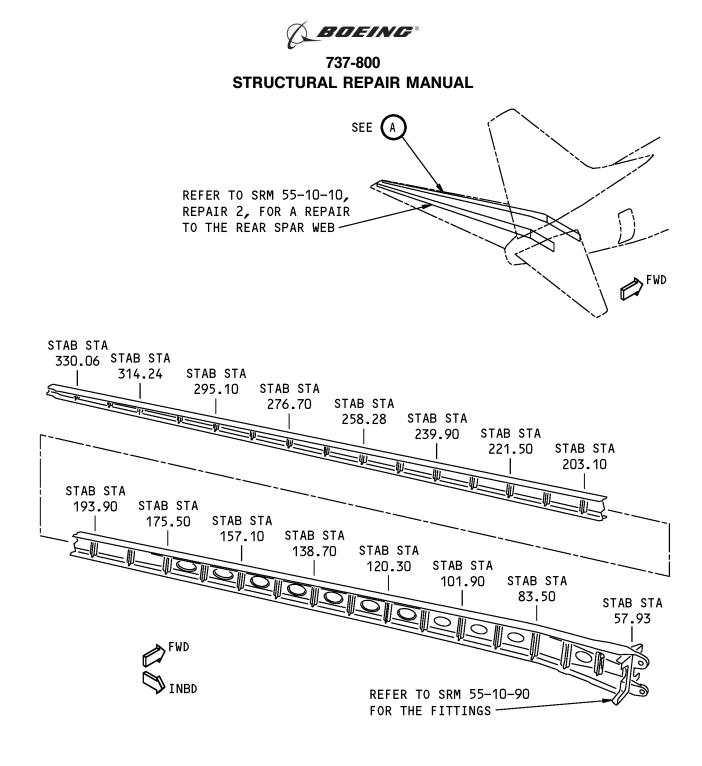
Horizontal Stabilizer Front Spar Location Figure 201

LEFT SIDE IS SHOWN, RIGHT SIDE IS OPPOSITE

- A. Repair 1 is applicable to damage to the web of the horizontal stabilizer front spar shown in Horizontal Stabilizer Front Spar Location, Figure 201/REPAIR 1 if:
 - (1) The damage is between Stabilizer Stations 111.10 and 175.50.

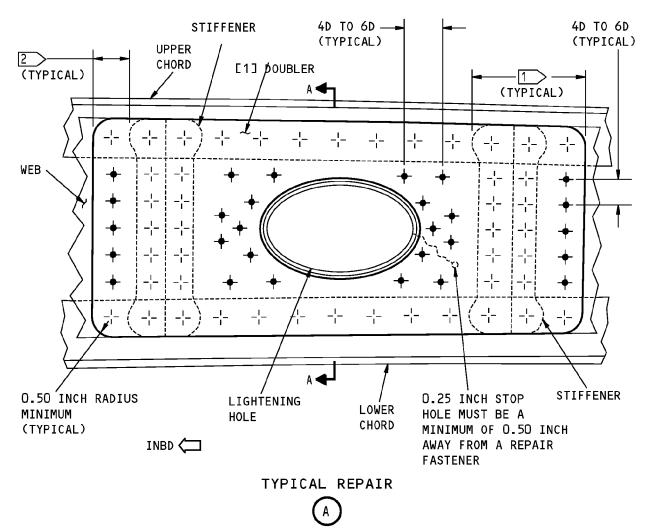
- (D) IS THE DIAMETER OF THE REPAIR FASTENER.
- 1 MAKE SURE THAT THERE IS A MINIMUM OF THREE FULL VERTICAL ROWS OF FASTENERS ON EACH SIDE OF THE DAMAGED AREA.
- 2 PUT THE LAST ROW OF FASTENERS AWAY FROM A STIFFENER.

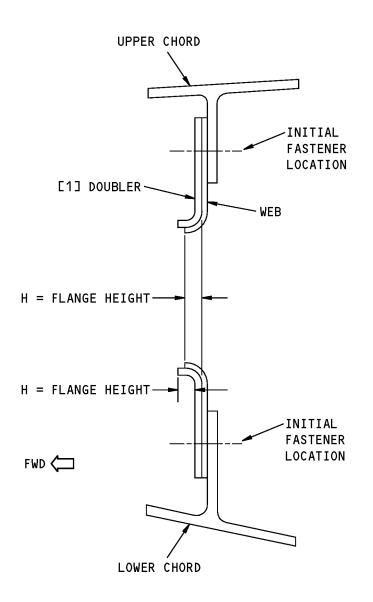
Horizontal Stabilizer Front Spar Web Repair Figure 202 (Sheet 2 of 3)

REPAIR SHOWN WITH THE BEST FLANGE FOR THE DOUBLER $\ensuremath{\mathsf{A-A}}$

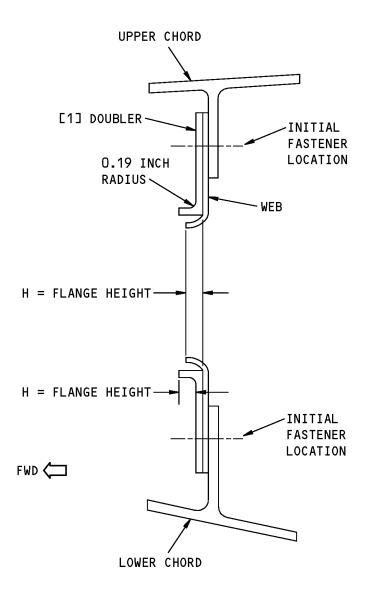
Horizontal Stabilizer Front Spar Web Repair Figure 202 (Sheet 3 of 3)

REPAIR SHOWN WITH OPTIONAL MACHINED DOUBLER

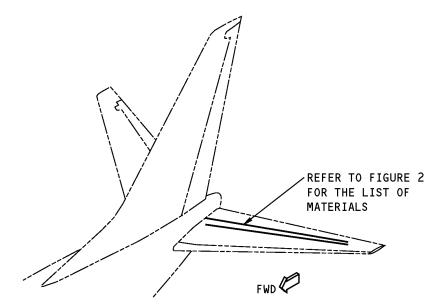
Horizontal Stabilizer Beam Location Figure 1

NOTE: REFER TO TABLE 1 FOR THE REFERENCE DRAWINGS.

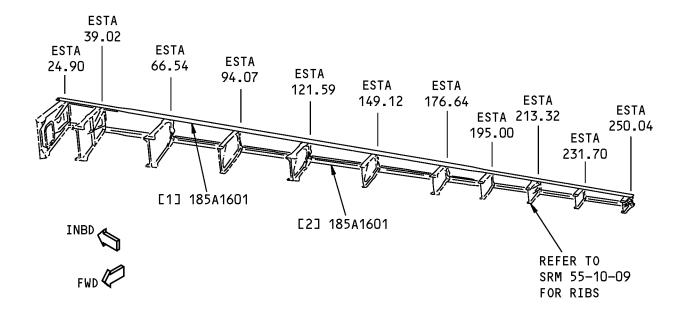
THE LEFT HORIZONTAL STABILIZER BEAM IS SHOWN, THE RIGHT HORIZONTAL STABILIZER BEAM IS OPPOSITE

NOTE: REFER TO TABLE 2 FOR THE LIST OF MATERIALS.

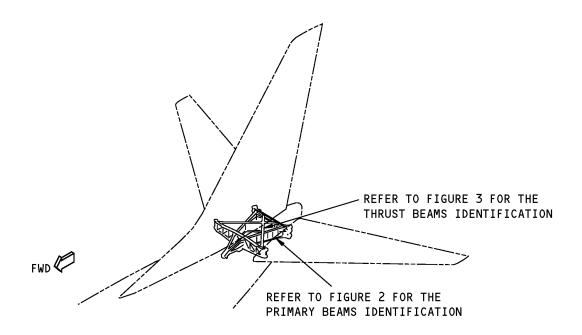
Horizontal Stabilizer Center Section Beam Locations Figure 1

NOTE: REFER TO TABLE 1 FOR THE REFERENCE DRAWINGS.
