CHAPTER 555

STABILIZERS

737-800 STRUCTURAL REPAIR MANUAL

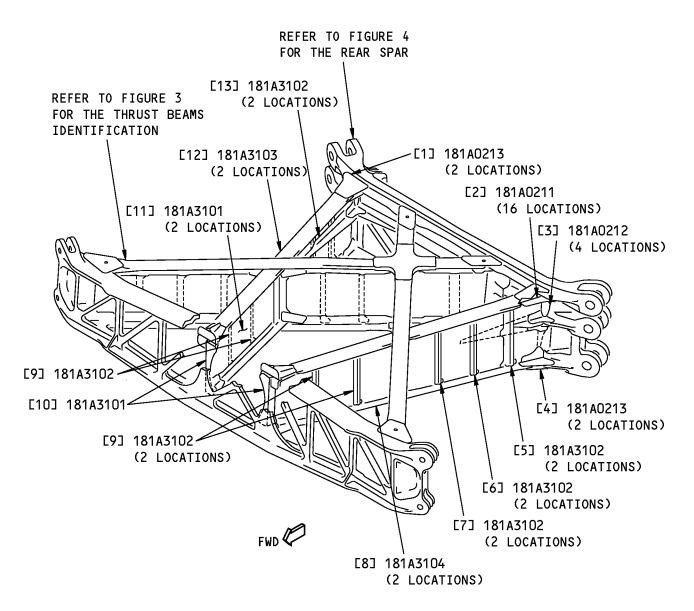
Horizontal Stabilizer Center Section Primary Beams Identification Figure 2

NOTE: REFER TO TABLE 2 FOR THE LIST OF MATERIALS.

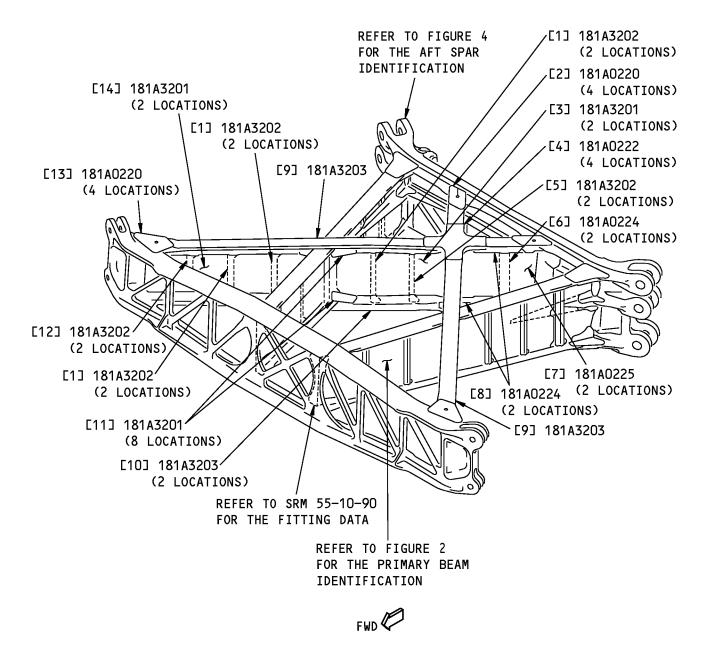
Horizontal Stabilizer Center Section Thrust Beams Identification Figure 3

NOTE: REFER TO TABLE 3 FOR THE LIST OF MATERIALS.

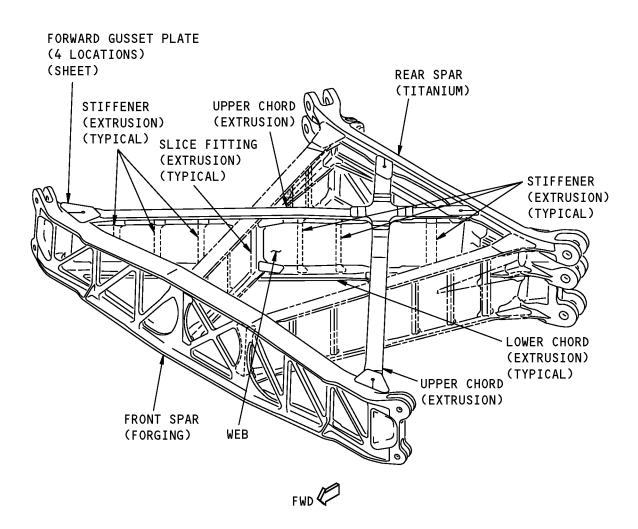
Horizontal Stabilizer Center Section - Thrust Beams Figure 103

NOTE: ALL PARTS OTHER THAN THE REAR SPAR ARE MADE OF ALUMINUM.

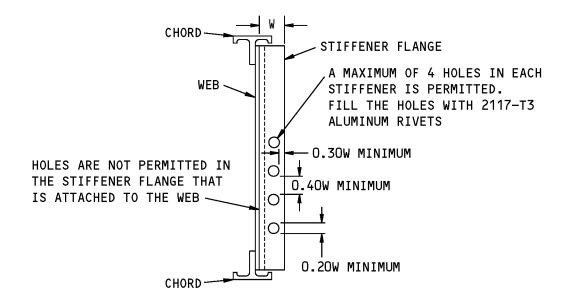
Allowable Damage Limits Figure 104 (Sheet 3 of 4)

HOLES THAT ARE PERMITTED TO REMOVE DAMAGED MATERIAL IN WEB STIFFENERS

- (3) Dents are not permitted.
 - (4) Holes and Punctures are permitted as shown in Allowable Damage Limits, Figure 104/ALLOWABLE DAMAGE 2, Detail F.
- E. Webs

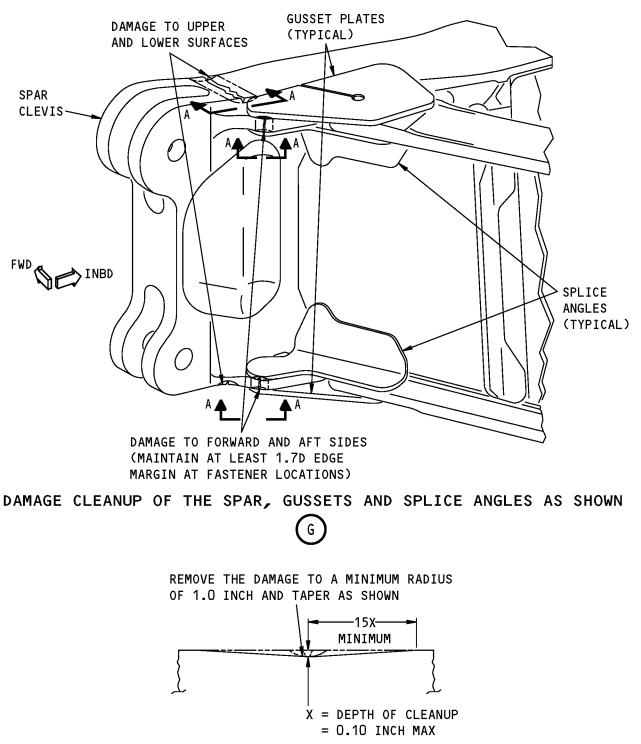
Allowable Damage Limits Figure 104 (Sheet 4 of 4)

SECTION A-A

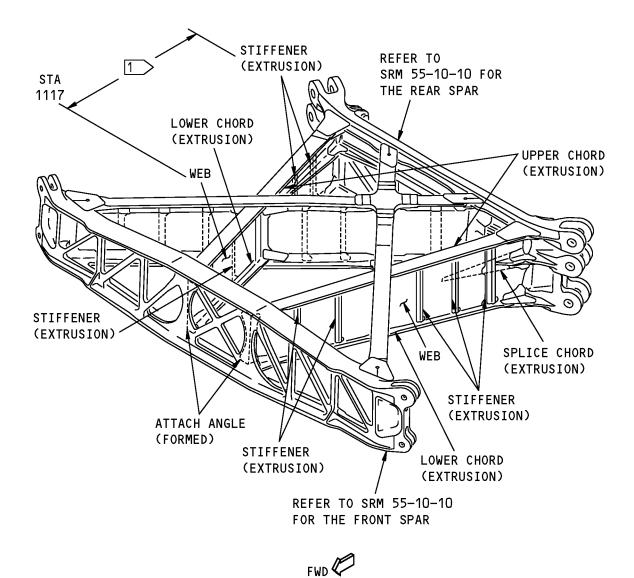
- ALL PARTS ARE MADE FROM ALUMINUM.
- 1 FOR THE PRIMARY BEAMS, NO REPAIRS ARE PERMITTED TO THE UPPER OR LOWER CHORDS AFT OF STA 1117.

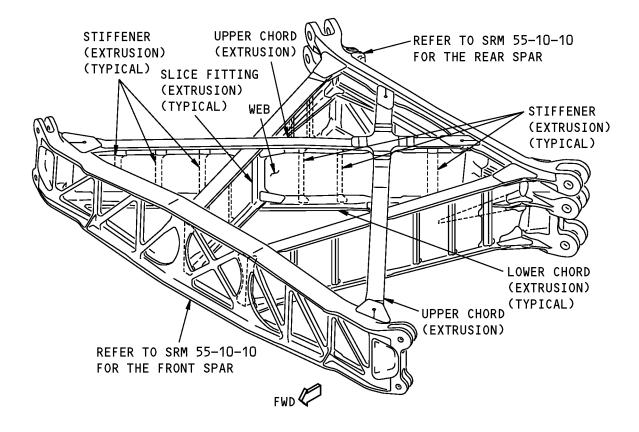
Horizontal Stabilizer Center Section - Thrust Beams Figure 203

NOTE: ALL PARTS ARE MADE OF ALUMINUM.

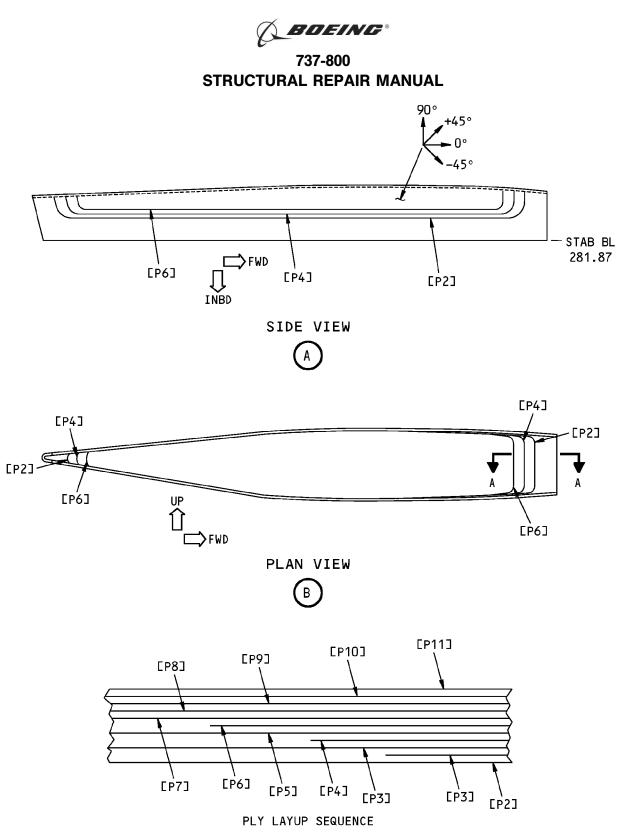
Ply Sequence for Figure 2, Item [1] Figure 3

A-A

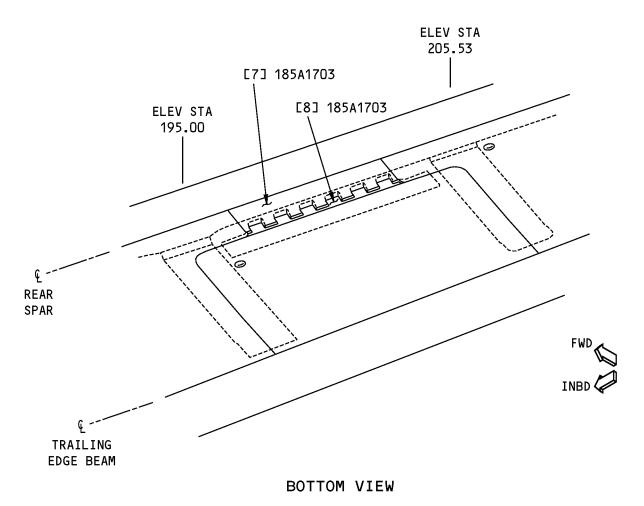
Horizontal Stabilizer Hinge Plate Identification Figure 4 (Sheet 2 of 2)

HORIZONTAL STABILIZER ACCESS DOOR HINGE

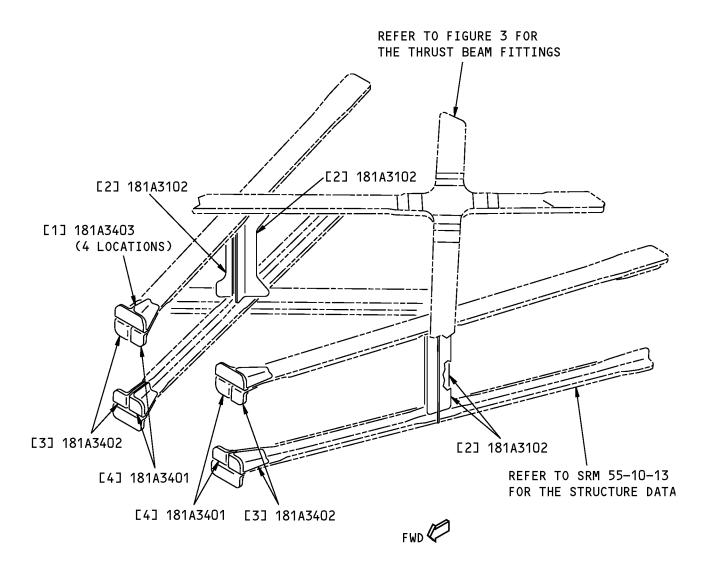
NOTE: REFER TO TABLE 2 FOR THE LIST OF MATERIALS.

Horizontal Stabilizer Center Section Primary Beam Fittings Identification Figure 2

LIST OF MATERIALS FOR FIGURE 2			
ITEM	DESCRIPTION	T ^{*[1]}	MATERIAL	EFFECTIVITY
[1]	Attach Fitting (2)		Ti-6AI-4V machined titanium bar as given in MIL-T- 9047, in the annealed condition. Refer to the production drawing for the machined thicknesses	
[2]	Splice Fitting (2)		7075-T73511 extruded bar, as given in QQ-A-200/11, Class A. Refer to the production drawing for the machined thicknesses	
[3]	Attach Fitting (2)		Ti-6AI-4V machined titanium bar as given in MIL-T- 9047, in the annealed condition. Refer to the production drawing for the machined thicknesses	
[4]	Attach Fitting (2)		Ti-6Al-4V machined titanium bar as given in MIL-T- 9047, in the annealed condition. Refer to the production drawing for the machined thicknesses

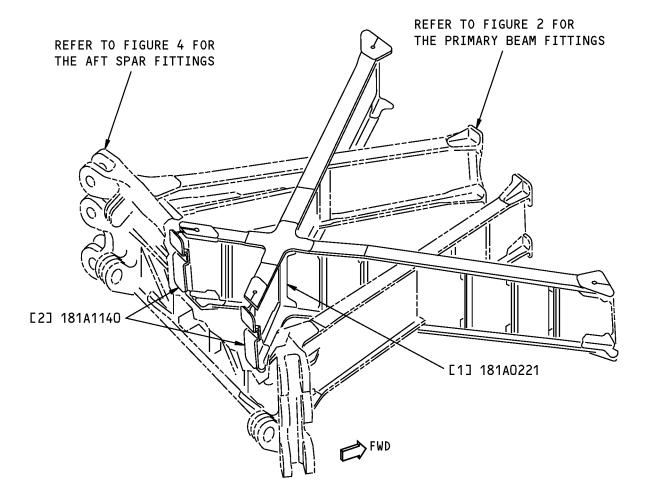
NOTE: REFER TO TABLE 3 FOR THE LIST OF MATERIALS.

Horizontal Stabilizer Center Section Thrust Beams Fittings Identification Figure 3

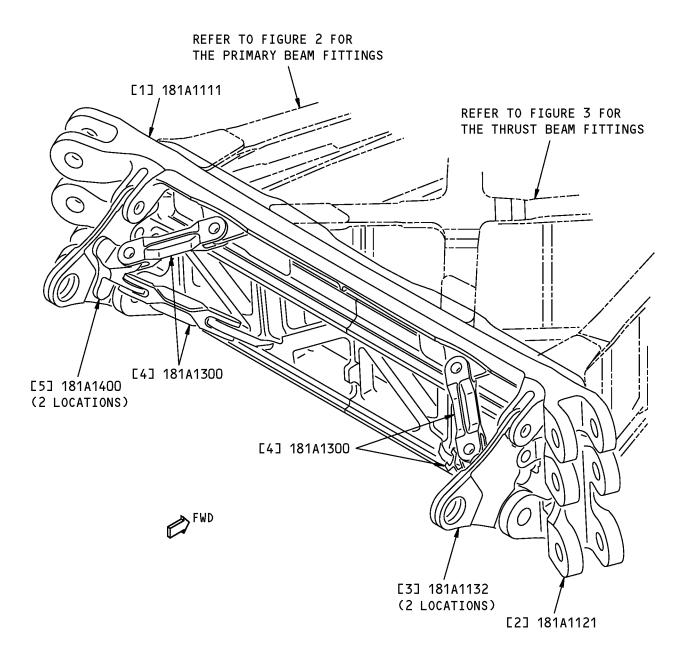
Horizontal Stabilizer Center Section Aft Spar Fittings Identification Figure 4

LIST OF MATERIALS FOR FIGURE 4			
ITEM	DESCRIPTION	T ^{*[1]}	MATERIAL	EFFECTIVITY
[1]	Upper Fitting		Ti-6AI-4V titanium forging as given in BMS 7-247, in the annealed condition. Refer to the production drawing for the machined thicknesses and grain direction	
[2]	Lower Fitting		7050-T74 forging as given in BMS 7-214, Class A. Refer to the production drawing for the machined thicknesses and grain direction	
[3]	Hinge Housing (2) Fitting		Ti-6AI-4V titanium as given in MIL-T-9046, Composition AB-1. Refer to the production drawing for the machined thicknesses and grain direction	
[4]	Brace Fitting (4)		7050-T7451 plate as given in AMS 4050, Class A. Refer to the production drawing for the machined thicknesses and grain direction	
[5]	Attach Fitting (2)		Ti-6AI-4V machined titanium bar as given in MIL-T- 9047, in the annealed condition. Refer to the production drawing for the machined thicknesses and grain direction

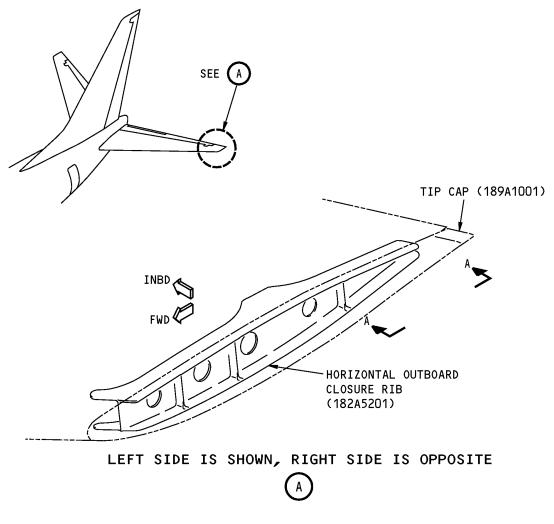
Layout of the Repair Parts Figure 201 (Sheet 1 of 3)

- A. Get access to the damaged area.
 - (1) Remove the necessary fasteners in the area of the damaged skin. Refer to 51-40-02, GENERAL.
 - (2) Remove the horizontal stabilizer outboard closure rib tip cap, as necessary.
 - (3) Remove the upper and/or lower horizontal stabilizer outboard aft trailing edge skin panels, as necessary.
 - (4) Remove the nutplates, as necessary, to install the Part [1] repair channel, as shown in Figure 201/REPAIR 1.
- B. Cut and remove the damaged part of the horizontal stabilizer outboard closure rib upper and/or lower aft flange, if necessary, as shown in Figure 201/REPAIR 1. Refer to 51-10-02, GENERAL.

- (1) Make the cut as shown in Figure 201/REPAIR 1.
 - (a) Refer to 51-10-02 for the inspection and removal of damage.
 - (b) Refer to 51-30-03 for possible sources of the abrasive and other materials you can use to remove the damage.

- G. Remove the horizontal stabilizer outboard closure rib finish that is common to the Part [1] repair channel.
- H. Assemble the repair parts as shown in Figure 201/REPAIR 1.

- O. Fillet seal the repair parts and fill all gaps with BMS 5-95 sealant. Refer to 51-20-05.
- P. Attach the initial nutplates from 4.A.(4) above to the repair parts as shown in Figure 201/REPAIR 1.

- (1) The initial nutplate fasteners will go through the Part [1] repair channel and the initial horizontal stabilizer outboard closure rib or the repair fillers, as shown in Figure 201/REPAIR 1.

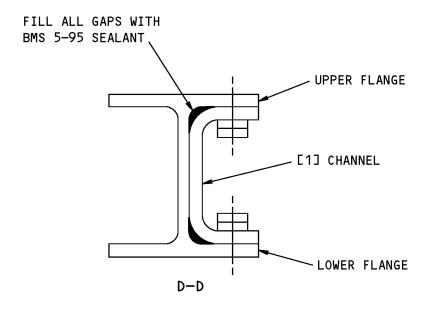
- 1 MAKE SURE THERE IS A MINIMUM OF 2D EDGE MARGIN.
- 2 MAKE SURE THERE IS A MINIMUM OF 3D TO 5D FASTENER SPACING FOR ALL NEW FASTENERS.
- 3 MAKE SURE THERE IS A MINIMUM OF 4D TO 6D FASTENER SPACING FOR ALL NEW FASTENERS.
- 4 MAKE SURE THERE IS A MAXIMUM OF 0.010 INCH GAP BETWEEN THE INITIAL PARTS AND THE REPAIR PARTS.

- ↔ INITIAL FASTENER LOCATION. INSTALL THE SAME TYPE AND SIZE AS THE INITIAL FASTENER. REPLACE ANY DAMAGED NUT PLATES OR FASTENERS.
- ---- REFERENCE FASTENER LOCATION
- \oplus REPAIR FASTENER LOCATION. INSTALL A BACB30VT6 BOLT AND A BACC30BL COLLAR WITH COLLAR OUTBOARD. 1 > 3 > 4
- + REPAIR FASTENER LOCATION. INSTALL A BACR15CE6 RIVET. 1 > 2 > 4 > 4

Layout of the Repair Parts Figure 201 (Sheet 3 of 3)

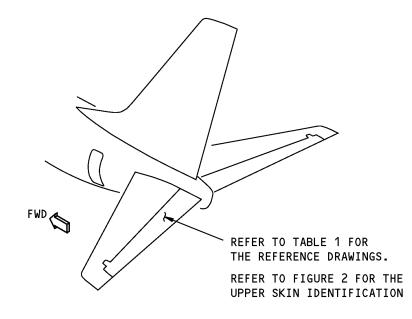
Elevator Upper Skin Location Figure 1

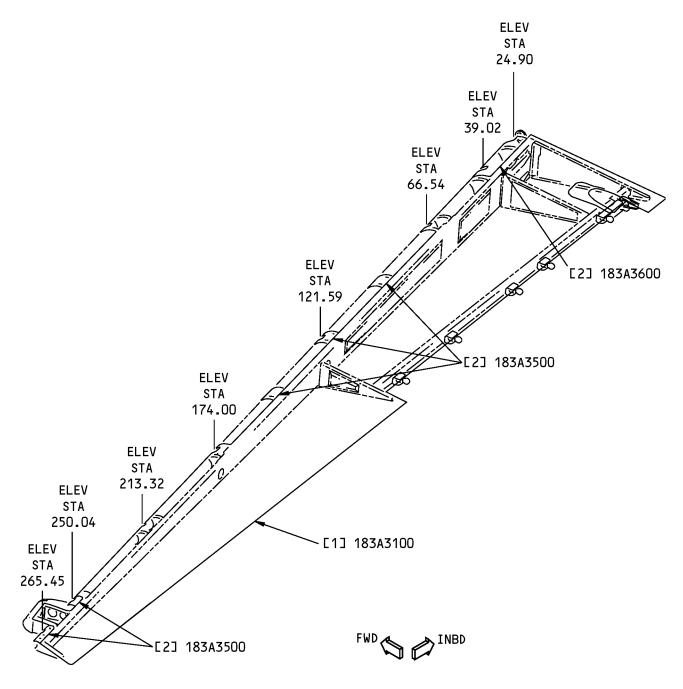
LEFT SIDE SHOWN, RIGHT SIDE OPPOSITE (FOR AIRPLANE LINE NUMBERS 1175 AND ON)

Elevator Upper Skin Identification Figure 2 (Sheet 2 of 2)

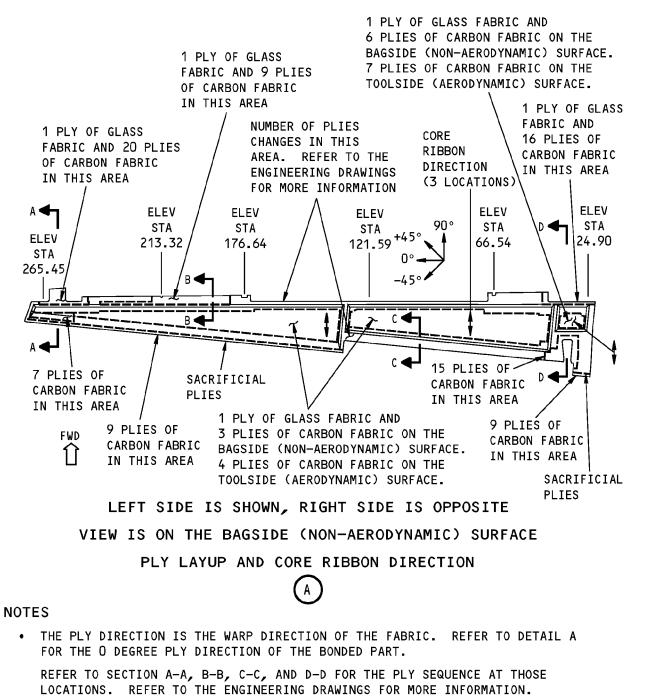
REFER TO TABLE 3 FOR THE DIRECTION AND MATERIAL OF THE PLIES SHOWN IN SECTIONS A-A, B-B, C-C, AND D-D.

Ply Direction, Core Ribbon Direction, and Ply Sequence for the Elevator Upper Skin Panel, Figure 2, Item [1] Figure 3 (Sheet 1 of 2)

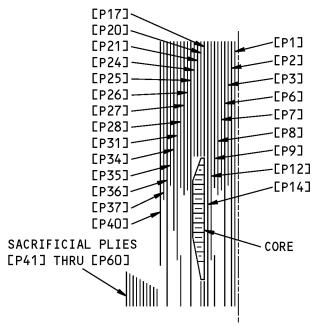
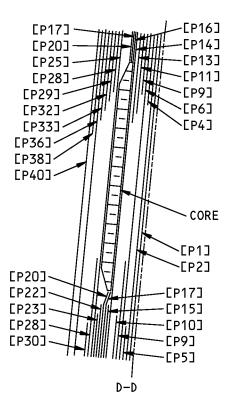
Ply Direction, Core Ribbon Direction, and Ply Sequence for the Elevator Upper Skin Panel, Figure 2, Item [1] Figure 3 (Sheet 2 of 2)

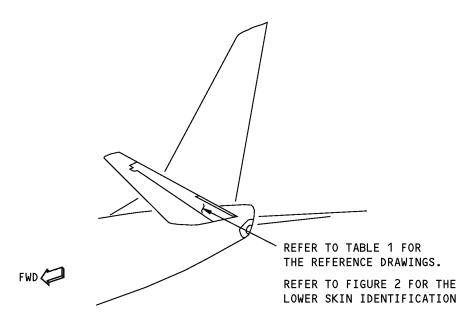
Elevator Lower Skin Location Figure 1

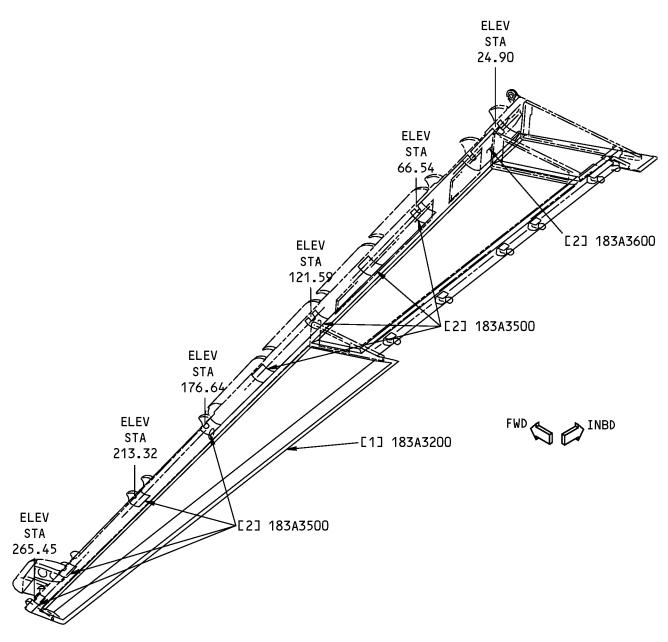
LEFT SIDE IS SHOWN, RIGHT SIDE IS OPPOSITE (FOR AIRPLANE LINE NUMBERS 1175 AND ON)

Elevator Lower Skin Identification Figure 2 (Sheet 2 of 2)

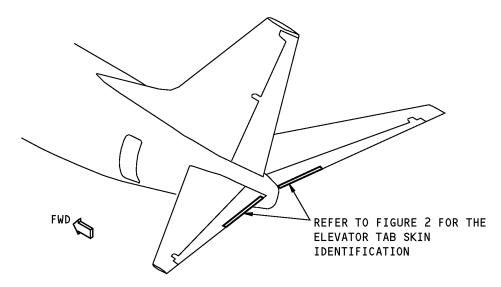
Elevator Tab Skin Locations Figure 1

REFERENCE DRAWINGS		
DRAWING NUMBER	TITLE		
183A8000	Elevator Tab Installation		
183A8100	Elevator Tab Assembly		
183A8200	Elevator Tab Bonded Part		
183A8210	Elevator Tab Skins Bonded Part		
183A8220	Elevator Tab Spar and Leading Edge Bonded Part		
183A8230	Elevator Tab End Closures

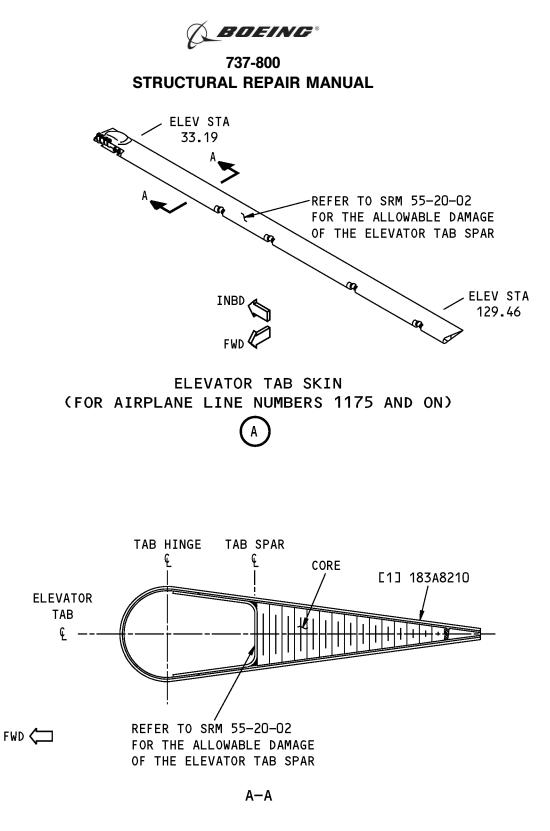
Elevator Tab Skin Identification Figure 2 (Sheet 1 of 2)

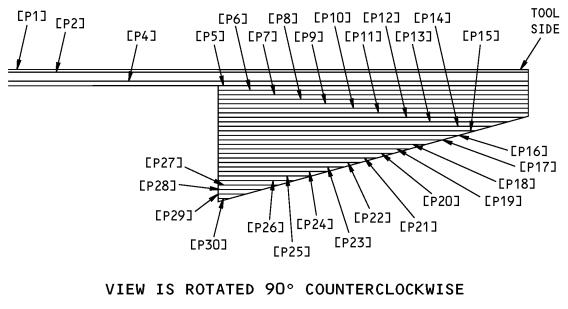
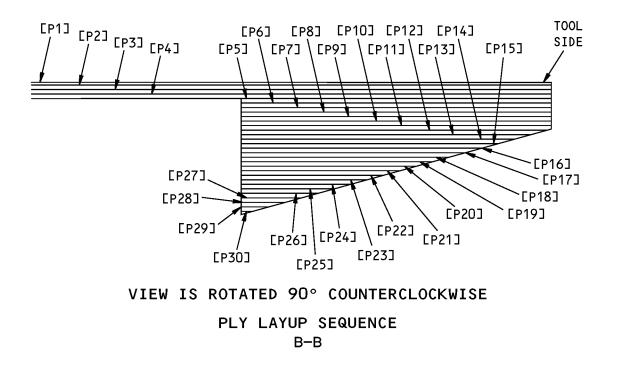
PLY LAYUP SEQUENCE

Ply Direction, Core Ribbon Direction and Ply Sequence for the Elevator Tab Upper Skin, Figure 2, Item [1] Figure 3 (Sheet 2 of 2)

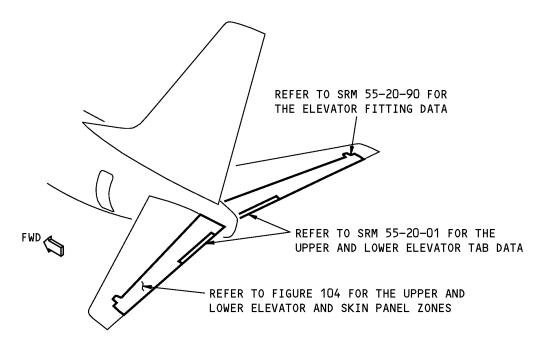
Upper and Lower Elevator Skin Location Figure 101

A. Allowable Damage 1 is applicable to damage on the Upper and Lower Elevator Skin made of carbon fiber reinforced plastic (CFRP) shown in Upper and Lower Elevator Skin Location, Figure 101/ALLOWABLE DAMAGE 1.

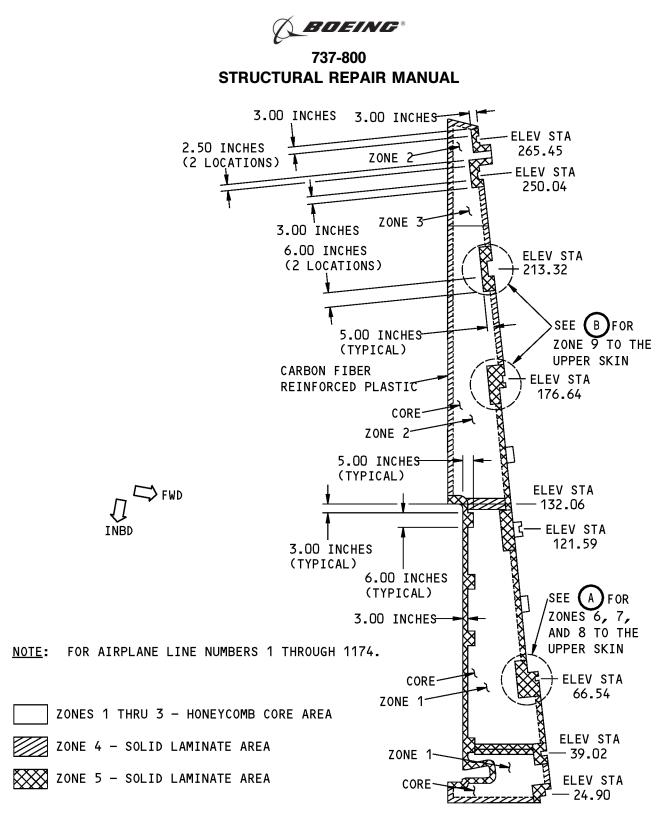
LEFT SIDE IS SHOWN, RIGHT SIDE IS OPPOSITE UPPER SKIN PANEL IS SHOWN, LOWER SKIN PANEL IS ALMOST THE SAME

> Upper and Lower Elevator Skin Panel Zones Figure 104 (Sheet 1 of 4)

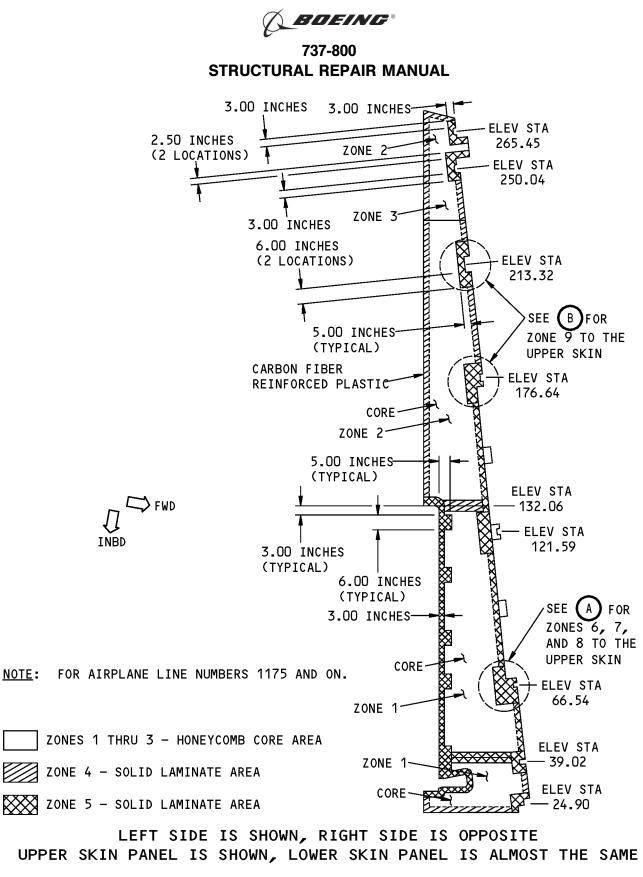
Upper and Lower Elevator Skin Panel Zones Figure 104 (Sheet 2 of 4)

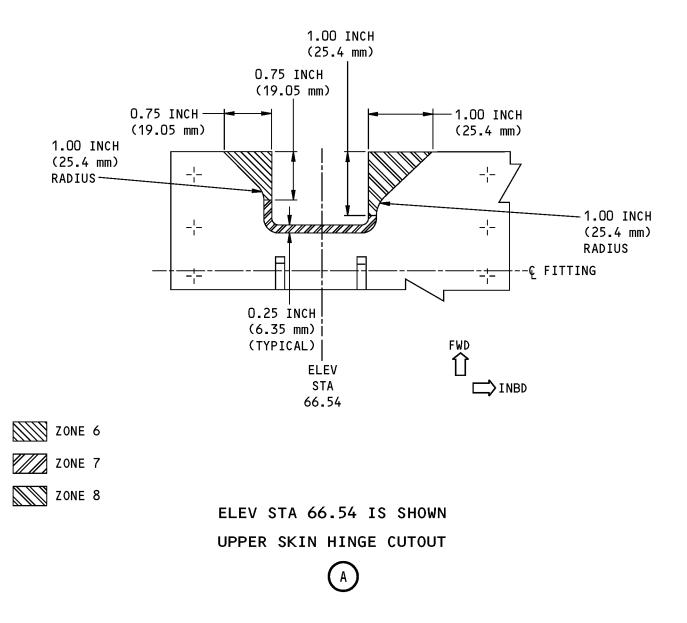
Upper and Lower Elevator Skin Panel Zones Figure 104 (Sheet 3 of 4)

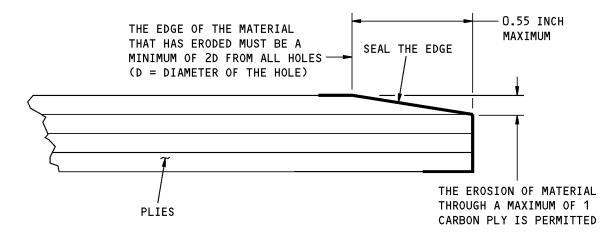
SEALING OF EROSION DAMAGE AT AN EDGE OF COMPOSITE PARTS

Upper and Lower Elevator Skin Panel Allowable Damage Figure 105

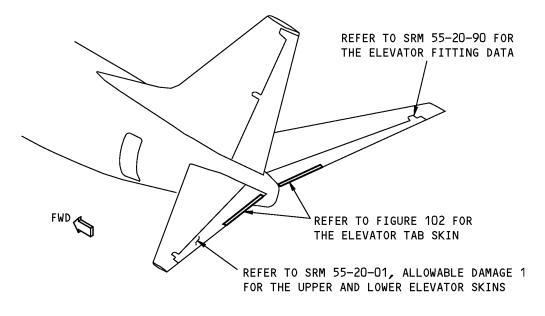
Elevator Tab Skin Location Figure 101

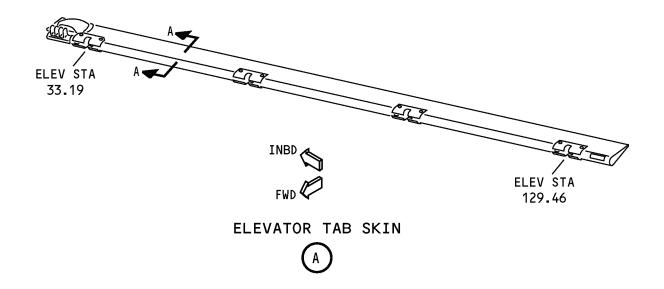
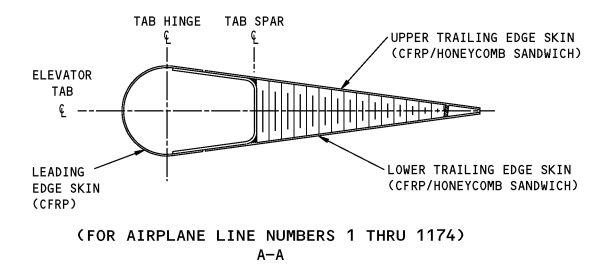
Elevator Tab Skin Figure 102

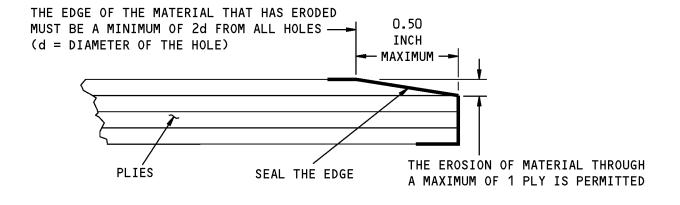
Elevator Tab Skin Allowable Damage Figure 105 (Sheet 1 of 2)

SEALING OF EROSION DAMAGE AT AN EDGE OF COMPOSITE PARTS (A)

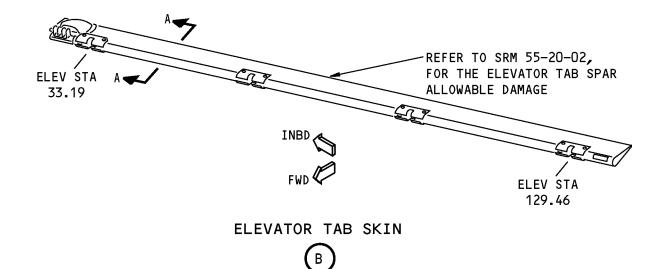
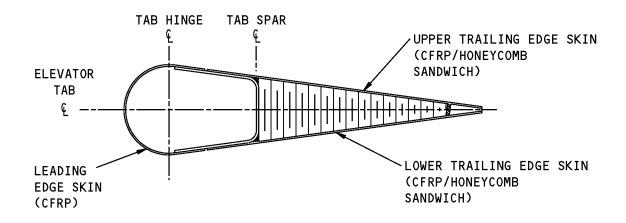
> Elevator Tab Skin Allowable Damage Figure 102 (Sheet 2 of 2)

(FOR AIRPLANE LINE NUMBERS 1 THRU 1174 WITH COMPLETION OF SERVICE BULLETINS 737-55-1080 AND 737-55-1082) A-A

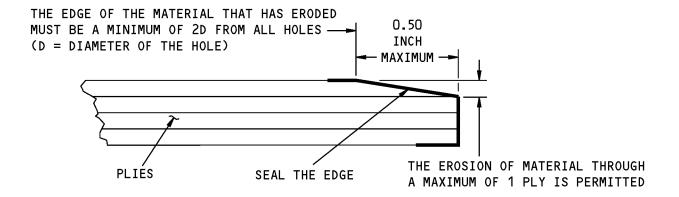
Elevator Tab Skin Allowable Damage Figure 105

SEALING OF EROSION DAMAGE AT AN EDGE OF COMPOSITE PARTS

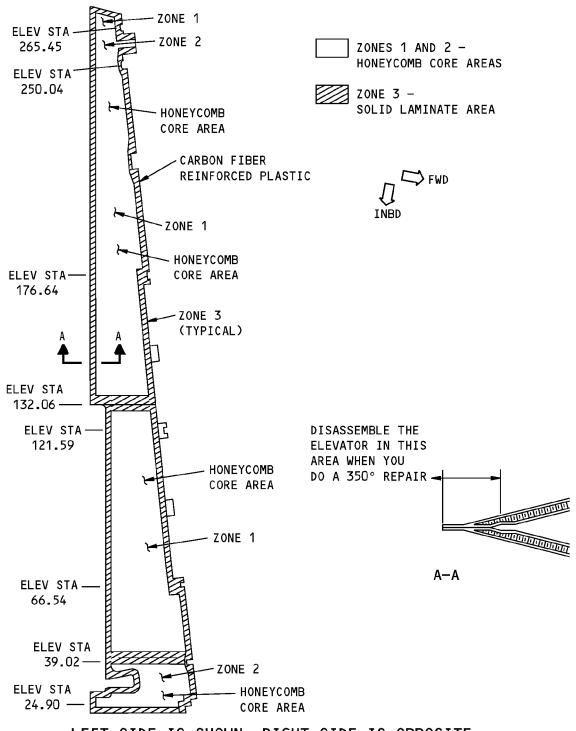
> Upper and Lower Elevator Skin Zones Figure 204

LEFT SIDE IS SHOWN, RIGHT SIDE IS OPPOSITE UPPER SKIN PANEL IS SHOWN, LOWER SKIN PANEL IS ALMOST THE SAME

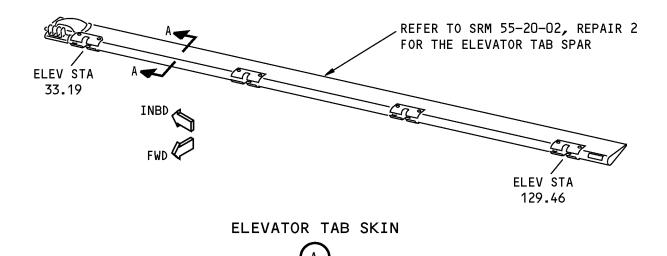
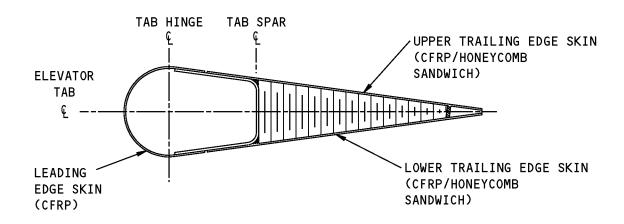
> Elevator Tab Skin Figure 201 (Sheet 2 of 2)

(FOR AIRPLANE LINE NUMBERS 1 THRU 1174) A-A

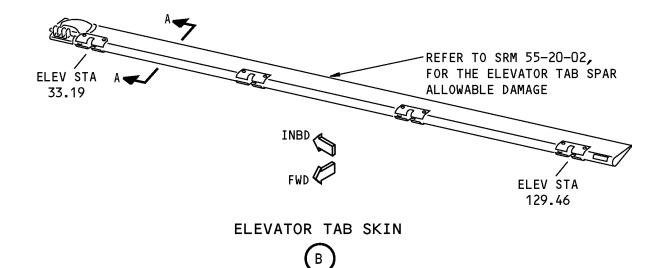
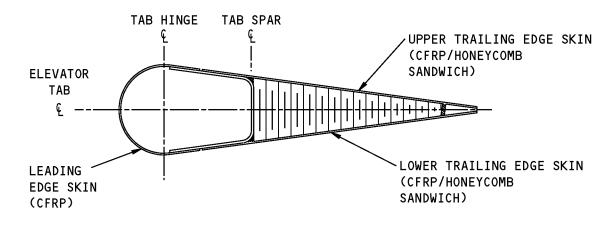
> Elevator Tab Skin Repairs Figure 202 (Sheet 2 of 2)

(FOR AIRPLANE LINE NUMBERS 1 THRU 1174 WITH COMPLETION OF SERVICE BULLETINS 737-55-1080 AND 737-55-1082) A-A

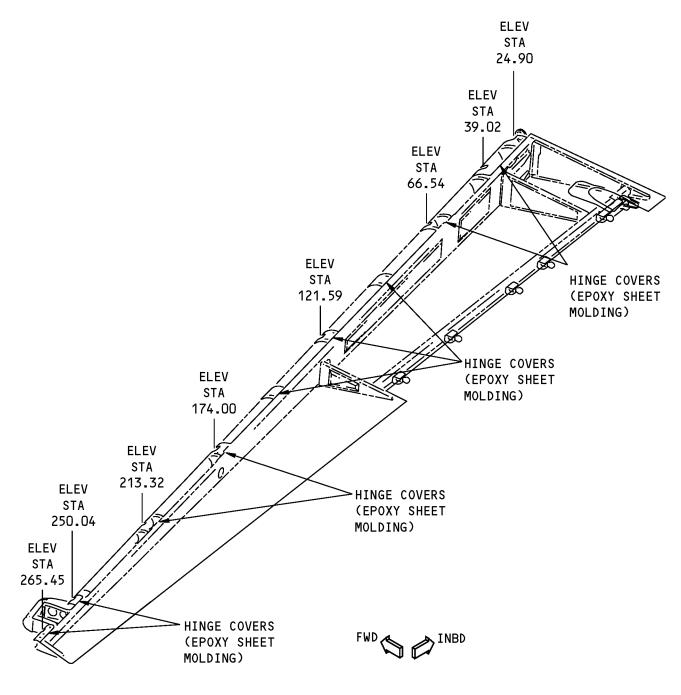
> Elevator Hinge Covers Figure 202 (Sheet 2 of 2)

LEFT SIDE SHOWN, RIGHT SIDE OPPOSITE (FOR AIRPLANE LINE NUMBERS 1175 AND ON)

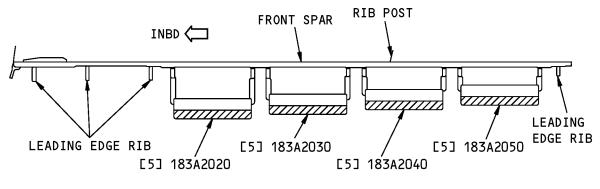
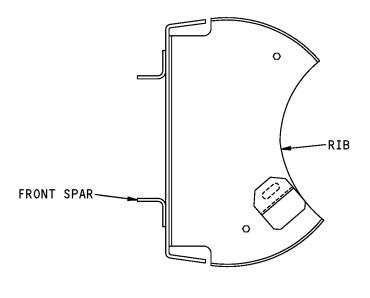
Leading Edge Structure Identification Figure 2 (Sheet 2 of 2)

A-A

B-B

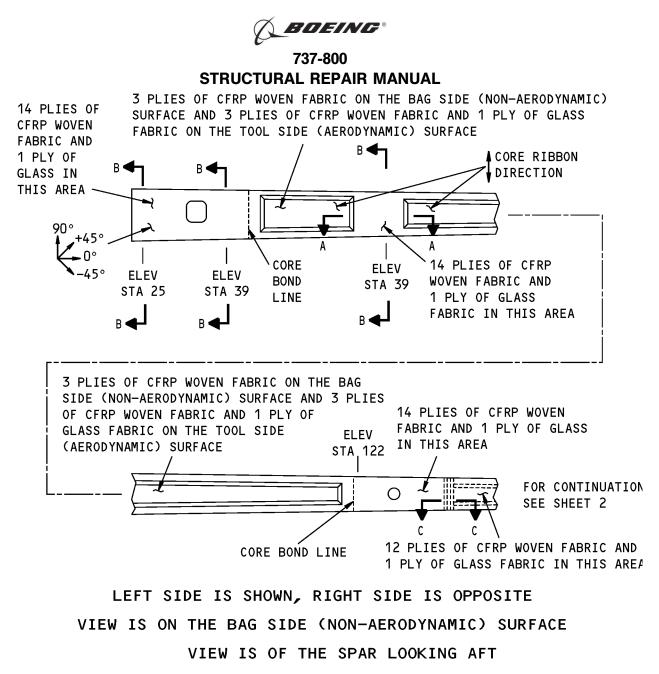
Ply Direction, Core Ribbon Direction, and Ply Sequence for the Front Spar, Figure 2, Item [1] Figure 3 (Sheet 1 of 4)

PLY LAYUP AND CORE RIBBON DIRECTION

PLY MATERIAL AND DIRECTION FOR FIGURE 2, ITEM [1]				
PLY	DIRECTION	MATERIAL			
P1	Optional	Epoxy impregnated glass woven fabric as given in BMS 8-139, Style 108			
P2, P4, P6 thru P8, P13, P14, P17, P18, P21, P22, P24, P26	+ or - 45 degrees	CFRP woven fabric as given in BMS 8-256, Type IV, Class 2, Style 3K-70-PW			
P3, P5, P9 thru P12, P15, P16, P19, P20, P23, P25	0 or 90 degrees	CFRP woven fabric as given in BMS 8-256, Type IV, Class 2, Style 3K-70-PW

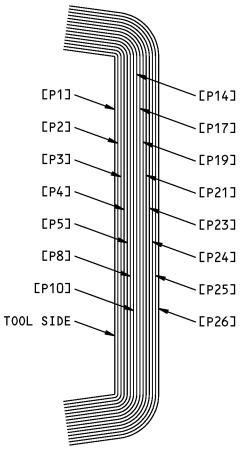
Ply Direction, Core Ribbon Direction, and Ply Sequence for the Front Spar, Figure 2, Item [1] Figure 3 (Sheet 3 of 4)

B-B

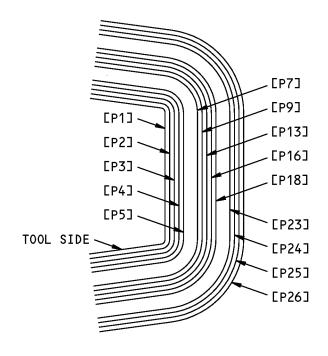
Ply Direction, Core Ribbon Direction, and Ply Sequence for the Front Spar, Figure 2, Item [1] Figure 3 (Sheet 4 of 4)

D-D

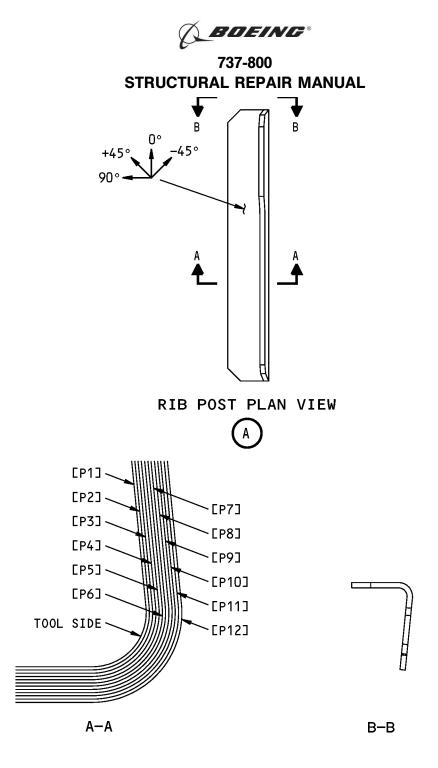
- THE PLY DIRECTION IS THE WARP DIRECTION OF THE FABRIC, REFER TO DETAIL A FOR THE O DEGREE PLY DIRECTION.
- REFER TO SECTIONS A-A AND B-B FOR THE PLY SEQUENCE AT THOSE LOCATIONS.
- REFER TO TABLE 4 FOR THE DIRECTION AND MATERIAL FOR EACH PLY.

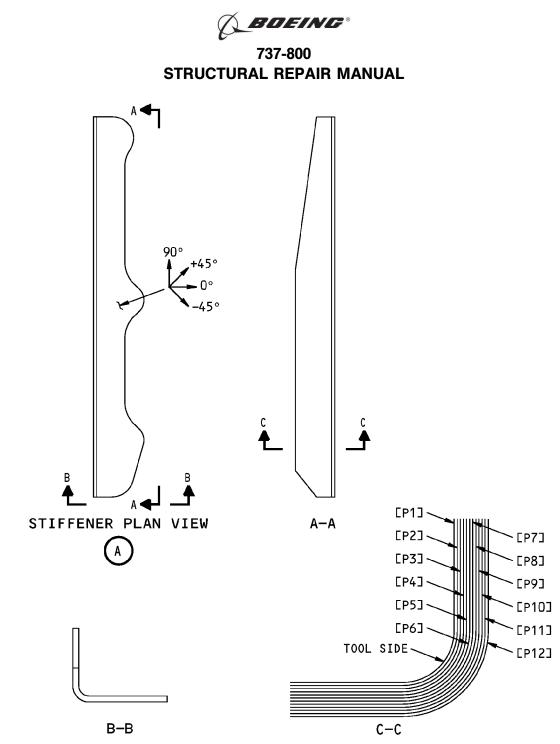
- THE PLY DIRECTION IS THE WARP DIRECTION OF THE FABRIC, REFER TO DETAIL A FOR THE O DEGREE PLY DIRECTION.
- REFER TO SECTIONS A-A THRU C-C FOR THE PLY SEQUENCE AT THOSE LOCATIONS.
- REFER TO TABLE 5 FOR THE DIRECTION AND MATERIAL FOR EACH PLY.

PLY MATERIAL AND DIRECTION FOR FIGURE 2, ITEM [2]				
PLY	DIRECTION	MATERIAL		
P1, P3, P5, P8, P10, P12	+ or - 45 degrees	CFRP woven fabric as given in BMS 8-256, Type IV, Class 2, Style 3K-70-PW		
P2, P4, P6, P7, P9, P11	0 or 90 degrees	CFRP woven fabric as given in BMS 8-256, Type IV, Class 2, Style 3K-70-PW

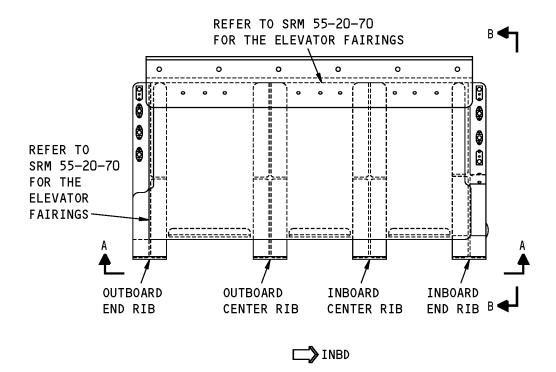
Balance Panel Assembly for Figure 2, Item [5] Figure 6 (Sheet 1 of 2)

LEFT SIDE IS SHOWN, RIGHT SIDE IS OPPOSITE

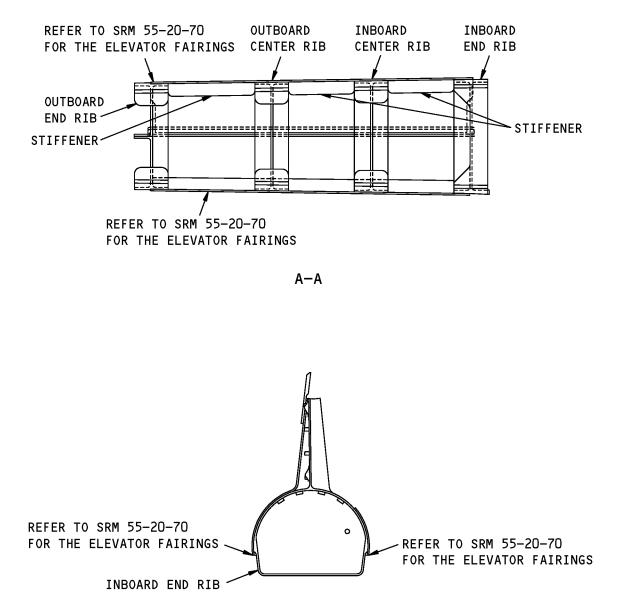
Balance Panel Assembly for Figure 2, Item [5] Figure 6 (Sheet 2 of 2)

В-В

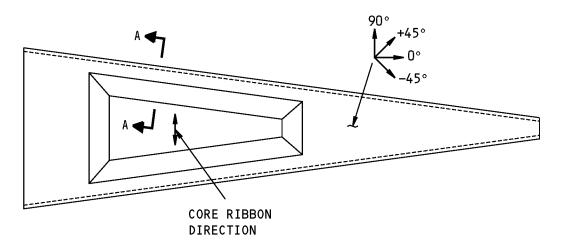
PLY LAYUP AND CORE RIBBON DIRECTION

• THE PLY DIRECTION IS THE WARP DIRECTION OF THE FABRIC. REFER TO DETAIL A FOR THE O DEGREE PLY DIRECTION OF THE BONDED PART.

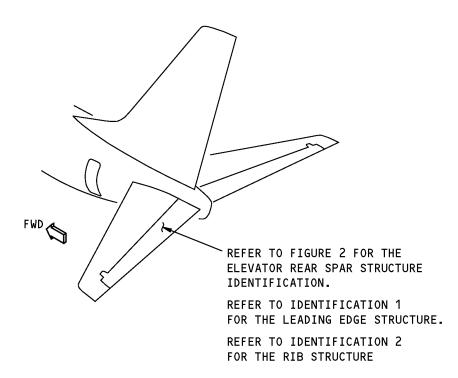
Elevator Rear Spar Structure Location Figure 1

NOTE: REFER TO TABLE 1 FOR THE REFERENCE DRAWINGS.

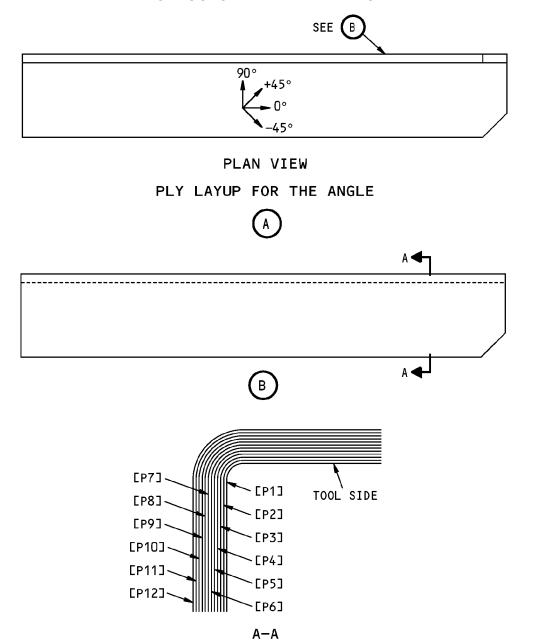
- THE PLY DIRECTION IS THE WRAP DIRECTION OF THE FABRIC. REFER TO DETAIL A FOR THE O DEGREE PLY DIRECTION OF THE PART.
- REFER TO SECTION A-A FOR THE PLY SEQUENCE AT THAT LOCATION. REFER TO THE ENGINEERING DRAWING FOR MORE INFORMATION.
- REFER TO TABLE 5 FOR THE DIRECTION AND MATERIAL OF THE PLIES SHOWN IN SECTION A-A.

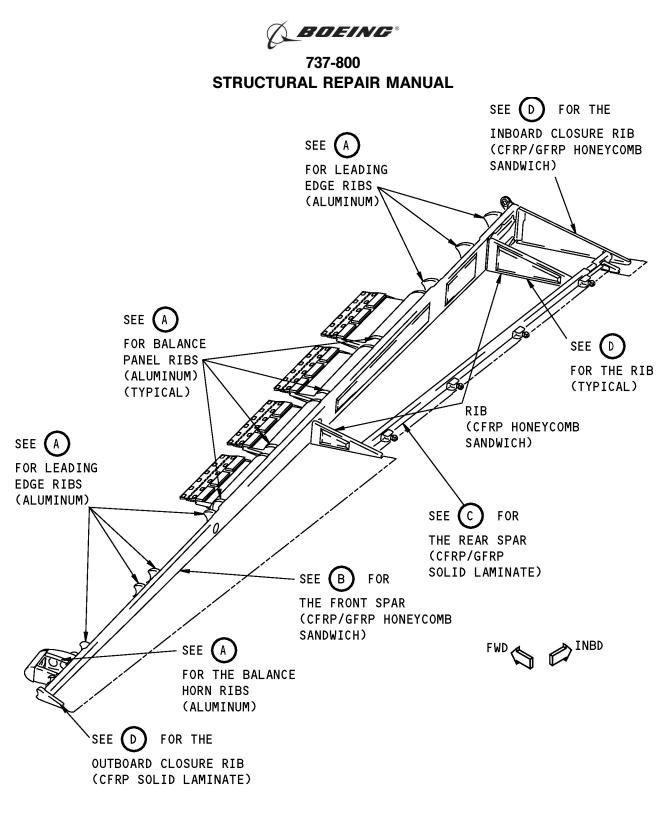
Elevator Structure Allowable Damage Figure 104 (Sheet 1 of 9)

(FOR AIRPLANE LINE NUMBERS 1 THROUGH 1174)

NOTE: REFER TO TABLE 101 FOR THE ALLOWABLE DAMAGE REFERENCES.

A. This subject gives the allowable damage limits for the elevator structure shown in Elevator Location, Figure 101/ALLOWABLE DAMAGE 1 and Elevator Structure Allowable Damage, Figure 104/ALLOWABLE DAMAGE 1.

- J. Refer to Table 101/ALLOWABLE DAMAGE 1 for the references for the allowable damage limits.
- K. Refer to Elevator Structure Allowable Damage, Figure 104/ALLOWABLE DAMAGE 1 for the locations of the allowable damage zones.

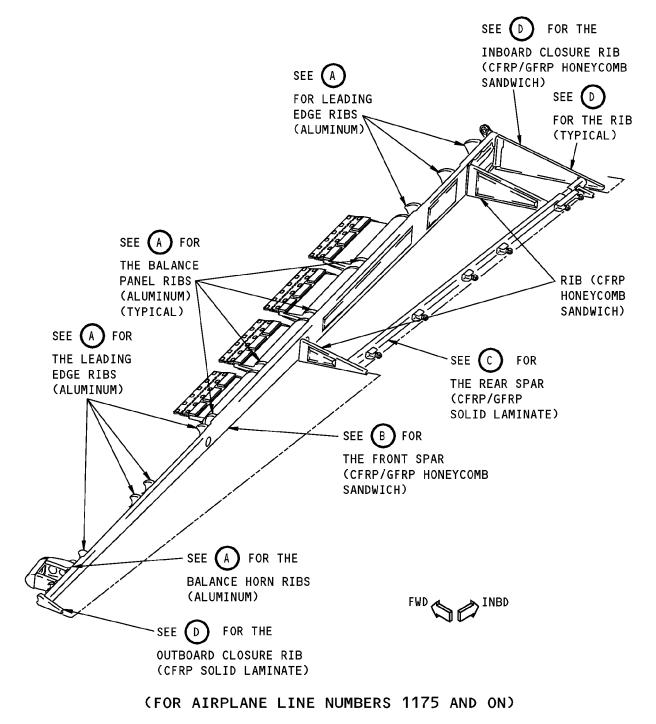
Elevator Structure Allowable Damage Figure 104 (Sheet 2 of 9)

NOTE: REFER TO TABLE 101 FOR THE ALLOWABLE DAMAGE REFERENCES.

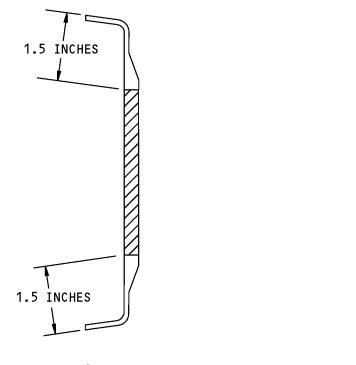
Elevator Structure Allowable Damage Figure 104 (Sheet 5 of 9)

CROSS-SECTION OF THE FRONT SPAR WHERE HONEYCOMB CORE IS LOCATED IN THE WEB

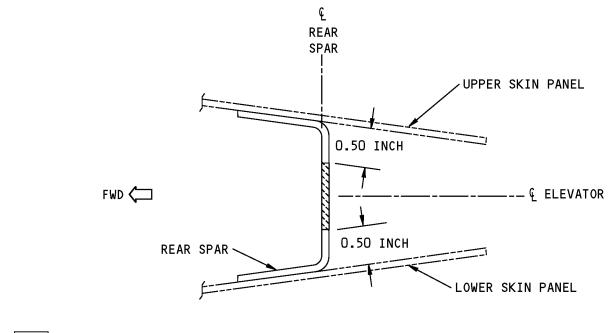
Elevator Structure Allowable Damage Figure 104 (Sheet 8 of 9)

ZONE 4

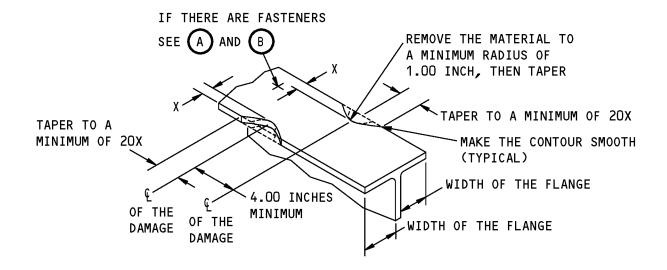
REMOVAL OF DAMAGED MATERIAL ON AN EDGE

X = THE WIDTH OF THE MATERIAL THAT IS REMOVED = A MAXIMUM OF 10 PERCENT OF THE WIDTH OF THE FLANGE

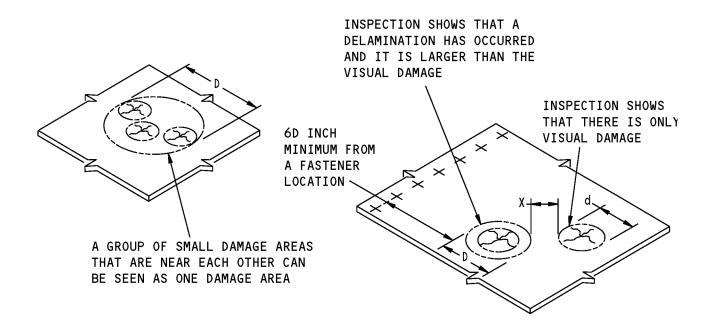
NOTE: TO FIND DELAMINATION, YOU CAN USE NONDESTRUCTIVE INSPECTION PROCEDURES. REFER TO NDT PART 1, 51-01-02.

THE DIAMETER OF A DAMAGE AREA IS EITHER THE DIAMETER OF THE VISUAL DAMAGE OR THE DIAMETER OF THE DELAMINATION. USE THE DIAMETER OF THE LARGER DAMAGE.

- (c) A minimum of 2D away from the edge of the part.
- (5) Delaminations are permitted as shown in Allowable Damage Limits for the Front Spar, Rear Spar, Ribs, and Closure Ribs - Solid Laminate Areas - Zones 2, 4, and 6, Figure 106/ALLOWABLE DAMAGE 1, if they are:

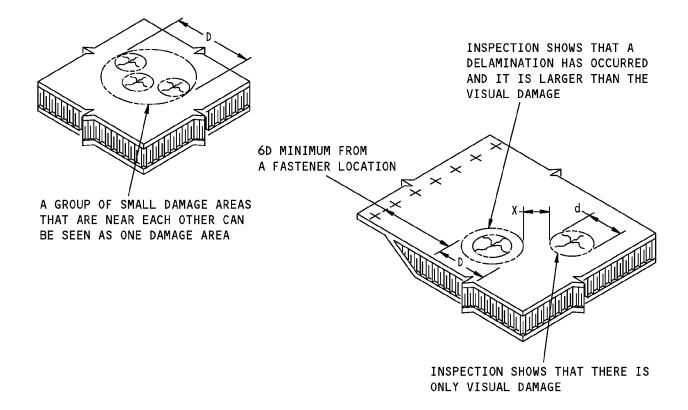
NOTE: TO FIND DELAMINATION, YOU CAN USE NONDESTRUCTIVE INSPECTION PROCEDURES. REFER TO NDT PART 1, 51-01-02.

THE DIAMETER OF A DAMAGE AREA IS EITHER THE DIAMETER OF THE VISUAL DAMAGE OR THE DIAMETER OF THE DELAMINATION. USE THE DIAMETER OF THE LARGER DAMAGE. D IS THE LARGER DIAMETER OF TWO ADJACENT DAMAGE AREAS AND CAN BE A MAXIMUM OF 0.5 INCH.

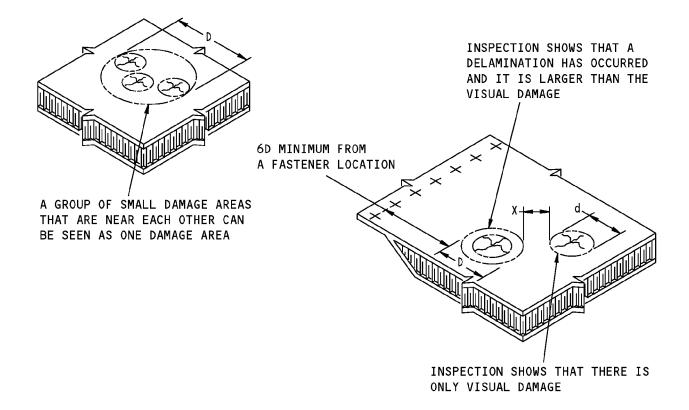
NOTE: TO FIND DELAMINATION, YOU CAN USE NONDESTRUCTIVE INSPECTION PROCEDURES. REFER TO NDT PART 1, 51-01-02. THE DIAMETER OF A DAMAGE AREA IS EITHER THE DIAMETER OF THE VISUAL DAMAGE OR THE DIAMETER OF THE DELAMINATION. USE THE DIAMETER OF THE LARGER DAMAGE. D IS THE LARGER DIAMETER OF TWO ADJACENT DAMAGE AREAS AND CAN BE A MAXIMUM OF 0.50 INCHES. d IS THE SMALLER DIAMETER OF TWO ADJACENT DAMAGE AREAS. X IS THE DISTANCE BETWEEN TWO ADJACENT DAMAGE AREAS.

THE MINIMUM X THAT IS PERMITTED IS 6D.

- (4) Holes and Punctures are permitted if they are:
 - (a) A maximum diameter of 0.25 inch
 - (b) A minimum of 6D away from the edge of a hole or other damage. D is equal to the maximum dimension of the damage

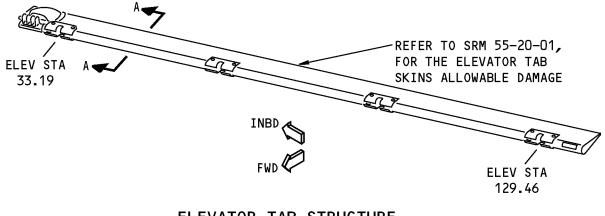
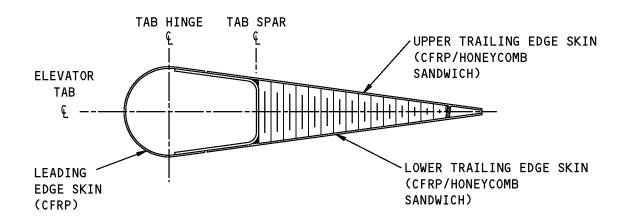
> Elevator Tab Spar Allowable Damage Figure 101 (Sheet 2 of 2)

(FOR AIRPLANE LINE NUMBERS 1 THRU 1174 WITH COMPLETION OF SERVICE BULLETINS 737-55-1080 AND 737-55-1082) A-A

A. Damage is not permitted. Refer to 55-20-02, REPAIR 2, for repairs to the elevator tab spar.

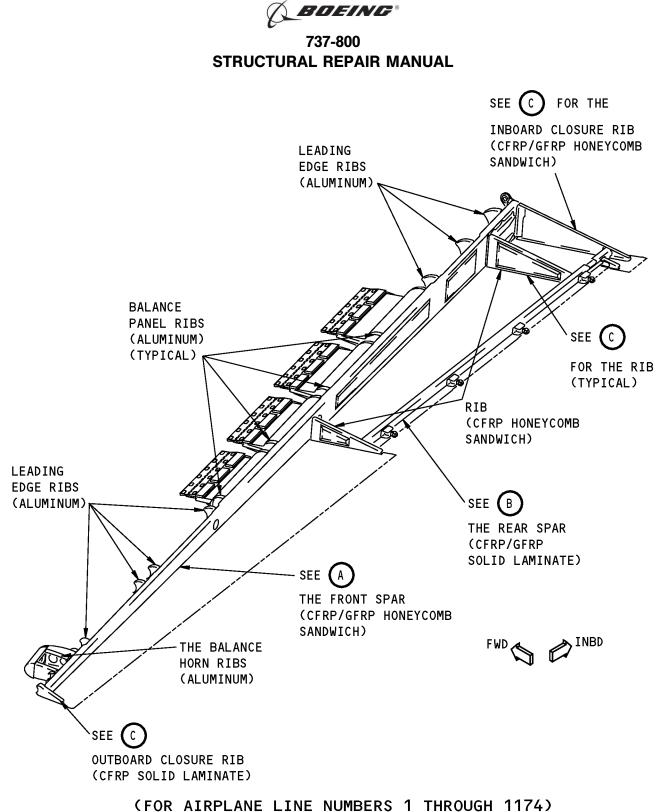
Elevator Structure Repairs Figure 204 (Sheet 1 of 8)

NOTE: REFER TO TABLE 201 FOR THE REPAIR REFERENCES.

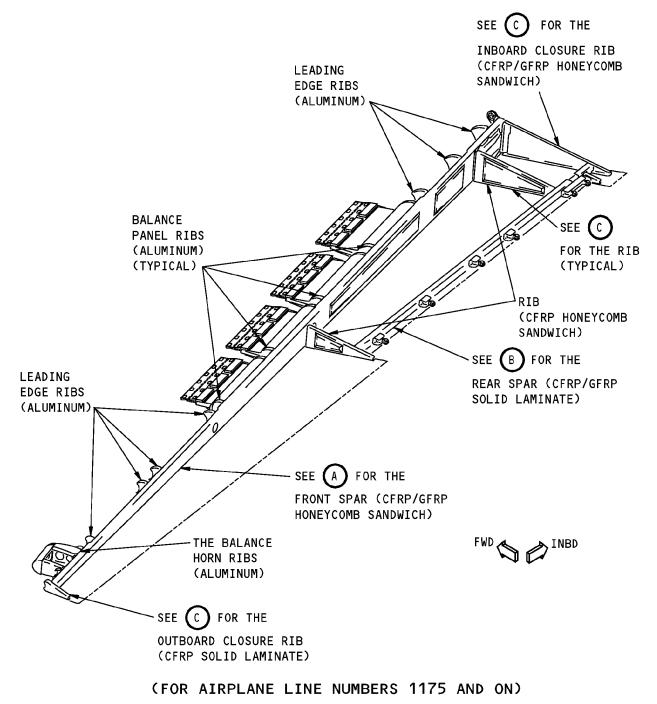
Elevator Structure Repairs Figure 204 (Sheet 2 of 8)

NOTE: REFER TO TABLE 201 FOR THE REPAIR REFERENCES.

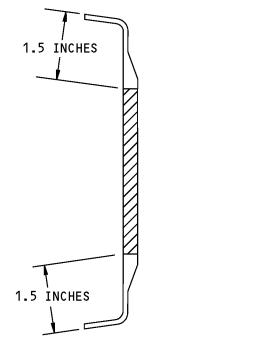
Elevator Structure Repairs Figure 204 (Sheet 4 of 8)

CROSS-SECTION OF THE FRONT SPAR WHERE HONEYCOMB CORE IS LOCATED IN THE WEB
