CHAPTER 555

STABILIZERS

737-800 STRUCTURAL REPAIR MANUAL

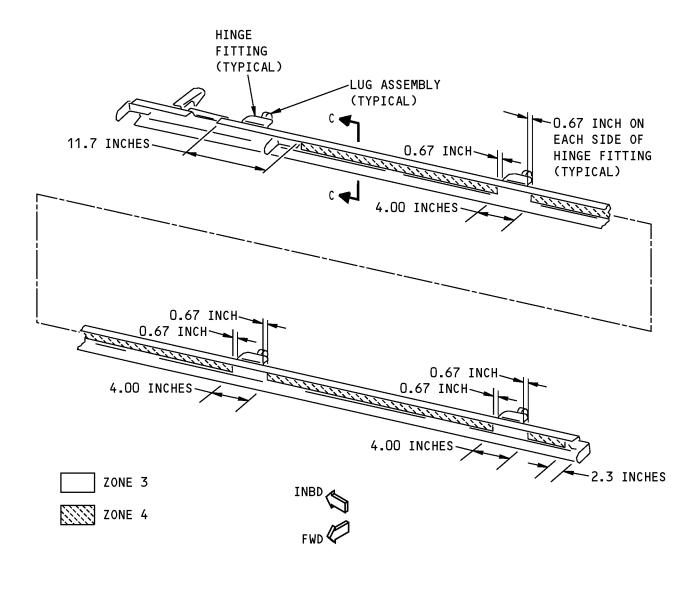
> Elevator Structure Repairs Figure 204 (Sheet 5 of 8)

(FOR AIRPLANE LINE NUMBERS 1 THROUGH 1174) REAR SPAR

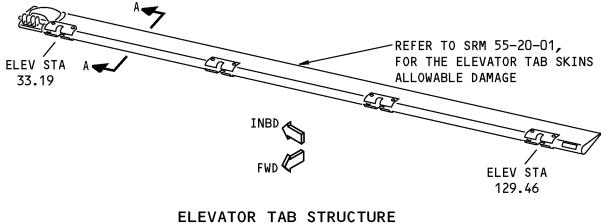
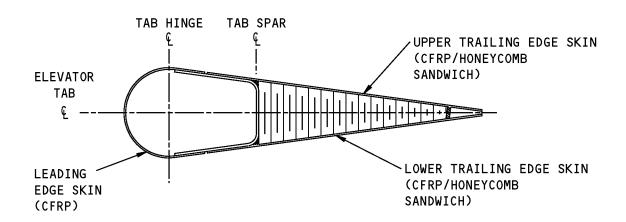
> Elevator Tab Spar Repairs Figure 201 (Sheet 2 of 2)

(FOR AIRPLANE LINE NUMBERS 1 THRU 1174 WITH COMPLETION OF SERVICE BULLETINS 737-55-1080 AND 737-55-1082) A-A

- A. Repair 2 is applicable to the elevator tab spar shown in Elevator Tab Spar Repairs, Figure 201/REPAIR 2.
 - **NOTE**: THIS REPAIR IS APPLICABLE TO AIRPLANE LINE NUMBERS 1 THROUGH 1174 PRIOR TO COMPLETION OF SERVICE BULLETINS 737-55-1080 AND 737-55-1082. REFER TO 55-20-02, REPAIR 3 FOR AIRPLANE LINE NUMBERS EQUAL TO OR GREATER THAN LINE NUMBER 1175 AND FOR ALL LINE NUMBERS WITH COMPLETION OF SERVICE BULLETINS 737-55-1080 AND 737-55-1082.

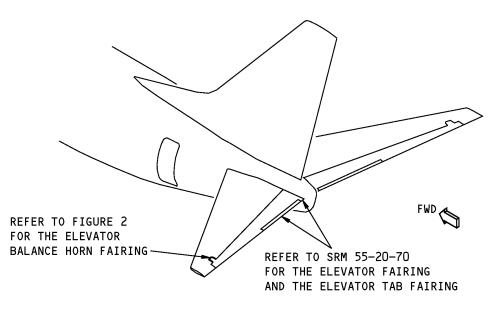
Elevator Balance Horn Fairing Location Figure 1

IDENTIFICATION 1 - ELEVATOR BALANCE HORN FAIRING

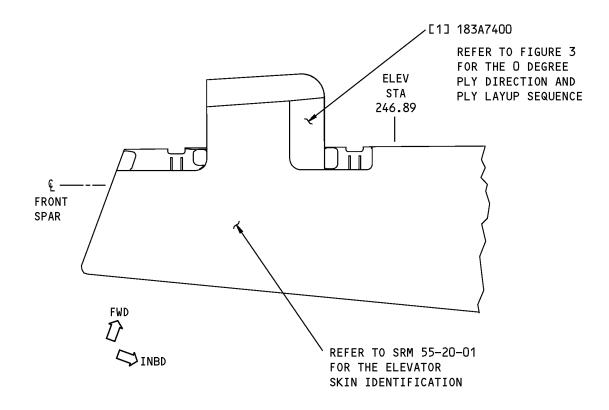
Elevator Balance Horn Fairing Identification Figure 2

THE LEFT ELEVATOR BALANCE HORN FAIRING IS SHOWN, THE RIGHT ELEVATOR BALANCE HORN FAIRING IS OPPOSITE

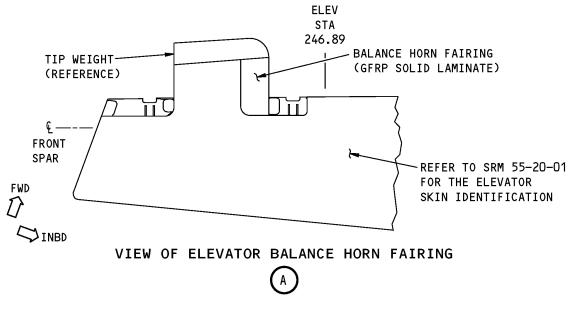
Elevator Balance Horn Fairing Location Figure 101

REFER TO SRM 55-20-70 FOR THE ELEVATOR FAIRING AND THE ELEVATOR TAB FAIRING

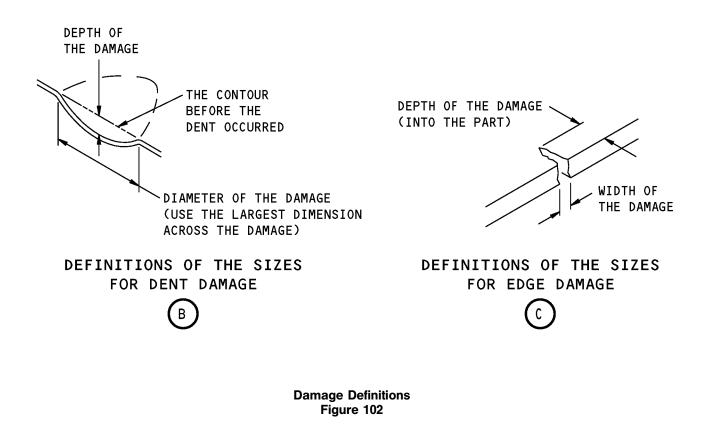
DEFINITIONS OF THE SIZES FOR NICK, GOUGE, AND SCRATCH DAMAGE

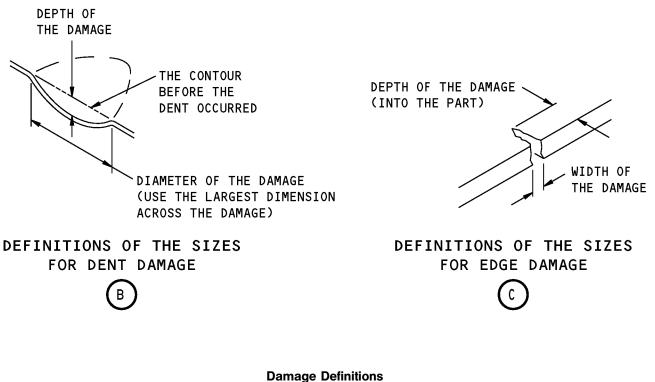
Figure 202

DEFINITIONS OF THE SIZES FOR NICK, GOUGE, AND SCRATCH DAMAGE

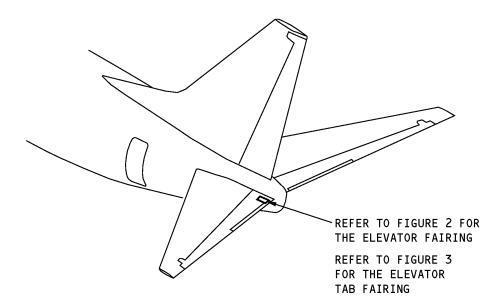
Elevator Fairing Skin Location Figure 1

IDENTIFICATION 1 - ELEVATOR FAIRING AND ELEVATOR TAB FAIRING SKIN

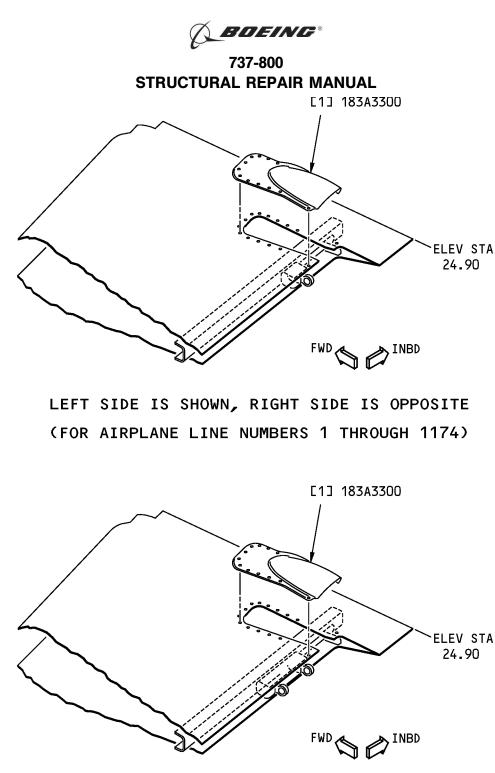
LEFT SIDE IS SHOWN, RIGHT SIDE IS OPPOSITE

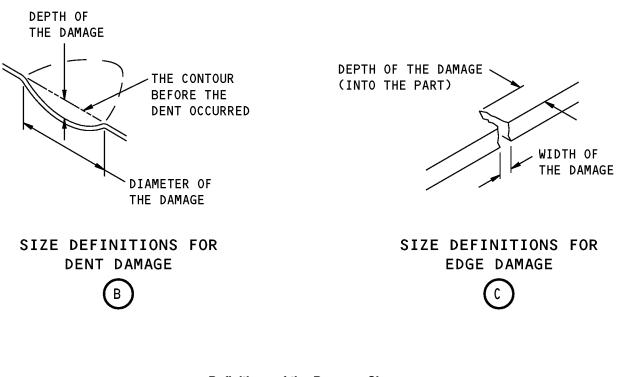
Definitions of the Damage Size Figure 104

SIZE DEFINITIONS FOR NICK, GOUGE, OR SCRATCH DAMAGE (A)

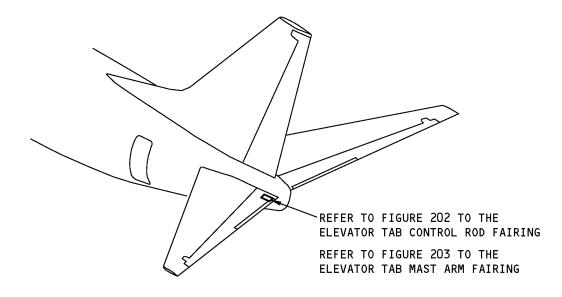
Elevator Fairing Skin Repair Figure 201

REPAIR 1 - ELEVATOR FAIRING AND ELEVATOR TAB FAIRING SKIN

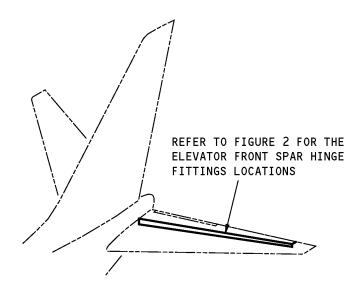
Elevator Front Spar Hinge Fittings Figure 1

IDENTIFICATION 1 - ELEVATOR FRONT SPAR HINGE FITTINGS

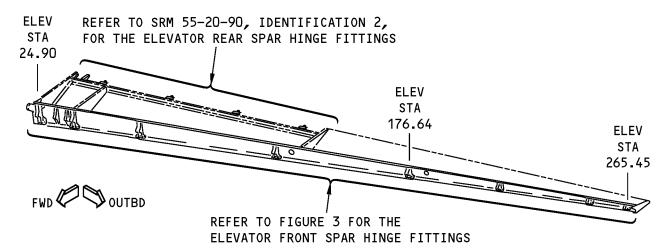
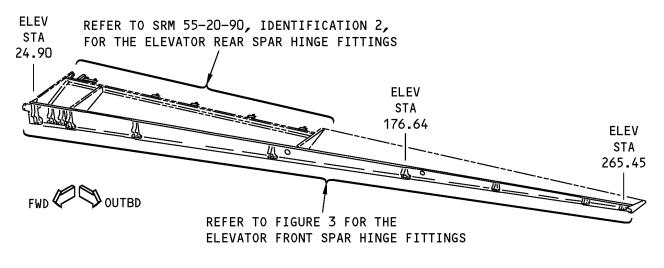
> **Elevator Front Spar Hinge Fittings Location** Figure 2

LEFT SIDE IS SHOWN, RIGHT SIDE IS OPPOSITE (FOR AIRPLANE LINE NUMBERS 1 THROUGH 1174)

LEFT SIDE IS SHOWN, RIGHT SIDE IS OPPOSITE (FOR AIRPLANE LINE NUMBERS 1175 AND ON)

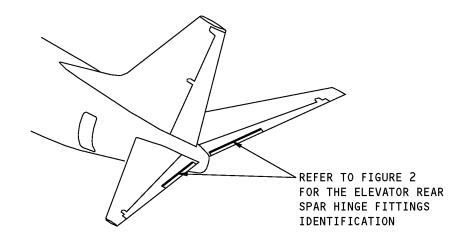
IDENTIFICATION 2 - ELEVATOR REAR SPAR HINGE FITTINGS

LEFT SIDE IS SHOWN, RIGHT SIDE IS OPPOSITE

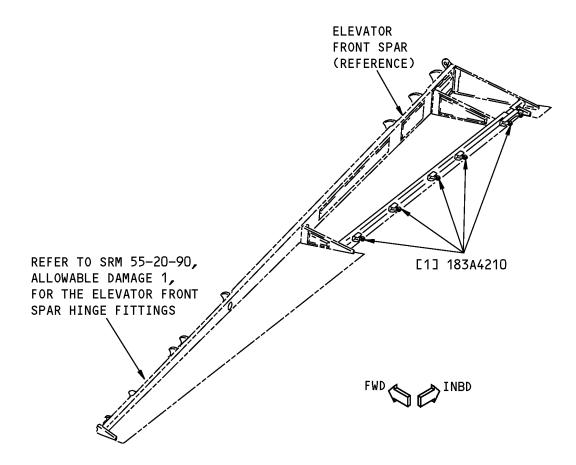
LEFT SIDE IS SHOWN, RIGHT SIDE IS OPPOSITE (FOR AIRPLANE LINE NUMBERS 1175 AND ON)

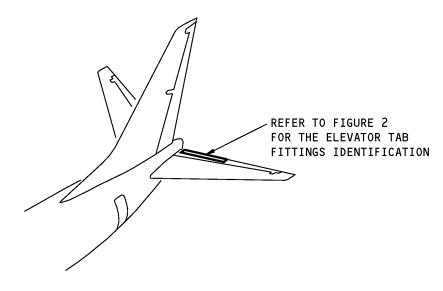
IDENTIFICATION 3 - ELEVATOR TAB FITTINGS

LEFT SIDE IS SHOWN, RIGHT SIDE IS OPPOSITE

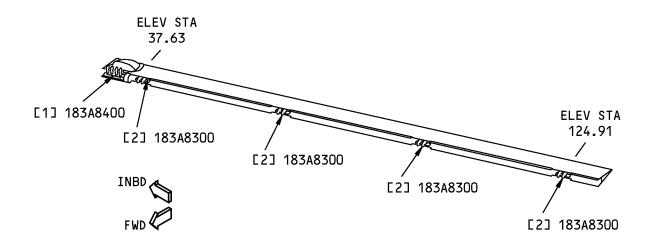
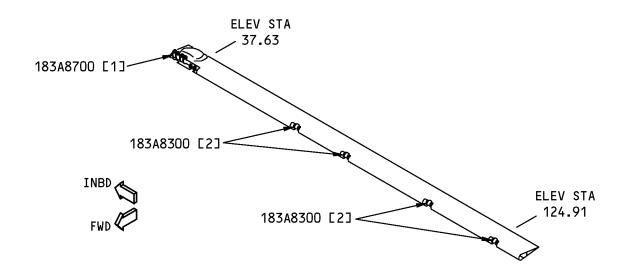
LEFT SIDE IS SHOWN, RIGHT SIDE IS OPPOSITE (FOR AIRPLANE LINE NUMBERS 1 THROUGH 1174)

LEFT SIDE IS SHOWN, RIGHT SIDE IS OPPOSITE (FOR AIRPLANE LINE NUMBERS 1175 AND ON)

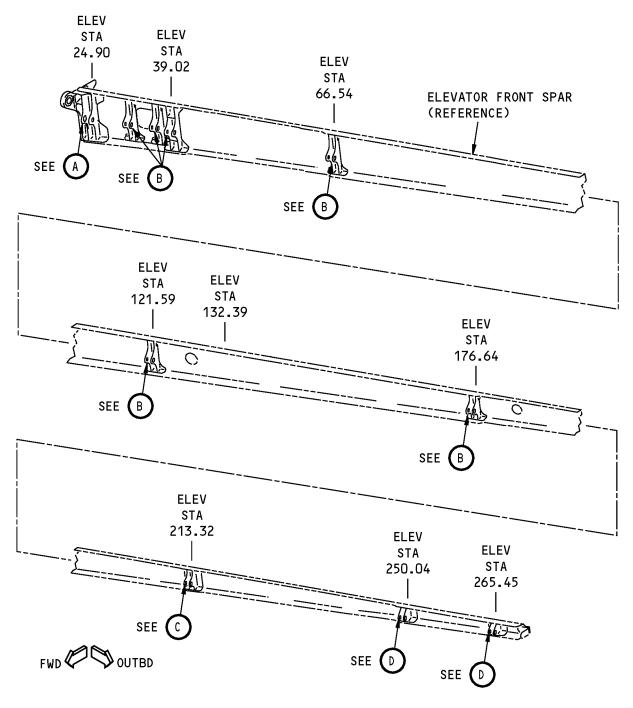
Elevator Front Spar Hinge Fittings Figure 102 (Sheet 1 of 5)

(FOR AIRPLANE LINE NUMBERS 1175 AND ON)

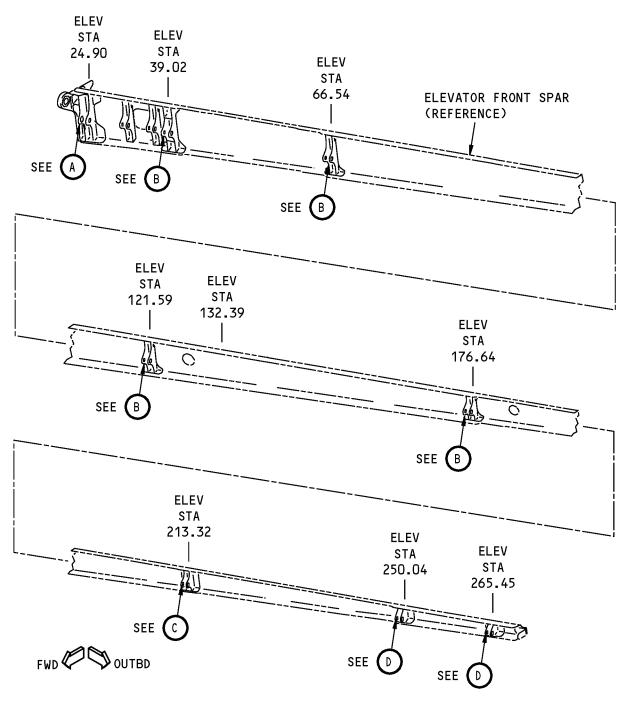
Elevator Front Spar Hinge Fittings Figure 102 (Sheet 2 of 5)

(FOR AIRPLANE LINE NUMBERS 1 THROUGH 1174)

A. This subject gives the allowable damage limits for the elevator front spar hinge fittings shown in Elevator Front Spar Hinge Fittings Location, Figure 101/ALLOWABLE DAMAGE 1.

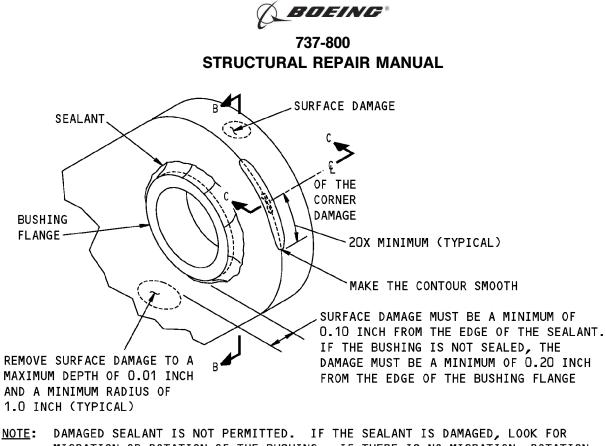
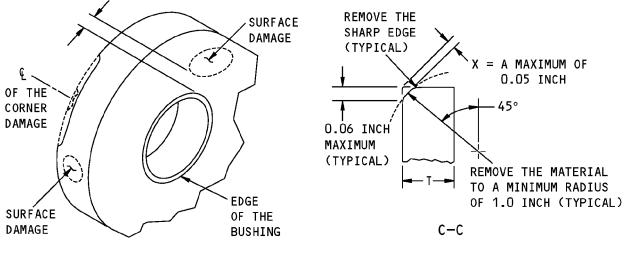
Allowable Damage Limits Figure 103 (Sheet 3 of 3)

NOTE: DAMAGED SEALANT IS NOT PERMITTED. IF THE SEALANT IS DAMAGED, LOOK FOR MIGRATION OR ROTATION OF THE BUSHING. IF THERE IS NO MIGRATION, ROTATION, OR CORROSION, REMOVE THE DAMAGED SEALANT AND APPLY A NEW FILLET SEAL.

REMOVAL OF SURFACE AND EDGE DAMAGE FROM A LUG THAT HAS A BUSHING

SURFACE DAMAGE MUST BE A MINIMUM OF 0.20 INCH FROM THE EDGE OF THE BUSHING

- A. Mast Arm Fitting and Elevator Hinge Fittings (Except at ELEV STA 39.02 and ELEV STA 66.54)
 - (1) Cracks:
 - (a) Remove the damage as shown in Allowable Damage Limits, Figure 103/ALLOWABLE DAMAGE 1, Details A, B, and C.
 - (2) Nicks, Gouges, Scratches, and Corrosion:
 - (a) Remove the damage as shown in Allowable Damage Limits, Figure 103/ALLOWABLE DAMAGE 1, Details A, B, C, D, and E.
 - (3) Dents are not permitted.
 - (4) Holes and Punctures are not permitted.
- B. Elevator Hinge Fittings (ELEV STA 39.02 and ELEV STA 66.54)
 - (1) Cracks:
 - (a) Remove the damage as shown in Allowable Damage Limits, Figure 103/ALLOWABLE DAMAGE 1, Details A and B.
 - (2) Nicks, Gouges, Scratches, and Corrosion:
 - (a) Remove the damage as shown in Allowable Damage Limits, Figure 103/ALLOWABLE DAMAGE 1, Details A, B, and E.
 - (3) Dents are not permitted.
 - (4) Holes and Punctures are not permitted.

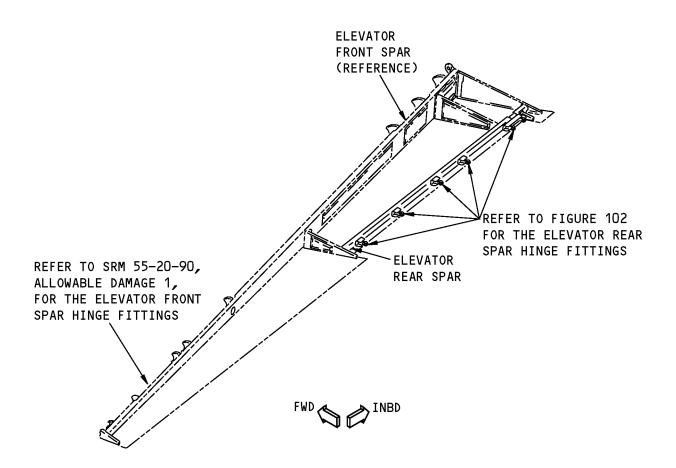
> **Elevator Rear Spar Hinge Fitting Locations** Figure 101 (Sheet 2 of 2)

LEFT SIDE IS SHOWN, RIGHT SIDE IS OPPOSITE (FOR AIRPLANE LINE NUMBERS 1175 AND ON)

A. This subject gives the allowable damage limits for the elevator rear spar hinge fittings shown in Figure 101.

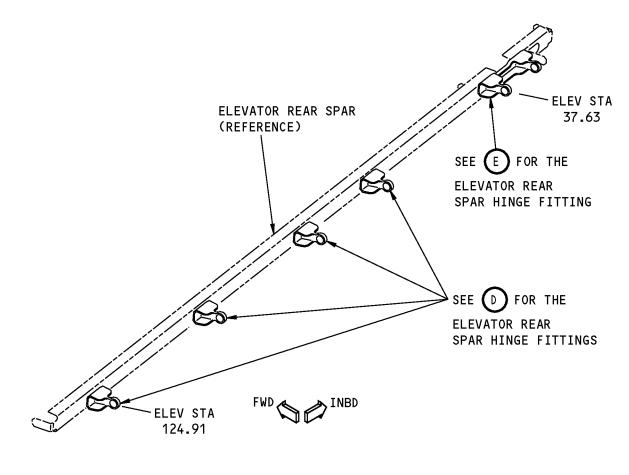
Elevator Rear Spar Hinge Fittings Figure 102 (Sheet 2 of 3)

ELEVATOR REAR SPAR HINGE FITTINGS (FOR AIRPLANE LINE NUMBERS 1175 AND ON) В

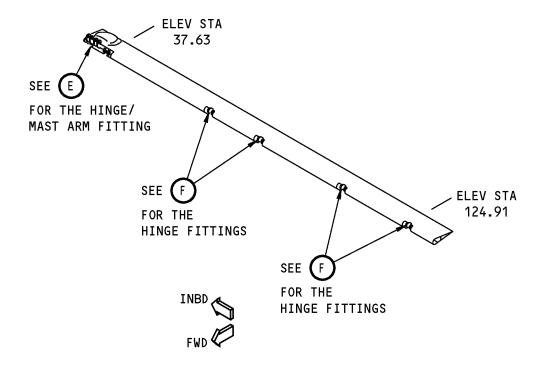
> Elevator Tab Fitting Location Figure 101 (Sheet 2 of 4)

LEFT SIDE IS SHOWN, RIGHT SIDE IS OPPOSITE (FOR AIRPLANE LINE NUMBERS 1175 AND ON)

A. This subject gives the allowable damage limits for the elevator tab fittings shown in Elevator Tab Fitting Location, Figure 101/ALLOWABLE DAMAGE 3.

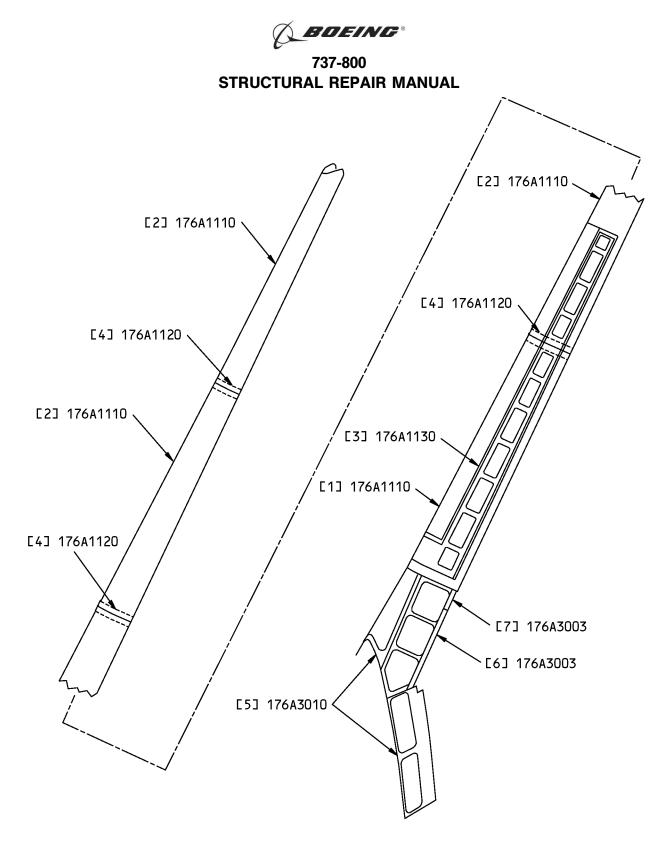
Vertical Fin Leading Edge Panel Identification Figure 2

NOTE: REFER TO TABLE 2 FOR THE LIST OF MATERIALS.

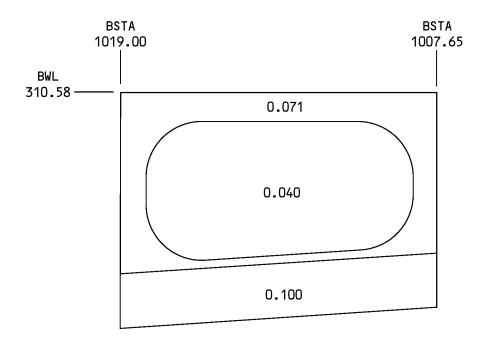
Chem-milled Areas for Figure 2, Item [1] Figure 3

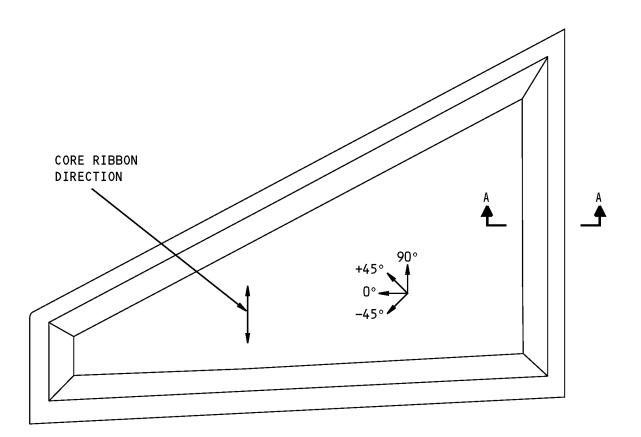
Ply Direction, Core Ribbon Direction, and Ply Sequence for the Inspar Closeout Panel, Figure 2, Item [2] Figure 4 (Sheet 1 of 2)

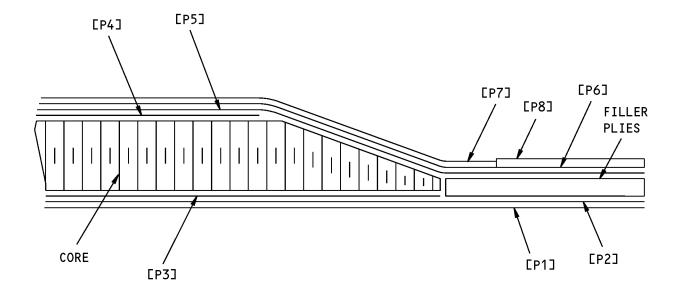
Ply Direction, Core Ribbon Direction, and Ply Sequence for the Inspar Closeout Panel, Figure 2, Item [2] Figure 4 (Sheet 2 of 2)

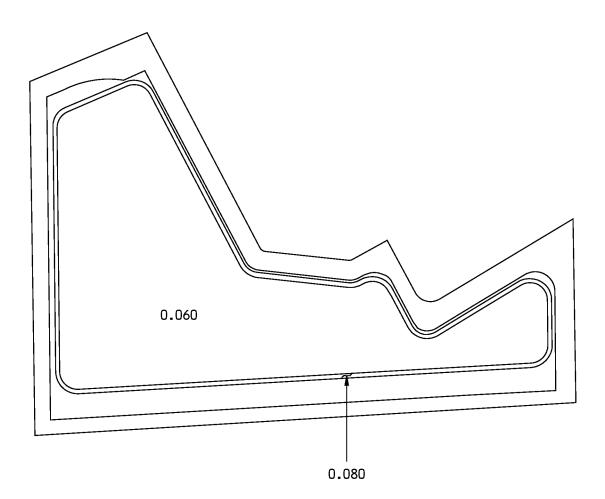
Chem-milled Areas for Figure 2, Item [3] Figure 5

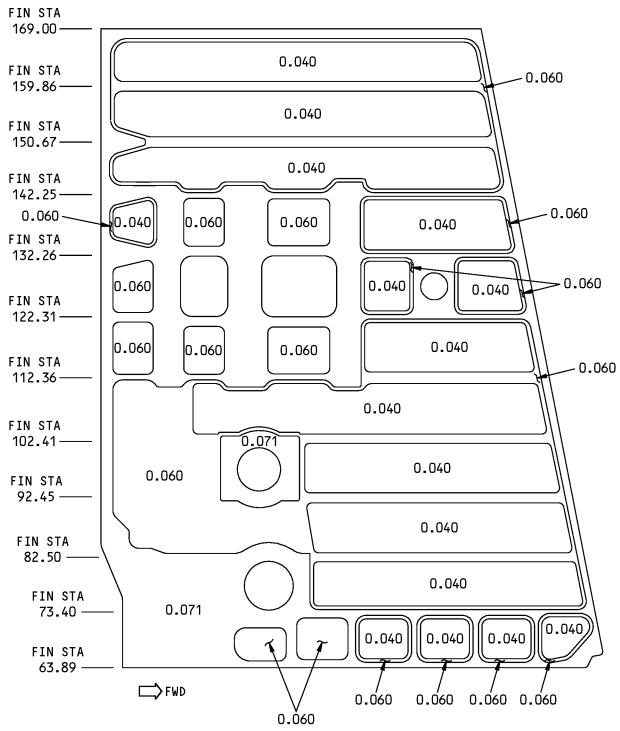
NOTE: ALL DIMENSIONS SHOWN ARE THICKNESSES IN INCHES.

Chem-milled Areas for Figure 2, Item [4] Figure 6

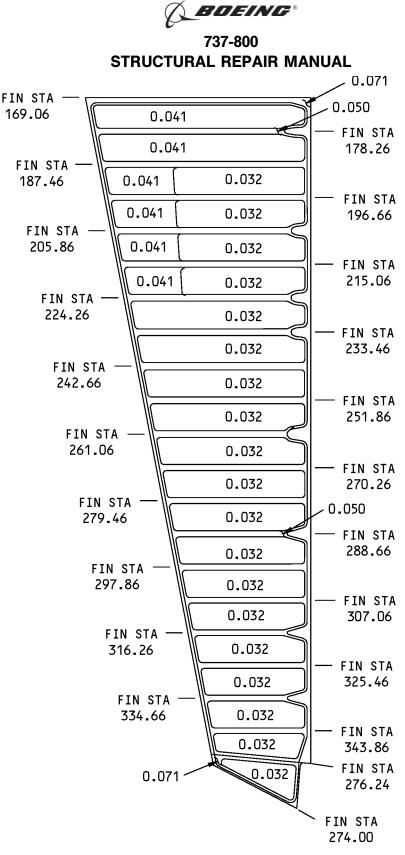
Chem-milled Areas of Figure 2, Item [5] Figure 7

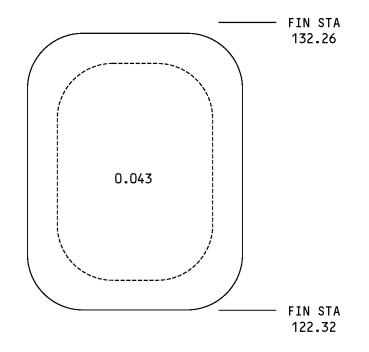
Chem-milled Areas of Figure 2, Item [6] Figure 8

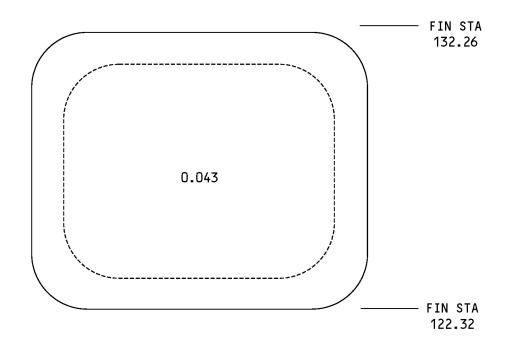
Chem-milled Areas of Figure 2, Item [7] Figure 9

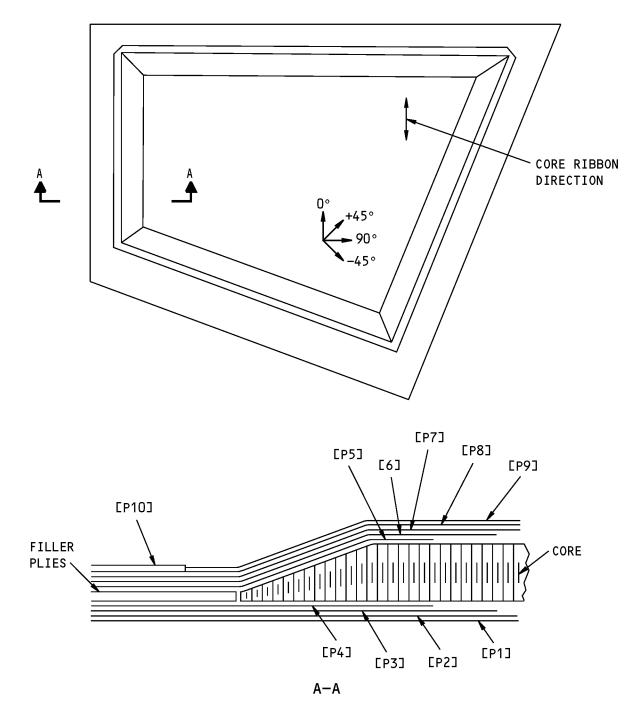
Ply Configuration for Figure 2, Item [1] Figure 3

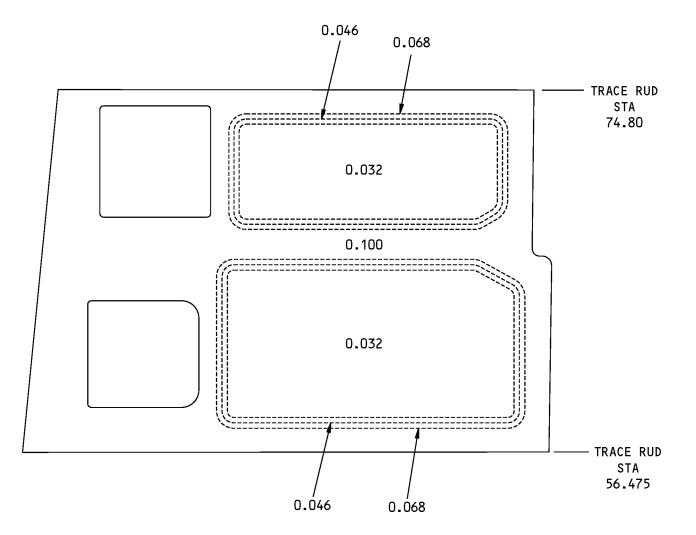
Chem-milled Areas for Figure 2, Item [3] Figure 5

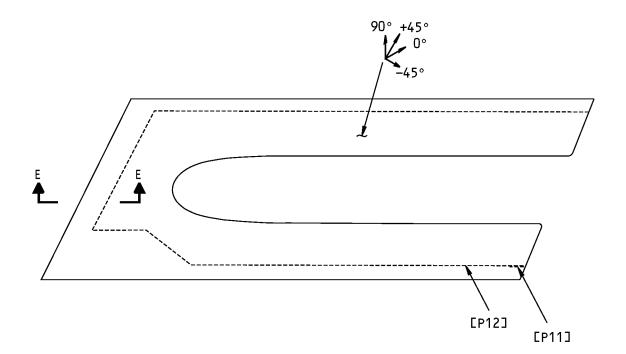
Ply Configuration for Figure 2, Item [5] Figure 7

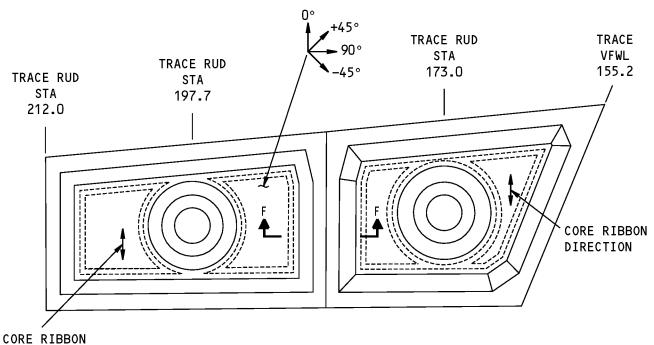
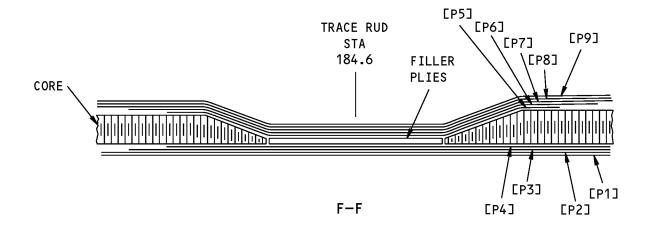
Ply Configuration for Figure 2, Item [6] Figure 8

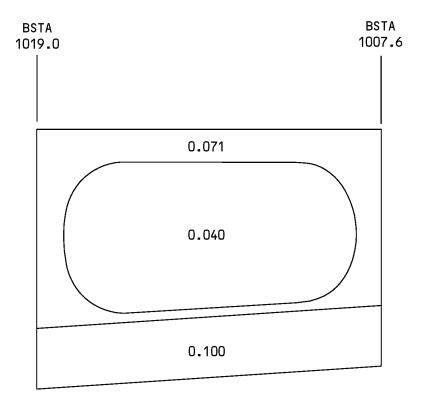
Chem-milled Areas for Figure 2, Item [1] Figure 3

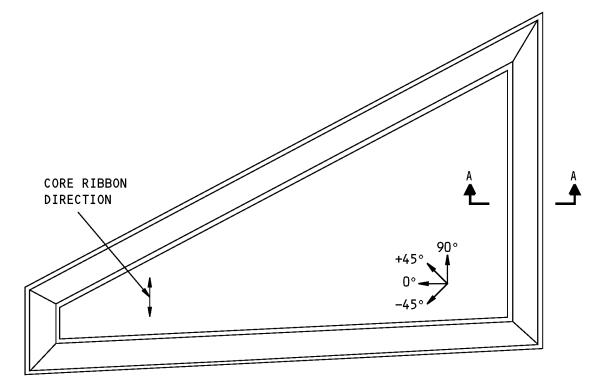
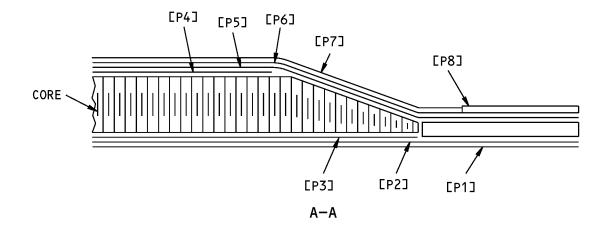
Ply Configuration for Figure 2, Item [2] Figure 4

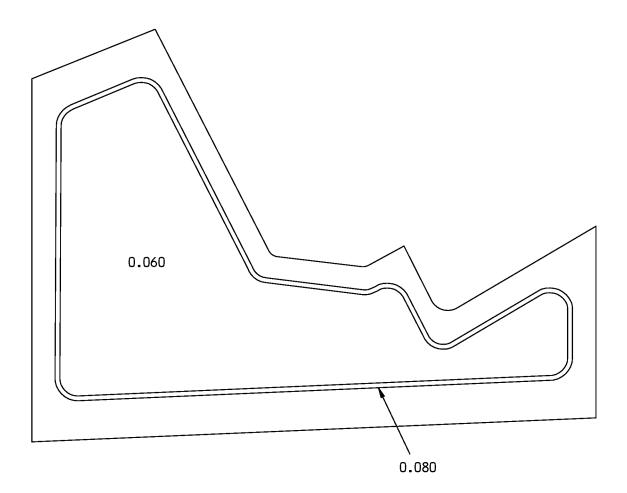
Chem-milled Areas for Figure 2, Item [3] Figure 5

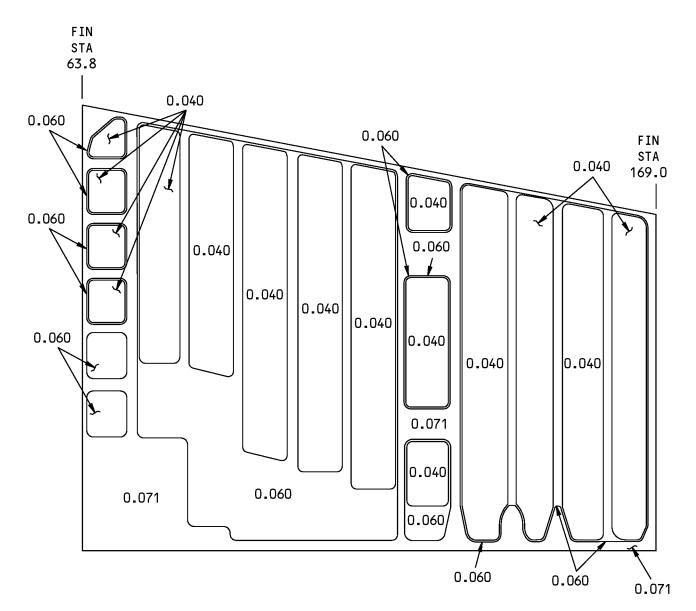
Chem-milled Areas for Figure 2, Item [4] Figure 6

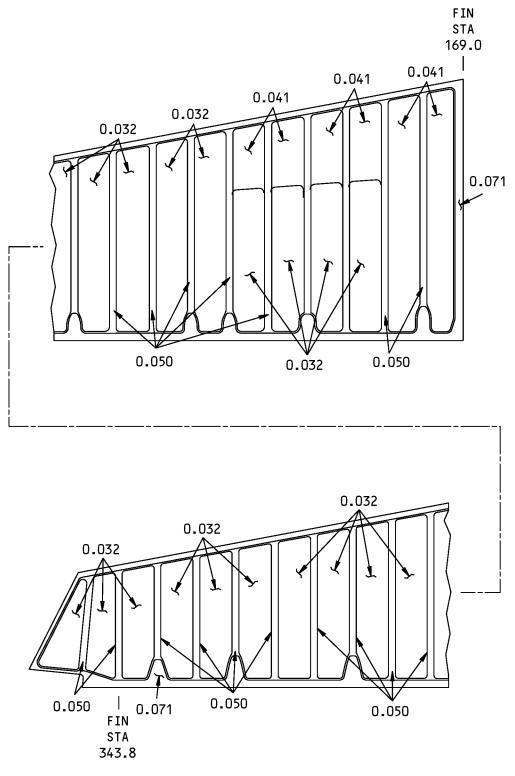
Chem-milled Areas for Figure 2, Item [5] Figure 7

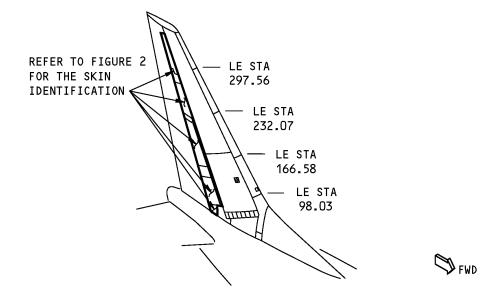
NOTE: REFER TO TABLE 1 FOR THE REFERENCE DRAWINGS. RIGHT SIDE IS SHOWN

Vertical Stabilizer Trailing Edge and Closeout Panel Locations Figure 1

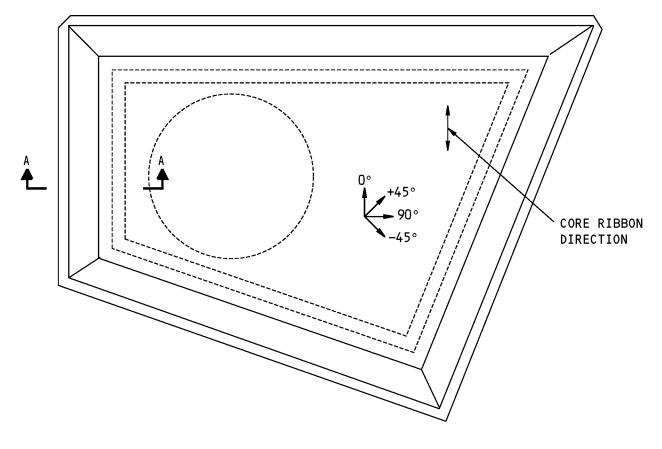
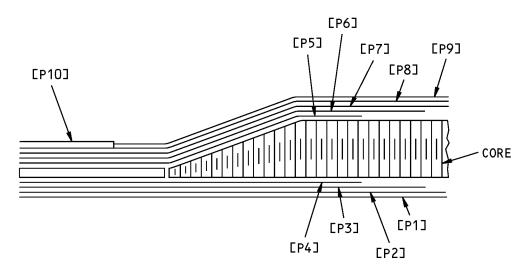
A-A

Ply Configuration for Figure 2, Item [1] Figure 3

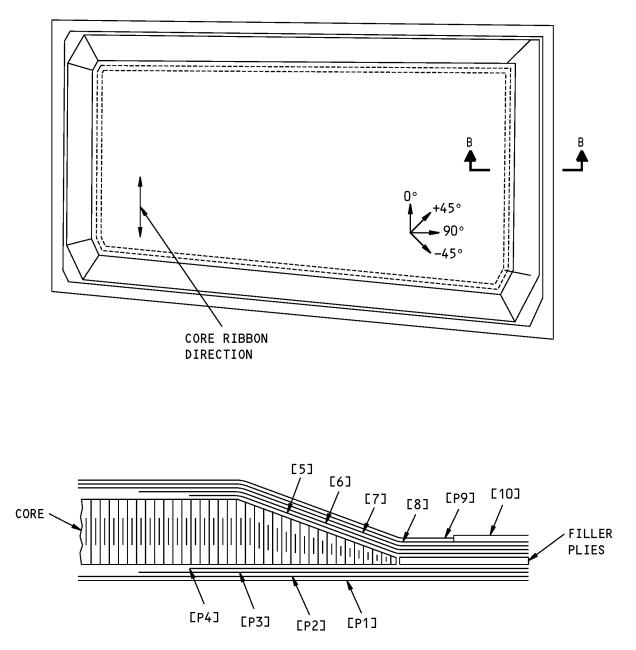
B-B

Ply Configuration for Figure 2, Item [2] Figure 4

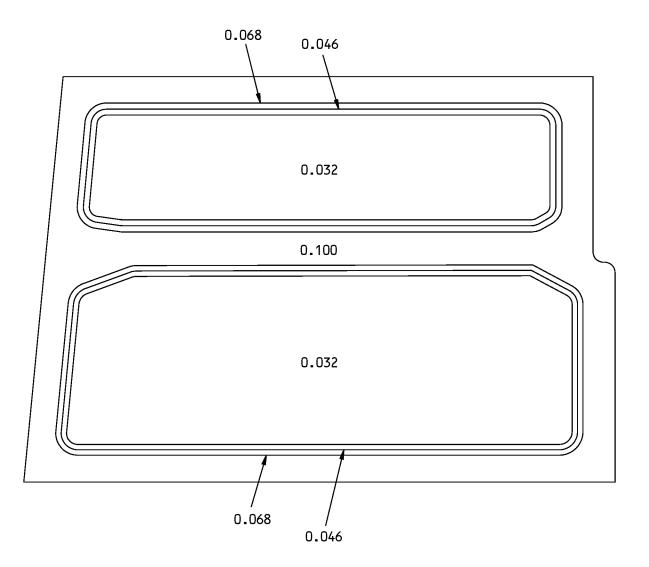
Chem-milled Areas for Figure 2, Item [3] Figure 5

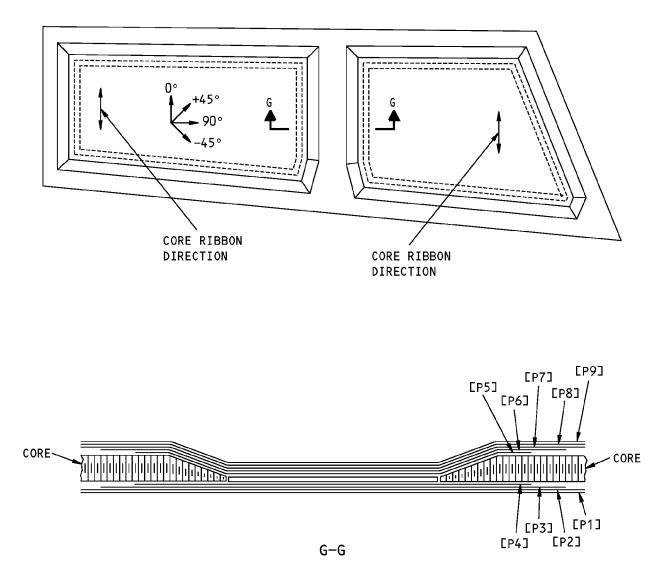
Ply Configuration of Figure 2, Item [6] Figure 8

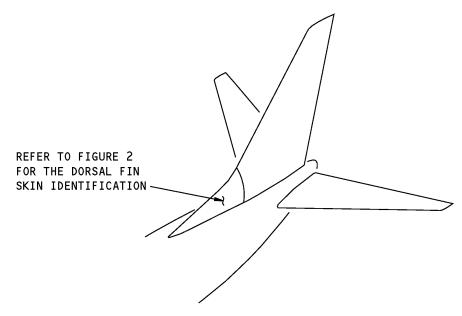
NOTE: REFER TO TABLE 1 FOR THE REFERENCE DRAWINGS.

Dorsal Fin Skin Location Figure 1

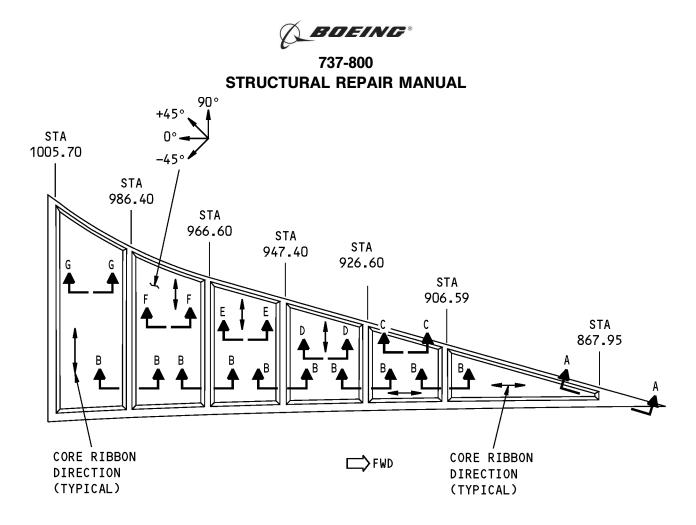
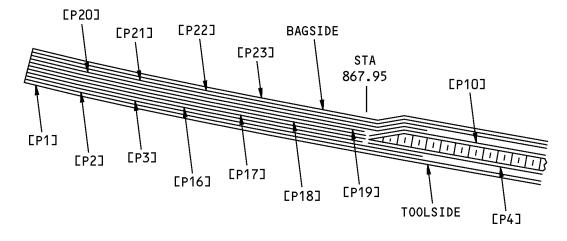
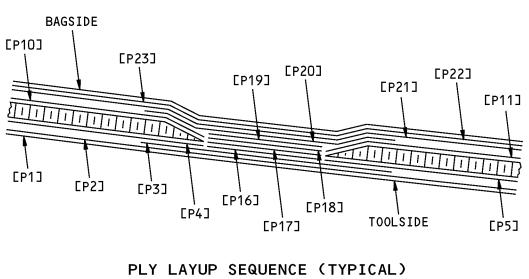
Ply Direction, Core Ribbon Direction, and Ply Sequence for the Dorsal Fin Skin Panel, Figure 2, Item [1] Figure 3 (Sheet 2 of 4)

LEFT SIDE DORSAL FIN SKIN PANEL IS SHOWN, RIGHT SIDE DORSAL FIN SKIN PANEL IS OPPOSITE VIEW IS ON THE BAGSIDE (NON-AERODYNAMIC) SURFACE PLY LAYUP DIRECTION AND CORE RIBBON DIRECTION

PLY LAYUP SEQUENCE A-A

B–B

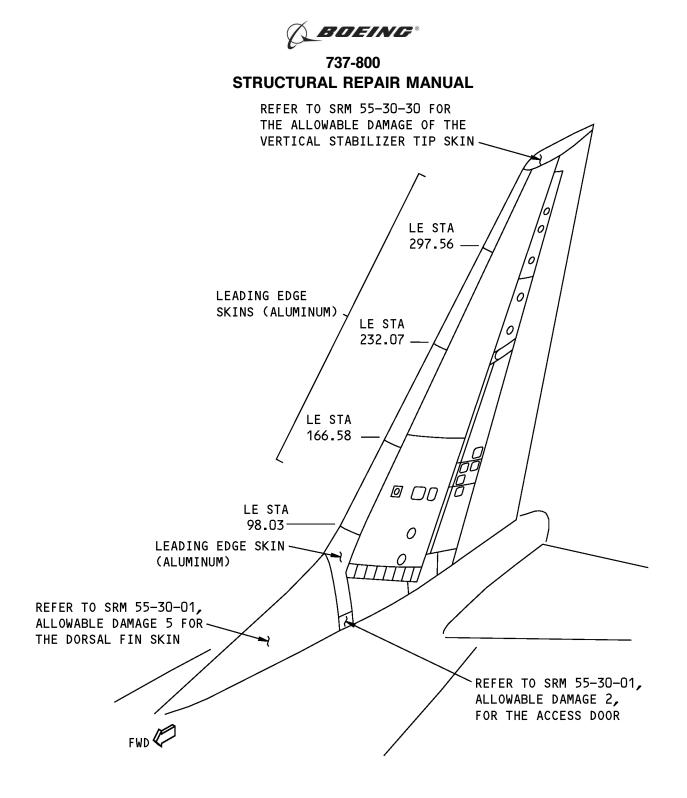
Vertical Stabilizer Leading Edge Skin Locations Figure 101

LEFT SIDE IS SHOWN, RIGHT SIDE IS OPPOSITE

A. This subject gives the allowable damage limits for the vertical stabilizer leading edge skins shown in Vertical Stabilizer Leading Edge Skin Locations, Figure 101/ALLOWABLE DAMAGE 1.

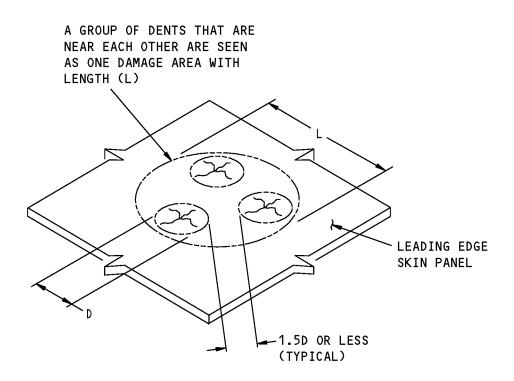
Damage Size and Spacing Limits for Adjacent Dents Figure 105

NOTE: D IS THE LARGEST LENGTH OF THE ADJACENT DENTS.

- (c) Refer to Damage Size and Spacing Limits for Adjacent Dents, Figure 105/ALLOWABLE DAMAGE 1 for the definition of the dimensions for adjacent dents.
- (d) Refer to Equivalent Length of Dents When the Depth is Large, Figure 106/ALLOWABLE DAMAGE 1 for the definition of the length if there is more than one dent in a bay.
- (2) General Conditions:
 - (a) The edge of the damage is a minimum of 1.0 inch away from a hole.
 - (b) There are no pulled or loose fasteners or missing fastener locations.
 - (c) There are no sharp creases, gouges, or cracks.
 - (d) There is no damage to the structure that is below the skin panels.
 - (e) There are no dents at the rib chord locations.
 - (f) The conditions of Table 101/ALLOWABLE DAMAGE 1 are kept.

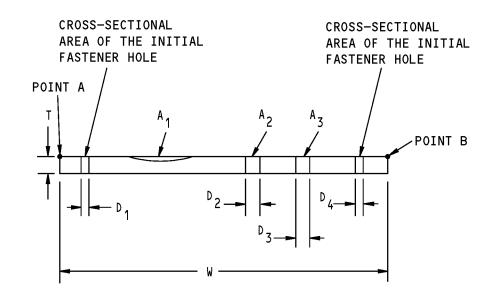
D_1 , D_4 = DIAMETERS OF THE INITIAL FASTENER HOLES D_2 , D_3 = DIAMETERS OF THE HOLES WHERE THERE IS DAMAGE W = WIDTH OF THE SKIN AT THE CROSS-SECTION BETWEEN POINTS A AND B T = THICKNESS OF THE SKIN AS GIVEN BY THE NOMINAL THICKNESS ON THE PRODUCTION DRAWING A₁ = INITIAL AREA OF THE SKIN = THE TOTAL CROSS-SECTIONAL AREA MINUS THE CROSS-SECTIONAL AREA OF THE INITIAL FASTENERS HOLES (AS MANUFACTURED BY BOEING) = WT - D_1T - DT_4 A₁ = CROSS-SECTIONAL AREA OF THE DAMAGE THAT IS REMOVED AT LOCATION 1 A₂ = CROSS-SECTIONAL AREA OF THE DAMAGE THAT IS REMOVED AT LOCATION 2 A₃ = CROSS-SECTIONAL AREA OF THE DAMAGE THAT IS REMOVED AT LOCATION 3 $\left(\frac{A_1 + A_2 + A_3}{A_1}\right)$ X 100 = PERCENT OF CROSS-SECTIONAL AREA REMOVED AS GIVEN IN TABLE 101

THE TOTAL CROSS-SECTIONAL AREA REMOVED IN ALL ZONES A-B (3.00 INCH (76.2 mm) ON EACH SIDE OF A LINE A-B) MUST NOT BE MORE THAN THE LIMITS GIVEN IN TABLE 101

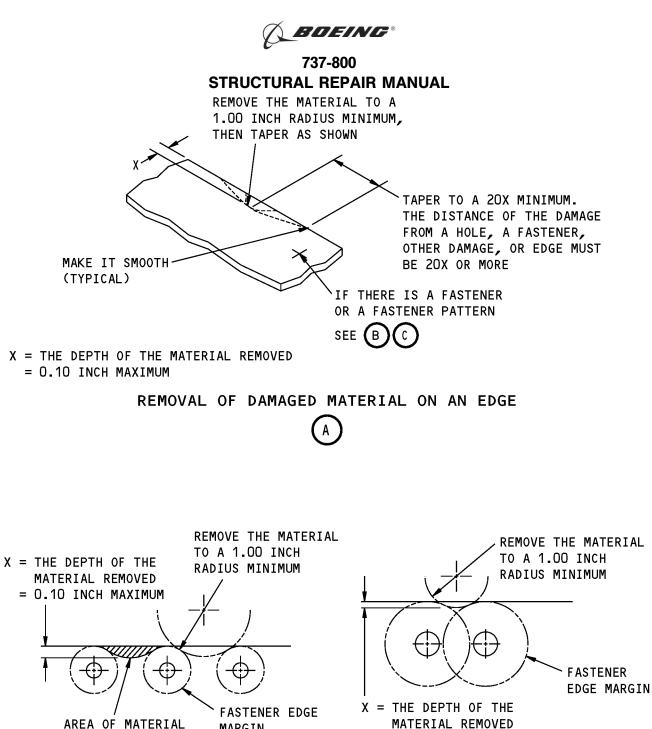
Allowable Damage Limits Figure 106

AREA OF MATERIAL MARGIN REMOVED

REMOVAL OF DAMAGED MATERIAL AT EDGES WHERE THE FASTENER EDGE MARGINS DO NOT HAVE AN OVERLAP REMOVAL OF DAMAGED MATERIAL AT EDGES WHERE THE FASTENER EDGE MARGINS HAVE AN OVERLAP

- (a) It is a maximum 0.10 inch in depth
 - (b) Not more than 10 percent of the edgeband for each side of panel is damaged
 - (c) It is removed as shown in Allowable Damage Limits, Figure 106/ALLOWABLE DAMAGE 3, Detail A

- (c) It is removed as shown in Allowable Damage Limits, Figure 106/ALLOWABLE DAMAGE 3, Detail A
- (d) It is sealed as given in Paragraph 2.

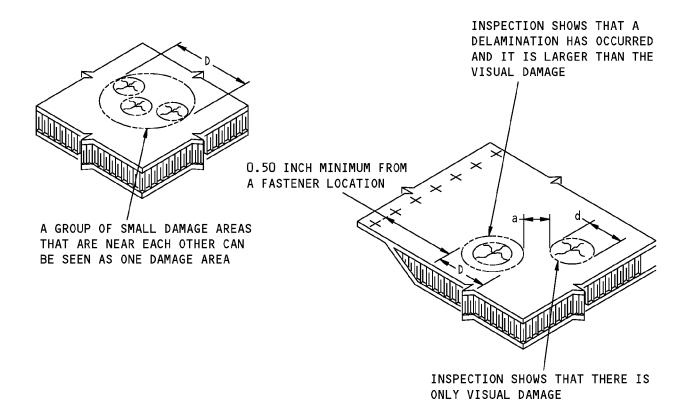
NOTE: TO FIND DELAMINATION YOU CAN USE NONDESTRUCTIVE INSPECTION PROCEDURES (REFER TO NDT PART 1, 51-01-02).

THE DIAMETER OF A DAMAGE AREA IS EITHER THE DIAMETER OF THE VISUAL DAMAGE OR THE DIAMETER OF THE DELAMINATION. USE THE DIAMETER OF THE LARGER DAMAGE.

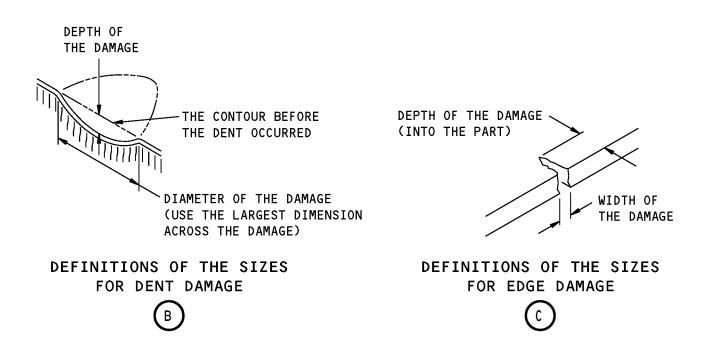
Definitions of the Dimensions of the Different Types of Damage Figure 102

DEFINITIONS OF THE SIZES FOR NICK, GOUGE, AND SCRATCH DAMAGE

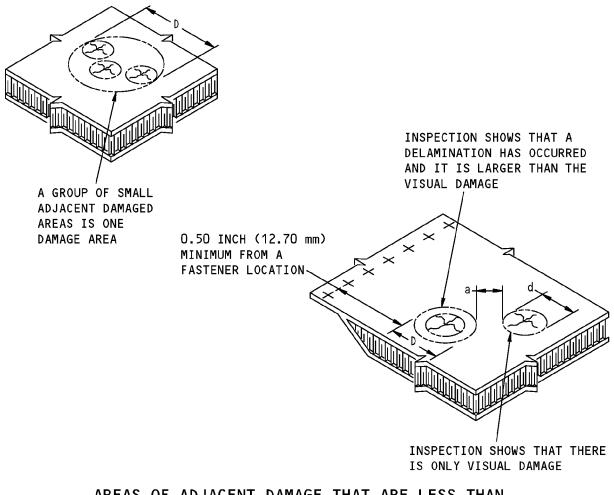
AREAS OF ADJACENT DAMAGE THAT ARE LESS THAN 3 INCHES (76.2 mm) APART

<u>NOTE</u>: TO FIND DELAMINATION USE NONDESTRUCTIVE INSPECTION PROCEDURES AS GIVEN IN NDT PART 1, 51-01-02.

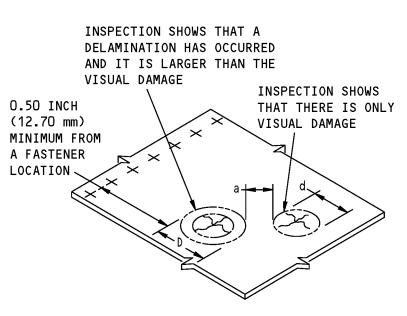
NOTE: TO FIND DELAMINATION, YOU CAN USE NONDESTRUCTIVE INSPECTION PROCEDURES. REFER TO NDT PART 1, 51-01-02.

THE DIAMETER OF A DAMAGE AREA IS EITHER THE DIAMETER OF THE VISUAL DAMAGE OR THE DIAMETER OF THE DELAMINATION. USE THE DIAMETER OF THE LARGER DAMAGE.

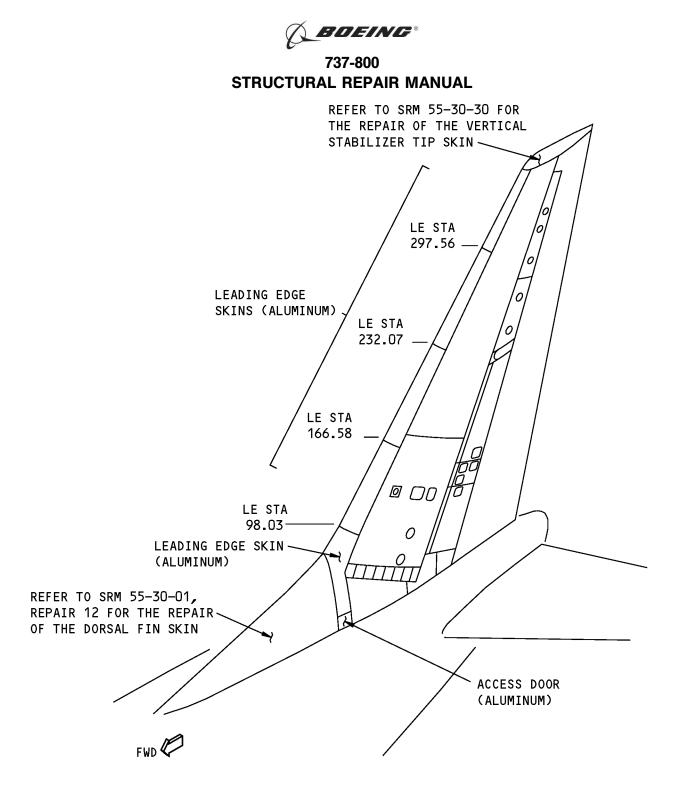
Vertical Stabilizer Leading Edge Skin Locations Figure 201

LEFT SIDE IS SHOWN, RIGHT SIDE IS OPPOSITE

- A. Repair 1 is applicable to damage to the vertical stabilizer leading edge skins shown in Vertical Stabilizer Leading Edge Skin Locations, Figure 201/REPAIR 1 if:
 - (1) You do inspections of the repair as given in Paragraph 5./REPAIR 1
 - (2) You replace Repair 1 no more than 15,000 hours after installation with one of the repairs that follow:
 - (a) A permanent flush repair as shown in Repair 2
 - (b) A replacement of the blind rivets with solid flush rivets for a permanent external repair.

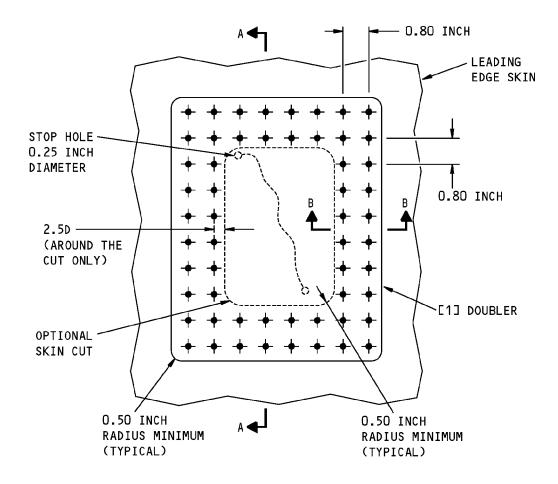
FLAT PATTERN OF THE REPAIR

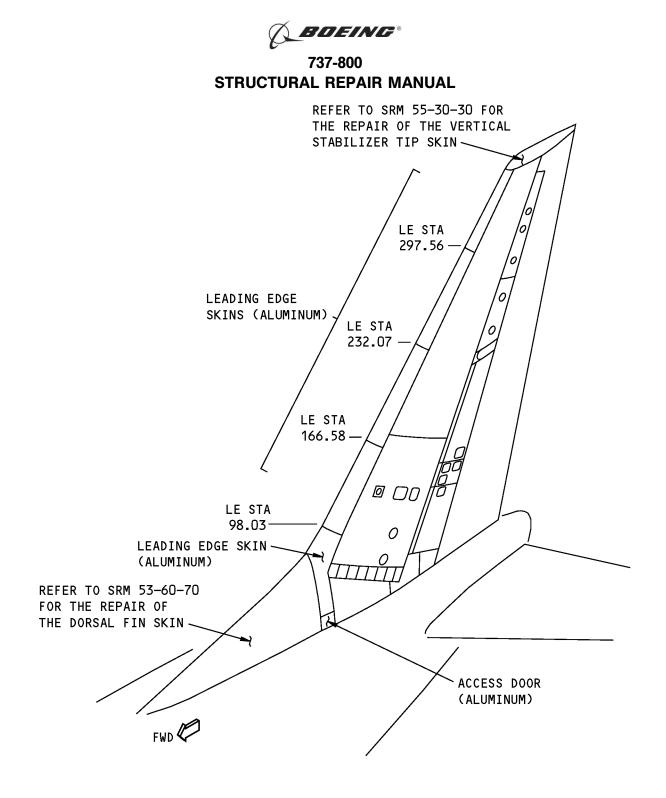
Vertical Stabilizer Leading Edge Skin Locations Figure 201

LEFT SIDE IS SHOWN, RIGHT SIDE IS OPPOSITE

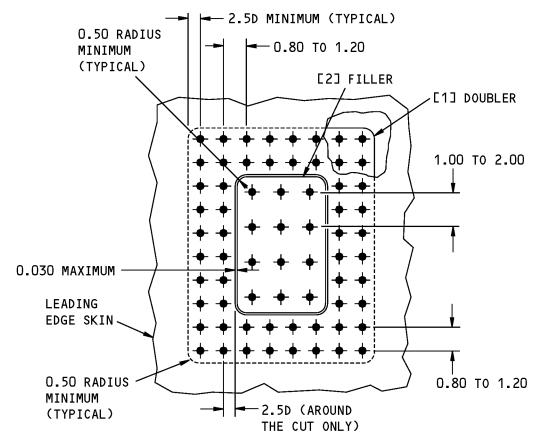
FLAT PATTERN OF THE REPAIR

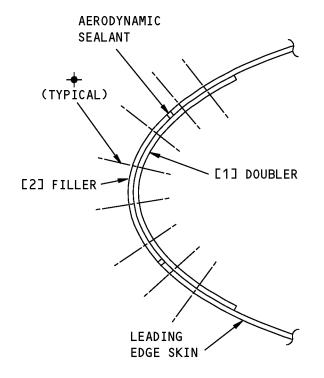
Vertical Stabilizer Leading Edge Skin Flush Repair Figure 202 (Sheet 2 of 2)

SECTION THROUGH LEADING EDGE REPAIR

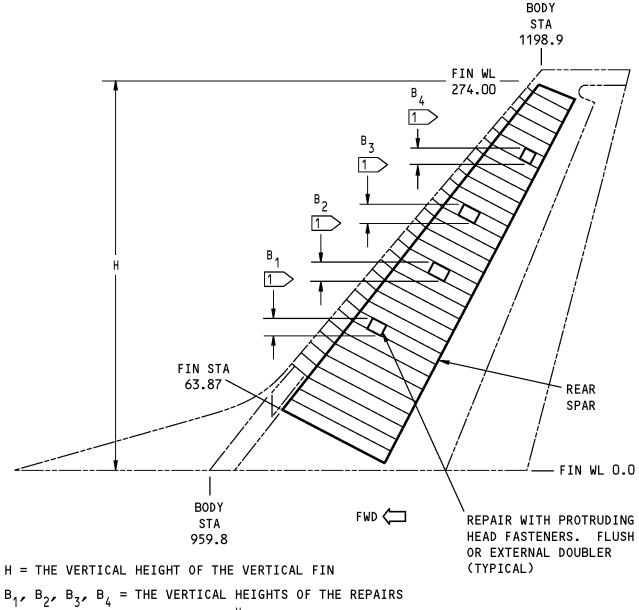
$B_1 + B_2 + B_3 + B_4 = A$ MAXIMUM OF $\frac{H}{4} = 68.5$ INCHES MAXIMUM

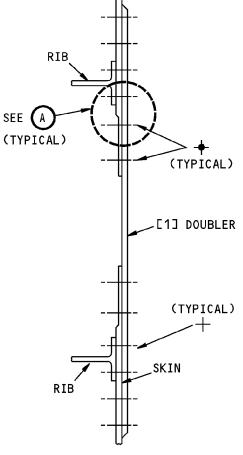
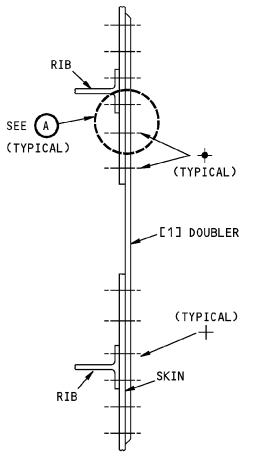
Inspar Skin External Repair - Fin Stations 73.400 thru 196.663 Figure 203 (Sheet 3 of 3)

SECTION THROUGH REPAIR OF CHEM-MILLED SKIN

SECTION THROUGH REPAIR OF SKIN WITH CONSTANT THICKNESS

- (D) IS THE DIAMETER OF THE REPAIR FASTENER. USE (D) TO CALCULATE EDGE MARGINS AND THE DISTANCE BETWEEN FASTENERS.
- MAKE SURE THAT THERE IS A MINIMUM OF SIX ROWS OF FASTENERS AROUND THE DAMAGE.
- MAKE SURE THAT THE REPAIR IS SYMMETRICAL AROUND THE DAMAGE.

- REPAIR FASTENER LOCATION. INSTALL A BACR15FP5E BLIND RIVET. INSTALL A BACR15DS7D RIVET FOR A PERMANENT REPAIR. REFER TO SRM 51-40-00 THROUGH 51-40-06 FOR THE FASTENER DATA.
- + INITIAL FASTENER LOCATION. INSTALL A BACR15FP()E BLIND RIVET THAT IS THE SAME DIAMETER (UP TO 1/32 INCH DIAMETER OVERSIZE) AS THE INITIAL FASTENER. INSTALL A BACR15CE() RIVET FOR A PERMANENT REPAIR. REFER TO SRM 51-40-00 THROUGH 51-40-08 FOR THE FASTENER DATA.
- ★ REPAIR FASTENER LOCATION. INSTALL A BACR15FP5E BLIND RIVET WHEN THERE IS CRACK DAMAGE. INSTALL A BACR15DS7D RIVET FOR A PERMANENT REPAIR. REFER TO SRM 51-40-00 THROUGH 51-40-06 FOR THE FASTENER DATA.
