CHAPTER 555

STABILIZERS

737-800 STRUCTURAL REPAIR MANUAL

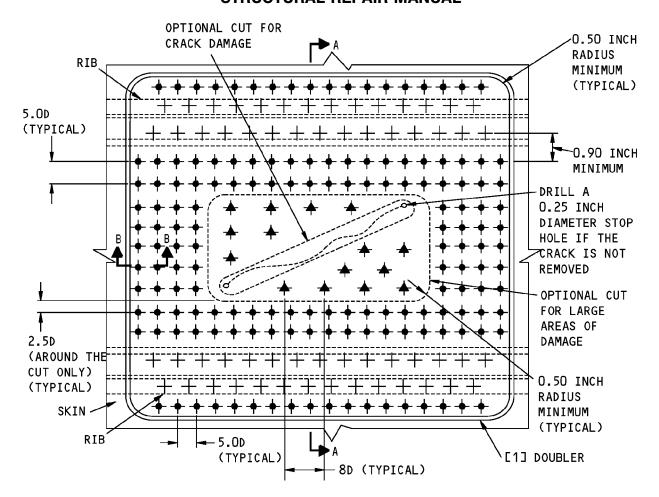
Inspar Skin External Repair - Fin Stations 73.400 thru 196.663 Figure 204 (Sheet 1 of 2)

- (D) IS THE DIAMETER OF THE REPAIR FASTENER. USE (D) TO CALCULATE EDGE MARGINS AND THE DISTANCE BETWEEN FASTENERS.
- MAKE SURE THAT THERE IS A MINIMUM OF THREE ROWS OF FASTENERS AROUND THE DAMAGE.
- MAKE SURE THAT THE REPAIR IS SYMMETRICAL AROUND THE DAMAGE.

- ➡ REPAIR FASTENER LOCATION. INSTALL A BACR15CE6 OR A BACR15CE8 SOLID RIVET. REFER TO SRM 51-40-00 THROUGH 51-40-06 FOR THE FASTENER DATA.
- + INITIAL FASTENER LOCATION. INSTALL A BACR15CE() SOLID RIVET THAT IS THE SAME DIAMETER (UP TO 1/32 INCH DIAMETER OVERSIZE) AS THE INITIAL FASTENER. REFER TO SRM 51-40-00 THROUGH 51-40-08 FOR THE FASTENER DATA.
- ✤ REPAIR FASTENER LOCATION. INSTALL A BACR15CE6 OR A BACR15CE8 SOLID RIVET WHEN THERE IS CRACK DAMAGE. REFER TO SRM 51-40-00 THROUGH 51-40-06 FOR THE FASTENER DATA.

- (1) Cut and remove the damaged part of the skin as shown in Inspar Skin External Repair Fin Stations 73.400 thru 196.663, Figure 203/REPAIR 3 or Inspar Skin External Repair - Fin Stations 73.400 thru 196.663, Figure 204/REPAIR 3. Refer to 51-10-02 for the procedures to remove the damage.

- C. Make the part [1] doubler as shown in Inspar Skin External Repair Fin Stations 73.400 thru 196.663, Figure 203/REPAIR 3 or Inspar Skin External Repair - Fin Stations 73.400 thru 196.663, Figure 204/REPAIR 3. Refer to Table 201/REPAIR 3 for the repair material.

- D. Assemble the part [1] doubler as shown in Inspar Skin External Repair Fin Stations 73.400 thru 196.663, Figure 203/REPAIR 3 or Inspar Skin External Repair - Fin Stations 73.400 thru 196.663, Figure 204/REPAIR 3.
- E. Drill the fastener holes.
- F. Remove the part [1] doubler.
- G. Remove the nicks, scratches, gouges, burrs, and sharp edges from the doubler and the bare surfaces of the skin.

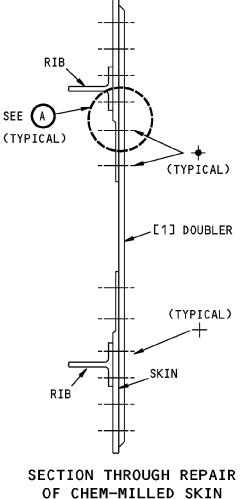
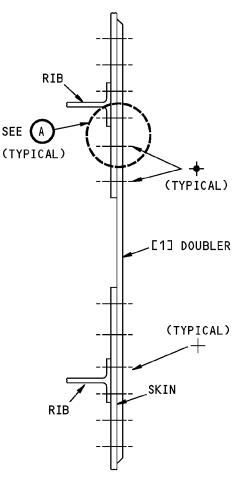
Inspar Skin External Repair - Fin Stations 73.400 thru 196.663 Figure 204 (Sheet 2 of 2)

OF CHEM-MILLED SKIN

SECTION THROUGH REPAIR OF SKIN WITH CONSTANT THICKNESS

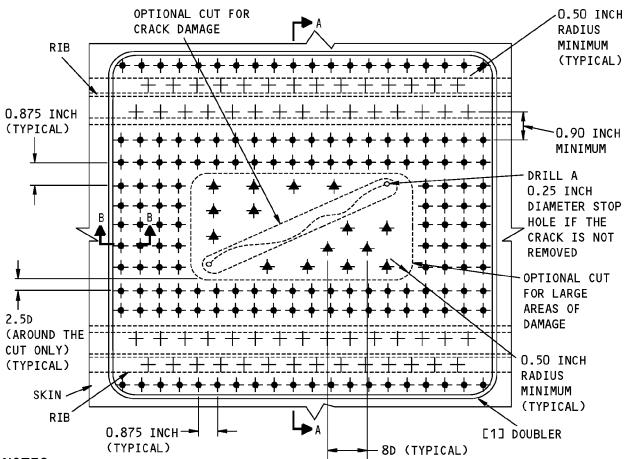
- (D) IS THE DIAMETER OF THE REPAIR FASTENER. USE (D) TO CALCULATE EDGE MARGINS AND THE DISTANCE BETWEEN FASTENERS.
- MAKE SURE THAT THERE IS A MINIMUM OF FOUR ROWS OF FASTENERS AROUND THE DAMAGE.
- MAKE SURE THAT THE REPAIR IS SYMMETRICAL AROUND THE DAMAGE.

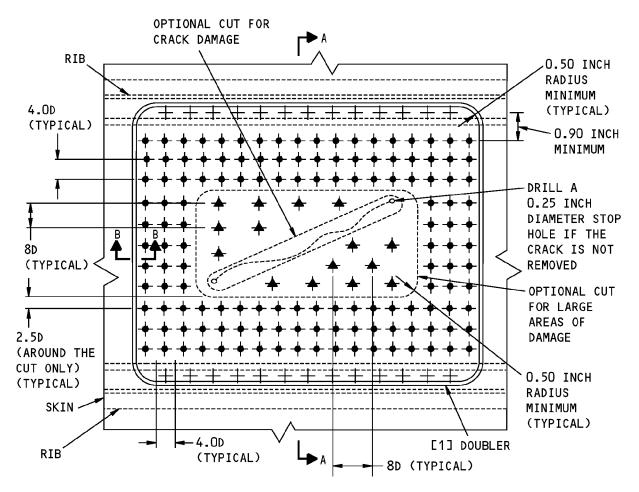
- (D) IS THE DIAMETER OF THE REPAIR FASTENER. USE (D) TO CALCULATE EDGE MARGINS AND THE DISTANCE BETWEEN FASTENERS.
- MAKE SURE THAT THERE IS A MINIMUM OF THREE ROWS OF FASTENERS AROUND THE DAMAGE.
- MAKE SURE THAT THE REPAIR IS SYMMETRICAL AROUND THE DAMAGE.

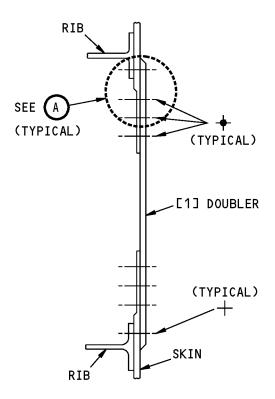
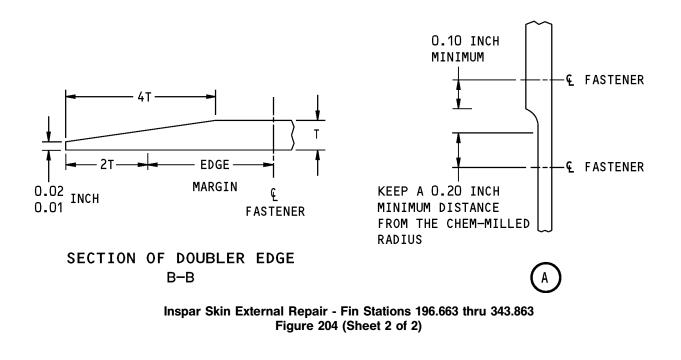
SECTION THROUGH REPAIR OF CHEM-MILLED SKIN

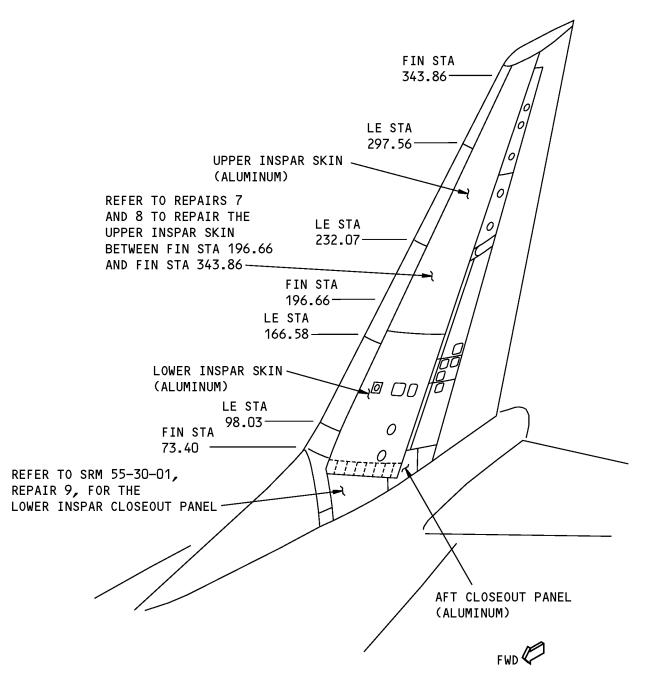
Vertical Stabilizer Inspar Skin Locations Figure 201

LEFT SIDE IS SHOWN, RIGHT SIDE IS ALMOST THE SAME

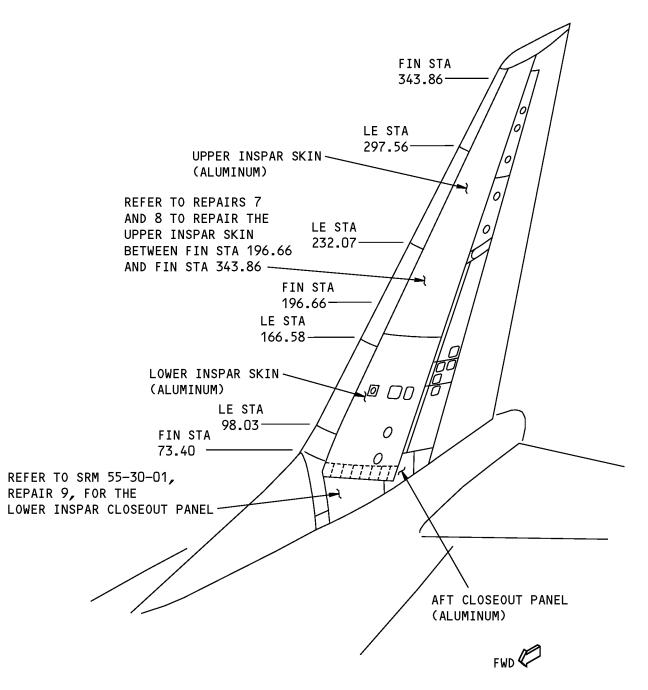
Vertical Stabilizer Inspar Skin Locations Figure 201

LEFT SIDE IS SHOWN, RIGHT SIDE IS ALMOST THE SAME

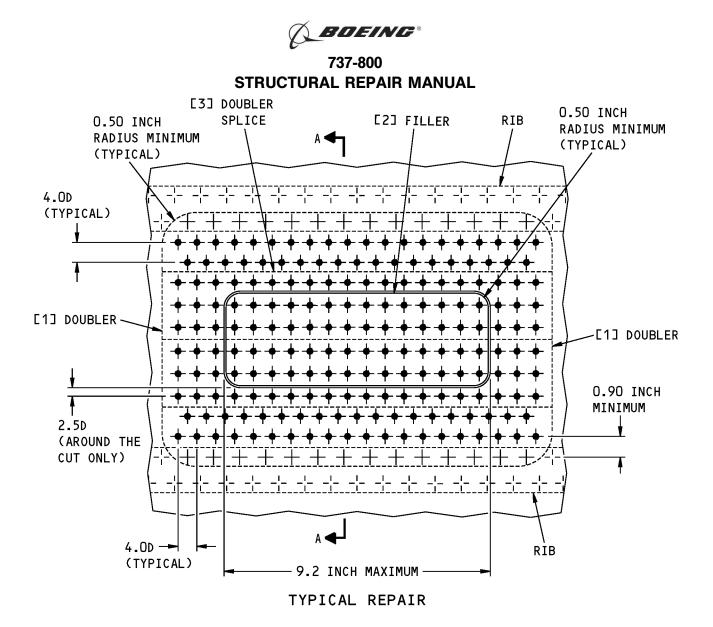
- (D) IS THE DIAMETER OF THE REPAIR FASTENER. USE (D) TO CALCULATE EDGE MARGINS AND THE DISTANCE BETWEEN FASTENERS.
- MAKE SURE THAT THERE IS A MINIMUM OF THREE ROWS OF FASTENERS AROUND THE DAMAGE.
- MAKE SURE THAT THE REPAIR IS SYMMETRICAL AROUND THE DAMAGE.

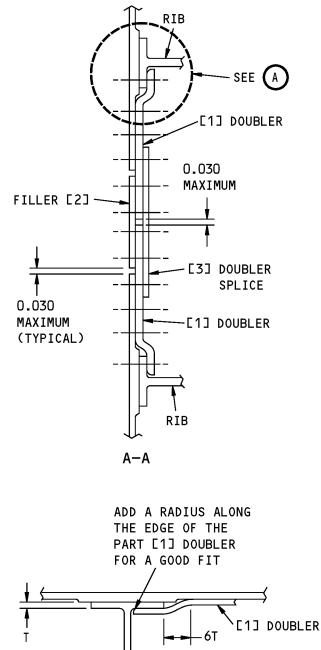
Vertical Stabilizer Inspar Skin Flush Repair with Spliced Doubler Between Ribs - Fin Stations 73.400 through 196.663 Figure 203 (Sheet 2 of 2)

T = RIB FLANGE THICKNESS JOGGLE (TYPICAL)

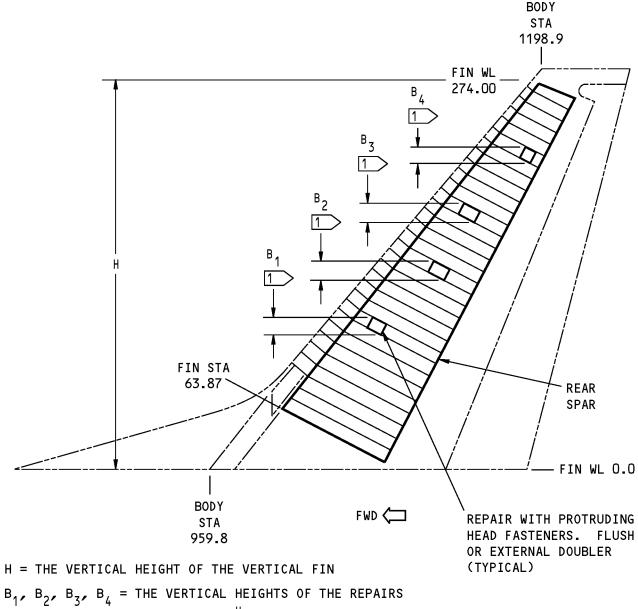
$B_1 + B_2 + B_3 + B_4 = A$ MAXIMUM OF $\frac{H}{4} = 68.5$ INCHES MAXIMUM

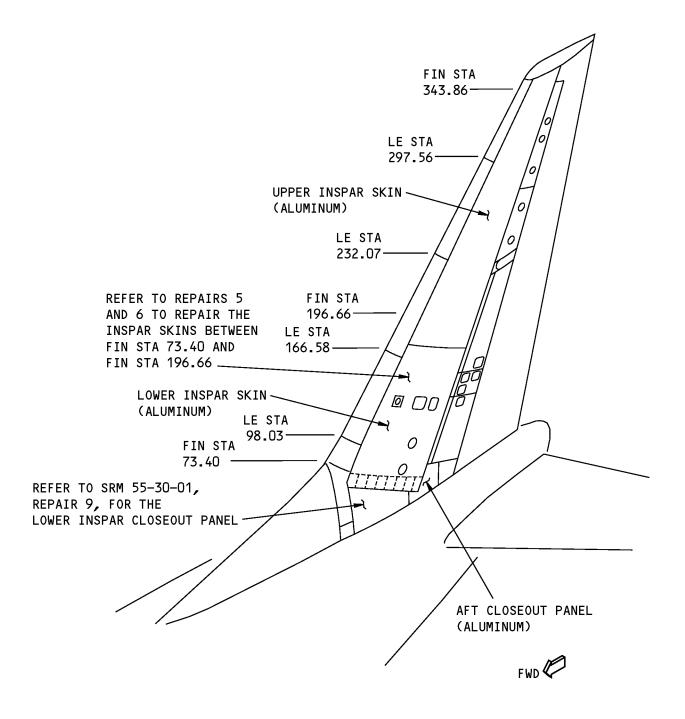
Vertical Stabilizer Inspar Skin Locations Figure 201

LEFT SIDE IS SHOWN, RIGHT SIDE IS ALMOST THE SAME

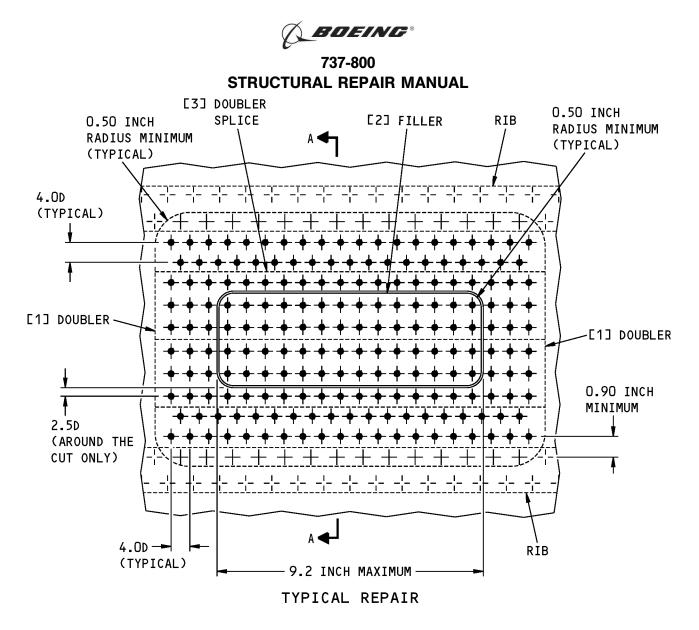
- (D) IS THE DIAMETER OF THE REPAIR FASTENER. USE (D) TO CALCULATE EDGE MARGINS AND THE DISTANCE BETWEEN FASTENERS.
- MAKE SURE THAT THERE IS A MINIMUM OF THREE ROWS OF FASTENERS AROUND THE DAMAGE.
- MAKE SURE THAT THE REPAIR IS SYMMETRICAL AROUND THE DAMAGE.

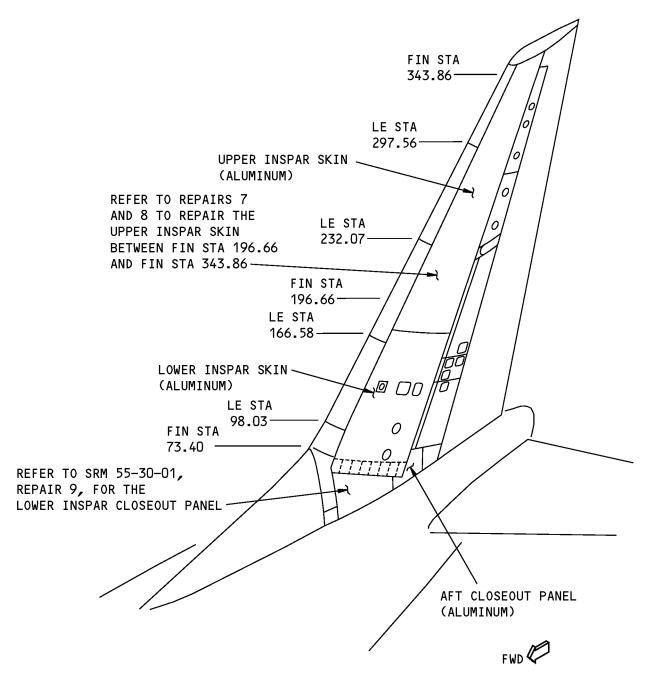
Vertical Stabilizer Inspar Skin Locations Figure 201

LEFT SIDE IS SHOWN, RIGHT SIDE IS ALMOST THE SAME

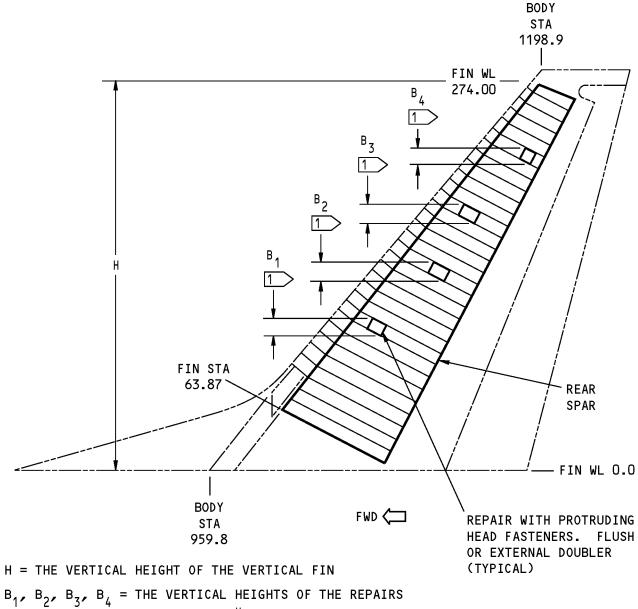
$B_1 + B_2 + B_3 + B_4 = A$ MAXIMUM OF $\frac{H}{4} = 68.5$ INCHES MAXIMUM

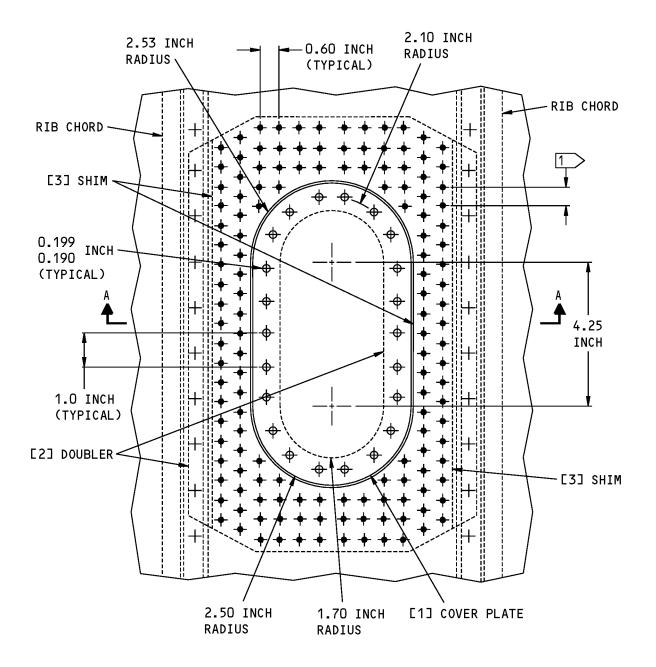
USE THE FASTENER SPACING AS FOLLOWS: - 0.80 INCH FOR FIN WL 150.67 TO THE TIP

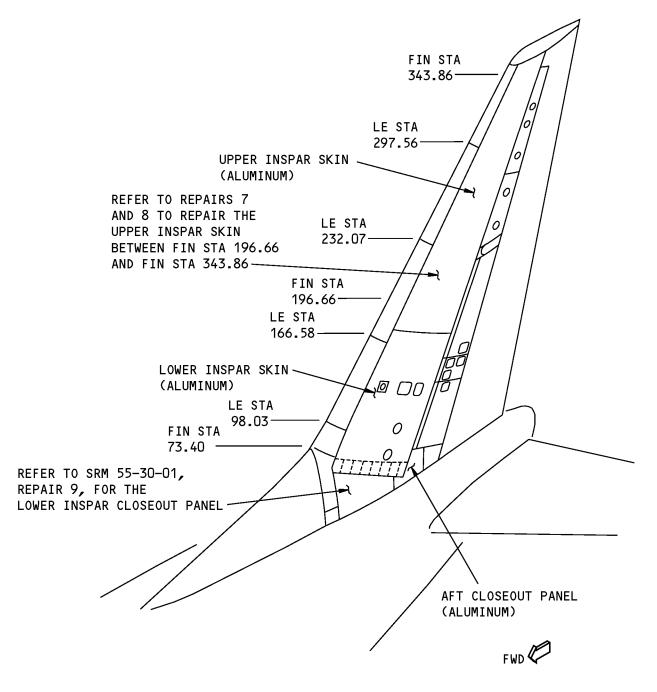
Vertical Stabilizer Inspar Skin Locations Figure 201

LEFT SIDE IS SHOWN, RIGHT SIDE IS ALMOST THE SAME

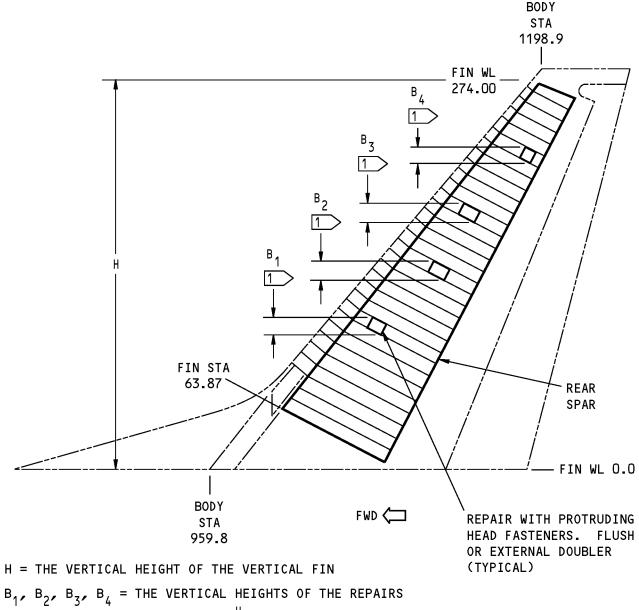
$B_1 + B_2 + B_3 + B_4 = A$ MAXIMUM OF $\frac{H}{4} = 68.5$ INCHES MAXIMUM

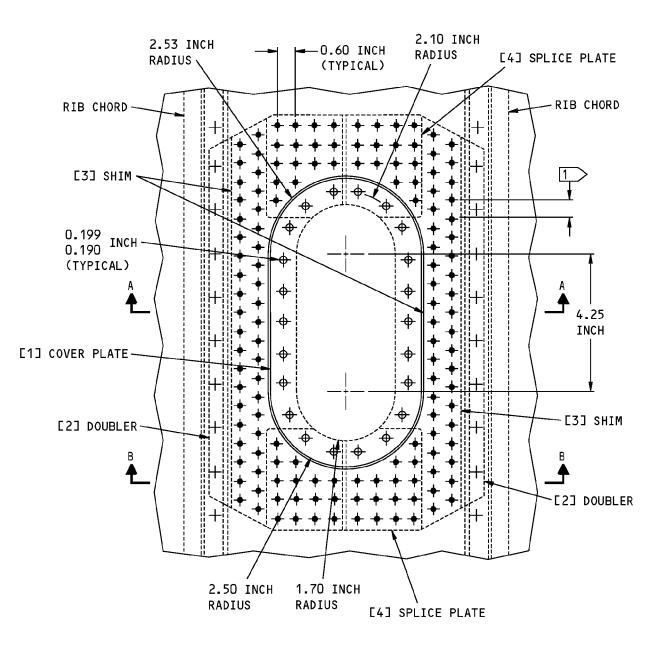
1 USE THE FASTENER SPACING AS FOLLOWS: - 0.80 INCH FOR FIN WL 150.67 TO THE TIP

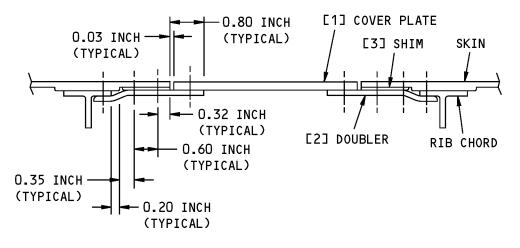
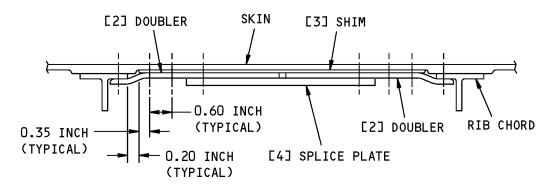
A-A

B-B

- H INITIAL FASTENER LOCATION. INSTALL A FASTENER THAT IS THE SAME TYPE AND DIAMETER AS THE INITIAL FASTENER. YOU CAN INSTALL A FASTENER THAT IS UP TO 1/32 INCH DIAMETER OVERSIZE.
- + REPAIR FASTENER LOCATION. INSTALL A BACB30VT5K HEX DRIVE BOLT.
- ➡ REPAIR FASTENER LOCATION. INSTALL BACN10JR03CFM NUTPLATE WITH BACR15BA3D RIVETS. INSTALL A BACB30EL3-() BOLT TO ATTACH THE PART [1] COVER PLATE.

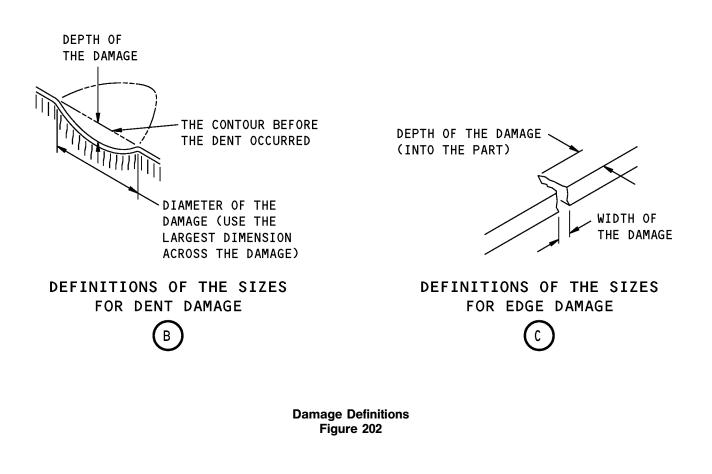
DEFINITIONS OF THE SIZES FOR NICK, GOUGE, AND SCRATCH DAMAGE

- (2) For the honeycomb core areas, the tap test is an alternative procedure to an instrumented NDT procedure.
- (3) Refer to Damage Definitions, Figure 202/REPAIR 12, for the definitions of the length, width, and depth of damage.
- D. Do the repair as given in Paragraph 4./REPAIR 12
- E. Make sure the aerodynamic smoothness is satisfactory or there will be a decrease in the performance of the airplane. Refer to 51-10-01.
- F. Put the dorsal fin skin back to the initial condition, as applicable.
 - (1) Install the skin if it was removed. Refer to AMM 55-32-11/401.

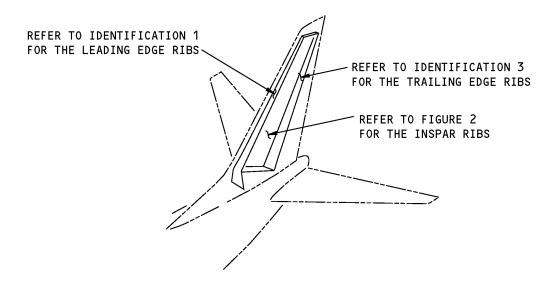
Vertical Stabilizer Inspar Rib Locations Figure 1

IDENTIFICATION 2 - VERTICAL STABILIZER INSPAR RIBS

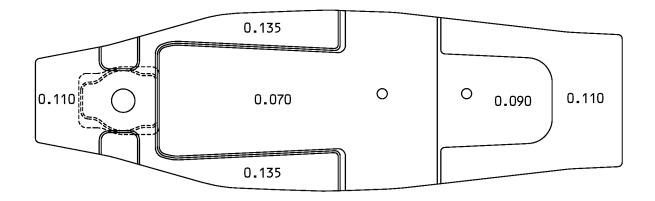
Chem-Milled Areas of Figure 2, Item [2] Figure 3

NOTE: ALL DIMENSIONS ARE IN INCHES.

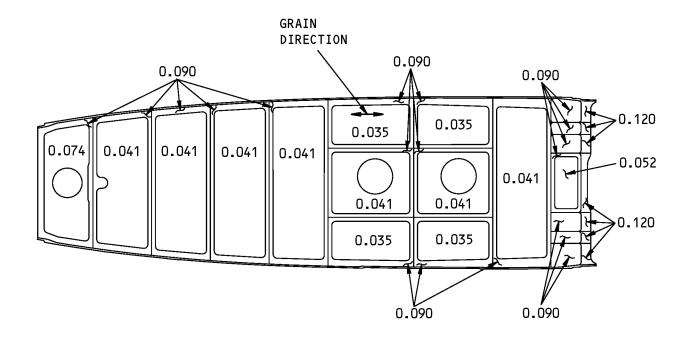
Machined Areas for Figure 2, Item [3] Figure 4

TYPICAL MACHINED RIB

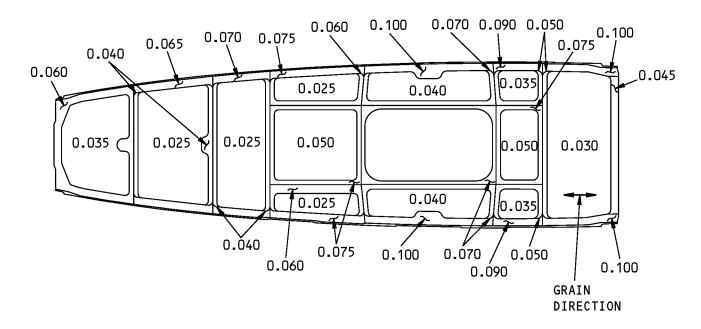
Machined Areas for Figure 2, Item [4] Figure 5

TYPICAL MACHINED RIB

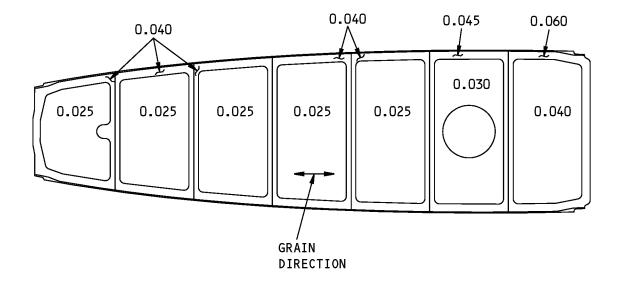
Machined Areas for Figure 2, Item [5] Figure 6

TYPICAL MACHINED RIB

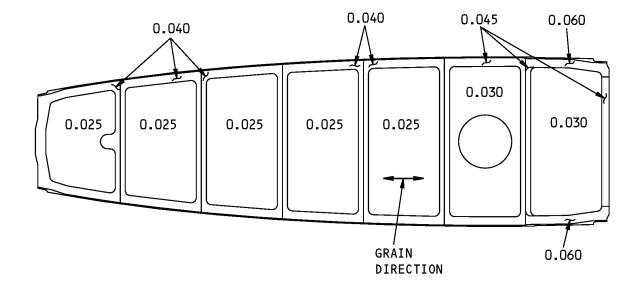
Machined Areas for Figure 2, Item [6] Figure 7

TYPICAL MACHINED RIB

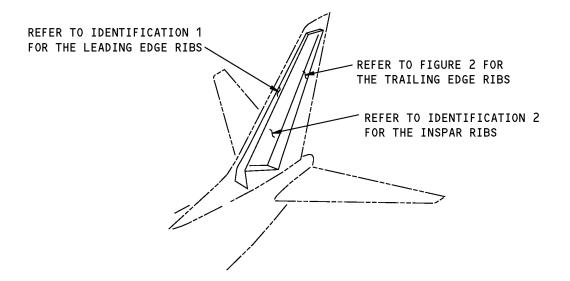
Vertical Stabilizer Trailing Edge Rib Locations Figure 1

IDENTIFICATION 3 - VERTICAL STABILIZER TRAILING EDGE RIBS

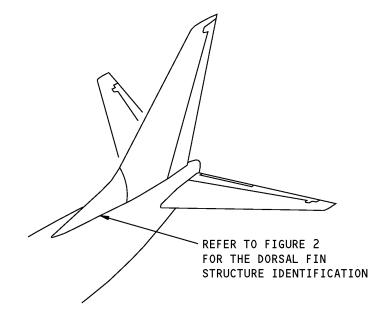
Dorsal Fin Structure Location Figure 1

IDENTIFICATION 4 - DORSAL FIN STRUCTURE

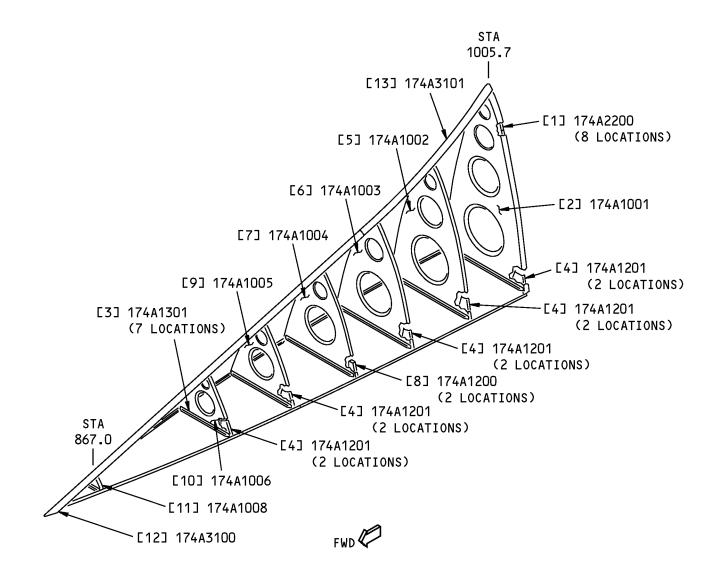
LEFT SIDE IS SHOWN, RIGHT SIDE IS OPPOSITE

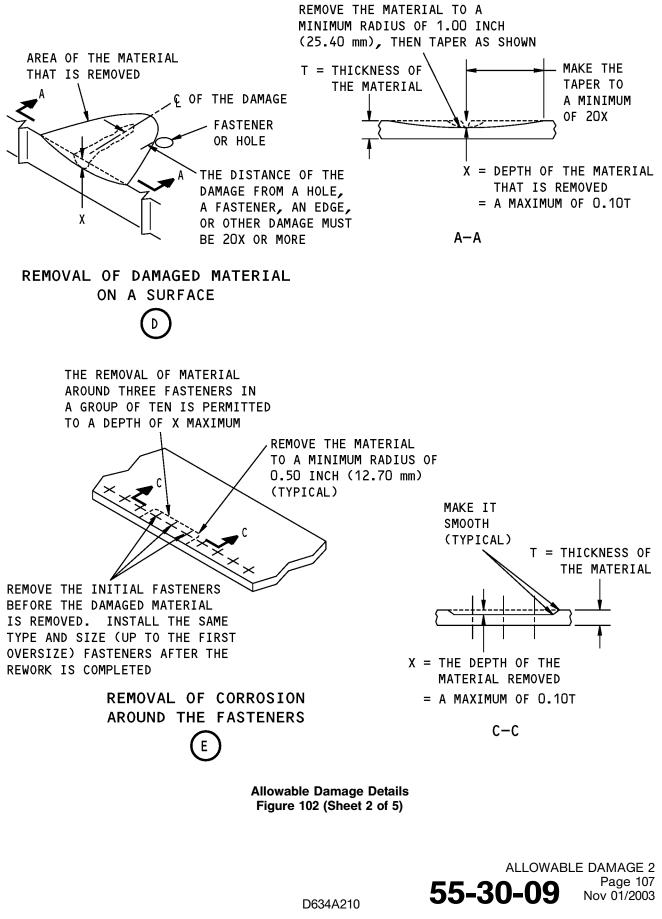
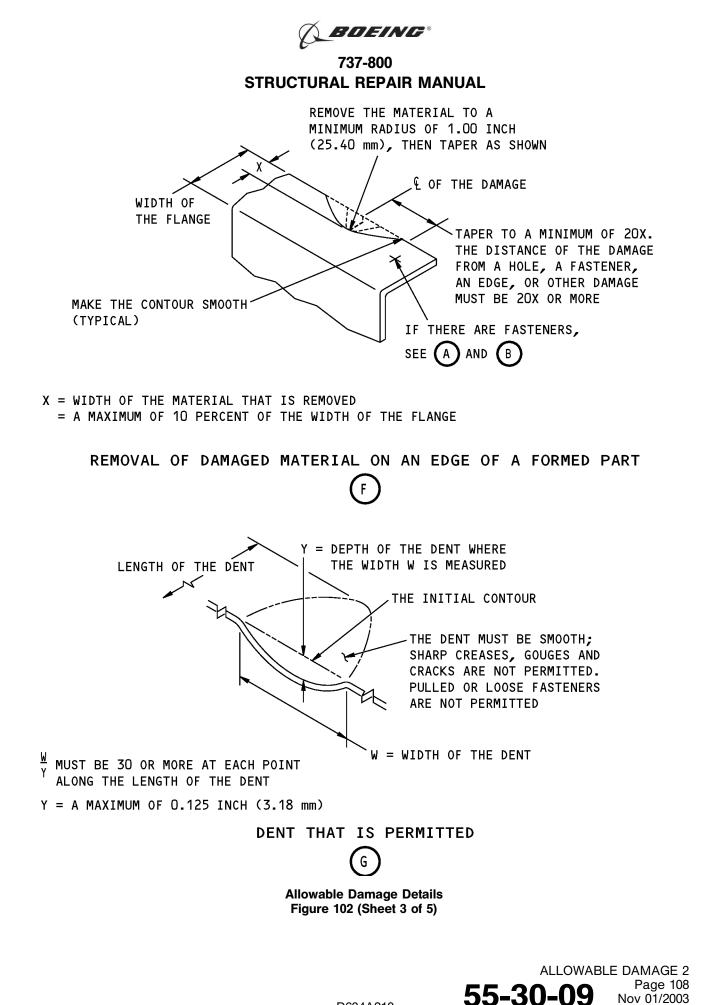
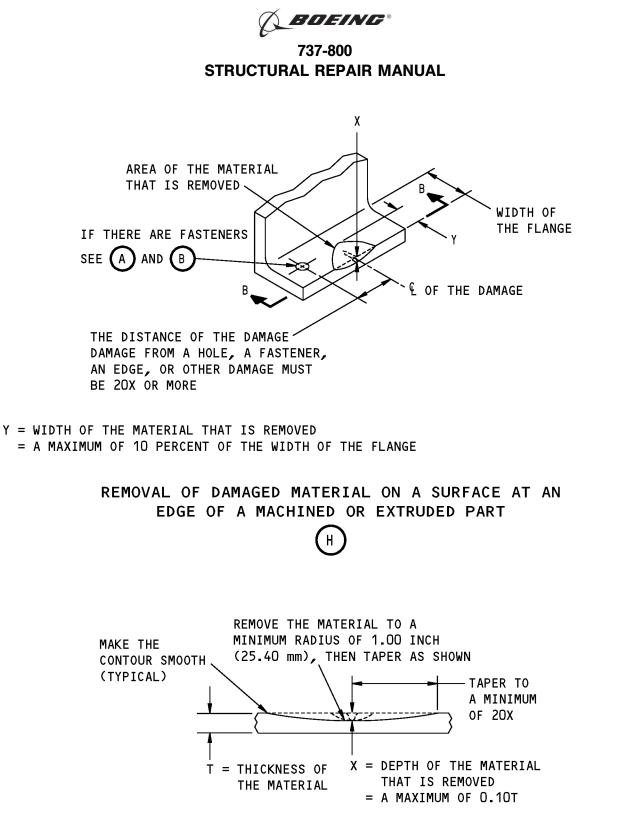
Allowable Damage Details Figure 102 (Sheet 4 of 5)

B-B

- A. Ribs and Gussets
 - (1) Cracks:
 - (a) Remove the damage as shown in Allowable Damage Details, Figure 102/ALLOWABLE DAMAGE 2, Details A, B, and C.
 - (2) Nicks, Gouges, Scratches, and Corrosion:

- (a) Remove the damage as shown in Allowable Damage Details, Figure 102/ALLOWABLE DAMAGE 2, Details A, B, C, D, E, and F.
 - (3) Dents are permitted as shown in Allowable Damage Details, Figure 102/ALLOWABLE DAMAGE 2, Detail G.

- (4) Holes and Punctures:
 - (a) Damage is permitted in the free flange as shown in Allowable Damage Details, Figure 102/ALLOWABLE DAMAGE 2, Detail I.

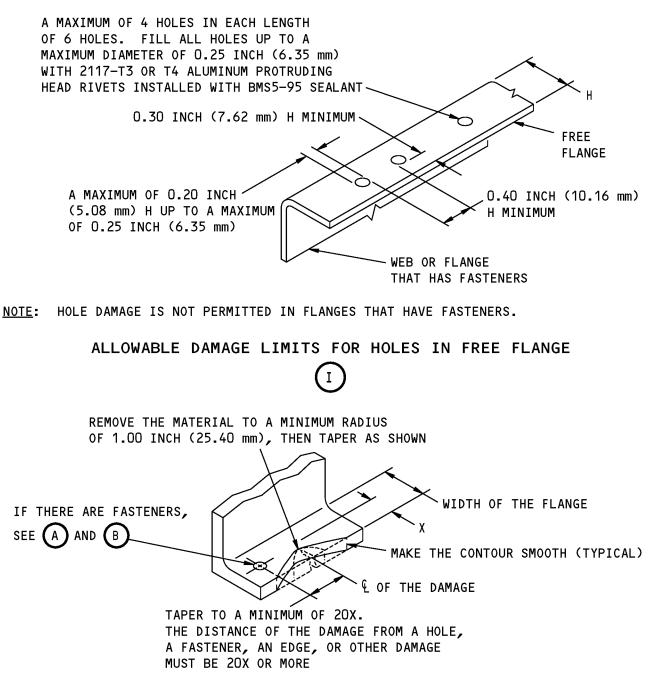
Allowable Damage Details Figure 102 (Sheet 5 of 5)

X = WIDTH OF THE MATERIAL REMOVED = A MAXIMUM OF 10 PERCENT OF THE WIDTH OF THE FLANGE

REMOVAL OF DAMAGED MATERIAL AT AN EDGE

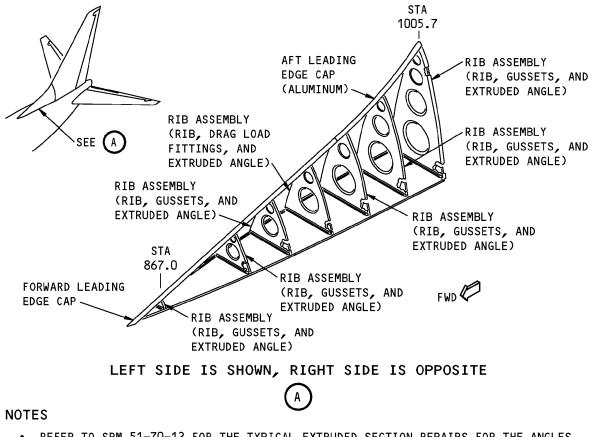
Dorsal Fin Structure Repair Figure 201

- REFER TO SRM 51-70-12 FOR THE TYPICAL EXTRUDED SECTION REPAIRS FOR THE ANGLES OF THE RIB ASSEMBLIES.
- YOU CAN USE THESE TYPICAL REPAIRS WHERE THEY ARE APPLICABLE IF:
 - SUFFICIENT SPACE IS AVAILABLE FOR THE INSTALLATION OF THE REPAIR PARTS, AND - THE REPAIR PARTS DO NOT TOUCH ADJACENT STRUCTURE.

A. Repair 2 is applicable to damage to the dorsal fin structure shown in 201.

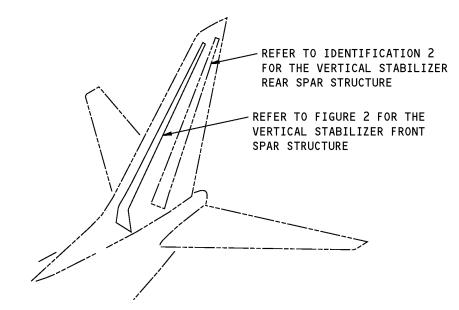
Vertical Stabilizer Front Spar Structure Locations Figure 1

IDENTIFICATION 1 - VERTICAL STABILIZER FRONT SPAR STRUCTURE

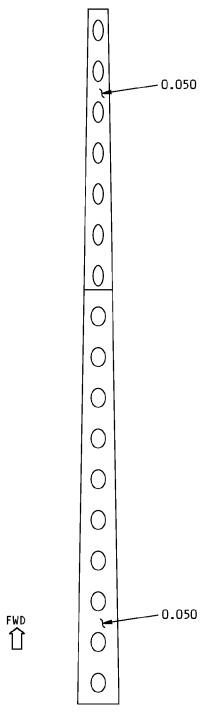
> Chem-Milled Areas for Figure 2, Item [2] Figure 4

NOTE: REFER TO TABLE 2 FOR THE LIST OF MATERIALS. ALL DIMENSIONS ARE IN INCHES.

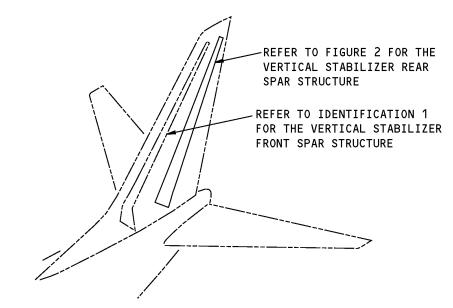
Vertical Stabilizer Rear Spar Structure Locations Figure 1

IDENTIFICATION 2 - VERTICAL STABILIZER REAR SPAR STRUCTURE

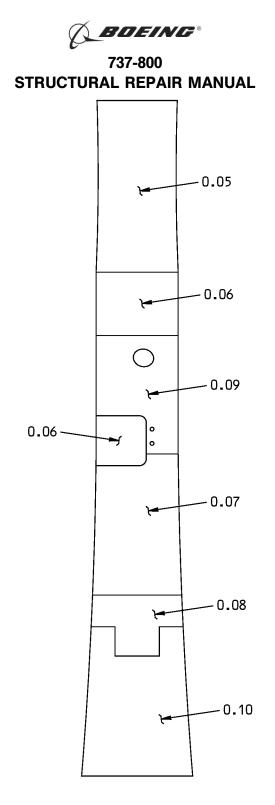
> Chem-Milled Areas for Figure 2, Item [3] Figure 3

NOTE: REFER TO TABLE 2 FOR THE LIST OF MATERIALS. ALL DIMENSIONS ARE IN INCHES.

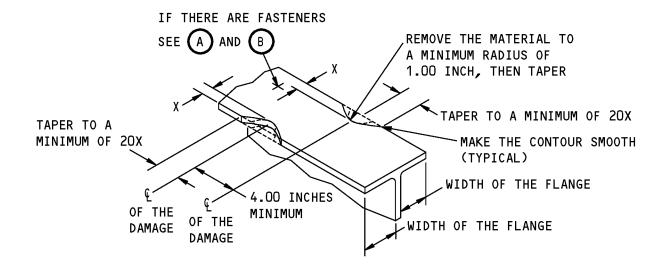
X = THE WIDTH OF THE MATERIAL THAT IS REMOVED = A MAXIMUM OF 10 PERCENT OF THE WIDTH OF THE FLANGE

REMOVAL OF DAMAGED MATERIAL ON AN EDGE

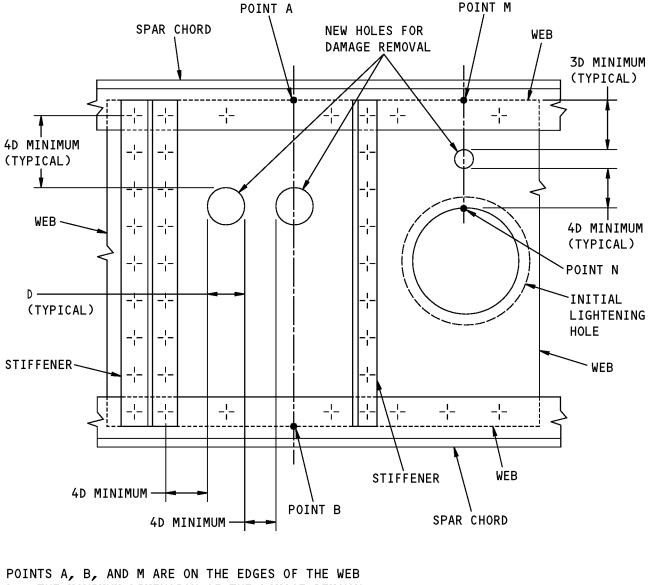
Allowable Damage Limits Figure 102 (Sheet 4 of 5)

D = THE MAXIMUM DIMENSION OF THE DAMAGE REMOVAL

= 1.00 INCH MAXIMUM

HOLES THAT ARE PERMITTED TO REMOVE DAMAGED MATERIAL IN WEBS

- (3) Dents are permitted as shown in Allowable Damage Limits, Figure 102/ALLOWABLE DAMAGE 2, Detail D.
 - (4) Holes and Punctures are permitted as shown in Allowable Damage Limits, Figure 102/ALLOWABLE DAMAGE 2, Detail G if:

- (a) They are a maximum diameter (D) of 1.00 inch. D is the maximum dimension of the largest damage.
 - (b) There is not more than two holes in each bay between two stiffeners

- (c) The edge of the damage is a minimum of 4D away from the edge of:
 - 1) An initial hole
 - 2) A fastener hole
 - 3) Other damage
 - (d) The edge of the damage is a minimum of 3D away from the edge of the part

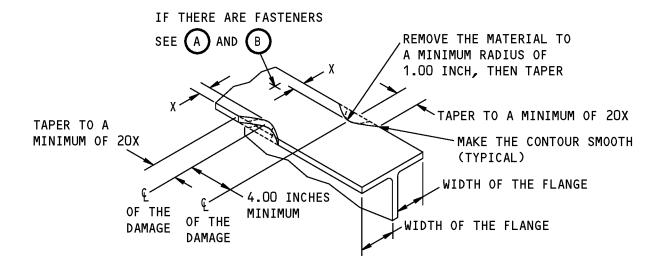
Allowable Damage Limits Figure 102 (Sheet 3 of 5)

X = THE WIDTH OF THE MATERIAL THAT IS REMOVED = A MAXIMUM OF 10 PERCENT OF THE WIDTH OF THE FLANGE

REMOVAL OF DAMAGED MATERIAL ON AN EDGE

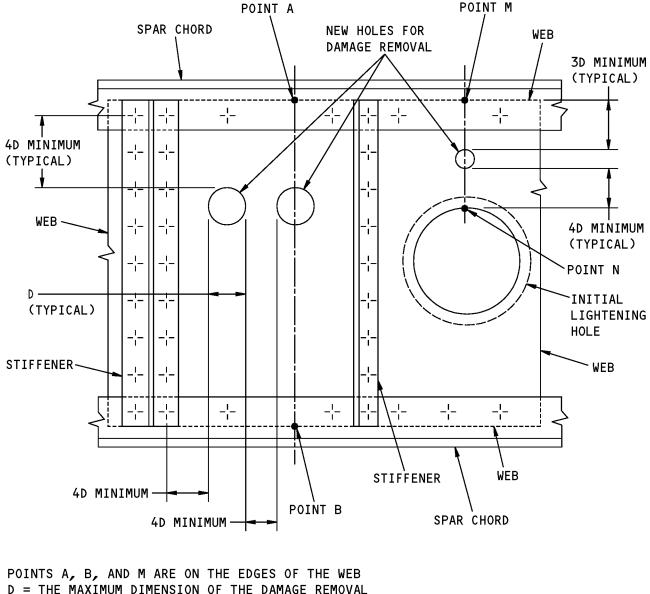
Allowable Damage Limits Figure 102 (Sheet 4 of 5)

D = THE MAXIMUM DIMENSION OF THE DAMAGE REMOVAL= 1.00 INCH MAXIMUM-'- FASTENER LOCATION

> HOLES THAT ARE PERMITTED TO REMOVE DAMAGED MATERIAL IN WEBS

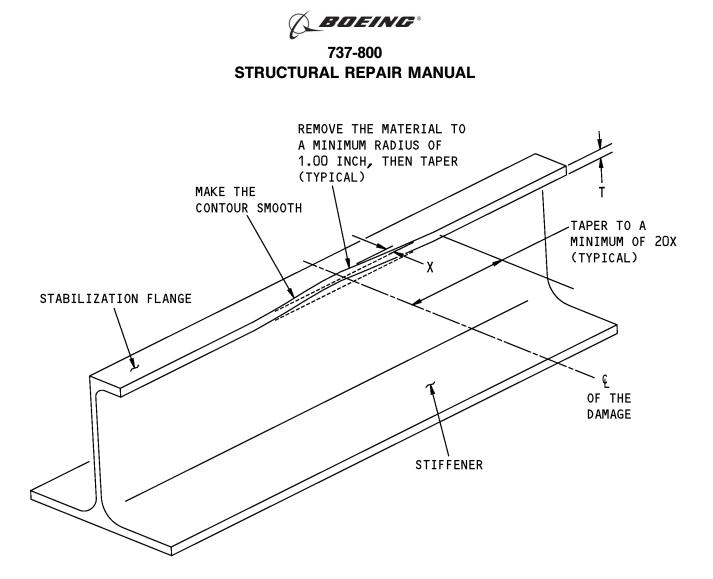
Allowable Damage Limits Figure 102 (Sheet 5 of 5)

- T = THE THICKNESS OF THE FLANGE
- X = THE DEPTH OF THE MATERIAL THAT IS REMOVED= A MAXIMUM OF 0.05T

REMOVAL OF DAMAGED MATERIAL FROM THE STABILIZATION FLANGE OF A STIFFENER

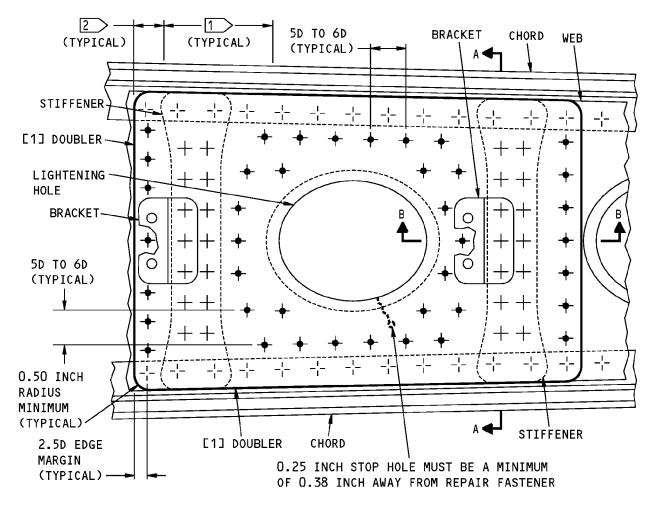
NOTES

- (D) IS THE DIAMETER OF THE REPAIR FASTENER.
- 1 MAKE SURE THAT THERE IS A MINIMUM OF THREE HORIZONTAL ROWS OF FASTENERS ON EACH SIDE OF THE DAMAGED AREA.

- (1) Cut and remove the damaged part of the web as shown in Vertical Stabilizer Front Spar Web Repair, Figure 202/REPAIR 2. Refer to 51-10-02 for the procedures to remove the damage.

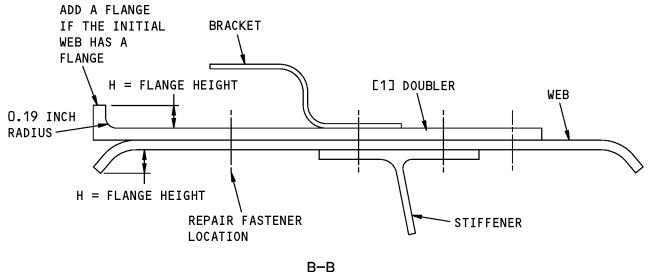
Vertical Stabilizer Front Spar Web Repair Figure 202 (Sheet 3 of 3)

REPAIR SHOWN WITH OPTIONAL MACHINED DOUBLER

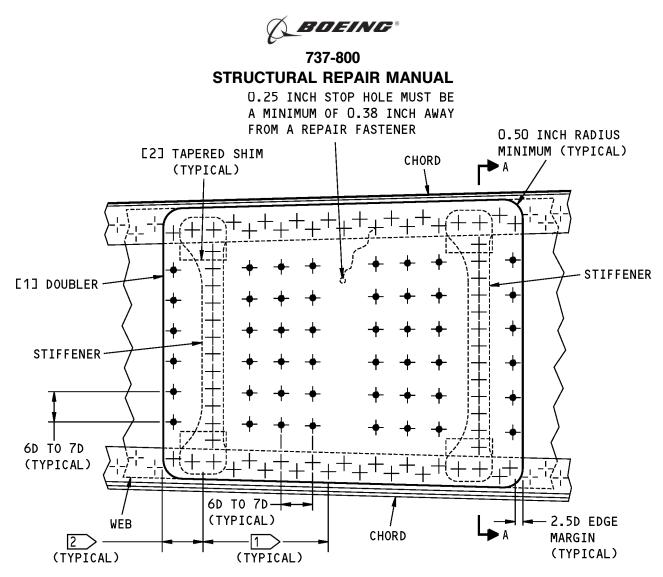
NOTES

- 1 MAKE SURE THERE IS A MINIMUM OF FOUR HORIZONTAL ROWS OF FASTENERS ON EACH SIDE OF THE DAMAGE.
- 2 PUT THE LAST ROW OF FASTENERS AWAY FROM A STIFFENER.
 - (D) IS THE DIAMETER OF THE REPAIR FASTENER.
 - MAKE SURE THE REPAIR IS SYMMETRICAL AROUND THE DAMAGE.

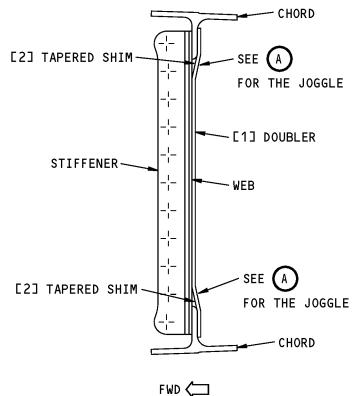
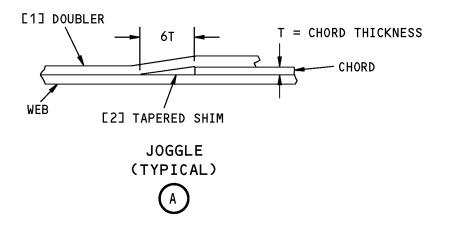
Vertical Stabilizer Rear Spar Web Repair Figure 202 (Sheet 2 of 2)

A-A

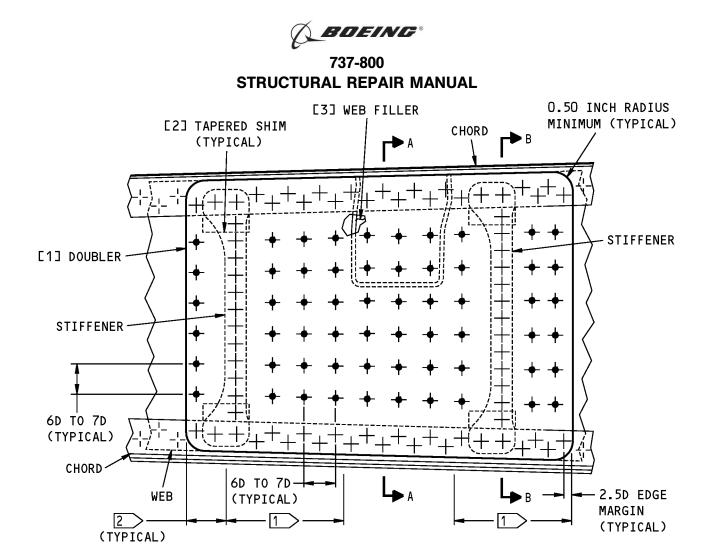
NOTES

- 1 MAKE SURE THERE IS A MINIMUM OF FOUR HORIZONTAL ROWS OF FASTENERS ON EACH SIDE OF THE DAMAGE.
- 2 PUT THE LAST ROW OF FASTENERS AWAY FROM A STIFFENER.
 - (D) IS THE DIAMETER OF THE REPAIR FASTENER.
 - MAKE SURE THE REPAIR IS SYMMETRICAL AROUND THE DAMAGE.

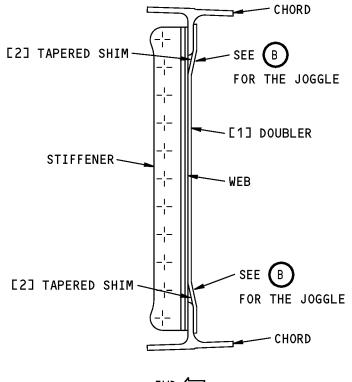
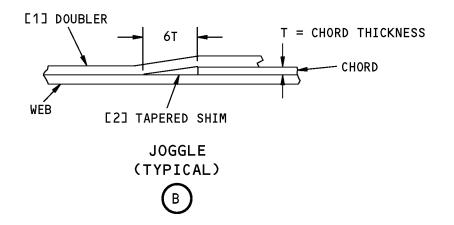
Vertical Stabilizer Rear Spar Web Repair With the Area of Damage Removed Figure 203 (Sheet 3 of 3)

В-В

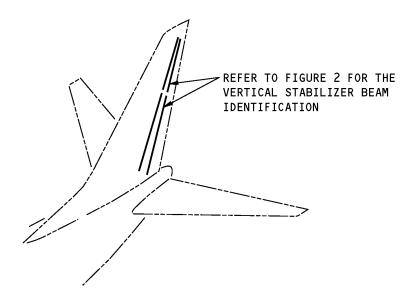
Vertical Stabilizer Beam Location Figure 1

NOTE: REFER TO TABLE 1 FOR THE REFERENCE DRAWINGS.

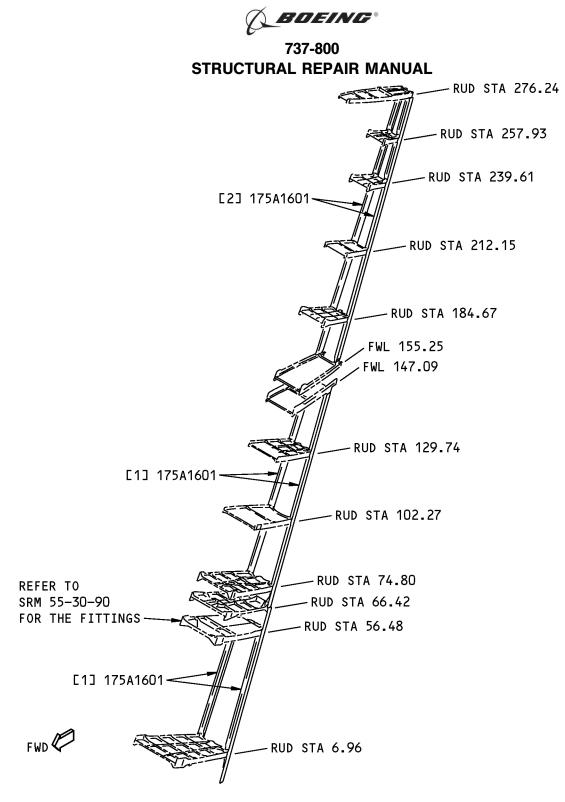
NOTE: REFER TO TABLE 2 FOR THE LIST OF MATERIALS.

VERTICAL STABILIZER BEAM UPPER AND LOWER SECTIONS

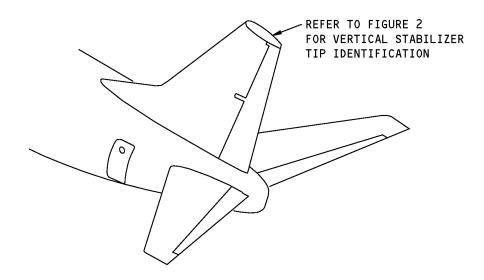
Vertical Stabilizer Tip Location Figure 1

NOTE: REFER TO TABLE 1 FOR THE REFERENCE DRAWINGS.

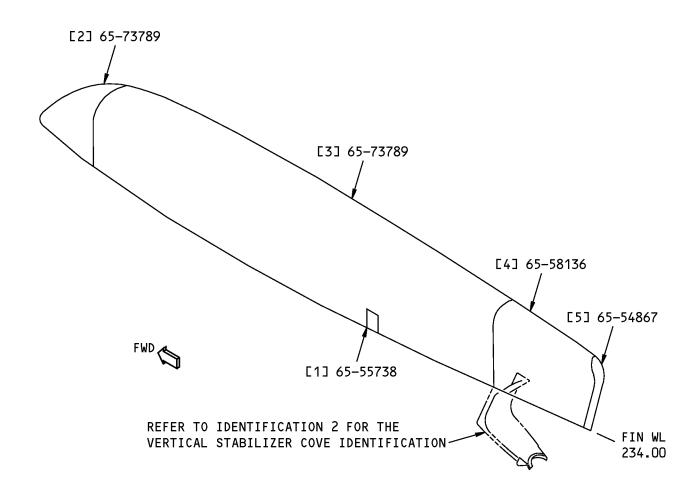
Vertical Stabilizer Tip Identification Figure 2

NOTE: REFER TO TABLE 2 FOR THE LIST OF MATERIALS.

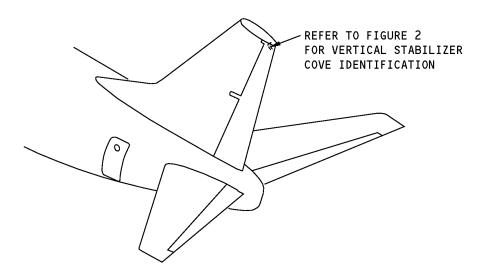
Vertical Stabilizer Cove Location Figure 1

NOTE: REFER TO TABLE 1 FOR THE REFERENCE DRAWINGS.

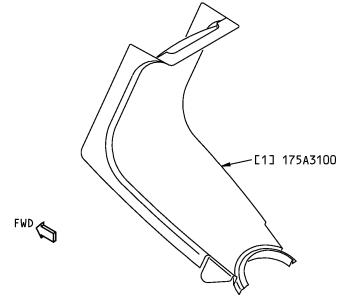
Vertical Stabilizer Cove Identification Figure 2

NOTE: REFER TO TABLE 2 FOR THE LIST OF MATERIALS.

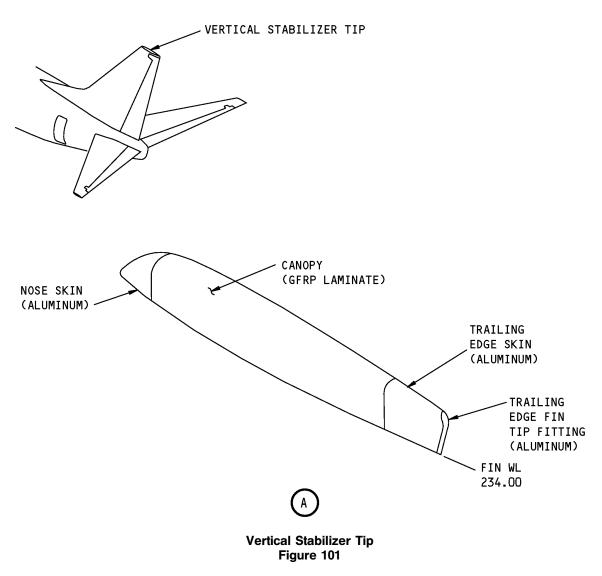
A. Allowable Damage 1 is applicable to damage on the vertical stabilizer tip skin and fitting as shown in Vertical Stabilizer Tip, Figure 101/ALLOWABLE DAMAGE 1.

- A. Do the steps that follow for the canopy made of Glass Fabric Reinforced Plastic (GFRP).
 - (1) Refer to Vertical Stabilizer Tip, Figure 101/ALLOWABLE DAMAGE 1 for the location of the canopy.
 - (2) Remove all the contamination and water from the structure. Refer to 51-30-05 and 51-70-04 for the tools and the cleanup procedures.

- B. Do the steps that follow for the parts made of aluminum.
 - (1) Refer to Vertical Stabilizer Tip, Figure 101/ALLOWABLE DAMAGE 1 for the location of the parts made of aluminum.

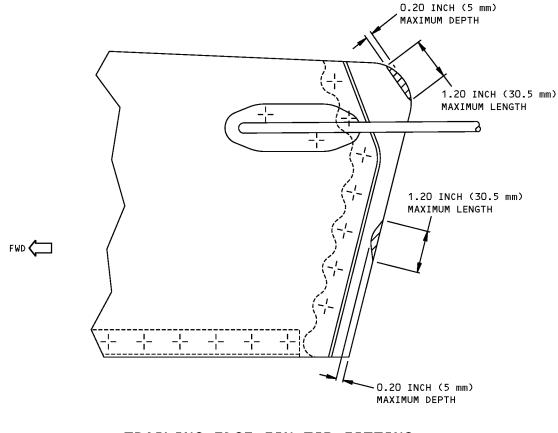
Allowable Damage Limits Figure 104 (Sheet 4 of 4)

TRAILING EDGE FIN TIP FITTING (LIGHTNING STRIKE LIMITS)

(a) You remove the damage as shown in Figure 104, Details D and G.

NOTE: If the damage is more than the limits shown in Figure 104, Details D and G then refer to 55-30-30, REPAIR 1.

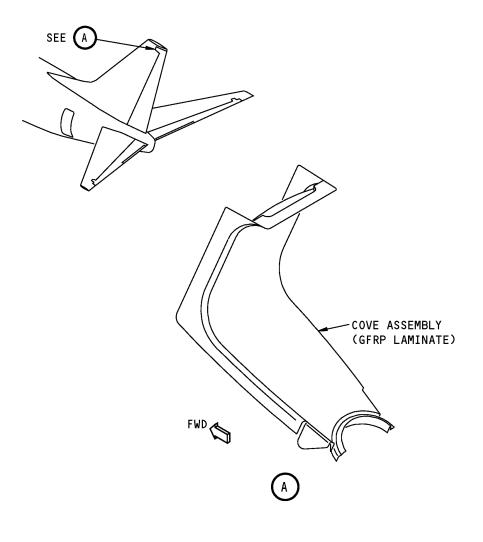
Vertical Stabilizer Cove Figure 101

A. Allowable Damage 2 is applicable to damage on the vertical stabilizer cove panel shown in Vertical Stabilizer Cove, Figure 101/ALLOWABLE DAMAGE 2.

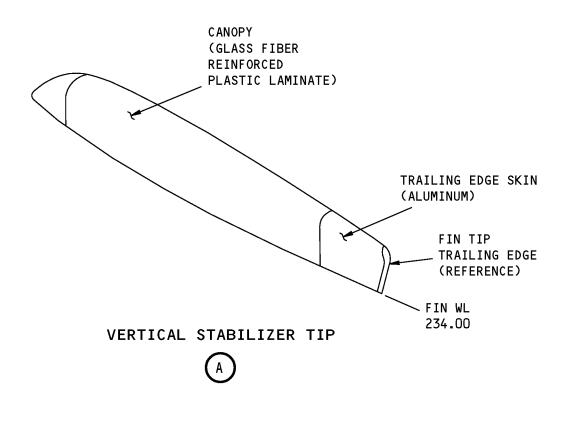
Vertical Stabilizer Tip Canopy Location Figure 201

SEE A FOR THE VERTICAL STABILIZER TIP

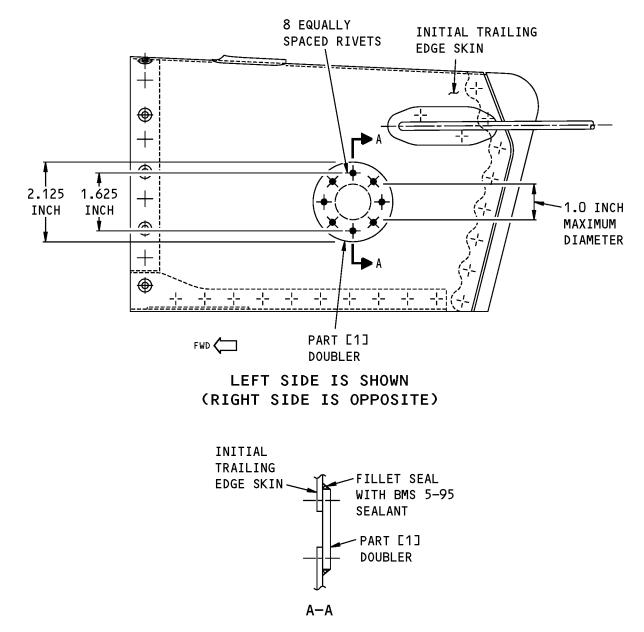
- MAKE SURE THERE IS A MINIMUM OF 2D EDGE MARGIN AT ALL LOCATIONS.
- MAKE SURE THE FASTENER SPACING IS 4D-6D.

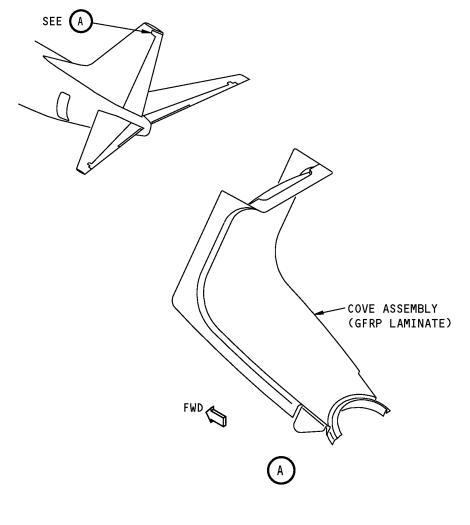
Vertical Stabilizer Cove Figure 201

- A. Repair 2 is applicable to the vertical stabilizer cove panel made of Glass Fiber Reinforced Plastic (GFRP) shown in Vertical Stabilizer Cove, Figure 201/REPAIR 2.
- B. Repair 2 is applicable to damage that is more than the limits permitted in Allowable Damage 2. Refer to Allowable Damage 2 for the type and size of damage that is permitted.

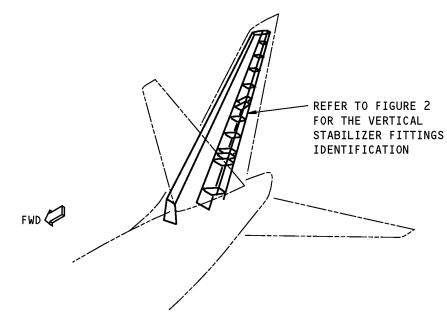
Vertical Stabilizer Fittings Location Figure 1

NOTE: REFER TO TABLE 1 FOR THE REFERENCE DRAWINGS.

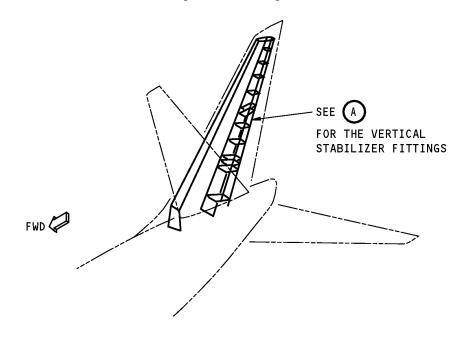
Vertical Stabilizer Fitting Locations Figure 101 (Sheet 1 of 2)

A. This subject gives the allowable damage limits for the fittings that attach to the vertical stabilizer shown in Vertical Stabilizer Fitting Locations, Figure 101/ALLOWABLE DAMAGE 1.
