CHAPTER 555

STABILIZERS

737-800 STRUCTURAL REPAIR MANUAL

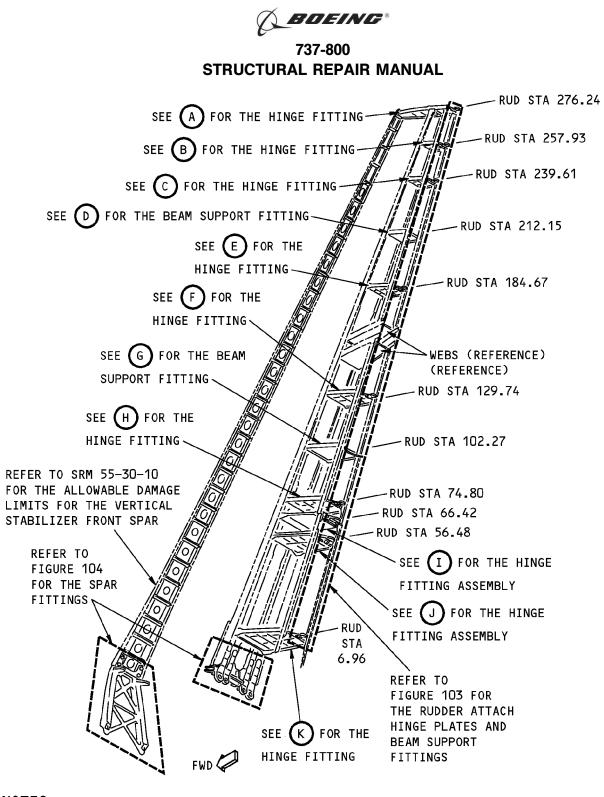
• ALL THE PARTS IDENTIFIED ARE MACHINED ALUMINUM.

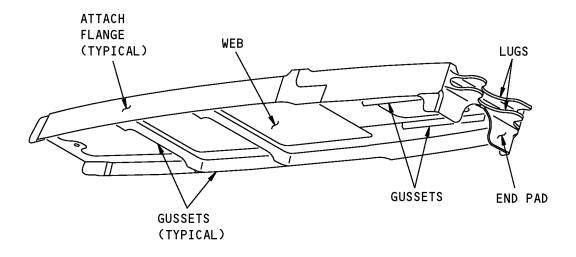
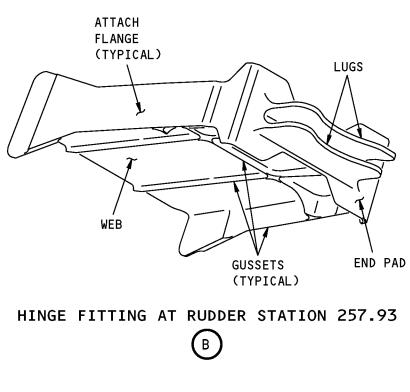
Vertical Stabilizer Hinge and Beam Support Fittings Figure 102 (Sheet 2 of 7)

HINGE FITTING AT RUDDER STATION 276.24

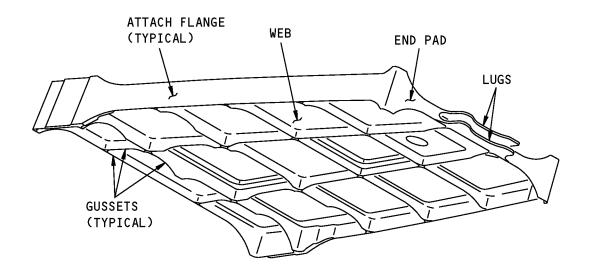
Vertical Stabilizer Hinge and Beam Support Fittings Figure 102 (Sheet 7 of 7)

HINGE FITTING AT RUDDER STATION 6.96

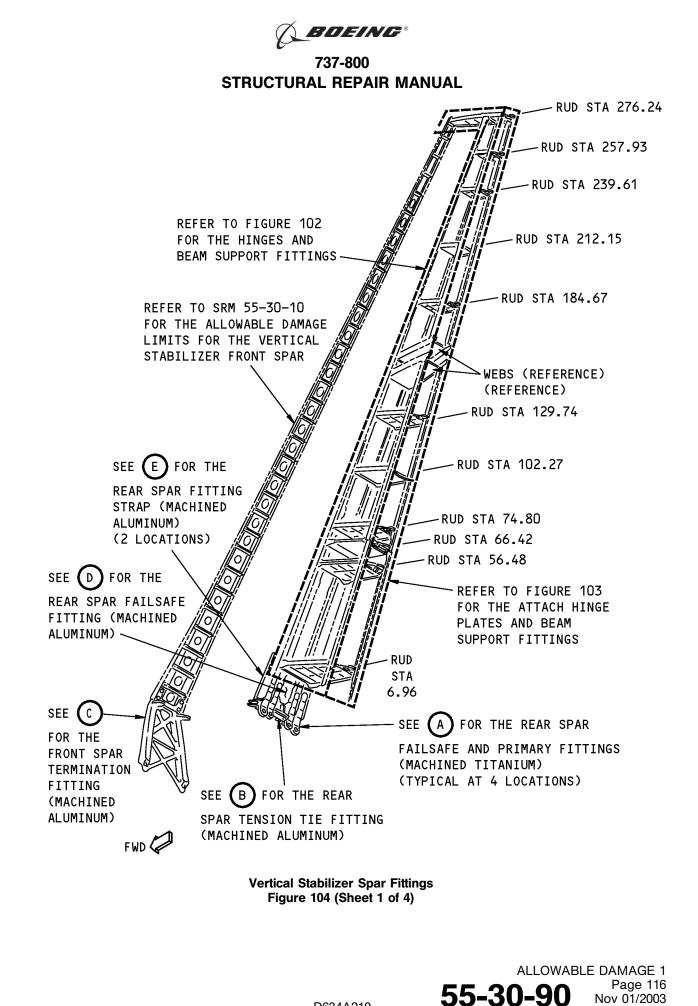
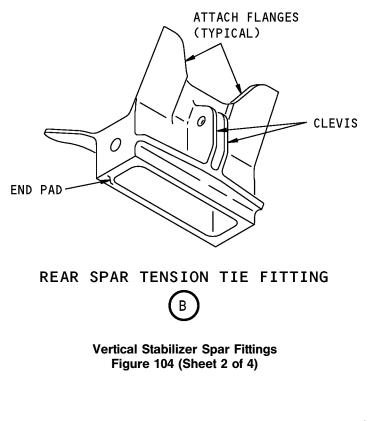
TYPICAL REAR SPAR TERMINAL, PRIMARY, AND FAILSAFE FITTING (A)

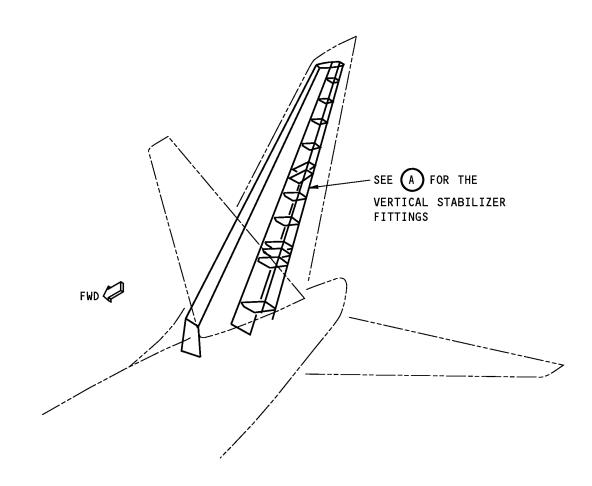
Vertical Stabilizer Fitting Repair Figure 201 (Sheet 1 of 2)

REPAIR GENERAL - VERTICAL STABILIZER HINGE FITTINGS

NOTE: THERE ARE NO REPAIRS FOR THESE PARTS IN THE STRUCTURAL REPAIR MANUAL AT THIS TIME.

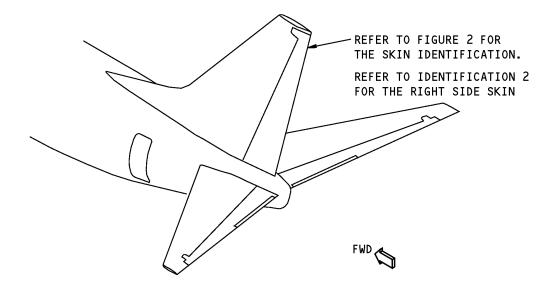
IDENTIFICATION 1 - RUDDER SKIN

LEFT SIDE IS SHOWN, RIGHT SIDE IS OPPOSITE

REFERENCE DRAWINGS		
DRAWING NUMBER	TITLE		
173A4300	Cover Panel Assembly - Rudder		
173A4301	Gap Cover Assembly - Balance Arm, Rudder		
173A5000	Balance Arm Installation - Rudder		
173A5001	Balance Arm Assembly - Rudder

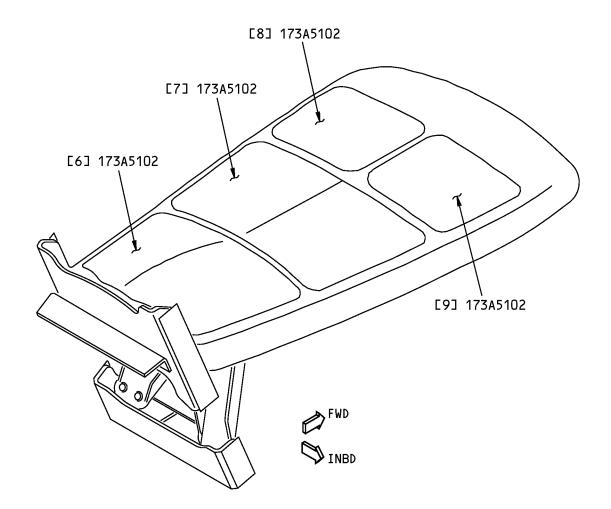
NOTE: REFER TO TABLE 2 FOR THE LIST OF MATERIALS.

LEFT SIDE BALANCE ARM IS SHOWN, RIGHT SIDE IS OPPOSITE (EXCEPT AS NOTED)

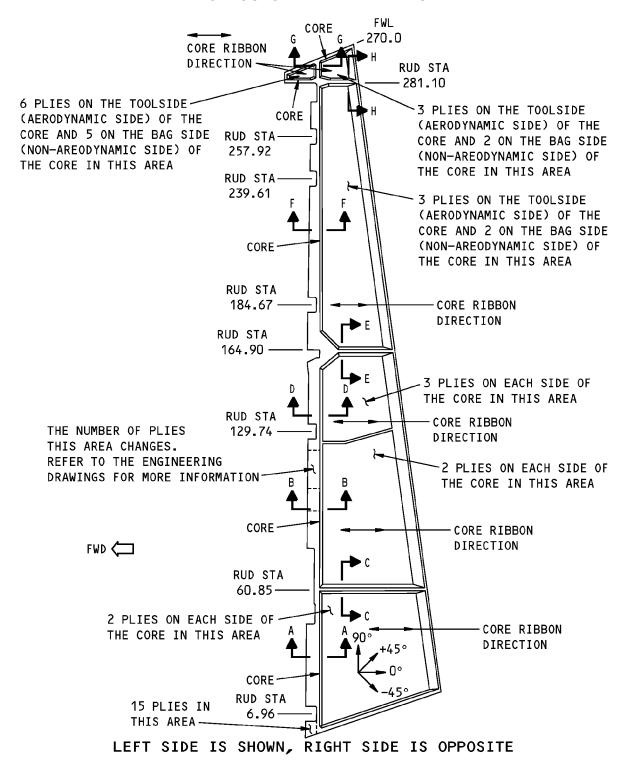
Ply Direction, Ply Sequence and Core Ribbon Direction for Figure 2, Item [1] Figure 3 (Sheet 1 of 4)

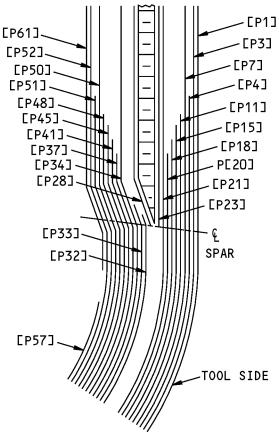
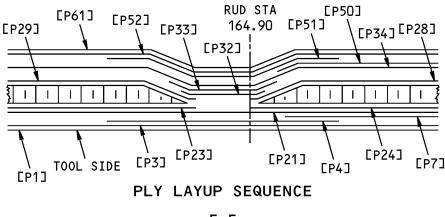
PLY LAYUP SEQUENCE

Ply Direction, Ply Sequence and Core Ribbon Direction for Figure 2, Item [1] Figure 3 (Sheet 3 of 4)

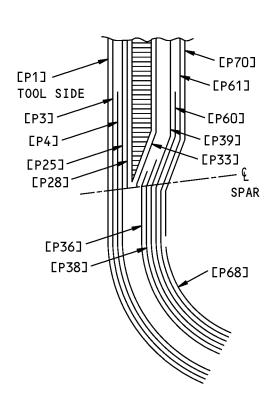
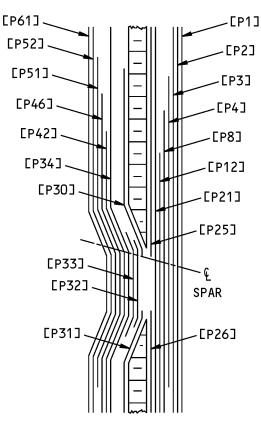
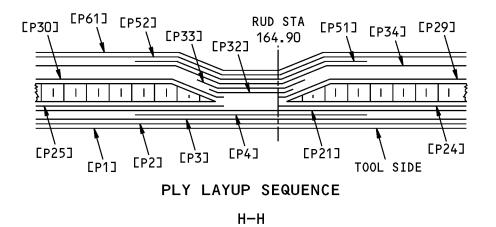
PLY LAYUP SEQUENCE

Ply Direction, Ply Sequence and Core Ribbon Direction for Figure 2, Item [1] Figure 3 (Sheet 4 of 4)

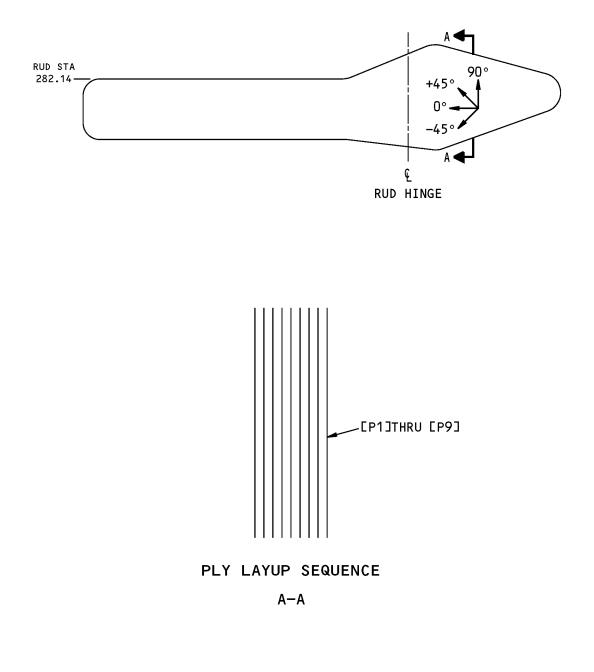
Ply Direction and Ply Sequence for Figure 2, Item [5] Figure 5

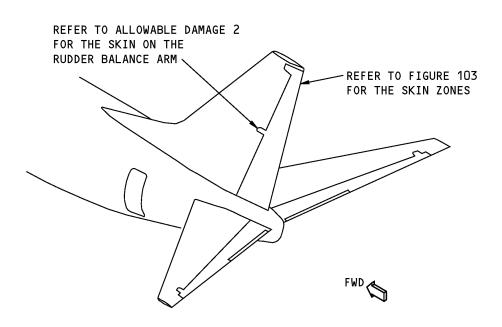
Rudder Skin Location Figure 101

A. Allowable Damage 1 gives the allowable damage limits for the Rudder Skin shown in Rudder Skin Location, Figure 101/ALLOWABLE DAMAGE 1.

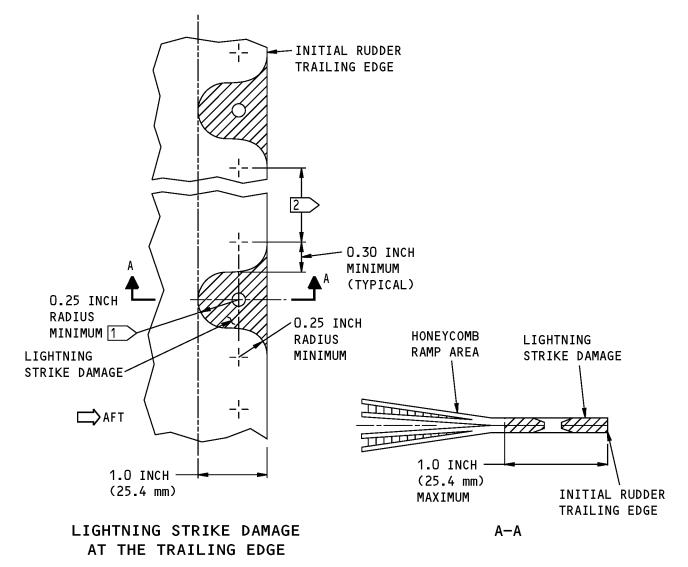
1 DAMAGE IS NOT PERMITTED INTO THE HONEYCOMB RAMP AREA.

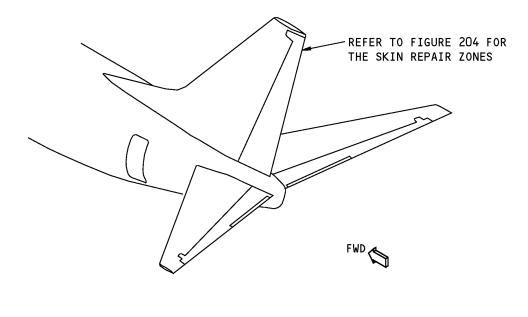
Rudder Skin Location Figure 201

- A. Repair 1 is applicable to the Rudder Skin panels as shown in Rudder Skin Location, Figure 201/REPAIR 1.
- B. Repair 1 is applicable to damage that is more than the limits permitted in Allowable Damage 1. Refer to Allowable Damage 1 for the type and size of damage that is permitted.

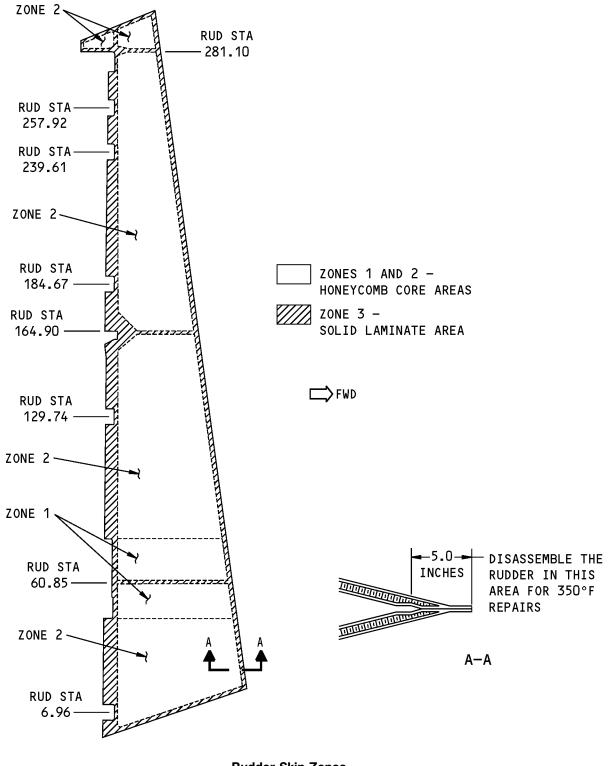
Rudder Skin Zones Figure 204

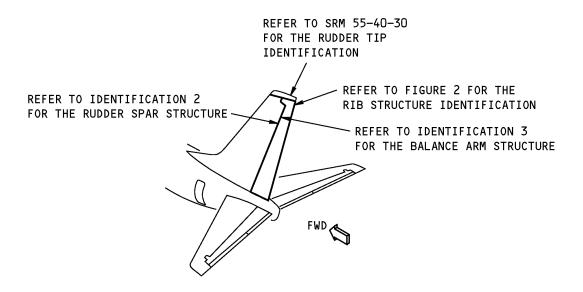
Rudder Structure Location Figure 1

-	Table 1:			
	REFERENCE DRAWINGS			
DRAWING NUMBER				
173A0100	Rudder Functional Product Collector			
173A0150	Centerline Diagram - Rudder			
173A1001	Rib Installation - Lower Closure, Rudder			
173A1002	Rib Installation - Main Actuator, Rudder			
173A1005	Rib Installation - Balance Arm, Rudder			
173A1006	Rib Installation - Forward Tip Balance, Rudder			
173A1007	Rib Installation - Aft Tip Balance, Rudder			
173A1008	Rib Installation - Upper Closure, Rudder

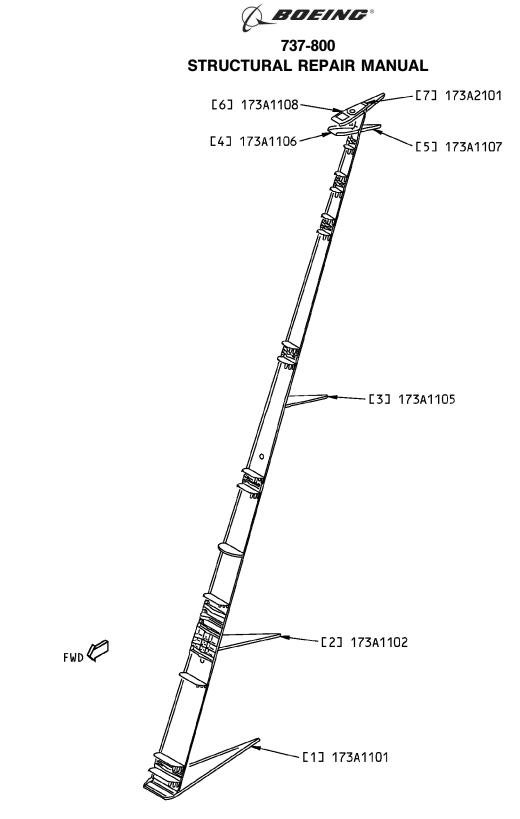
Rudder Rib Structure Identification Figure 2

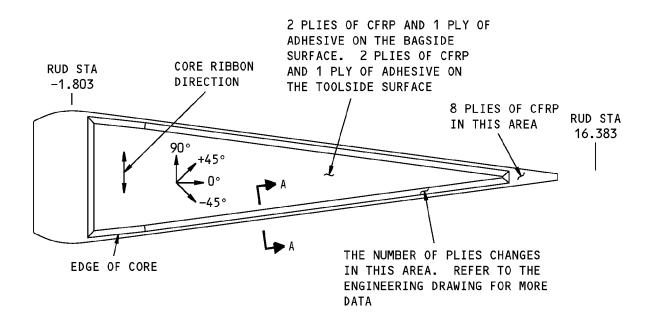
PLAN VIEW IS SHOWN VIEW IS ON THE BAGSIDE SURFACE PLY LAYUP DIRECTION AND CORE RIBBON DIRECTION А

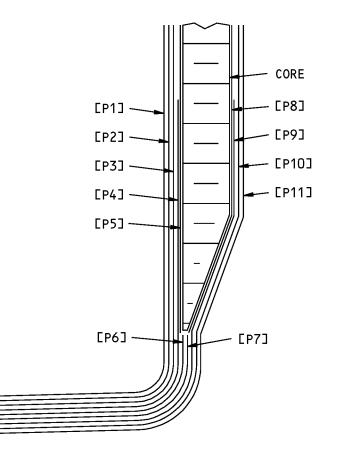
PLY LAYUP SEQUENCE A-A

Ply Direction, Core Ribbon Direction, and Ply Sequence for the Lower Closure Rib, Figure 2, Item [1] Figure 3 (Sheet 2 of 4)

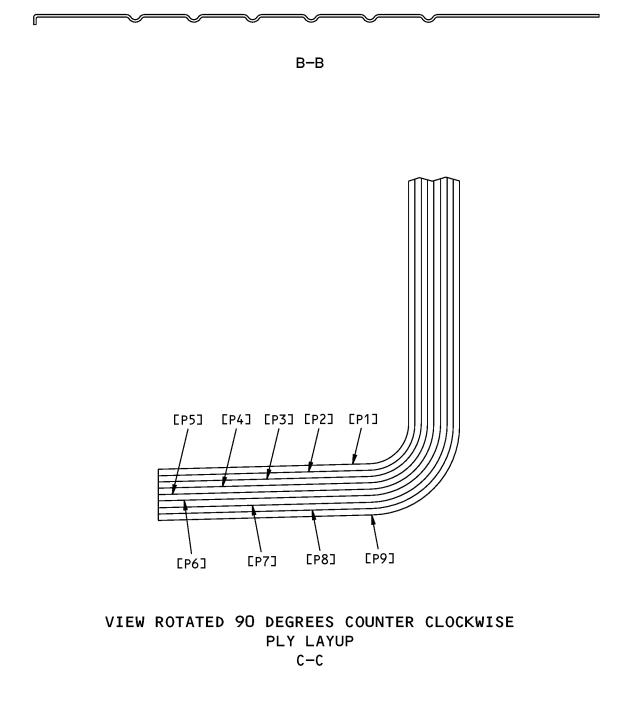
Ply Direction, Core Ribbon Direction, and Ply Sequence for the Lower Closure Rib, Figure 2, Item [1] Figure 3 (Sheet 4 of 4)

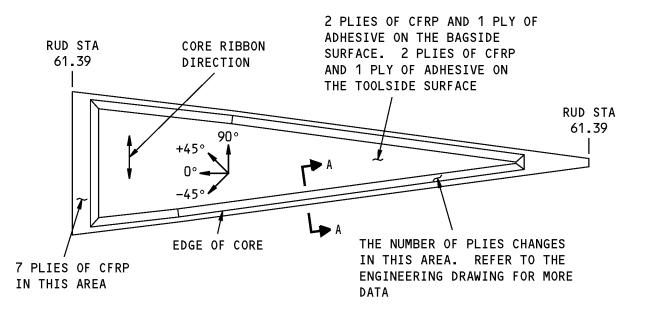
PLAN VIEW IS SHOWN VIEW IS ON THE BAGSIDE SURFACE PLY LAYUP DIRECTION AND CORE RIBBON DIRECTION

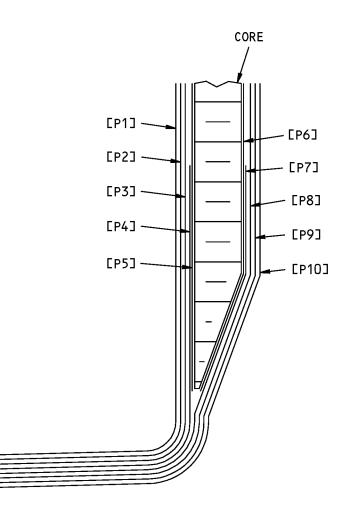
PLY LAYUP SEQUENCE A-A

Ply Direction, Core Ribbon Direction, and Ply Sequence for the Main Actuator Rib, Figure 2, Item [2] Figure 4 (Sheet 2 of 2)

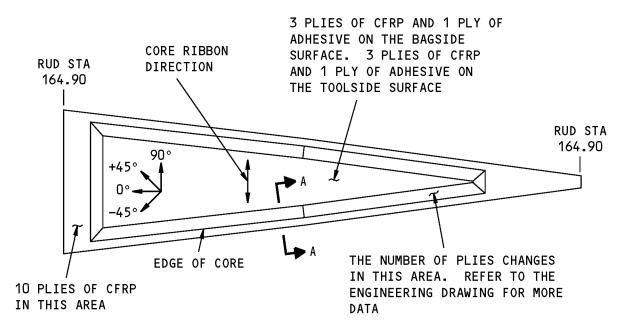
PLAN VIEW IS SHOWN VIEW IS ON THE BAGSIDE SURFACE PLY LAYUP DIRECTION AND CORE RIBBON DIRECTION

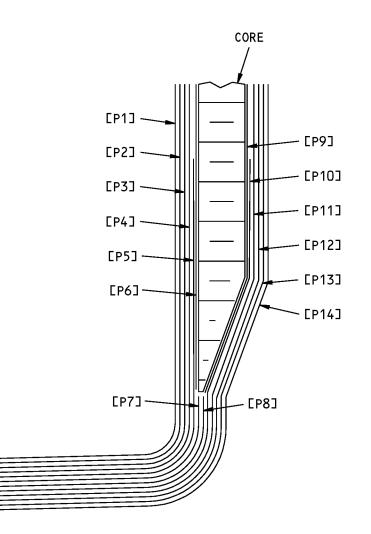
PLY LAYUP SEQUENCE A-A

Ply Direction, Core Ribbon Direction, and Ply Sequence for the Balance Arm Rib, Figure 2, Item [3] Figure 5 (Sheet 2 of 2)

PLY MATERIAL AND DIRECTION FOR FIGURE 5				
PLY	DIRECTION	MATERIAL		
P1, P14	Optional	1 mil white Tedlar as given in BAC 5317-4		
P2, P4, P7, P8, P11, P13	+ or - 45 degrees	CFRP woven fabric as given in BMS 8-256, Type IV, Class 2, Style 3K-70-PW		
P3, P5, P10, P12	0 or 90 degrees	CFRP woven fabric as given in BMS 8-256, Type IV, Class 2, Style 3K-70-PW		
P6, P9	Optional	Adhesive film as given in BMS 8-245, Type II, Class 1, Grade 03A

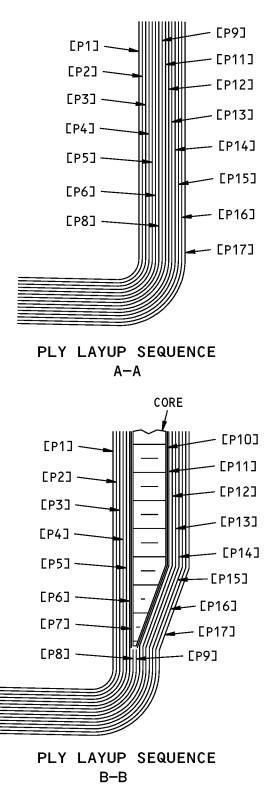
Ply Direction, Core Ribbon Direction, and Ply Sequence for the Forward Tip Balance Rib, Figure 2, Item [4] Figure 6 (Sheet 2 of 2)

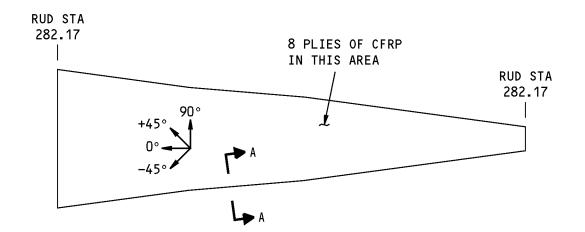
PLAN VIEW IS SHOWN VIEW IS ON THE BAGSIDE SURFACE PLY LAYUP DIRECTION А

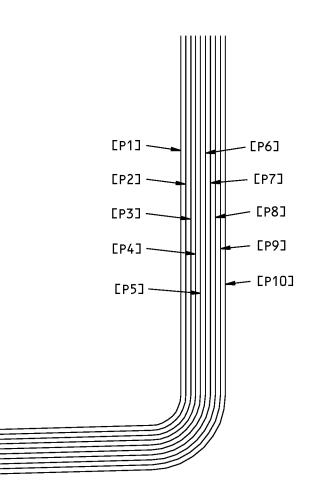
PLY LAYUP SEQUENCE A-A

Ply Direction, and Ply Sequence for the Aft Tip Balance Rib, Figure 2, Item [5] Figure 7 (Sheet 2 of 2)

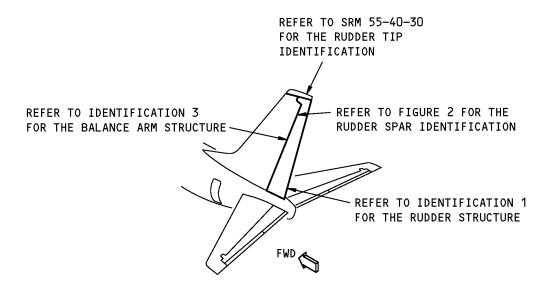
Rudder Spar Rib Structure Location Figure 1

NOTE: REFER TO TABLE 1 FOR THE REFERENCE DRAWINGS.

REFERENCE DRAWINGS			
DRAWING NUMBER	TITLE		
173A0100	Rudder Functional Product Collector		
173A0150	Centerline Diagram - Rudder		
173A2001	Spar Installation - Rudder

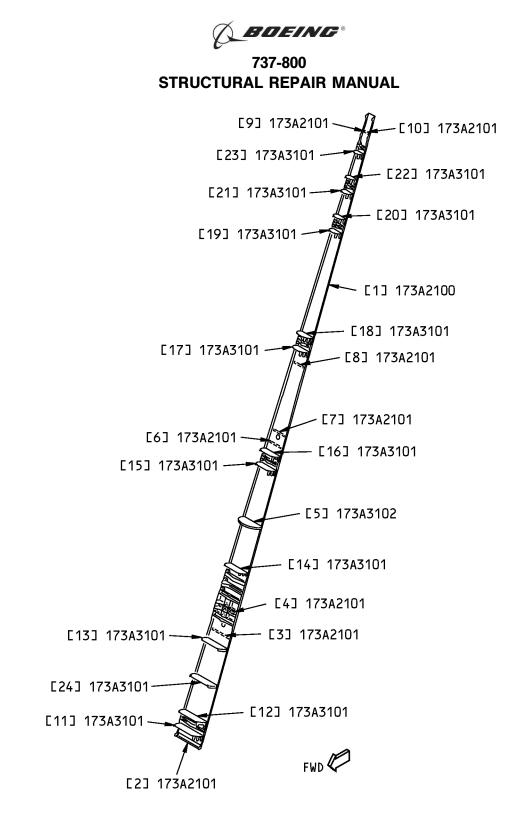
Rudder Spar Rib Structure Identification Figure 2

NOTE: REFER TO TABLE 2 FOR THE LIST OF MATERIALS.

[7]	Stiffener		CFRP woven fabric Refer to Figure 8		
[8]	Stiffener		CFRP woven fabric Refer to Figure 9		
[9]	Rib Post		CFRP woven fabric Refer to Figure 10		
[10]	Rib Post		CFRP woven fabric Refer to Figure 11		
[11]	Rib - RUD STA 4.50	0.040 (1.02)	2024-T42 clad sheet as given in QQ-A-250/5		
[12]	Rib - RUD STA 11.00	0.040 (1.02)	2024-T42 clad sheet as given in QQ-A-250/5	CUM LINE 001 THRU 120	
	Rib - RUD STA 11.00	0.063 (1.02)	2024-T42 clad sheet as given in QQ-A-250/5	CUM LINE 121 AND ON	
[13]	Rib - RUD STA 45.70	0.040 (1.02)	2024-T42 clad sheet as given in QQ-A-250/5	CUM LINE 001 THRU 120	
	Rib - RUD STA 45.70	0.063 (1.02)	2024-T42 clad sheet as given in QQ-A-250/5	CUM LINE 121 AND ON	
[14]	Rib - RUD STA 79.92	0.040 (1.02)	2024-T42 clad sheet as given in QQ-A-250/5		
[15]	Rib - RUD STA 127.30	0.040 (1.02)	2024-T42 clad sheet as given in QQ-A-250/5		
[16]	Rib - RUD STA 133.80	0.040 (1.02)	2024-T42 clad sheet as given in QQ-A-250/5

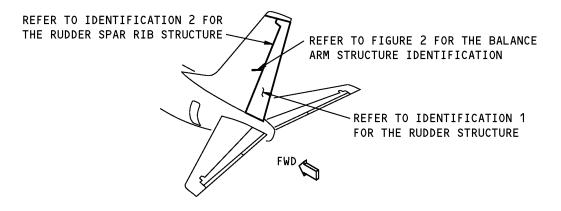
Balance Arm Structure Location Figure 1

NOTE: REFER TO TABLE 1 FOR THE REFERENCE DRAWINGS.

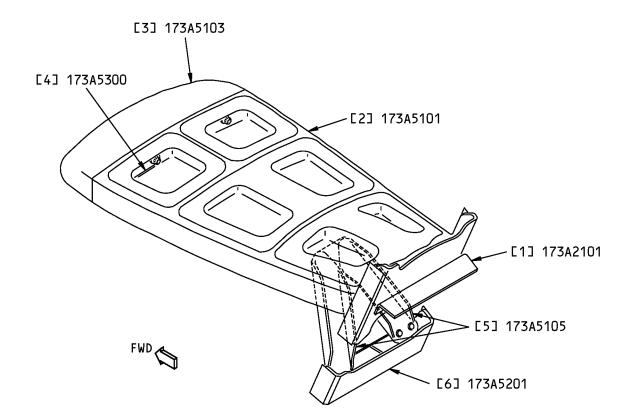
Balance Arm Structure Identification Figure 2

NOTE: REFER TO TABLE 2 FOR THE LIST OF MATERIALS.

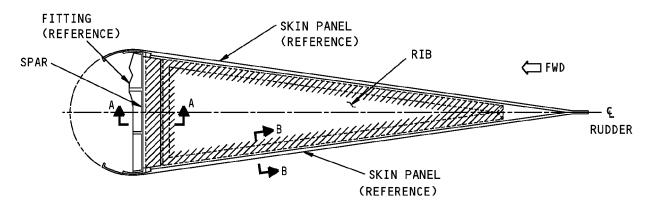
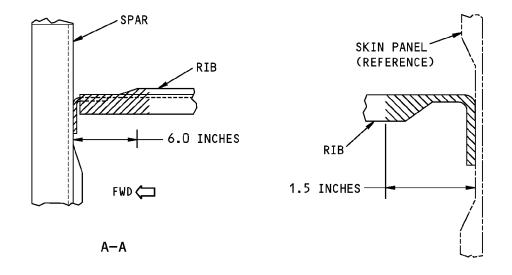
THE BALANCE ARM RIB IS SHOWN, THE OTHER RIBS ARE ALMOST THE SAME

- (1) For the honeycomb core areas, the tap test is an alternative procedure to an instrumented NDT.
- (2) Refer to Definitions of Damage Size, Figure 102/ALLOWABLE DAMAGE 1, Details A, B, and C for the definitions of the length, width, and depth of the damage.

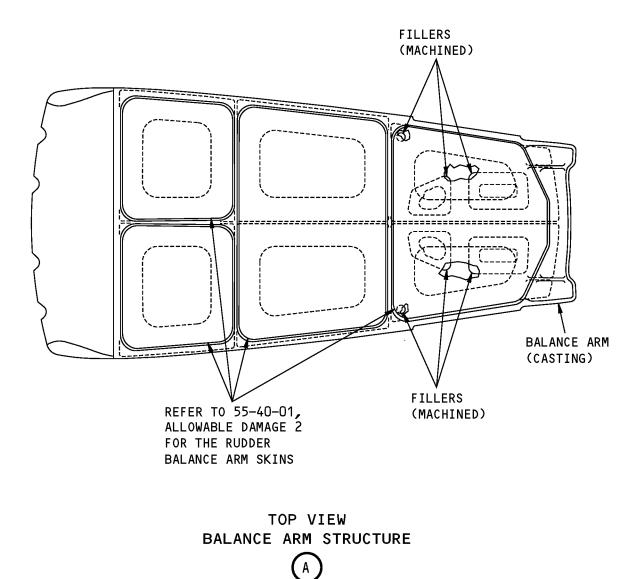
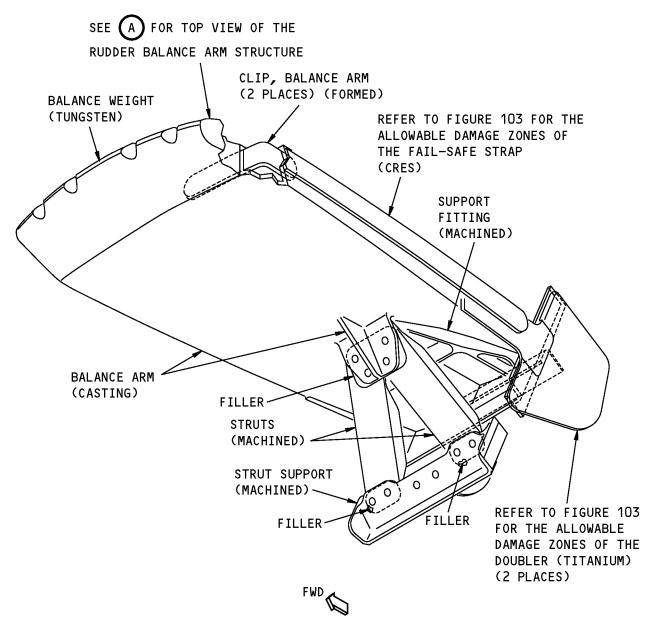
Rudder Balance Arm Figure 102 (Sheet 2 of 2)

• ALL PARTS ARE MADE OF ALUMINUM UNLESS OTHERWISE NOTED.

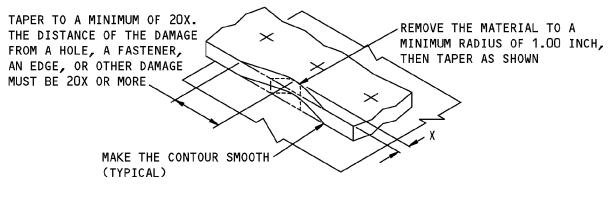
REMOVAL OF DAMAGED MATERIAL FROM THE FAIL-SAFE STRAP

X = DEPTH OF THE MATERIAL THAT IS REMOVED (REFER TO FIGURE 103 ON PAGE 106)

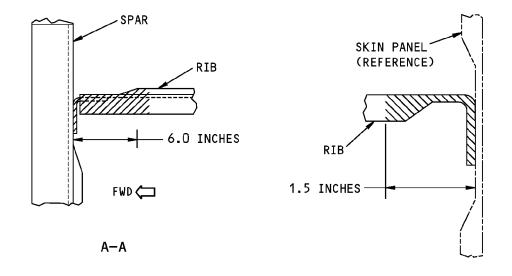
B-B

THE BALANCE ARM RIB IS SHOWN, THE OTHER RIBS ARE ALMOST THE SAME

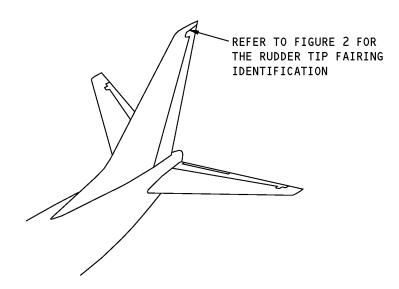
Rudder Tip Fairing Skin Location Figure 1

IDENTIFICATION 1 - RUDDER TIP FAIRING SKINS

NOTE: REFER TO TABLE 1 FOR THE REFERENCE DRAWINGS.

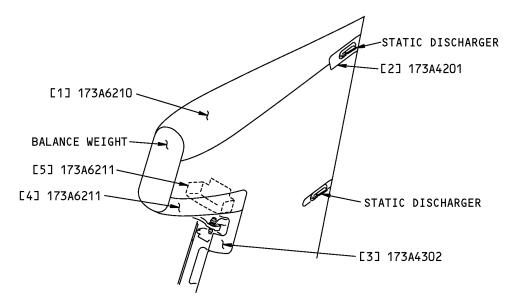
Rudder Tip Fairing Skin Identification Figure 2

NOTE: REFER TO TABLE 2 FOR THE LIST OF MATERIALS. LEFT SIDE IS SHOWN, RIGHT SIDE IS OPPOSITE

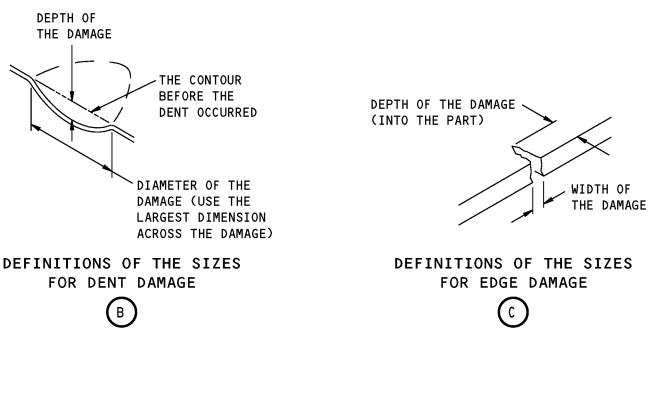
Damage Definitions Figure 102

DEFINITIONS OF THE SIZES FOR NICK, GOUGE, AND SCRATCH DAMAGE

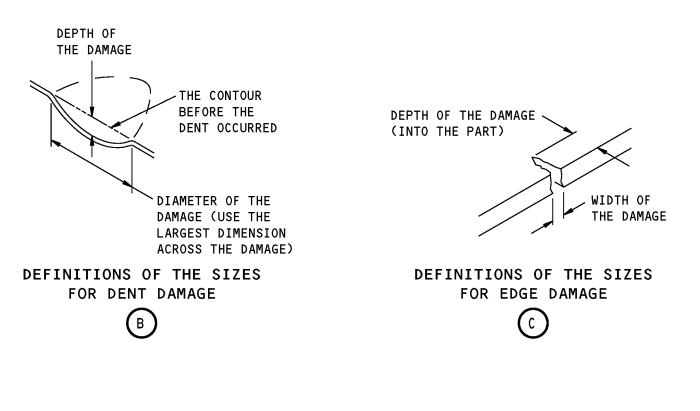
Damage Definitions Figure 202

DEFINITIONS OF THE SIZES FOR NICK, GOUGE, AND SCRATCH DAMAGE

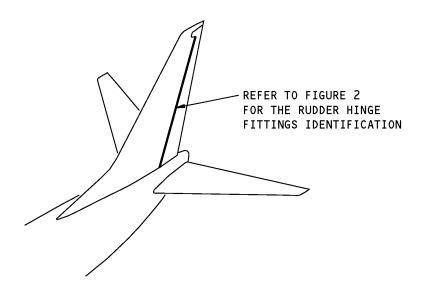
Rudder Hinge Fittings Location Figure 1

IDENTIFICATION 1 - RUDDER HINGE FITTINGS

NOTE: REFER TO TABLE 1 FOR THE REFERENCE DRAWINGS.

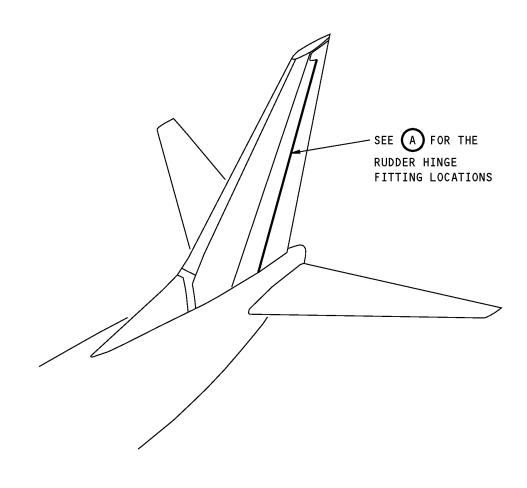
Rudder Hinge Fitting Repair Figure 201 (Sheet 1 of 2)

REPAIR 1 - RUDDER HINGE FITTINGS
