Aerolineas Argentinas

CHAPTER 56
EFFECTIVE PAGES
PAGE 1
CONTINUED

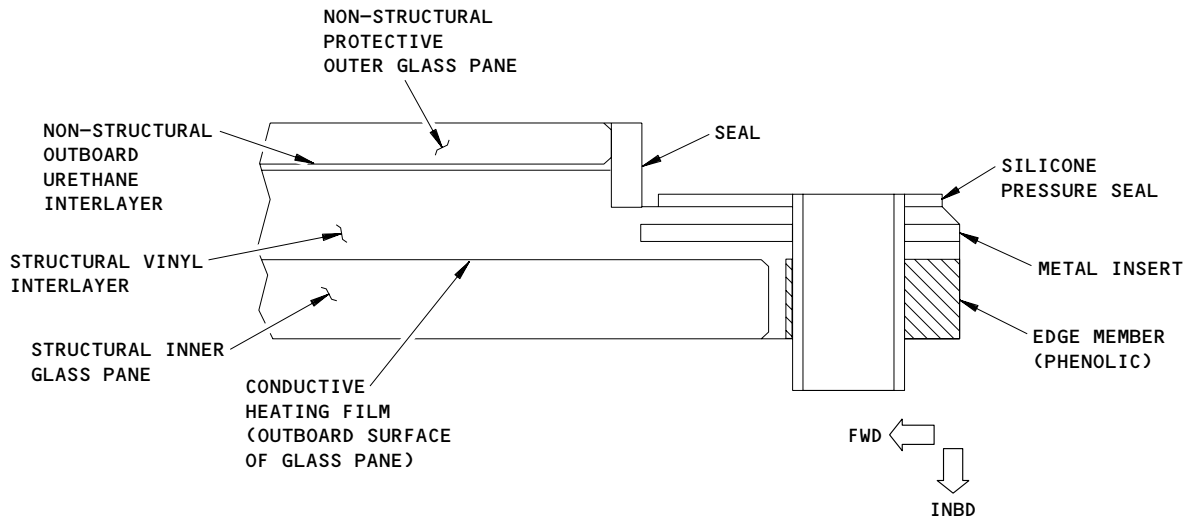
WINDOW NO. 5
A-A

Windows - Control Cabin Fixed Window - No. 5
Figure 604

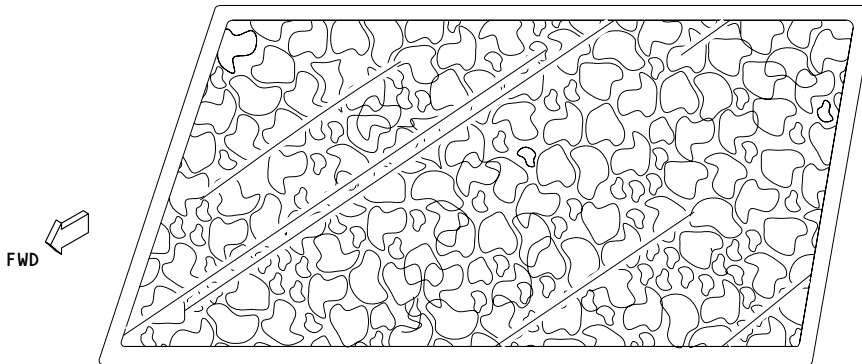
GLASS PANE CRACKS
 WINDOW NO. 1

GLASS PANE CRACKS
 (NON-STRUCTURAL)

GLASS PANE CRACKS
 (STRUCTURAL)

- a) **Non-Structural Pane:** Cracks will look equivalent to smooth fissures perpendicular to the surface and through the entire thickness of the pane. There are usually many cracks across the glass surface (spider web pattern) of the pane. Cracks will not significantly decrease visual quality. (Example: Fig 604).

- b) **Structural Pane:** The pane will break into many small irregularly shaped pieces, typically no larger than 0.5 in. (12.7 mm) maximum dimension. Visual quality is significantly decreased. (Example: Fig 604).

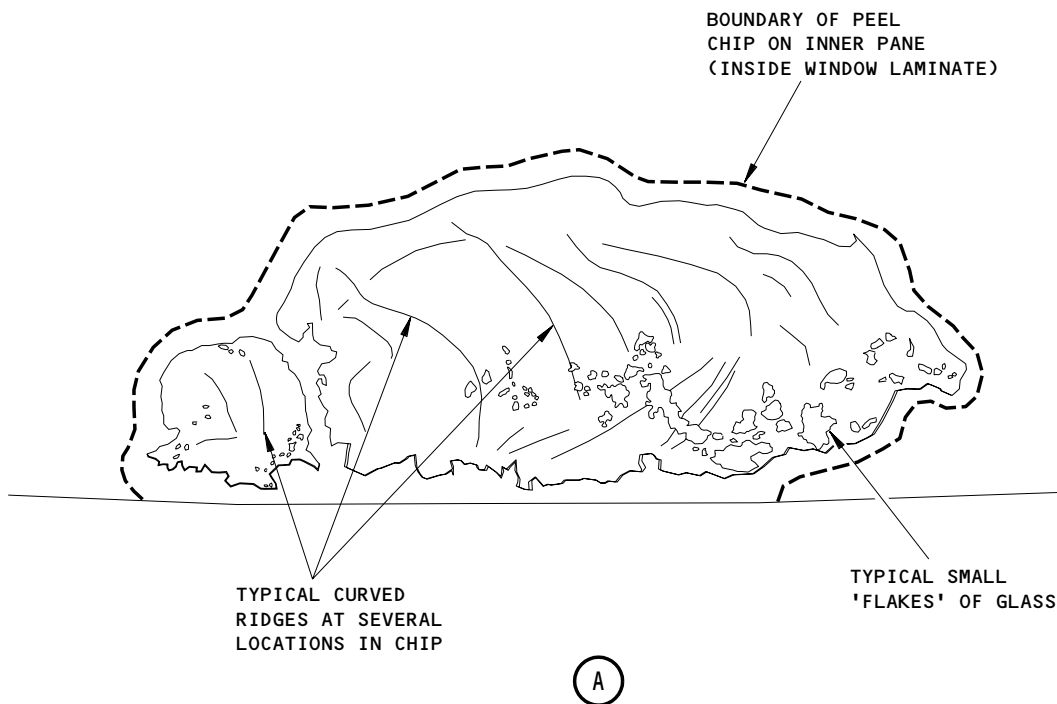
(TYPICAL)

Peel Chips
 Figure 609

- b) "V" shaped chips have the shape of a sharp narrow "V". Depth of the chip is equal to or larger than the width.
 - 2) Internal chips:
 - a) Peel Chips: Chips that occur on the internal surface of glass panes. Chipped areas have a curved, rough grained shape, and are easily seen in reflected light. The chipped area can have small glass flakes, usually white. The view through the window will distort through the rough surface of the chip. Usually the chips start very small but can continue to grow with the continued use of the airplane. (Example: Figure 609)

- (1) Examine the window for chips in the structural inner glass pane (Fig 609).

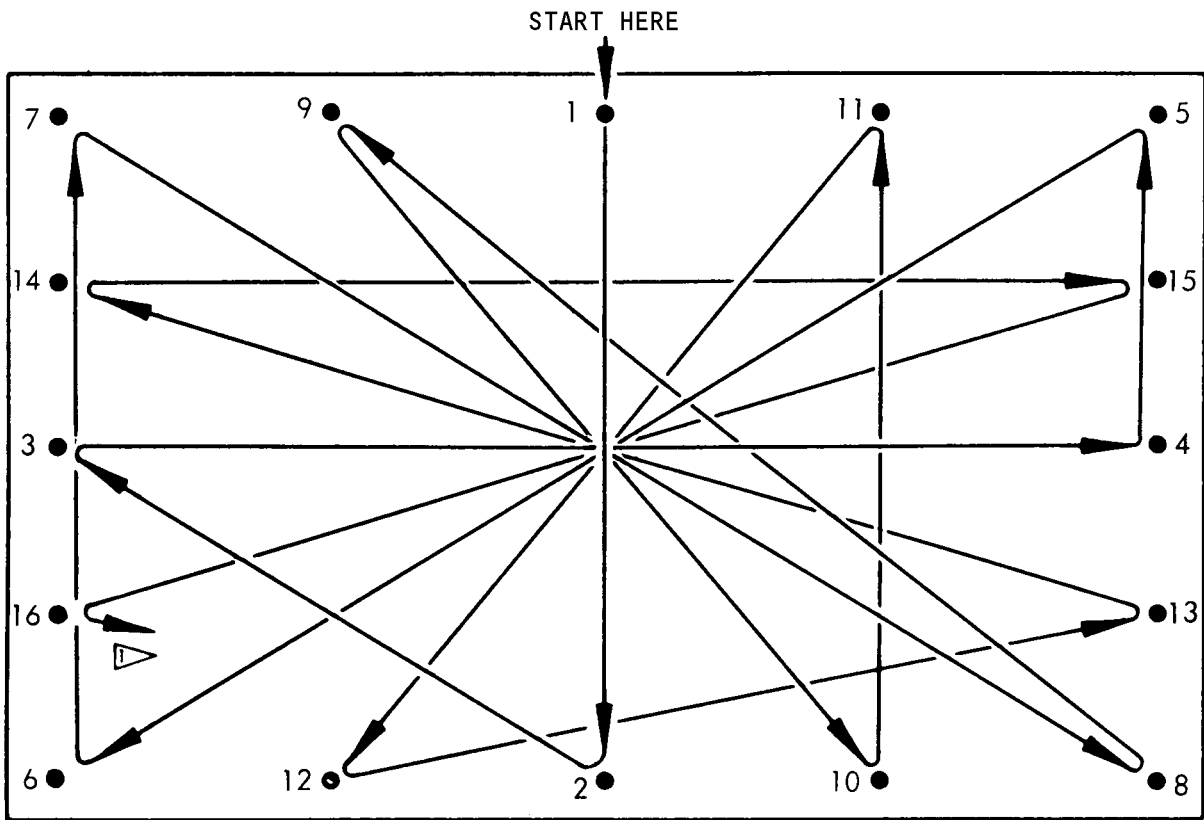
Pattern for Typical Window Fastener Installation
 Figure 405

CONTINUE IN THIS MANNER, ALWAYS PROCEEDING TO A FASTENER WHICH IS MIDWAY BETWEEN TWO INSTALLED FASTENERS AND ON A SIDE OTHER THAN THAT IN WHICH THE LAST ONE WAS INSTALLED.

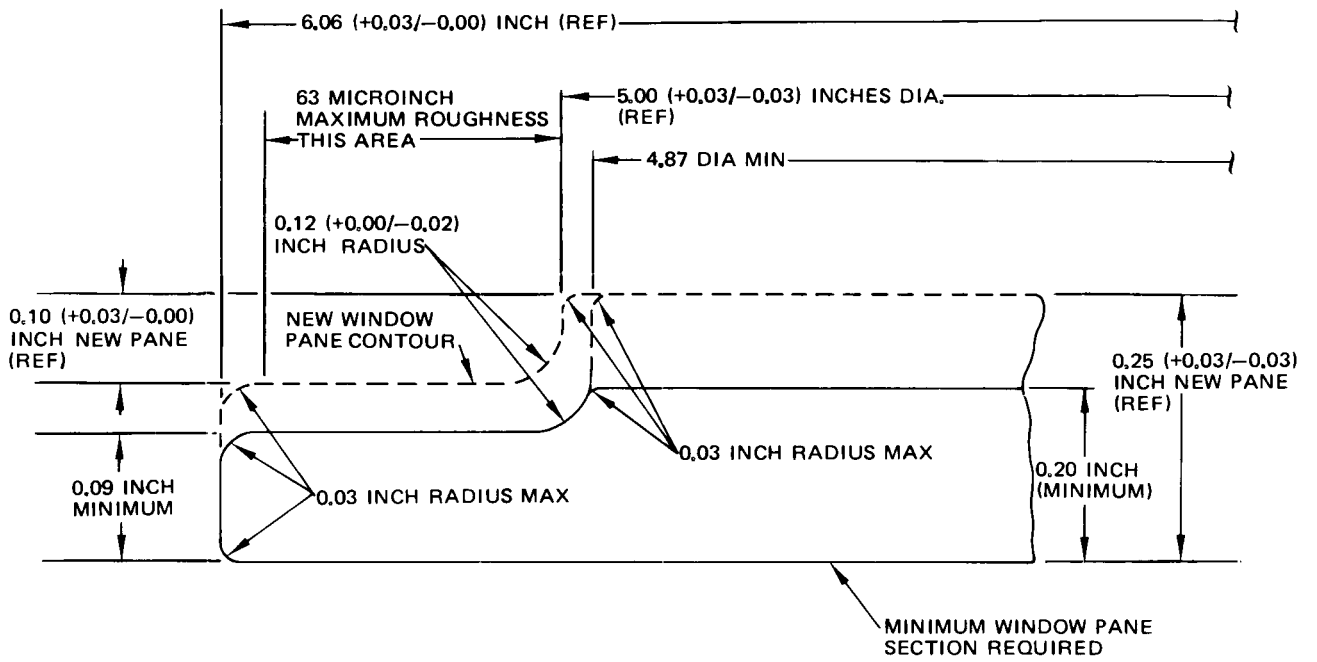
Entry and Galley Service Window Outer
 Figure 801

- F. Sandpaper
 - (1) Carborundum Wet-and-Dry paper - 400A and 600A grit
 - 3. Repair Outer Windowpane
 - A. Rework limits on outer panes should be limited to the minimum thicknesses after rework as shown of Fig. 801.
