# **CHAPTER**

# 52

**DOORS**

### CHAPTER 52 DOORS

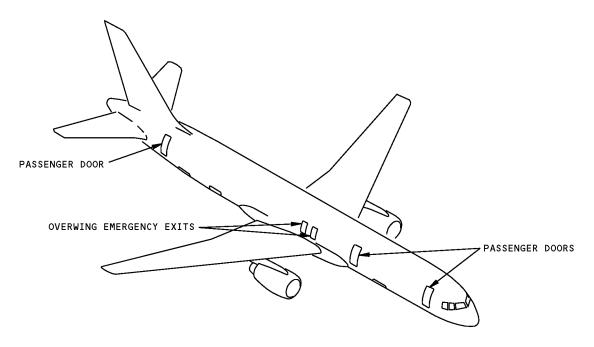
RIGHT SIDE SHOWN, LEFT SIDE OPPOSITE
BASIC CONFIGURATION - OVERWING EMERGENCY EXITS

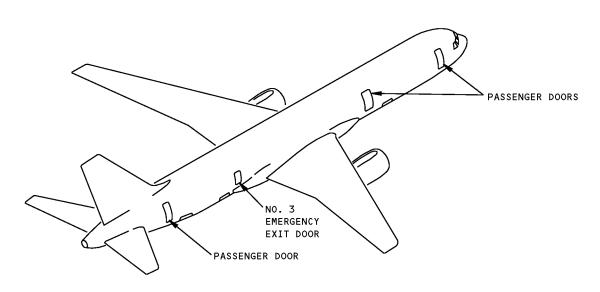
Door Location Diagram Figure 1 (Sheet 2 of 2)

RIGHT SIDE SHOWN, LEFT SIDE OPPOSITE BASIC CONFIGURATION - FOUR DOOR

A. Refer to Figure 1/GENERAL for the door locations.

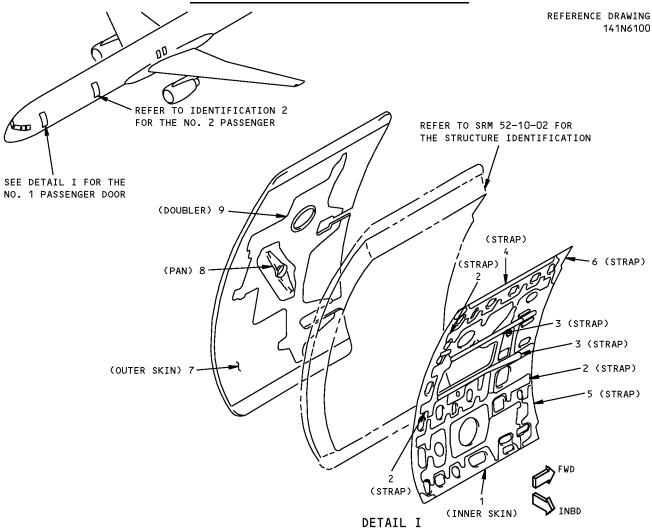
### **IDENTIFICATION 1 - NO. 1 ENTRY DOOR SKIN**

ITEM	DESCRIPTION	GAGE	MATERIAL	EFFECTIVITY
1	INNER SKIN	0.050	CLAD 7075-T6	
2	STRAP	0.071	7075 <b>-</b> T6	
3	STRAP	0.050	CLAD 7075-T6	
4	STRAP	0.160	7075-T6	
5	STRAP	0.100	7075-T6, OPTIONAL: TI-6AL-4V	
6	STRAP	0.080	7075-T6	
7	OUTER SKIN	0.063	CLAD 2024-T3 (CHEM-MILLED TO 0.040 MIN)	
8	PAN	0.071	2024-T42	
9	DOUBLER	0.071	2024-T3

LIST OF MATERIALS FOR DETAIL I

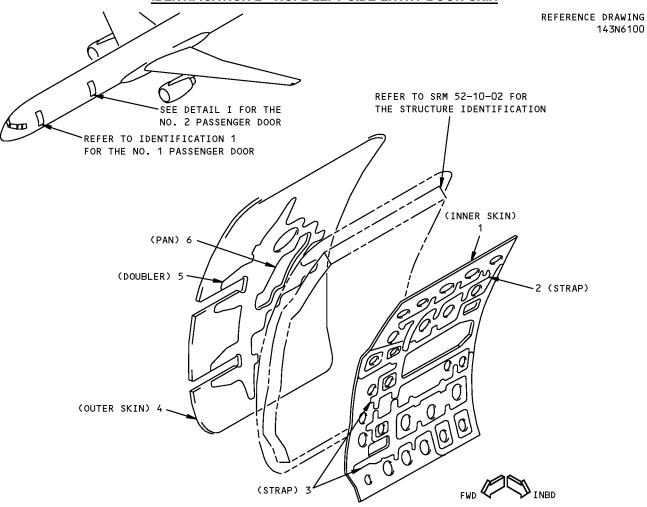
### **IDENTIFICATION 2 - NO. 2 LEFT SIDE ENTRY DOOR SKIN**

ITEM	DESCRIPTION	GAGE	MATERIAL	EFFECTIVITY
1	INNER SKIN	0.050	CLAD 7075-T6	
2	STRAP	0.100	7075-T6	
3	STRAP	1.071	7075 <b>-</b> T6	
4	OUTER SKIN	0.063	CLAD 2024-T3 (CHEM-MILLED TO 0.040 MIN)	
5	DOUBLER	0.071	2024-T3	
6	PAN	0.063	2024-T42

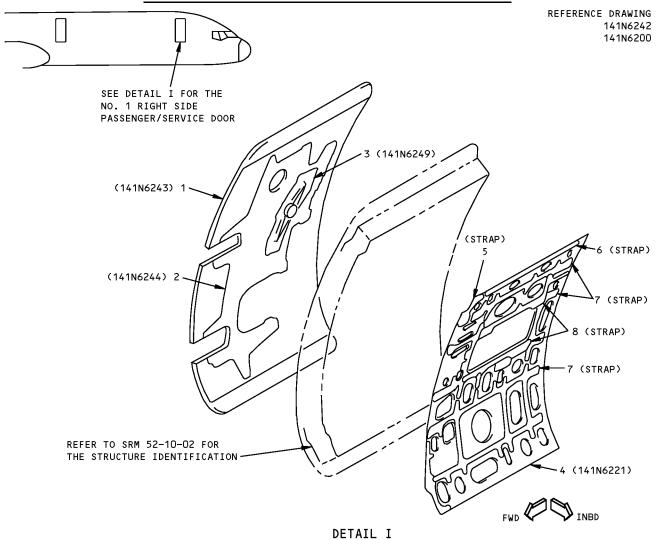
### **IDENTIFICATION 3 - NO. 1 RIGHT SIDE SERVICE DOOR SKIN**

ITEM	DESCRIPTION	GAGE	MATERIAL	EFFECTIVITY
1	OUTER SKIN	0.063	CLAD 2024-T3 (CHEM-MILLED TO 0.040 MIN)	
2	DOUBLER	0.071	2024-T3	
3	PAN	0.071	2024-T42	
4	INNER SKIN	0.050	CLAD 7075-T6	
5	STRAP	0.100	7075-T6	
6	STRAP	0.125	7075-T6	
7	STRAP	0.071	7075-T6	
8	STRAP	0.050	CLAD 7075-T6

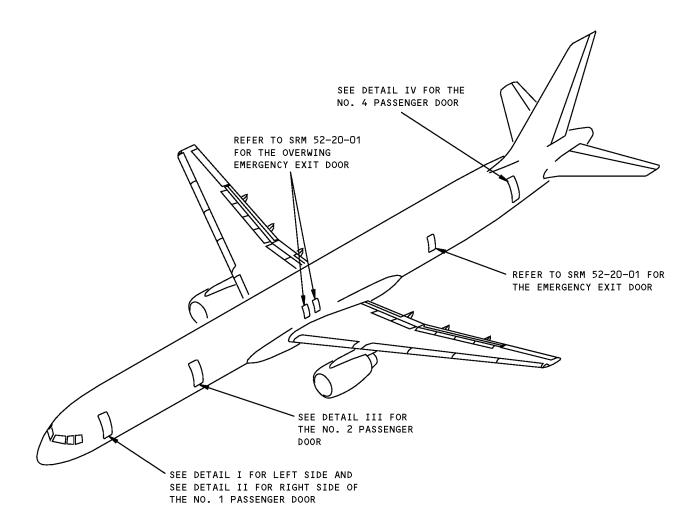
Entry Door Skin Allowable Damage Figure 101 (Sheet 1 of 7)

### **ALLOWABLE DAMAGE 1 - ENTRY DOOR SKIN**

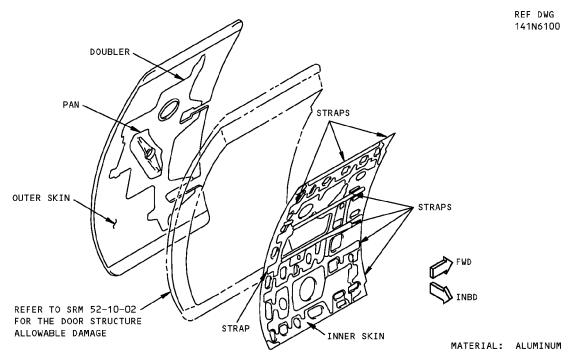
NO. 1 LEFT SIDE PASSENGER DOOR DETAIL I

ALLOWABLE DAMAGE FOR DETAILS I, II, III AND IV

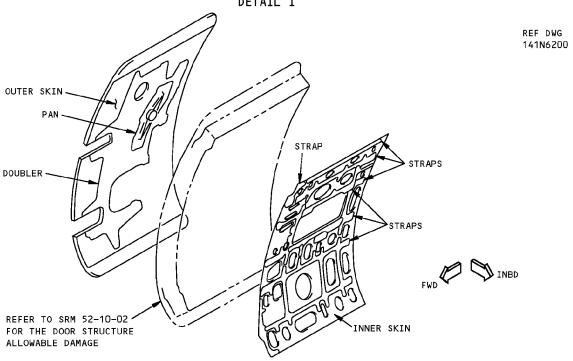
Entry Door Skin Allowable Damage Figure 101 (Sheet 2 of 7)

NO. 1 RIGHT SIDE PASSENGER DOOR DETAIL II

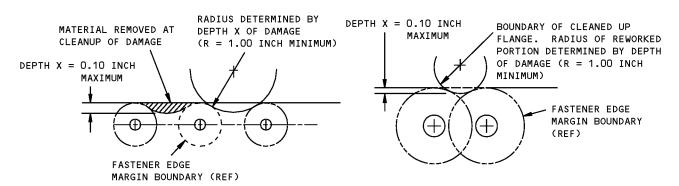
### DETAIL V

DAMAGE CLEAN UP OF EDGES WHERE FASTENER EDGE MARGINS DO NOT OVERLAP

DAMAGE CLEAN UP OF EDGES WHERE FASTENER EDGE MARGINS OVERLAP

- REFINISH REWORKED AREAS AS SHOWN IN AMM 51-20.
- REFER TO SRM 51-10-02 FOR INSPECTION AND REMOVAL OF DAMAGE.
- A REFER TO SRM 51-10-01 FOR AERODYNAMIC SMOOTHNESS REQUIREMENTS. WHERE THE DAMAGE IS MORE THAN THE LIMITS SHOWN IN SRM 51-10-01, CONSIDERATION SHOULD BE GIVEN TO THE LOSS OF PERFORMANCE INVOLVED.
- B CRACKS ARE NOT PERMITTED EXCEPT FOR EDGE CRACKS WHICH MUST BE REMOVED AS SHOWN IN DETAILS V AND IX.
- FOR EDGE CRACKS SEE DETAIL V. FOR OTHERS SEE DETAIL X. FOR LIGHTENING HOLE EDGE CRACKS SEE DETAIL XI.
- D REMOVE DAMAGE AS SHOWN IN DETAILS V, VI, VIII AND IX.
- E CLEAN OUT DAMAGE UP TO 0.25 INCH (6 mm)

- F CLEAN OUT DAMAGE UP TO 0.25 INCH (6 mm)
  MAXIMUM DIAMETER AND NOT CLOSER THAN
  1.0 INCH (25 mm) TO FASTENER HOLE, MATERIAL
  EDGE, OR OTHER DAMAGE.
- G REMOVE DAMAGE AS SHOWN IN DETAILS V, VI, VIII AND IX. CORROSION MAY BE DRILLED OUT UP TO 0.5 INCH (13 mm) MAXIMUM DIAMETER PROVIDED EDGE MARGINS ARE MAINTAINED AS SHOWN IN DETAIL X.
- H 1.50 INCH (38 mm) MINIMUM TO EDGE OF INITIAL FASTENER HOLE, TO EDGE OF FLANGED HOLE OR TO EDGE OF CUTOUT.
- REMOVE EDGE DAMAGE AS SHOWN IN DETAILS V AND IX. REMOVE CORROSION AROUND FASTENERS AS SHOWN IN DETAIL VIII. REMOVE SURFACE DAMAGE AS SHOWN IN DETAIL XII.

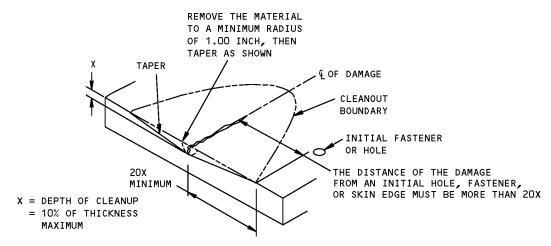
# REMOVAL OF NICK, GOUGE, CORROSION, AND SCRATCH DAMAGE ON A SURFACE DETAIL VI

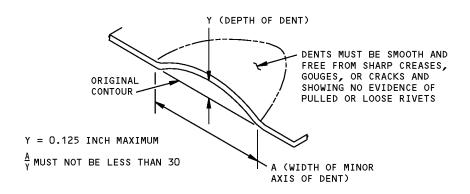
ALLOWABLE DAMAGE FOR DENT DETAIL VII

- REFER TO ALLOWABLE DAMAGE 2 FOR THE PASSENGER/CREW ENTRY DOOR SKIN OPERATING LIMITS AFTER DAMAGE HAS BEEN REMOVED.
- L DENTS THAT ARE MORE THAN THE LIMITS SHOWN IN DETAIL VII SHOULD BE PERMANENTLY REPAIRED. HOWEVER, A REPAIR CAN BE DELAYED IF THE CONDITIONS THAT FOLLOW ARE MET:
  - DENTS MUST BE SMOOTH AND FREE FROM SHARP CREASES, GOUGES, OR CRACKS, AND SHOW NO EVIDENCE OF PULLED, LOOSE, OR MISSING FASTENERS
  - THERE ARE NO DAMAGED OR ELONGATED FASTENER HOLES
  - THE DENT IS NOT FILLED
  - AN EXAMINATION OF THE DENT IS MADE EVERY 300 FLIGHT CYCLES
  - A PERMANENT REPAIR IS MADE AT THE SUBSEQUENT C-CHECK OR BEFORE 24 MONTHS
  - THE DAMAGE IS A MINIMUM OF 0.5 INCH (13 mm) FROM ANY PART OF A BEAM, SKIN DOUBLER, STRAP, FRAME, INTERCOSTAL, OR STIFFENER
  - THE DAMAGE IS A MINIMUM OF 10.0 INCHES (250 mm) FROM A SKIN SPLICE OR CUTOUT, INCLUDING A HINGE CUTOUT OR A HANDLE PAN CUTOUT.

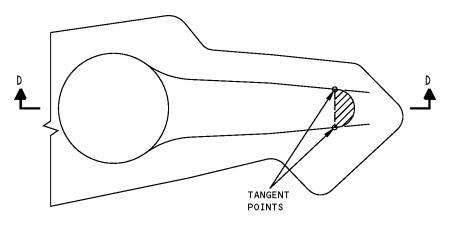
### REPAIR ZONES FOR HANDLE PAN DETAIL XII

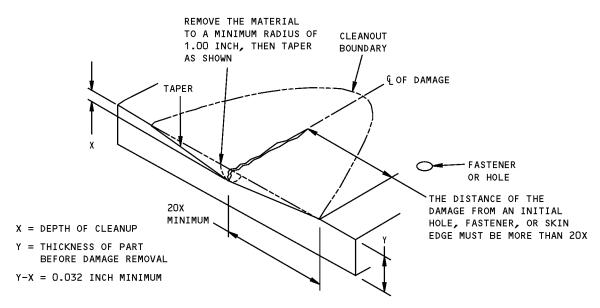
Entry Door Skin Allowable Damage Figure 101 (Sheet 7 of 7)

REMOVAL OF NICK, GOUGE, CORROSION, AND SCRATCH DAMAGE ON A SURFACE DETAIL XIII

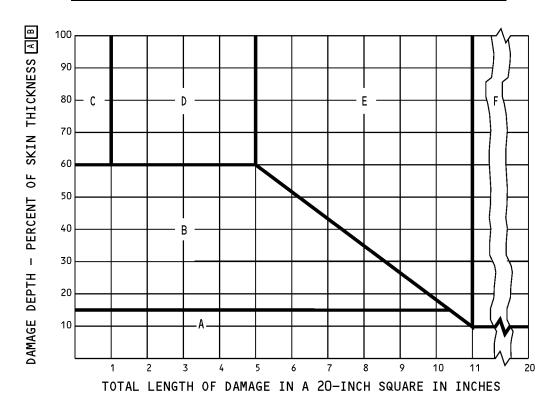
### ALLOWABLE DAMAGE 2 - OPERATING LIMITS FOR ENTRY DOOR SKIN

- A SKIN THICKNESS DOES NOT INCLUDE THE THICKNESS OF THE DOUBLERS, TRIPLERS, OR STRAPS.
- B DAMAGE INCLUDES HOLES, PUNCTURES, NICKS, GOUGES, SCRATCHES, CORROSION AND CRACKS.

DAMAGE DOES NOT INCLUDE DENTS.
- C CABIN PRESSURE LIMITS ARE FOR SKIN DAMAGE TO THE PRESSURIZED FUSELAGE SKIN ONLY.

CHART AREA	DAMAGE TREATMENT	ALLOWABLE AIRPLANE OPERATIONS		
A	CLEAN UP AS SHOWN IN ALLOWABLE DAMAGE 1.	NO FLIGHT RESTRICTIONS.		
В	CLEAN UP AS SHOWN IN ALLOWABLE DAMAGE 1 TO DAMAGE DEPTH.	LIMITED TO 50 HOURS OF FLIGHT OR 25 FLIGHTS WHICHEVER COMES FIRST (INCLUDING REVENUE FLIGHTS).		
	DO AN APPLICABLE REPAIR AS GIVEN IN SRM 52-10-01.	REFER TO THE APPLICABLE REPAIR FOR THE LIMITS.		
С	CLEAN UP AS SHOWN IN ALLOWABLE DAMAGE 1 TO DAMAGE DEPTH. STOP DRILL 0.25 INCH (6 mm) DIAMETER HOLES AT THE ENDS OF THE CRACKS.	A NON-REVENUE FLIGHT TO A REPAIR STATION IS PERMITTED IF THE APPLICABLE REGULATORY AUTHORITY GIVES APPROVAL BEFORE THE FLIGHT. IT IS RECOMMENDED THAT THE PROPOSED REPAIR PROCEDURE BE GIVEN TO BOEING.		
		THE MAXIMUM CABIN PRESSURE DIFFERENTIAL C IS LIMITED TO 6.0 PSIG UNLESS THE SKIN IS REPAIRED.		
	DO AN APPLICABLE REPAIR AS GIVEN IN SRM 52-10-01.	REFER TO THE APPLICABLE REPAIR FOR THE LIMITS.

D	CLEAN UP AS SHOWN IN ALLOWABLE DAMAGE 1 TO DAMAGE DEPTH. STOP DRILL 0.25 INCH (6 mm) DIAMETER HOLES AT THE ENDS OF THE CRACKS.	A NON-REVENUE FLIGHT TO A REPAIR STATION IS PERMITTED IF THE APPLICABLE REGULATORY AUTHORITY GIVES APPROVAL BEFORE THE FLIGHT. IT IS RECOMMENDED THAT THE PROPOSED REPAIR PROCEDURE BE GIVEN TO BOEING.		
		THE MAXIMUM CABIN PRESSURE DIFFERENTIAL C IS LIMITED TO 6.0 PSIG UNLESS THE SKIN IS REPAIRED.		
	DO AN APPLICABLE REPAIR AS GIVEN IN SRM 52-10-01.	REFER TO THE APPLICABLE REPAIR FOR THE LIMITS.		
E	CLEAN UP AS SHOWN IN ALLOWABLE DAMAGE 1 TO DAMAGE DEPTH. STOP DRILL 0.25 INCH (6 mm) DIAMETER HOLES AT THE ENDS OF THE CRACKS.	A NON-REVENUE FLIGHT TO A REPAIR STATION IS PERMITTED IF THE APPLICABLE REGULATORY AUTHORITY GIVES APPROVAL BEFORE THE FLIGHT. IT IS RECOMMENDED THAT THE PROPOSED REPAIR PROCEDURE BE GIVEN TO BOEING.		
		THE MAXIMUM CABIN PRESSURE DIFFERENTIAL C IS LIMITED TO ZERO PSIG.

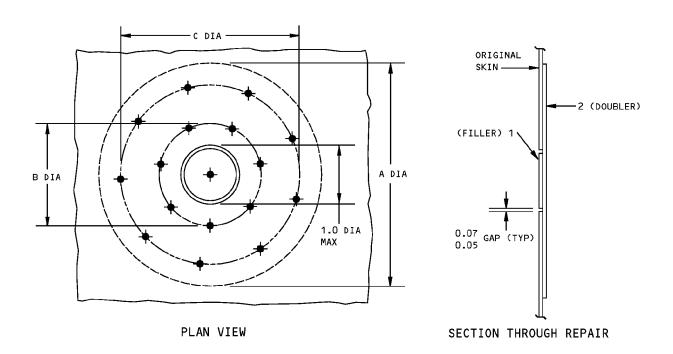
Small Hole in Entry Door Skin - Flush Repair Figure 201 (Sheet 2 of 2)

REPAIR MATERIAL					
PART		QTY	MATERIAL		
1	FILLER	1	SAME MATERIAL AND GAGE AS ORIGINAL SKIN		
2	DOUBLER	1	SAME MATERIAL AS ORIGINAL SKIN. FOR GAGE SEE TABLE 1

REPAIR FASTENER LOCATION
BACR15CE( )KE RIVET
SEE TABLE 1 FOR SIZE AND
NUMBER REQUIRED

- Clean out the damaged hole to 1 inch (25 mm) diameter maximum. The center of the hole to an edge or cutout must not be less than 1/2 of dimension A from Table I.

SKIN GAGE	PART 2 DOUBLER GAGE  A B C INCHES INCHES INCHES	**	_	_	INNER CIR		OUTER CIR	
GAGE		INCHES	NUMBER	SIZE	NUMBER	SIZE		
0.040	0.050	3.80	1.70	3.10	7	5/32	9	5/32
0.045	0.050	3.80	1.70	3.10	7	5/32	9	5/32
0.050	0.063	4.30	1.80	3.50	6	3/16	9	3/16
0.063	0.071	4.30	1.80	3.50	6	3/16	9	3/16

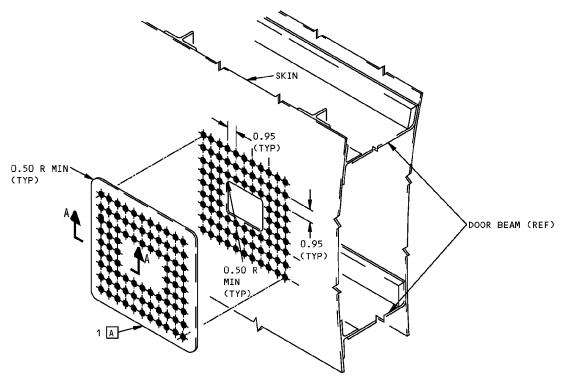
### REPAIR BETWEEN BEAMS

- Remove the inner skin panel for access if required.
- Clean out the damage to the skin in a rectangular shape with a minimum of 0.50 inch (13 mm) radius at the corners. The cutout should be parallel to the centerline of the adjacent beam.

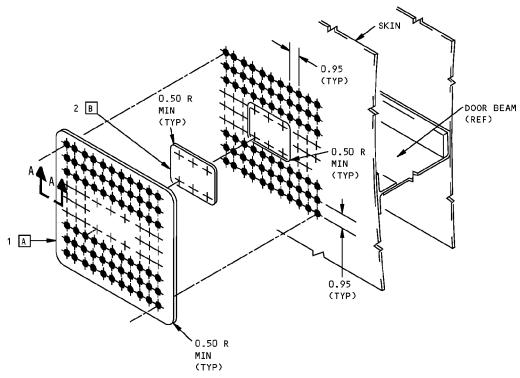
Entry Door Skin - Non-Flush Repair Figure 201 (Sheet 3 of 3)

REPAIR AT BEAM

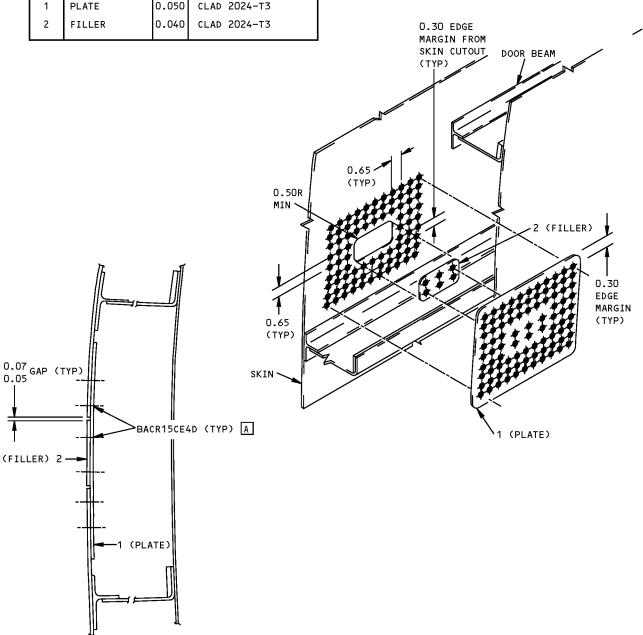
Crew Entry Door Skin - Flush Repair Between Beam (0.040 Chem-Mill Pocket 0nly) Figure 201 (Sheet 2 of 2)

REPAIR MATERIAL						
PART QTY MATERIAL							
1 2	PLATE FILLER	0.050 0.040

SECTION THROUGH REPAIR

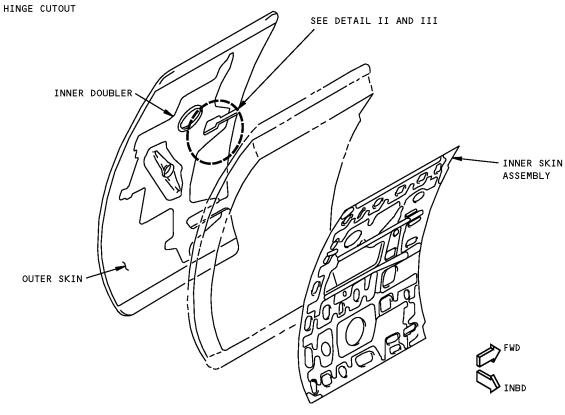
SEE DETAIL I FOR INNER DOUBLER GOUGE DAMAGE REPAIR OF THE OUTER SKIN ASSEMBLY AT THE DOOR

Passenger / Service Door Skin - Inner Doubler Repair of the Outer Skin Figure 201 (Sheet 2 of 4)

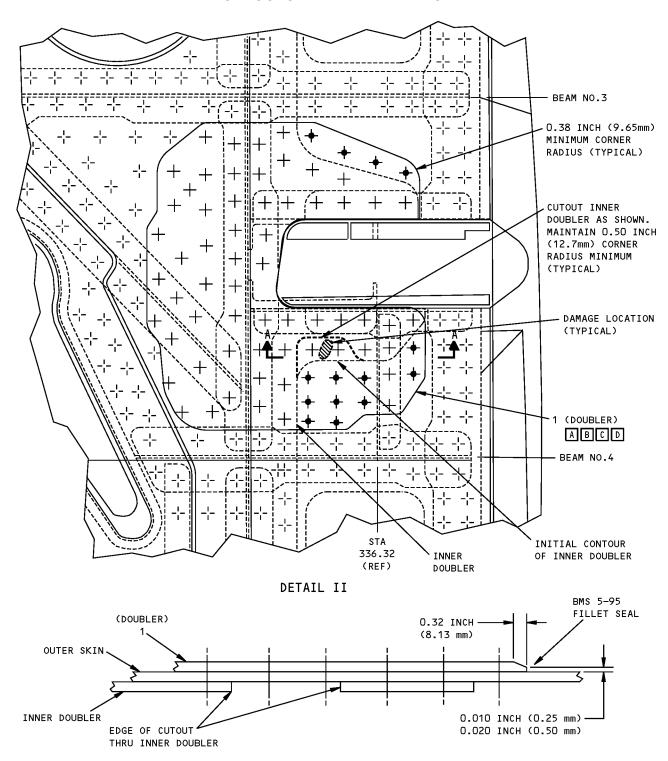
Passenger / Service Door Skin - Inner Doubler Repair of the Outer Skin Figure 201 (Sheet 3 of 4)

(STRUCTURE BELOW SKIN ASSEMBLY NOT SHOWN FOR CLARITY)
SECTION A-A

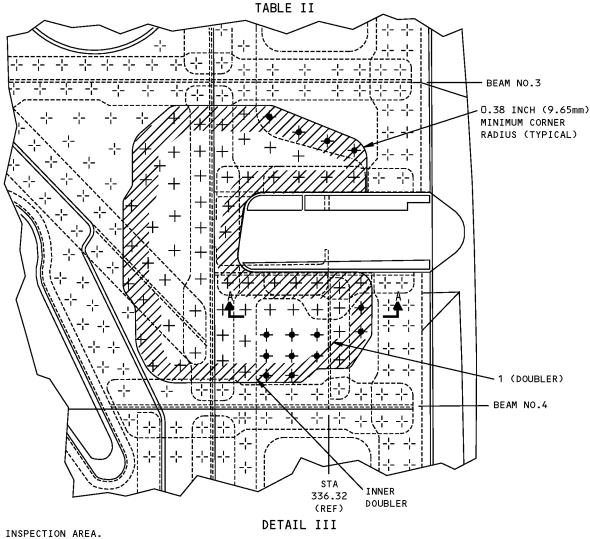
> Passenger / Service Door Skin - Inner Doubler Repair of the Outer Skin Figure 201 (Sheet 4 of 4)

CATEGORY B REPAIR INSPECTION REQUIREMENTS						
INSPECTION THRESHOLD	METHOD	INTERVAL	REFERENCE			
12,000 CYCLES AFTER REPAIR IS DONE. (ALSO SEE NOTE BELOW)	LOW FREQUENCY EDDY CURRENT (LFEC)	12,000 CYCLES	NDT PART 6 53-00-06

NOTE: INSPECT THE SKIN AROUND THE OUTER ROW OF FASTENERS ALONG THE EDGE OF THE DOUBLER AS SHOWN IN DETAIL III. IF THE DOOR WAS NOT REMOVED FROM THE INITIAL AIRPLANE, START THE INSPECTION AT 37,500 AIRPLANE FLIGHT CYCLES SINCE DELIVERED. IF THE DOOR WAS REMOVED BUT THE FLIGHT CYCLES WERE RECORDED, START THE INSPECTION AT 37,500 DOOR FLIGHT CYCLES SINCE NEW. RECORD THE DOOR FLIGHT CYCLES AT THE TIME OF THE REPAIR. THIS HELPS THAT INSPECTIONS WILL BE DONE AT THE CORRECT INTERVALS.

DO THE INSPECTION OF THE SKIN EXTERNALLY THROUGH THE DOUBLER.

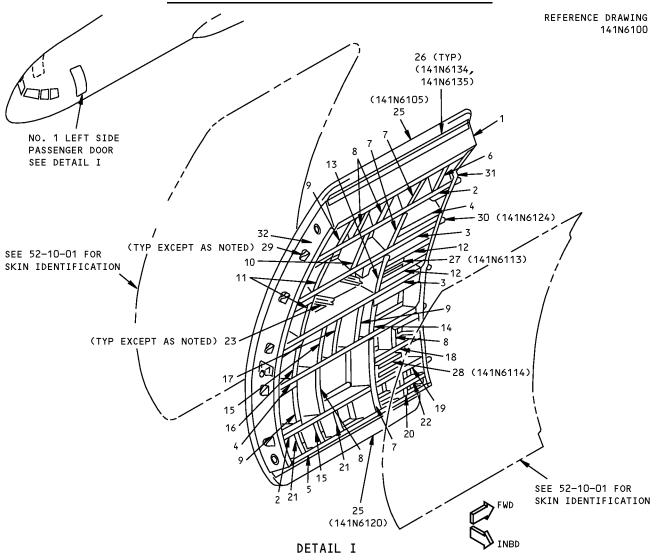
#### **IDENTIFICATION 1 - NO. 1 ENTRY DOOR STRUCTURE**

ITEM	DESCRIPTION	GAGE	MATERIAL	EFFECTIVITY
1	WEB	0.080	7075-T6	
2	BEAM OUTER CHORD WEB	0.063	BAC1505-100543 2024-T42 CLAD 2024-T42	
3	BEAM OUTER CHORD WEB	0.063	BAC1506-3161 2024-T42 CLAD 2024-T42	
4	OUTER CHORD ANGLE	0.063 0.063	CLAD 2024-T42 CLAD 7075-T6	
5	LOWER BEAM		7075-T73 FORGING

LIST OF MATERIALS FOR DETAIL I

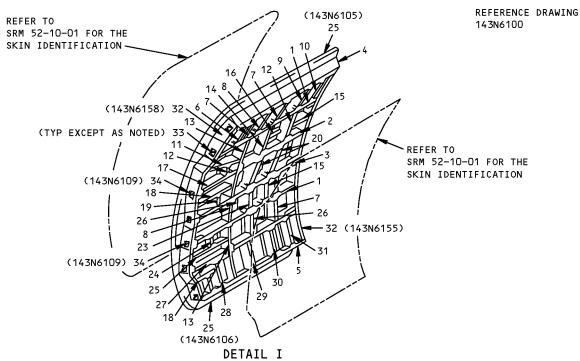
No. 2 Passenger and Service Door Structure Identification Figure 1 (Sheet 2 of 3)

ITEM	DESCRIPTION	GAGE	MATERIAL	EFFECTIVITY
1	BEAM WEB OUTER CHORD	0.063	CLAD 7075-T6 BAC1505-100350 2024-T42	
2	BEAM WEB OUTER CHORD	0.063 2.5	CLAD 7075-T6 7075-T73 PLATE	
3	BEAM WEB OUTER CHORD	0.063 2.5	CLAD 7075-T6 7075-T6 PLATE	
4	WEB	0.080	7075–T6	
5	STOP BEAM		7075-T73 FORGING	
6	OUTER CHORD INNER CHORD		BAC1503-100142 2024-T42 BAC1503-2811 7075-T6	
7	INTERCOSTAL OUTER CHORD	0.056	CLAD 7075-T6 BAC1505-100052 2024-T42	
8	INTERCOSTAL OUTER CHORD	0.063	CLAD 7075-T6 BAC1505-100052 2024-T42	
9	INTERCOSTAL	0.056	CLAD 7075-T6	
10	INNER CHORD OUTER CHORD		BAC1503-2811 7075-T6 BAC1505-100350 2024-T42	
11	WEB INNER CHORD OUTER CHORD	0.063 0.063	CLAD 7075-T6 CLAD 7075-T6 BAC1505-100270 2024-T42	
12	INTERCOSTAL OUTER CHORD	0.056 0.063	CLAD 7075-T6 CLAD 2024-T42

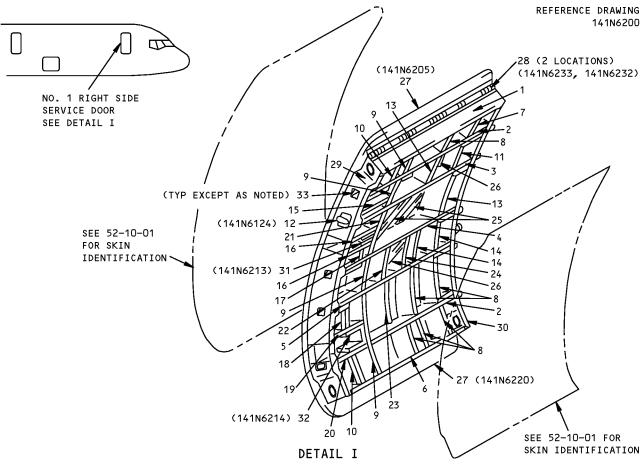
#### **IDENTIFICATION 3 - NO. 1 RIGHT SIDE SERVICE DOOR STRUCTURE**

ITEM	DESCRIPTION	GAGE	MATERIAL	EFFECTIVITY
1	BEAM SUPPORT ANGLE	0.080	7075-T6 BAC1503-521 7075-T6	
2	BEAM OUTER CHORD WEB	0.063	BAC1505-100543 2024-T42 CLAD 7075-T6	
3	BEAM OUTER CHORD WEB SPLICE CHORD	0.063	BAC1505-100543 2024-T42 CLAD 2024-T42 BAC1505-100696 2024-T3511	
4	BEAM OUTER CHORD WEB SPLICE CHORD	0.063	BAC1505-100544 2024-T42 CLAD 2024-T42 BAC1505-100696 2024-T3511	
5	BEAM OUTER CHORD WEB	0.063	BAC1505-100543 2024-T42 CLAD 2024-T42	
6	LOWER BEAM		7075-T73 FORGING

LIST OF MATERIALS FOR DETAIL I

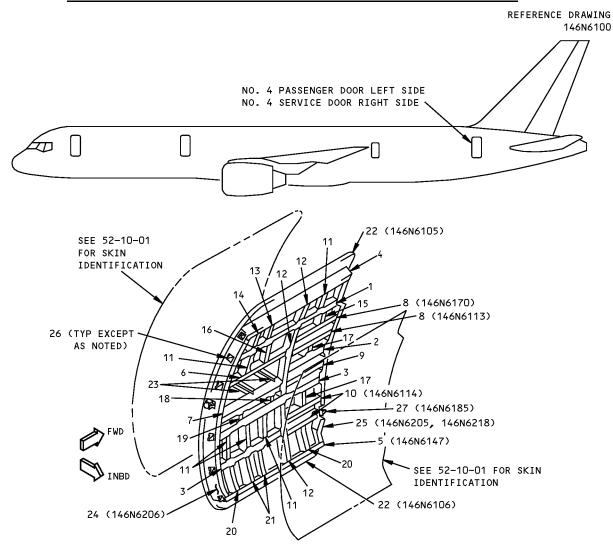
#### **IDENTIFICATION 4 - NO. 4 PASSENGER AND SERVICE DOOR STRUCTURE**

LEFT SIDE DOOR SHOWN RIGHT SIDE DOOR OPPOSITE

ITEM	DESCRIPTION	GAGE	MATERIAL	EFFECTIVITY
1	BEAM OUTER CHORD WEB INNER CHORD	0.080	BAC1505-100624 2024-T42 7075-T6 BAC1505-100624 7075-T6	
2	BEAM OUTER CHORD WEB INNER CHORD	0.063	BAC1505-100624 2024-T42 CLAD 2024-T3 BAC1505-100168 7075-T6

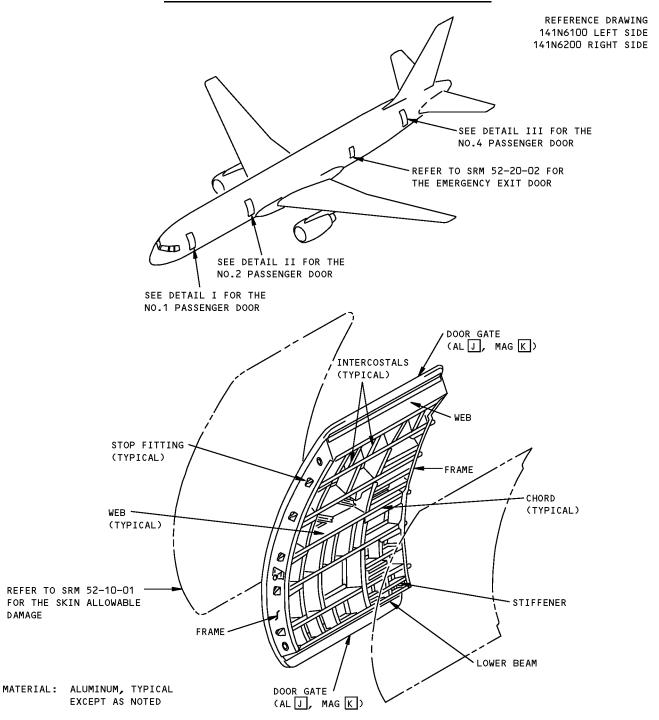
## ALLOWABLE DAMAGE 1 - ENTRY DOOR STRUCTURE

LEFT SIDE IS SHOWN, RIGHT SIDE IS SIMILAR

NO.1 PASSENGER DOOR DETAIL I

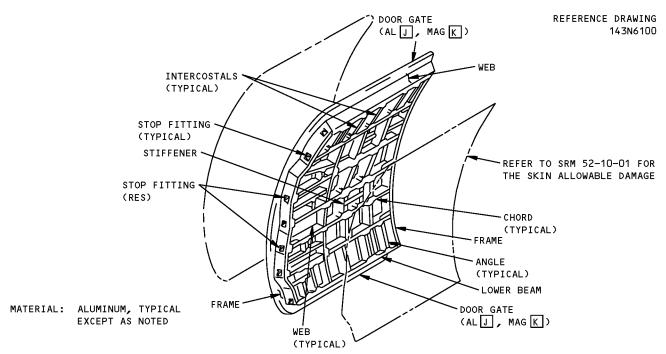
LEFT SIDE IS SHOWN, RIGHT SIDE IS OPPOSITE
NO.2 PASSENGER DOOR
DETAIL II

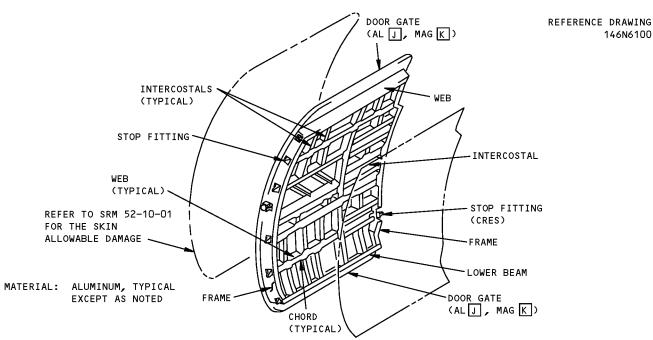
Entry Door Structure Allowable Damage Figure 101 (Sheet 2 of 8)

LEFT SIDE IS SHOWN, RIGHT SIDE IS OPPOSITE
NO.4 PASSENGER DOOR
DETAIL III

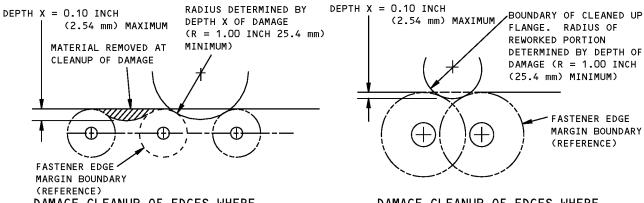
#### DETAIL IV

DAMAGE CLEANUP OF EDGES WHERE FASTENER EDGE MARGINS DO NOT OVERLAP

DAMAGE CLEANUP OF EDGES WHERE FASTENER EDGE MARGINS OVERLAP

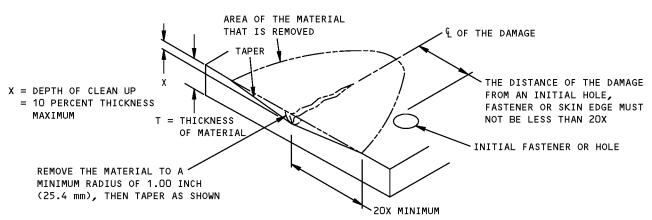
# REMOVAL OF NICK, GOUGE AND SCRATCH DAMAGE ON A SURFACE DETAIL V

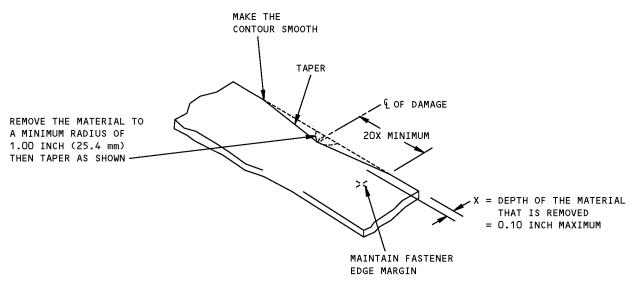
REMOVAL OF NICK OR CRACK DAMAGE ON AN EDGE DETAIL VIII

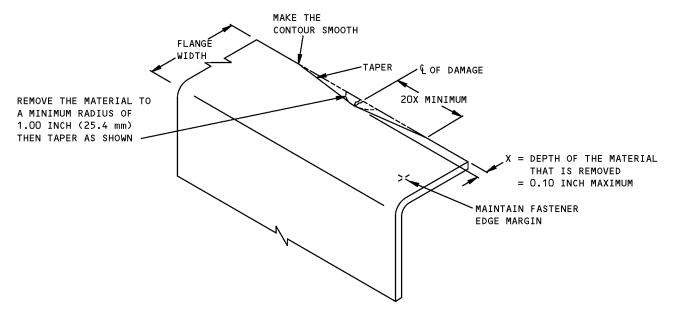
Entry Door Structure Allowable Damage Figure 101 (Sheet 5 of 8)

REMOVAL OF NICK, OR CRACK DAMAGE ON AN EDGE DETAIL IX

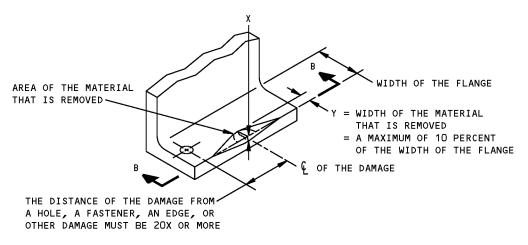
# REMOVAL OF DAMAGED MATERIAL ON A SURFACE AT AN EDGE DETAIL X

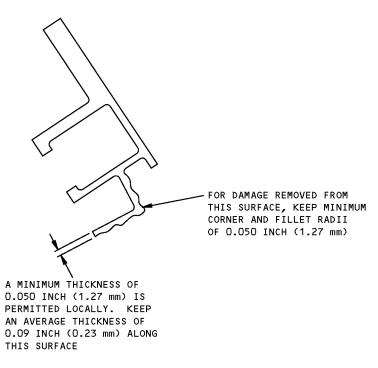
Entry Door Structure Allowable Damage Figure 101 (Sheet 7 of 8)

# CROSS SECTION OF LOWER DOOR GATE DETAIL XII

SECTION C-C

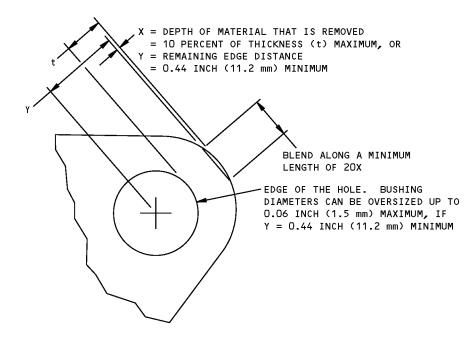
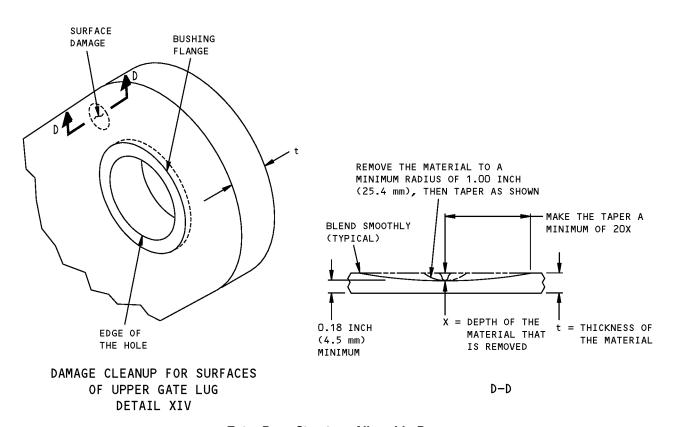
Entry Door Structure Allowable Damage Figure 101 (Sheet 8 of 8)

DAMAGE CLEANUP FOR EDGES OF UPPER GATE LUG
DETAIL XIII

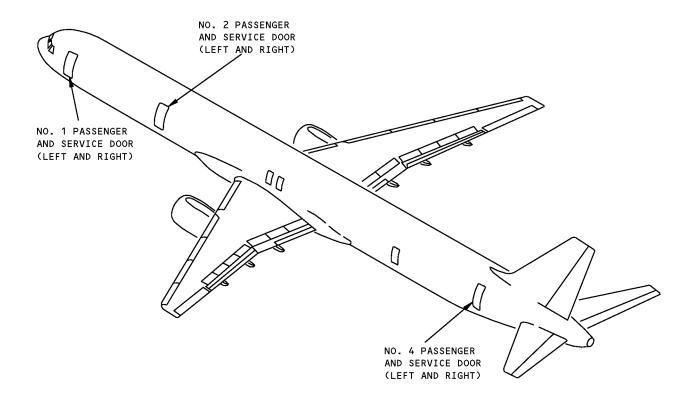
Passenger and Service Door Structure Repairs Figure 201

#### **REPAIR GENERAL - ENTRY DOOR STRUCTURE**

DAMAGED COMPONENTS IN THE DOOR STRUCTURE MAY BE REPLACED OR REPAIRED. IF REPAIRS ARE TO BE MADE, REFER TO SRM 51-70 FOR TYPICAL WEB, FORMED SECTION, OR EXTRUDED SECTION REPAIRS

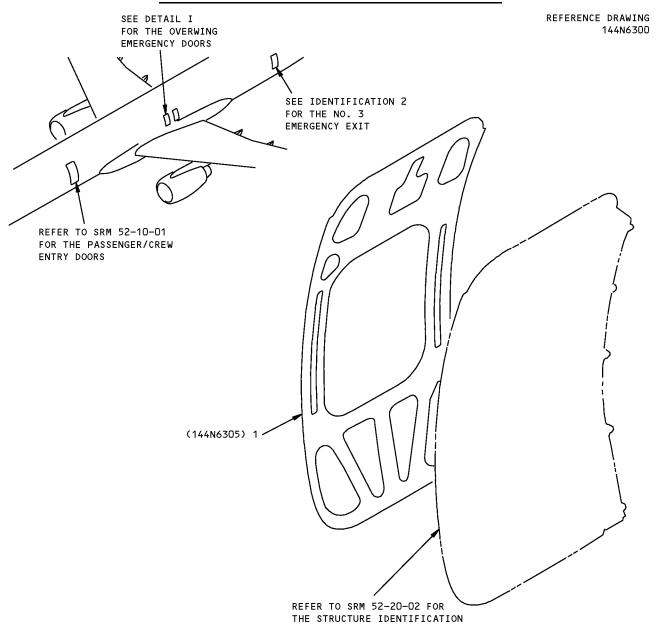
#### DETAIL I

#### **IDENTIFICATION 1 - OVERWING EMERGENCY EXIT SKIN**

ITEM	DESCRIPTION	GAGE	MATERIAL	EFFECTIVITY
1	OUTER SKIN	0.063	CLAD 2024-T3 (CHEM-MILLED TO 0.040 MIN)

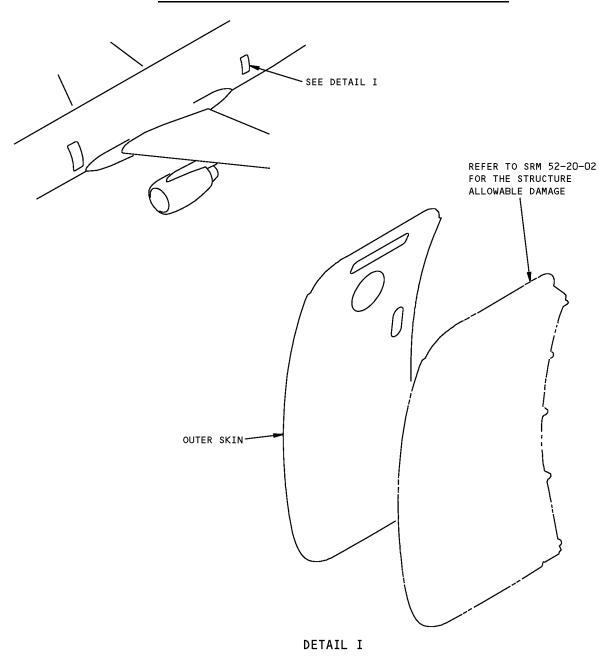
Emergency Exit Door Skin Allowable Damage Figure 101 (Sheet 1 of 3)

# **ALLOWABLE DAMAGE 1 - EMERGENCY EXIT DOOR SKIN**

DESCRIPTION	CRACKS	NICKS, GOUGES AND CORROSION	DENTS	HOLES AND PUNCTURES
OUTER SKIN	A D	BD	SEE DETAIL IV	СЪ

- REFINISH THE REWORKED AREAS AS SHOWN IN AMM 51-20
- REFER TO SRM 51-10-01 FOR AERODYNAMIC SMOOTHNESS REQUIREMENTS. WHERE THE DAMAGE IS MORE THAN THE LIMITS AS SHOWN IN SRM 51-10-01, CONSIDERATION SHOULD BE GIVEN TO THE LOSS OF PERFORMANCE INVOLVED
- A CRACKS ARE NOT PERMITTED EXCEPT FOR EDGE CRACKS WHICH MUST BE REMOVED AS SHOWN IN DETAILS II AND VI.

B REMOVE DAMAGE AS SHOWN IN DETAILS II, III, V AND VI.

- C CLEAN OUT DAMAGE UP TO 0.25 INCH (6 mm)
  MAXIMUM DIAMETER AND NOT CLOSER THAN
  1.0 INCH (25 mm) TO FASTENER HOLE,
  MATERIAL EDGE, OR OTHER DAMAGE. FILL
  HOLE WITH 2117-T3 OR T4 ALUMINUM RIVET
  INSTALLED WET WITH BMS 5-95 SEALANT.
  ALL OTHER HOLES TO BE REPAIRED.
- D REFER TO ALLOWABLE DAMAGE 2 FOR THE EMERGENCY EXIT DOOR SKIN OPERATING LIMITS AFTER DAMAGE HAS BEEN REMOVED.

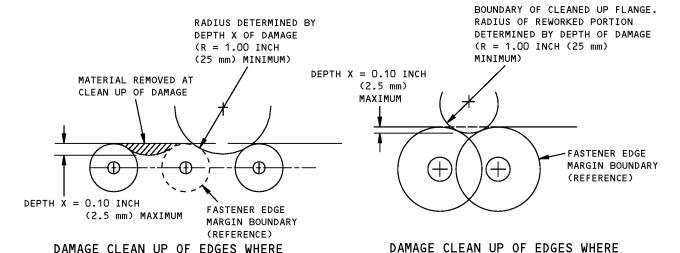
Emergency Exit Door Skin Allowable Damage Figure 101 (Sheet 2 of 3)

DETAIL II

REMOVE THE MATERIAL TO A MINIMUM RADIUS OF 1.00 INCH (25 mm), THEN TAPER AS SHOWN TAPER € OF DAMAGE CLEANOUT BOUNDARY INITIAL FASTENER OR HOLE THE DISTANCE OF THE DAMAGE 20x FROM AN INITIAL HOLE, FASTENER, MINIMUM OR SKIN EDGE MUST BE MORE THAN 20X X = DEPTH OF CLEANUP= 10% OF THICKNESS MAXIMUM

REMOVAL OF NICK, GOUGE, CORROSION, AND SCRATCH DAMAGE ON A SURFACE DETAIL III

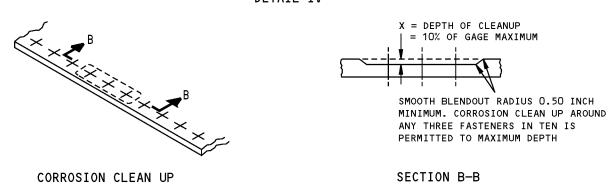
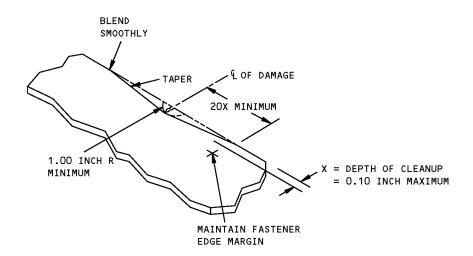
Emergency Exit Door Skin Allowable Damage Figure 101 (Sheet 3 of 3)

# ALLOWABLE DAMAGE FOR DENT DETAIL IV

DETAIL V

REMOVAL OF NICK OR CRACK DAMAGE ON AN EDGE DETAIL VI

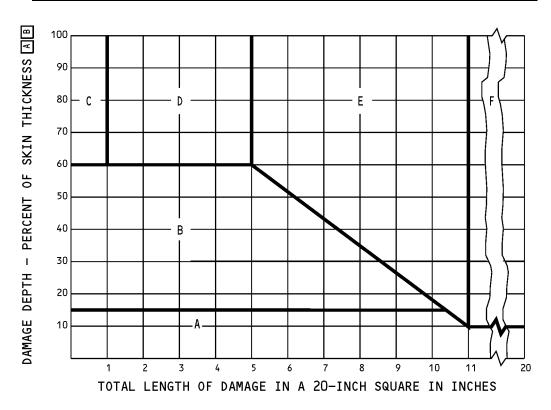
#### ALLOWABLE DAMAGE 2 - OPERATING LIMITS FOR EMERGENCY EXIT DOOR SKIN

- A SKIN THICKNESS DOES NOT INCLUDE THE THICKNESS OF THE DOUBLERS, TRIPLERS, OR STRAPS.
- B DAMAGE INCLUDES HOLES, PUNCTURES, NICKS, GOUGES, SCRATCHES, CORROSION AND CRACKS.

DAMAGE DOES NOT INCLUDE DENTS.
- C CABIN PRESSURE LIMITS ARE FOR SKIN DAMAGE TO THE PRESSURIZED FUSELAGE SKIN ONLY.

CHART AREA	DAMAGE TREATMENT	ALLOWABLE AIRPLANE OPERATIONS	
A	CLEAN UP AS SHOWN IN ALLOWABLE DAMAGE 1.	NO FLIGHT RESTRICTIONS.	
В	CLEAN UP AS SHOWN IN ALLOWABLE DAMAGE 1 TO DEMAGE DEPTH.	LIMITED TO 50 HOURS OF FLIGHT OR 25 FLIGHTS, WHICHEVER COMES FIRST (INCLUDING REVENUE FLIGHTS).	
	DO AN APPLICABLE REPAIR AS GIVEN IN SRM 52-20-01.	REFER TO THE APPLICABLE REPAIR FOR THE LIMITS.	
С	CLEAN UP AS SHOWN IN ALLOWABLE DAMAGE 1 TO DAMAGE DEPTH. STOP DRILL 0.25 INCH (6 mm) DIAMETER HOLES AT THE ENDS OF THE CRACKS.	A NON-REVENUE FLIGHT TO A REPAIR STATION IS PERMITTED IF THE APPLICABLE REGULATORY AUTHORITY GIVES APPROVAL BEFORE THE FLIGHT. IT IS RECOMMENDED THAT THE PROPOSED REPAIR PROCEDURE BE GIVEN TO BOEING.	
		THE MAXIMUM CABIN PRESSURE DIFFERENTIAL C IS LIMITED TO 6.0 PSIG UNLESS THE SKIN IS REPAIRED.	
	DO AN APPLICABLE REPAIR AS GIVEN IN SRM 52-20-01.	REFER TO THE APPLICABLE REPAIR FOR THE LIMITS.

D	CLEAN UP AS SHOWN IN ALLOWABLE DAMAGE 1 TO DAMAGE DEPTH. STOP DRILL 0.25 INCH (6 mm) DIAMETER HOLES AT THE ENDS OF THE CRACKS.	A NON-REVENUE FLIGHT TO A REPAIR STATION IS PERMITTED IF THE APPLICABLE REGULATORY AUTHORITY GIVES APPROVAL BEFORE THE FLIGHT. IT IS RECOMMENDED THAT THE PROPOSED REPAIR PROCEDURE BE GIVEN TO BOEING.	
		THE MAXIMUM CABIN PRESSURE DIFFERENTIAL C IS LIMITED TO 6.0 PSIG UNLESS THE SKIN IS REPAIRED.	
	DO AN APPLICABLE REPAIR AS GIVEN IN SRM 52-20-01.	REFER TO THE APPLICABLE REPAIR FOR THE LIMITS.	
E	CLEAN UP AS SHOWN IN ALLOWABLE DAMAGE 1 TO DAMAGE DEPTH. STOP DRILL 0.25 INCH (6 mm) DIAMETER HOLES AT THE ENDS OF THE CRACKS.	A NON-REVENUE FLIGHT TO A REPAIR STATION IS PERMITTED IF THE APPLICABLE REGULATORY AUTHORITY GIVES APPROVAL BEFORE THE FLIGHT. IT IS RECOMMENDED THAT THE PROPOSED REPAIR PROCEDURE BE GIVEN TO BOEING.	
		THE MAXIMUM CABIN PRESSURE DIFFERENTIAL C IS LIMITED TO ZERO PSIG.

DO APPLICABLE REPAIR AS GIVEN IN SRM 52-20-01.	REFER TO THE APPLICABLE REPAIR FOR THE LIMITS.	
F	CLEAN UP AS SHOWN IN ALLOWABLE DAMAGE 1 TO DAMAGE DEPTH. STOP DRILL 0.25 INCH (6 mm) DIAMETER HOLES AT THE ENDS OF THE CRACKS.	OPERATION IS NOT PERMITTED BEFORE BOEING AND THE APPLICABLE REGULATORY AUTHORITY GIVES APPROVAL.	
г	DO APPLICABLE REPAIR AS GIVEN IN SRM 52-20-01.	REFER TO THE APPLICABLE REPAIR FOR THE LIMITS.

LIMITS FOR CORROSION, CRACKS, NICKS, GOUGES, AND HOLE DAMAGE

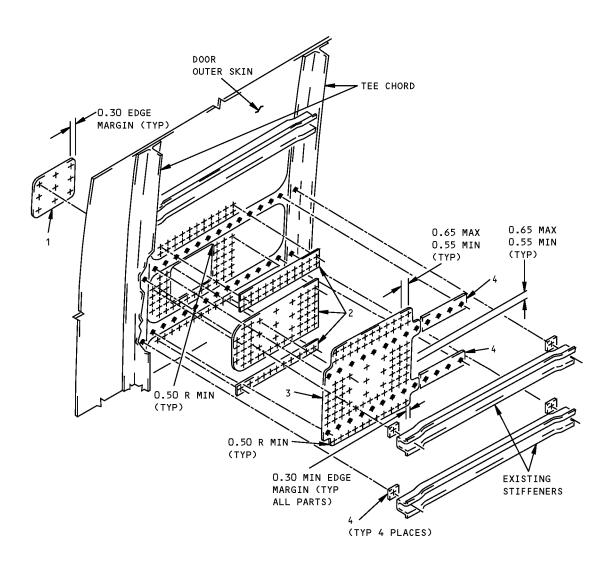
Emergency Exit Door Skin - Flush Repair Between Stiffeners Figure 201 (Sheet 2 of 3)

FASTENER SYMBOLS

- Remove the inner skin panel and outer skin stiffeners for access as required.
- Clean out the damage to the skin in a rectangular shape with a minimum of 0.50 radius at the corners. The cutout should be parallel to the centerline of the adjacent stiffener.

- 3. Fabricate repair parts.
- Assemble repair parts in installed positions and drill fastener holes.
- 5. Remove repair parts.
- Break sharp edges of original and repair parts 0.015 to 0.030.

- Remove all nicks, scratches, burrs, sharp edges and corners from original and repair parts.
- Alodize all raw edges of existing parts and all surfaces and edges of new parts per 51-20-01.

- 10. Install the repair parts with the fasteners wet with BMS 5-95 sealant and making faying surface seals between all parts in accordance with 51-20-05. If necessary, install 1/32 oversize fasteners in existing fastener locations. A bead of sealant should be apparent all around repair parts after installation. Where there is sufficient sealant squeezed out, it may be formed into a fillet, otherwise an additional fillet seal should be applied.

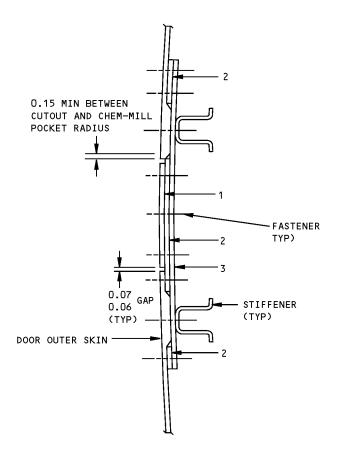
Emergency Exit Door Skin - Flush Repair Between Stiffeners Figure 201 (Sheet 3 of 3)

SECTION THRU REPAIR

REPAIR MATERIAL				
PART		QTY	GAGE	MATERIAL
1	FILLER	1	0.040	CLAD 2024-T3
2	SHIM	AS REQ'D	0.020 OR 0.025	CLAD 2024-T3
3	PLATE	1	0.050	CLAD 2024-T3
4	SHIM	AS REQ'D	0.050	CLAD 2024-T3

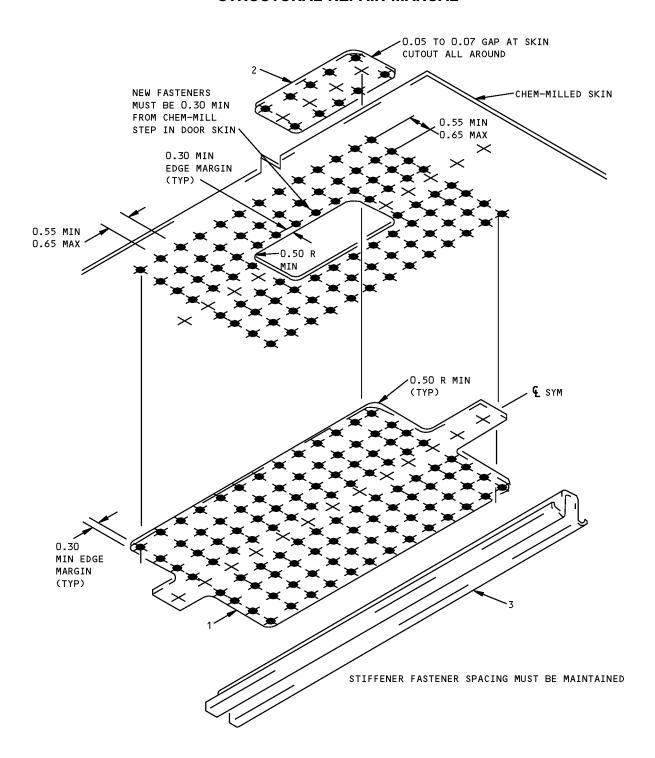
Emergency Exit Door Skin - Flush Repair at Stiffener Figure 201 (Sheet 2 of 2)

REPAIR MATERIAL						
PART QTY GAGE MATERIAL							
1	PLATE	1	0.063	2024-T3			
2	FILLER	1	0.063	2024-T3			
3	STIFFENER	1		BAC1498-212 2024-T42 OR EQUIVALENT

- Remove inner skin panel for access to the damaged area.
- 2. Remove stiffener from damaged area.
- 3. Clean out damage to skin to a rectangular shape parallel to the stiffener, with a minimum corner radius of 0.50 inch. The skin cutout must be in the .040 chem-milled area and at least 0.20 from chem-mill radius.
- 4. Make repair parts.

NOTE: Since the door outer skin is chemmilled, .020 or .025 shims must be used as required to fill the chemmill pockets between the repair plate and door skin. All shims are to be 2024-T3.

- 11. Install the repair parts and fasteners with BMS 5-95 sealant making faying surface seals between all parts in accordance with 51-20-05. A bead of sealant should be apparent all around repair parts after installation. Where there is sufficient sealant squeezed out it may be formed into a fillet, otherwise an additional fillet seal should be applied.

- 12. Apply BMS 5-95 sealant in the gap between the filler, part 2, and the skin.
- 13. Replace inner skin panel.
- 14. Restore surface finish in accordance with 51-21 of the 757 Maintenance Manual.

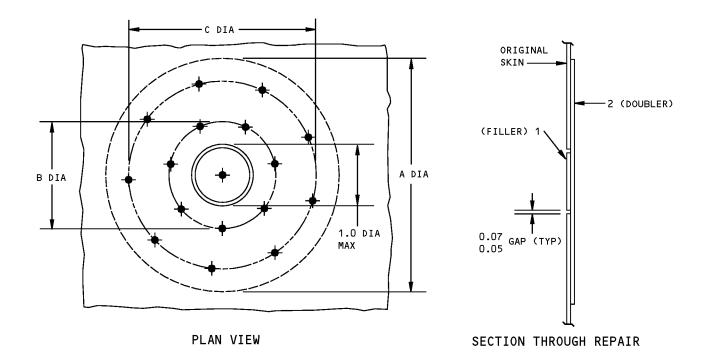
Small Hole Flush Repair - Emergency Exit Door Skin Figure 201 (Sheet 2 of 2)

SKIN GAGE	PART 2 DOUBLER	A INCHES	B INCHES	C INCHES	INNER CIR		OUTER CIR	
GAGE	GAGE	INCHES	INCHES	INCHES	NUMBER	SIZE	NUMBER	SIZE
0.040	0.050	3.80	1.70	3.10	7	5/32	9	5/32
0.045	0.056	3.80	1.70	3.10	7	5/32	9	5/32
0.050	0.063	4.30	1.80	3.50	6	3/16	9	3/16
0.063	0.071	4.30	1.80	3.50	6	3/16	9	3/16

TABLE I

- Clean out the damaged hole to 1-inch (25 mm) diameter maximum. The center of the hole to an edge or cutout must not be less than 1/2 of dimension A from Table I.

REPAIR FASTENER LOCATION
BACR15CE( )KE RIVET
SEE TABLE 1 FOR SIZE AND NUMBER REQUIRED

REPAIR MATERIAL							
PA	RT	QTY	MATERIAL				
1	FILLER	1	SAME MATERIAL AND GAGE AS ORIGINAL SKIN				
2	DOUBLER	1	SAME MATERIAL AS ORIGINAL SKIN. FOR GAGE SEE TABLE 1

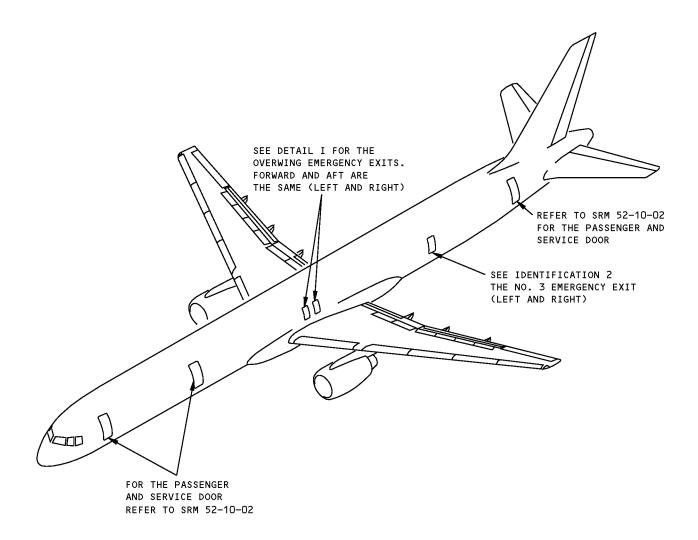
**Overwing Emergency Exit Structure** Figure 1 (Sheet 1 of 3)

## **IDENTIFICATION 1 - OVERWING EMERGENCY EXIT STRUCTURE**

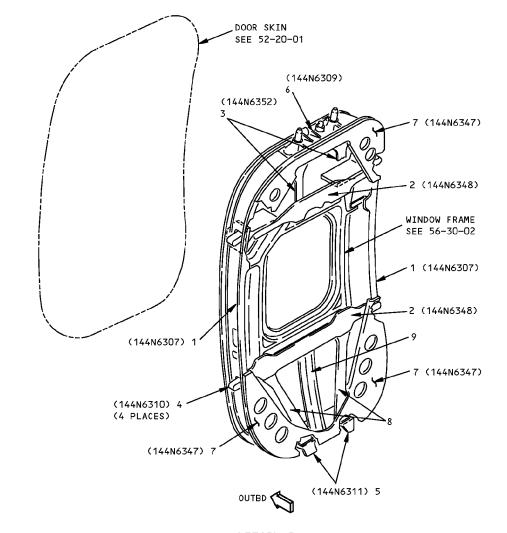
Overwing Emergency Exit Structure Figure 1 (Sheet 2 of 3)

REF DWG 144N6302

DETAIL I

ITEM	DESCRIPTION	GAGE	MATERIAL	EFFECTIVITY
1	EDGE BEAM	0.071	2024-T42	
2	STOP BEAM		BAC1518-887 2024-T42	
3	INTERCOSTAL TEE WEB	0.063	BAC1505-100881 2024-T3511 2024-T42	
4	STOP FITTING		7075-T73 FORGING OR 7075-T73 FORGED BLOCK	
5	PIVOT FITTING	1.25	7075-T73 FORGING OR 7075-T7351 PLATE	
6	LATCH PIN FITTING		FORGING 7075-T73 OR FORGED BLOCK 7075-T73	
7	GUSSET	0.063	7075-T6	
8	INTERCOSTAL OUTER TEE INNER TEE WEB	0.063	BAC1505-100818 2024-T3511 OR 7075-T3511 BAC1505-100881 2024-T3511 OR 7075-T3511 2024-T42	
9	ZEE		BAC1517-130 2024-T42 OR 2024-T4

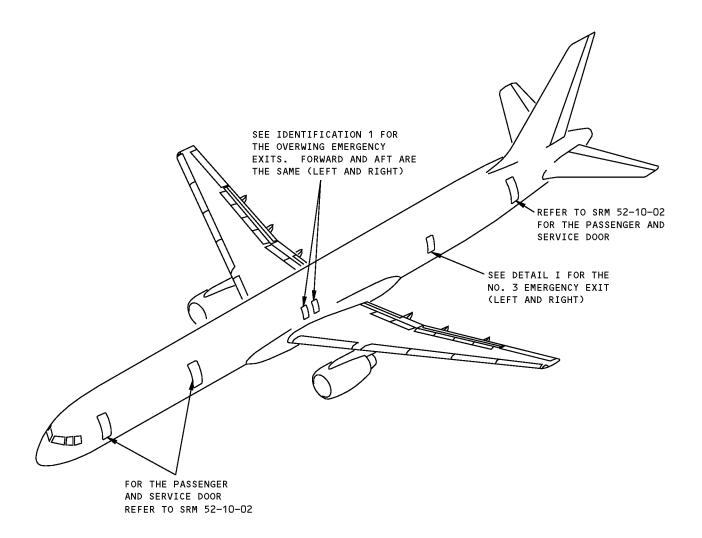
N0. 3 Emergency Exit Structure Figure 1 (Sheet 1 of 3)

## **IDENTIFICATION 2 - NO. 3 EMERGENCY EXIT STRUCTURE**

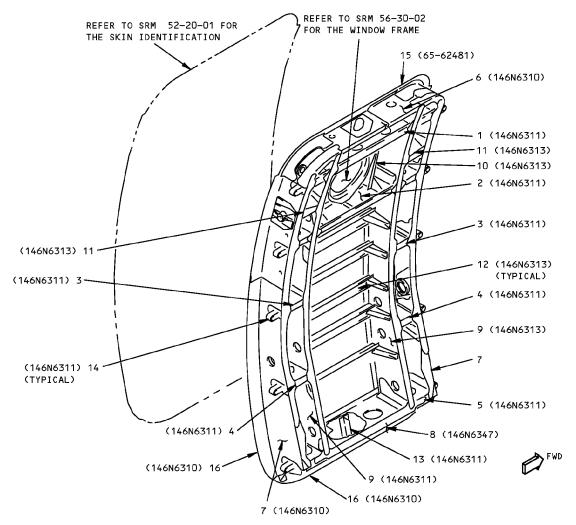
DETAIL I

REFERENCE DRAWING 146N6300

ITEM	DESCRIPTION	GAGE	MATERIAL	EFFECTIVITY
1	BEAM OUTER CHORD INNER CHORD WEB SUPPORT FITTING	0.063	CLAD 2024-T42 BAC1506-1920 7075-T73511 CLAD 7075-T6 BAR 7075-T7351	
2	BEAM OUTER CHORD INNER CHORD WEB	0.063 0.063	BAC1506-1614 2024-T42 CLAD 7075-T6 CLAD 7075-T6

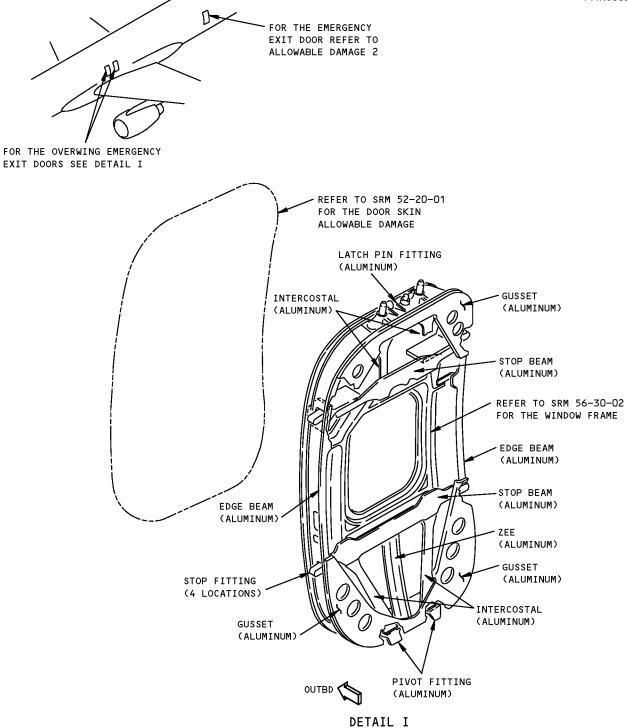
Allowable Damage - Overwing Emergency Exit Structure Figure 101 (Sheet 1 of 4)

## ALLOWABLE DAMAGE 1 - OVERWING EMERGENCY EXIT DOOR STRUCTURE

REFERENCE DRAWING 144N6302

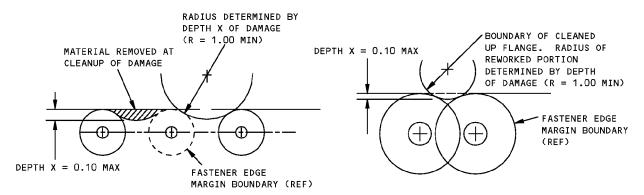
DAMAGE CLEANUP OF EDGES WHERE FASTENER EDGE MARGINS DO NOT OVERLAP

DAMAGE CLEANUP OF EDGES WHERE FASTENER EDGE MARGINS OVERLAP

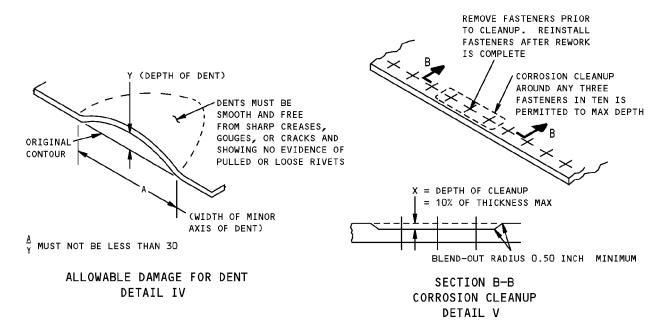
Allowable Damage - Overwing Emergency Exit Structure Figure 101 (Sheet 3 of 4)

REMOVAL OF NICK, GOUGE AND SCRATCH DAMAGE ON A SURFACE DETAIL III

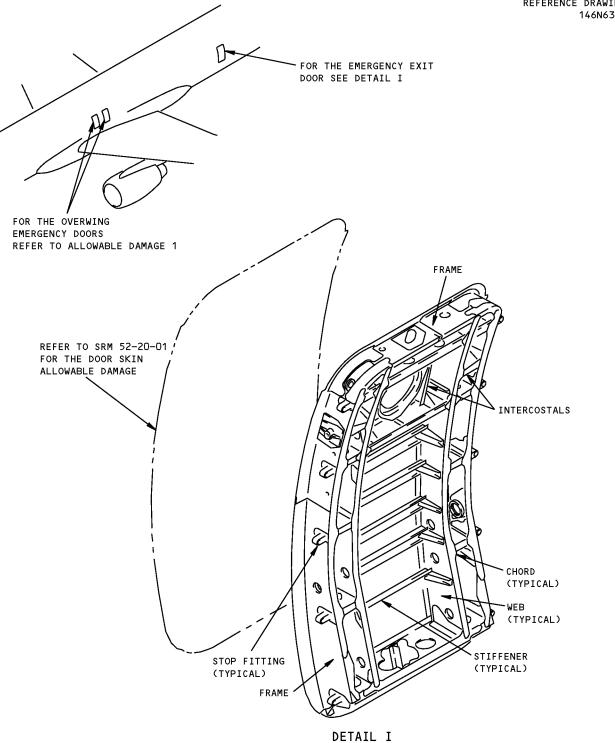
No. 3 Emergency Exit Door Structure Figure 101 (Sheet 1 of 4)

## **ALLOWABLE DAMAGE 2 - NO. 3 EMERGENCY EXIT DOOR STRUCTURE**

REFERENCE DRAWING 146N6300

MATERIAL: ALUMINUM

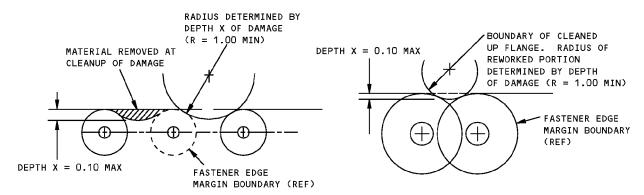
DAMAGE CLEANUP OF EDGES WHERE FASTENER EDGE MARGINS DO NOT OVERLAP

DAMAGE CLEANUP OF EDGES WHERE FASTENER EDGE MARGINS OVERLAP

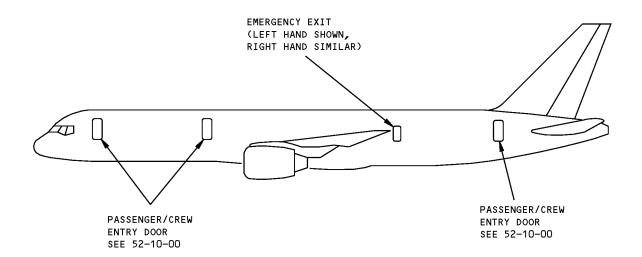
## **REPAIR GENERAL - EMERGENCY EXIT STRUCTURE**

• DAMAGED COMPONENTS IN DOOR STRUCTURE MAY BE REPLACED OR REPAIRED. IF REPAIRS ARE TO BE MADE, SEE 51-70 FOR TYPICAL WEB, FORMED SECTION, OR EXTRUDED SECTION REPAIRS

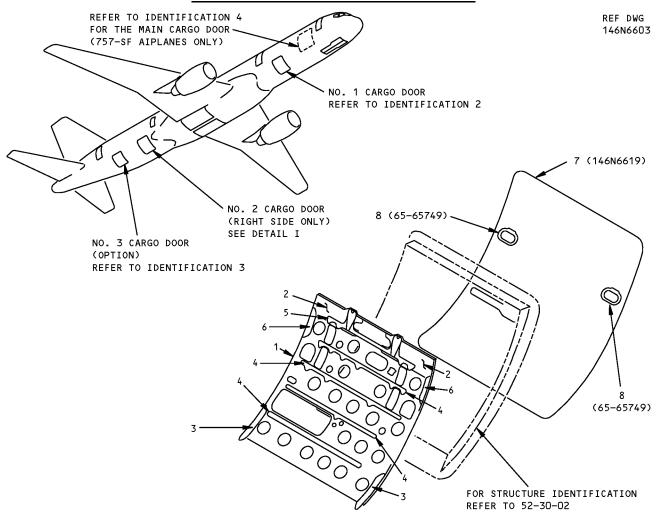
DETAIL I

# **IDENTIFICATION 1 - NO. 2 CARGO DOOR SKIN**

ITEM	DESCRIPTION	GAGE	MATERIAL	EFFECTIVITY
1	INNER SKIN	0.045	CLAD 7075-T6	
2	DOUBLER	0.032	CLAD 7075-T6	
3	STRAP	0.125	7075-T6	
4	STRAP	0.100	7075-T6	
5	DOUBLER	0.140	7075 <b>-</b> T6	
6	STRAP	0.080	7075 <b>-</b> T6	
7	OUTER SKIN	0.063	CLAD 2024-T3 (CHEM-MILLED TO 0.040 MIN)	
8	DOUBLER		2024-T351 PLATE

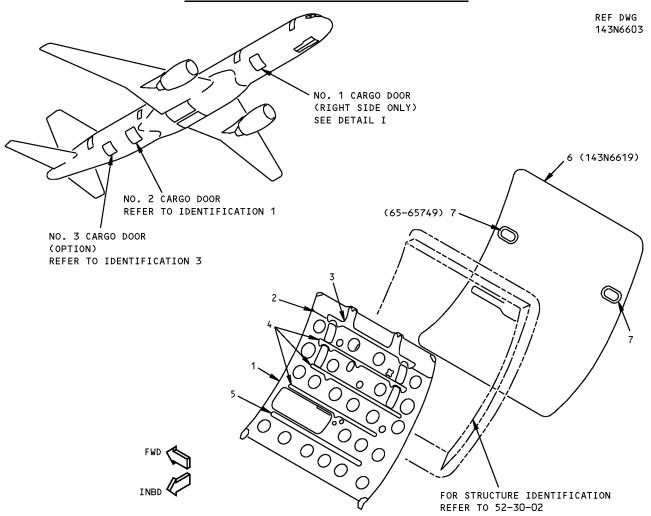
DETAIL I

## **IDENTIFICATION 2 - NO. 1 CARGO DOOR SKIN**

ITEM	DESCRIPTION	GAGE	MATERIAL	EFFECTIVITY
1	INNER SKIN	0.045	CLAD 7075-T6	
2	DOUBLER	0.032	CLAD 7075-T6	
3	STRAP	0.032	CLAD 2024-T3	
4	STRAP	0.100	CLAD 7075-T6	
5	STRAP		7075-T6 PLATE	
6	OUTER SKIN	0.063	CLAD 2024-T3 (CHEM-MILLED TO 0.040 MIN)	
7	DOUBLER		2024-T351 PLATE

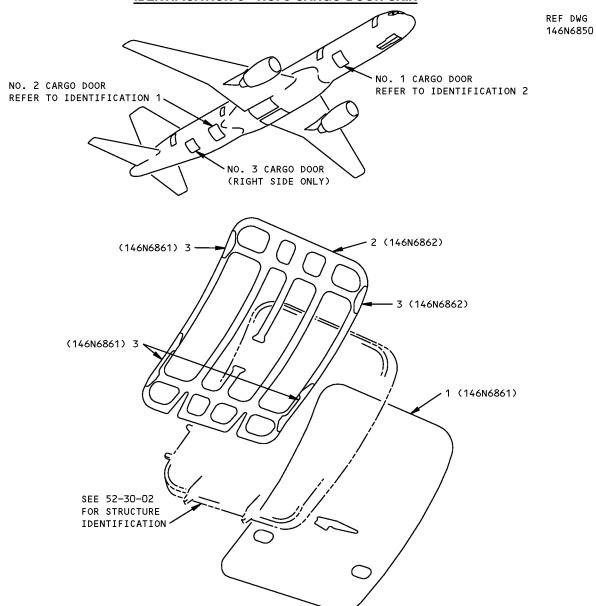
## **IDENTIFICATION 3 - NO. 3 CARGO DOOR SKIN**

ITEM	DESCRIPTION	GAGE	MATERIAL	EFFECTIVITY
1	OUTER SKIN	0.071	CLAD 2024-T3 (CHEM-MILLED TO 0.040 MIN)	
2	INNER SKIN	0.063	CLAD 2024-T3	
3	STRAP	0.063	CLAD 2024-T3

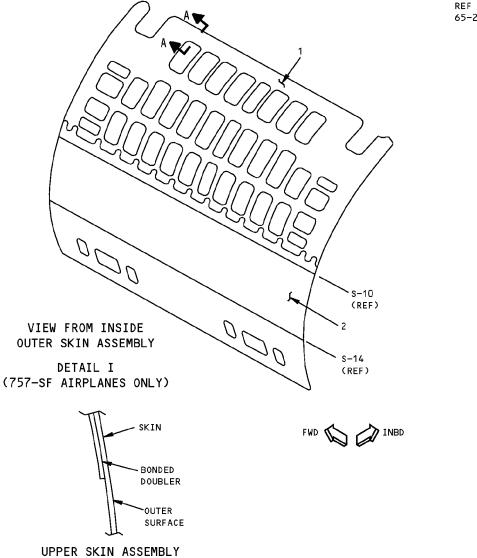
## **IDENTIFICATION 4 - MAIN DECK CARGO DOOR - SKIN**

REF DWG 65-25326

ITEM	DESCRIPTION	GAGE	MATERIAL	EFFECTIVITY
1	UPPER SKIN ASSEMBLY SKIN BONDED DOUBLER	0.040 0.040	CLAD 2024-T3 CLAD 2024-T3	
2	LOWER SKIN	0.063	CLAD 2024-T3

SECTION A-A
