# **CHAPTER**

# 52

**DOORS**

### CHAPTER 52 DOORS

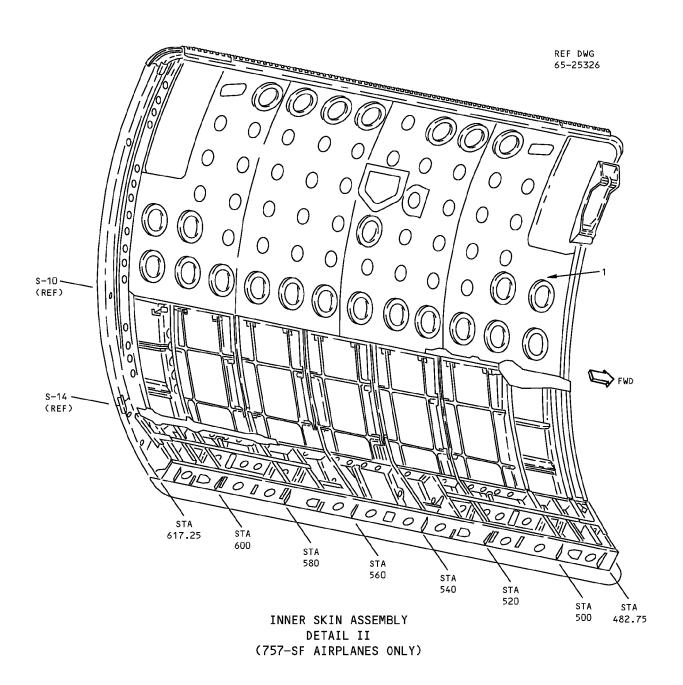
Main Deck Cargo Door - Skin Figure 1 (Sheet 2 of 2)

IT	EM	DESCRIPTION	GAGE	MATERIAL	EFFECTIVITY
1		SKIN	0.032	CLAD 7075-T6

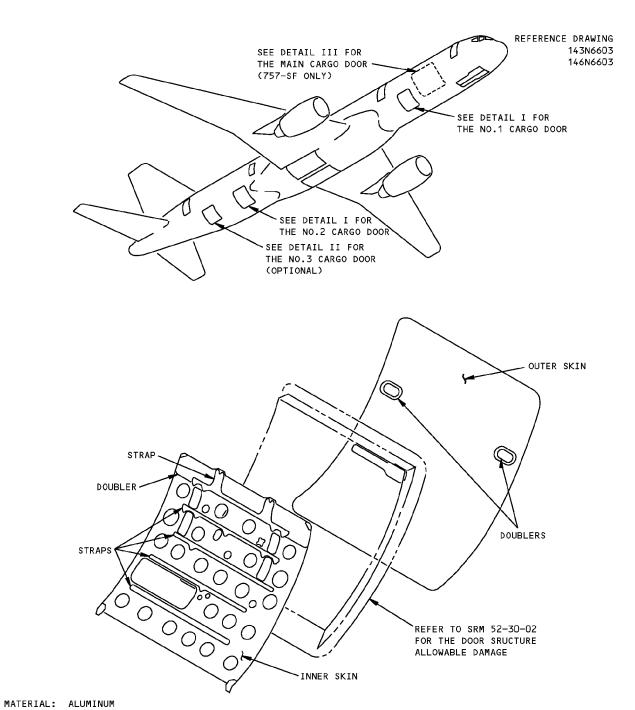
> Cargo Door Skin Figure 101 (Sheet 1 of 5)

## **ALLOWABLE DAMAGE 1 - CARGO DOOR SKIN**

NO.1 AND NO.2 CARGO DOORS DETAIL I

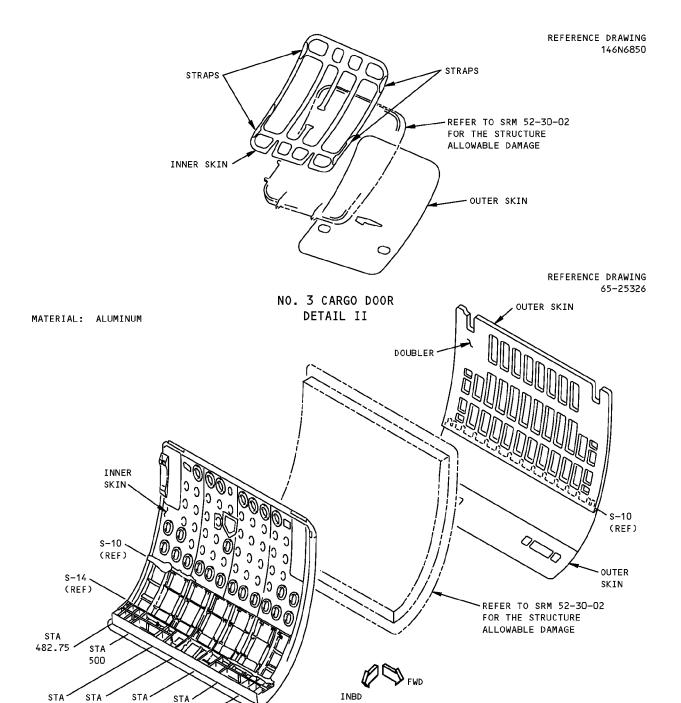
Cargo Door Skin Figure 101 (Sheet 2 of 5)

MAIN DECK CARGO DOOR

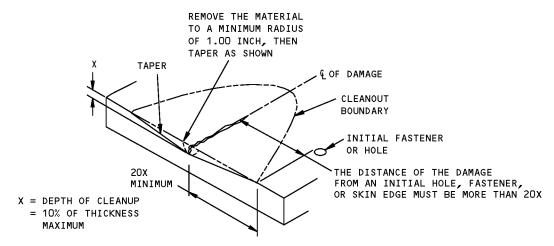
DAMAGE CLEAN UP OF EDGES WHERE FASTENER EDGE MARGINS OVERLAP

## DETAIL IV

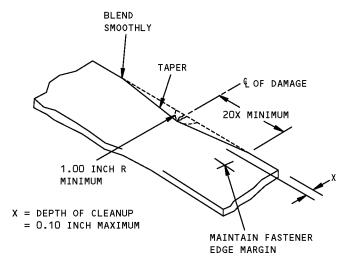
SMOOTH BLENDOUT RADIUS 0.50 INCH MINIMUM. CORROSION CLEANUP AROUND ANY THREE FASTENERS IN TEN IS PERMITTED TO MAXIMUM DEPTH

SECTION B-B

FIELD CRACK CLEAN UP DETAIL IX

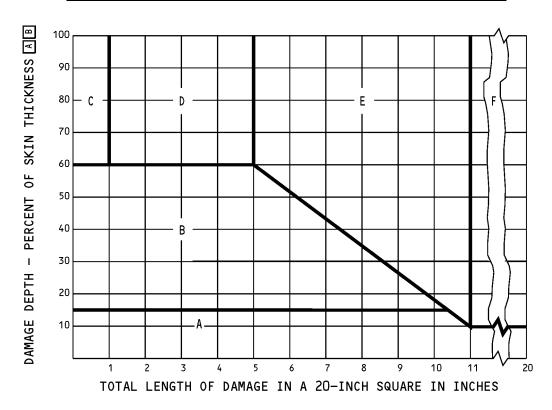
## ALLOWABLE DAMAGE 2 - OPERATING LIMITS FOR CARGO DOOR SKIN

- A SKIN THICKNESS DOES NOT INCLUDE THE THICKNESS OF THE DOUBLERS, TRIPLERS, OR STRAPS.
- B DAMAGE INCLUDES HOLES, PUNCTURES, NICKS, GOUGES, SCRATCHES, CORROSION AND CRACKS.

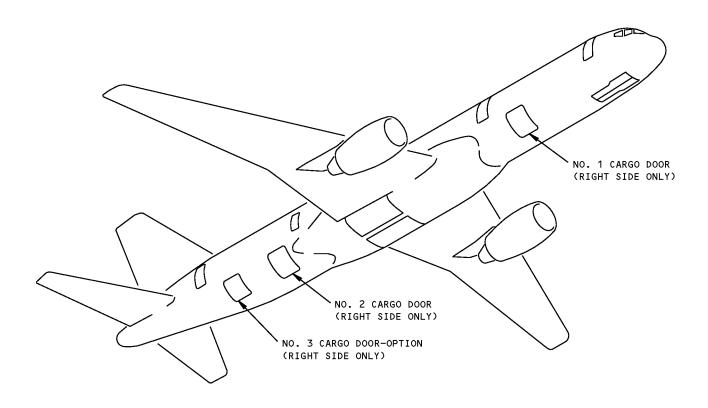
## **REPAIR GENERAL - TYPICAL SKIN REPAIRS FOR CARGO DOORS**

• REPAIRS FOR CARGO DOORS:

REFER TO REPAIR 1 FOR FLUSH SKIN REPAIR BETWEEN BEAMS

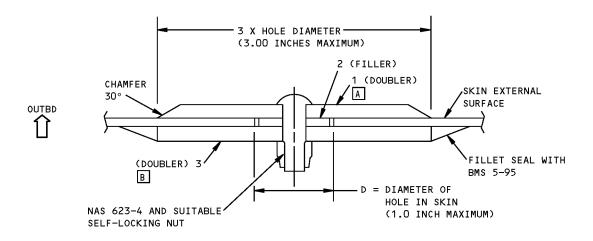
REPAIR MATERIAL						
	PART	MATERIAL					
1	DOUBLER	1	CLAD 2024-T3. 0.126 INCH THICK				
2	FILLER	1	CLAD 2024-T3. SAME THICKNESS AS THE TRIMMED SKIN				
3	DOUBLER	1	CLAD 2024-T3. 0.126 INCH THICK

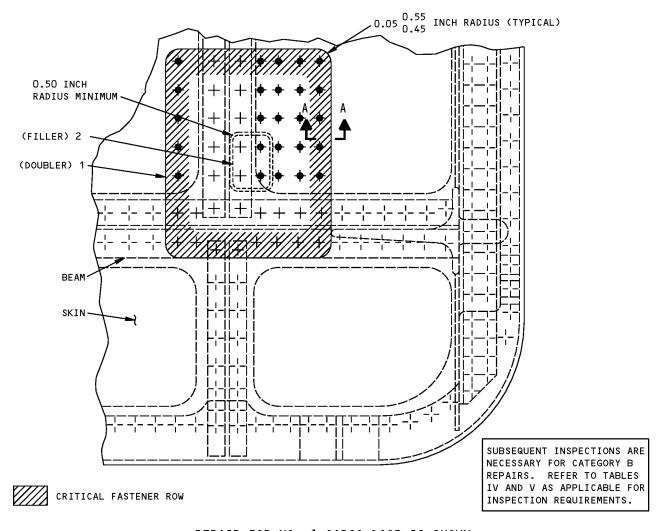
Cargo Doors - External Skin Repair Figure 201 (Sheet 3 of 6)

REPAIR FOR NO. 1 CARGO DOOR IS SHOWN ALL OTHER CARGO DOORS ARE ALMOST THE SAME DETAIL I

- Remove inner skin panel for access to damage area if required.
- 2. Remove fasteners as necessary.
- 3. Remove the damage to the skin to a rectangular shape with a minimum of 0.50 inch radius at the corners. The cutout must be parallel to the center line of the adjacent beams.

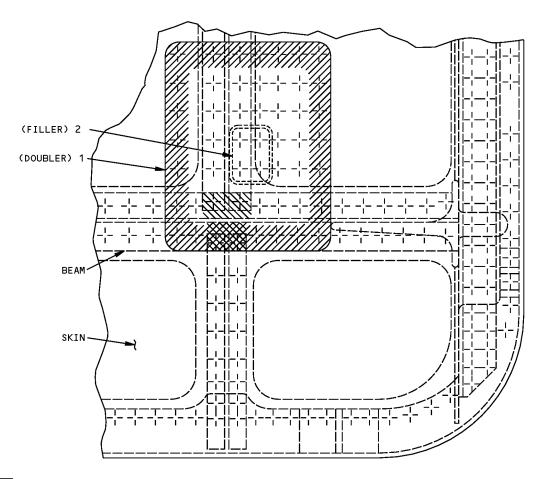
Cargo Doors - External Skin Repair Figure 201 (Sheet 5 of 6)

ALTERNATIVE (I) LFEC METHOD INSPECTION AREA. DO THE INSPECTION OF THE SKIN EXTERNALLY THROUGH THE PART 1 DOUBLER AT EVERY 3,000 FLIGHT CYCLES.

CATEGORY B REPAIR INSPECTION REQUIREMENTS FOR LOWER FORWARD, AFT AND BULK CARGO DOORS B							
INSPECTION	REFERENCE						
THRESHOLD	ALTERNATIVE METHOD		INTERVAL	KEI EKENCE			
37,500 TOTAL DOOR FLIGHT CYCLES FROM DATE	Ι	LOW FREQUENCY EDDY CURRENT (LFEC)	3,000 FLIGHT CYCLES	NDT PART 6, 53-00-06			
OF DELIVERY C	II	LOW FREQUENCY EDDY CURRENT (LFEC)	6,000 FLIGHT CYCLES	NDT PART 6, 53-00-07

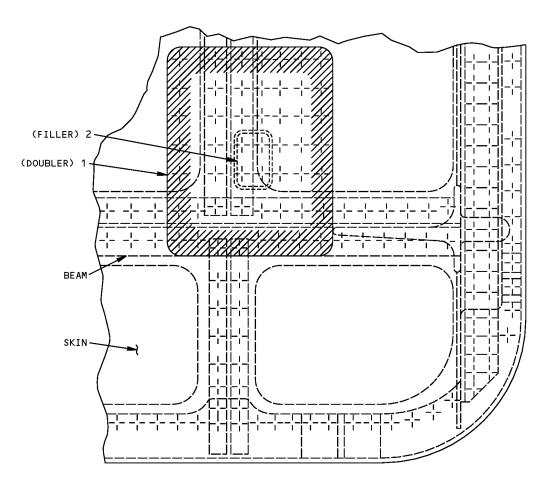
Cargo Doors - External Skin Repair Figure 201 (Sheet 6 of 6)

SKIN INSPECTION AREA. USE LFEC METHOD TO INSPECT THE SKIN EXTERNALLY THROUGH THE PART 1 DOUBLER AT EVERY 3,000 flight cycles.

INSPECTIONS FOR THE MAIN DECK CARGO DOOR DETAIL III

CATEGORY B REPAIR INSPECTION REQUIREMENTS FOR MAIN DECK CARGO DOOR							
INSPECTION	INSPECTION REPEAT INSPECTIONS REFERENCE						
THRESHOLD	METHOD	INTERVAL	REFERENCE				
37,500 TOTAL DOOR FLIGHT CYCLES FROM DATE OF DELIVERY C	LOW FREQUENCY EDDY CURRENT (LFEC)	3,000 FLIGHT CYCLES	NDT PART 6, 53-00-06

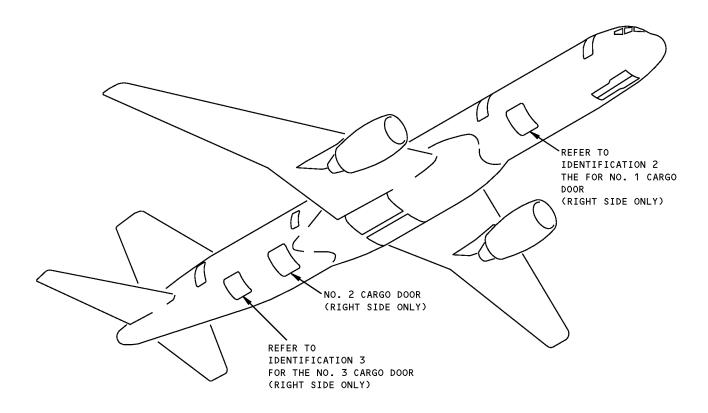
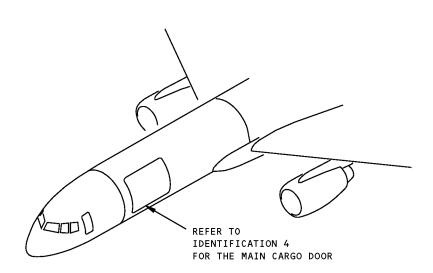
No. 2 Cargo Door Structure Identification Figure 1 (Sheet 1 of 4)

## **IDENTIFICATION 1 - NO. 2 CARGO DOOR STRUCTURE**

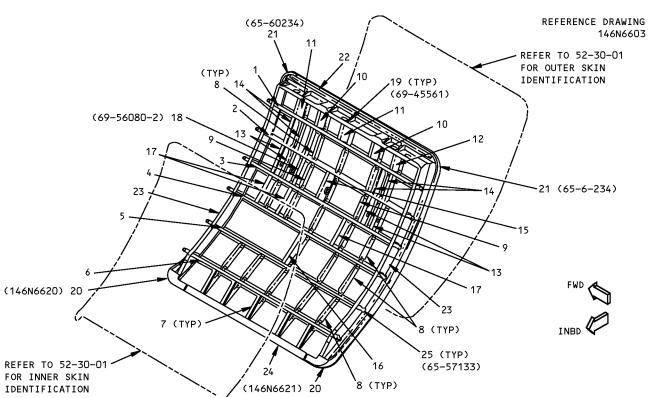
LIST OF MATERIALS

ITEM	DESCRIPTION	GAGE	MATERIAL	EFFECTIVITY
1	BEAM OUTER TEE		BAC1506-1912 2024-T3511 OR BAC1506-1912 2024-T42	
	WEB INNER ANGLE	0.071	7075-T6 BAC1514-1776 7075-T6511	
2	BEAM OUTER TEE		BAC1506-1926 2024-T3511 OR BAC1506-1926 2024-T42	
	WEB INNER ANGLE	0.063	7075-T6 BAC1514-1778 7075-T6511	
3	BEAM OUTER TEE		BAC1506-1924 2024-T3511 OR BAC1506-1924 2024-T42	
	WEB INNER ANGLE	0.063	7075-T6 BAC1514-1778 7075-T6511	
4	BEAM OUTER TEE		BAC1506-1925 2024-T3511 OR BAC1506-1925 2024-T42	
	WEB INNER ANGLE	0.063	7075-T6 BAC1514-1779 7075-T6511	
5	BEAM OUTER TEE		BAC1506-1926 2024-T3511 OR BAC1506-1926 2024-T42	
	WEB INNER ANGLE	0.063	7075-T6 BAC1514-1780 7075-T6511

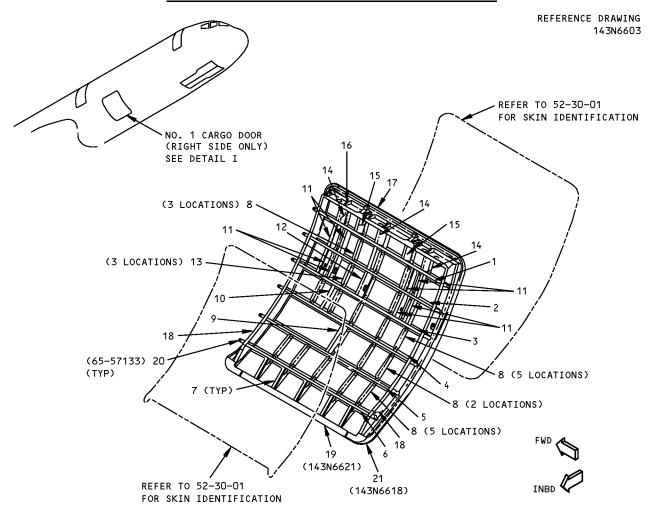
DETAIL I

## **IDENTIFICATION 2 - NO. 1 CARGO DOOR STRUCTURE**

ITEM	DESCRIPTION	GAGE	MATERIAL	EFFECTIVITY
1	BEAM OUTER TEE WEB ANGLE	0.071	BAC1506-1910 2024-T3511 CLAD 7075-T6 BAC1514-1776 7075-T6511	
2	BEAM OUTER TEE WEB ANGLE	0.063	BAC1506-1926 2024-T3511 CLAD 7075-T6 BAC1514-1777 7075-T6511	
3	BEAM OUTER TEE WEB ANGLE	0.063	BAC1506-1924 2024-T3511 CLAD 7075-T6 BAC1514-1778 7075-T6

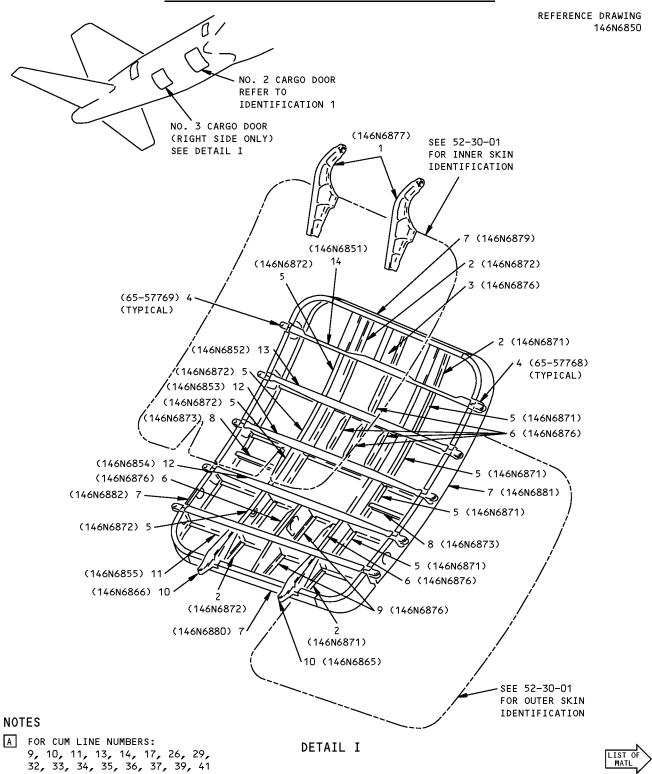
No. 3 Cargo Door Structure Identification Figure 1 (Sheet 1 of 2)

#### **IDENTIFICATION 3 - NO. 3 CARGO DOOR STRUCTURE**

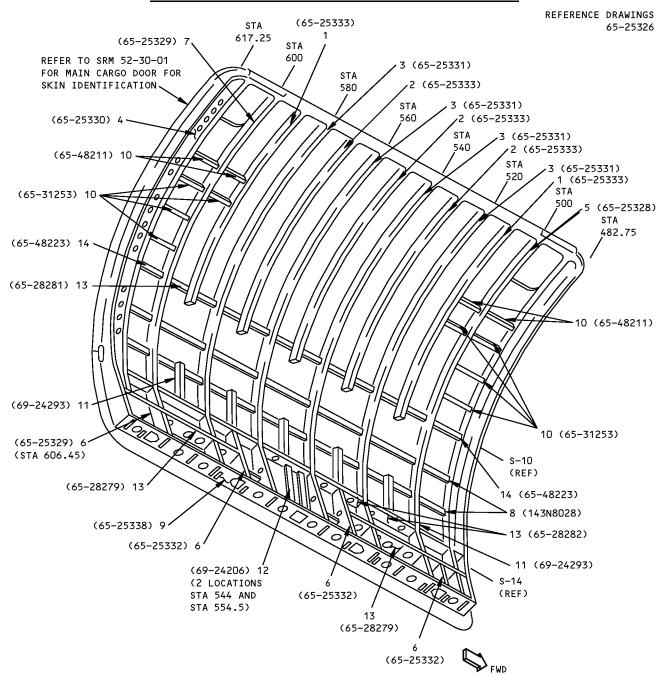
VIEW FROM INSIDE

#### **IDENTIFICATION 4 - MAIN DECK CARGO DOOR STRUCTURE**

(757-SF AIRPLANES ONLY)

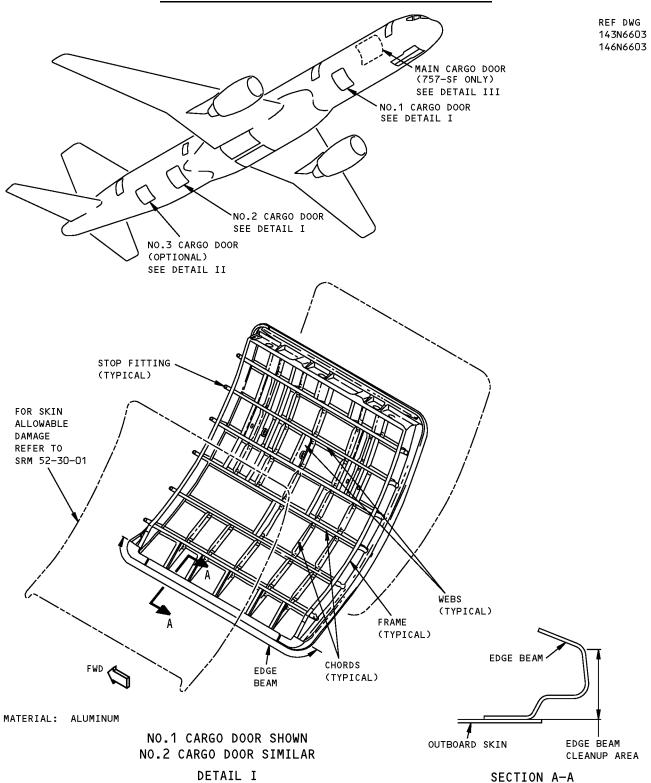
Cargo Door Structure Allowable Damage Figure 101 (Sheet 1 of 7)

## **ALLOWABLE DAMAGE 1 - CARGO DOOR STRUCTURE**

DESCRIPTION	CRACKS	NICKS, GOUGES AND CORROSION	DENTS	HOLES AND PUNCTURES
CHORD	А	D	NOT ALLOWED	NOT ALLOWED
FRAME	В	E	SEE DETAIL V	H
WEB	С	F	SEE DETAIL V	H
STOP FITTING I	A	G	NOT ALLOWED	NOT ALLOWED
HINGE I	Α	G	NOT ALLOWED	NOT ALLOWED
MACHINED FITTING [	А	G	NOT ALLOWED	NOT ALLOWED
EDGE BEAM	В	E	SEE DETAIL V	H

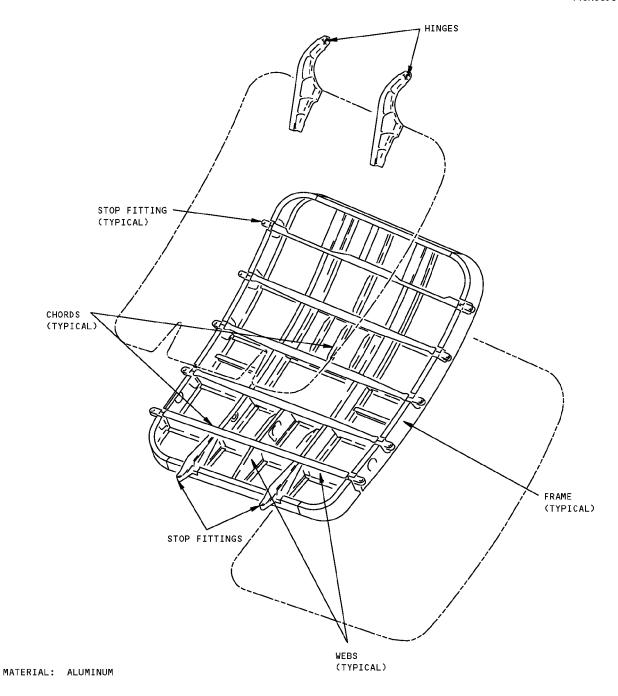
Cargo Door Structure Allowable Damage Figure 101 (Sheet 2 of 7)

NO.3 CARGO DOOR DETAIL II

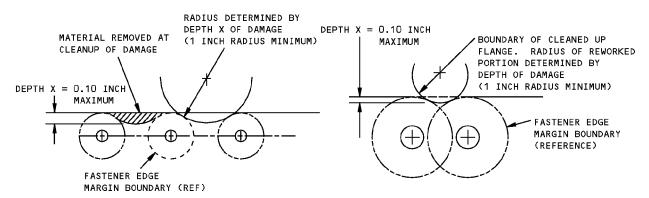
#### DETAIL III

DAMAGE CLEANUP OF EDGES WHERE FASTENER EDGE MARGINS DO NOT OVERLAP

DAMAGE CLEANUP OF EDGES WHERE FASTENER EDGE MARGINS OVERLAP

- D REMOVE DAMAGE PER DETAILS III, IV, VI
- E REMOVE DAMAGE PER DETAILS III, IV, VI AND
- F REMOVE DAMAGE PER DETAILS III, IV, VI AND VII
- G FOR EDGE DAMAGE SEE DETAILS III AND IX. FOR LUG DAMAGE, SEE DETAIL X. FOR OTHER DAMAGE, SEE DETAIL IV. DAMAGE NOT ALLOWED IN VICINITY OF BUSHINGS
- H CLEAN OUT DAMAGE UP TO 0.25 INCH (6.4 mm) MAXIMUM DIAMETER AND NOT CLOSER THAN 1.0 INCH (25.4 mm) TO FASTENER HOLE, MATERIAL EDGE, OR OTHER DAMAGE. FILL HOLE WITH 2117-T3 OR T4 ALUMINUM RIVET INSTALLED WET WITH BMS 5-95 SEALANT. ALL OTHER HOLES TO BE REPAIRED
- I SHOT PEEN REWORKED AREAS AS GIVEN IN SRM 51-20-06

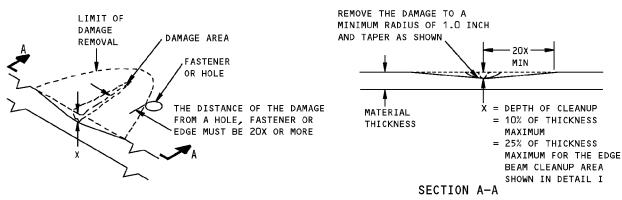
# REMOVAL OF DAMAGE ON A SURFACE DETAIL IV

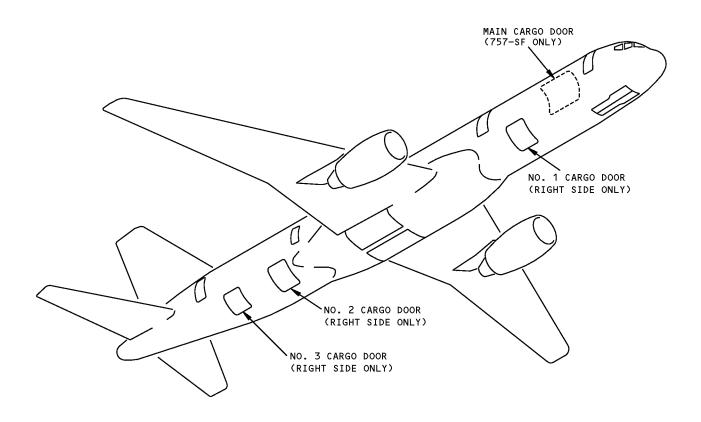
> Cargo Door Structure Repair Figure 201

## **REPAIR GENERAL - CARGO DOOR STRUCTURE**

• DAMAGED COMPONENTS IN DOOR STRUCTURE MAY BE REPLACED OR REPAIRED. IF REPAIRS ARE TO BE MADE, SEE 51-70 FOR TYPICAL WEB, FORMED SECTION, OR EXTRUDED SECTION REPAIRS

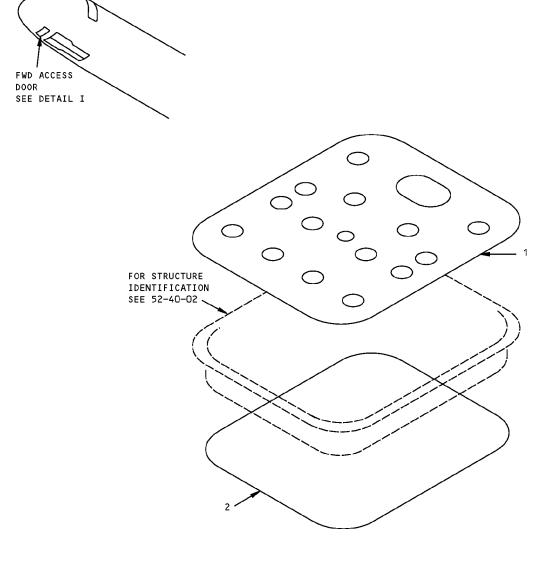
DETAIL I

## **IDENTIFICATION 1 - FORWARD ACCESS DOOR SKIN**

ITEM	DESCRIPTION	GAGE	MATERIAL	EFFECTIVITY
1	INNER SKIN	0.032	CLAD 2024-T3 OR 2024-T42	
2	OUTER SKIN	0.063	CLAD 2024-T3 (CHEM-MILLED TO 0.042 MIN)

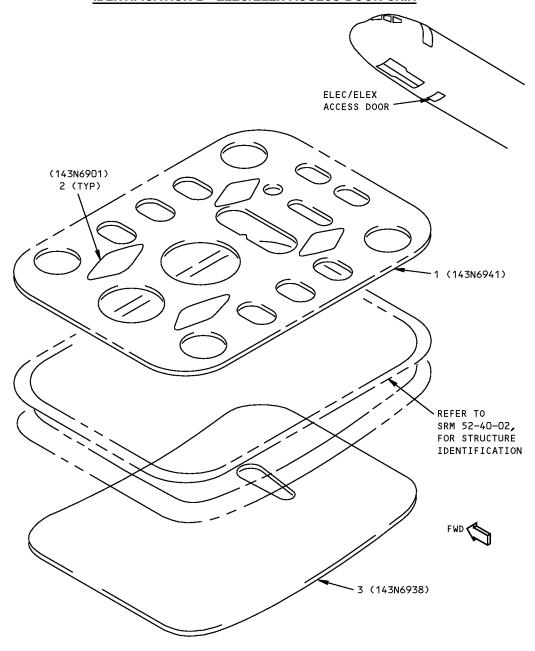
# IDENTIFICATION 2 - ELEC/ELEX ACCESS DOOR SKIN

ITEM	DESCRIPTION	GAGE	MATERIAL	EFFECTIVITY
1	INNER SKIN		CLAD 2024-T3	
2	STRAP	0.040	CLAD 2024-T3	
3	OUTER SKIN	0.063	CLAD 2024-T3 (CHEM-MILLED TO 0.040 MIN)

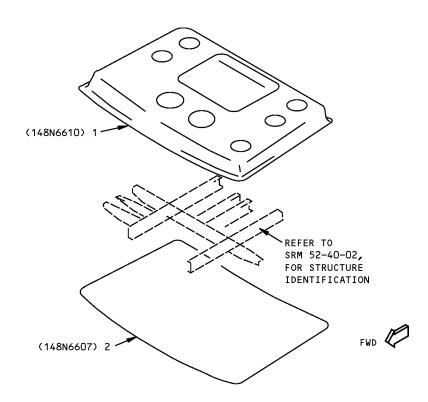
## **IDENTIFICATION 3 - ELEVATOR CONTROL ACCESS DOOR SKIN**

ITEM	DESCRIPTION	GAGE	MATERIAL	EFFECTIVITY
1	INNER SKIN	0.040	CLAD 2024-T42	
2	OUTER SKIN	0.056	CLAD 7075-T6 (CHEM-MILLED TO 0.036 MIN)

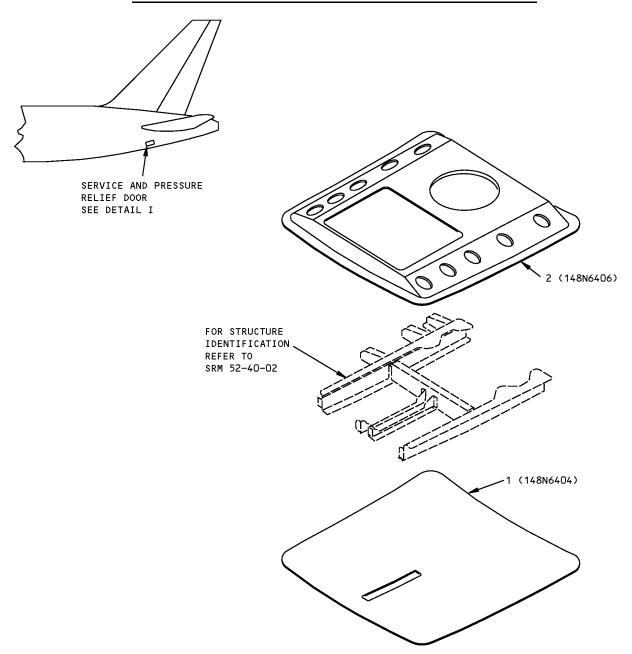
DETAIL I

## **IDENTIFICATION 4 - SERVICE AND PRESSURE RELIEF DOOR SKIN**

ITEM	DESCRIPTION	GAGE	MATERIAL	EFFECTIVITY
1	OUTER SKIN	0.056	CLAD 7075-T6 (CHEM-MILLED TO 0.036 MIN)	
2	INNER SKIN	0.040	CLAD 2024-T42

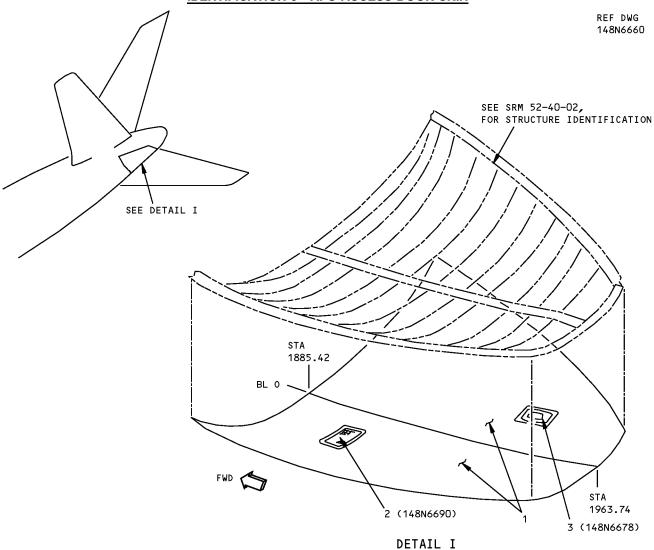
LIST OF MATERIALS FOR DETAIL I

## **IDENTIFICATION 5 - APU ACCESS DOOR SKIN**

ITEM	DESCRIPTION	GAGE	MATERIAL	EFFECTIVITY
1	skin	0.016	ALUMINUM LAMINATED SHEETS PER BMS 5-69, TYPE 1, CLASS 1, GRADE B	
2	VENTED DOOR			
	SKIN	0.04	CLAD 2024-T3	
	DOUBLER	0.056	CLAD 2024-T3	
3	DOUBLER	0.04	CLAD 2024-T42

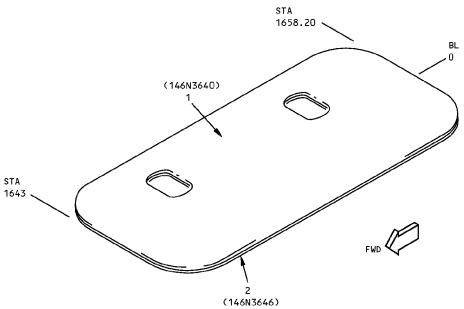
LIST OF MATERIALS

ITEM	DESCRIPTION	GAGE	MATERIAL	EFFECTIVITY
1	OUTER SKIN	0.040	CLAD 2024-T3	
2	INNER SKIN	0.032	CLAD 2024-T42

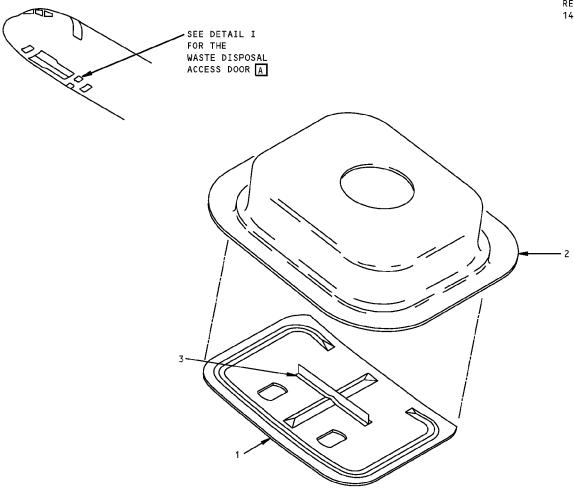
## **IDENTIFICATION 7 - WASTE DISPOSAL ACCESS DOOR SKIN**

A FOR CUM LINE NUMBERS: 1 THRU 846

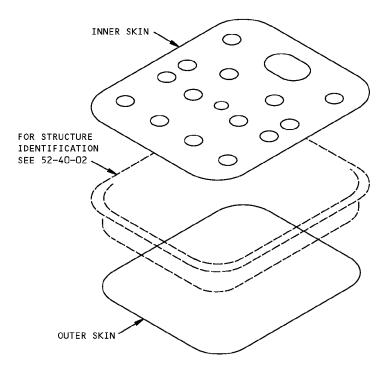
Allowable Damage - Forward Access Door Skin Figure 101 (Sheet 1 of 3)

### ALLOWABLE DAMAGE 1 - ALLOWABLE DAMAGE - FORWARD ACCESS DOOR SKIN

ITEM	CRACKS	NICKS, GOUGES AND CORROSION	DENTS	HOLES AND PUNCTURES
OUTER SKIN A	В	D	SEE DETAIL IV	E
INNER SKIN	С	G	SEE DETAIL IV	F

- REFER TO 51-10-01 FOR INVESTIGATION AND CLEANUP OF DAMAGE
- REFINISH REWORK AREAS PER 51-20 OF THE MAINTENANCE MANUAL
- A REFER TO 51-10-01 FOR AERODYNAMIC SMOOTH-NESS REQUIREMENTS. WHERE THE DAMAGE EXCEEDS THE LIMITS SHOWN IN 51-10-01, CONSIDERATION SHOULD BE GIVEN TO THE LOSS OF PERFORMANCE INVOLVED
- B CRACKS NOT ALLOWED EXCEPT FOR EDGE CRACKS WHICH MUST BE REMOVED PER DETAILS II AND VI
- C SEE DETAIL VIII FOR LIGHTENING HOLE EDGE CRACKS. FOR OTHER EDGE CRACKS, SEE DETAIL II. FOR OTHER CRACKS, SEE DETAIL VII

- D REMOVE DAMAGE PER DETAILS II, III, V AND VI
- E CLEAN OUT DAMAGE UP TO 0.25 MAX DIA AND NOT CLOSER THAN 1.0 INCH TO FASTENER HOLE, MATERIAL EDGE, OR OTHER DAMAGE. FILL HOLE WITH 2117-T3 OR T4 ALUMINUM RIVET INSTALLED WET WITH BMS 5-95 SEALANT. ALL OTHER HOLES TO BE REPAIRED
- F CLEAN OUT DAMAGE UP TO 0.50 MAX DIA AND NOT CLOSER THAN 1.0 INCH TO FASTENER HOLE, MATERIAL EDGE, OR OTHER DAMAGE
- G REMOVE DAMAGE PER DETAILS II, III, V AND VI. CORROSION MAY BE DRILLED OUT UP TO 0.5 MAX DIA PROVIDED FASTENER EDGE MARGINS ARE MAINTAINED PER DETAIL VII

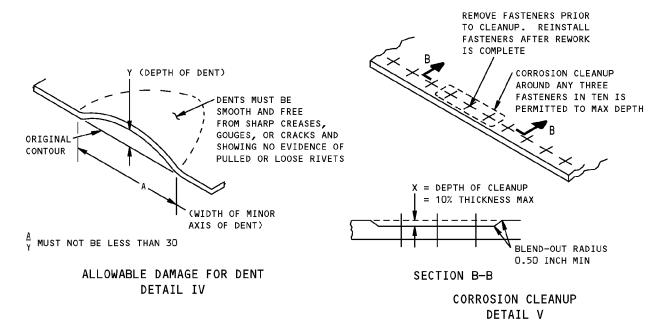
Allowable Damage - Forward Access Door Skin Figure 101 (Sheet 2 of 3)

REMOVAL OF NICK, GOUGE AND SCRATCH DAMAGE ON A SURFACE DETAIL III

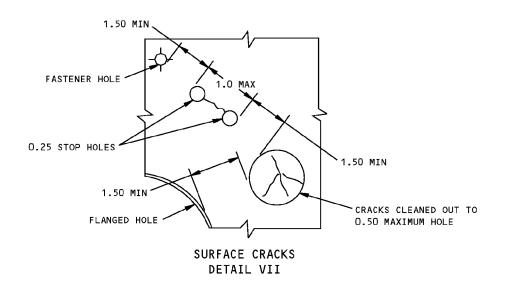
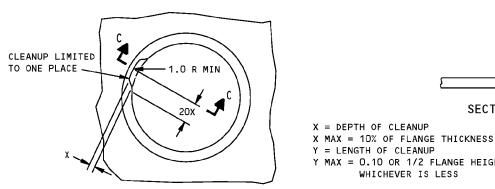
REMOVAL OF NICK OR CRACK DAMAGE ON AN EDGE DETAIL VI

Y MAX = 0.10 OR 1/2 FLANGE HEIGHT, WHICHEVER IS LESS

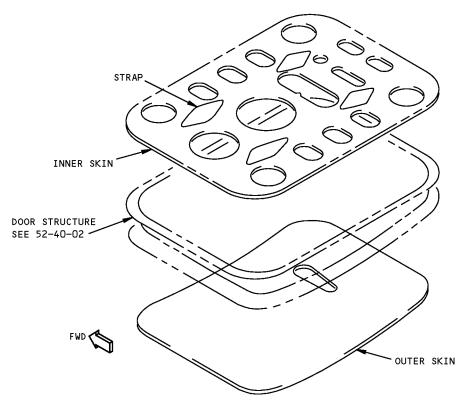
DETAIL I

#### ALLOWABLE DAMAGE 2 - ALLOWABLE DAMAGE - ELEC/ELEX ACCESS DOOR SKIN

ITEM	CRACKS	NICKS, GOUGES AND CORROSION	DENTS	HOLES AND PUNCTURES
OUTER SKIN A	В	D	SEE DETAIL IV	E
INNER SKIN	С	G	SEE DETAIL IV	F
STRAPS	В	D	SEE DETAIL IV	E

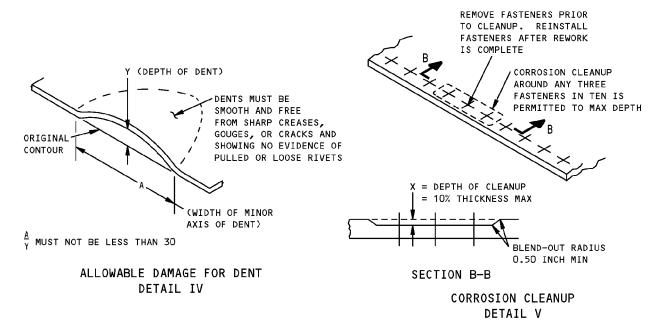
Allowable Damage - Elec/Elex Access Door Skin Figure 101 (Sheet 2 of 3)

REMOVAL OF NICK, GOUGE AND SCRATCH DAMAGE ON A SURFACE DETAIL III

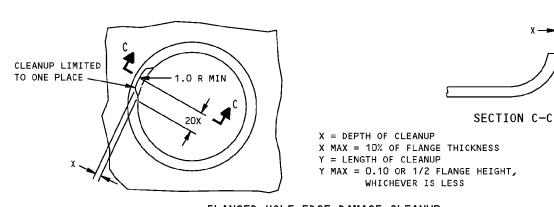
FLANGED HOLE EDGE DAMAGE CLEANUP
DETAIL VIII

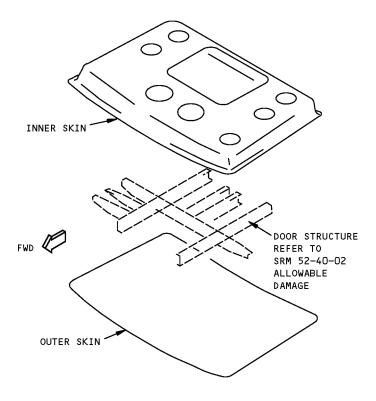
DETAIL I

#### ALLOWABLE DAMAGE 3 - ALLOWABLE DAMAGE - ELEVATOR CONTROL ACCESS DOOR SKIN

ITEM	CRACKS	NICKS, GOUGES AND CORROSION	DENTS	HOLES AND PUNCTURES
OUTER SKIN A	В	D	SEE DETAIL IV	DE
INNER SKIN	С	G	SEE DETAIL IV	F

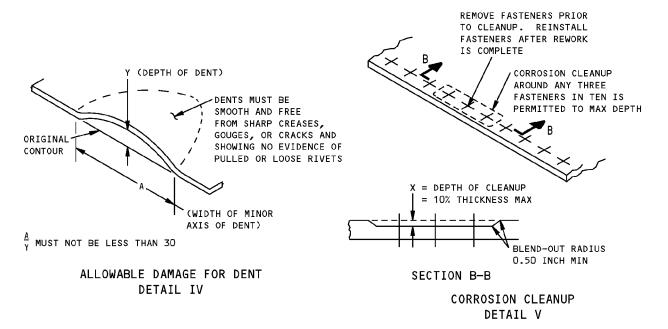
Allowable Damage - Elevator Control Access Door Skin Figure 101 (Sheet 2 of 3)

REMOVAL OF NICK, GOUGE AND SCRATCH DAMAGE ON A SURFACE DETAIL III

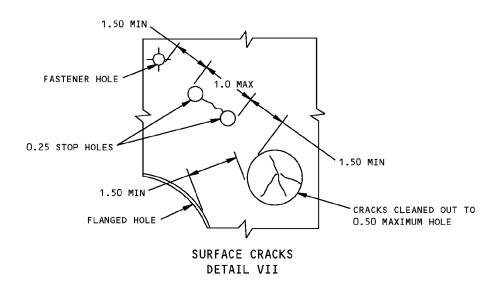
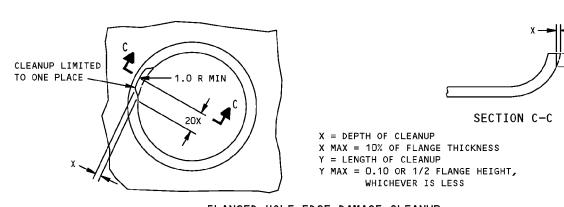
REMOVAL OF NICK OR CRACK DAMAGE ON AN EDGE DETAIL VI

FLANGED HOLE EDGE DAMAGE CLEANUP
DETAIL VIII

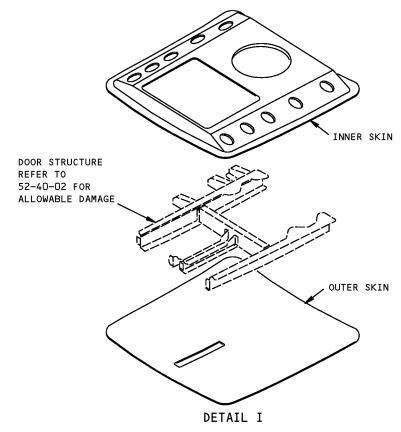
### ALLOWABLE DAMAGE 4 - ALLOWABLE DAMAGE - AFT BODY ACCESS DOOR SKIN

ITEM	CRACKS	NICKS, GOUGES AND CORROSION	DENTS	HOLES AND PUNCTURE'S
OUTER SKIN A	В	D	SEE DETAIL IV	E
INNER SKIN	C	G	SEE DETAIL IV	F

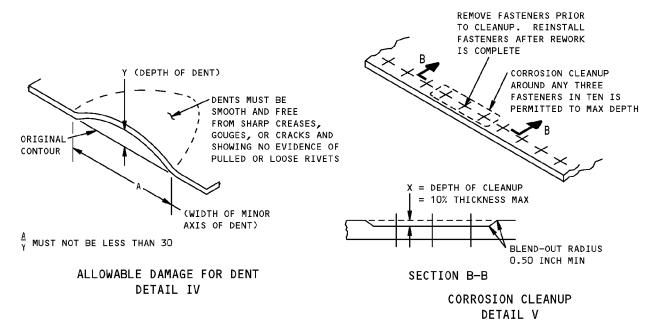
Allowable Damage - Aft Body Access Door Skin Figure 101 (Sheet 2 of 3)

REMOVAL OF NICK, GOUGE AND SCRATCH DAMAGE ON A SURFACE DETAIL III

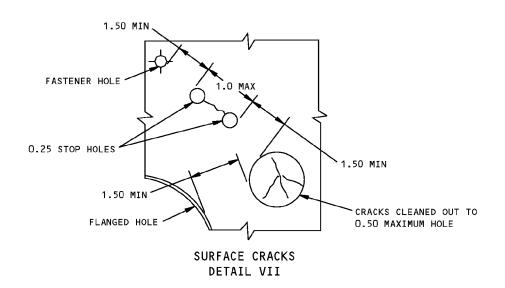
REMOVAL OF NICK OR CRACK DAMAGE ON AN EDGE DETAIL VI

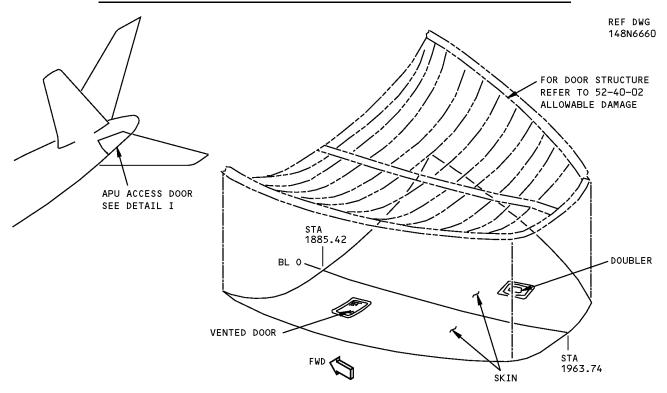
DETAIL I

### ALLOWABLE DAMAGE 5 - ALLOWABLE DAMAGE - APU ACCESS DOOR SKIN

ITEM	CRACKS	NICKS, GOUGES AND CORROSION	DENTS	HOLES AND PUNCTURES
OUTER SKIN A	В	D	SEE DETAIL IV	E
INNER SKIN	С	G	SEE DETAIL IV	F
DOUBLER	В	D	SEE DETAIL IV	E

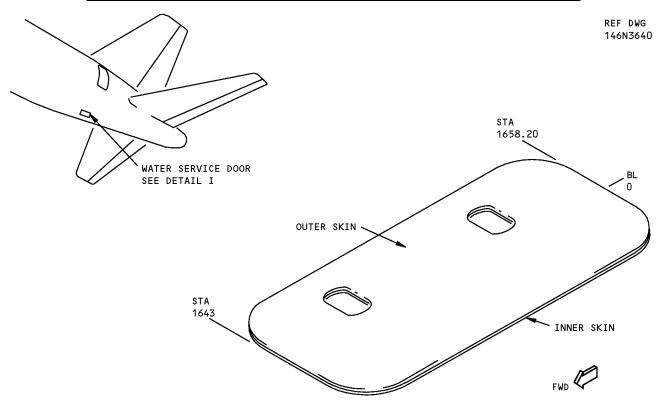
#### ALLOWABLE DAMAGE 6 - ALLOWABLE DAMAGE - WATER SERVICE DOOR SKIN

ITEM	CRACKS	NICKS, GOUGES AND CORROSION	DENTS	HOLES AND PUNCTURE'S
OUTER SKIN A	В	D	SEE DETAIL IV	E
INNER SKIN	С	G	SEE DETAIL IV	F

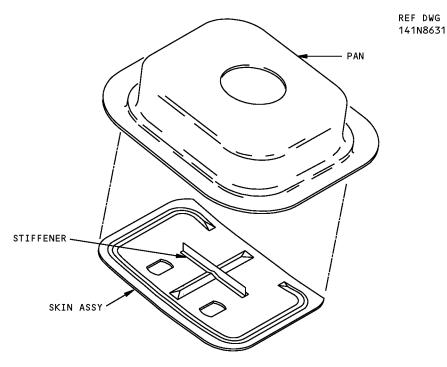
DETAIL I

### ALLOWABLE DAMAGE 7 - ALLOWABLE DAMAGE - WASTE DISPOSAL ACCESS DOOR SKIN

ITEM	CRACKS	NICKS, GOUGES AND CORROSION	DENTS	HOLES AND PUNCTURES
OUTER SKIN A	В	D	SEE DETAIL IV	E
PAN	С	G	SEE DETAIL IV	F

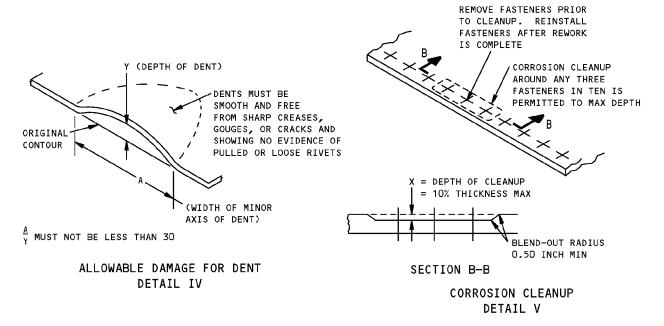
REMOVAL OF NICK, GOUGE AND SCRATCH DAMAGE ON A SURFACE DETAIL III

Allowable Damage - Waste Disposal Access Door Skin Figure 101 (Sheet 2 of 3)

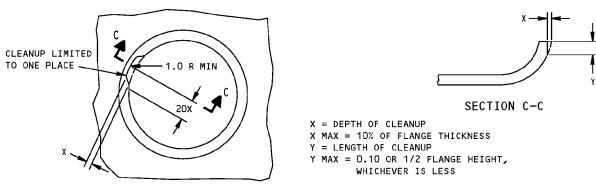
FLANGED HOLE EDGE DAMAGE CLEANUP
DETAIL VIII

Allowable Damage - Waste Disposal Access Door Skin Figure 101 (Sheet 3 of 3)

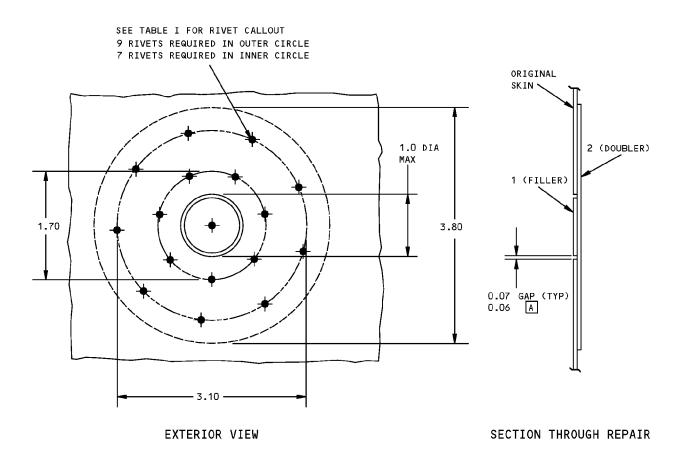
Small Hole Flush Repair - Access Doors Figure 201 (Sheet 2 of 2)

REPAIR MATERIAL						
PART QTY G			GAGE	MATERIAL			
1	FILLER	1	С	CLAD 2024-T3			
2	DOUBLER	1	D	CLAD 2024-T3 FOR SEC 41 THRU SEC 46 CLAD 7075-T6 FOR SEC 48

ORIGINAL SKIN THICKNESS	REPAIR RIVET
0.040	BACR15CE4D
0.040 THRU 0.050	BACR15CE5D
0.063 THRU 0.071	BACR15CE6D

- Remove the inner skin panel for access if required.
- Clean out the damaged hole to 1-inch (25 mm) diameter maximum. The center of the hole to an edge or cutout must not be less than 1.90 inches (48 mm).

- 3. Make repair parts 1 and 2.
- 4. Assemble repair parts in installed position and drill fastener holes.
- 5. Remove repair parts.
- 6. Break sharp edges of original and repair parts 0.015 to 0.030 inch (0.4 to 0.8 mm).

- THIS REPAIR IS NOT TO BE USED IN AREAS WITH DOUBLERS AND THE SKIN GAGE MUST BE CONSTANT
- REFER TO 51-10-02 FOR INSPECTION AND REMOVAL OF DAMAGE
- REFER TO SRM 51-40 FOR FASTENER CODE, REMOVAL, INSTALLATION, HOLE SIZES, EDGE MARGINS AND SUBSTITUTIONS
- A REFER TO SRM 51-10-01 FOR AERODYNAMIC SMOOTHNESS REQUIREMENTS
- B WHERE RIVET SUBSTITUTIONS ARE MADE THE COUNTERSINK DEPTH FOR BACR15CE RIVETS MUST BE MAINTAINED AND THE EXCESS PORTION OF THE SUBSTITUTE RIVET HEAD SHAVED OFF AFTER INSTALLATION PER SRM 51-10-01
- MATERIAL THICKNESS TO BE THE SAME GAGE AS TOTAL SKIN THICKNESS IN REPAIR AREA (LAMINATED SKINS)
- D MATERIAL THICKNESS TO BE ONE GAGE THICKER THAN TOTAL SKIN THICKNESS IN REPAIR AREA

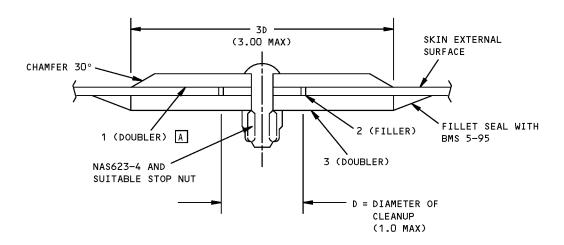
Small Hole - External Repair Figure 201 (Sheet 2 of 2)

REPAIR MATERIAL					
PART QTY GAGE MATERIAL						
1	DOUBLER	1	В	CLAD 2024-T3		
2	FILLER	1	С	CLAD 2024-T3		
3	DOUBLER	1	В	CLAD 2024-T3

- Remove the inner skin panel for access if required.
- Clean out the damaged hole to 1.00 inch (25 mm) diameter maximum. The center of the hole to an edge or cutout must not be less than 4D.

- REFER TO SRM 51-10-01 FOR AERODYNAMIC SMOOTHNESS REQUIREMENTS
- REFER TO SRM 51-10-02 FOR INSPECTION AND REMOVAL OF DAMAGE
- REFER TO SRM 51-40 FOR FASTENER CODE, REMOVAL, INSTALLATION, HOLE SIZES, EDGE MARGINS AND SUBSTITUTIONS
- A THIS REPAIR IS NOT TO BE USED IN AREAS WITH DOUBLERS. THE AREA UNDER REPAIR PART 1 MUST NOT HAVE ANY FASTENERS, AND THE SKIN GAGE MUST BE CONSTANT
- B MATERIAL THICKNESS TO BE 2 TIMES THE TOTAL SKIN THICKNESS IN REPAIR AREA
- MATERIAL THICKNESS TO BE THE SAME GAGE AS TOTAL SKIN THICKNESS IN REPAIR AREA (LAMINATED SKINS)

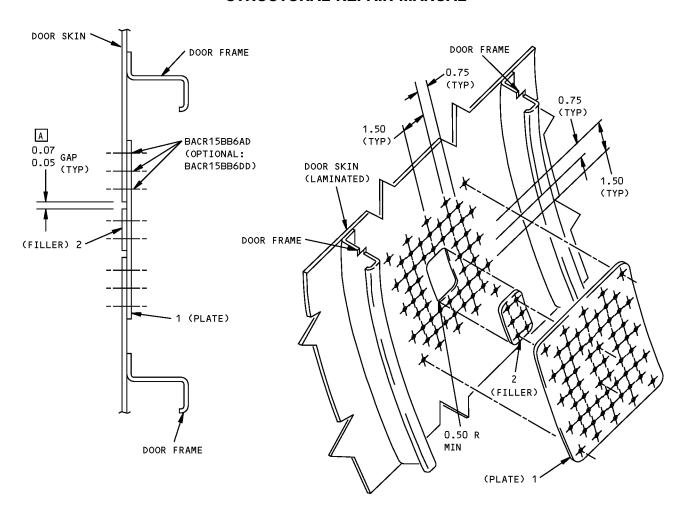
APU Access Door - Flush Skin Repair Between Beams Figure 201 (Sheet 2 of 2)

REPAIR MATERIAL					
PART		QTY	GAGE	MATERIAL	
1	PLATE	1	0.040	CLAD 2024-T3	
2	FILLER	1	0.032	CLAD 2024-T3

- Remove the inner skin panel for access if required.
- Clean out the damage to the skin to a rectangular shape with a minimum of 0.50 inch (12.7 mm) radius at the corners. The cutout should be parallel to the centerline of the adjacent beam.

- REFER TO 51-10-02 FOR INSPECTION AND REMOVAL OF DAMAGE
- REFER TO SRM 51-40 FOR FASTENER CODE, REMOVAL, INSTALLATION, HOLE SIZES, EDGE MARGINS AND SUBSTITUTIONS.
- A REFER TO SRM 51-10-01 FOR AERODYNAMIC SMOOTHNESS REQUIREMENTS
- B WHERE RIVET SUBSTITUTIONS ARE MADE THE COUNTERSINK DEPTH FOR BACR15CE RIVETS MUST BE MAINTAINED AND THE EXCESS PORTION OF THE SUBSTITUTE RIVET HEAD SHAVED OFF AFTER INSTALLATION PER SRM 51-10-01

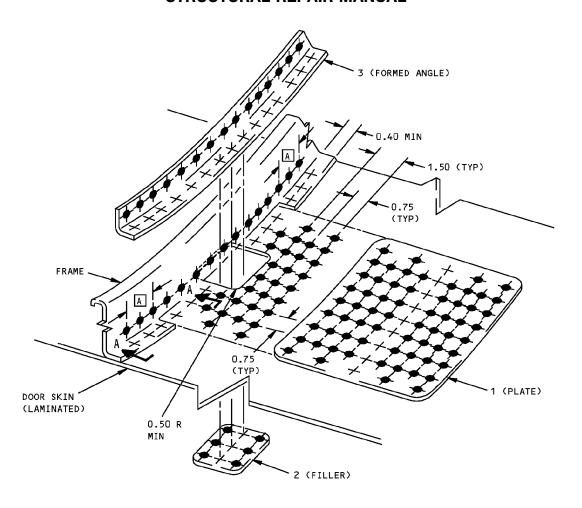
APU Accss Door - Flush Skin Repair at Frames Figure 201 (Sheet 2 of 2)

REPAIR MATERIAL					
PART		QTY	GAGE	MATERIAL		
1	PLATE	1	E	CLAD 2024-T3		
2	FILLER	1	0.032	CLAD 2024-T3		
3	FORMED ANGLE	1	0.063	CLAD 2024-T4 OR CLAD 2024-O HT TR T42 D

- Remove inner skin panel for access to the damaged area if required.
- Clean out damage to skin to a rectangular shape parallel to the frames with a minimum corner radius of 0.50 inch (12.7 mm).

- Cut out frame flanges to width of repair plate to permit its insertion against the skin.
- 4. Make repair parts.
- 5. Assemble repair parts and drill the fastener holes in original and new locations. Add spacer or shims between part 1 plate or inner side of frame flange and new angles, whichever is required to fill gap.

- REFER TO SRM 51-10-02 FOR INSPECTION AND REMOVAL OF DAMAGE
- REFER TO SRM 51-40 FOR FASTENER CODE, REMOVAL, INSTALLATION, HOLE SIZES, EDGE MARGINS, COUNTERSINKING, AND FASTENER SUBSTITUTIONS
- A MINIMUM OF THREE FASTENERS IN EACH ROW
  JOINING REPAIR ANGLES TO ORIGINAL SECTION
- B FOR AERODYNAMIC SMOOTHNESS REQUIREMENTS, REFER TO SRM 51-10-01
- C WHERE RIVET SUBSTITUTIONS ARE MADE, THE COUNTERSINK DEPTH FOR BACR15CE RIVETS MUST BE MAINTAINED AND THE EXCESS PORTION OF THE SUBSTITUTE RIVET HEAD SHAVED OFF AFTER INSTALLATION PER SRM 51-10-01
- D SELECT MATERIAL SO THAT FORMED HEADS OF RIVET DO NOT RIDE RADIUS OF FORMED ANGLE
- E SAME GAGE AS ORIGINAL FRAME

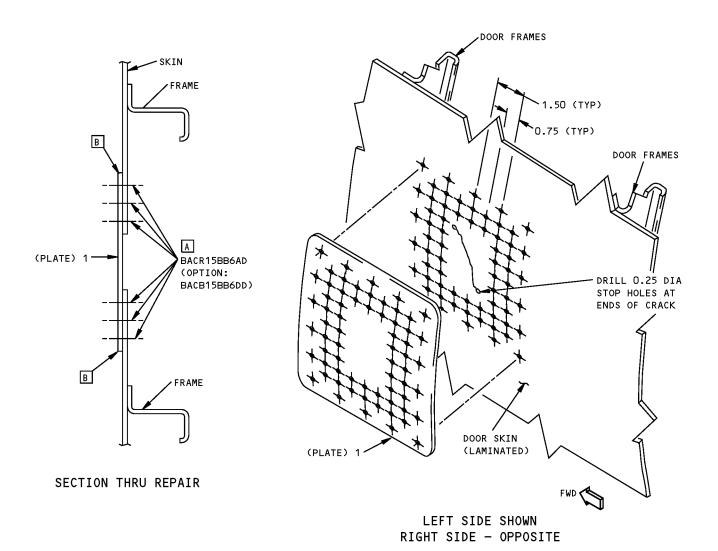
APU Access Door - External Skin Repairs Figure 201 (Sheet 2 of 2)

REPAIR MATERIAL					
PART		QTY	GAGE	MATERIAL	
1	PLATE	1	0.040	CLAD 2024-T3

- Remove inner skin panel for access to damaged area if required.
- 2. Drill 0.25 inch (6 mm) diameter stop hole at extremities of crack.
- 3. Remove fasteners as required.
- 4. Make repair part.
- Assemble repair part and drill fastener holes.
- 6. Remove repair part.
- 7. Break sharp edges of repair part 0.015 to 0.030 inch (0.4 to 0.8 mm).
- Remove all nicks, scratches, burrs, sharp edges and corners from original and repair part.
- Alodize the raw edges of repair part per SRM 51-20-01.
- 10. Apply one coat of BMS 10-11, type 1, primer in accordance with AMM 51-21-00.
- 11. Install plate (part 1), making a faying surface seal with BMS 5-95 sealant as described in SRM 51-20-05.
- Install fasteners wet with BMS 5-95 sealant.
- 13. Restore finish in accordance with AMM 51-20-00.

- REFER TO SRM 51-10-02 FOR INSPECTION AND REMOVAL OF DAMAGE
- REFER TO SRM 51-40 FOR FASTENER CODE, REMOVAL, INSTALLATION, HOLE SIZES, EDGE MARGINS, COUNTERSINKING, AND FASTENER SUBSTITUTIONS
- WHERE RIVET SUBSTITUTIONS ARE MADE, THE COUNTERSINK DEPTH FOR BACR15CE RIVETS MUST BE MAINTAINED AND THE EXCESS PORTION OF THE SUBSTITUTE RIVET HEAD SHAVED OFF AFTER INSTALLATION PER SRM 51-10-01
- B REFER TO SRM 51-10-01 FOR AERODYNAMIC SMOOTHNESS REQUIREMENTS

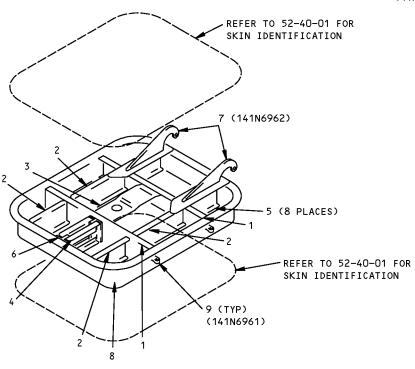
DETAIL I

ITEM	DESCRIPTION	GAGE	MATERIAL	EFFECTIVITY
1	BEAM WEB TEE	0.071	CLAD 7075-T6 BAC1505-100350 2024-T3511	
2	INTERCOSTAL WEB TEE	0.050	CLAD 7075-T6 BAC1506-2195 2024-T3511	
3	CHANNEL	0.071	CLAD 7075-T62	
4	ANGLE		BAC1490-2507 CLAD 7075-T6	
5	ANGLE		BAC1490-2736 CLAD 7075-T6	
6	LATCH FITTING		7075-T73 FORGING	
7	HINGE ARM	0.313	7075-T651	
8	PAN	0.050	CLAD 2024-T42	
9	STOP FITTING		BAC1520-2207 2024-T3511 OR BAC1520-2215 2024-T3511

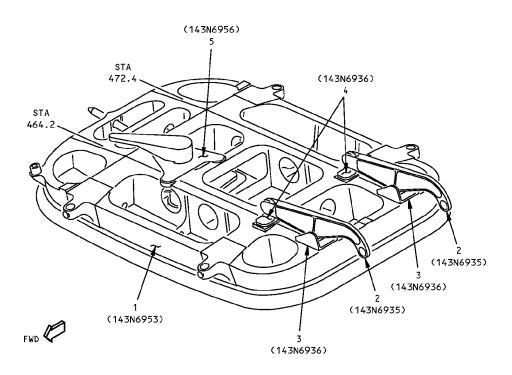
DETAIL II B

ITEM	DESCRIPTION	GAGE	MATERIAL	EFFECTIVITY
1	FRAMEWORK		357.0-T6 CASTING AS GIVEN IN BMS 7-330	
2	HINGE FITTING		7075-T73 FORGING AS GIVEN IN BMS 7-186	
3	HINGE ATTACHMENT FITTING		BAC1509-100043 7075-T7351 PLATE (OPTIONAL: 7075-T73511 EXTRUSION)	
4	HINGE ATTACHMENT FITTING		BAC1505-100552 7075-T7351 PLATE (OPTIONAL: 7075-T73511 EXTRUSION)	
5	HANDLE PLATE		7050-T7451 PLATE (OPTIONAL: 7075-T7351 PLATE)

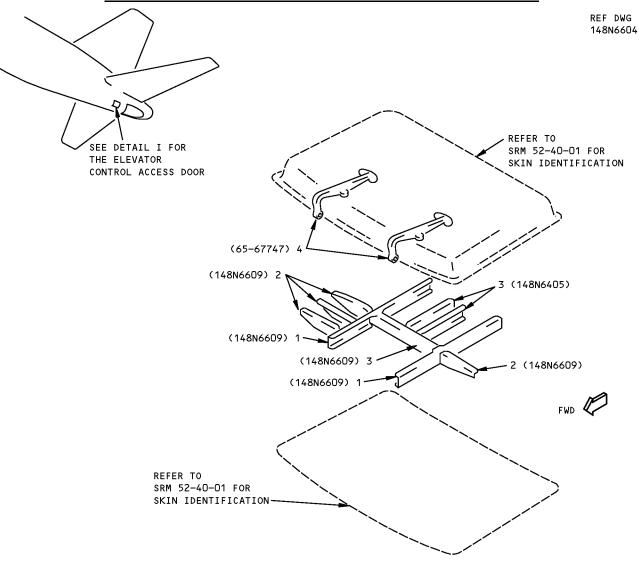
### **IDENTIFICATION 3 - ELEVATOR CONTROL ACCESS DOOR STRUCTURE**

ITEM	DESCRIPTION	GAGE	MATERIAL	EFFECTIVITY
1	BEAM TEE ANGLE	0.040	BAC1505-101127 7075-T6511 CLAD 2024-T42	
2	GUSSET	0.040	CLAD 2024-T42	
3	CHORD	0.040	CLAD 2024-T42	
4	HINGE		7075-T6 FORGING

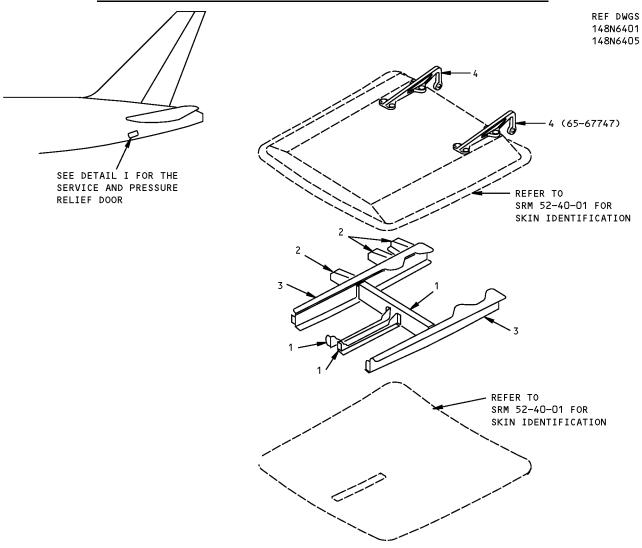
### **IDENTIFICATION 4 - SERVICE AND PRESSURE RELIEF DOOR STRUCTURE**

ITEM	DESCRIPTION	GAGE	MATERIAL	EFFECTIVITY
1	CHORD	0.040	CLAD 2024-T42	
2	GUSSET	0.040	CLAD 2024-T42	
3	STRINGER ASSY			
	ANGLE	0.040	CLAD 2024-T42	
	TEE		BAC1505-101127 7075-T6511	
4	HINGE		7075-T6 FORGING

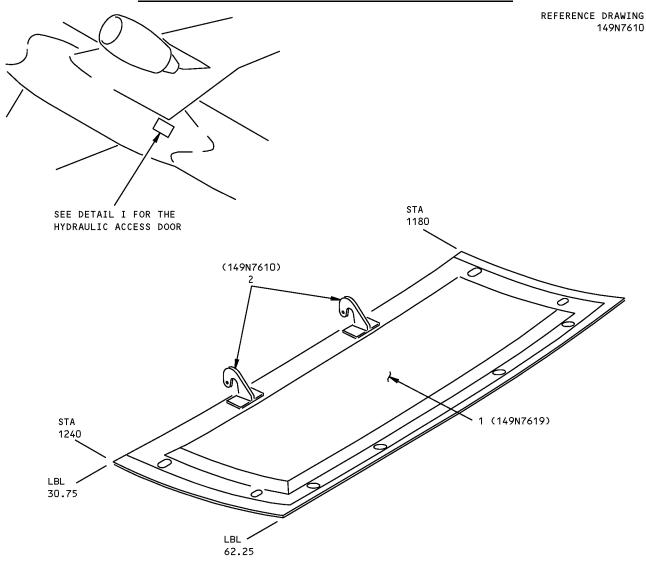
### **IDENTIFICATION 5 - HYDRAULIC ACCESS DOOR STRUCTURE**

ITEM	DESCRIPTION	GAGE	MATERIAL	EFFECTIVITY
1	SKIN PANEL SKIN CORE		ARAMID/GRAPHITE/EPOXY HONEYCOMB SANDWICH  SEE DETAIL I  NOMEX HONEYCOMB PER BMS 8-124, CLASS IV, TYPE  V, GRADE 3.0	
2	CLEVIS		FORGING OR FORGED BLOCK 7075-T73

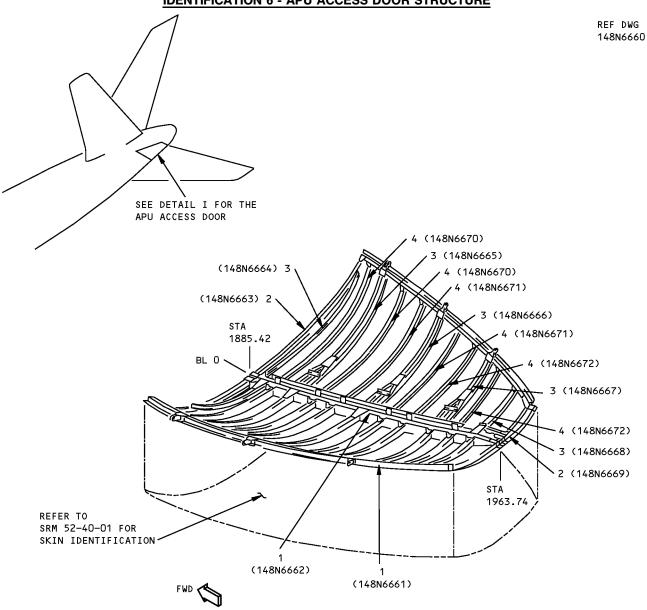
### **IDENTIFICATION 6 - APU ACCESS DOOR STRUCTURE**

ITEM	DESCRIPTION	GAGE	MATERIAL	EFFECTIVITY
1	EDGE MEMBER	0.056	CLAD 2024-T42	
2	FRAME	0.071	CLAD 2024-T42	
3	FRAME	0.05	CLAD 2024-T42	
4	FRAME		BAC1517-334 CLAD 2024-T42

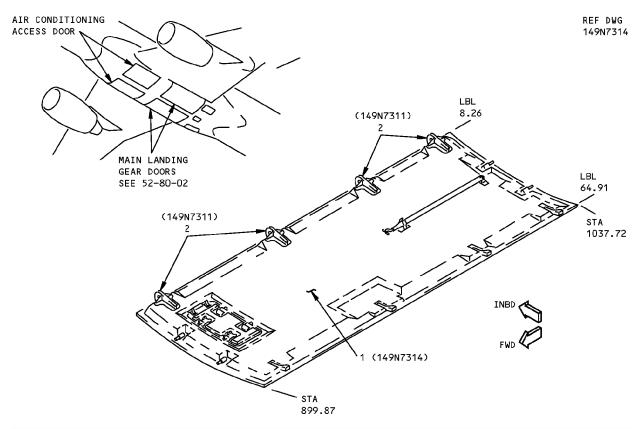
#### **IDENTIFICATION 7 - AIR CONDITIONING ACCESS DOOR STRUCTURE**

ITEM	DESCRIPTION	GAGE	MATERIAL	EFFECTIVITY
1	DOOR PANEL SKIN CORE		ARAMID/GRAPHITE/EPOXY HONEYCOMB SANDWICH SEE DETAIL I NOMEX HONEYCOMB PER BMS 8-124, CLASS IV, TYPE V, GRADE 3.0	
2	HINGE FITTING		7075-T73 FORGING

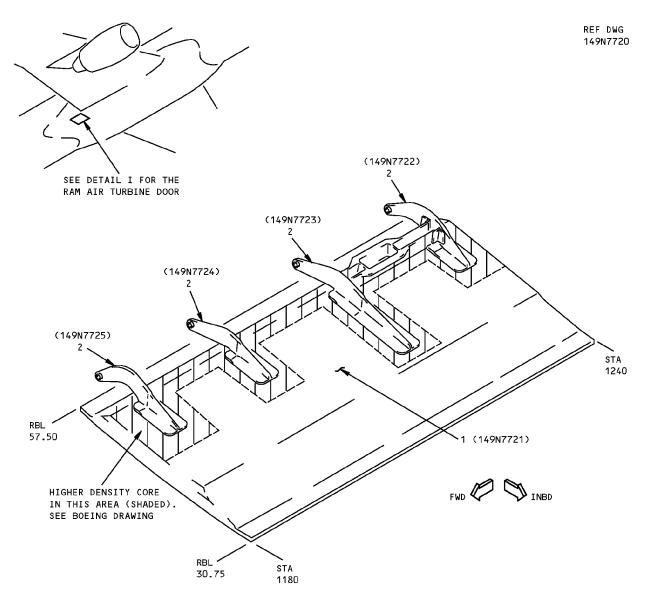
### **IDENTIFICATION 8 - RAM AIR TURBINE DOOR STRUCTURE**

ITEM	DESCRIPTION	GAGE	MATERIAL	EFFECTIVITY
1	DOOR PANEL SKIN CORE		ARAMID/GRAPHITE/EPOXY HONEYCOMB SANDWICH SEE DETAIL I NOMEX HONEYCOMB PER BMS 8-124, CLASS IV, TYPE V, GRADE 3.0	
2	HINGE FITTING		7075-T73 FORGING

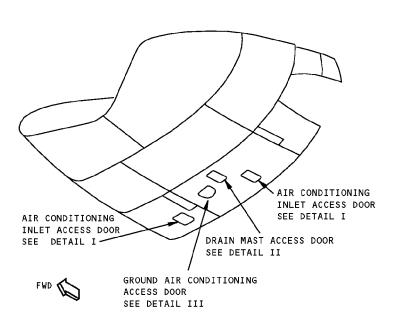
AIR CONDITIONING INLET
ACCESS DOOR
DETAIL I

# IDENTIFICATION 9 - SECTION 43 - WING-TO-BODY FAIRING ACCESS DOOR STRUCTURE: AIR CONDITIONING INLET, DRAIN MAST, GROUND AIR CONDITIONING

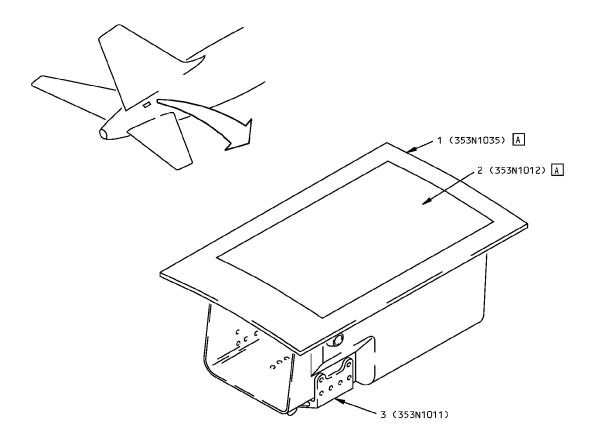
### **IDENTIFICATION 11 - APU INTAKE PORT - FRAME/DOOR STRUCTURE**

ITEM	DESCRIPTION	GAGE	MATERIAL	EFFECTIVITY
1	FRAME		FIBERGLASS/GRAPHITE/EPOXY LAMINATE FIBERGLASS PLIES - BMS 8-79, TYPE 120 GRAPHITE PLIES - BMS 8-168, TYPE 2, CLASS 2, STYLE 3K-50-PW	
2	BONDED DOOR ASSY		FIBERGLASS/EPOXY HONEYCOMB SANDWICH	
	DOOR		FIBERGLASS CLOTH EPOXY PER BMS 8-79, STYLE 1581, 1584, 7781	
	INNER CORE		NON-METALLIC HONEYCOMB PER BMS 8-124, CLASS I, TYPE III	
	OUTER CORE		NON-METALLIC HONEYCOMB PER BMS 8-124, CLASS IV, TYPE V	
3	ACTUATOR FITTING		ALUMINUM CASTING 356-T6

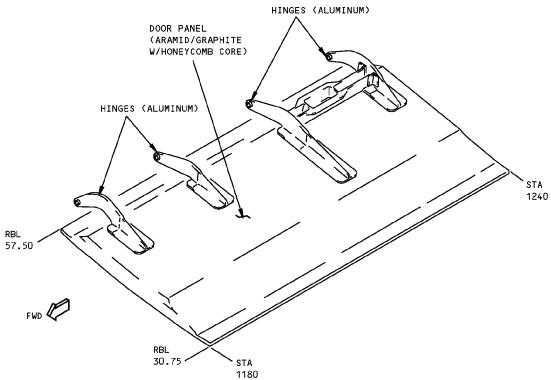
Ram Air Turbine Door Figure 101 (Sheet 1 of 3)

DESCRIPTION	CRACKS	NICKS, GOUGES AND CORROSION	DENTS	HOLES AND PUNCTURES	DELAMINATION	EDGE EROSION
DOOR PANEL	В	C	D	E	F	SEE DETAIL V
HINGE	G	Н	NOT ALLOWED	NOT ALLOWED

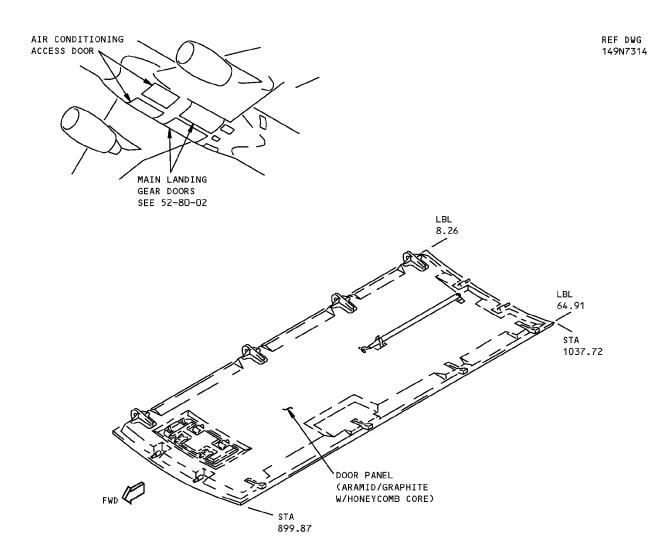
Air Conditioning Access Door Figure 101 (Sheet 1 of 3)

DESCRIPTION	CRACKS	NICKS, GOUGES AND CORROSION	DENTS	HOLES AND PUNCTURES	DELAMINATION	EDGE EROSION
DOOR PANEL	В	٥	D	E	F	SEE DETAIL II
