# **CHAPTER**

# 52

**DOORS**

### CHAPTER 52 DOORS

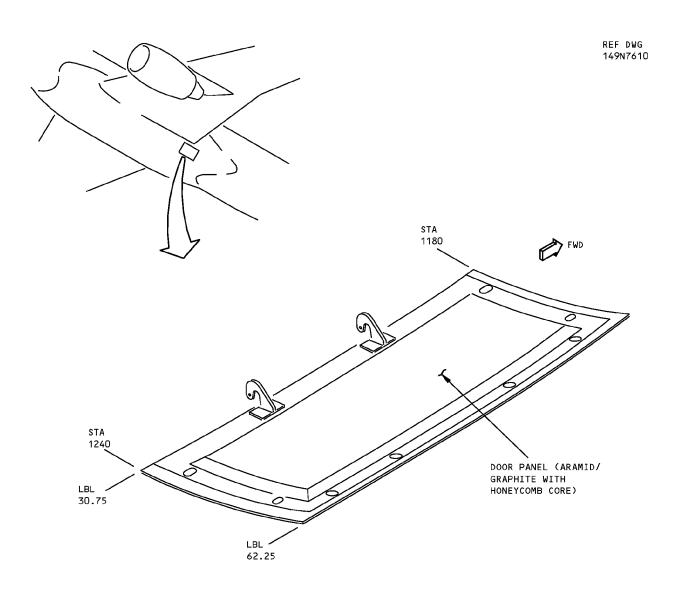
Hydraulic Access Door Figure 101 (Sheet 1 of 3)

DESCRIPTION	CRACKS	NICKS, GOUGES AND CORROSION	DENTS	HOLES AND PUNCTURES	DELAMINATION	EDGE EROSION
DOOR PANEL	В	C	D	E	F	SEE DETAIL II

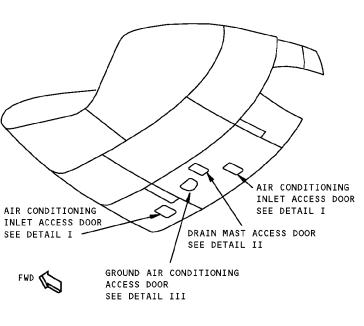
AIR CONDITIONING INLET
ACCESS DOOR
DETAIL I

# ALLOWABLE DAMAGE 4 - SECTION 43 - WING-TO-BODY FAIRING ACCESS DOORS AIR CONDITIONING INLET, DRAIN MAST, GROUND AIR CONDITIONING

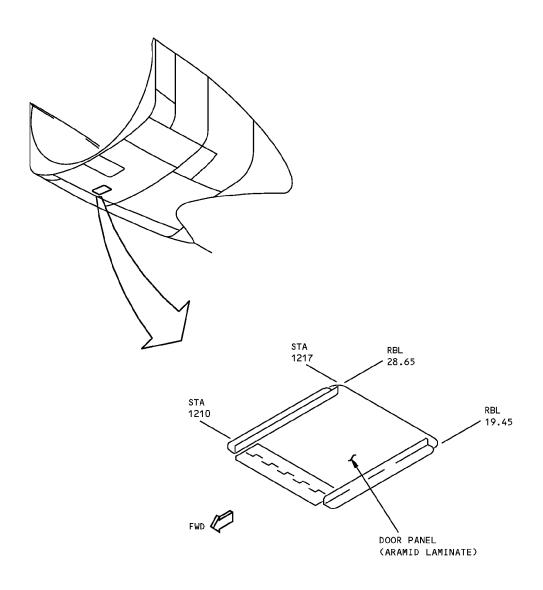
Landing Gear Ground Access Door Figure 101 (Sheet 1 of 3)

DESCRIPTION	CRACKS	NICKS, GOUGES AND CORROSION	DENTS	HOLES AND PUNCTURES	DELAMINATION	EDGE EROSION
DOOR PANEL	В	С	D	E	F	SEE DETAIL II

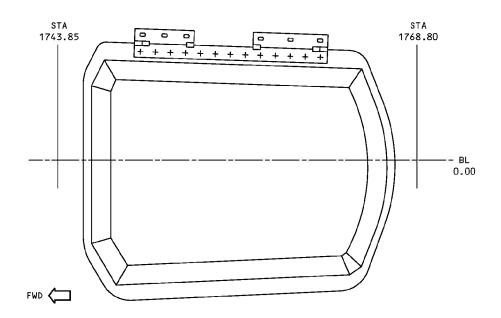
DETAIL I

DOOR PANEL (FIBERGLASS/EPOXY WITH HONEYCOMB CORE)

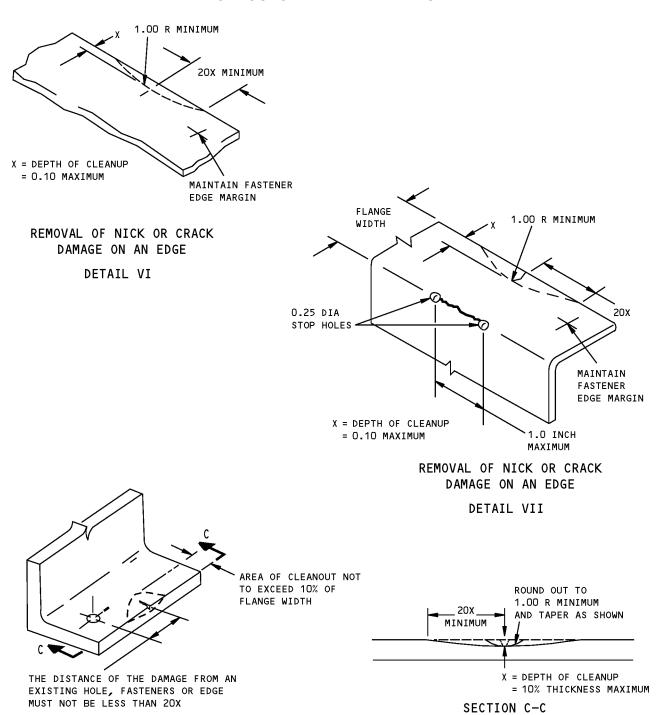
DETAIL VIII

REMOVAL OF NICK OR CRACK DAMAGE ON AN EDGE

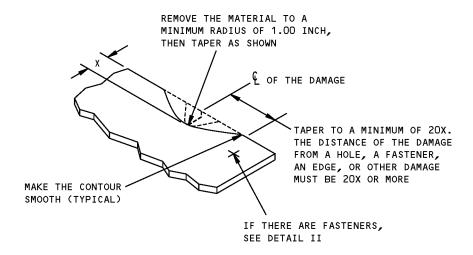
# REMOVAL OF DAMAGED MATERIAL ON AN EDGE DETAIL X

X = WIDTH OF THE MATERIAL THAT IS REMOVED A MAXIMUM OF 0.10 INCH

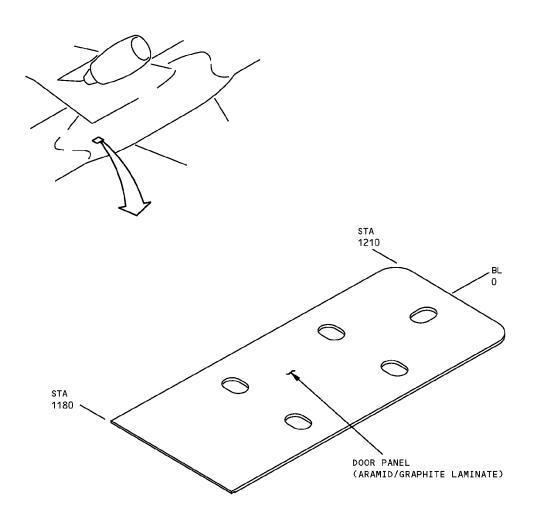
Toilet Drain Access Door Figure 101 (Sheet 1 of 3)

DESCRIPTION	CRACKS	NICKS, GOUGES AND CORROSION	DENTS	HOLES AND PUNCTURES	DELAMINATION	EDGE EROSION
DOOR PANEL	В	C	D	E	F	SEE DETAIL II

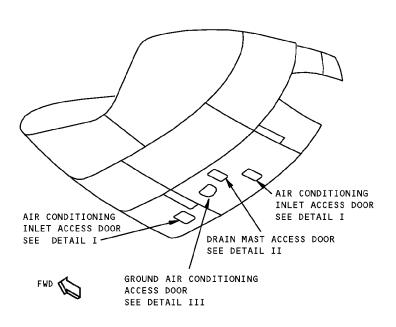
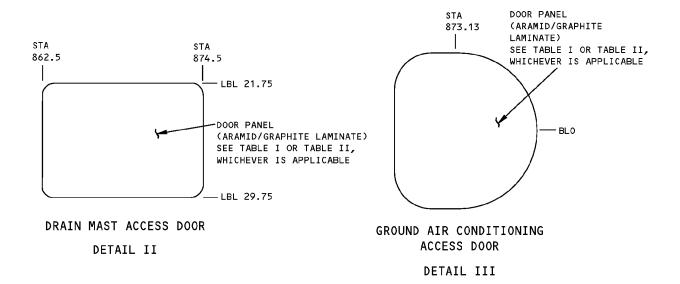
Figure 201 (Sheet 1 of 3)

Section 43 - Wing to Body Fairing Access Door Repairs - Air Conditioning Inlet, Drain Mast, Ground Air Conditioning

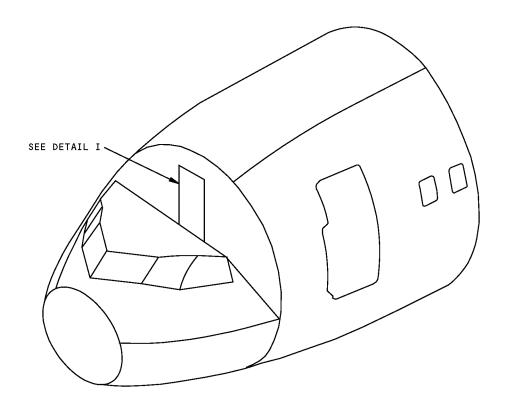
# **IDENTIFICATION 1 - FLIGHT DECK DOOR STRUCTURE**

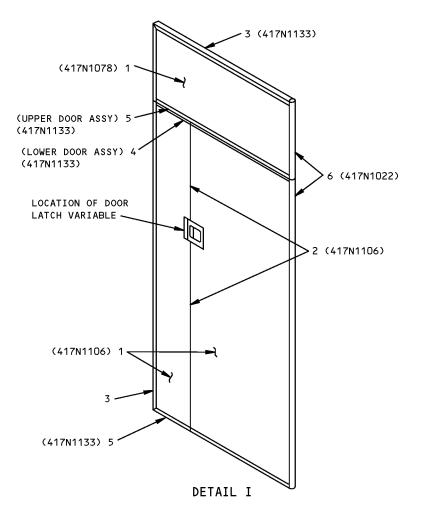
REF DWG 417N1076

ITEM	DESCRIPTION	GAGE	MATERIAL	EFFECTIVITY
1	DOOR PANEL OUTER FWD SKIN INNER FWD SKIN CORE AFT SKIN		NONMETALLIC/FIBERGLASS HONEYCOMB SANDWICH ACOUSTIC FABRIC PER BMS 8-64, TYPE I FIBERGLASS PER BMS 8-151, TYPE IV, STYLE 8800 NOMEX HONEYCOMB PER BMS 8-124, TYPE V, CLASS IV, GRADE 3.0 FIBERGLASS PER BMS 8-151, TYPE I, STYLE 8800	
2	TEE		BAC1505-11 2024-T3511	A
3	TRIM		BAC1509-100151 6063-T5	
4	TRIM		BAC1490-2727 2024-T3	
5	TRIM		BAC1518-308 6063-T5	
6	DOOR POST COVER	0.032	2024-Т3

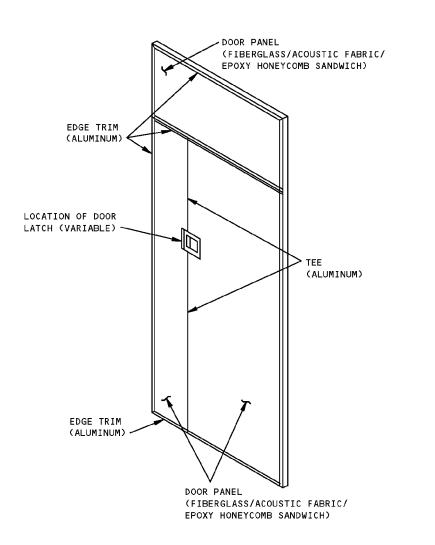
Allowable Damage - Flight Deck Door Structure Figure 101 (Sheet 1 of 4)

### ALLOWABLE DAMAGE 1 - ALLOWABLE DAMAGE - FLIGHT DECK DOOR STRUCTURE

DESCRIPTION	CRACKS	NICKS, GOUGES AND CORROSION	DENTS	HOLES AND PUNCTURES	DELAMINATION
DOOR PANELS	А	В	С	Α	A
TEE	E	F	NOT ALLOWED	NOT ALLOWED	
EDGE TRIM	E	F	SEE DETAIL IV	G

- REFINISH REWORKED AREAS PER 51-20 OF THE MAINTENANCE MANUAL
- REFER TO SRM 51-10-02 FOR INSPECTION AND REMOVAL OF DAMAGE
- THE ALLOWABLE DAMAGE LIMITS CONTAINED HERE-IN APPLY ONLY TO THE STRUCTURAL INTEGRITY OF THE DOOR. REWORK TO RESTORE ACOUSTIC PROPERTIES AND/OR COSMETIC APPEARANCE OF THE DOOR SHALL BE AN OPERATOR OPTION

- A DAMAGE TO SKIN PANEL EDGES MAY BE A COMBINATION OF EDGE DELAMINATION AND/OR CRACKS, GOUGES, ETC. WHICH CAN RESULT IN FIBER DAMAGE AND A LOSS OF CROSS-SECTIONAL AREA. REMOVE EDGE DAMAGE PER DETAILS I. 2.0 INCHES (50 mm) MAX DIA ALLOWED FOR SINGLE DAMAGE SITE IN HONEYCOMB AREA. MULTIPLE DAMAGE SITES MUST NOT BE CLOSER THAN A MINIMUM OF a/D = 3.0. SEE DETAIL V FOR DAMAGE CRITERIA. DAMAGE ALLOWED TO ONE SURFACE AND HONEYCOMB CORE ONLY. PROTECT DAMAGE NOT REWORKED PER D

- B DAMAGE ALLOWED ON SURFACE RESIN ONLY WITH NO FIBER DAMAGE. CLEAN UP EDGE DAMAGE PER DETAILS I. REFER TO A FOR FIBER DAMAGE IN OTHER AREAS
- C DENTS RESULT IN DELAMINATION AND FIBER
  DAMAGE AND MUST BE TREATED AS A HOLE OR
  PUNCTURE DAMAGE

- D REMOVE MOISTURE FROM DAMAGE AREA. USE OF VACUUM AND HEAT (MAX OF 125°F (52°C)) TO REMOVE MOISTURE FROM HONEYCOMB CELLS IS RECOMMENDED. PROTECT DAMAGE FROM ENTRANCE OF WATER, SUNLIGHT OR OTHER FOREIGN MATTER BY SEALING WITH ALUMINUM FOIL TAPE (SPEED TAPE). RECORD THE LOCATION AND INSPECT EVERY AIRPLANE "A" CHECK. REPLACE THE ALUMINUM FOIL TAPE IF ANY PEELING OR DETERIORATION EVIDENT. REPAIR NO LATER THAN NEXT AIRPLANE "C" CHECK.
- E CRACKS NOT ALLOWED EXCEPT FOR EDGE CRACKS
  WHICH MUST BE REMOVED PER DETAIL II
- F REMOVE DAMAGE PER DETAILS II AND III
- G CLEAN OUT HOLE OR PUNCTURE DAMAGE UP TO 0.25 INCH (6 mm) DIAMETER. FILL HOLE WITH BMS 5-95 SEALANT
- H THESE ALLOWABLE DAMAGE LIMITS HAVE FAA
  APPROVAL CONTINGENT ON ACCOMPLISHMENT OF
  THE INSPECTIONS CONTAINED HEREIN

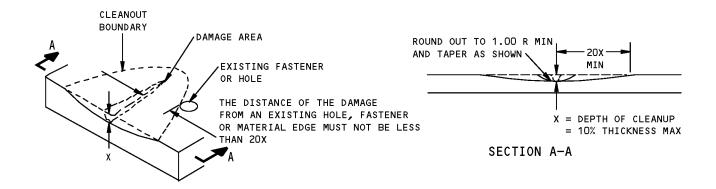
REMOVAL OF NICK, GOUGE AND SCRATCH DAMAGE ON A SURFACE DETAIL III

DENT ALLOWABLE DAMAGE DETAIL IV

Allowable Damage - Flight Deck Door Structure Figure 101 (Sheet 3 of 4)

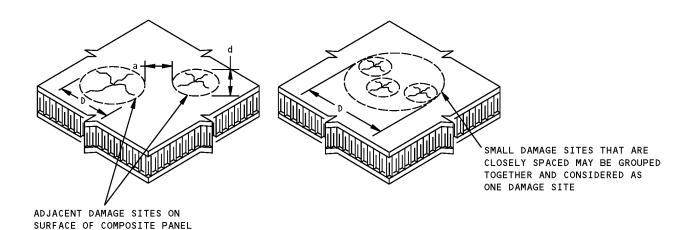
Allowable Damage - Flight Deck Door Structure Figure 101 (Sheet 4 of 4)

- DAMAGE TO COMPOSITE PANELS EXPOSED TO MULTIPLE IMPACTS, I.E., HAIL DAMAGE, CAN BE DETECTED BY USING INSTRUMENTED NON-DESTRUCTIVE INSPECTION METHODS OR BY TAPPING THE SUSPECTED DAMAGE AREA WITH A SMALL METALLIC DISK OBJECT. INSPECTION SHOULD COVER THE AREA WITHIN 3 DIAMETERS AROUND THE EDGE OF THE VISIBLE DAMAGE SITE. FOR TAP TEST, USE A SOLID METAL DISK AND TAP THE DAMAGE AREA LIGHTLY BUT FIRMLY. VOID AREAS SHOULD PRODUCE A DULL SOUND AS OPPOSED TO A SHARP RING ON A SOLID BONDED AREA
- DAMAGE SITE IS ANY SINGLE AREA OF A PANEL WHERE A DENT, CRACK, DELAMINATION, PUNCTURE OR ANY COMBINATION OF THESE EXIST. SMALL DAMAGE SITES THAT ARE CLOSELY SPACED MAY BE GROUPED TOGETHER AND CONSIDERED AS ONE DAMAGE SITE

- "D" IS DETERMINED BY MEASURING THE MAX DIMENSION OF A DENT, CRACK, OR OTHER DAMAGE, WHICHEVER IS GREATER
- "a" IS THE DISTANCE BETWEEN TWO ADJACENT DAMAGE SITES
- "d" IS THE MAX DIMENSION OF THE SMALLER OF TWO ADJACENT DAMAGE SITES
- CALCULATE a/D BY DIVIDING DISTANCE "a" BY DIAMETER "D"
- DAMAGE IS ALLOWED WHEN "D" IS EQUAL TO OR LESS THAN THE MAXIMUM ALLOWABLE "D" FROM TABLE I AND WHEN a/D IS EQUAL TO OR GREATER THAN THE MINIMUM a/D GIVEN IN TABLE

DAMAGE SIZING AND SPACING DATA FOR COMPOSITE PANELS DETAIL V

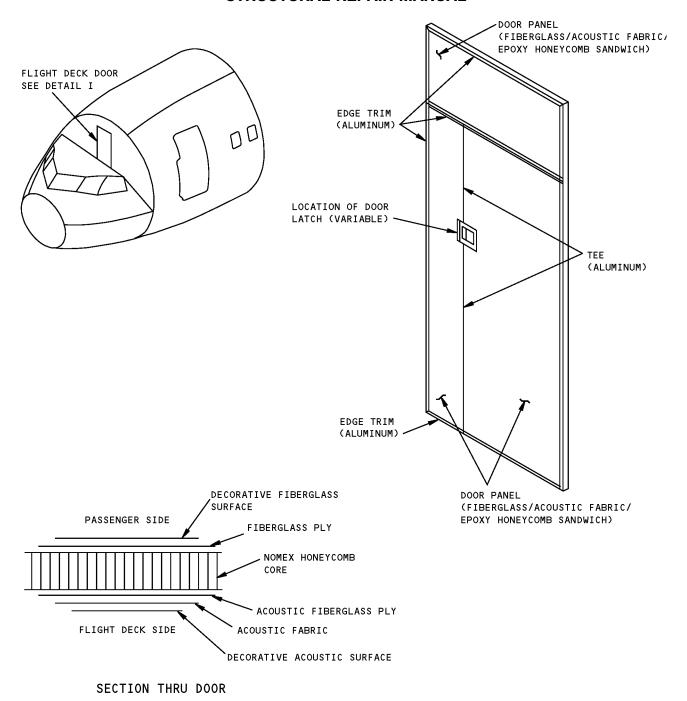
Flight Deck Door Figure 201 (Sheet 2 of 4)

DETAIL I

- Refer to 25-00-00 of the 757 Maintenance Manual for repair of nicks and scratches, for gouges not exceeding 1.5 inches, and for repairs to BMS 8-133 urethane foam.
- Refer to 51-70-06, figure 19 for repair of cracks up to 6.0. Restore the decorative surface per par. 4.
- Refer to details II and III for repair to BMS 8-143 and BMS 8-151 fiberglass plies and for repair to NOMEX honeycomb core. Use BMS 9-3 Type H-2 or H-3 glass fabric. Extra repair plies are not required.

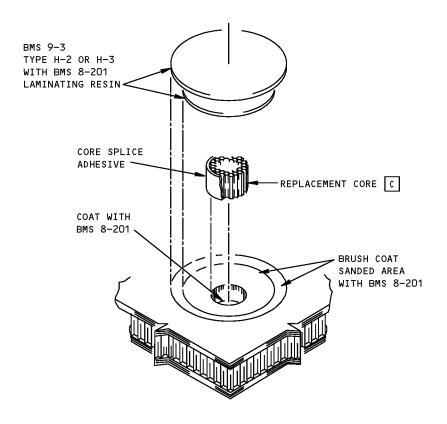
#### PASSENGER SIDE

FLIGHT DECK SIDE SECTION THRU REPAIR

REPAIR OF DAMAGE TO ONE PANEL SIDE DETAIL II

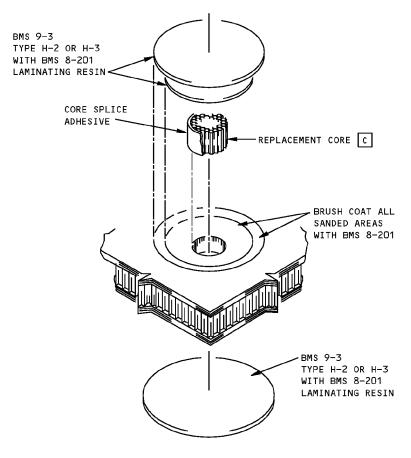
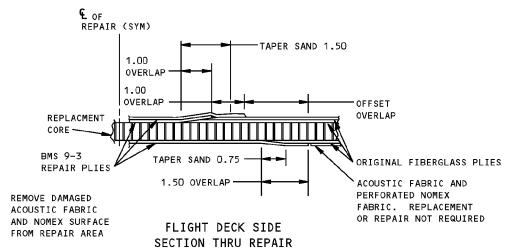
#### PASSENGER SIDE

REPAIR OF DAMAGE TO BOTH PANEL SIDES

DETAIL III

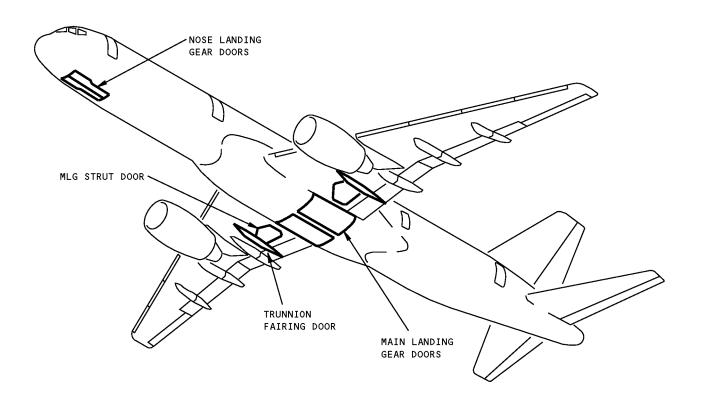
# **GENERAL - LANDING GEAR DOOR INDEX**

REFER TO THE FOLLOWING IN 52-80-02 FOR LANDING GEAR DOOR INDENTIFICATION:

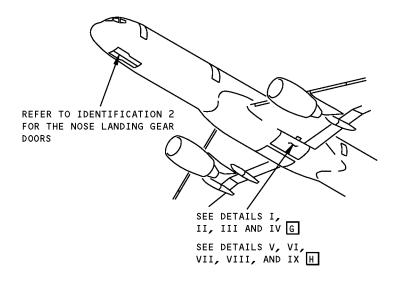
REFERENCE DRAWING 149N6002

#### **IDENTIFICATION 1 - MAIN LANDING GEAR DOOR**

- · CORE DENSITIES VARY. SEE DRAWING 149N6003 FOR CORE POSITIONS.
- A PLY ORIENTATION CONVENTION, O DEGREES, IS PARALLEL TO THE FABRIC WARP DIRECTION.
- B GRAPHITE/EPOXY FABRIC PER BMS 8-212, TYPE IV, CLASS II, STYLE 3K-70-PW.
- C FOR AIRPLANES WITH CUM LINE NUMBERS: 1 THRU 36
- D FOR AIRPLANES WITH CUM LINE NUMBERS: 37 AND ON
- E HEAT SHIELD PLY ORIENTATIONS ARE OPTIONAL.
- F HEAT SHIELD ON RH DOOR IS CENTERED AT RBL 53.75.
- G FOR AIRPLANES WITH ONE-PIECE MLG DOOR AND TANG.
- H FOR AIRPLANES WITH TWO-PIECE MLG DOOR AND TANG.

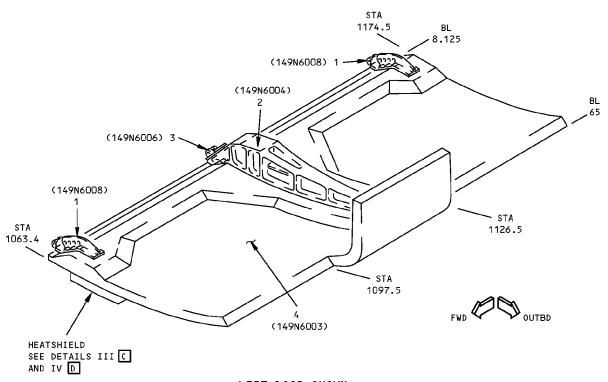
LEFT DOOR SHOWN RIGHT DOOR SIMILAR

DETAIL I G

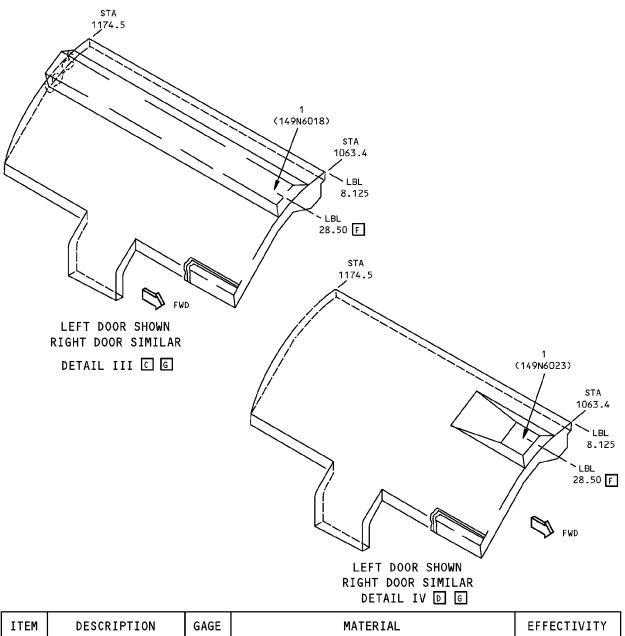
LIST OF MATERIALS FOR DETAILS III AND IV G

ITEM	DESCRIPTION	GAGE	MATERIAL	EFFECTIVITY
1	HEAT SHIELD PANEL ASSEMBLY INNER AND OUTER SKINS CORE		ONE PLY OF ARAMID/EPOXY PREPREG PER BMS 8-218, STYLE 285 BONDED TO CORE PLUS ONE PLY OF FIBER- GLASS/EPOXY PREPREG PER BMS 8-139, TYPE 120 E NONMETALLIC HONEYCOMB PER BMS 8-124, CLASS I, TYPE I, GRADE 4.0

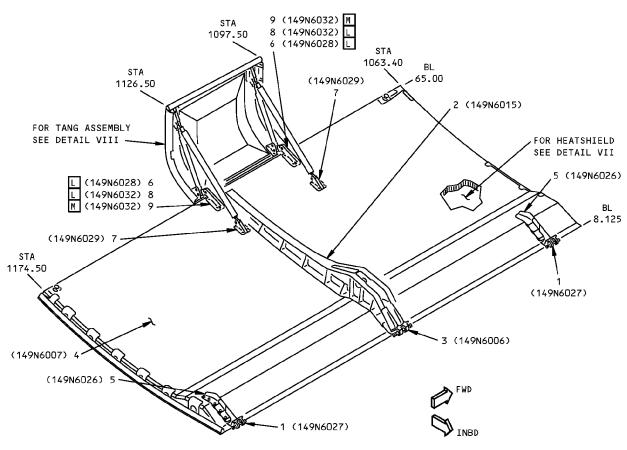
1			
ITEM	DESCRIPTION	GAGE	MATERIAL	EFFECTIVITY
1	HINGE FITTING ASSEMBLY		FORGING 7075-T73	
2	STRONGBACK BEAM		FORGING 7075-T73	
3	CENTER HINGE FITTING		15-5PH CRES PER AMS 5659 HT TR TO 180-200 KSI	
4	DOOR PANEL ASSEMBLY SKINS CORE		FIBERGLASS/GRAPHITE/EPOXY HONEYCOMB SANDWICH SEE DETAIL VI NONMETALLIC HONEYCOMB PER BMS 8-124, CLASS 1, TYPE 1, GRADE 4.0	
5	HINGE FITTING		FORGING 7075-T73	
6	CLEVIS ASSEMBLY CLEVIS BASE PLATE	0.125	BAC1507-48821 7075-T73 EXTRUSION 15-5PH CRES SHEET HT TR TO 125-145 KSI	
7	CLEVIS		BAC1507-48822 7075-T73 EXTRUSION	
8	DROP LINK		7075-T7351 PLATE	L
9	LINK FITTING ASSEMBLY LINK FITTING BASE PLATE	0.125	7075-T7351 PLATE 15-5PH CRES SHEET HT TR TO 125-145 KSI	М

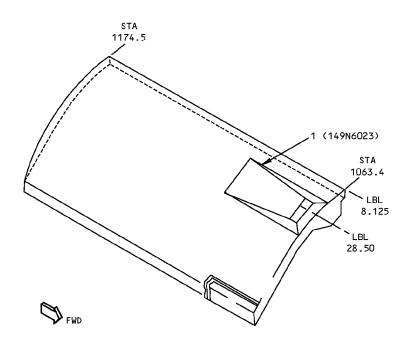
LEFT DOOR SHOWN
RIGHT DOOR SIMILAR
DETAIL VII H

ITEM	DESCRIPTION	GAGE	MATERIAL	EFFECTIVITY
1	HEAT SHIELD PANEL ASSEMBLY INNER SKIN OUTER SKIN CORE		TWO PLIES OF GLASS/EPOXY PREPREG PER BMS 8-139, TYPE 1581 THREE PLIES OF GLASS/EPOXY PREPREG PER BMS 8-139, TYPE 1581 NONMETALLIC HONEYCOMB PER BMS 8-124, CLASS I, TYPE I, GRADE 4.0

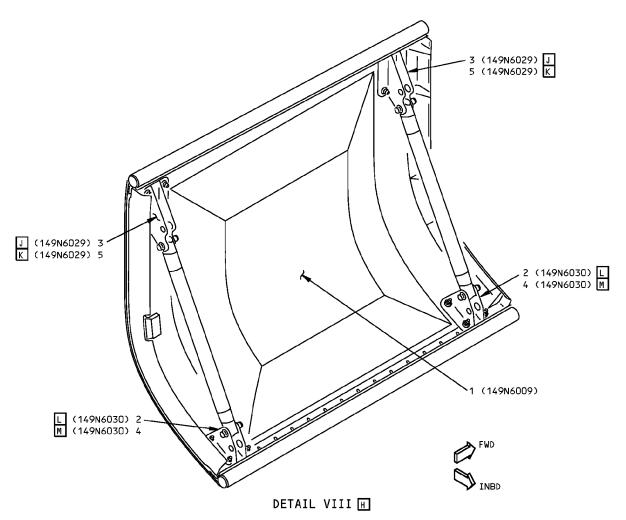
LIST OF MATERIALS FOR DETAIL VIII H

ITEM	DESCRIPTION	GAGE	MATERIAL	EFFECTIVITY
1	TANG ASSEMBLY INNER AND OUTER SKINS CORE		SEE DETAIL IX NONMETALLIC HONEYCOMB PER BMS 8-124, CLASS 4, TYPE V, GRADE 3.0	
2	LOWER CLEVIS FITTING		BAC1507-48823 7075-T73 EXTRUSION	I
3	UPPER CLEVIS FITTING		BAC1507-48822 7075-T73 EXTRUSION	J
4	LOWER CLEVIS FITTING		7075-T7351 PLATE	М
5	UPPER CLEVIS FITTING		BAC1507-48822 7075-T73511 EXTRUSION	K

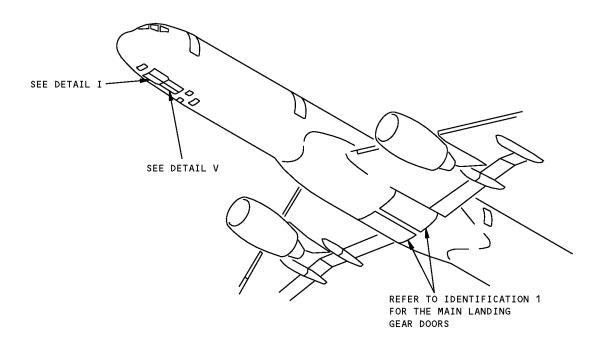
#### **IDENTIFICATION 2 - NOSE LANDING GEAR DOOR SKIN**

- A FOR CUM LINE NUMBERS: 1 THRU 19
- B FOR CUM LINE NUMBERS: 20 AND ON
- C HEAVIER DENSITY HONEYCOMB CORES INSTALLED IN AREA INDICATED
- D PLY ORIENTATION CONVENTION, O DEGREES, IS PARALLEL TO THE FABRIC WARP DIRECTION
- E ARAMID PREPREG FABRIC PER BMS 8-219, STYLE 120
- F GRAPHITE EPOXY PREPREG FABRIC PER BMS 8-168, TYPE II, CLASS 2, STYLE 3K-70-PW

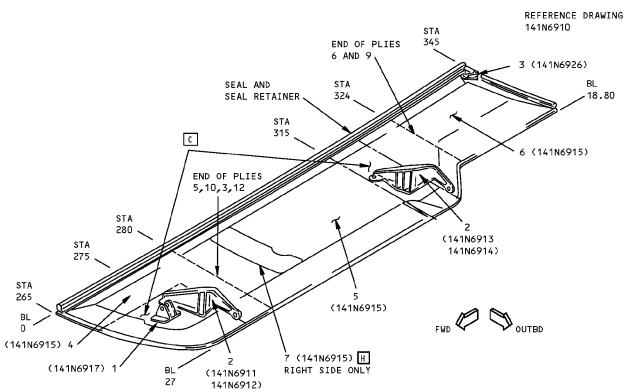
FORWARD DOOR LEFT DOOR SHOWN RIGHT DOOR OPPOSITE DETAIL I

ITEM	DESCRIPTION	GAGE	MATERIAL	EFFECTIVITY
1	ROD ATTACH FITTING		FORGED BLOCK 7075-T73	
2	HINGE FITTING		FORGED BLOCK 7075-T73 DIE FORGING 7075-T73	A B
3	DOOR STOP FITTING		EXTRUDED BAR 7075-T73511	
4	DOOR PANEL SKIN CORE		GRAPHITE HYBRID HONEYCOMB SANDWICH SEE DETAIL II FIBERGLASS HONEYCOMB PER BMS 8-124, CLASS 1, TYPE 1, GRADE 4.0	
5	DOOR PANEL SKIN CORE		GRAPHITE HYBRID HONEYCOMB SANDWICH SEE DETAIL III FIBERGLASS HONEYCOMB PER BMS 8-124, CLASS 1, TYPE 1, GRADE 4.0	
6	DOOR PANEL SKIN CORE		GRAPHITE HYBRID HONEYCOMB SANDWICH SEE DETAIL IV FIBERGLASS HONEYCOMB PER BMS 8-124, CLASS 1, TYPE 1, GRADE 4.0	
7	SCUFF PLATE	0.020	301 CRES	H

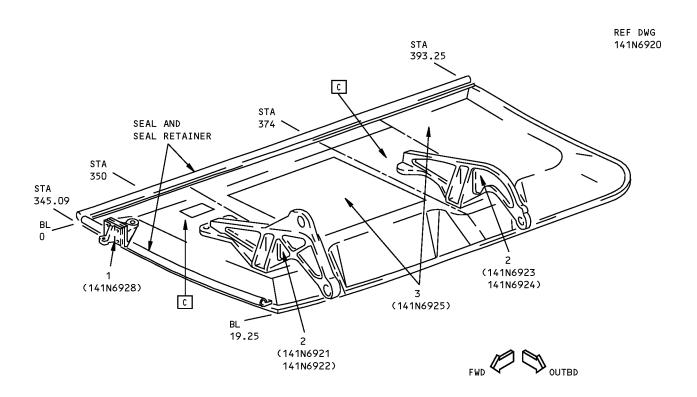
#### AFT DOOR LEFT DOOR SHOWN RIGHT DOOR OPPOSITE DETAIL V

ITEM	DESCRIPTION	GAGE	MATERIAL	EFFECTIVITY
1 2 3	DOOR SUPPORT FITTING HINGE FITTING DOOR PANEL SKIN CORE		EXTRUDED BAR 7075-T73511  FORGED BLOCK 7075-T73 DIE FORGING 7075-T73  GRAPHITE HYBRID HONEYCOMB SANDWICH SEE DETAIL VI FIBERGLASS HONEYCOMB PER BMS 8-124, CLASS 1, TYPE 1, GRADE 4.0	A B

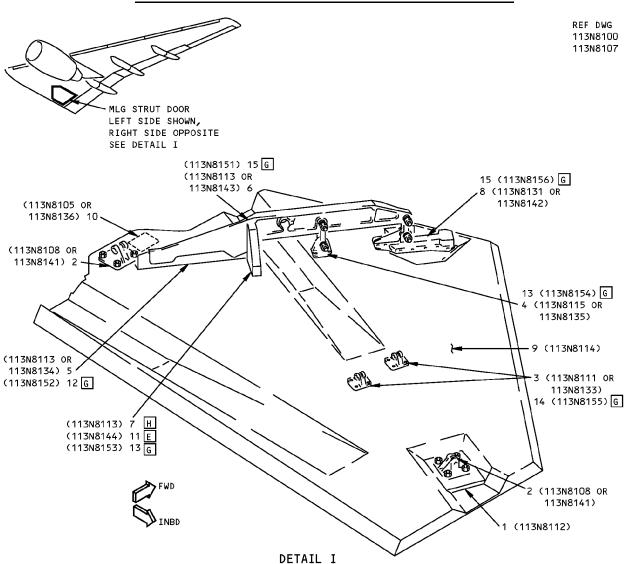
#### **IDENTIFICATION 3 - MAIN LANDING GEAR STRUT DOOR SKIN**

- A GRAPHITE EPOXY FABRIC PER BMS 8-168, TYPE II, CLASS 2, STYLE 3K-70-PW
- B ARAMID FABRIC PER BMS 8-219, STYLE 285
- MATERIAL AND PLY ORIENTATION SHOWN FOR FIELD AREAS ONLY. SEE BOEING DRAWINGS FOR EDGE BANDS AND AREAS WITH DOUBLERS
- PLY ORIENTATION CONVENTION O DEGREES IS PARALLEL TO THE FABRIC WRAP DIRECTION
- E FOR CUM LINE NUMBERS 53 THRU 67,69,73,76, 79 THRU 83,91,92,95,96,98,103,104,107,112, 115,119,124 THRU 131,138,139,146,151,168, 174,175,178
- F FIBERGLASS PER BMS 8-79, TYPE 120, CLASS III, GRADE 1
- G FOR AIRPLANES WITH CUM LINE NUMBERS 225 AND ON
- H FOR AIRPLANES WITH CUM LINE NUMBERS NOT IN E OR G
- I FOR AIRPLANES WITH CUM LINE NUMBERS NOT IN G

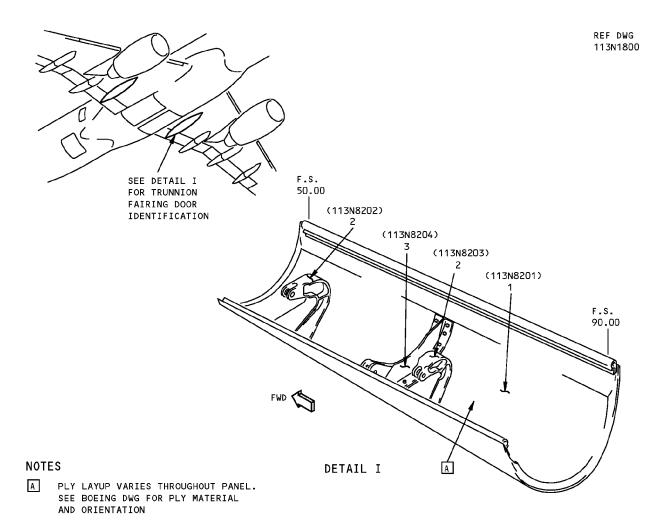
LIST OF MATERIALS FOR DETAIL I

#### **IDENTIFICATION 4 - TRUNNION FAIRING DOOR**

ITEM	DESCRIPTION	GAGE	MATERIAL	EFFECTIVITY
1	TRUNNION DOOR PANEL		ARAMID/GRAPHITE/EPOXY HONEYCOMB SANDWICH	
	OUTER PLY		ARAMID FABRIC PER BMS 8-219, STYLE 285 A	
	INNER PLIES		GRAPHITE FABRIC PER BMS 8-168, CLASS II, TYPE II, STYLE 3K-70-PW A	
	CORE		NONMETALLIC HONEYCOMB PER BMS 8-124, CLASS I, TYPE I, GRADE 5.5	
2	HINGE		FORGED BLOCK OR DIE FORGING 7075-T73	
3	SUPPORT FITTING		FORGED BLOCK OR DIE FORGING 7075-T73

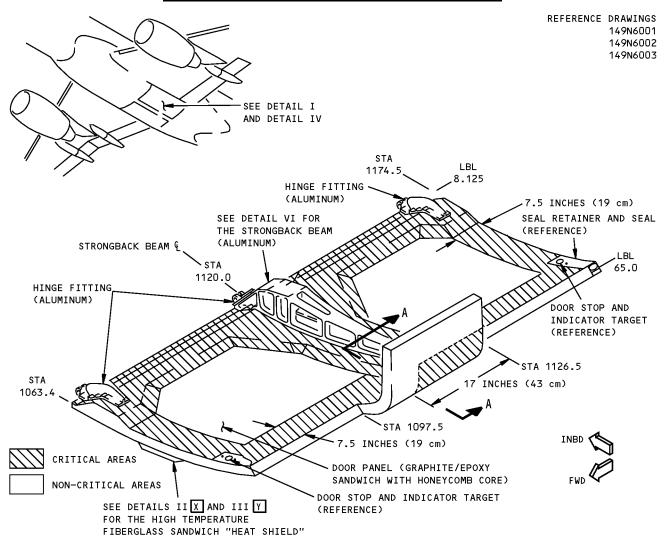
Allowable Damage - Main Landing Gear Door Figure 101 (Sheet 1 of 10)

LEFT SIDE MAIN LANDING GEAR DOOR IS SHOWN, RIGHT SIDE IS OPPOSITE

DETAIL I AA

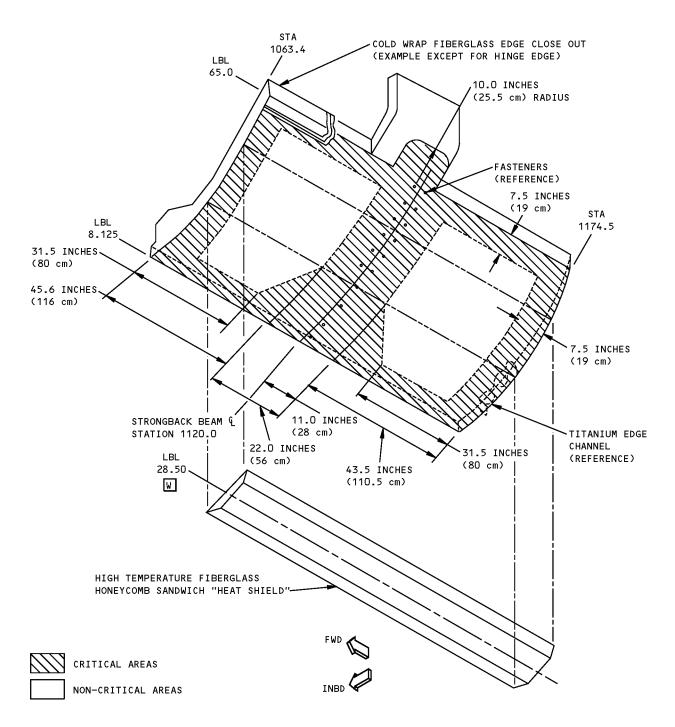
Allowable Damage - Main Landing Gear Door Figure 101 (Sheet 2 of 10)

LEFT SIDE MAIN LANDING GEAR DOOR IS SHOWN, RIGHT SIDE IS OPPOSITE

DETAIL II X AA

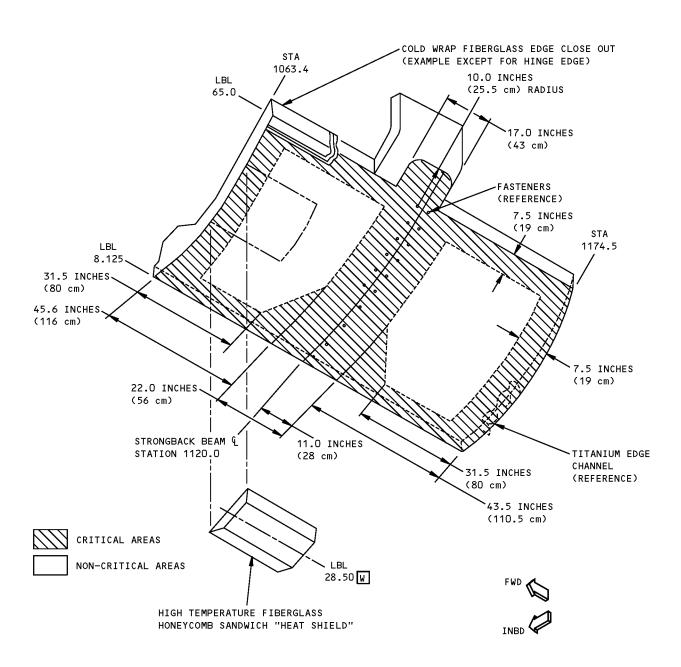
Allowable Damage - Main Landing Gear Door Figure 101 (Sheet 3 of 10)

LEFT SIDE MAIN LANDING GEAR DOOR IS SHOWN, RIGHT SIDE IS OPPOSITE

DETAIL III Y AA

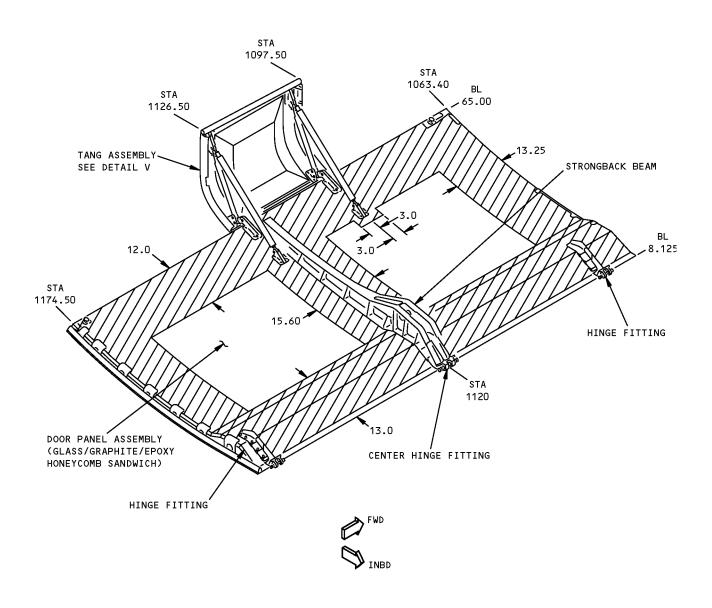
Allowable Damage - Main Landing Gear Door Figure 101 (Sheet 4 of 10)

DETAIL IV AB

CRITICAL AREA

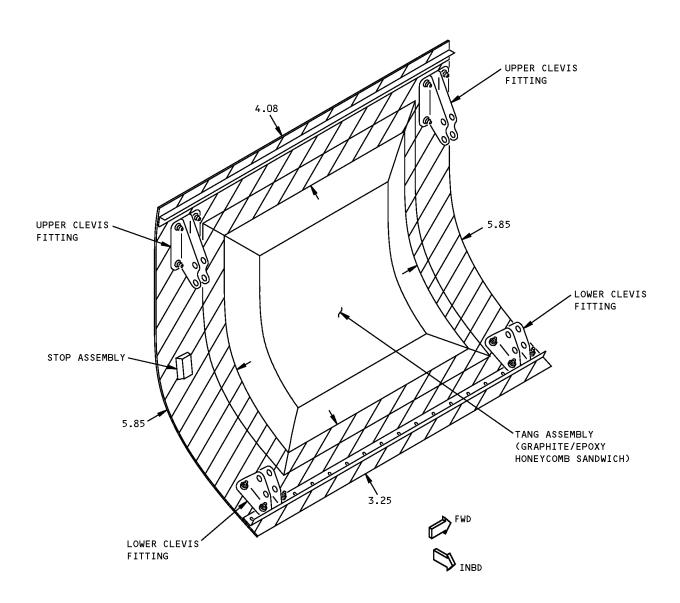
Allowable Damage - Main Landing Gear Door Figure 101 (Sheet 5 of 10)

7 7	_
CRITICAL AREA	
NON-CRITICAL AREA

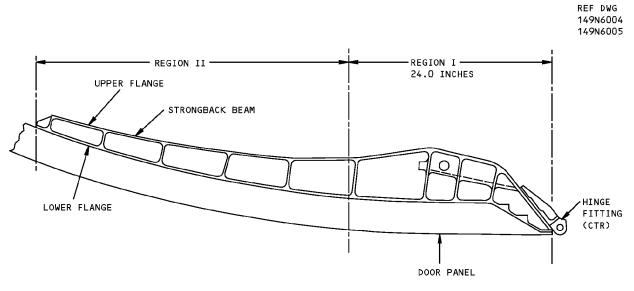
Allowable Damage - Main Landing Gear Door Figure 101 (Sheet 6 of 10)

DESCRIPTION		CRACKS	NICKS, GOUGES AND CORROSION	DENTS	HOLES AND PUNCTURES	DELAMINATION
	COLD WRAPPED FIBERGLASS EDGES	s	s	<u>s</u>	s	s
DOOR PANEL	FACE SKIN- CRITICAL AREAS (SHADED)	С	F	K	M	P
	FACE SKIN- NON-CRITICAL AREAS	Π	G	K	N	Q
STRONGBACK BEAM R	REGION I	NOT ALLOWED	H	NOT ALLOWED	NOT ALLOWED	NOT APPLICABLE
HINGE FITTINGS R	FWD AND AFT	D I		NOT ALLOWED	NOT ALLOWED	NOT APPLICABLE
TITANIUM EDGE CHANNELS	DGE E J		L	NOT ALLOWED	NOT APPLICABLE	
FIBERGLASS HEAT SHIELD	LBL 28.50 RBL 53.80	T	П	K	0	V

- DAMAGE TO PANEL EDGES MAY BE CONFINED TO DELAMINATION OR MAY TAKE A FORM WHICH RESULTS IN DAMAGE TO FIBERS AND A LOSS OF EFFECTIVE CROSS-SECIIONAL AREA. THIS TYPE OF DAMAGE SHOULD BE REMOVED AND THE LIMITATIONS GIVEN FOR CRACKS APPLIED.

- REFINISH AREAS PER AMM 51-20
- REFER TO SRM 51-10-01 FOR AERODYNAMIC SMOOTHNESS REQUIREMENTS. WHERE THE DAMAGE EXCEEDS THE LIMITS SHOWN IN SRM 51-10-01, CONSIDERATION SHOULD BE GIVEN TO THE LOSS OF PERFORMANCE INVOLVED.

- REFER TO SRM 51-10-02 FOR INSPECTION AND REMOVAL OF DAMAGE
- A REMOVE MOISTURE FROM DAMAGE AREA. USE OF VACUUM AND HEAT (MAX OF 125°F [52°C]) TO REMOVE MOISTURE FROM HONEYCOMB CELLS IS RECOMMENDED. PROTECT DAMAGE FROM ENTRANCE OF WATER, SUNLIGHT OR OTHER FOREIGN MATTER BY SEALING WITH ALUMINUM FOIL TAPE (SPEED TAPE) 3M-Y436 OR EQUIVALENT. RECORD LOCATION AND INSPECT AT AIRPLANE "A" CHECK. REPLACE ALUMINUM FOIL TAPE IF ANY PEELING OR DETERIORATION OF TAPE IS EVIDENT. REPAIR DAMAGE PER SRM 51-70 NO LATER THAN THE NEXT "C" CHECK.

- B REMOVE MOISTURE FROM DAMAGE AREA. USE OF VACUUM AND HEAT (MAX OF 125°F (52°C)) TO REMOVE MOISTURE FROM HONEYCOMB CELLS IS RECOMMENDED. PROTECT DAMAGE FROM ENTRANCE OF WATER, SUNLIGHT OR OTHER FOREIGN MATTER BY SEALING WITH ALUMINUM FOIL TAPE (SPEED TAPE) 3M-Y436 OR EQUIVALENT. RECORD LOCATION AND INSPECT AIRPLANE EVERY 100 HOURS. REPLACE ALUMINUM FOIL TAPE IF ANY PEELING OR DETERIORATION OF TAPE IS EVIDENT. REPAIR DAMAGE PER SRM 51-70 BEFORE THE EXPIRATION OF 60 CALENDAR DAYS.

- C 2.0 INCHES (50 mm) MAX DIMENSION (D) IN HONEYCOMB AREA IS ALLOWED PER SQUARE FOOT (930 SQUARE cm) AREA AND A MINIMUM OF 6D (EDGE TO EDGE) FROM ANY OTHER CRACK, FITTING OR FASTENER HOLE AND A MINIMUM OF 6.0 INCHES (150 mm) FROM MATERIAL EDGE.

- D CLEAN UP EDGE CRACKS PER DETAILS VII AND X. CLEAN UP CORNER CRACKS PER DETAIL XI. OTHER CRACKS NOT ALLOWED. B
- E CLEAN UP EDGE CRACKS PER DETAILS VII AND XIII. CLEAN UP CORNER CRACKS PER DETAIL XI. OTHER CRACKS NOT ALLOWED.

- F DAMAGE ALLOWED ON SURFACE RESIN ONLY. DAMAGED TO FIBERS NOT ALLOWED. PROTECT EDGE DAMAGE PER B.
- G DAMAGE ALLOWED ON SURFACE RESIN ONLY. DAMAGE TO FIBERS NOT ALLOWED. PROTECT EDGE DAMAGE PER A.
- H CLEAN UP DAMAGE PER DETAILS VII, VIII, AND X. CLEAN UP CORNER DAMAGE PER DETAIL XI.
- I CLEAN UP EDGE DAMAGE PER DETAILS VII AND X. CLEAN UP LUG DAMAGE PER DETAIL XII. CLEAN UP OTHER DAMAGE PER DETAIL VIII.
- J REMOVE DAMAGE PER DETAILS VII, VIII, AND XIII.
- K DENTS GENERALLY RESULT IN FIBER DAMAGE OR DELAMINATION. HOWEVER, PROVIDED THAT THERE IS NO FIBER DAMAGE OR DELAMINATION DENTS UP TO 2.0 INCHES (50 mm) DIA MAX ARE ALLOWED. ONE DENT PER SQUARE FOOT (930 SQUARE cm) OF AREA ALLOWED WHICH MUST BE A MINIMUM OF 6.0 INCHES (150 mm) FROM ANY OTHER DAMAGE, FASTENER HOLE OR PANEL EDGE. REFER TO APPLICABLE DAMAGE DATA IN TABLE IF FIBER DAMAGE OR DELAMINATION EXISTS.
- L SEE DETAIL XIV.

- M 2.0 MAX DIMENSION (D) IN HONEYCOMB AREA IS ALLOWED PER SQUARE FOOT OF AREA AND A MINIMUM OF 6D (EDGE TO EDGE) FROM ANY OTHER DAMAGE, FITTING OR FASTENER HOLE, AND A MINIMUM OF 6.0 INCHES FROM MATERIAL EDGE. DO NOT CLEAN UP DAMAGE EXCEPT TO REMOVE RESIN BURRS EXTENDING INTO SURFACE. B

- N 2.0 MAX DIMENSION (D) IN HONEYCOMB AREA IS ALLOWED PER SQUARE FOOT OF AREA AND A MINIMUM OF 6D (EDGE TO EDGE) FROM ANY OTHER DAMAGE, FASTENER HOLE, OR FITTING. DO NOT CLEAN UP DAMAGE EXCEPT TO REMOVE RESIN BURRS EXTENDING INTO SURFACE.

- 2.0 MAX DIMENSION (D) IN "HEAT SHIELD"
  ALLOWED PER SQUARE FOOT OF AREA AND A
  MINIMUM OF 6D (EDGE TO EDGE) FROM ANY
  OTHER DAMAGE OR MATERIAL EDGE. DO NOT
  CLEAN UP DAMAGE EXCEPT TO REMOVE RESIN
  BURRS EXTENDING INTO SURFACE CONTOUR AND
  PROTECT DAMAGE PER A.

- P 2.0 MAX DIMENSION (D) DELAMINATION IN HONEYCOMB AREA IS ALLOWED PER SQUARE FOOT OF AREA AND A MINIMUM OF 6D (EDGE TO EDGE) FROM ANY OTHER DAMAGE, FITTING OR FASTENER HOLE, AND A MINIMUM OF 6.0 FROM PANEL EDGE. REPAIR DELAMINATION IN HONEYCOMB AREA AS GIVEN IN SRM 51-70 BEFORE THE EXPIRATION OF 60 CALENDAR DAYS. PROTECT EDGE DAMAGE PER B.

- Q 2.0 MAX DIMENSION (D) DELAMINATION IN HONEYCOMB AREA IS ALLOWED PER SQUARE FOOT OF AREA AND A MINIMUM OF 6D (EDGE TO EDGE) FROM ANY OTHER DAMAGE, FITTING OR FASTENER HOLE. REPAIR DELAMINATION IN HONEYCOMB AREA AS GIVEN IN SRM 51-70 NO LATER THAN THE NEXT "C" CHECK. PROTECT EDGE DAMAGE PER A.

- R SHOT PEEN REWORKED AREAS AS GIVEN IN SRM 51-20-06 SHOT PEEN INTENSITIES WILL VARY WITH THE THICKNESS REMAINING AFTER REWORK.
- 3 12.0 MAX DIMENSION ALLOWED. MAXIMUM DEPTH OF DAMAGE, 0.50. PROTECT DAMAGE PER B.

- 2.0 MAX DIMENSION (D) IN HONEYCOMB AREA IS ALLOWED PER SQUARE FOOT AREA AND A MINIMUM OF 6D (EDGE TO EDGE) FROM ANY OTHER DAMAGE, MATERIAL EDGE OR FASTENER HOLE.

- U DAMAGE ALLOWED ON SURFACE RESIN ONLY.
  DAMAGE TO FIBERS NOT ALLOWED.
  PROTECT EDGE DAMAGE PER A.
- 2.0 MAX DIMENSION (D) DELAMINATION IN HONEYCOMB AREA IS ALLOWED PER SQUARE FOOT OF AREA AND A MINIMUM OF 6D (EDGE TO EDGE) FROM ANY OTHER DAMAGE OR MATERIAL EDGE. REPAIR DELAMINATION IN HONEYCOMB AREA AS GIVEN IN SRM 51-70 NO LATER THAN THE NEXT "C" CHECK. PROTECT EDGE DAMAGE PER A.
- W HEAT SHIELD ON THE RH DOOR IS CENTERED AT RBL 53.75.
- X FOR CUM LINE NUMBERS: 1 THRU 36
- Y FOR CUM LINE NUMBERS: 37 AND ON
- AA FOR ONE-PIECE DOOR AND TANG. REFER TO
- AB FOR TWO-PIECE DOOR AND TANG. REFER TO FIGURE 1.

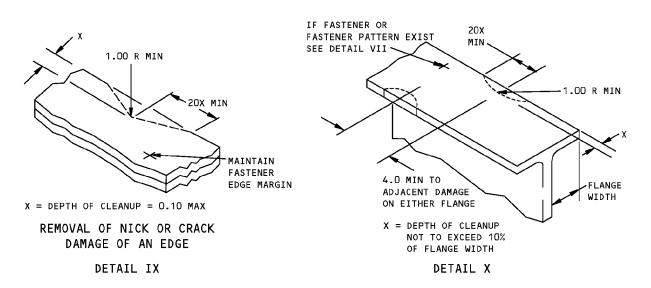
Allowable Damage - Main Landing Gear Door Figure 101 (Sheet 9 of 10)

# REMOVAL OF NICK, GOUGE AND SCRATCH DAMAGE ON A SURFACE DETAIL VIII

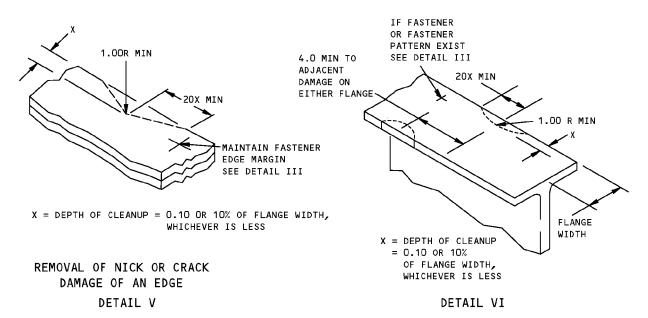
Allowable Damage - Nose Landing Gear Door Figure 101 (Sheet 4 of 5)

# REMOVAL OF NICK, GOUGE AND SCRATCH DAMAGE ON A SURFACE DETAIL IV

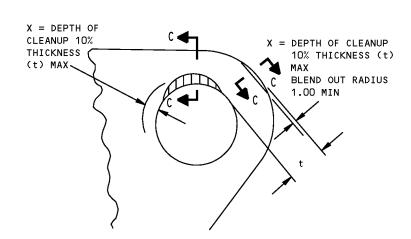
DAMAGE CLEANUP FOR EDGES OF LUG
DETAIL VIII

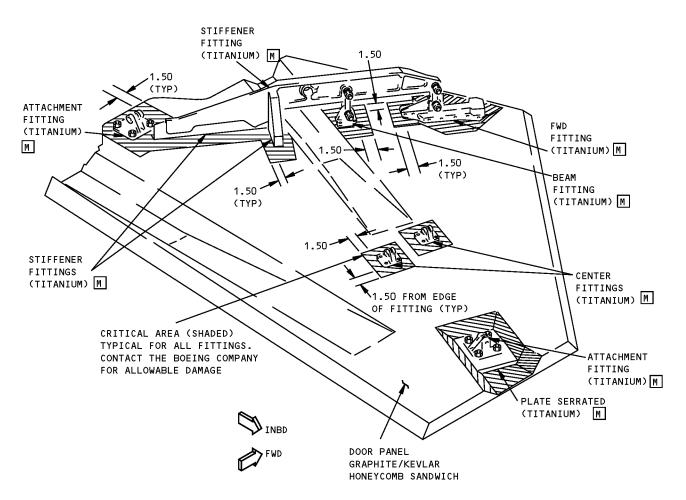
Allowable Damage - Main Landing Gear Strut Door Figure 101 (Sheet 1 of 5)

DETAIL I

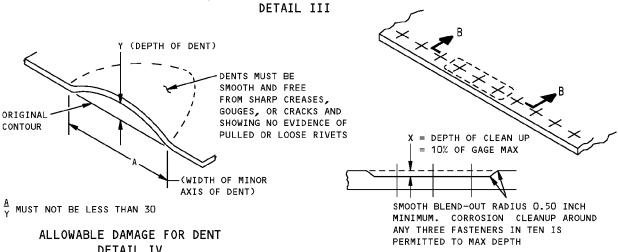
DETAIL IV

SECTION B-B CORROSION CLEANUP DETAIL V

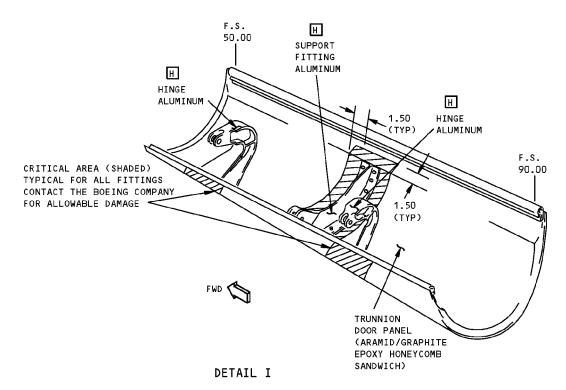
Allowable Damage - Trunnion Fairing Door Figure 101 (Sheet 1 of 4)

DESCRIPTION	CRACKS	NICKS, GOUGES AND CORROSION	DENTS	HOLES AND PUNCTURES	DELAMI- NATION	EDGE EROSION
TRUNNION DOOR PANEL	В	С	D	E	F	SEE DETAIL II
HINGE	I	G	NOT ALLOWED	NOT ALLOWED		
SUPPORT FITTING	I	G	NOT ALLOWED	NOT ALLOWED

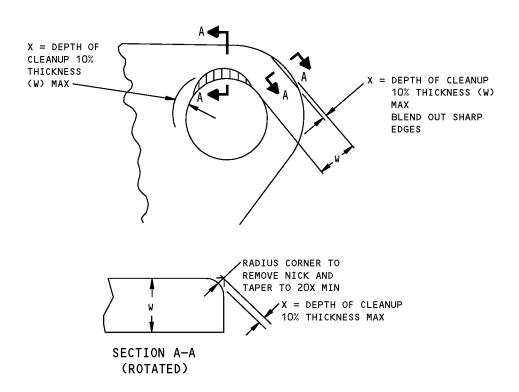
Allowable Damage - Trunnion Fairing Door Figure 101 (Sheet 3 of 4)

X = DEPTH OF CLEANUP = 0.10 MAX

# REMOVAL OF NICK OR CRACK DAMAGE OF AN EDGE DETAIL III

DAMAGE CLEANUP FOR EDGES OF LUG DETAIL IV

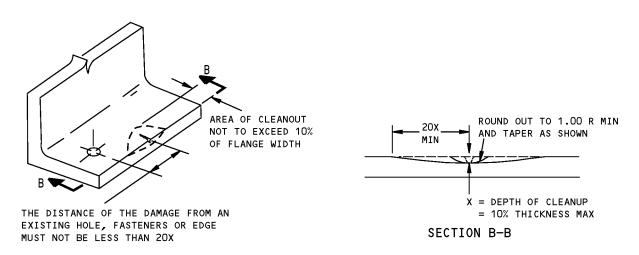
# REMOVAL OF NICK OR CRACK DAMAGE ON AN EDGE DETAIL V

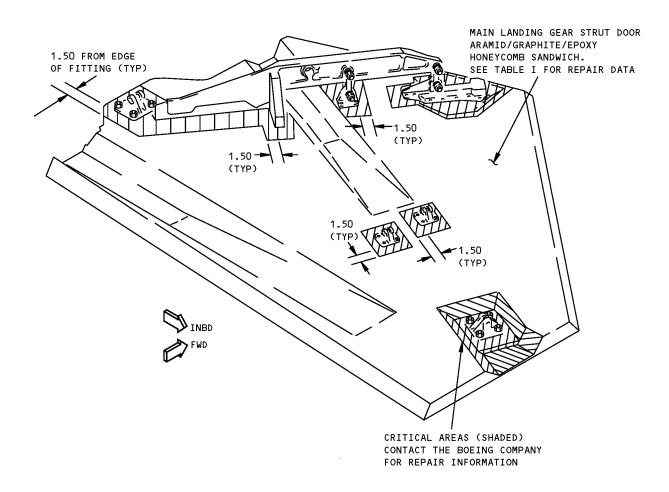
Main Landing Gear Strut Door Figure 201 (Sheet 1 of 2)

REF DWG 113N8100 113N8107

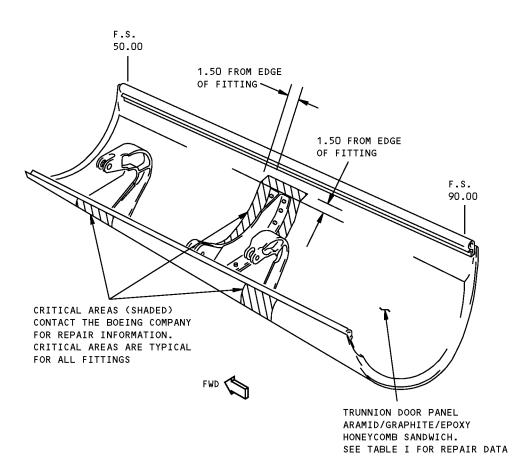
Trunnion Fairing Door Figure 201 (Sheet 1 of 2)

DETAIL I

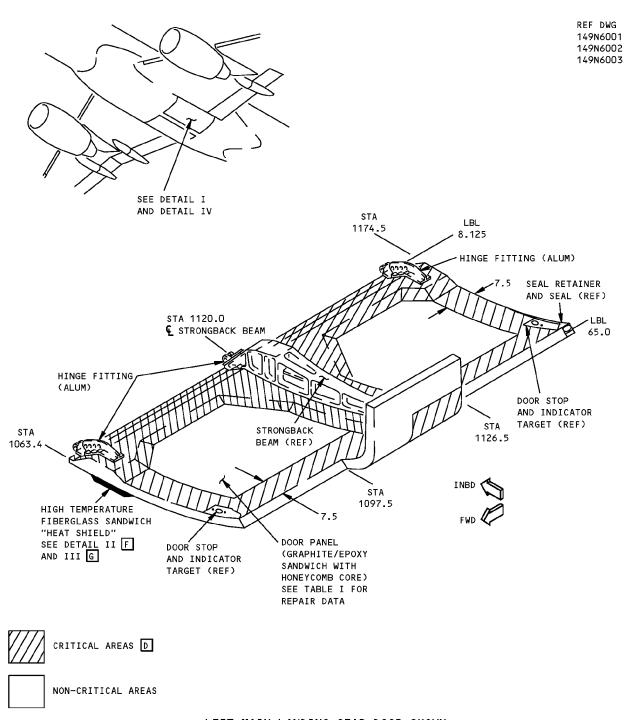
#### **REPAIR 3 - MAIN LANDING GEAR DOOR**

LEFT MAIN LANDING GEAR DOOR SHOWN RIGHT MAIN LANDING GEAR DOOR EQUIVALENT

DETAIL I H

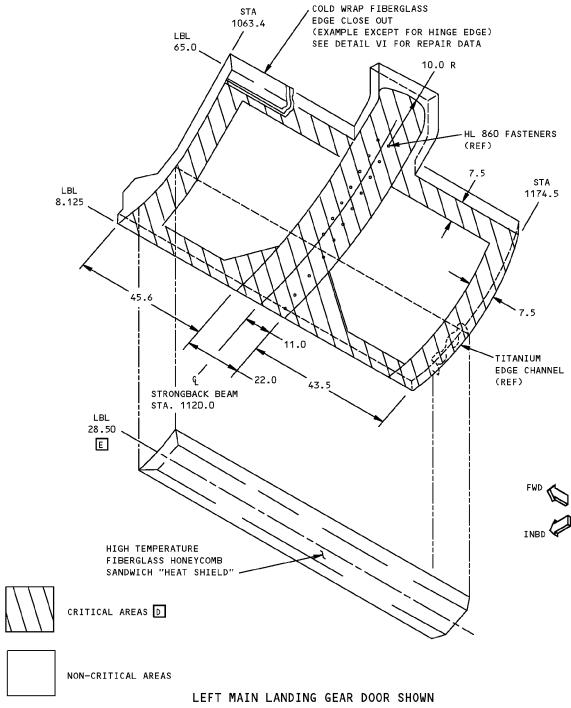
**Main Landing Gear Doors** Figure 201 (Sheet 2 of 8)

RIGHT MAIN LANDING GEAR DOOR EQUIVALENT

DETAIL II F H

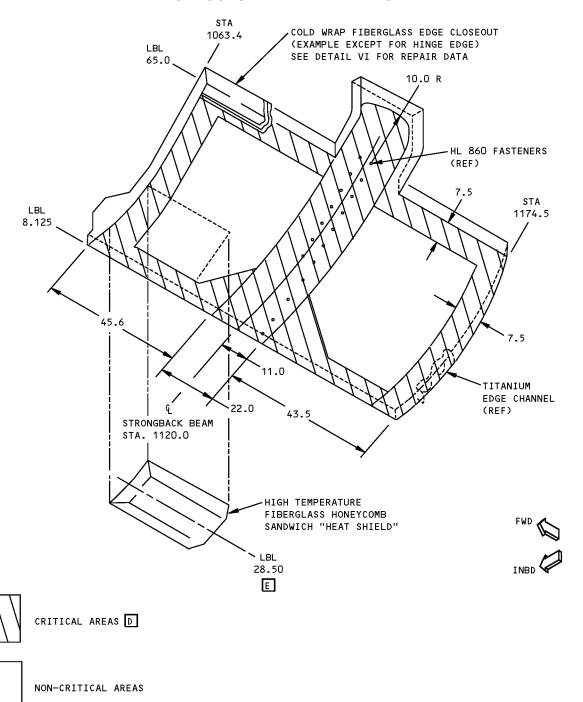
Main Landing Gear Doors Figure 201 (Sheet 3 of 8)

LEFT MAIN LANDING GEAR DOOR SHOWN RIGHT MAIN LANDING GEAR DOOR EQUIVALENT

DETAIL III G H

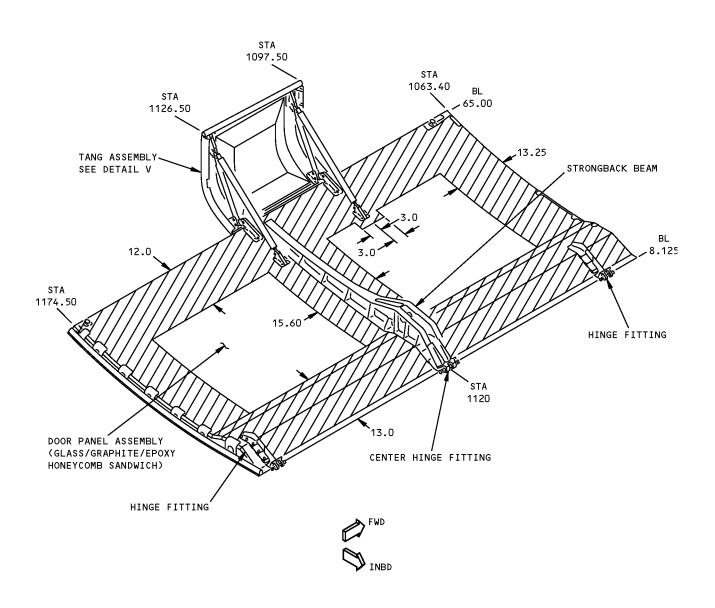
Main Landing Gear Doors Figure 201 (Sheet 4 of 8)

CRITICAL AREA D	DETAIL IV I
NON-CRITICAL AREA

- D CONTACT THE BOEING COMPANY FOR REPAIR INFORMATION IN CRITICAL AREAS. INTERIM, 200°F (93°C), AND 250°F (121°C) CURE REPAIRS ARE NOT ALLOWED IN CRITICAL AREAS UNLESS SPECIFICALLY APPROVED BY THE BOEING COMPANY.

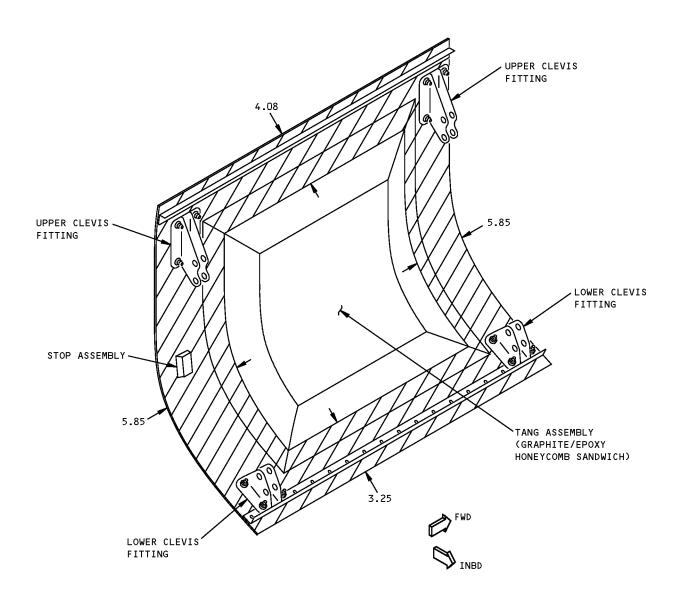
Main Landing Gear Doors Figure 201 (Sheet 5 of 8)

DETAIL	٧	I
CRITICAL AREA D			
NON-CRITICAL AREA

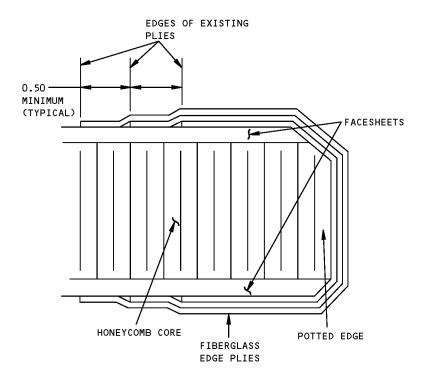
#### REPAIR OF FIBERGLASS WRAPPED EDGE

SECTION THRU COLD WRAPPED FIBERGLASS EDGE (TYPICAL)

- 1. Remove plies in the damaged area.
- Remove water and debris using vacuum and oil-free compressed air.
- Clean damaged area with MIBK, MEK, or acetone.
- Taper sand existing fiberglass edge plies allowing 0.50-inch overlap for each repair ply.
- Apply one ply of BMS 9-3, Type H fiberglass for each damaged ply using BMS 8-201, Type II resin.
- 6. Cure repair as given in SRM 51-70-06.
- Lightly sand the edge of the topmost repair ply to fair the edge.
- Restore original finish as given in Chapter
   of the Maintenance Manual.

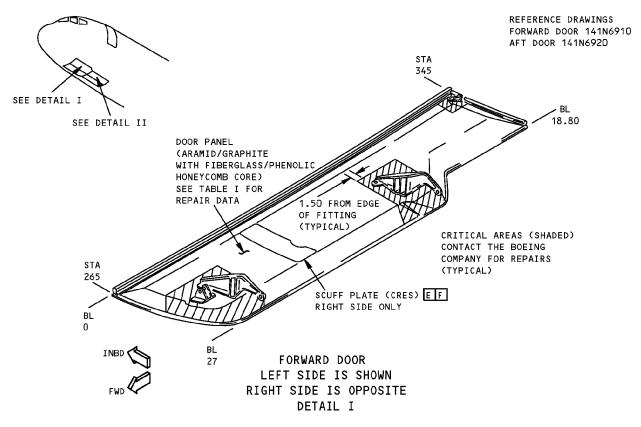
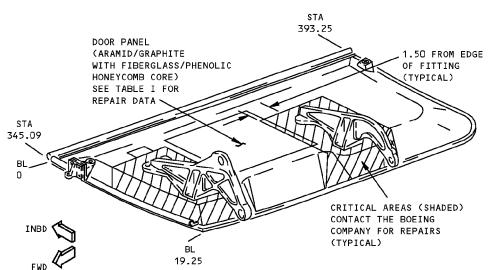
Nose Landing Gear Doors Figure 201 (Sheet 1 of 3)

AFT DOOR
LEFT SIDE IS SHOWN
RIGHT SIDE IS OPPOSITE
DETAIL II

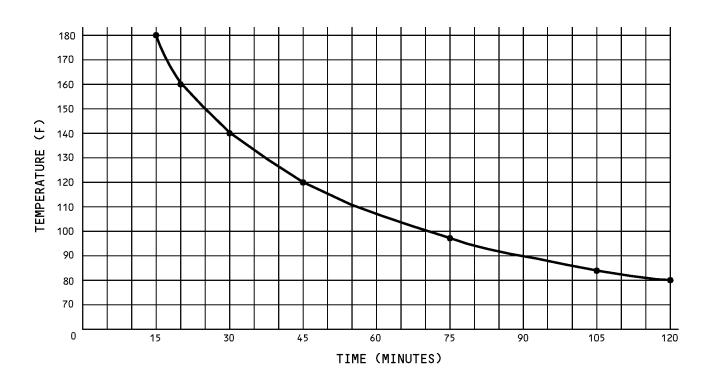
Repair of Delaminated Aramid Skin Plies - Nose Landing Gear Door Figure 201 (Sheet 2 of 2)

DRYING TIMES FOR LAMINAR X-500 SURFACER DETAIL I
