# CHAPTER 52

## DOORS

## **52-EFFECTIVE PAGES**

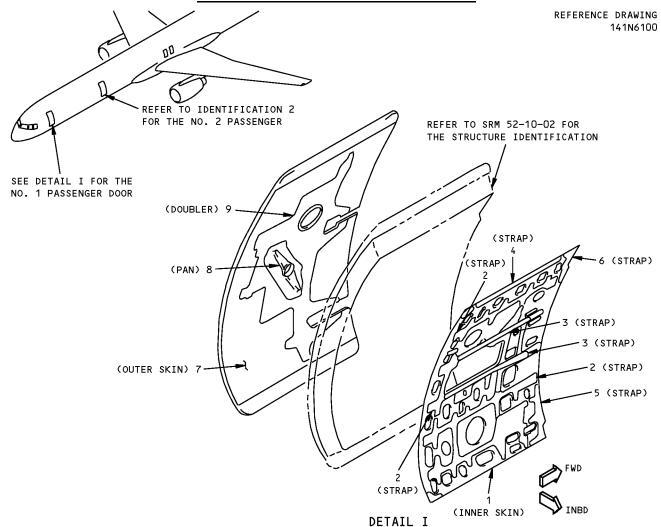
LIST OF MATERIALS FOR DETAIL I

**IDENTIFICATION 1 - NO. 1 ENTRY DOOR SKIN**

ITEM	DESCRIPTION	GAGE	MATERIAL	EFFECTIVITY
1	INNER SKIN	0.050	CLAD 7075-T6	
2	STRAP	0.071	7075-T6	
3	STRAP	0.050	CLAD 7075-T6	
4	STRAP	0.160	7075-T6	
5	STRAP	0.100	7075-T6, OPTIONAL: TI-6AL-4V	
6	STRAP	0.080	7075-T6	
7	OUTER SKIN	0.063	CLAD 2024-T3 (CHEM-MILLED TO 0.040 MIN)	
8	PAN	0.071	2024-T42	
9	DOUBLER	0.071	2024-T3

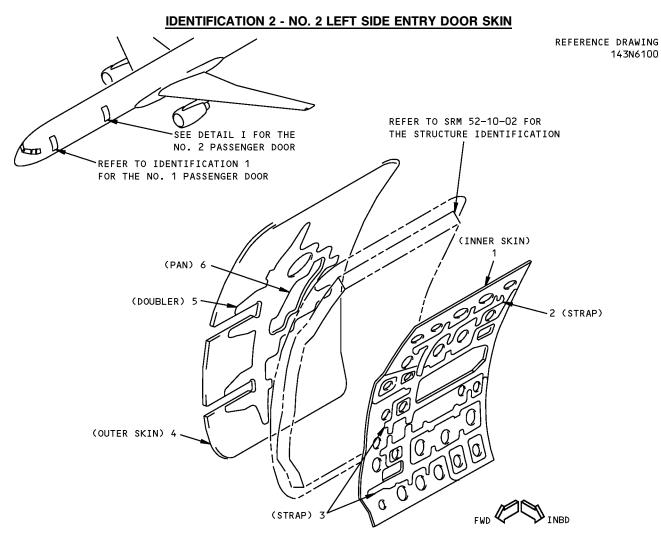
RIGHT SIDE DOOR IS SHOWN, LEFT SIDE DOOR IS OPPOSITE DETAIL I

ITEM	DESCRIPTION	GAGE	MATERIAL	EFFECTIVITY
1	INNER SKIN	0.050	CLAD 7075-T6	
2	STRAP	0.100	7075-T6	
3	STRAP	1.071	7075-T6	
4	OUTER SKIN	0.063	CLAD 2024-T3 (CHEM-MILLED TO 0.040 MIN)	
5	DOUBLER	0.071	2024-т3	
6	PAN	0.063	2024-T42

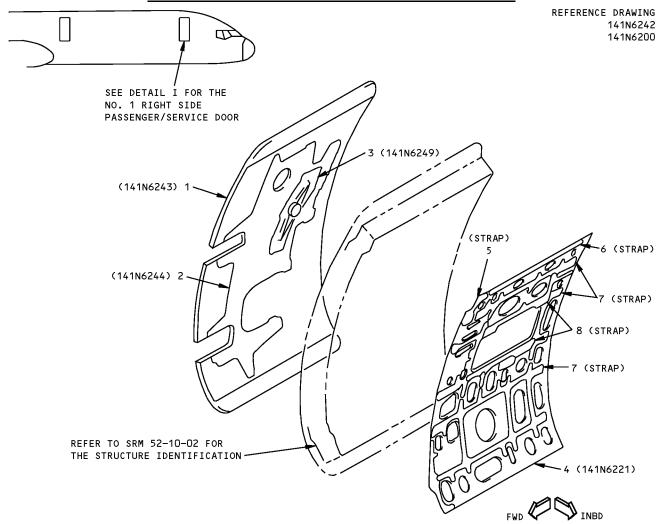
DETAIL I

#### **IDENTIFICATION 3 - NO. 1 RIGHT SIDE SERVICE DOOR SKIN**

ITEM	DESCRIPTION	GAGE	MATERIAL EFFECTIVI	
1	OUTER SKIN	0.063	CLAD 2024-T3 (CHEM-MILLED TO 0.040 MIN)	
2	DOUBLER	0.071	2024-T3	
3	PAN	0.071	2024-T42	
4	INNER SKIN	0.050	CLAD 7075-T6	
5	STRAP	0.100	7075-т6	
6	STRAP	0.125	7075-T6	
7	STRAP	0.071	7075-T6	
8	STRAP	0.050	CLAD 7075-T6

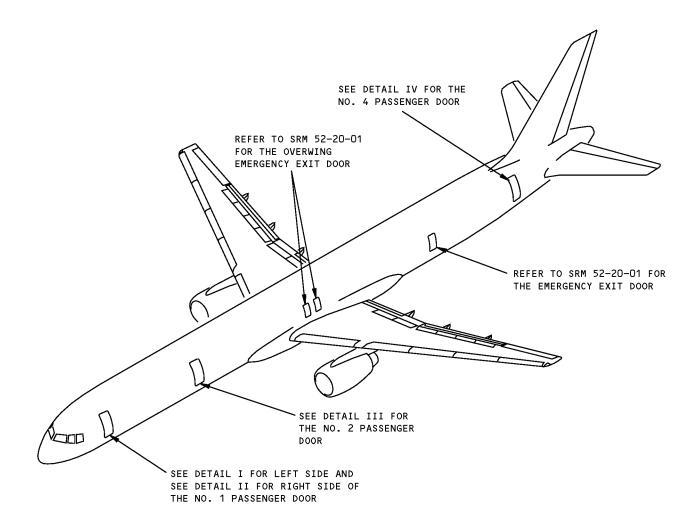
Entry Door Skin Allowable Damage Figure 101 (Sheet 1 of 7)

#### ALLOWABLE DAMAGE 1 - ENTRY DOOR SKIN

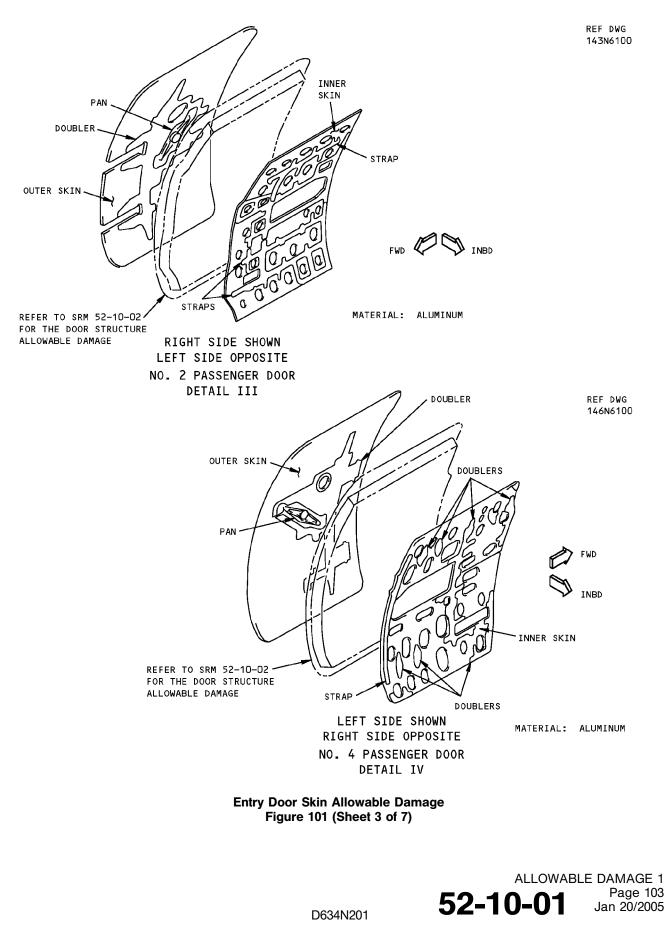
Entry Door Skin Allowable Damage Figure 101 (Sheet 4 of 7)

DESCRIPTION	CRACKS	NICKS, GOUGES AND CORROSION	DENTS	HOLES AND PUNCTURES
OUTER SKIN A	ВК	DK	L	EK
INNER SKIN	C	G	Ŀ	F
STRAPS AND DOUBLERS	В	D	SEE DETAIL VII	F
PAN	В	I	SEE DETAIL VII	Ţ

ALLOWABLE DAMAGE FOR DETAILS I, II, III AND IV

- F CLEAN OUT DAMAGE UP TO 0.25 INCH (6 mm)
   MAXIMUM DIAMETER AND NOT CLOSER THAN
   1.0 INCH (25 mm) TO FASTENER HOLE, MATERIAL
   EDGE, OR OTHER DAMAGE.
- G REMOVE DAMAGE AS SHOWN IN DETAILS V, VI, VIII AND IX. CORROSION MAY BE DRILLED OUT UP TO 0.5 INCH (13 mm) MAXIMUM DIAMETER PROVIDED EDGE MARGINS ARE MAINTAINED AS SHOWN IN DETAIL X.
- H 1.50 INCH (38 mm) MINIMUM TO EDGE OF INITIAL FASTENER HOLE, TO EDGE OF FLANGED HOLE OR TO EDGE OF CUTOUT.
- I REMOVE EDGE DAMAGE AS SHOWN IN DETAILS V AND IX. REMOVE CORROSION AROUND FASTENERS AS SHOWN IN DETAIL VIII. REMOVE SURFACE DAMAGE AS SHOWN IN DETAIL XII.

- I REMOVE THE DAMAGE TO A MAXIMUM DIAMETER OF 0.25 INCH (6 mm). THE EDGE OF THE DAMAGE CLEANUP MUST BE:
  - MORE THAN 1 INCH (25 mm) FROM ANY ADJACENT HOLE OR OTHER DAMAGE.
  - MORE THAN 1 INCH (25 mm) FROM THE EDGE OF THE PART.

INSTALL A 2117-T3 OR -T4 ALUMINUM RIVET INTO THE HOLE. MAKE SURE THE LATCH DOES NOT HIT THE HEAD OF THE RIVET WHEN THE LATCH IS OPERATED. IF THE LATCH HITS THE HEAD OF THE RIVET, THEN YOU MUST REMOVE THE RIVET AND REPAIR THE HOLE.

- K REFER TO ALLOWABLE DAMAGE 2 FOR THE PASSENGER/CREW ENTRY DOOR SKIN OPERATING LIMITS AFTER DAMAGE HAS BEEN REMOVED.
- L DENTS THAT ARE MORE THAN THE LIMITS SHOWN IN DETAIL VII SHOULD BE PERMANENTLY REPAIRED. HOWEVER, A REPAIR CAN BE DELAYED IF THE CONDITIONS THAT FOLLOW ARE MET:
  - DENTS MUST BE SMOOTH AND FREE FROM SHARP CREASES, GOUGES, OR CRACKS, AND SHOW NO EVIDENCE OF PULLED, LOOSE, OR MISSING FASTENERS
  - THERE ARE NO DAMAGED OR ELONGATED FASTENER HOLES
  - THE DENT IS NOT FILLED
  - AN EXAMINATION OF THE DENT IS MADE EVERY 300 FLIGHT CYCLES
  - A PERMANENT REPAIR IS MADE AT THE SUBSEQUENT C-CHECK OR BEFORE 24 MONTHS
  - THE DAMAGE IS A MINIMUM OF 0.5 INCH (13 mm) FROM ANY PART OF A BEAM, SKIN DOUBLER, STRAP, FRAME, INTERCOSTAL, OR STIFFENER
  - THE DAMAGE IS A MINIMUM OF 10.0 INCHES (250 mm) FROM A SKIN SPLICE OR CUTOUT, INCLUDING A HINGE CUTOUT OR A HANDLE PAN CUTOUT.

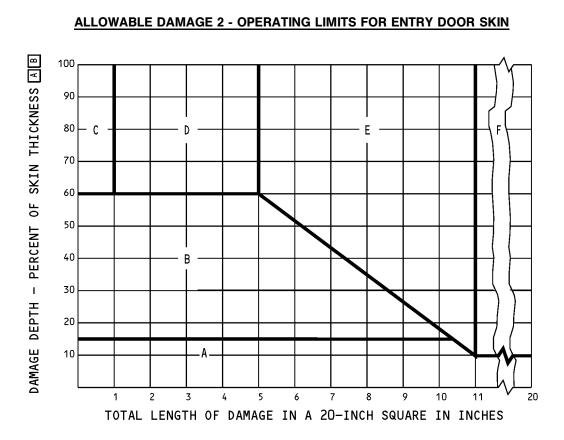
LIMITS FOR CORROSION, CRACKS, NICKS, GOUGES, AND HOLE DAMAGE

- A SKIN THICKNESS DOES NOT INCLUDE THE THICKNESS OF THE DOUBLERS, TRIPLERS, OR STRAPS.
- B DAMAGE INCLUDES HOLES, PUNCTURES, NICKS, GOUGES, SCRATCHES, CORROSION AND CRACKS. DAMAGE DOES NOT INCLUDE DENTS.
- C CABIN PRESSURE LIMITS ARE FOR SKIN DAMAGE TO THE PRESSURIZED FUSELAGE SKIN ONLY.

CHART AREA	DAMAGE TREATMENT	ALLOWABLE AIRPLANE OPERATIONS
A	CLEAN UP AS SHOWN IN ALLOWABLE DAMAGE 1.	NO FLIGHT RESTRICTIONS.
В	CLEAN UP AS SHOWN IN ALLOWABLE DAMAGE 1 TO DAMAGE DEPTH.	LIMITED TO 50 HOURS OF FLIGHT OR 25 FLIGHTS, WHICHEVER COMES FIRST (INCLUDING REVENUE FLIGHTS).
	DO AN APPLICABLE REPAIR AS GIVEN IN SRM 52-10-01.	REFER TO THE APPLICABLE REPAIR FOR THE LIMITS.
С	CLEAN UP AS SHOWN IN ALLOWABLE DAMAGE 1 TO DAMAGE DEPTH. STOP DRILL 0.25 INCH (6 mm) DIAMETER HOLES AT THE ENDS OF THE CRACKS.	A NON-REVENUE FLIGHT TO A REPAIR STATION IS PERMITTED IF THE APPLICABLE REGULATORY AUTHORITY GIVES APPROVAL BEFORE THE FLIGHT. IT IS RECOMMENDED THAT THE PROPOSED REPAIR PROCEDURE BE GIVEN TO BOEING.
		THE MAXIMUM CABIN PRESSURE DIFFERENTIAL C IS LIMITED TO 6.0 PSIG UNLESS THE SKIN IS REPAIRED.
	DO AN APPLICABLE REPAIR AS GIVEN IN SRM 52-10-01.	REFER TO THE APPLICABLE REPAIR FOR THE LIMITS.
D	CLEAN UP AS SHOWN IN ALLOWABLE DAMAGE 1 TO DAMAGE DEPTH. STOP DRILL 0.25 INCH (6 mm) DIAMETER HOLES AT THE ENDS OF THE CRACKS.	A NON-REVENUE FLIGHT TO A REPAIR STATION IS PERMITTED IF THE APPLICABLE REGULATORY AUTHORITY GIVES APPROVAL BEFORE THE FLIGHT. IT IS RECOMMENDED THAT THE PROPOSED REPAIR PROCEDURE BE GIVEN TO BOEING.

THE MAXIMUM CABIN PRESSURE DIFFERENTIAL [] IS LIMITED TO 6.0 PSIG UNLESS THE SKIN IS REPAIRED.
	DO AN APPLICABLE REPAIR AS GIVEN IN SRM 52-10-01.	REFER TO THE APPLICABLE REPAIR FOR THE LIMITS.
E	CLEAN UP AS SHOWN IN ALLOWABLE DAMAGE 1 TO DAMAGE DEPTH. STOP DRILL 0.25 INCH (6 mm) DIAMETER HOLES AT THE ENDS OF THE CRACKS.	A NON-REVENUE FLIGHT TO A REPAIR STATION IS PERMITTED IF THE APPLICABLE REGULATORY AUTHORITY GIVES APPROVAL BEFORE THE FLIGHT. IT IS RECOMMENDED THAT THE PROPOSED REPAIR PROCEDURE BE GIVEN TO BOEING.
		THE MAXIMUM CABIN PRESSURE DIFFERENTIAL C IS LIMITED TO ZERO PSIG.
	DO APPLICABLE REPAIR AS GIVEN IN SRM 52-10-01.	REFER TO THE APPLICABLE REPAIR FOR THE LIMITS.
F	CLEAN UP AS SHOWN IN ALLOWABLE DAMAGE 1 TO DAMAGE DEPTH. STOP DRILL 0.25 INCH (6 mm) DIAMETER HOLES AT THE ENDS OF THE CRACKS.	OPERATION IS NOT PERMITTED BEFORE BOEING AND THE APPLICABLE REGULATORY AUTHORITY GIVES APPROVAL.

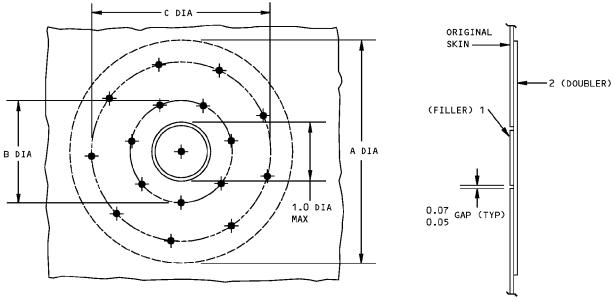
#### Small Hole in Entry Door Skin - Flush Repair Figure 201 (Sheet 2 of 2)

SKIN GAGE	PART 2 DOUBLER	A INCHES	B INCHES	C INCHES	INNER CIR		OUTER CIR	
GAGE	GAGE	INCHES	INCHES	INCHES	NUMBER	SIZE	NUMBER	SIZE
0.040	0.050	3.80	1.70	3.10	7	5/32	9	5/32
0.045	0.050	3.80	1.70	3.10	7	5/32	9	5/32
0.050	0.063	4.30	1.80	3.50	6	3/16	9	3/16
0.063	0.071	4.30	1.80	3.50	6	3/16	9	3/16

PLAN VIEW

SECTION THROUGH REPAIR

REPAIR MATERIAL					
PART QTY MATERIAL					
1	FILLER	1	SAME MATERIAL AND GAGE AS ORIGINAL SKIN		
2	DOUBLER	1	SAME MATERIAL AS ORIGINAL SKIN. FOR GAGE SEE TABLE 1

REPAIR FASTENER LOCATION BACR15CE( )KE RIVET SEE TABLE 1 FOR SIZE AND NUMBER REQUIRED

- Clean out the damaged hole to 1 inch (25 mm) diameter maximum. The center of the hole to an edge or cutout must not be less than 1/2 of dimension A from Table I.

- 2. Fabricate repair parts 1 and 2.
- 3. Break sharp edges of original and repair parts 0.015 to 0.030 inch (0.4 to 0.8 mm).
- Remove all nicks, scratches, burrs, sharp edges and corners from initial and repair parts.

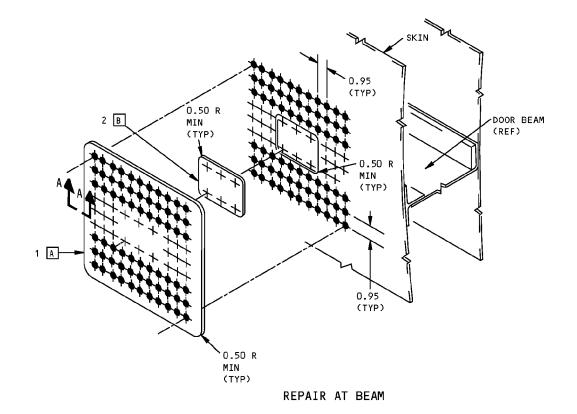
Entry Door Skin - Non-Flush Repair Figure 201 (Sheet 3 of 3)

SECTION THRU REPAIR

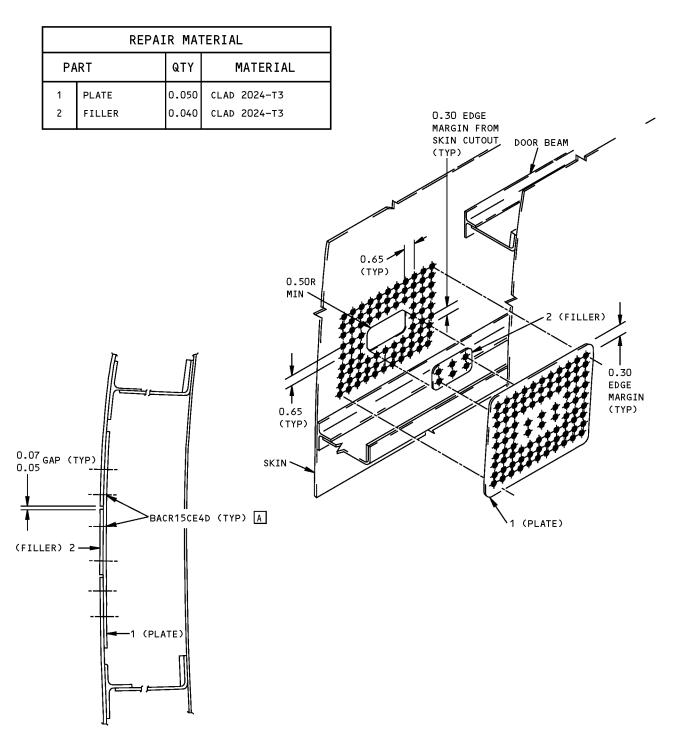
Crew Entry Door Skin - Flush Repair Between Beam (0.040 Chem-Mill Pocket 0nly) Figure 201 (Sheet 2 of 2)

SECTION THROUGH REPAIR

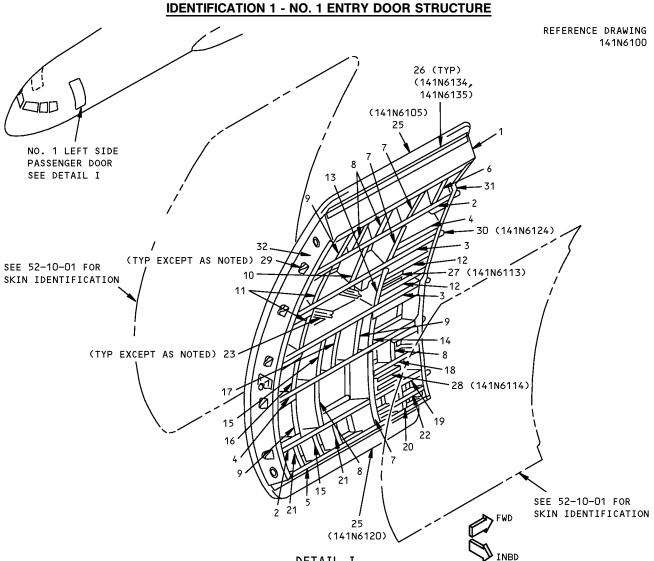
DETAIL I

ITEM	DESCRIPTION	GAGE	MATERIAL	EFFECTIVITY
1	WEB	0.080	7075–T6	
2	BEAM OUTER CHORD WEB	0.063	BAC1505-100543 2024-T42 CLAD 2024-T42	
3	BEAM OUTER CHORD WEB	0.063	BAC1506-3161 2024-T42 CLAD 2024-T42	
4	OUTER CHORD ANGLE	0.063 0.063	CLAD 2024-T42 CLAD 7075-T6	
5	LOWER BEAM		7075-T73 FORGING

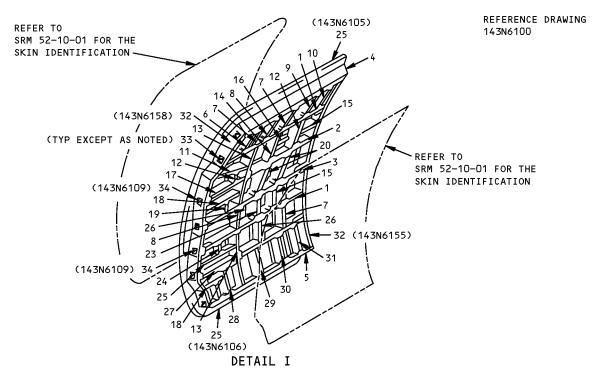
No. 2 Passenger and Service Door Structure Identification Figure 1 (Sheet 2 of 3)

ITEM	DESCRIPTION	GAGE	MATERIAL	EFFECTIVITY
1	BEAM WEB OUTER CHORD	0.063	CLAD 7075-T6 BAC1505-100350 2024-T42	
2	BEAM WEB OUTER CHORD	0.063 2.5	CLAD 7075-T6 7075-T73 PLATE	
3	BEAM WEB OUTER CHORD	0.063 2.5	CLAD 7075-T6 7075-T6 PLATE	
4	WEB	0.080	7075-T6	
5	STOP BEAM		7075-T73 FORGING	
6	OUTER CHORD INNER CHORD		BAC1503-100142 2024-T42 BAC1503-2811 7075-T6	
7	INTERCOSTAL OUTER CHORD	0.056	CLAD 7075-T6 BAC1505-100052 2024-T42	
8	INTERCOSTAL OUTER CHORD	0.063	CLAD 7075-T6 BAC1505-100052 2024-T42	
9	INTERCOSTAL	0.056	CLAD 7075-T6	
10	INNER CHORD OUTER CHORD		BAC1503-2811 7075-T6 BAC1505-100350 2024-T42	
11	WEB INNER CHORD OUTER CHORD	0.063 0.063	CLAD 7075-T6 CLAD 7075-T6 BAC1505-100270 2024-T42	
12	INTERCOSTAL OUTER CHORD	0.056 0.063	CLAD 7075-T6 CLAD 2024-T42

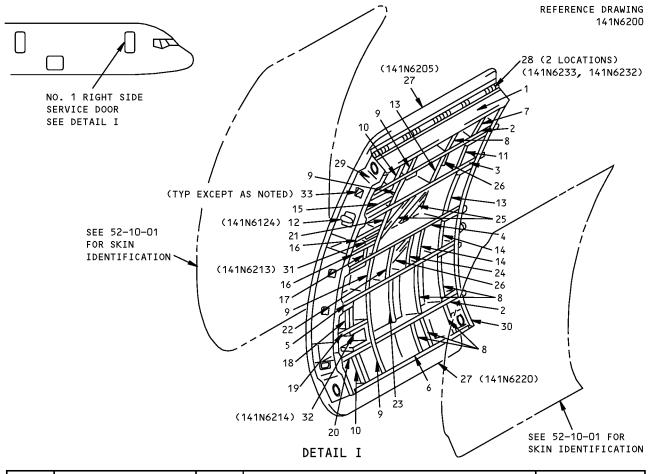
LIST OF MATERIALS FOR DETAIL I

#### **IDENTIFICATION 3 - NO. 1 RIGHT SIDE SERVICE DOOR STRUCTURE**

ITEM	DESCRIPTION	GAGE	MATERIAL	EFFECTIVITY
1	BEAM SUPPORT ANGLE	0.080	7075-T6 BAC1503-521 7075-T6	
2	BEAM OUTER CHORD WEB	0.063	BAC1505-100543 2024-T42 CLAD 7075-T6	
3	BEAM OUTER CHORD WEB SPLICE CHORD	0.063	BAC1505–100543 2024–T42 CLAD 2024–T42 BAC1505–100696 2024–T3511	
4	BEAM OUTER CHORD WEB SPLICE CHORD	0.063	BAC1505–100544 2024–T42 CLAD 2024–T42 BAC1505–100696 2024–T3511	
5	BEAM OUTER CHORD WEB	0.063	BAC1505-100543 2024-T42 CLAD 2024-T42	
6	LOWER BEAM		7075-T73 FORGING

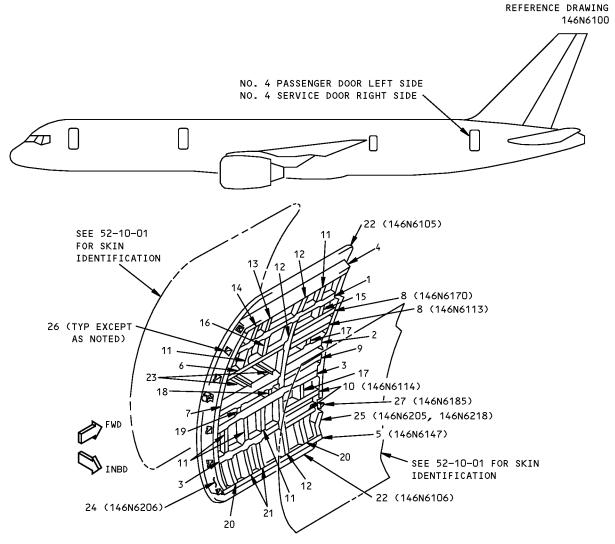
### **IDENTIFICATION 4 - NO. 4 PASSENGER AND SERVICE DOOR STRUCTURE**

LEFT SIDE DOOR SHOWN RIGHT SIDE DOOR OPPOSITE

ITEM	DESCRIPTION	GAGE	MATERIAL	EFFECTIVITY
1	BEAM OUTER CHORD WEB INNER CHORD	0.080	BAC1505–100624 2024–T42 7075–T6 BAC1505–100624 7075–T6	
2	BEAM OUTER CHORD WEB INNER CHORD	0.063	BAC1505-100624 2024-T42 CLAD 2024-T3 BAC1505-100168 7075-T6

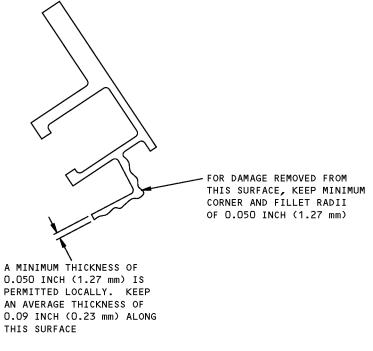
Entry Door Structure Allowable Damage Figure 101 (Sheet 7 of 8)

CROSS SECTION OF LOWER DOOR GATE DETAIL XII

SECTION C-C

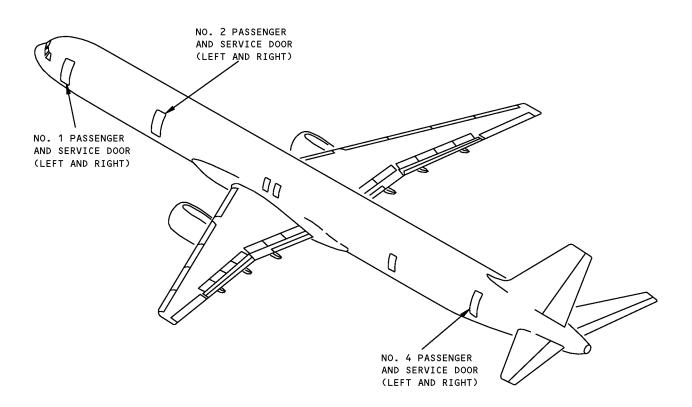
**REPAIR GENERAL - ENTRY DOOR STRUCTURE**

• DAMAGED COMPONENTS IN THE DOOR STRUCTURE MAY BE REPLACED OR REPAIRED. IF REPAIRS ARE TO BE MADE, REFER TO SRM 51-70 FOR TYPICAL WEB, FORMED SECTION, OR EXTRUDED SECTION REPAIRS

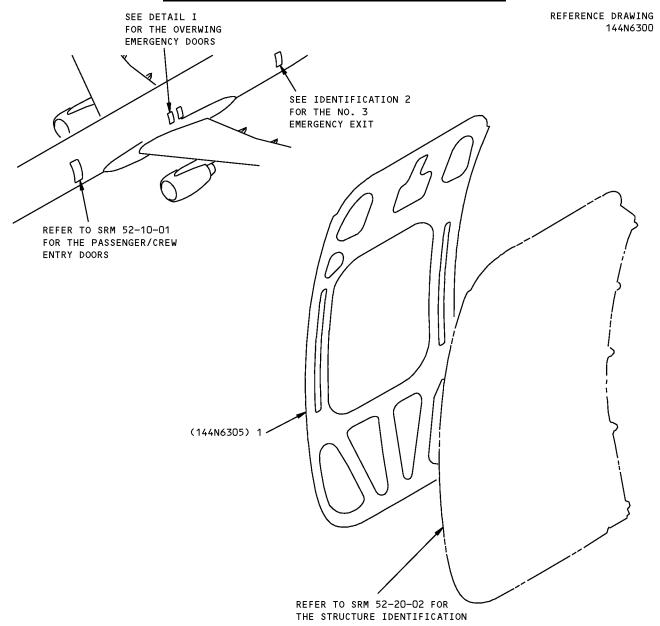
DETAIL I

### **IDENTIFICATION 1 - OVERWING EMERGENCY EXIT SKIN**

ITEM	DESCRIPTION	GAGE	MATERIAL	EFFECTIVITY
1	OUTER SKIN	0.063	CLAD 2024-T3 (CHEM-MILLED TO 0.040 MIN)

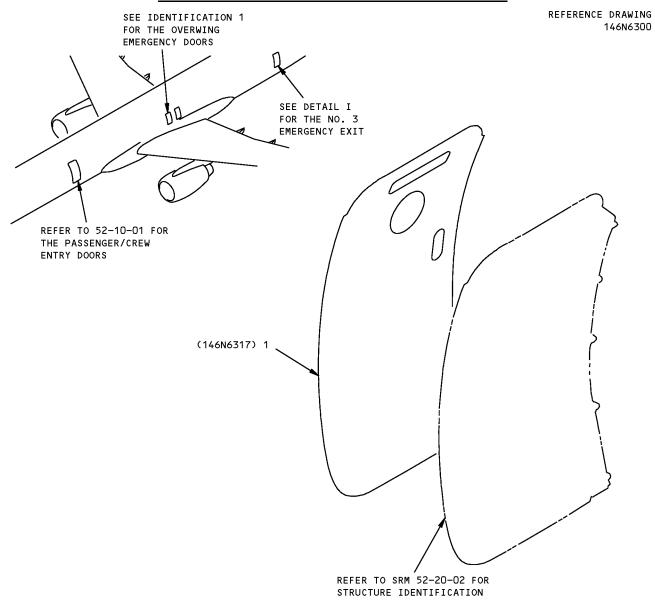
### DETAIL I

### **IDENTIFICATION 2 - NO. 3 EMERGENCY EXIT DOOR SKIN**

ITEM	DESCRIPTION	GAGE	MATERIAL	EFFECTIVITY
1	OUTER SKIN	0.063	CLAD 2024-T3 (CHEM-MILLED TO 0.040 MIN)

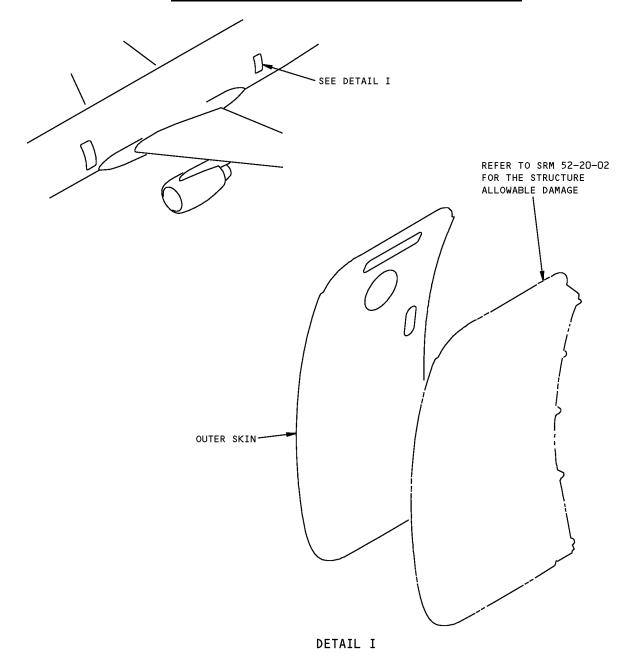
Emergency Exit Door Skin Allowable Damage Figure 101 (Sheet 1 of 3)

### ALLOWABLE DAMAGE 1 - EMERGENCY EXIT DOOR SKIN

DESCRIPTION	CRACKS	NICKS, GOUGES AND CORROSION	DENTS	HOLES AND PUNCTURES
OUTER SKIN	A D	BD	SEE DETAIL IV	93

- REFINISH THE REWORKED AREAS AS SHOWN IN AMM 51-20
- REFER TO SRM 51-10-01 FOR AERODYNAMIC SMOOTHNESS REQUIREMENTS. WHERE THE DAMAGE IS MORE THAN THE LIMITS AS SHOWN IN SRM 51-10-01, CONSIDERATION SHOULD BE GIVEN TO THE LOSS OF PERFORMANCE INVOLVED
- A CRACKS ARE NOT PERMITTED EXCEPT FOR EDGE CRACKS WHICH MUST BE REMOVED AS SHOWN IN DETAILS II AND VI.
- B REMOVE DAMAGE AS SHOWN IN DETAILS II, III, V AND VI.

- C CLEAN OUT DAMAGE UP TO 0.25 INCH (6 mm) MAXIMUM DIAMETER AND NOT CLOSER THAN 1.0 INCH (25 mm) TO FASTENER HOLE, MATERIAL EDGE, OR OTHER DAMAGE. FILL HOLE WITH 2117-T3 OR T4 ALUMINUM RIVET INSTALLED WET WITH BMS 5-95 SEALANT. ALL OTHER HOLES TO BE REPAIRED.
- D REFER TO ALLOWABLE DAMAGE 2 FOR THE EMERGENCY EXIT DOOR SKIN OPERATING LIMITS AFTER DAMAGE HAS BEEN REMOVED.

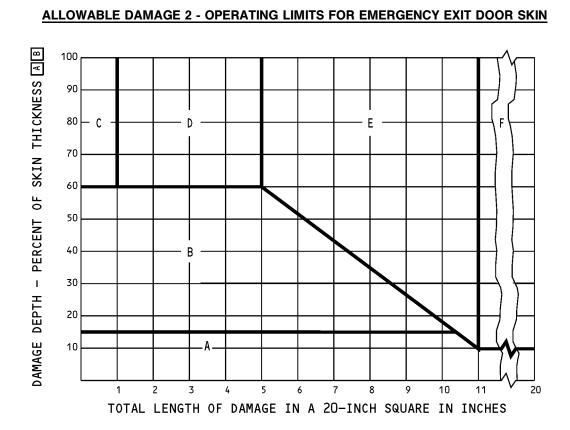
- A SKIN THICKNESS DOES NOT INCLUDE THE THICKNESS OF THE DOUBLERS, TRIPLERS, OR STRAPS.
- B DAMAGE INCLUDES HOLES, PUNCTURES, NICKS, GOUGES, SCRATCHES, CORROSION AND CRACKS. DAMAGE DOES NOT INCLUDE DENTS.
- C CABIN PRESSURE LIMITS ARE FOR SKIN DAMAGE TO THE PRESSURIZED FUSELAGE SKIN ONLY.

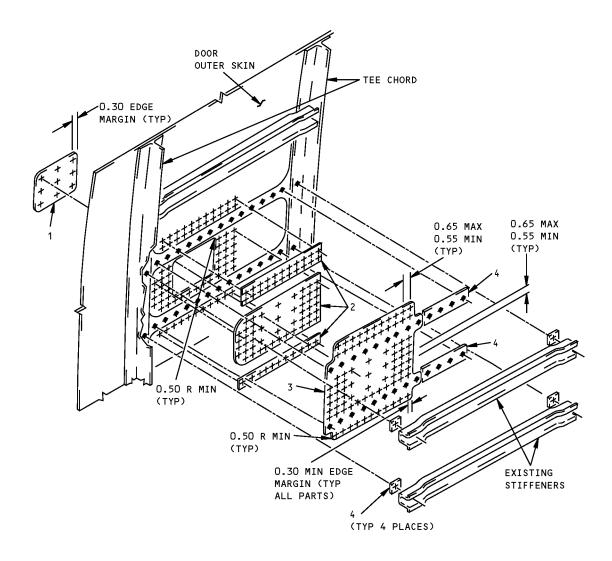
> Emergency Exit Door Skin - Flush Repair Between Stiffeners Figure 201 (Sheet 2 of 3)

FASTENER SYMBOLS + BACR15CE5D A + BACR15CE4D

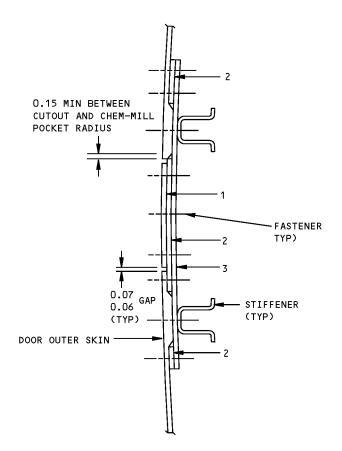
Emergency Exit Door Skin - Flush Repair Between Stiffeners Figure 201 (Sheet 3 of 3)

REPAIR MATERIAL					
P	ART	QTY	GAGE	MATERIAL	
1	FILLER	1	0.040	CLAD 2024-T3	
2	SHIM	AS REQ'D	0.020 OR 0.025	CLAD 2024-T3	
3	PLATE	1	0.050	CLAD 2024-T3	
4	SHIM	AS REQ'D	0.050	CLAD 2024-T3

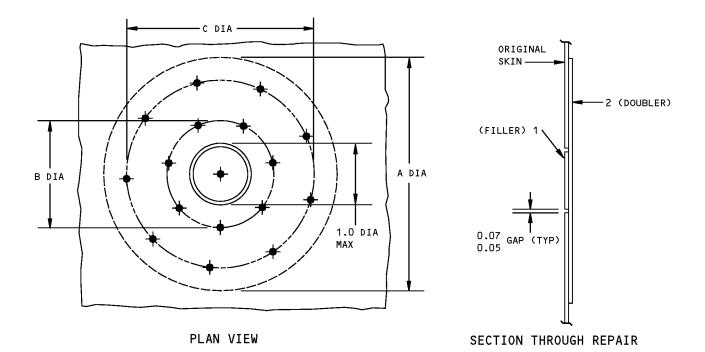
Small Hole Flush Repair - Emergency Exit Door Skin Figure 201 (Sheet 2 of 2)

SKIN GAGE	PART 2 DOUBLER	A INCHES	BINCHES	C INCHES	INNER CIR		OUTER CIR	
GAGE	GAGE	INCHES	INCHES	INCHES	NUMBER	SIZE	NUMBER	SIZE
0.040	0.050	3.80	1.70	3.10	7	5/32	9	5/32
0.045	0.056	3.80	1.70	3.10	7	5/32	9	5/32
0.050	0.063	4.30	1.80	3.50	6	3/16	9	3/16
0.063	0.071	4.30	1.80	3.50	6	3/16	9	3/16

- Clean out the damaged hole to 1-inch (25 mm) diameter maximum. The center of the hole to an edge or cutout must not be less than 1/2 of dimension A from Table I.

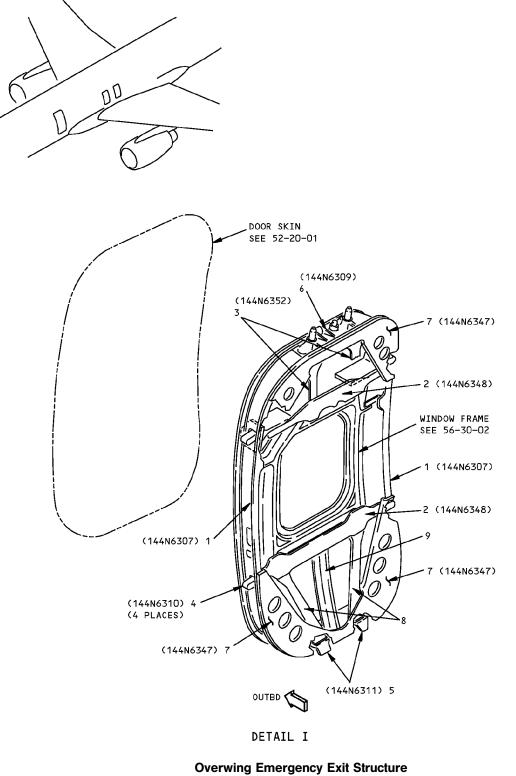
Figure 1 (Sheet 2 of 3)

ITEM	DESCRIPTION	GAGE	MATERIAL	EFFECTIVITY
1	EDGE BEAM	0.071	2024-T42	
2	STOP BEAM		BAC1518-887 2024-T42	
3	INTERCOSTAL TEE WEB	0.063	BAC1505–100881 2024–T3511 2024–T42	
4	STOP FITTING		7075-T73 FORGING OR 7075-T73 FORGED BLOCK	
5	PIVOT FITTING	1.25	7075-T73 FORGING OR 7075-T7351 PLATE	
6	LATCH PIN FITTING		FORGING 7075-T73 OR FORGED BLOCK 7075-T73	
7	GUSSET	0.063	7075-T6	
8	INTERCOSTAL OUTER TEE INNER TEE WEB	0.063	BAC1505–100818 2024–T3511 OR 7075–T3511 BAC1505–100881 2024–T3511 OR 7075–T3511 2024–T42	
9	ZEE		BAC1517-130 2024-T42 OR 2024-T4

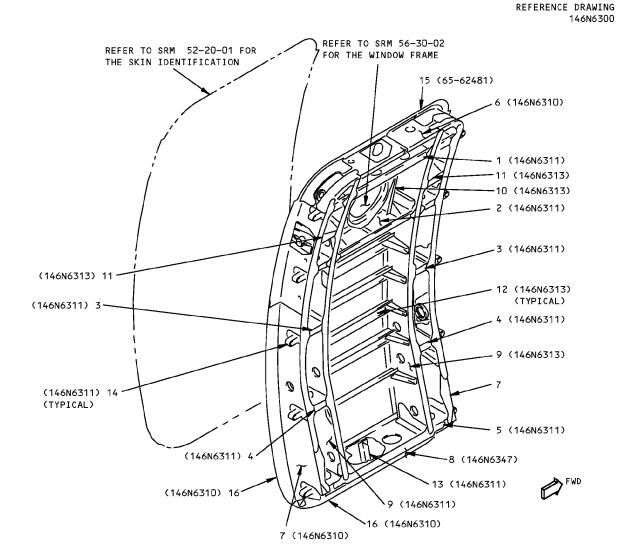
DETAIL I

ITEM	DESCRIPTION	GAGE	MATERIAL	EFFECTIVITY
1	BEAM OUTER CHORD INNER CHORD WEB SUPPORT FITTING	0.063 0.056	CLAD 2024-T42 BAC1506-1920 7075-T73511 CLAD 7075-T6 BAR 7075-T7351	
2	BEAM OUTER CHORD INNER CHORD WEB	0.063 0.063	BAC1506-1614 2024-T42 CLAD 7075-T6 CLAD 7075-T6

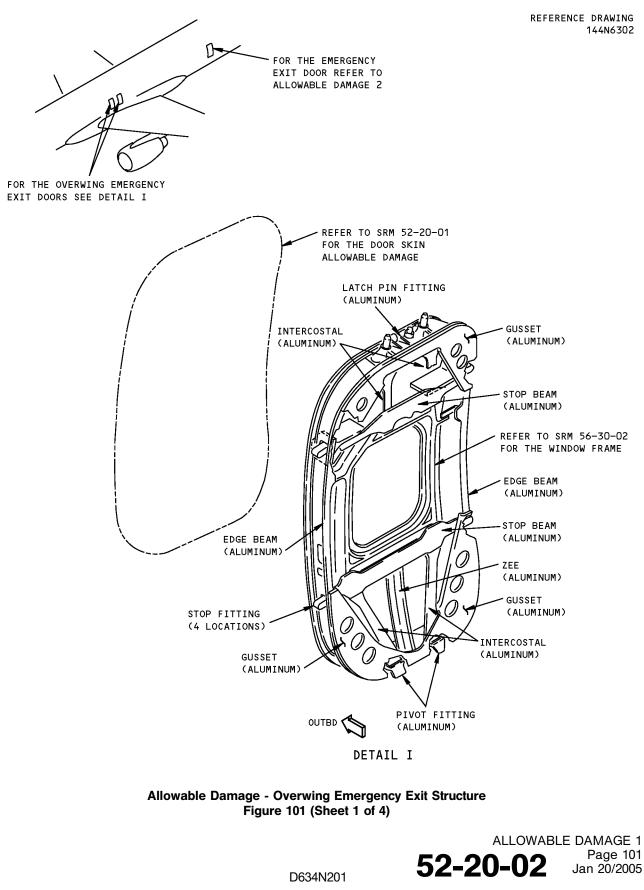
Allowable Damage - Overwing Emergency Exit Structure Figure 101 (Sheet 2 of 4)

DESCRIPTION	CRACKS	NICKS, GOUGES AND CORROSION	DENTS	HOLES AND PUNCTURES
INTERCOSTAL WEB	В	E	SEE DETAIL IV	G
TEE	A	D	NOT ALLOWED	NOT ALLOWED
EDGE BEAM	В	E	SEE DETAIL IV	G
STOP BEAM	A	D	SEE DETAIL IV	G
GUSSET	В	E	SEE DETAIL IV	G
FITTINGS	C	F	NOT ALLOWED	NOT ALLOWED
ZEE	A	D	NOT ALLOWED	NOT ALLOWED

- REFER TO SRM 51-10-02 FOR INSPECTION AND REMOVAL OF DAMAGE.
- REFINISH REWORKED AREAS AS GIVEN IN AMM 51-20
- A CRACKS NOT ALLOWED EXCEPT FOR EDGE CRACKS WHICH MUST BE REMOVED AS GIVEN IN DETAILS II VII
- B CRACKS NOT ALLOWED EXCEPT FOR EDGE CRACKS WHICH MUST BE REMOVED AS GIVEN IN DETAILS II AND VI
- C CRACKS NOT ALLOWED EXCEPT FOR EDGE CRACKS WHICH MUST BE REMOVED AS GIVEN IN DETAILS II AND VII. SHOT PEEN REWORKED AREA AS GIVEN IN SRM 51-20-06
- D REMOVE DAMAGE AS GIVEN IN DETAILS II, III, V AND VII
- E REMOVE DAMAGE AS GIVEN IN DETAILS II, III, V AND VI

- F FOR EDGE DAMAGE SEE DETAIL VII. FOR LUG DAMAGE, SEE DETAIL VIII. FOR OTHER DAMAGE, SEE DETAIL III. DAMAGE NOT ALLOWED IN VICINITY OF BUSHINGS. SHOT PEEN REWORKED AREA AS GIVEN IN SRM 51-20-06
- G CLEAN OUT DAMAGE UP TO 0.25 INCH (6 mm) MAX DIA AND NOT CLOSER THAN 1.0 INCH (25 mm) TO FASTENER HOLE, MATERIAL EDGE, OR OTHER DAMAGE. FILL HOLE WITH 2117-T3 OR T4 ALUMINUM RIVET INSTALLED WET WITH BMS 5-95 SEALANT. ALL OTHER HOLES TO BE REPAIRED

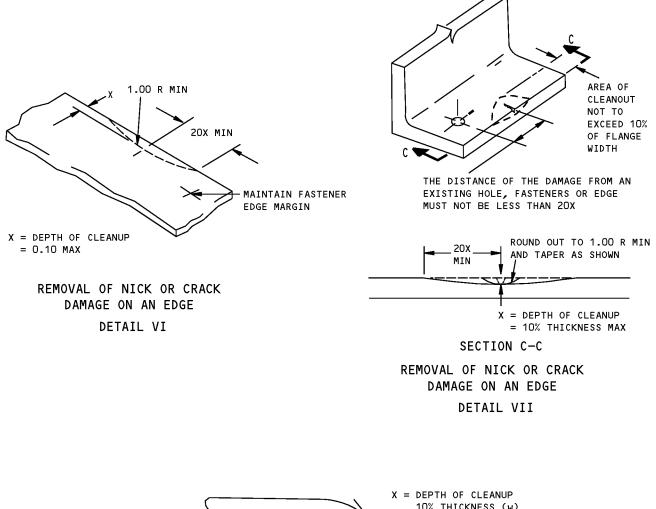
Allowable Damage - Overwing Emergency Exit Structure Figure 101 (Sheet 4 of 4)

DAMAGE CLEANUP FOR EDGES OF LUG DETAIL VIII

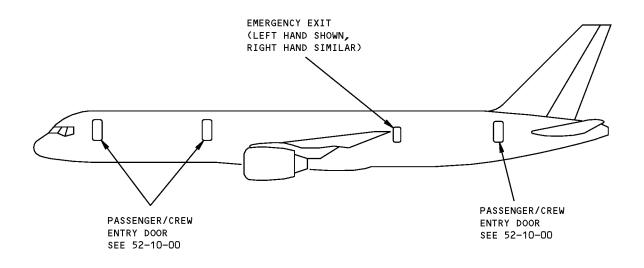
> Emergency Exit Door Structure Repair Figure 201

• DAMAGED COMPONENTS IN DOOR STRUCTURE MAY BE REPLACED OR REPAIRED. IF REPAIRS ARE TO BE MADE, SEE 51-70 FOR TYPICAL WEB, FORMED SECTION, OR EXTRUDED SECTION REPAIRS

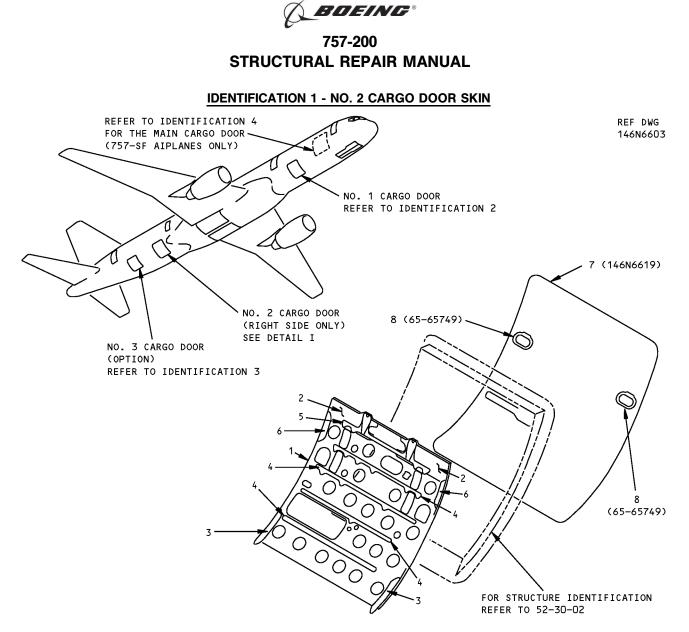
DETAIL I

ITEM	DESCRIPTION	GAGE	MATERIAL	EFFECTIVITY
1	INNER SKIN	0.045	CLAD 7075-T6	
2	DOUBLER	0.032	CLAD 7075-T6	
3	STRAP	0.125	7075–T6	
4	STRAP	0.100	7075-T6	
5	DOUBLER	0.140	7075-T6	
6	STRAP	0.080	7075-T6	
7	OUTER SKIN	0.063	CLAD 2024-T3 (CHEM-MILLED TO 0.040 MIN)	
8	DOUBLER		2024-T351 PLATE

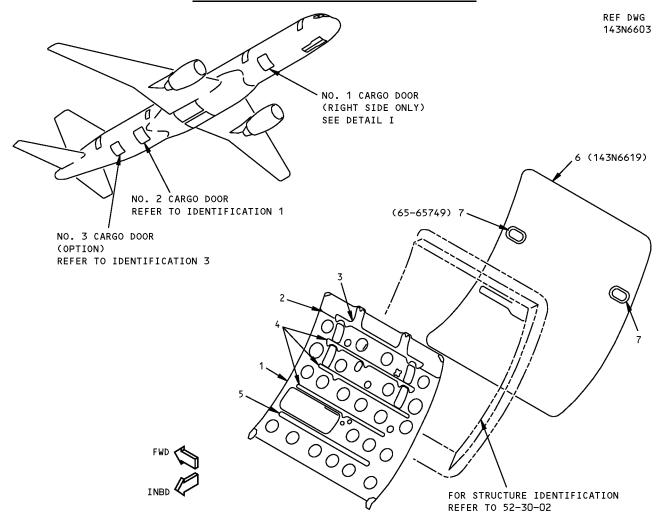
DETAIL I

ITEM	DESCRIPTION	GAGE	MATERIAL	EFFECTIVITY
1	INNER SKIN	0.045	CLAD 7075-T6	
2	DOUBLER	0.032	CLAD 7075-T6	
3	STRAP	0.032	CLAD 2024-T3	
4	STRAP	0.100	CLAD 7075-T6	
5	STRAP		7075-T6 PLATE	
6	OUTER SKIN	0.063	CLAD 2024-T3 (CHEM-MILLED TO 0.040 MIN)	
7	DOUBLER		2024-T351 PLATE

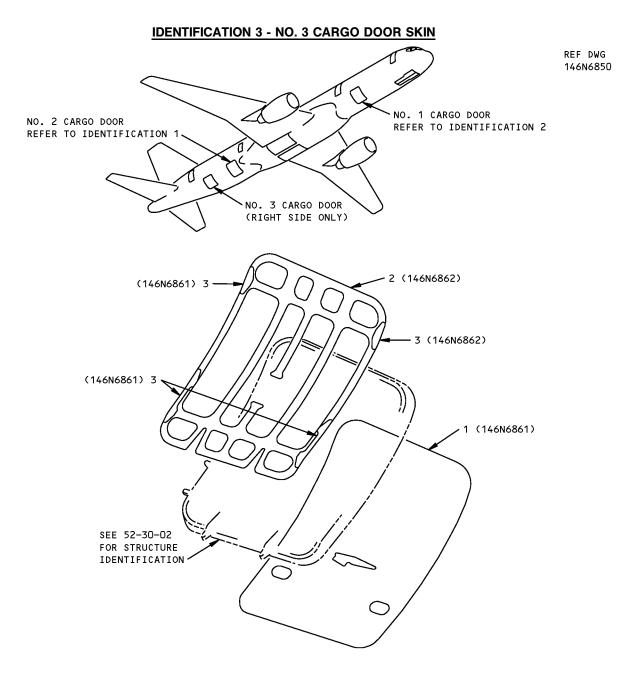
ITEM	DESCRIPTION	GAGE	MATERIAL	EFFECTIVITY
1	OUTER SKIN	0.071	CLAD 2024-T3 (CHEM-MILLED TO 0.040 MIN)	
2	INNER SKIN	0.063	CLAD 2024-T3	
3	STRAP	0.063	CLAD 2024-T3

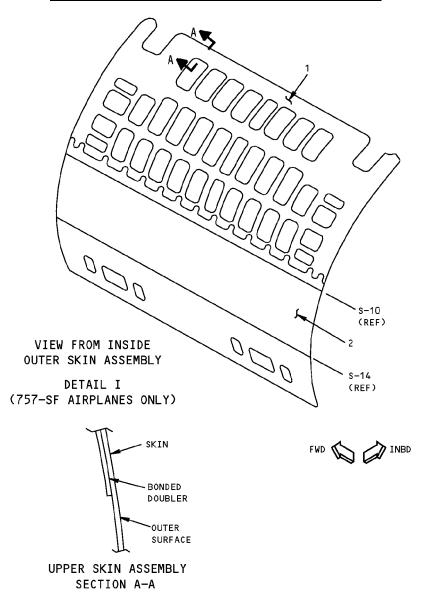
ITEM	DESCRIPTION	GAGE	MATERIAL	EFFECTIVITY
1	UPPER SKIN ASSEMBLY SKIN BONDED DOUBLER	0.040 0.040	CLAD 2024-T3 CLAD 2024-T3	
2	LOWER SKIN	0.063	CLAD 2024-T3

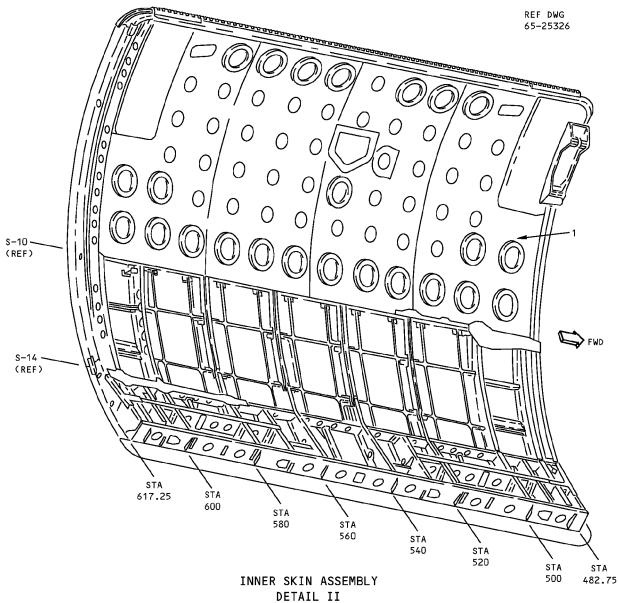
(757-SF AIRPLANES ONLY)

ITEM	DESCRIPTION	GAGE	MATERIAL	EFFECTIVITY
1	SKIN	0.032	CLAD 7075-T6

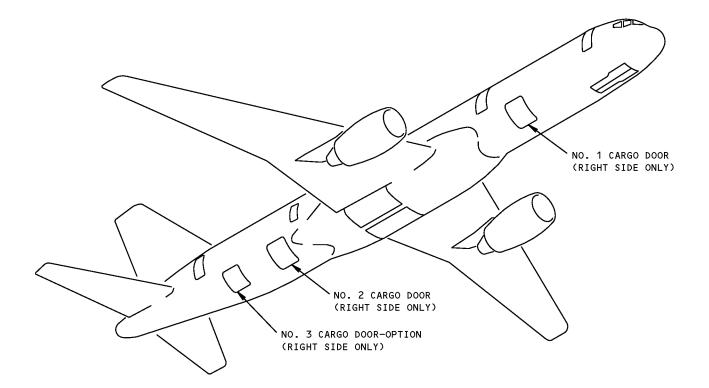
Typical Skin Repairs for Cargo Doors Figure 201

REPAIRS FOR CARGO DOORS:
 REFER TO REPAIR 1 FOR FLUSH SKIN REPAIR BETWEEN BEAMS
 REFER TO REPAIR 2 FOR SMALL HOLE - FLUSH REPAIR
 REFER TO REPAIR 3 FOR EXTERNAL REPAIR
 REFER TO REPAIR 4 FOR EXTERNAL REPAIR

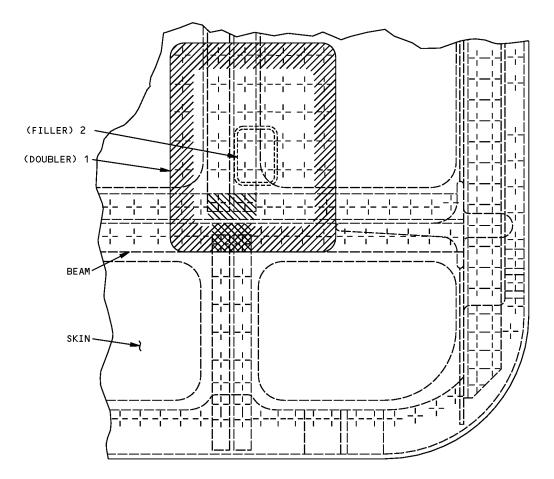
ALTERNATIVE (I) LFEC METHOD INSPECTION AREA. DO THE INSPECTION OF THE SKIN EXTERNALLY THROUGH THE PART 1 DOUBLER AT EVERY 3,000 FLIGHT CYCLES.

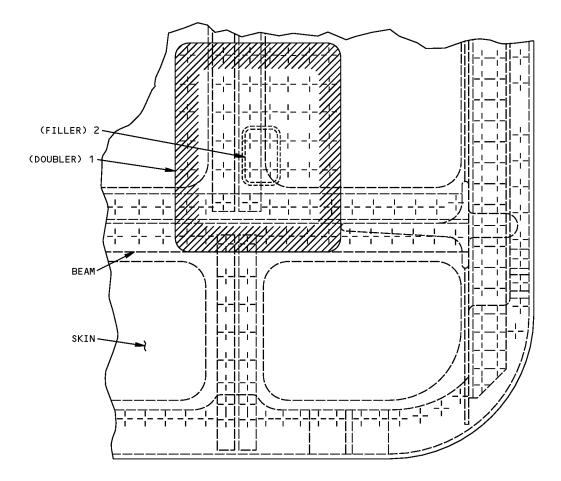
SKIN INSPECTION AREA. USE LFEC METHOD TO INSPECT THE SKIN EXTERNALLY THROUGH THE PART 1 DOUBLER AT EVERY 3,000 FLIGHT CYCLES.

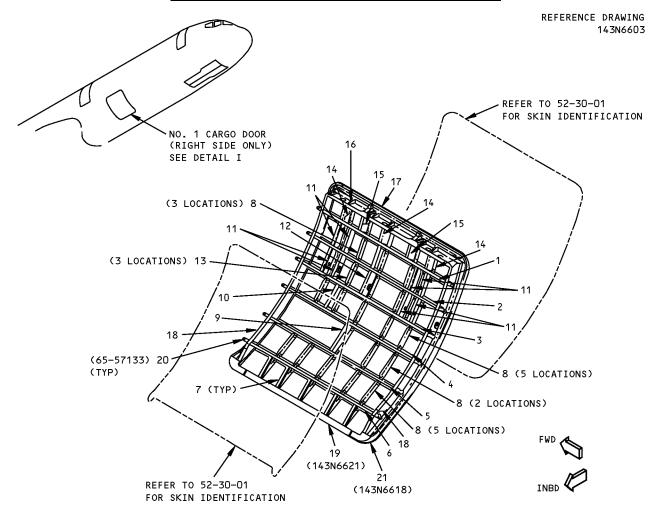
D	E	Т	A	Ι	L	]

ITEM	DESCRIPTION	GAGE	MATERIAL	EFFECTIVITY
1	BEAM OUTER TEE WEB ANGLE	0.071	BAC1506-1910 2024-T3511 CLAD 7075-T6 BAC1514-1776 7075-T6511	
2	BEAM OUTER TEE WEB ANGLE	0.063	BAC1506-1926 2024-T3511 CLAD 7075-T6 BAC1514-1777 7075-T6511	
3	BEAM OUTER TEE WEB ANGLE	0.063	BAC1506-1924 2024-T3511 CLAD 7075-T6 BAC1514-1778 7075-T6

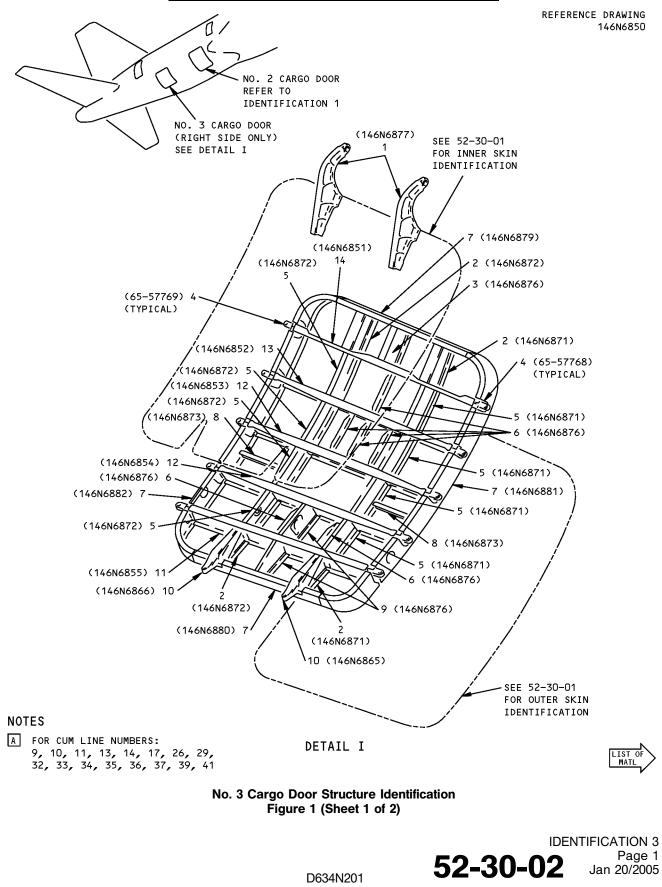
ITEM	DESCRIPTION	GAGE	MATERIAL	EFFECTIVITY
1	HINGE		7075-T73 DIE FORGING OPTIONAL: 7075-T73 FORGED BLOCK	A
2	TEE		BAC1505-100274 2024-T4	
3	INTERCOSTAL OUTER CHORD INNER CHORD WEB	0.063	BAC1505-100274 2024-T42 BAC1505-100274 7075-T6 CLAD 7075-T6	
4	STOP FITTING		7075-T73 DIE FORGING	
5	FRAME ASSY WEB TEE	0.063	CLAD 7075-T6 BAC1505-100274 2024-T4	
6	INTERCOSTAL		BAC1505-100274 2024-T42	
7	FRAME	0.063	CLAD 2024-T42	
8	SUPPORT ZEE	0.063	CLAD 2024-T42	
9	INTERCOSTAL CHORD WEB	0.063	BAC1505-100274 2024-T42 CLAD 7075-T6	
10	STOP FITTING		7075-T73 DIE FORGING OPTIONAL: 7075-T73 FORGED BLOCK	A
11	BEAM ASSY OUTER CHORD INNER CHORD WEB	0.063	BAC1505-100543 2024-T42 BAC1505-101270 7075-T62 CLAD 7075-T6	
12	BEAM ASSY OUTER CHORD INNER CHORD WEB	0.063	BAC1505-100543 2024-T4 BAC1505-101054 7075-T6 CLAD 2024-T3	
13	BEAM ASSY OUTER CHORD INNER CHORD WEB	0.063	BAC1505-100543 2024-T42 BAC1505-101054 7075-T62 CLAD 2024-T3

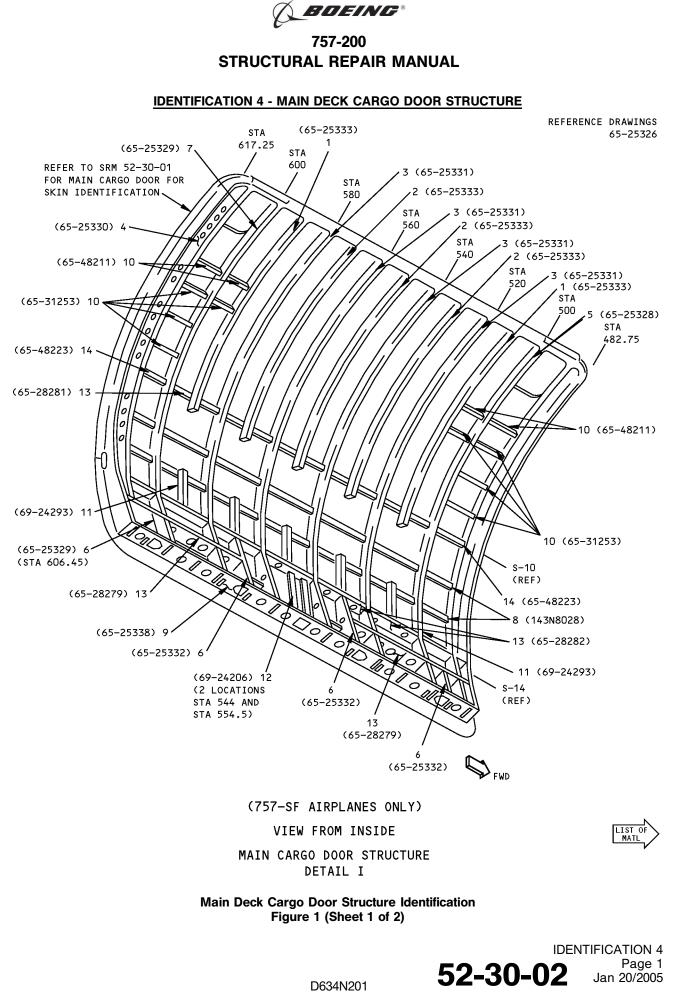
ITEM	DESCRIPTION	GAGE	MATERIAL	EFFECTIVITY
1	FRAME	0.0800	CLAD 7075-T6	
2	FRAME		BAC1517-1099 CLAD 7075-T6	
3	FRAME ASSY UPPER FRAME OUTER CHORD MID CHORD LOWER FRAME	0.071	BAC1517–1099 CLAD 7075–T6 BAC1506–992 CLAD 7075–T6511 BAC1490–2631 7075–T6 CLAD 7075–T6	
4	FRAME ASSY UPPER FRAME ANGLE LOWER FRAME	0.071	BAC1506–993 7075–T6 AND10134–1602 7075–T6511 7075–T6	
5	FRAME ASSY UPPER FRAME FWD ANGLE AFT ANGLE LOWER FRAME	0.071	BAC1506–992 7075–T6 AND10133–1203 7075–T6 AND10134–1602 7075–T6 7075–T6	
6	FRAME ASSY CHORD WEB	0.071	BAC1506-992 7075-T6511 CLAD 7075-T6	
7	FRAME ASSY UPPER FRAME FWD ANGLE AFT ANGLE LOWER FRAME	0.071	BAC1506–992 7075–T6 AND10134–1602 7075–T6 AND10133–1203 7075–T6 CLAD 7075–T6	
8	STRINGER		BAC1506-2092 7075-T6511	
9	BEAM ASSY BEAM WEB	0.125 0.063	CLAD 7075-T6 CLAD 7075-T6	
10	STIFFENER ASSSY STIFFENER ANGLE		AND10135-1005 7075-T6511 AND10134-1206 7075-T6511	
11	STIFFENER		AND10136-1003 7075-T6

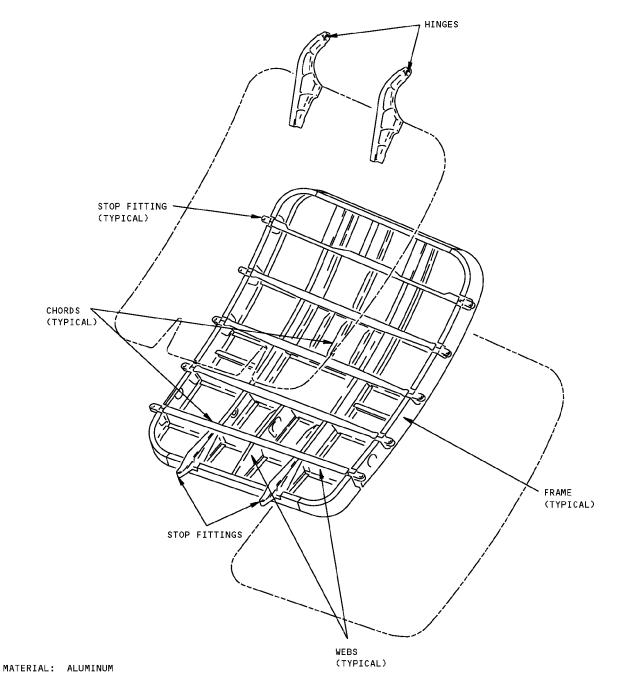
Cargo Door Structure Allowable Damage Figure 101 (Sheet 2 of 7)

NO.3 CARGO DOOR DETAIL II

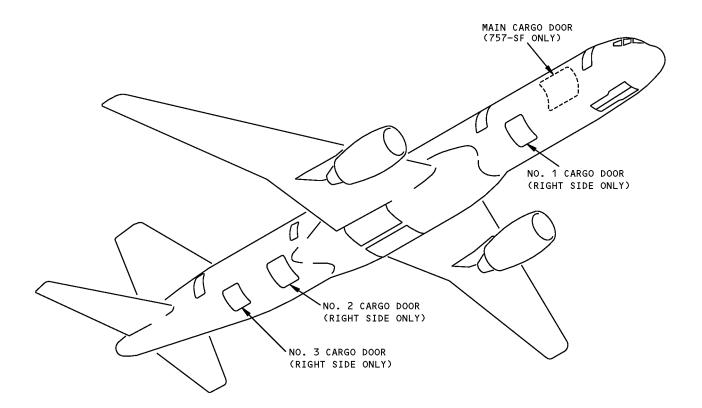
> Cargo Door Structure Repair Figure 201

**REPAIR GENERAL - CARGO DOOR STRUCTURE**

• DAMAGED COMPONENTS IN DOOR STRUCTURE MAY BE REPLACED OR REPAIRED. IF REPAIRS ARE TO BE MADE, SEE 51-70 FOR TYPICAL WEB, FORMED SECTION, OR EXTRUDED SECTION REPAIRS

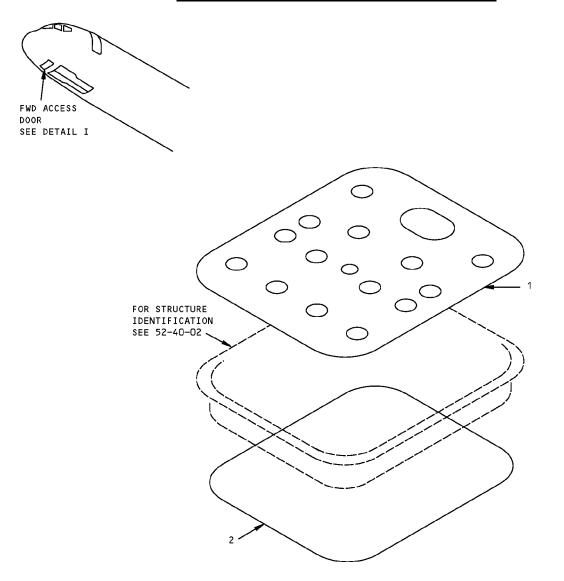
### **IDENTIFICATION 1 - FORWARD ACCESS DOOR SKIN**

ITEM	DESCRIPTION	GAGE	MATERIAL	EFFECTIVITY
1	INNER SKIN	0.032	CLAD 2024-T3 OR 2024-T42	
2	OUTER SKIN	0.063	CLAD 2024-T3 (CHEM-MILLED TO 0.042 MIN)

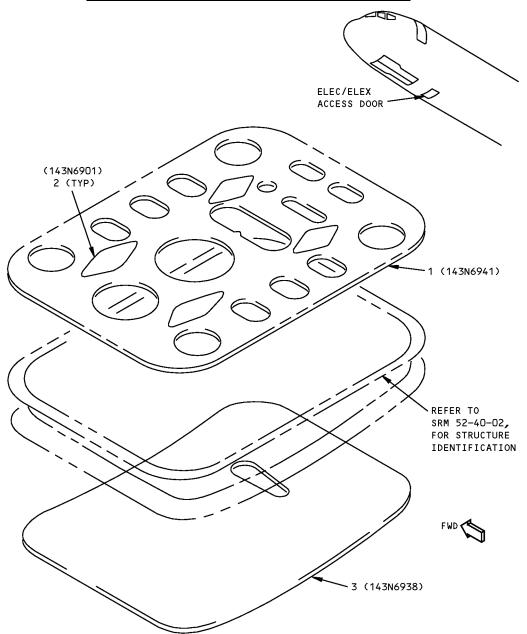
### **IDENTIFICATION 2 - ELEC/ELEX ACCESS DOOR SKIN**

ITEM	DESCRIPTION	GAGE	MATERIAL	EFFECTIVITY		
1 2 3	INNER SKIN STRAP OUTER SKIN	0.032 0.040 0.063	CLAD 2024-T3 CLAD 2024-T3 CLAD 2024-T3 (CHEM-MILLED TO 0.040 MIN)			
	LIST OF MATERIALS

Elec/Elex Access Door Skin Identification

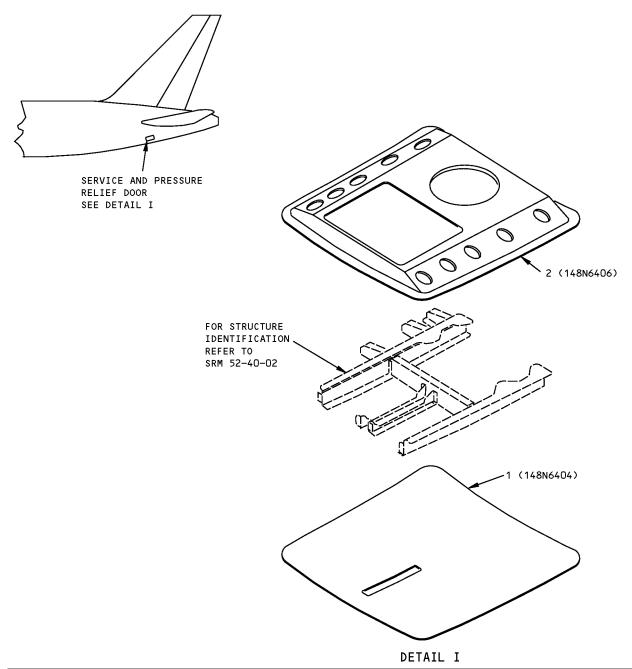
### **IDENTIFICATION 4 - SERVICE AND PRESSURE RELIEF DOOR SKIN**

ITEM	DESCRIPTION	GAGE	MATERIAL	EFFECTIVITY
1	OUTER SKIN	0.056	CLAD 7075-T6 (CHEM-MILLED TO 0.036 MIN)	
2	INNER SKIN	0.040	CLAD 2024-T42

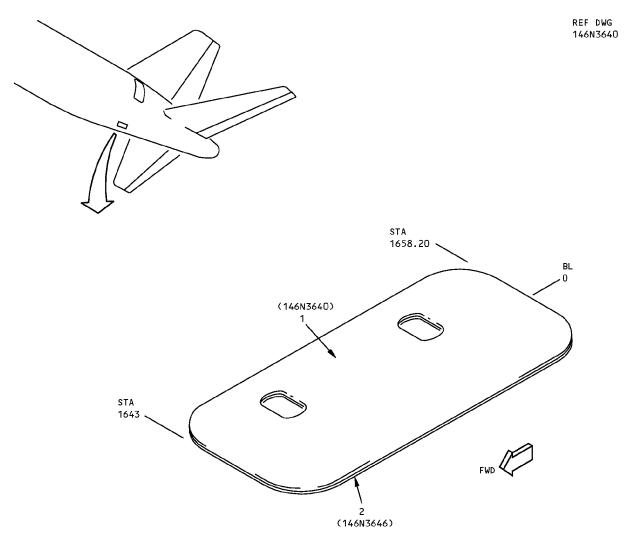
### **IDENTIFICATION 6 - WATER SERVICE DOOR**

ITEM	DESCRIPTION	GAGE	MATERIAL	EFFECTIVITY
1	OUTER SKIN	0.040	CLAD 2024-T3	
2	INNER SKIN	0.032	CLAD 2024-T42

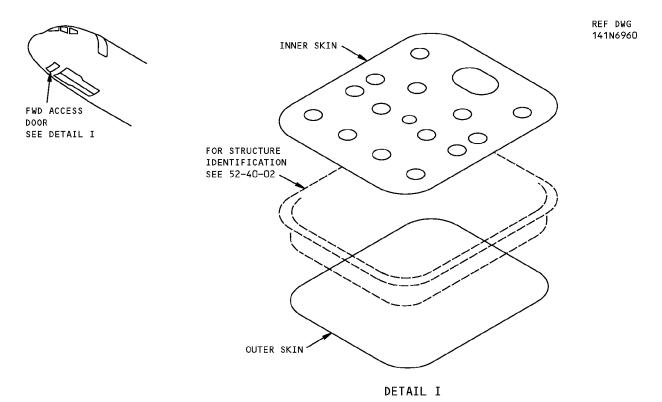
Allowable Damage - Forward Access Door Skin Figure 101 (Sheet 1 of 3)

### ALLOWABLE DAMAGE 1 - ALLOWABLE DAMAGE - FORWARD ACCESS DOOR SKIN

ITEM	CRACKS	NICKS, GOUGES AND CORROSION	DENTS	HOLES AND PUNCTURES
OUTER SKIN A	В	D	SEE DETAIL IV	E
INNER SKIN	C	G	SEE DETAIL IV	F

- REFER TO 51-10-01 FOR INVESTIGATION AND CLEANUP OF DAMAGE
- REFINISH REWORK AREAS PER 51-20 OF THE MAINTENANCE MANUAL
- A REFER TO 51-10-01 FOR AERODYNAMIC SMOOTH-NESS REQUIREMENTS. WHERE THE DAMAGE EXCEEDS THE LIMITS SHOWN IN 51-10-01, CONSIDERATION SHOULD BE GIVEN TO THE LOSS OF PERFORMANCE INVOLVED
- B CRACKS NOT ALLOWED EXCEPT FOR EDGE CRACKS WHICH MUST BE REMOVED PER DETAILS II AND VI
- C SEE DETAIL VIII FOR LIGHTENING HOLE EDGE CRACKS. FOR OTHER EDGE CRACKS, SEE DETAIL II. FOR OTHER CRACKS, SEE DETAIL VII

- D REMOVE DAMAGE PER DETAILS II, III, V AND VI
- E CLEAN OUT DAMAGE UP TO 0.25 MAX DIA AND NOT CLOSER THAN 1.0 INCH TO FASTENER HOLE, MATERIAL EDGE, OR OTHER DAMAGE. FILL HOLE WITH 2117-T3 OR T4 ALUMINUM RIVET INSTALLED WET WITH BMS 5-95 SEALANT. ALL OTHER HOLES TO BE REPAIRED
- F CLEAN OUT DAMAGE UP TO 0.50 MAX DIA AND NOT CLOSER THAN 1.0 INCH TO FASTENER HOLE, MATERIAL EDGE, OR OTHER DAMAGE
- G REMOVE DAMAGE PER DETAILS II, III, V AND VI. CORROSION MAY BE DRILLED OUT UP TO 0.5 MAX DIA PROVIDED FASTENER EDGE MARGINS ARE MAINTAINED PER DETAIL VII

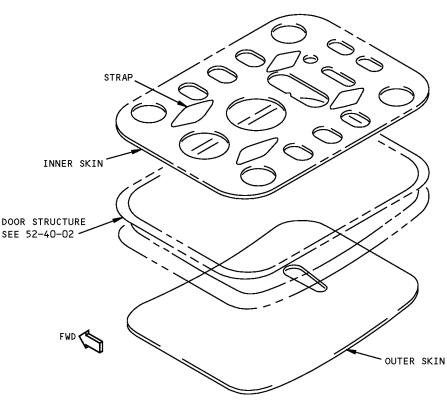
Allowable Damage - Elec/Elex Access Door Skin Figure 101 (Sheet 1 of 3)

#### ALLOWABLE DAMAGE 2 - ALLOWABLE DAMAGE - ELEC/ELEX ACCESS DOOR SKIN

ITEM	CRACKS	NICKS, GOUGES AND CORROSION	DENTS	HOLES AND PUNCTURES
OUTER SKIN A	В	D	SEE DETAIL IV	E
INNER SKIN	C	G	SEE DETAIL IV	F
STRAPS	В	D	SEE DETAIL IV	E

- REFINISH REWORK AREAS PER AMM 51-20
- REFER TO 51-10-02 FOR INSPECTION AND ٠ REMOVAL OF DAMAGE
- A REFER TO SRM 51-10-01 FOR AERODYNAMIC SMOOTHNESS REQUIREMENTS. WHERE THE DAMAGE EXCEEDS THE LIMITS SHOWN IN SRM 51-10-01, CONSIDERATION SHOULD BE GIVEN TO THE LOSS OF PERFORMANCE INVOLVED
- B CRACKS NOT ALLOWED EXCEPT FOR EDGE CRACKS WHICH MUST BE REMOVED PER DETAILS II AND VI
- C SEE DETAIL VIII FOR LIGHTENING HOLE EDGE CRACKS. FOR OTHER EDGE CRACKS, SEE DETAIL II. FOR OTHER CRACKS, SEE DETAIL VII

- D REMOVE DAMAGE PER DETAILS II, III, V AND VI
- E CLEAN OUT DAMAGE UP TO 0.25 INCH (6 mm) MAX DIA AND NOT CLOSER THAN 1.0 INCH (25 mm) TO FASTENER HOLE, MATERIAL EDGE, OR OTHER DAMAGE. FILL HOLE WITH 2117-T3 OR T4 ALUMINUM RIVET INSTALLED WET WITH BMS 5-95 SEALANT. ALL OTHER HOLES TO BE REPAIRED
- F CLEAN OUT DAMAGE UP TO 0.50 INCH (12.7 mm) MAX DIA AND NOT CLOSER THAN 1.0 INCH (25 mm) TO FASTENER HOLE, MATERIAL EDGE, OR OTHER DAMAGE
- G REMOVE DAMAGE PER DETAILS II, III, V AND VI. CORROSION MAY BE DRILLED OUT UP TO 0.5 INCH (12.7 mm) MAX DIA PROVIDED FASTENER EDGE MARGINS ARE MAINTAINED PER DETAIL VII

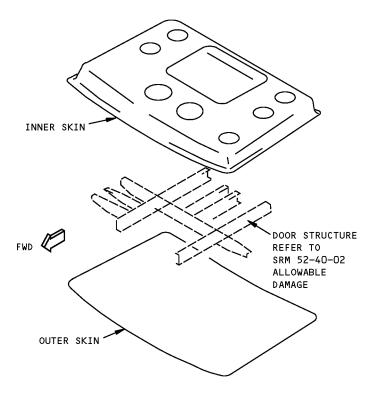
Allowable Damage - Elevator Control Access Door Skin Figure 101 (Sheet 1 of 3)

### ALLOWABLE DAMAGE 3 - ALLOWABLE DAMAGE - ELEVATOR CONTROL ACCESS DOOR SKIN

ITEM	CRACKS	NICKS, GOUGES AND CORROSION	DENTS	HOLES AND PUNCTURES
OUTER SKIN A	В	D	SEE DETAIL IV	DE
INNER SKIN	C	G	SEE DETAIL IV	F

- REFINISH REWORK AREAS PER AMM 51-20
- REFER TO 51-10-02 FOR INSPECTION AND REMOVAL OF DAMAGE
- A REFER TO SRM 51-10-01 FOR AERODYNAMIC SMOOTHNESS REQUIREMENTS. WHERE THE DAMAGE EXCEEDS THE LIMITS SHOWN IN SRM 51-10-01, CONSIDERATION SHOULD BE GIVEN TO THE LOSS OF PERFORMANCE INVOLVED
- B CRACKS NOT ALLOWED EXCEPT FOR EDGE CRACKS WHICH MUST BE REMOVED PER DETAILS II AND VI
- C SEE DETAIL VIII FOR LIGHTENING HOLE EDGE CRACKS. FOR OTHER EDGE CRACKS, SEE DETAIL II. FOR OTHER CRACKS, SEE DETAIL VII

- D REMOVE DAMAGE PER DETAILS II, III, V AND VI
- E CLEAN OUT DAMAGE UP TO 0.25 INCH (6 mm) MAX DIA AND NOT CLOSER THAN 1.0 INCH (25 mm) TO FASTENER HOLE, MATERIAL EDGE, OR OTHER DAMAGE. FILL HOLE WITH 2117-T3 OR T4 ALUMINUM RIVET INSTALLED WET WITH BMS 5-95 SEALANT. ALL OTHER HOLES TO BE REPAIRED
- F CLEAN OUT DAMAGE UP TO 0.50 INCH (12.7 mm) MAX DIA AND NOT CLOSER THAN 1.0 INCH (25 mm) TO FASTENER HOLE, MATERIAL EDGE, OR OTHER DAMAGE
- G REMOVE DAMAGE PER DETAILS II, III, V AND VI. CORROSION MAY BE DRILLED OUT UP TO 0.5 INCH (12.7 mm) MAX DIA PROVIDED FASTENER EDGE MARGINS ARE MAINTAINED PER DETAIL VII
