# CHAPTER 52

## DOORS

## **52-EFFECTIVE PAGES**

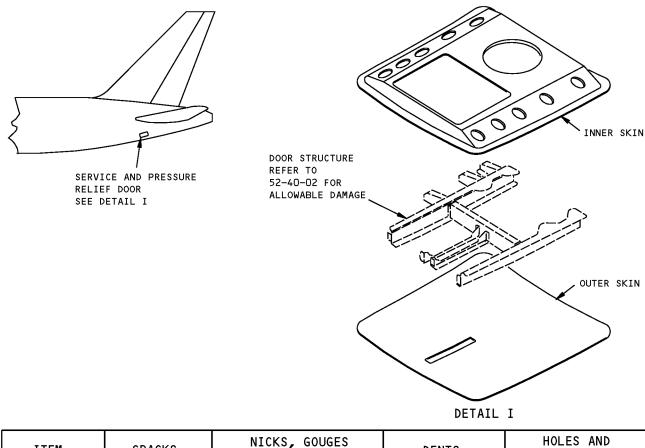
Allowable Damage - Aft Body Access Door Skin Figure 101 (Sheet 1 of 3)

### ALLOWABLE DAMAGE 4 - ALLOWABLE DAMAGE - AFT BODY ACCESS DOOR SKIN

ITE	EM	CRACKS	NICKS, GOUGES AND CORROSION	DENTS	HOLES AND PUNCTURE'S
OUTER SK	(IN A	В	D	SEE DETAIL IV	E
INNER SK	CIN	C	G	SEE DETAIL IV	F

- REFINISH REWORK AREAS PER AMM 51-20
- REFER TO 51-10-02 FOR INSPECTION AND REMOVAL OF DAMAGE
- A REFER TO SRM 51-10-01 FOR AERODYNAMIC SMOOTHNESS REQUIREMENTS. WHERE THE DAMAGE EXCEEDS THE LIMITS SHOWN IN SRM 51-10-01, CONSIDERATION SHOULD BE GIVEN TO THE LOSS OF PERFORMANCE INVOLVED
- B CRACKS NOT ALLOWED EXCEPT FOR EDGE CRACKS WHICH MUST BE REMOVED PER DETAILS II AND VI
- C SEE DETAIL VIII FOR LIGHTENING HOLE EDGE CRACKS. FOR OTHER EDGE CRACKS, SEE DETAIL II. FOR OTHER CRACKS, SEE DETAIL VII

- D REMOVE DAMAGE PER DETAILS II, III, V AND VI
- E CLEAN OUT DAMAGE UP TO 0.25 INCH (6 mm) MAX DIA AND NOT CLOSER THAN 1.0 INCH (25 mm) TO FASTENER HOLE, MATERIAL EDGE, OR OTHER DAMAGE. FILL HOLE WITH 2117-T3 OR T4 ALUMINUM RIVET INSTALLED WET WITH BMS 5-95 SEALANT. ALL OTHER HOLES TO BE REPAIRED
- F CLEAN OUT DAMAGE UP TO 0.50 INCH (12.7 mm) MAX DIA AND NOT CLOSER THAN 1.0 INCH (25 mm) TO FASTENER HOLE, MATERIAL EDGE, OR OTHER DAMAGE
- G REMOVE DAMAGE PER DETAILS II, III, V AND VI. CORROSION MAY BE DRILLED OUT UP TO 0.5 INCH (12.7 mm) MAX DIA PROVIDED FASTENER EDGE MARGINS ARE MAINTAINED PER DETAIL VII

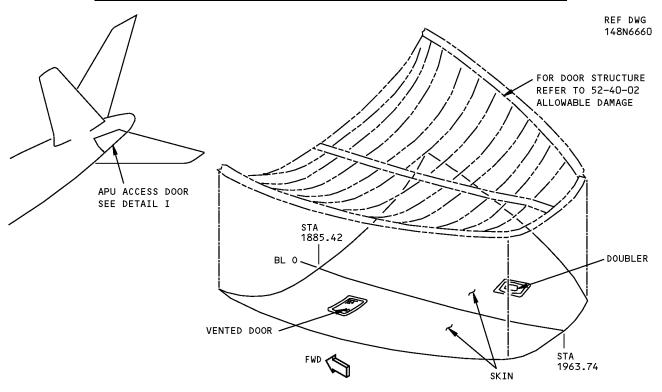
Allowable Damage - APU Access Door Skin Figure 101 (Sheet 1 of 3)

#### ALLOWABLE DAMAGE 5 - ALLOWABLE DAMAGE - APU ACCESS DOOR SKIN

ITEM	CRACKS	NICKS, GOUGES AND CORROSION	DENTS	HOLES AND PUNCTURES
OUTER SKIN A	В	D	SEE DETAIL IV	E
INNER SKIN	C	G	SEE DETAIL IV	F
DOUBLER	В	D	SEE DETAIL IV	E

- REFINISH REWORK AREAS PER AMM 51-20
- REFER TO 51-10-02 FOR INSPECTION AND REMOVAL OF DAMAGE
- A REFER TO SRM 51-10-01 FOR AERODYNAMIC SMOOTHNESS REQUIREMENTS. WHERE THE DAMAGE EXCEEDS THE LIMITS SHOWN IN SRM 51-10-01, CONSIDERATION SHOULD BE GIVEN TO THE LOSS OF PERFORMANCE INVOLVED
- B CRACKS NOT ALLOWED EXCEPT FOR EDGE CRACKS WHICH MUST BE REMOVED PER DETAILS II AND VI
- C SEE DETAIL VIII FOR LIGHTENING HOLE EDGE CRACKS. FOR OTHER EDGE CRACKS, SEE DETAIL II. FOR OTHER CRACKS, SEE DETAIL VII

D REMOVE DAMAGE PER DETAILS II, III, V AND VI

E CLEAN OUT DAMAGE UP TO 0.25 INCH (6 mm) MAX DIA AND NOT CLOSER THAN 1.0 INCH (25 mm) TO FASTENER HOLE, MATERIAL EDGE, OR OTHER DAMAGE. FILL HOLE WITH 2117-T3 OR T4 ALUMINUM RIVET INSTALLED WET WITH BMS 5-95 SEALANT. ALL OTHER HOLES TO BE REPAIRED

F CLEAN OUT DAMAGE UP TO 0.50 INCH (12.7 mm) MAX DIA AND NOT CLOSER THAN 1.0 INCH (25 mm) TO FASTENER HOLE, MATERIAL EDGE, OR OTHER DAMAGE

G REMOVE DAMAGE PER DETAILS II, III, V AND VI. CORROSION MAY BE DRILLED OUT UP TO 0.5 INCH (12.7 mm) MAX DIA PROVIDED FASTENER EDGE MARGINS ARE MAINTAINED PER DETAIL VII

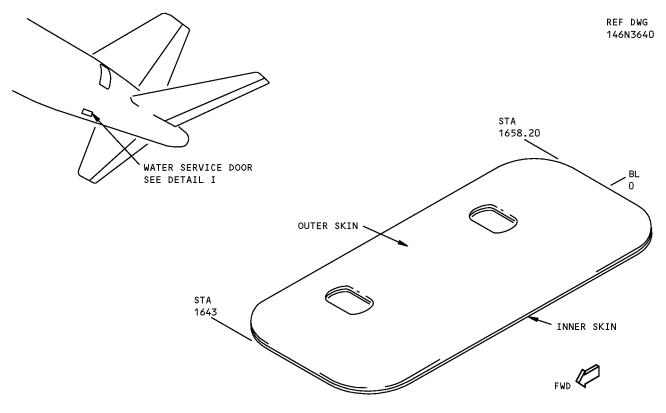
Allowable Damage - Water Service Door Skin Figure 101 (Sheet 1 of 3)

#### ALLOWABLE DAMAGE 6 - ALLOWABLE DAMAGE - WATER SERVICE DOOR SKIN

ITEM	CRACKS	NICKS, GOUGES AND CORROSION	DENTS	HOLES AND PUNCTURE'S
OUTER SKIN A	В	D	SEE DETAIL IV	E
INNER SKIN	C	G	SEE DETAIL IV	F

- REFINISH REWORK AREAS PER AMM 51-20
- REFER TO 51-10-02 FOR INSPECTION AND REMOVAL OF DAMAGE
- A REFER TO SRM 51-10-01 FOR AERODYNAMIC SMOOTHNESS REQUIREMENTS. WHERE THE DAMAGE EXCEEDS THE LIMITS SHOWN IN SRM 51-10-01, CONSIDERATION SHOULD BE GIVEN TO THE LOSS OF PERFORMANCE INVOLVED
- B CRACKS NOT ALLOWED EXCEPT FOR EDGE CRACKS WHICH MUST BE REMOVED PER DETAILS II AND VI
- C SEE DETAIL VIII FOR LIGHTENING HOLE EDGE CRACKS. FOR OTHER EDGE CRACKS, SEE DETAIL II. FOR OTHER CRACKS, SEE DETAIL VII

- D REMOVE DAMAGE PER DETAILS II, III, V AND VI
- E CLEAN OUT DAMAGE UP TO 0.25 INCH (6 mm) MAX DIA AND NOT CLOSER THAN 1.0 INCH (25 mm) TO FASTENER HOLE, MATERIAL EDGE, OR OTHER DAMAGE. FILL HOLE WITH 2117-T3 OR T4 ALUMINUM RIVET INSTALLED WET WITH BMS 5-95 SEALANT. ALL OTHER HOLES TO BE REPAIRED
- F CLEAN OUT DAMAGE UP TO 0.50 INCH (12.7 mm) MAX DIA AND NOT CLOSER THAN 1.0 INCH (25 mm) TO FASTENER HOLE, MATERIAL EDGE, OR OTHER DAMAGE
- G REMOVE DAMAGE PER DETAILS II, III, V AND VI. CORROSION MAY BE DRILLED OUT UP TO 0.5 INCH (12.7 mm) MAX DIA PROVIDED FASTENER EDGE MARGINS ARE MAINTAINED PER DETAIL VII

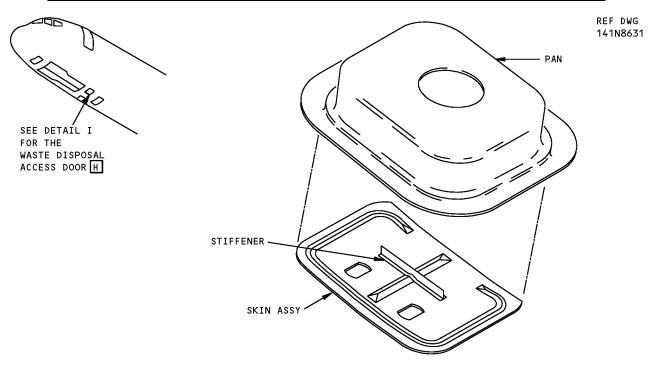
Allowable Damage - Waste Disposal Access Door Skin Figure 101 (Sheet 1 of 3)

### ALLOWABLE DAMAGE 7 - ALLOWABLE DAMAGE - WASTE DISPOSAL ACCESS DOOR SKIN

ITEM	CRACKS	NICKS, GOUGES AND CORROSION	DENTS	HOLES AND PUNCTURES
OUTER SKIN A	В	D	SEE DETAIL IV	E
PAN	C	G	SEE DETAIL IV	F

- REFINISH REWORK AREAS PER AMM 51-20
- REFER TO 51-10-02 FOR INSPECTION AND REMOVAL OF DAMAGE
- A REFER TO SRM 51-10-01 FOR AERODYNAMIC SMOOTH-NESS REQUIREMENTS. WHERE THE DAMAGE EXCEEDS THE LIMITS SHOWN IN SRM 51-10-01, CONSIDERATION SHOULD BE GIVEN TO THE LOSS OF PERFORMANCE INVOLVED
- B CRACKS NOT PERMITTED EXCEPT FOR EDGE CRACKS WHICH MUST BE REMOVED AS SHOWN IN DETAILS II AND II
- C SEE DETAIL VIII FOR LIGHTNING HOLE EDGE CRACKS. FOR OTHER EDGE CRACKS, SEE DETAIL II. FOR OTHER CRACKS, SEE DETAIL VII
- REMOVE DAMAGE AS SHOWN IN DETAILS II, III, V, AND VI

- E CLEAN OUT DAMAGE UP TO 0.25 INCH (6 mm) MAXIMUM DIAMETER AND NOT CLOSER THAN 1.0 INCH (25 mm) TO FASTENER HOLE, MATERIAL EDGE, OR OTHER DAMAGE. FILL HOLE WITH 2117-T3 OT T4 ALUMINUM RIVET INSTALLED WET WITH BMS 5-95 SEALANT. ALL OTHER HOLES TO BE REPAIRED
- F CLEAN OUT DAMAGE UP TO 0.50 INCH (12.7 mm) MAXIMUM DIAMETER AND NOT CLOSER THAN 1.0 INCH (25 mm) TO FASTENER HOLE, MATERIAL EDGE, OR OTHER DAMAGE
- G REMOVE DAMAGE AS SHOWN IN DETAILS II, III, V AND VI. CORROSION MAY BE DRILLED OUT UP TO 0.5 INCH (12.7 mm) MAXIMUM DIAMETER PROVIDED FASTENER EDGE MARGINS ARE MAINTAINED AS SHOWN IN DETAIL VII
- H FOR CUM LINE NUMBERS: 1 THRU 846

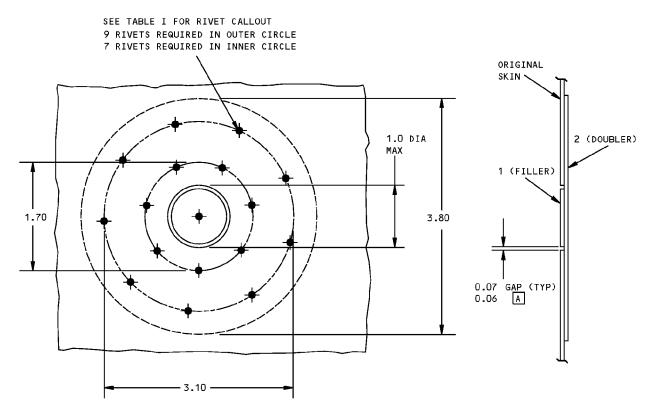
Small Hole Flush Repair - Access Doors Figure 201 (Sheet 1 of 2)

### **REPAIR 1 - SMALL HOLE FLUSH REPAIR - ACCESS DOORS**

- 1. Remove the inner skin panel for access if required.
- Clean out the damaged hole to 1-inch (25 mm) diameter maximum. The center of the hole to an edge or cutout must not be less than 1.90 inches (48 mm).

- 3. Make repair parts 1 and 2.
- 4. Assemble repair parts in installed position and drill fastener holes.
- 5. Remove repair parts.
- Break sharp edges of original and repair parts 0.015 to 0.030 inch (0.4 to 0.8 mm).

- Remove all nicks, scratches, burrs, sharp edges and corners from original and repair parts.
- Alodize all raw edges of existing and repair parts per SRM 51-20-01.

- Apply one coat of BMS 10-11, type 1, primer to all of part 2 and to the edges and inner surface of part 1 in accordance with AMM 51-21-00.
- Install repair parts, making a faying surface seal with BMS 5–95 sealant as described in SRM 51–20–05.

- 11. Install fasteners wet with BMS 5-95 sealant.
- 12. Form a fillet seal around the edge of the repair parts, using the sealant squeezed out during installation. Apply additional sealant where necessary.

- THIS REPAIR IS NOT TO BE USED IN AREAS WITH DOUBLERS AND THE SKIN GAGE MUST BE CONSTANT
- REFER TO 51-10-02 FOR INSPECTION AND REMOVAL OF DAMAGE
- REFER TO SRM 51-40 FOR FASTENER CODE, REMOVAL, INSTALLATION, HOLE SIZES, EDGE MARGINS AND SUBSTITUTIONS
- A REFER TO SRM 51-10-01 FOR AERODYNAMIC SMOOTHNESS REQUIREMENTS
- B WHERE RIVET SUBSTITUTIONS ARE MADE THE COUNTERSINK DEPTH FOR BACR15CE RIVETS MUST BE MAINTAINED AND THE EXCESS PORTION OF THE SUBSTITUTE RIVET HEAD SHAVED OFF AFTER INSTALLATION PER SRM 51-10-01
- C MATERIAL THICKNESS TO BE THE SAME GAGE AS TOTAL SKIN THICKNESS IN REPAIR AREA (LAMINATED SKINS)
- D MATERIAL THICKNESS TO BE ONE GAGE THICKER THAN TOTAL SKIN THICKNESS IN REPAIR AREA

EXTERIOR VIEW

SECTION THROUGH REPAIR

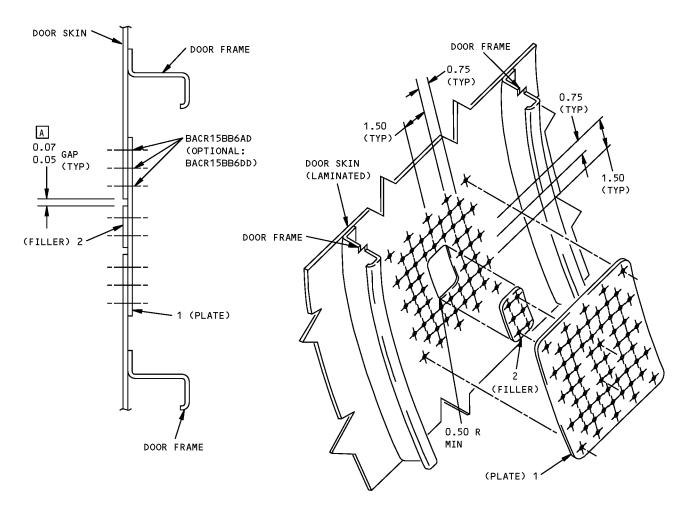
APU Access Door - Flush Skin Repair Between Beams Figure 201 (Sheet 2 of 2)

REPAIR MATERIAL						
	PART	QTY	GAGE	MATERIAL			
1	PLATE	1	0.040	CLAD 2024-T3			
2	FILLER	1	0.032	CLAD 2024-T3

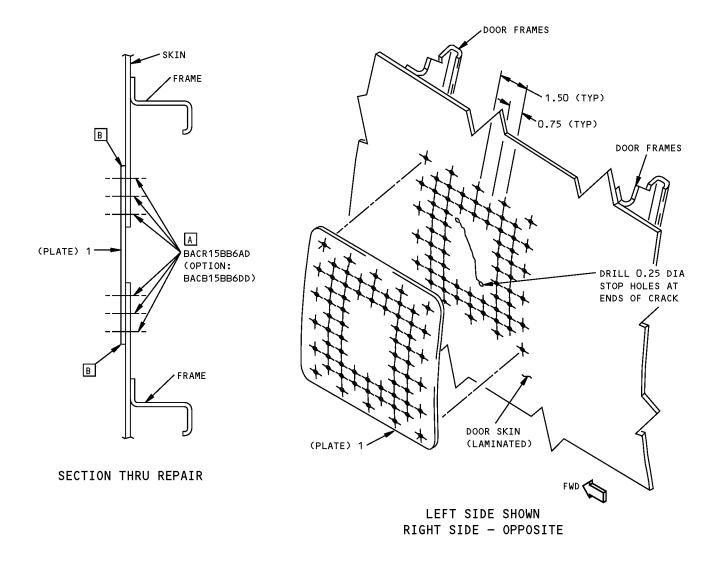
APU Access Door - External Skin Repairs Figure 201 (Sheet 2 of 2)

REPAIR MATERIAL						
PART		QTY	GAGE	MATERIAL		
1	PLATE	1	0.040	CLAD 2024-T3

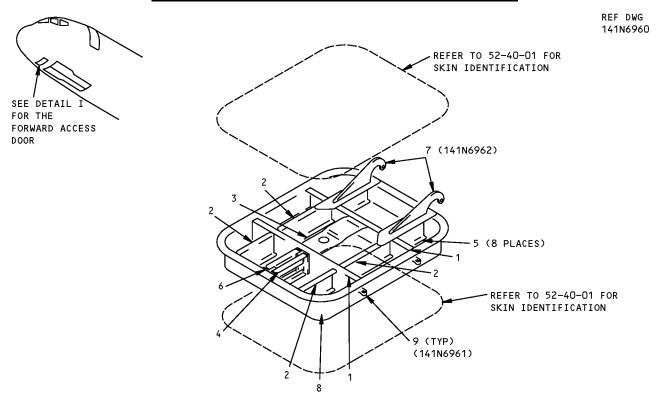
### **IDENTIFICATION 1 - FORWARD ACCESS DOOR STRUCTURE**

ITEM	DESCRIPTION	GAGE	MATERIAL	EFFECTIVITY
1	BEAM WEB TEE	0.071	CLAD 7075-T6 BAC1505-100350 2024-T3511	
2	INTERCOSTAL WEB TEE	0.050	CLAD 7075-T6 BAC1506-2195 2024-T3511	
3	CHANNEL	0.071	CLAD 7075-T62	
4	ANGLE		BAC1490-2507 CLAD 7075-T6	
5	ANGLE		BAC1490-2736 CLAD 7075-T6	
6	LATCH FITTING		7075-T73 FORGING	
7	HINGE ARM	0.313	7075-T651	
8	PAN	0.050	CLAD 2024-T42	
9	STOP FITTING		BAC1520-2207 2024-T3511 OR BAC1520-2215 2024-T3511

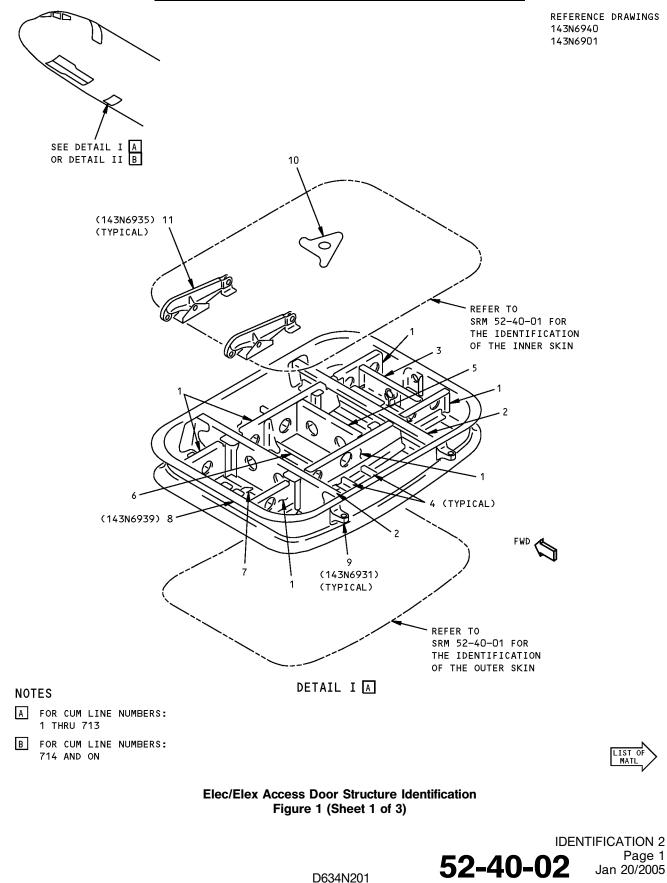
### **IDENTIFICATION 2 - ELEC/ELEX ACCESS DOOR STRUCTURE**

ITEM	DESCRIPTION	GAGE	MATERIAL	EFFECTIVITY
1	INTERCOSTAL ANGLE WEB	0.050 0.050	CLAD 2024-T42 CLAD 2024-T42	
2	BEAM TEE WEB	0.050	BAC1505-100910 2024-T3511 CLAD 7075-T6	
3	INTERCOSTAL ANGLE WEB	0.050	BAC1490-2715 CLAD 2024-T42 CLAD 2024-T42	
4	ANGLE		BAC1490-2505 CLAD 2024-T42	
5	INTERCOSTAL ANGLE WEB	0.050	BAC1490-2506 CLAD 2024-T42 CLAD 2024-T42	
6	ZEE		BAC1517-1056 CLAD 2024-T42	
7	ANGLE	0.063	CLAD 2024-T42	
8	FRAME	0.050	CLAD 2024-T42	
9	STOP FITTING		BAC1520-2273 7075-T3511	
10	PLATE	0.080	CLAD 7075-T6	
11	HINGE FITTING		7075-T73 FORGING

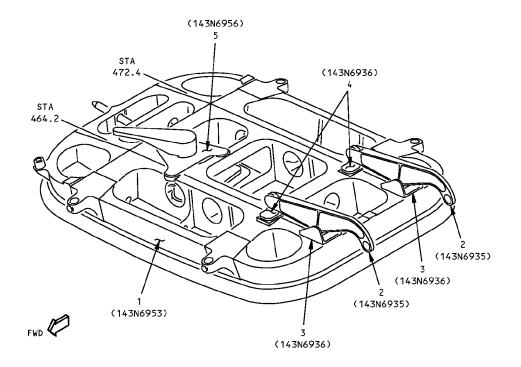
REFERENCE DRAWING 143N6901

ITEM	DESCRIPTION	GAGE	MATERIAL	EFFECTIVITY
1	FRAMEWORK		357.0-T6 CASTING AS GIVEN IN BMS 7-330	
2	HINGE FITTING		7075-T73 FORGING AS GIVEN IN BMS 7-186	
3	HINGE ATTACHMENT FITTING		BAC1509-100043 7075-T7351 PLATE (OPTIONAL: 7075-T73511 EXTRUSION)	
4	HINGE ATTACHMENT FITTING		BAC1505-100552 7075-T7351 PLATE (OPTIONAL: 7075-T73511 EXTRUSION)	
5	HANDLE PLATE		7050-T7451 PLATE (OPTIONAL: 7075-T7351 PLATE)

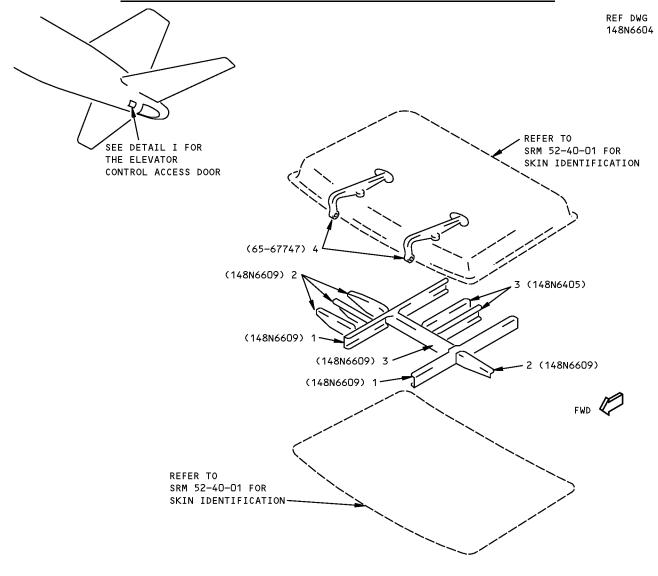
### **IDENTIFICATION 3 - ELEVATOR CONTROL ACCESS DOOR STRUCTURE**

ITEM	DESCRIPTION	GAGE	MATERIAL	EFFECTIVITY
1	BEAM TEE ANGLE	0.040	BAC1505-101127 7075-T6511 CLAD 2024-T42	
2	GUSSET	0.040	CLAD 2024-T42	
3	CHORD	0.040	CLAD 2024-T42	
4	HINGE		7075-T6 FORGING

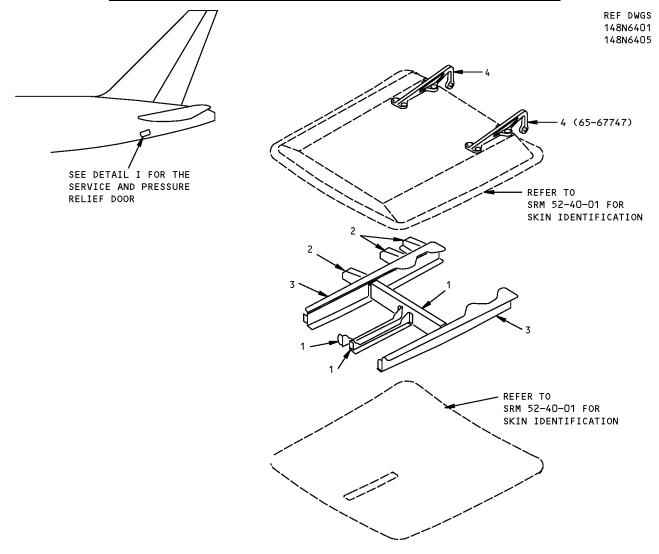
## **IDENTIFICATION 4 - SERVICE AND PRESSURE RELIEF DOOR STRUCTURE**

ITEM	DESCRIPTION	GAGE	MATERIAL	EFFECTIVITY
1	CHORD	0.040	CLAD 2024-T42	
2	GUSSET	0.040	CLAD 2024-T42	
3	STRINGER ASSY			
	ANGLE	0.040	CLAD 2024-T42	
	TEE		BAC1505-101127 7075-T6511	
4	HINGE		7075-T6 FORGING

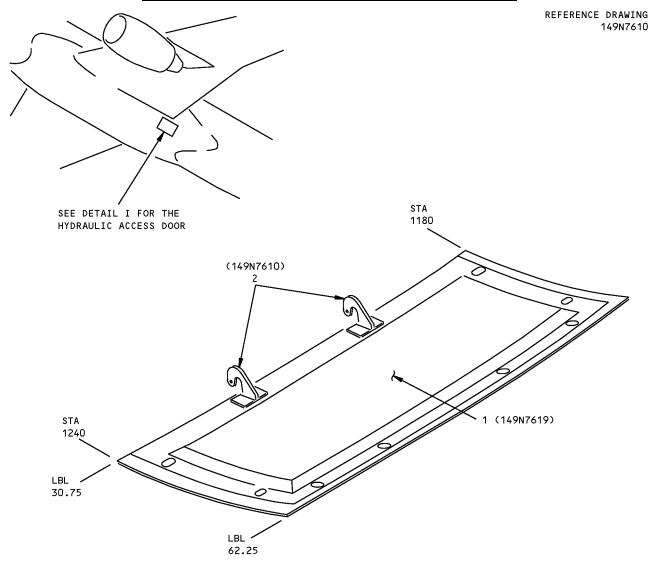
### **IDENTIFICATION 5 - HYDRAULIC ACCESS DOOR STRUCTURE**

ITEM	DESCRIPTION	GAGE	MATERIAL	EFFECTIVITY
1	SKIN PANEL SKIN CORE		ARAMID/GRAPHITE/EPOXY HONEYCOMB SANDWICH SEE DETAIL I NOMEX HONEYCOMB PER BMS 8-124, CLASS IV, TYPE V, GRADE 3.0	
2	CLEVIS		FORGING OR FORGED BLOCK 7075-T73

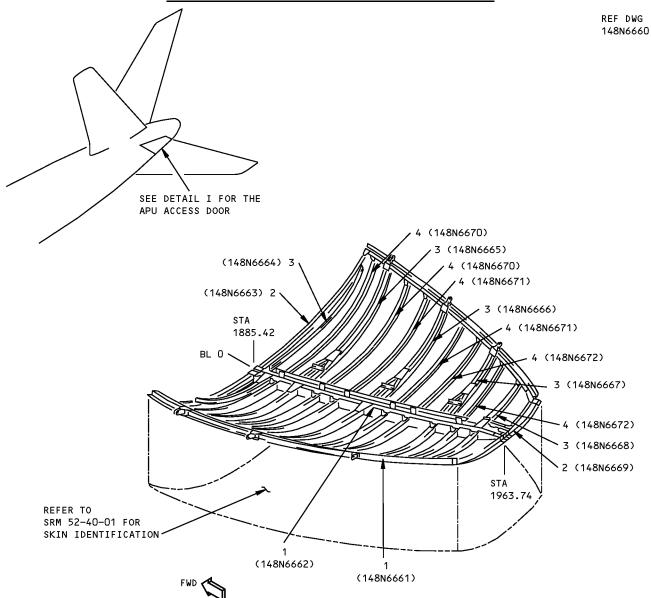
### **IDENTIFICATION 6 - APU ACCESS DOOR STRUCTURE**

ITEM	DESCRIPTION	GAGE	MATERIAL	EFFECTIVITY
1	EDGE MEMBER	0.056	CLAD 2024-T42	
2	FRAME	0.071	CLAD 2024-T42	
3	FRAME	0.05	CLAD 2024-T42	
4	FRAME		BAC1517-334 CLAD 2024-T42

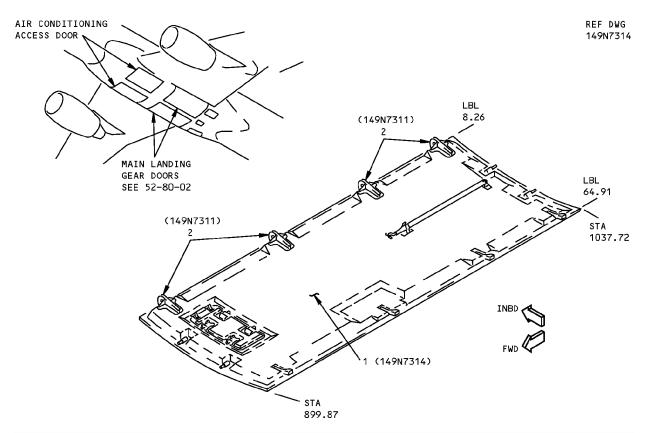
## **IDENTIFICATION 7 - AIR CONDITIONING ACCESS DOOR STRUCTURE**

ITEM	DESCRIPTION	GAGE	MATERIAL	EFFECTIVITY
1	DOOR PANEL SKIN CORE		ARAMID/GRAPHITE/EPOXY HONEYCOMB SANDWICH SEE DETAIL I NOMEX HONEYCOMB PER BMS 8-124, CLASS IV, TYPE V, GRADE 3.0	
2	HINGE FITTING		7075-T73 FORGING

Air Conditioning Access Door Structure Identification Figure 1 (Sheet 1 of 2)

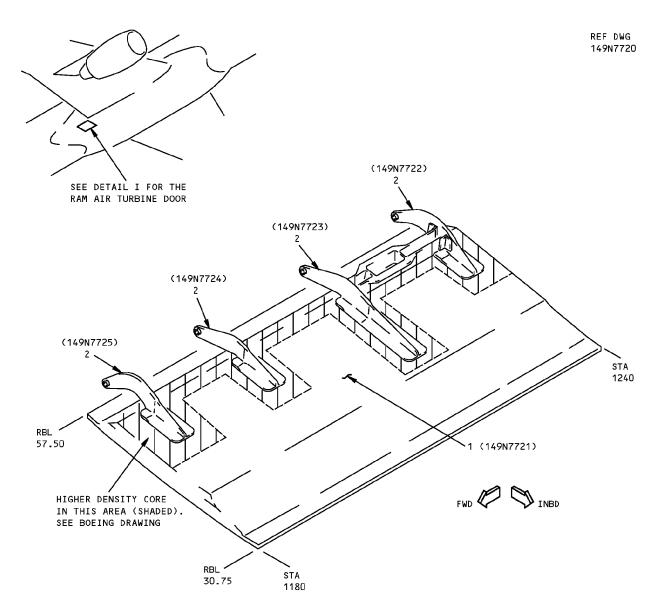
## **IDENTIFICATION 8 - RAM AIR TURBINE DOOR STRUCTURE**

ITEM	DESCRIPTION	GAGE	MATERIAL	EFFECTIVITY
1	DOOR PANEL SKIN CORE		ARAMID/GRAPHITE/EPOXY HONEYCOMB SANDWICH SEE DETAIL I NOMEX HONEYCOMB PER BMS 8-124, CLASS IV, TYPE V, GRADE 3.0	
2	HINGE FITTING		7075-T73 FORGING

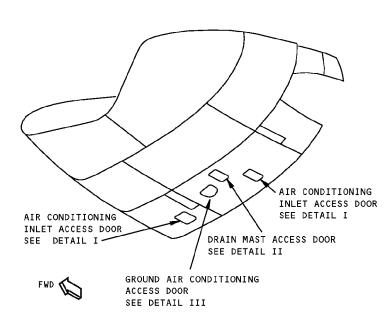
## IDENTIFICATION 9 - SECTION 43 - WING-TO-BODY FAIRING ACCESS DOOR STRUCTURE: AIR CONDITIONING INLET, DRAIN MAST, GROUND AIR CONDITIONING

AIR CONDITIONING INLET ACCESS DOOR

Section 43 - Wing-to-Body Fairing Access Door Structure Identification: Air Conditioning Inlet, Drain Mast, Ground Air Conditioning Figure 1 (Sheet 1 of 2)

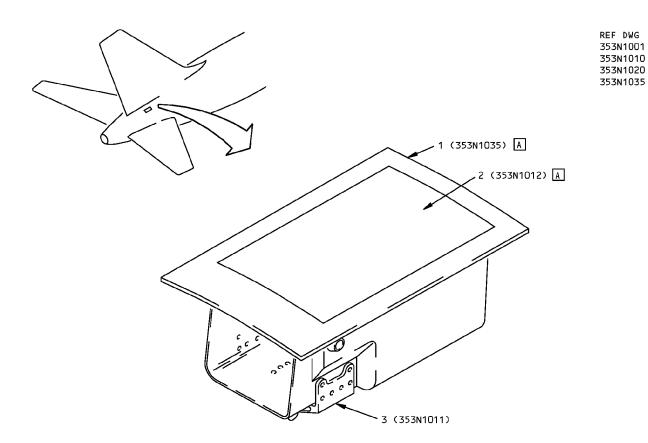
### **IDENTIFICATION 11 - APU INTAKE PORT - FRAME/DOOR STRUCTURE**

ITEM	DESCRIPTION	GAGE	MATERIAL	EFFECTIVITY
1	FRAME		FIBERGLASS/GRAPHITE/EPOXY LAMINATE FIBERGLASS PLIES - EMS 8-79, TYPE 120 GRAPHITE PLIES - EMS 8-168, TYPE 2, CLASS 2, STYLE 3K-50-PW	
2	BONDED DOOR ASSY		FIBERGLASS/EPOXY HONEYCOMB SANDWICH	
	DOOR		FIBERGLASS CLOTH EPOXY PER BMS 8-79, STYLE 1581, 1584, 7781	
	INNER CORE		NON-METALLIC HONEYCOMB PER BMS 8-124, CLASS I, TYPE III	
	OUTER CORE		NON-METALLIC HONEYCOMB PER BMS 8-124, CLASS IV, TYPE V	
3	ACTUATOR FITTING		ALUMINUM CASTING 356-T6

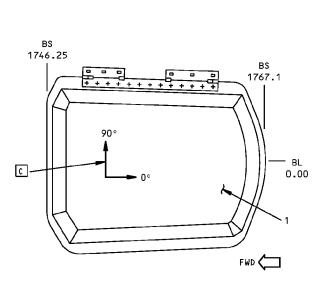
DETAIL I

- A PLY ORIENTATION CONVENTION, DEGREES INDICATED IS PARALLEL TO THE FABRIC WARP DIRECTION
- B MATERIAL AND PLY ORIENTATION SHOWN FOR FIELD AREAS ONLY, SEE BOEING DRAWINGS FOR EDGE BANDS AND AREAS WITH DOUBLERS
- C DIAGRAM OF PLY ORIENTATION, SEE PLY TABLE FOR PLY ORIENTATION AND MATERIAL
- ▶ FIBERGLASS/EPOXY FABRIC PER BMS 8-79, TYPE 1581 OR 7781, CLASS III, GRADE 1
- E FOR AIRPLANES WITH CUM LINE NUMBERS 139 AND ON AND AIRPLANES WITH SB 757-53-0038 INCORPORATED

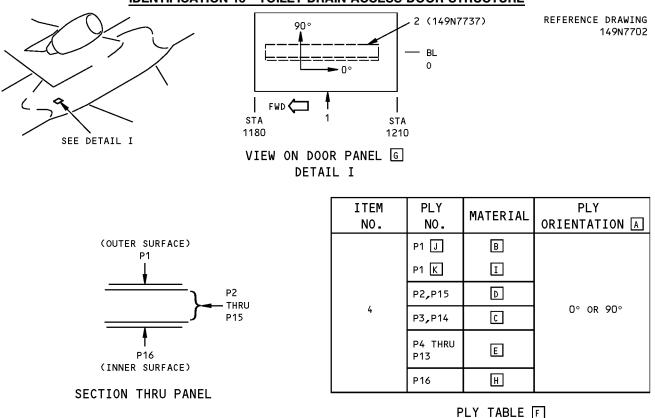
### **IDENTIFICATION 13 - TOILET DRAIN ACCESS DOOR STRUCTURE**

ITEM	DESCRIPTION	GAGE	MATERIAL	EFFECTIVITY
1	DOOR PANEL SKIN		FIBERGLASS/ARAMID/GRAPHITE LAMINATE SEE DETAIL II	
2	STIFFENER	0.050	CLAD 7075-T6

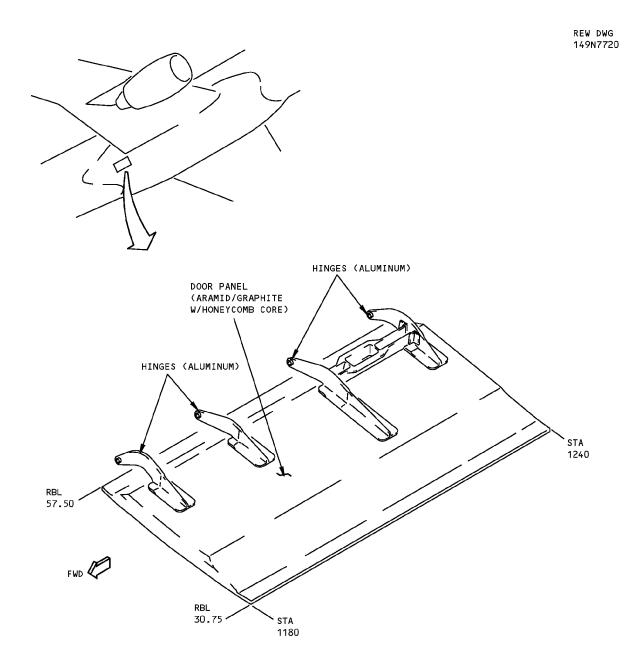
Ram Air Turbine Door Figure 101 (Sheet 1 of 3)

## ALLOWABLE DAMAGE 1 - RAM AIR TURBINE DOOR

DESCRIPTION	CRACKS	NICKS, GOUGES AND CORROSION	DENTS	HOLES AND PUNCTURES	DELAMINATION	EDGE EROSION
DOOR PANEL	В	C	D	E	F	SEE DETAIL V
HINGE	G	H	NOT ALLOWED	NOT ALLOWED

- TYPICAL DAMAGE TO A PANEL EDGEBAND MAY CONSIST OF EDGE CRUSHING, CRACKS OR DELAMINATION. DAMAGE AROUND HOLES MAY CONSIST OF OVALIZATION, FASTENER PULL-THROUGH OR CRACKS OUT OF HOLE. DAMAGE MAY REDUCE THE EFFECTIVE CROSS-SECTIONAL AREA OF AN EDGEBAND. DAMAGE TO EDGES SHOULD BE BLENDED OUT TO LIMITATIONS GIVEN FOR COMPONENT

- B 2.0 INCH (50 mm) MAX LENGTH IN HONEYCOMB AREA IS ALLOWED PER SQUARE FOOT (930 SQUARE cm) OF AREA AND A MINIMUM OF 6.0 INCHES (150 mm) FROM ANY OTHER CRACK OR HINGE FITTING. CLEAN UP EDGE CRACKS PER DETAIL I. CRACKS THROUGH CONSECUTIVE FASTENERS OR THROUGH THE PANEL EDGEBAND ARE ALLOWED PROVIDED DAMAGE DOES NOT EXCEED 10% EDGEBAND LENGTH PER SIDE. A

- C DAMAGE ALLOWED ON SURFACE RESIN ONLY. DAMAGE TO FIBERS NOT ALLOWED. CLEAN UP EDGE DAMAGE PER DETAIL I. A
- D DENTS GENERALLY RESULT IN FIBER DAMAGE OR DELAMINATION. HOWEVER, IF THERE IS NO FIBER DAMAGE OR DELAMINATION, DENTS UP TO 1.5 INCH (38 mm) DIA MAX ARE ALLOWED. ONE DENT PER SQUARE FOOT (930 SQUARE cm) OF AREA ALLOWED WHICH MUST BE A MINIMUM OF 6 INCHES (150 mm) FROM ANY OTHER DAMAGE FASTENER HOLE, OR PANEL EDGE. SEE OR F IF FIBER DAMAGE OR DELAMINATION IS PRESENT

- E 1.0 INCH (25 mm) MAX DIA IS ALLOWED PROVIDED IS MIN OF 2.5 D FROM OTHER DAMAGE, NEAREST HOLE, OR MATERIAL EDGE. DO NOT CLEAN UP DAMAGE EXCEPT TO REMOVE RESIN BURRS EXTENDING INTO SURFACE CONTOUR. A

- F 1.0 INCH (25 mm) MAX DIA IS ALLOWED IN HONEYCOMB AREA. A MAXIMUM OF 0.10 INCH (2.5 mm) DELAMINATION FROM EDGE IS ALLOWED. REPAIR DELAMINATION IN HONEYCOMB AREA PER SRM 51-70 NO LATER THAN THE NEXT "C" CHECK. PROTECT EDGE DAMAGE PER A

- G CRACKS NOT ALLOWED EXCEPT FOR EDGE CRACKS WHICH MUST BE REMOVED PER DETAIL I. SHOT PEEN REWORKED AREAS PER SRM 51-20-06. SHOT PEEN INTENSITIES VARY WITH THE THICKNESS REMAINING AFTER REWORK

- H REMOVE CORNER DAMAGE PER DETAIL III. REMOVE LUG DAMAGE PER DETAIL IV. REMOVE OTHER DAMAGE PER DETAIL II. DAMAGE NOT ALLOWED IN VICINITY OF BUSHINGS. SHOT PEEN REWORKED AREAS PER SRM 51-20-06. SHOT PEEN INTENSITIES VARY WITH THE THICKNESS REMAINING AFTER REWORK

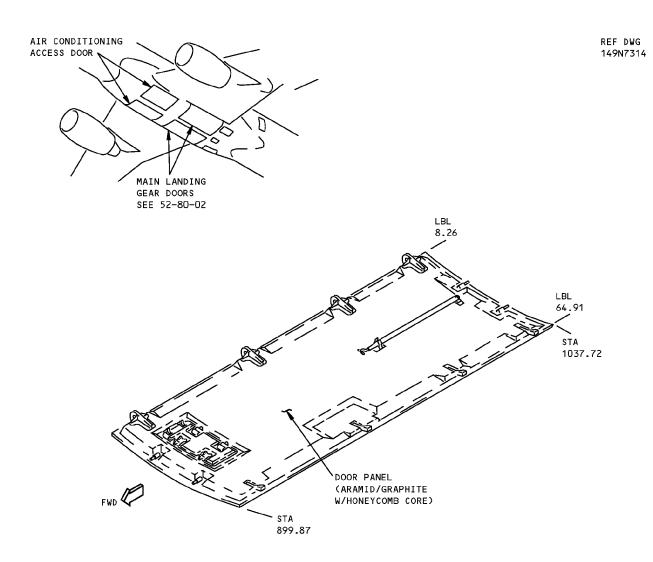
Air Conditioning Access Door Figure 101 (Sheet 1 of 3)

## ALLOWABLE DAMAGE 2 - AIR CONDITIONING ACCESS DOOR

DESCRIPTION	CRACKS	NICKS, GOUGES AND CORROSION	DENTS	HOLES AND PUNCTURES	DELAMINATION	EDGE EROSION
DOOR PANEL	В	C	D	E	F	SEE DETAIL II

- TYPICAL DAMAGE TO A PANEL EDGEBAND MAY CONSIST OF EDGE CRUSHING, CRACKS OR DELAMINATION. DAMAGE AROUND HOLES MAY CONSIST OF OVALIZATION, FASTENER PULL-THROUGH OR CRACKS OUT OF HOLE. DAMAGE MAY REDUCE THE EFFECTIVE CROSS-SECTIONAL AREA OF AN EDGEBAND. DAMAGE TO EDGES SHOULD BE BLENDED OUT TO LIMITATIONS GIVEN FOR COMPONENT

- B 2.0 INCHES (50 mm) MAX LENGTH IN FACE SHEETS OF HONEYCOMB AREA NOT CLOSER THAN 10 INCHES (250 mm) TO ANY OTHER CRACK. ONE CRACK PER SQUARE FOOT (930 SQUARE cm) OF AREA ALLOWED. FOR CRACKS IN EDGEBAND, 1.0 INCH (25 mm) MAX LENGTH PER SQUARE FOOT (930 SQUARE cm) OF AREA AND A MIN OF 6 INCHES (150 mm) FROM ANY OTHER CRACK. CLEAN UP UP EDGE CRACKS PER DETAIL I. CRACKS THROUGH TWO CONSECUTIVE FASTENERS THROUGH THE EDGEBAND ARE ALLOWED. A

- C DAMAGE ALLOWED ON SURFACE RESIN ONLY. DAMAGE TO FIBERS NOT ALLOWED. CLEAN UP EDGE DAMAGE PER DETAIL I. A
- D DENTS GENERALLY RESULT IN FIBER DAMAGE OR DELAMINATION. HOWEVER, IF THERE IS NO FIBER DAMAGE OR DELAMINATION, DENTS UP TO 1.5 INCH (38 mm) DIA MAX ARE ALLOWED. ONE DENT PER SQUARE FOOT (930 SQUARE cm) OF AREA ALLOWED WHICH MUST BE A MINIMUM OF 6 INCHES (150 mm) FROM ANY OTHER DAMAGE, FASTENER HOLE, OR PANEL EDGE. SEE OR F IF FIBER DAMAGE OR DELAMINATION IS PRESENT
- E 1.0 INCH (25 mm) MAX DIA ALLOWED PROVIDED DAMAGE IS MIN OF 2.5 D FROM OTHER DAMAGE, NEAREST HOLE, OR MATERIAL EDGE. DO NOT CLEAN UP DAMAGE EXCEPT TO REMOVE RESIN BURRS EXTENDING INTO SURFACE CONTOUR. A
- F 1.00 INCH (25 mm) MAX DIA IS ALLOWED IN HONEYCOMB AREA. A MAXIMUM OF 0.10 INCH (2.5 mm) DELAMINATION IN HONEYCOMB AREA PER SRM 51-70 NO LATER THAN THE NEXT "C" CHECK. PROTECT EDGE DAMAGE PER A

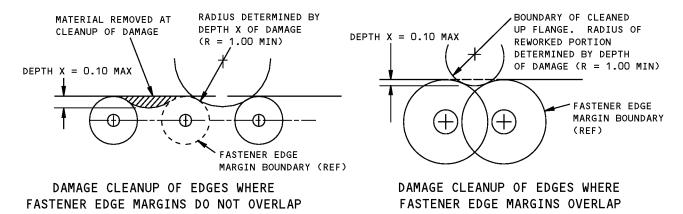
Air Conditioning Access Door Figure 101 (Sheet 3 of 3)

DETAIL I

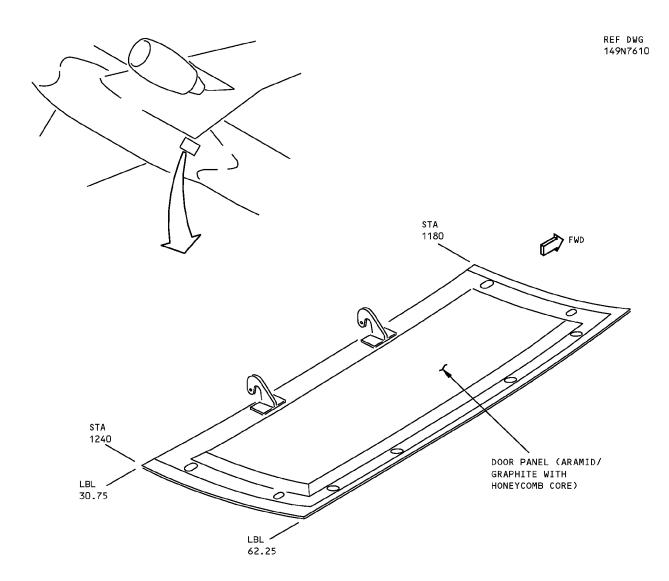
Hydraulic Access Door Figure 101 (Sheet 1 of 3)

## ALLOWABLE DAMAGE 3 - HYDRAULIC ACCESS DOOR

DESCRIPTION	CRACKS	NICKS, GOUGES AND CORROSION	DENTS	HOLES AND PUNCTURES	DELAMINATION	EDGE EROSION
DOOR PANEL	В	C	Þ	E	F	SEE DETAIL II

- REFER TO 51-10-02 FOR INSPECTION AND REMOVAL OF DAMAGE
- TYPICAL DAMAGE TO A PANEL EDGEBAND MAY CONSIST OF EDGE CRUSHING, CRACKS OR DELAMINATION. DAMAGE AROUND HOLES MAY CONSIST OF OVALIZATION, FASTENER PULL-THROUGH OR CRACKS OUT OF HOLE. DAMAGE MAY REDUCE THE EFFECTIVE CROSS-SECTIONAL AREA OF AN EDGEBAND. DAMAGE TO EDGES SHOULD BE BLENDED OUT TO LIMITATIONS GIVEN FOR COMPONENT

- B 2.0 INCHES (50 mm) MAX LENGTH IS ALLOWED PER SQUARE FOOT (930 SQUARE cm) OF AREA AND A MINIMUM OF 6.0 INCHES (150 mm) FROM ANY OTHER CRACK. CLEAN UP EDGE CRACKS PER DETAIL IV. CRACKS THROUGH CONSECUTIVE FASTENERS OR THROUGH THE PANEL EDGEBAND ARE ALLOWED PROVIDED DAMAGE DOES NOT EXCEED 10% EDGEBAND LENGTH PER SIDE.

- E 0.50 INCH (12.7 mm) MAX DIA ALLOWED PROVIDED DAMAGE IS MIN OF 3D FROM OTHER DAMAGE, NEAREST HOLE, OR MATERIAL EDGE. DO NOT CLEAN UP DAMAGE EXCEPT TO REMOVE RESIN BURRS EXTENDING INTO SURFACE CONTOUR. A

- F 1.50 INCHES (38 mm) MAX DIA IS ALLOWED IN HONEYCOMB AREA. A MAXIMUM OF 0.10 INCH (2.5 mm) DELAMINATION FROM EDGE IS ALLOWED. REPAIR DELAMINATION IN HONEYCOMB AREA PER SRM 51-70 NO LATER THAN THE NEXT "C" CHECK. PROTECT EDGE DAMAGE PER A

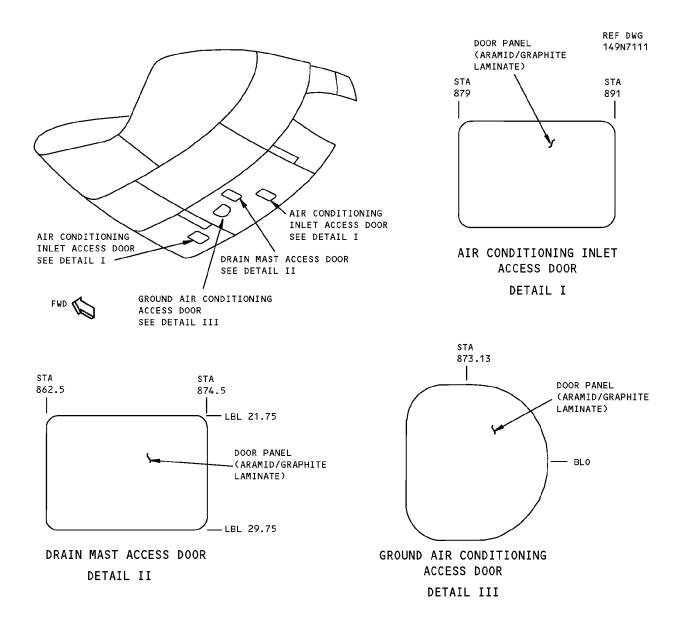
Section 43 - Wing to Body Fairing Access Doors Air Conditioning Inlet, Drain Mast, Ground Air Conditioning Figure 101 (Sheet 1 of 2)

## ALLOWABLE DAMAGE 4 - SECTION 43 - WING-TO-BODY FAIRING ACCESS DOORS AIR CONDITIONING INLET, DRAIN MAST, GROUND AIR CONDITIONING

DESCRIPTION	CRACKS	NICKS, GOUGES AND CORROSION	DENTS	HOLES AND PUNCTURES	DELAMINATION	EDGE EROSION
DOOR PANEL	В	C	D	E	F	SEE DETAIL V

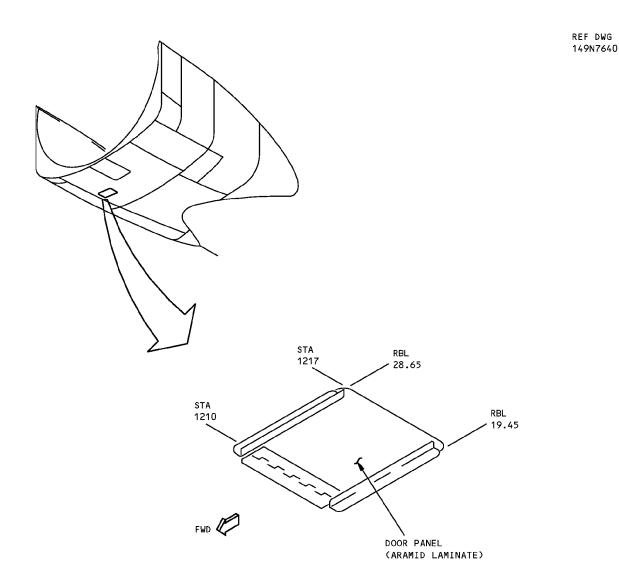
Landing Gear Ground Access Door Figure 101 (Sheet 1 of 3)

## ALLOWABLE DAMAGE 5 - LANDING GEAR GROUND ACCESS DOOR

DESCRIPTION	CRACKS	NICKS, GOUGES AND CORROSION	DENTS	HOLES AND PUNCTURES	DELAMINATION	EDGE EROSION
DOOR PANEL	В	C	D	E	F	SEE DETAIL II

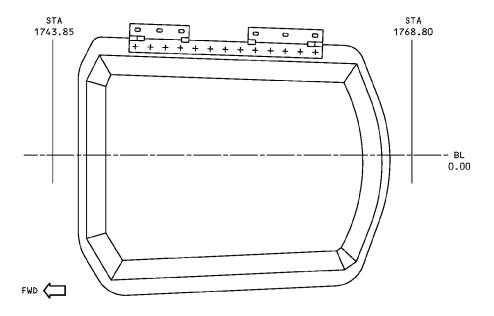
## **ALLOWABLE DAMAGE 6 - FIN ACCESS DOOR**

DESCRIPTION	CRACKS	NICKS, GOUGES AND CORROSION	DENTS	HOLES AND PUNCTURES	DELAMINATION	EDGE EROSION
DOOR PANEL	В	C	D	E	F	SEE DETAIL III

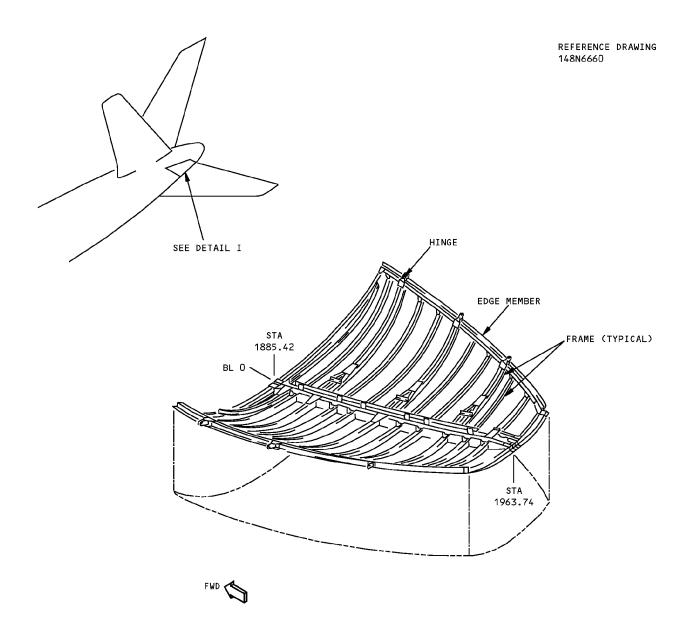
APU Access Door Structure Figure 101 (Sheet 1 of 5)

## ALLOWABLE DAMAGE 7 - APU ACCESS DOOR STRUCTURE

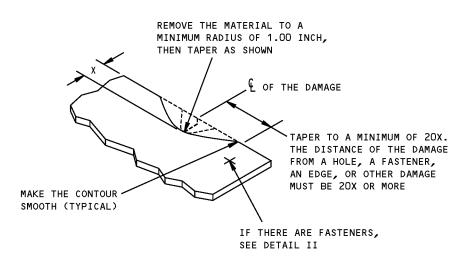
DAMAGE CLEANUP FOR EDGES OF LUG DETAIL IX

X = WIDTH OF THE MATERIAL THAT IS REMOVED A MAXIMUM OF 0.10 INCH

#### REMOVAL OF DAMAGED MATERIAL ON AN EDGE

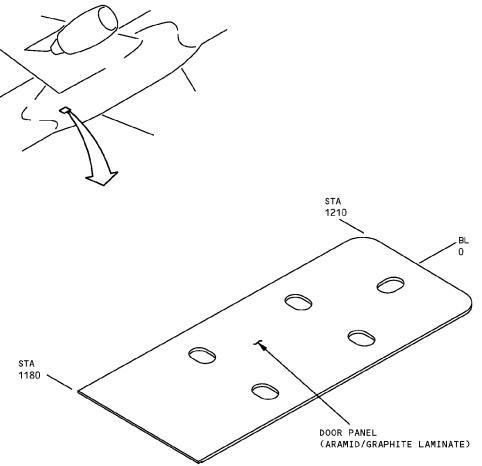
Toilet Drain Access Door Figure 101 (Sheet 1 of 3)

## ALLOWABLE DAMAGE 8 - TOILET DRAIN ACCESS DOOR

DESCRIPTION	CRACKS	NICKS, GOUGES AND CORROSION	DENTS	HOLES AND PUNCTURES	DELAMINATION	EDGE EROSION
DOOR PANEL	В	C	D	E	F	SEE DETAIL II

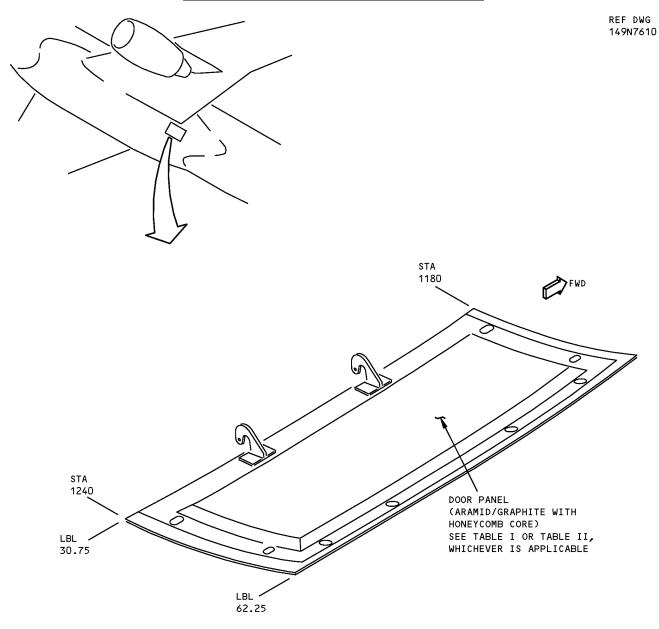
Hydraulic Access Door Repairs Figure 201 (Sheet 1 of 3)

## **REPAIR 1 - HYDRAULIC ACCESS DOOR REPAIRS**

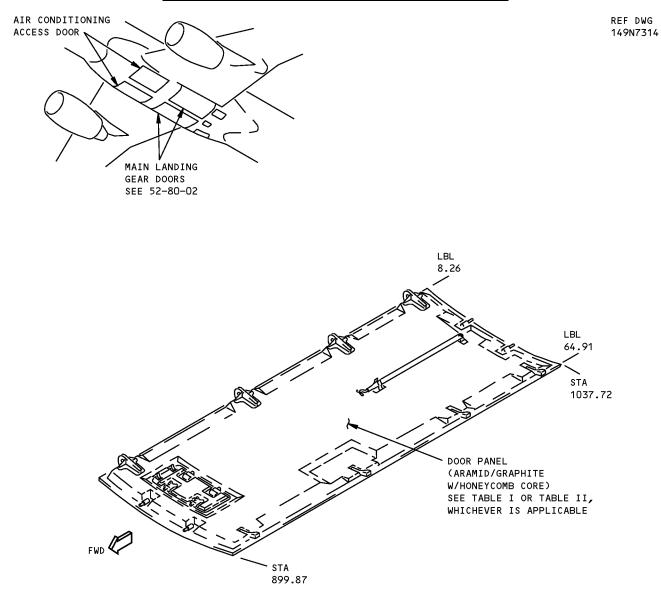
Air Conditioning Access Door Repairs Figure 201 (Sheet 1 of 3)

### **REPAIR 2 - AIR CONDITIONING ACCESS DOOR REPAIRS**

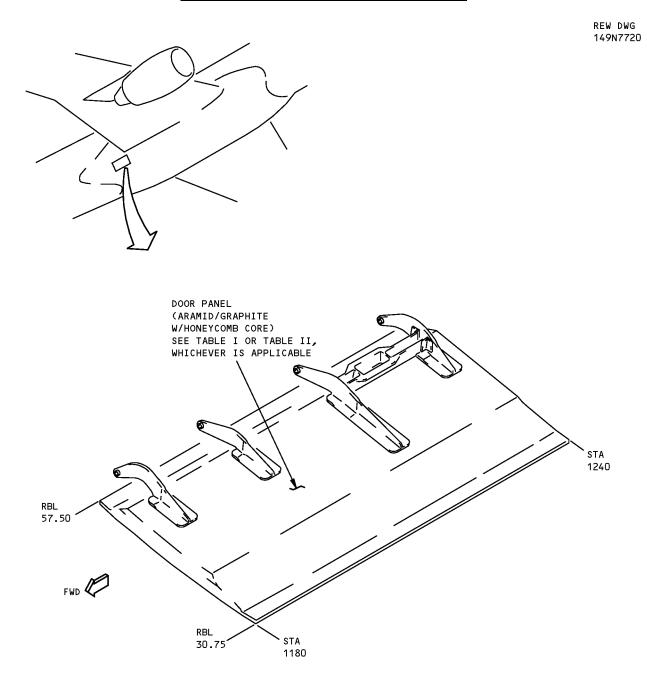
Ram Air Turbine Door Repairs Figure 201 (Sheet 1 of 3)

### **REPAIR 3 - RAM AIR TURBINE DOOR REPAIRS**

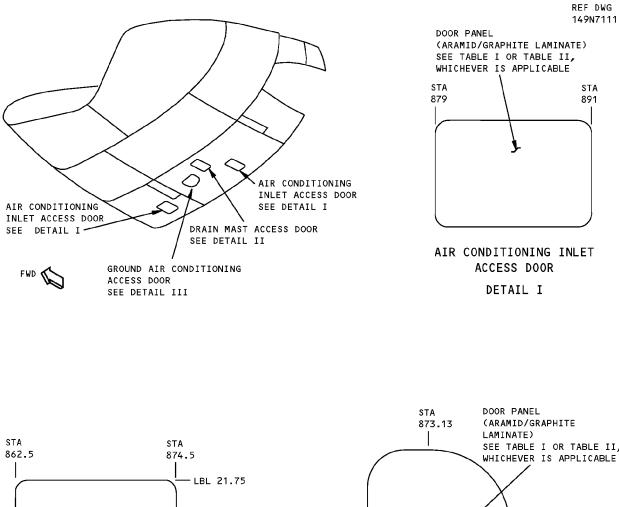
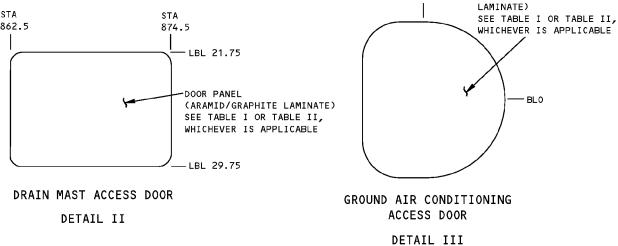
Section 43 - Wing to Body Fairing Access Door Repairs - Air Conditioning Inlet, Drain Mast, Ground Air Conditioning Figure 201 (Sheet 1 of 3)

### REPAIR 4 - SECTION 43 - WING TO BODY FAIRING ACCESS DOOR REPAIRS - AIR CONDITIONING INLET, DRAIN MAST, GROUND AIR CONDITIONING

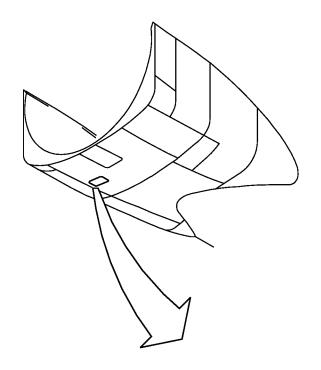
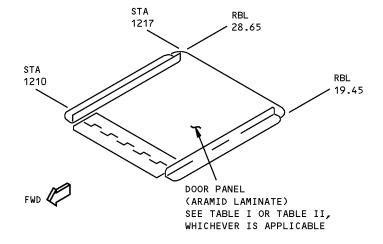
Landing Gear Ground Access Door Repairs Figure 201 (Sheet 1 of 3)

### **REPAIR 5 - LANDING GEAR GROUND ACCESS DOOR REPAIRS**

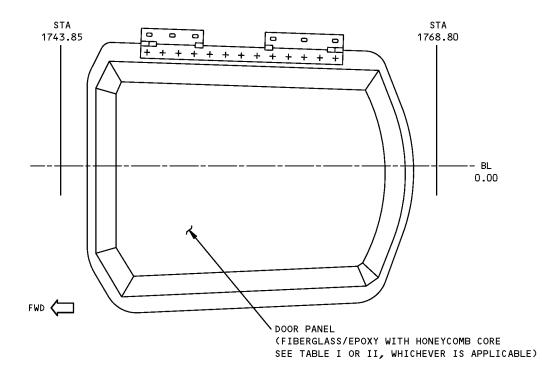
Fin Access Door Repairs Figure 201 (Sheet 1 of 3)

### **REPAIR 6 - FIN ACCESS DOOR REPAIRS**

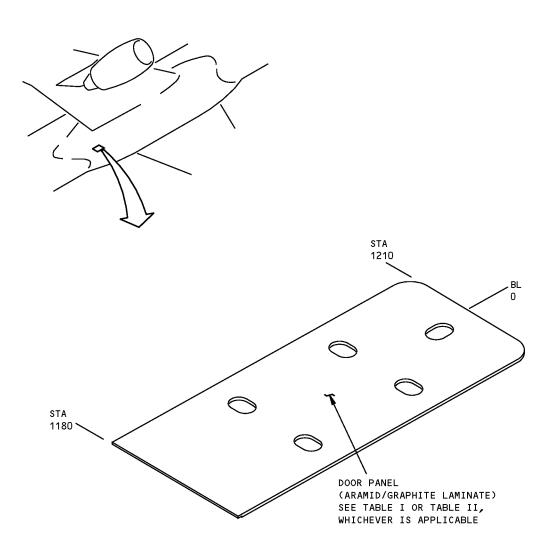
Toilet Drain Access Door Repairs Figure 201 (Sheet 1 of 3)

### **REPAIR 7 - TOILET DRAIN ACCESS DOOR REPAIRS**

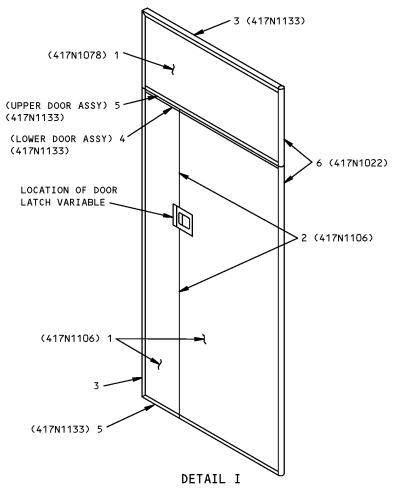
LIST OF MATERIALS FOR DETAIL I

ITEM DESCRIPTION GAGE MATERIAL EFFECTIVITY NONMETALLIC/FIBERGLASS HONEYCOMB SANDWICH 1 DOOR PANEL OUTER FWD SKIN ACOUSTIC FABRIC PER BMS 8-64, TYPE I FIBERGLASS PER BMS 8-151, TYPE IV, STYLE 8800 INNER FWD SKIN CORE NOMEX HONEYCOMB PER BMS 8-124, TYPE V, CLASS IV, GRADE 3.0 AFT SKIN FIBERGLASS PER BMS 8-151, TYPE I, STYLE 8800 Α 2 TEE BAC1505-11 2024-T3511 3 TRIM BAC1509-100151 6063-T5 4 TRIM BAC1490-2727 2024-T3 5 TRIM BAC1518-308 6063-T5 6 DOOR POST COVER 0.032 2024-T3

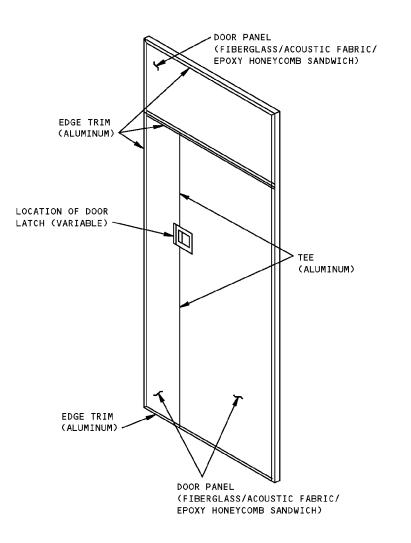
Allowable Damage - Flight Deck Door Structure Figure 101 (Sheet 1 of 4)

## ALLOWABLE DAMAGE 1 - ALLOWABLE DAMAGE - FLIGHT DECK DOOR STRUCTURE

DESCRIPTION	CRACKS	NICKS, GOUGES AND CORROSION	DENTS	HOLES AND PUNCTURES	DELAMINATION
DOOR PANELS	A	В	C	A	A
TEE	E	F	NOT ALLOWED	NOT ALLOWED	
EDGE TRIM	E	F	SEE DETAIL IV	G

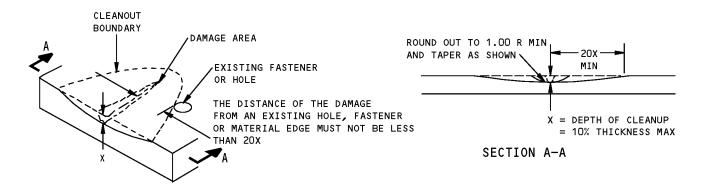
REMOVAL OF NICK, GOUGE AND SCRATCH DAMAGE ON A SURFACE DETAIL III

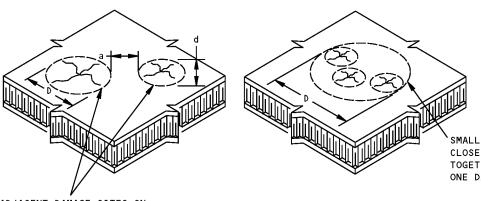
SMALL DAMAGE SITES THAT ARE CLOSELY SPACED MAY BE GROUPED TOGETHER AND CONSIDERED AS ONE DAMAGE SITE

ADJACENT DAMAGE SITES ON SURFACE OF COMPOSITE PANEL

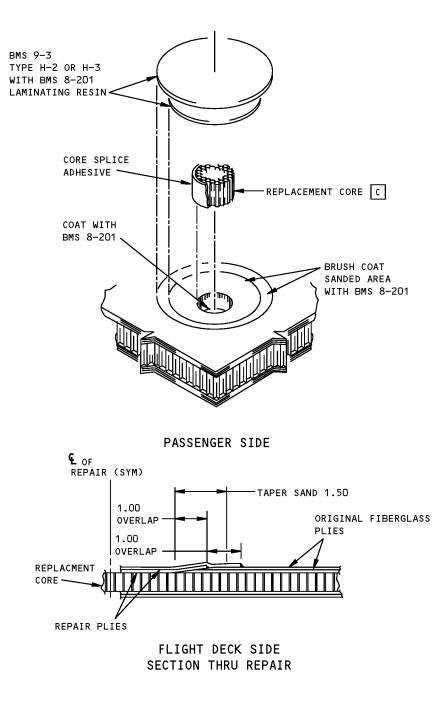
> Flight Deck Door Figure 201 (Sheet 3 of 4)

REPAIR OF DAMAGE TO ONE PANEL SIDE DETAIL II

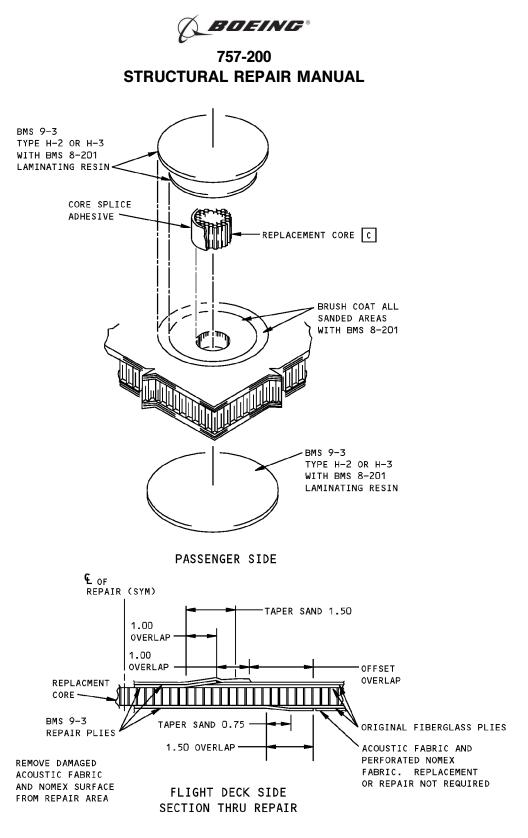
> Flight Deck Door Figure 201 (Sheet 4 of 4)

REPAIR OF DAMAGE TO BOTH PANEL SIDES DETAIL III

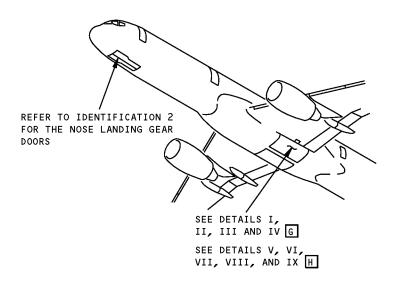
REFERENCE DRAWING 149N6002

#### **IDENTIFICATION 1 - MAIN LANDING GEAR DOOR**

- CORE DENSITIES VARY. SEE DRAWING 149N6003 FOR CORE POSITIONS.
- A PLY ORIENTATION CONVENTION, O DEGREES, IS PARALLEL TO THE FABRIC WARP DIRECTION.
- B GRAPHITE/EPOXY FABRIC PER BMS 8-212, TYPE IV, CLASS II, STYLE 3K-70-PW.
- C FOR AIRPLANES WITH CUM LINE NUMBERS: 1 THRU 36
- FOR AIRPLANES WITH CUM LINE NUMBERS: 37 AND ON
- E HEAT SHIELD PLY ORIENTATIONS ARE OPTIONAL.
- F HEAT SHIELD ON RH DOOR IS CENTERED AT RBL 53.75.
- G FOR AIRPLANES WITH ONE-PIECE MLG DOOR AND TANG.
- H FOR AIRPLANES WITH TWO-PIECE MLG DOOR AND TANG.

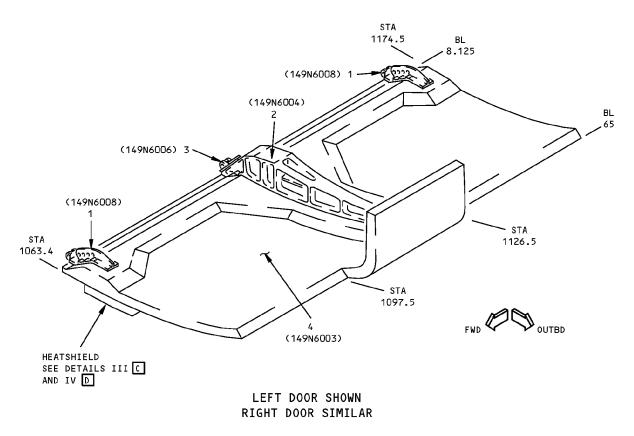
DETAIL I G

ITEM	DESCRIPTION	GAGE	MATERIAL	EFFECTIVITY
1	HINGE FITTING		MACHINED, FORGED BLOCK 7075-T73	
2	STRONG BACK BEAM		FORGING 7075-T73	
3	CENTER HINGE FITTING		15-5PH CRES HT TR 180-200 KSI	
4	DOOR PANEL SKINS CORE		FIBERGLASS/GRAPHITE/EPOXY HONEYCOMB SANDWICH SEE DETAIL II NONMETALLIC HONEYCOMB PER BMS 8-124, CLASS I, TYPE I, GRADE 4.0

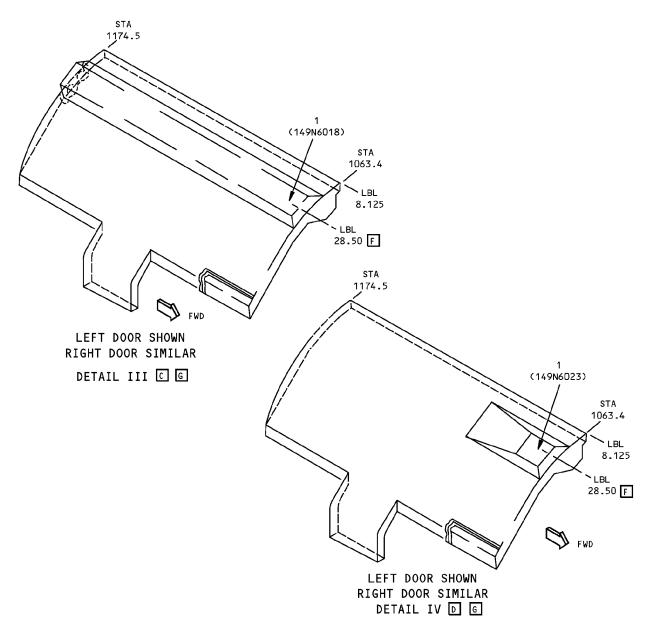
LIST OF MATERIALS FOR DETAILS III AND IV G

ITEM GAGE EFFECTIVITY DESCRIPTION MATERIAL 1 HEAT SHIELD PANEL ASSEMBLY ONE PLY OF ARAMID/EPOXY PREPREG PER BMS 8-218, INNER AND OUTER SKINS STYLE 285 BONDED TO CORE PLUS ONE PLY OF FIBER-GLASS/EPOXY PREPREG PER BMS 8-139, TYPE 120 E NONMETALLIC HONEYCOMB PER BMS 8-124, CLASS I, CORE TYPE I, GRADE 4.0

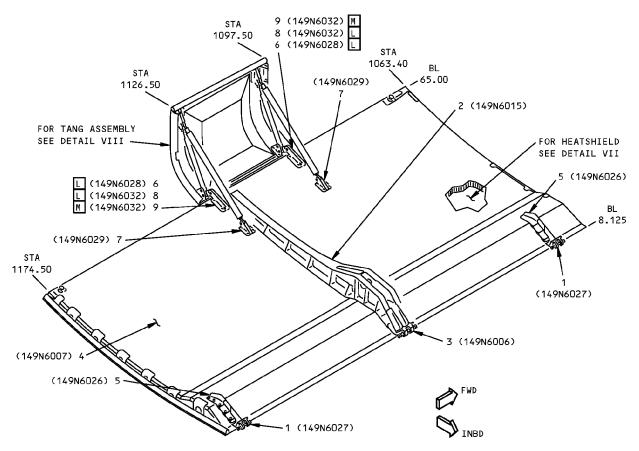
DETAIL V H

ITEM	DESCRIPTION	GAGE	MATERIAL	EFFECTIVITY
1	HINGE FITTING ASSEMBLY		FORGING 7075-T73	
2	STRONGBACK BEAM		FORGING 7075-T73	
3	CENTER HINGE FITTING		15-5PH CRES PER AMS 5659 HT TR TO 180-200 KSI	
4	DOOR PANEL ASSEMBLY SKINS CORE		FIBERGLASS/GRAPHITE/EPOXY HONEYCOMB SANDWICH SEE DETAIL VI NONMETALLIC HONEYCOMB PER BMS 8-124, CLASS 1, TYPE 1, GRADE 4.0	
5	HINGE FITTING		FORGING 7075-T73	
6	CLEVIS ASSEMBLY CLEVIS BASE PLATE	0.125	BAC1507-48821 7075-T73 EXTRUSION 15-5PH CRES SHEET HT TR TO 125-145 KSI	L
7	CLEVIS		BAC1507-48822 7075-T73 EXTRUSION	
8	DROP LINK		7075-T7351 PLATE	L
9	LINK FITTING ASSEMBLY LINK FITTING BASE PLATE	0.125	7075-T7351 PLATE 15-5PH CRES SHEET HT TR TO 125-145 KSI	M

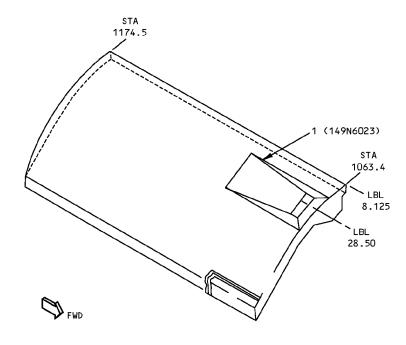
LEFT DOOR SHOWN RIGHT DOOR SIMILAR DETAIL VII H

ITEM	DESCRIPTION	GAGE	MATERIAL	EFFECTIVITY
1	HEAT SHIELD PANEL ASSEMBLY INNER SKIN OUTER SKIN CORE		TWO PLIES OF GLASS/EPOXY PREPREG PER BMS 8-139, TYPE 1581 THREE PLIES OF GLASS/EPOXY PREPREG PER BMS 8-139, TYPE 1581 NONMETALLIC HONEYCOMB PER BMS 8-124, CLASS I, TYPE I, GRADE 4.0

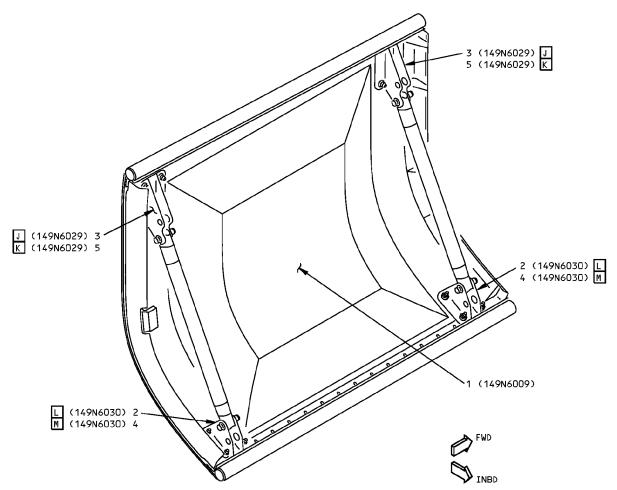
DETAIL VIII 田

ITEM	DESCRIPTION	GAGE	MATERIAL	EFFECTIVITY
1	TANG ASSEMBLY INNER AND OUTER SKINS CORE		SEE DETAIL IX NONMETALLIC HONEYCOMB PER BMS 8-124, CLASS 4, TYPE V, GRADE 3.0	
2	LOWER CLEVIS FITTING		BAC1507-48823 7075-T73 EXTRUSION	I
3	UPPER CLEVIS FITTING		BAC1507-48822 7075-T73 EXTRUSION	J
4	LOWER CLEVIS FITTING		7075-T7351 PLATE	Μ
5	UPPER CLEVIS FITTING		BAC1507-48822 7075-T73511 EXTRUSION	ĸ

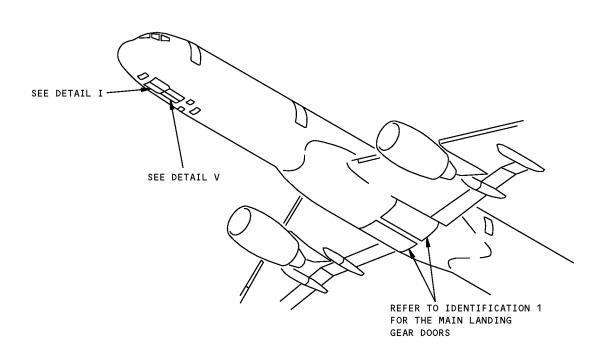
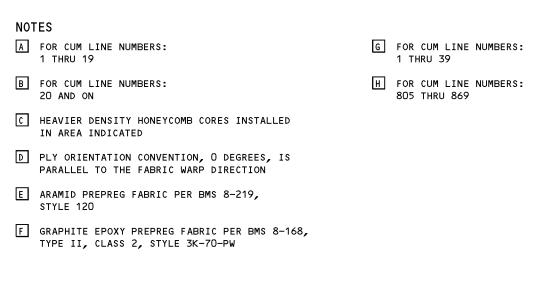
Nose Landing Gear Door Figure 1 (Sheet 1 of 5)

#### **IDENTIFICATION 2 - NOSE LANDING GEAR DOOR SKIN**

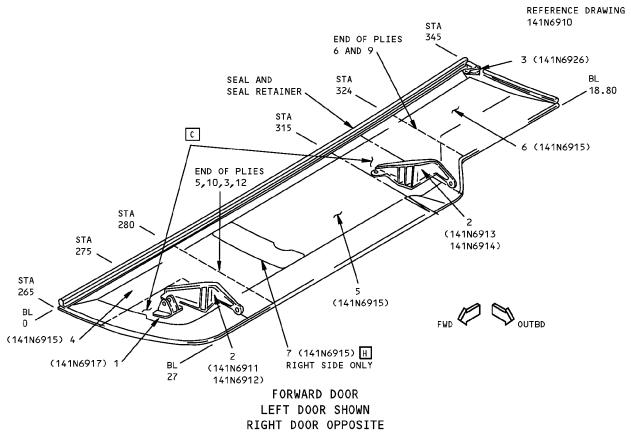
DETAIL I

ITEM	DESCRIPTION	GAGE	MATERIAL	EFFECTIVITY
1	ROD ATTACH FITTING		FORGED BLOCK 7075-T73	
2	HINGE FITTING		FORGED BLOCK 7075-T73 DIE FORGING 7075-T73	A B
3	DOOR STOP FITTING		EXTRUDED BAR 7075-T73511	
4	DOOR PANEL SKIN CORE		GRAPHITE HYBRID HONEYCOMB SANDWICH SEE DETAIL II FIBERGLASS HONEYCOMB PER BMS 8-124, CLASS 1, TYPE 1, GRADE 4.0	
5	DOOR PANEL SKIN CORE		GRAPHITE HYBRID HONEYCOMB SANDWICH SEE DETAIL III FIBERGLASS HONEYCOMB PER BMS 8-124, CLASS 1, TYPE 1, GRADE 4.0	
6	DOOR PANEL SKIN CORE		GRAPHITE HYBRID HONEYCOMB SANDWICH SEE DETAIL IV FIBERGLASS HONEYCOMB PER BMS 8-124, CLASS 1, TYPE 1, GRADE 4.0	
7	SCUFF PLATE	0.020	301 CRES	Н
