# CHAPTER 52

## DOORS

## **52-EFFECTIVE PAGES**

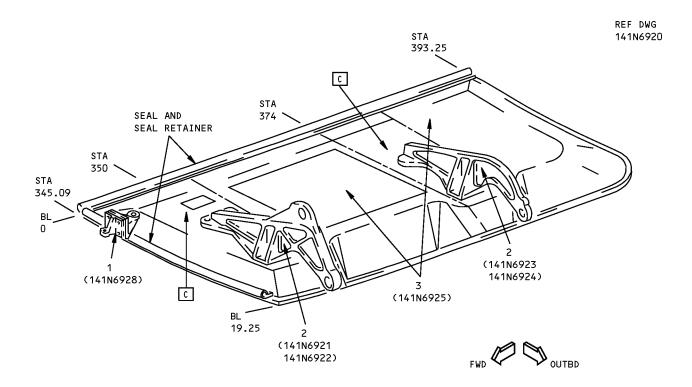
AFT DOOR LEFT DOOR SHOWN RIGHT DOOR OPPOSITE DETAIL V

ITEM	DESCRIPTION	GAGE	MATERIAL	EFFECTIVITY
1 2 3	DOOR SUPPORT FITTING HINGE FITTING DOOR PANEL SKIN CORE		EXTRUDED BAR 7075-T73511 FORGED BLOCK 7075-T73 DIE FORGING 7075-T73 GRAPHITE HYBRID HONEYCOMB SANDWICH SEE DETAIL VI FIBERGLASS HONEYCOMB PER BMS 8-124, CLASS 1, TYPE 1, GRADE 4.0	A B

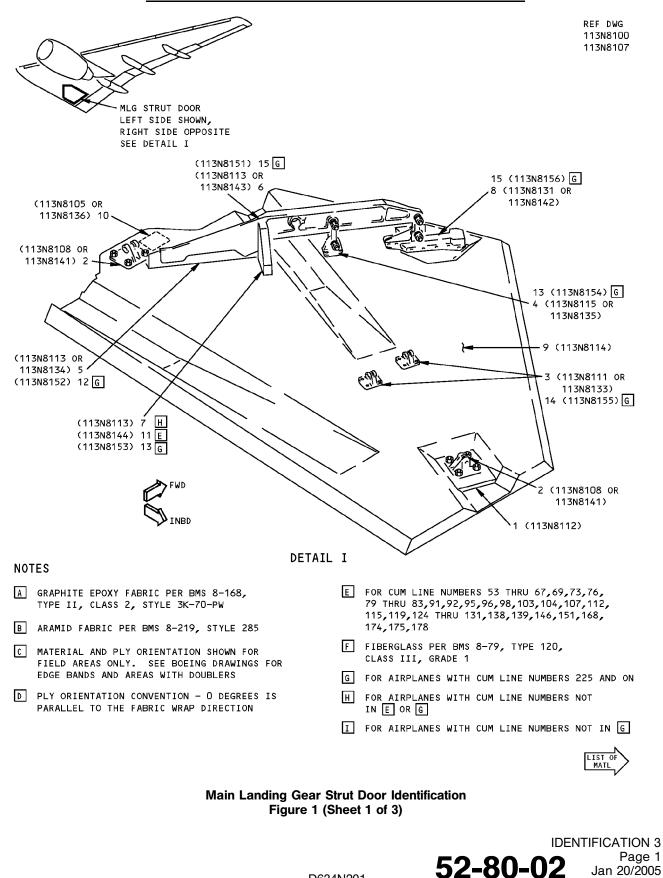
#### **IDENTIFICATION 3 - MAIN LANDING GEAR STRUT DOOR SKIN**

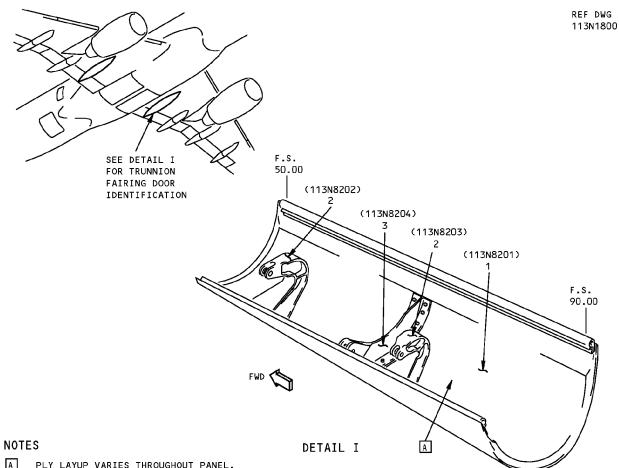
#### **IDENTIFICATION 4 - TRUNNION FAIRING DOOR**

A PLY LAYUP VARIES THROUGHOUT PANEL. SEE BOEING DWG FOR PLY MATERIAL AND ORIENTATION

ITEM	DESCRIPTION	GAGE	MATERIAL	EFFECTIVITY
1	TRUNNION DOOR PANEL SKIN		ARAMID/GRAPHITE/EPOXY HONEYCOMB SANDWICH	
	OUTER PLY		ARAMID FABRIC PER BMS 8-219, STYLE 285 A	
	INNER PLIES		GRAPHITE FABRIC PER BMS 8-168, CLASS II, TYPE II, STYLE 3K-70-PW A	
	CORE		NONMETALLIC HONEYCOMB PER BMS 8-124, CLASS I, TYPE I, GRADE 5.5	
2	HINGE		FORGED BLOCK OR DIE FORGING 7075-T73	
3	SUPPORT FITTING		FORGED BLOCK OR DIE FORGING 7075-T73

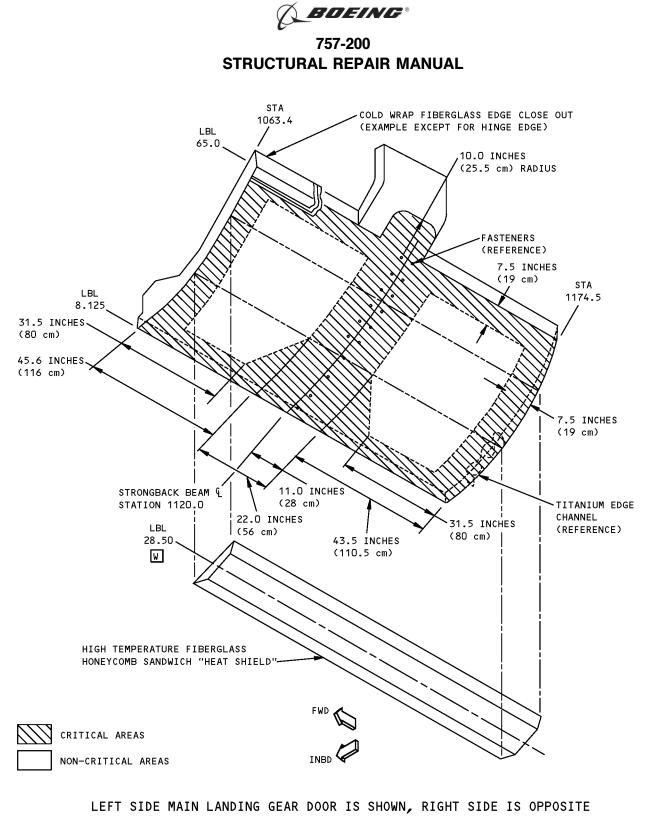
Allowable Damage - Main Landing Gear Door Figure 101 (Sheet 2 of 10)

DETAIL II X AA

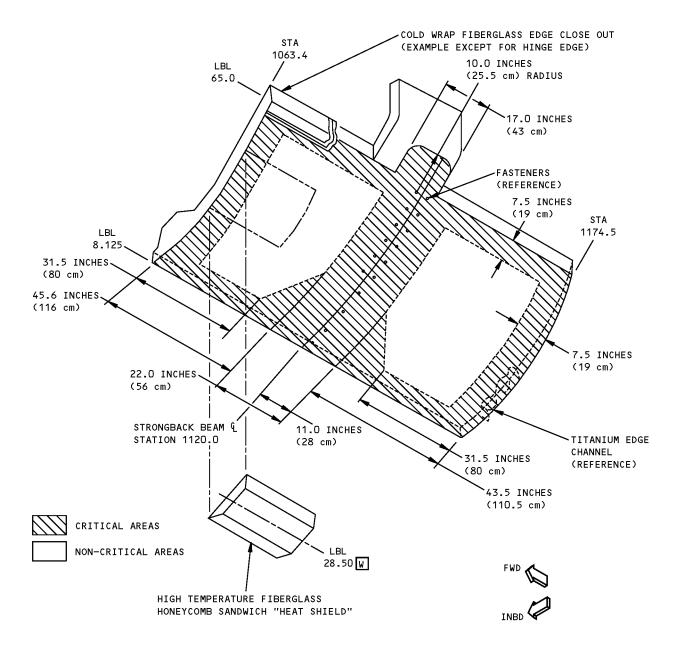
Allowable Damage - Main Landing Gear Door Figure 101 (Sheet 3 of 10)

### LEFT SIDE MAIN LANDING GEAR DOOR IS SHOWN, RIGHT SIDE IS OPPOSITE DETAIL III Y AA

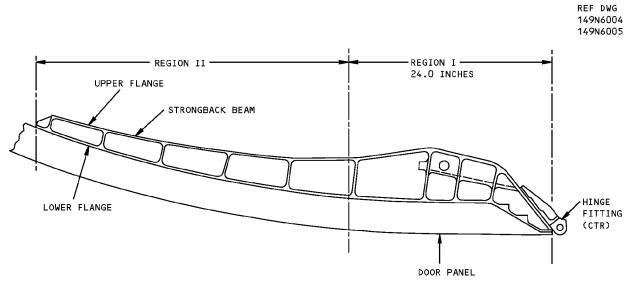
Allowable Damage - Main Landing Gear Door Figure 101 (Sheet 6 of 10)

DETAIL IV

DESCRIPTION		CRACKS	NICKS, GOUGES AND CORROSION	DENTS	HOLES AND PUNCTURES	DELAMINATION
	COLD WRAPPED FIBERGLASS EDGES	S	S	S	S	5
DOOR PANEL	FACE SKIN- CRITICAL AREAS (SHADED)	C	F	K	Μ	٩
	FACE SKIN- NON-CRITICAL AREAS	T	G	K	N	Q
STRONGBACK	REGION I	NOT ALLOWED	н	NOT Allowed	NOT Allowed	NOT APPLICABLE
BEAM R	REGION II	D				
HINGE FITTINGS R	FWD AND AFT CENTER	D	I	NOT Allowed	NOT Allowed	NOT APPLICABLE
TITANIUM EDGE CHANNELS	LBL 28.50 RBL 53.80	E	L	L	NOT Allowed	NOT APPLICABLE
FIBERGLASS HEAT SHIELD	LBL 28.50 RBL 53.80	T	U	K	0	V

- DAMAGE TO PANEL EDGES MAY BE CONFINED TO DELAMINATION OR MAY TAKE A FORM WHICH RESULTS IN DAMAGE TO FIBERS AND A LOSS OF EFFECTIVE CROSS-SECIIONAL AREA. THIS TYPE OF DAMAGE SHOULD BE REMOVED AND THE LIMITATIONS GIVEN FOR CRACKS APPLIED.

- REFER TO SRM 51-10-02 FOR INSPECTION AND REMOVAL OF DAMAGE
- A REMOVE MOISTURE FROM DAMAGE AREA. USE OF VACUUM AND HEAT (MAX OF 125°F E52°C]) TO REMOVE MOISTURE FROM HONEYCOMB CELLS IS RECOMMENDED. PROTECT DAMAGE FROM ENTRANCE OF WATER, SUNLIGHT OR OTHER FOREIGN MATTER BY SEALING WITH ALUMINUM FOIL TAPE (SPEED TAPE) 3M-Y436 OR EQUIVALENT. RECORD LOCATION AND INSPECT AT AIRPLANE "A" CHECK. REPLACE ALUMINUM FOIL TAPE IF ANY PEELING OR DETERIORATION OF TAPE IS EVIDENT. REPAIR DAMAGE PER SRM 51-70 NO LATER THAN THE NEXT "C" CHECK.

- C 2.0 INCHES (50 mm) MAX DIMENSION (D) IN HONEYCOMB AREA IS ALLOWED PER SQUARE FOOT (930 SQUARE cm) AREA AND A MINIMUM OF 6D (EDGE TO EDGE) FROM ANY OTHER CRACK, FITTING OR FASTENER HOLE AND A MINIMUM OF 6.0 INCHES (150 mm) FROM MATERIAL EDGE.

- D CLEAN UP EDGE CRACKS PER DETAILS VII AND X. CLEAN UP CORNER CRACKS PER DETAIL XI. OTHER CRACKS NOT ALLOWED. B
- E CLEAN UP EDGE CRACKS PER DETAILS VII AND XIII. CLEAN UP CORNER CRACKS PER DETAIL XI. OTHER CRACKS NOT ALLOWED.

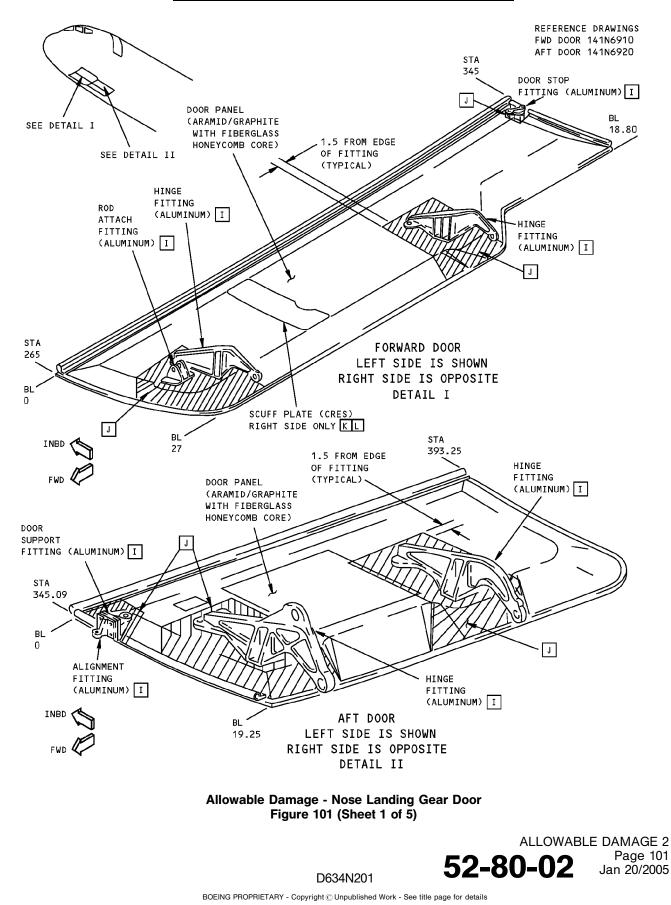
#### ALLOWABLE DAMAGE 2 - NOSE LANDING GEAR DOOR

DESCRIPTION	CRACKS	NICKS, GOUGES AND CORROSION	DENTS	HOLES AND PUNCTURES	DELAMINATION
DOOR PANELS	В	C	D	E	F
HINGE FITTINGS	G	H	NOT ALLOWED	NOT ALLOWED	
DOOR STOP FITTING	G	Н	NOT ALLOWED	NOT ALLOWED	
DOOR SUPPORT FITTING	G	H	NOT ALLOWED	NOT ALLOWED	
ROD ATTACH FITTING	G	H	NOT ALLOWED	NOT ALLOWED	
ALIGNMENT FITTING	G	H	NOT ALLOWED	NOT ALLOWED	
SCUFF PLATE		К	К

- CONDUCTIVE COATING ON ALL DOOR PANELS. FOR ALLOWABLE DAMAGE TO CONDUCTIVE COATING REFER TO AMM 51-20.
- TYPICAL DAMAGE TO A PANEL EDGEBAND MAY CONSIST OF EDGE CRUSHING, CRACKS OR DELAMI-NATION. DAMAGE AROUND HOLES MAY CONSIST OF OVALIZATION, FASTENER PULL-THROUGH OR CRACKS OUT OF HOLE. DAMAGE MAY REDUCE THE EFFECTIVE CROSS SECTIONAL AREA OF AN EDGE-BAND. DAMAGE TO EDGES SHOULD BE BLENDED OUT TO LIMITATIONS GIVEN FOR COMPONENT

- B 0.50 MAX LENGTH IN HONEYCOMB AREA IS ALLOWED PER SQUARE FOOT OF AREA AND A MINIMUM OF 6 INCHES FROM ANY OTHER CRACK. EDGE CRACKS MUST BE REMOVED PER DETAILS III AND V. A

- C DAMAGE ALLOWED ON SURFACE RESIN ONLY. DAMAGE TO FIBERS NOT ALLOWED. CLEAN\_UP EDGE DAMAGE PER DETAILS III AND V. A
- D DENTS GENERALLY RESULT IN FIBER DAMAGE OR DELAMINATION. HOWEVER, IF THERE IS NO FIBER DAMAGE OR DELAMINATION, DENTS UP TO 1.10 DIA MAX ARE ALLOWED, ONE DENT PER

- F 0.50 MAX DIA IN HONEYCOMB AREA AND NOT TO EXCEED 25% OF HONEYCOMB CORE LENGTH PER SIDE. A MAXIMUM OF 0.03 DELAMINATION FROM EDGE IS ALLOWED. REPAIR DELAMINATION IN HONEYCOMB AREA PER SRM 51-70 AND NO LATER THAN THE NEXT AIRPLANE "C" CHECK. PROTECT EDGE DAMAGE PER A.

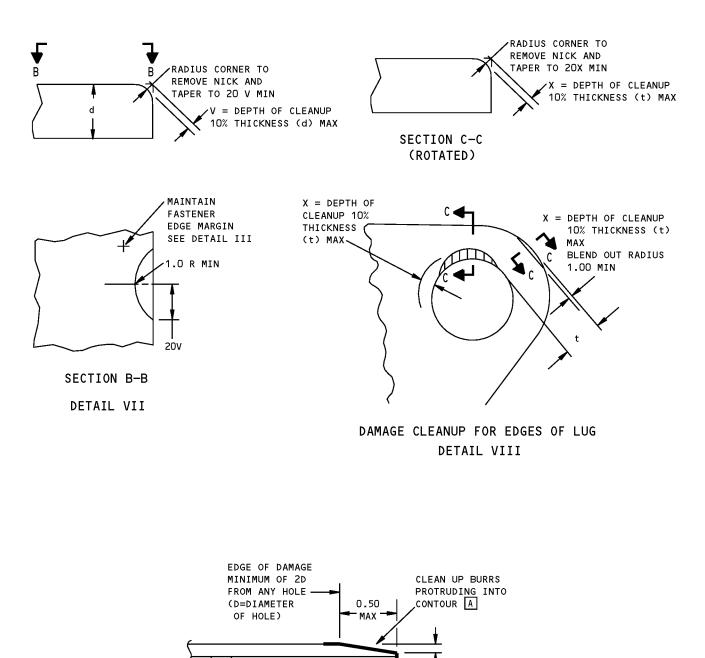
Allowable Damage - Nose Landing Gear Door Figure 101 (Sheet 5 of 5)

DAMAGE CLEANUP AND SEALING OF EDGE EROSION DETAIL IX

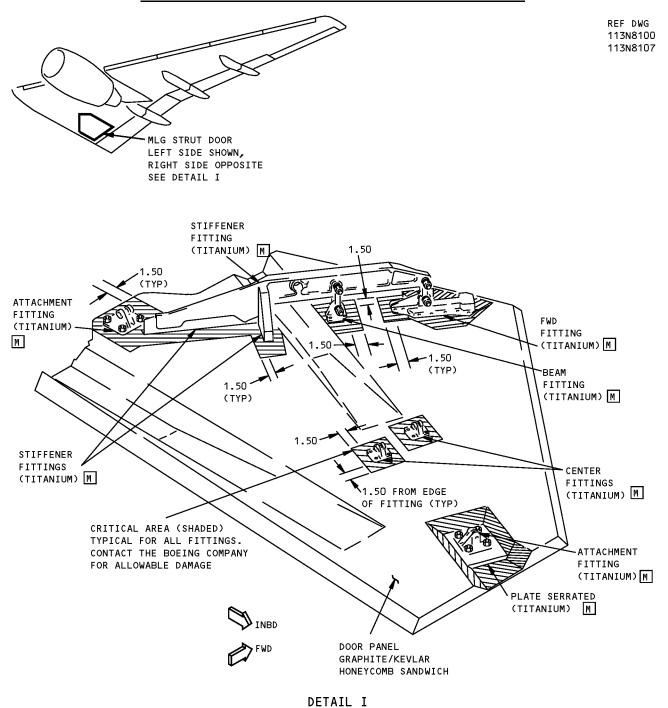
Allowable Damage - Main Landing Gear Strut Door Figure 101 (Sheet 1 of 5)

#### ALLOWABLE DAMAGE 3 - MAIN LANDING GEAR STRUT DOOR

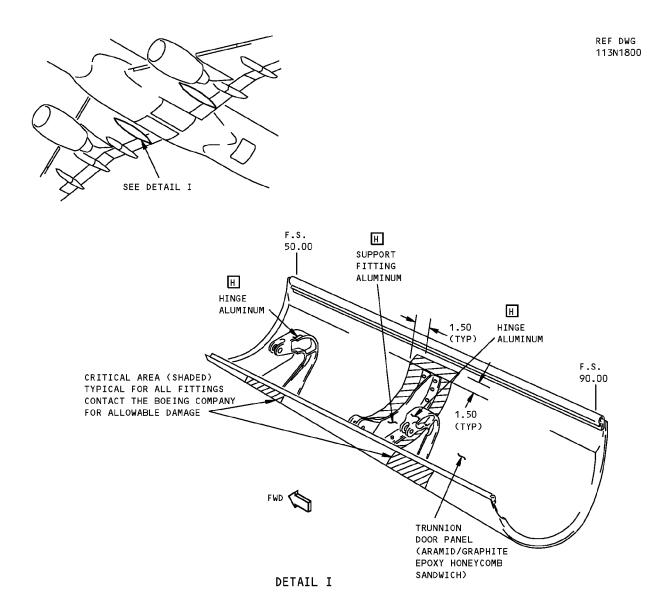
Allowable Damage - Trunnion Fairing Door Figure 101 (Sheet 1 of 4)

#### ALLOWABLE DAMAGE 4 - TRUNNION FAIRING DOOR

DESCRIPTION	CRACKS	NICKS, GOUGES AND CORROSION	DENTS	HOLES AND PUNCTURES	DELAMI- NATION	EDGE EROSION
TRUNNION DOOR PANEL	В	C	D	E	F	SEE DETAIL II
HINGE	Ι	G	NOT ALLOWED	NOT ALLOWED		
SUPPORT FITTING	I	G	NOT ALLOWED	NOT ALLOWED

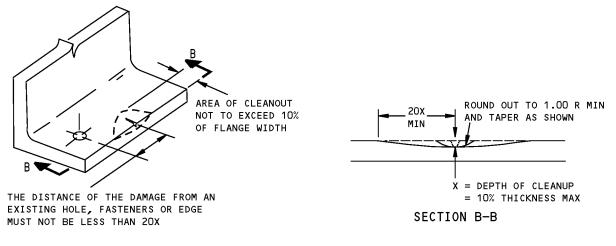
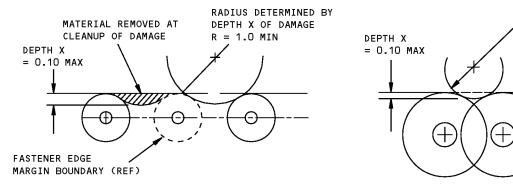
DAMAGE CLEANUP OF EDGES WHERE

FASTENER EDGE MARGINS DO NOT OVERLAP

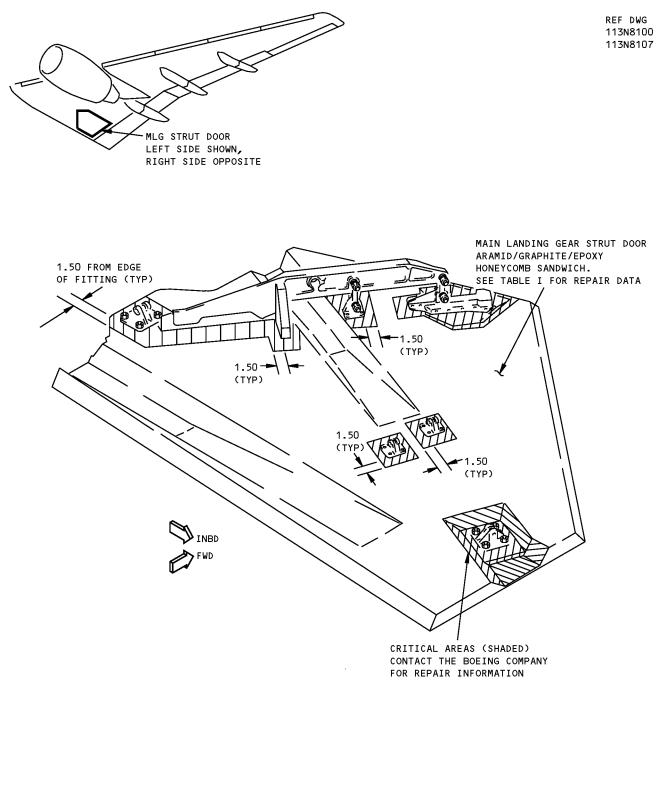
Main Landing Gear Strut Door Figure 201 (Sheet 1 of 2)

#### **REPAIR 1 - MAIN LANDING GEAR STRUT DOOR**

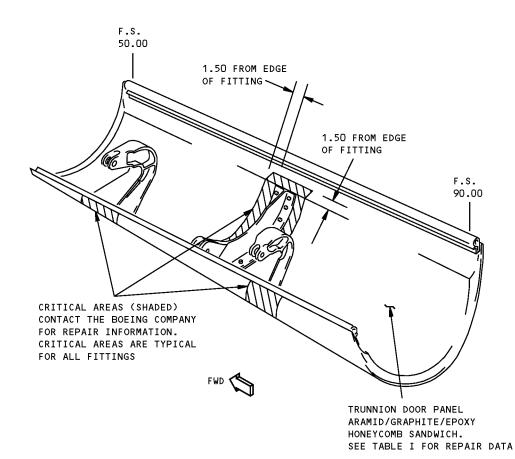
Trunnion Fairing Door Figure 201 (Sheet 1 of 2)

REF DWG 113N1800

#### DETAIL I

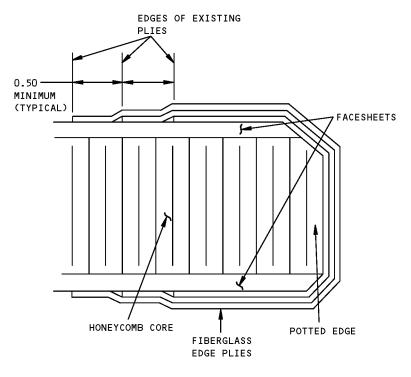
SECTION THRU COLD WRAPPED FIBERGLASS EDGE (TYPICAL)

#### REPAIR OF FIBERGLASS WRAPPED EDGE

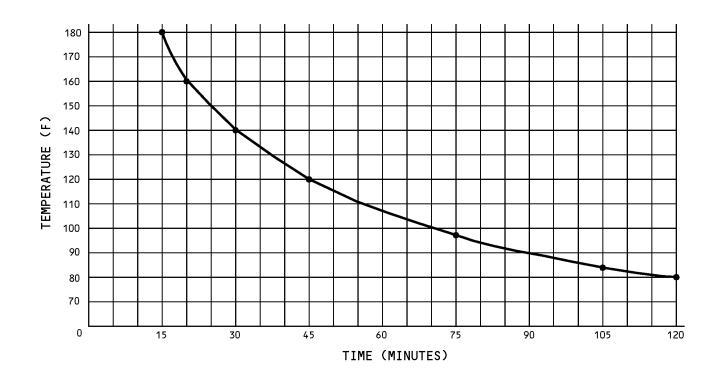
Repair of Delaminated Aramid Skin Plies - Nose Landing Gear Door Figure 201 (Sheet 2 of 2)

DRYING TIMES FOR LAMINAR X-500 SURFACER DETAIL I
