FUSELAGE

757-200 STRUCTURAL REPAIR MANUAL

CHAPTER 53 FUSELAGE

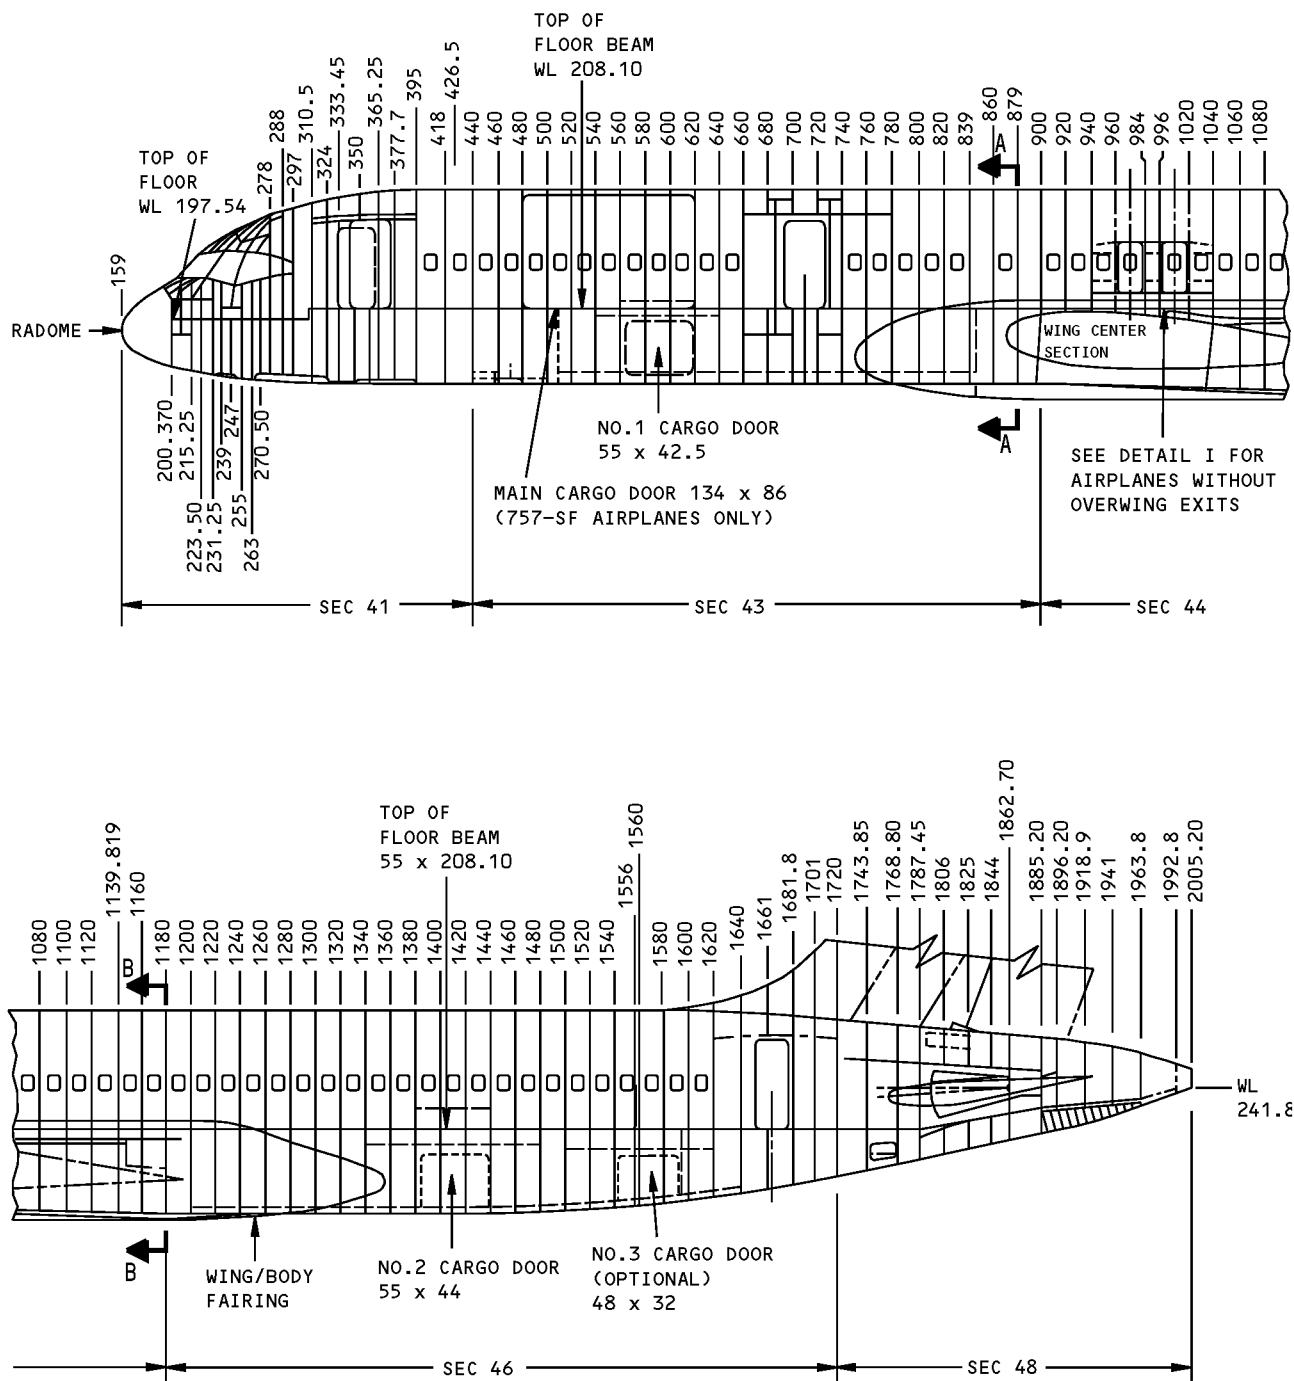
**Fuselage Station Diagram
Figure 1 (Sheet 1 of 2)**

REF DWG
140N1510

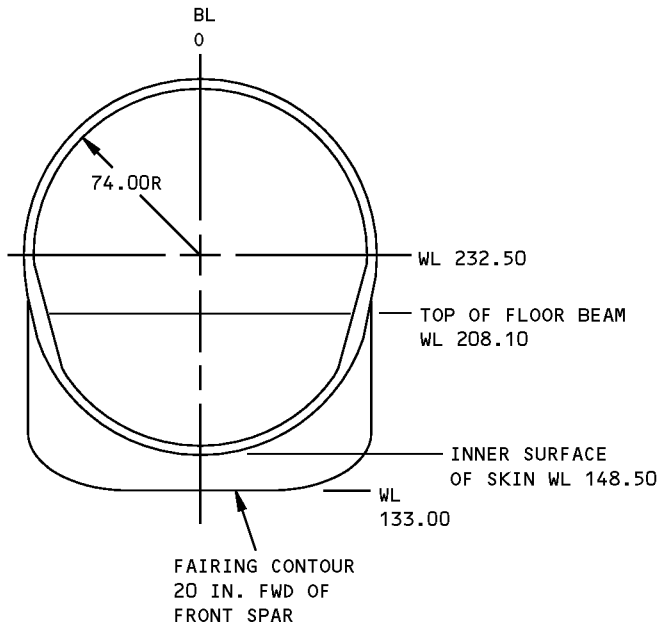
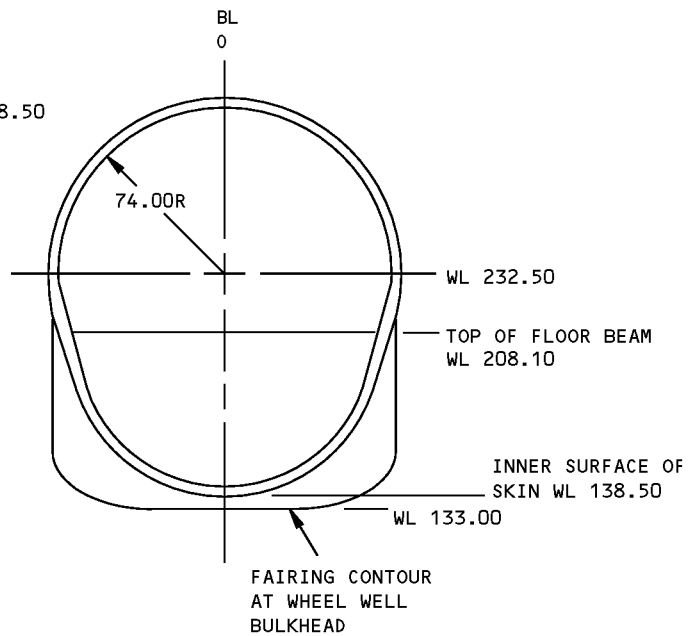
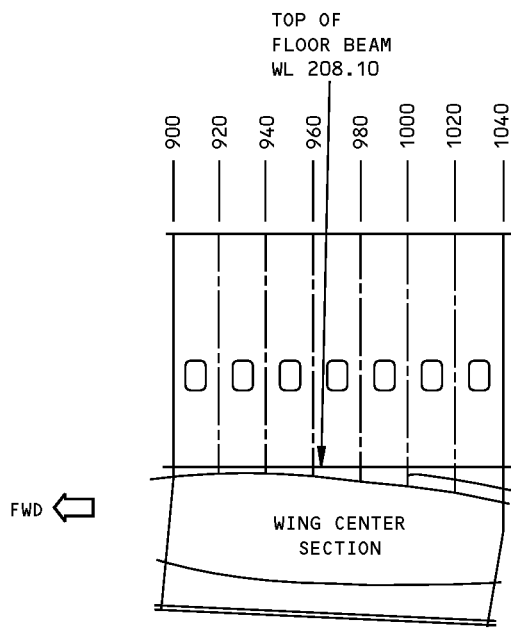
Fuselage Station Diagram
Figure 1 (Sheet 2 of 2)

SECTION A-A

SECTION B-B

DETAIL I

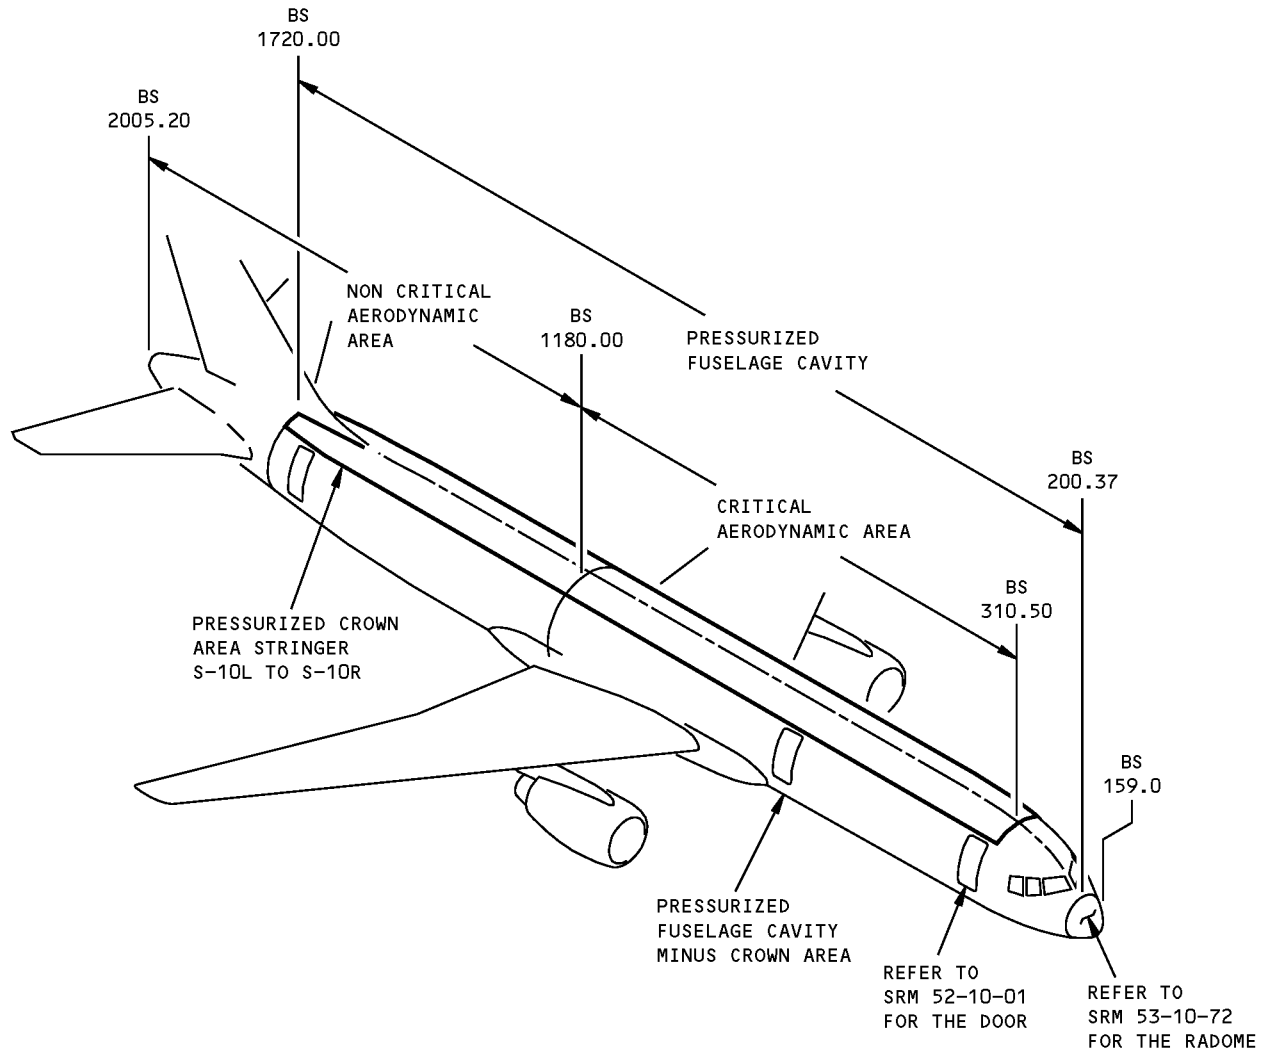
**Fuselage Skin Allowable Damage
Figure 101 (Sheet 1 of 6)**

ALLOWABLE DAMAGE 1 - FUSELAGE SKIN

REFERENCE DRAWING
140N1580

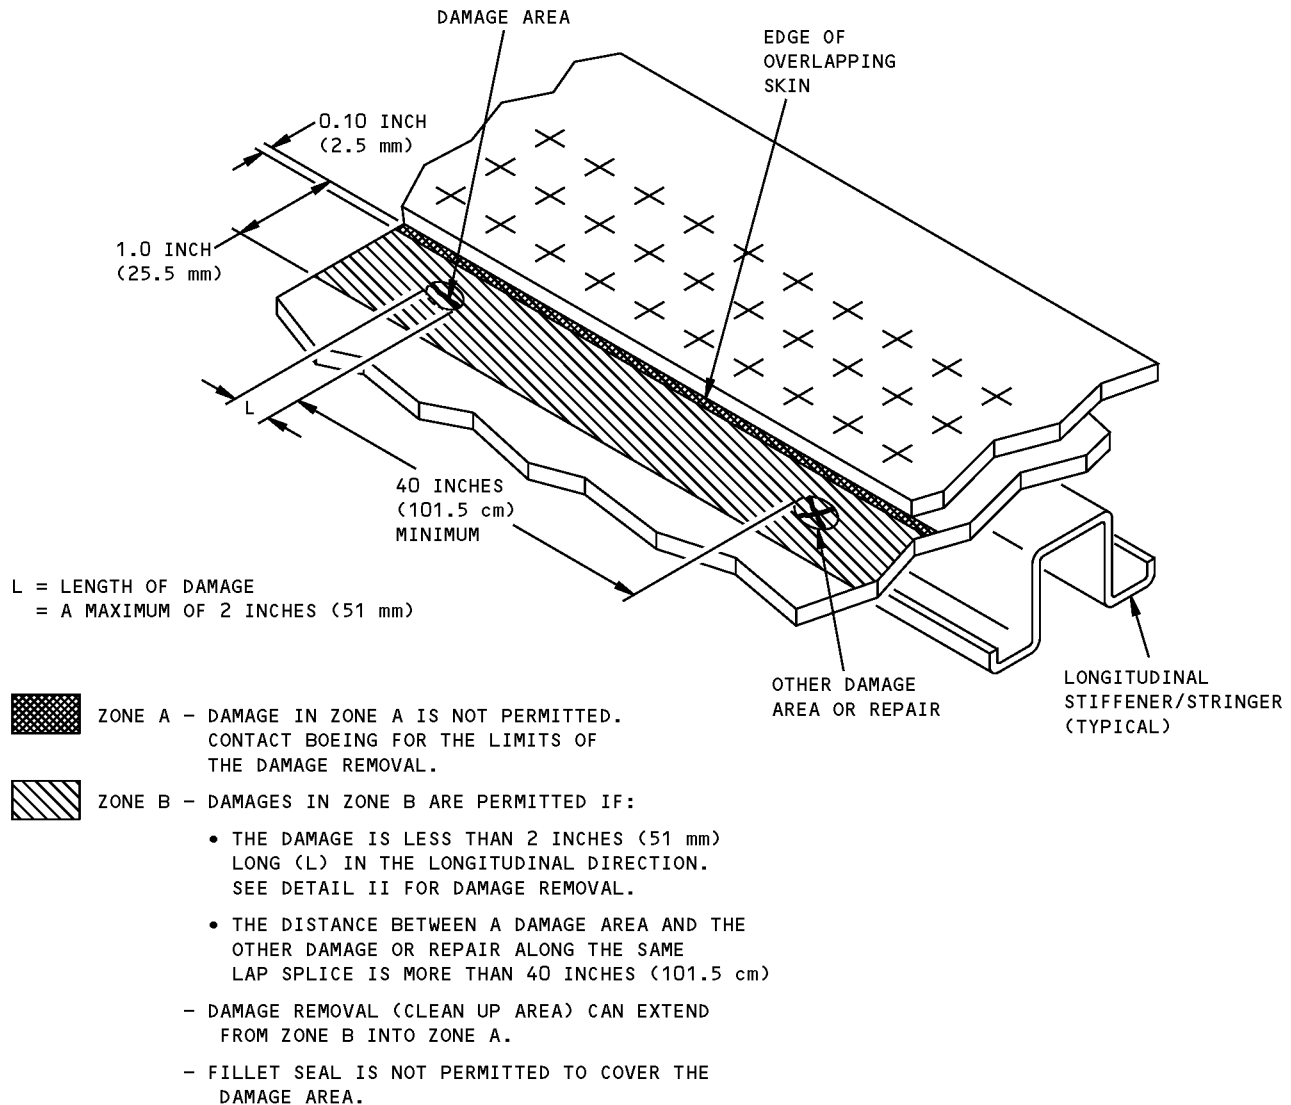
**Fuselage Skin Allowable Damage
Figure 101 (Sheet 5 of 6)**

DAMAGE AT THE LONGITUDINAL LAP SPLICE DETAIL IV

| AREA | CRACKS [C] | NICKS, GOUGES, SCRATCHES AND CORROSION [C] | DENTS [K] | HOLES | WRINKLES OR BUCKLES |
|--|---|--|---|---|---|
| THE PRESSURIZED FUSELAGE SKIN MINUS THE CROWN (S10L-S10R) | FOR EDGE CRACKS SEE DETAIL I [A]. OTHER CRACKS ARE NOT PERMITTED. | FOR EDGE DAMAGE SEE DETAIL I [A]. FOR DAMAGE IN THE LONGITUDINAL LAP SPLICES SEE DETAIL IV [D]. FOR OTHER DAMAGE SEE DETAIL II [D]. | SEE DETAIL III [B] [F] [I] [J] | NOT PERMITTED | [B] [H] |
| THE PRESSURIZED FUSELAGE CROWN SKIN (S10L-S10R) | FOR EDGE CRACKS SEE DETAIL I [A]. OTHER CRACKS ARE NOT PERMITTED. | FOR EDGE DAMAGE SEE DETAIL I [A]. FOR DAMAGE IN THE LONGITUDINAL LAP SPLICES SEE DETAIL IV [E]. FOR DAMAGE IN THE CIRCUMFERENTIAL BUTT SPLICE SEE DETAIL V. FOR OTHER DAMAGE SEE DETAIL II [E]. | SEE DETAIL III [B] [I] [J] | NOT PERMITTED | [B] |

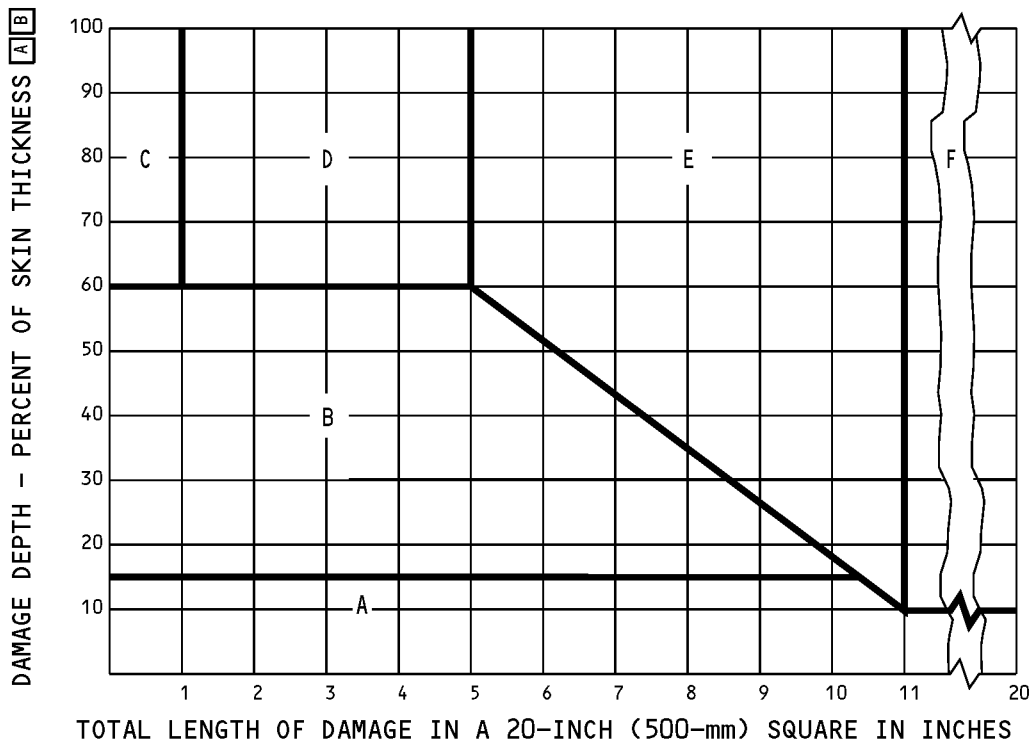
ALLOWABLE DAMAGE 2 - OPERATING LIMITS FOR FUSELAGE SKIN

B DAMAGE INCLUDES HOLES, PUNCTURES, NICKS, GOUGES, SCRATCHES, CORROSION AND CRACKS.

DAMAGE DOES NOT INCLUDE DENTS.

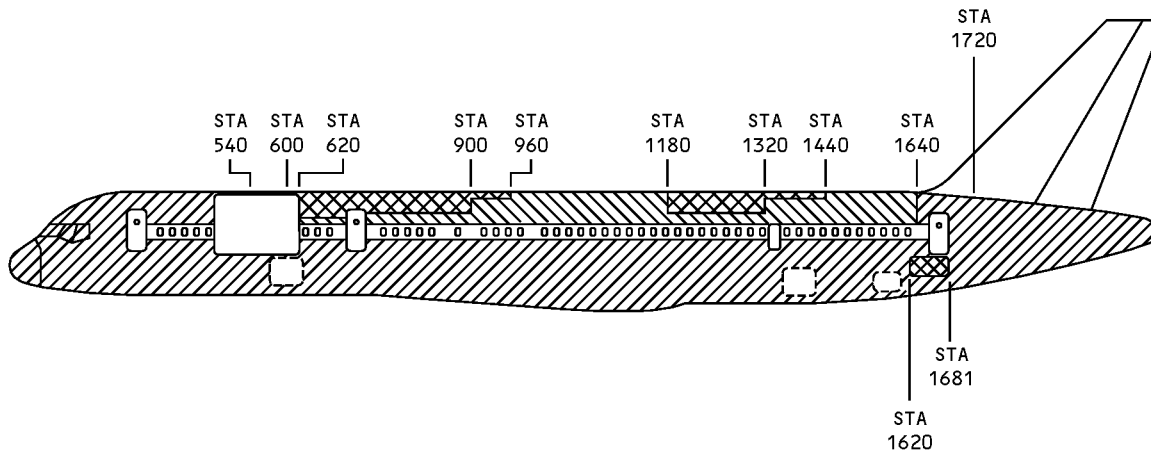
**Fuselage Skin - Definition of Repair Zones
Figure 202 (Sheet 1 of 2)**

ZONE A - FROM STA 192 TO STA 540 AND FROM STA 1640 TO THE TAIL CONE ANYWHERE IN THE FUSELAGE SKIN, AND FROM STA 540 TO STA 1640 BELOW STRINGER 13

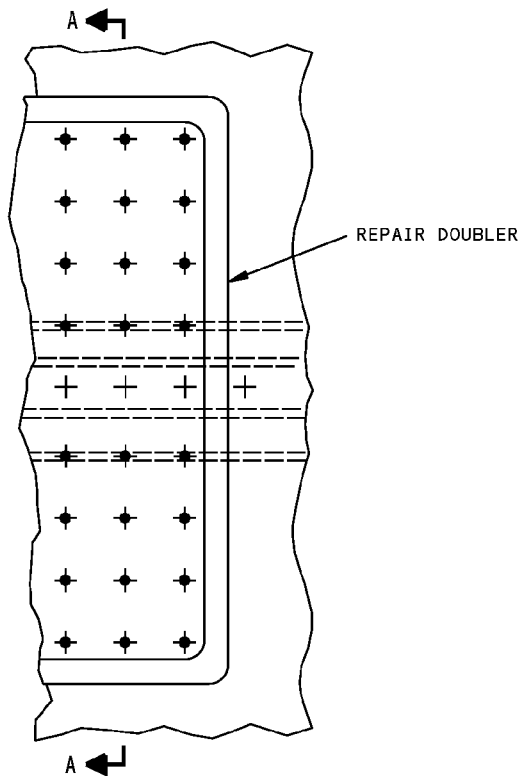
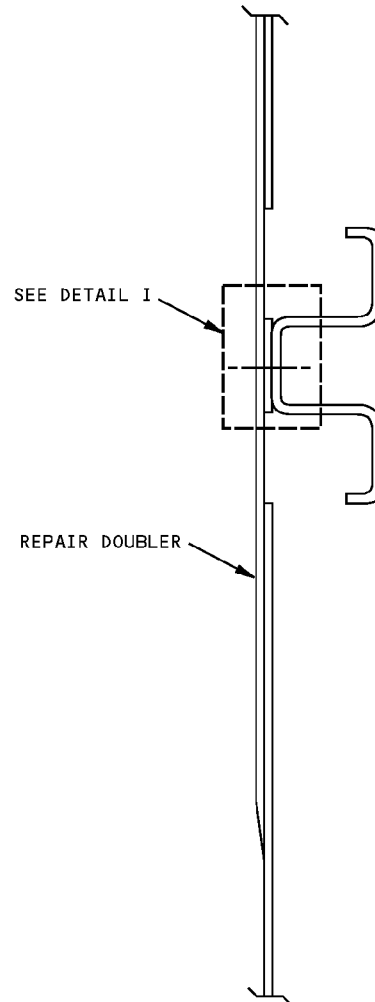
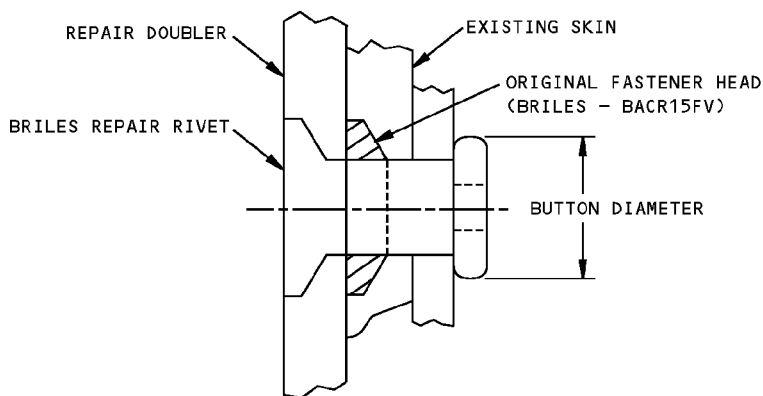
**Method of Using Briles Rivet Head as Repair Washer for External Skin Repair
Figure 201 (Sheet 2 of 2)**

TYPICAL SKIN REPAIR DOUBLER

SECTION A-A
(2X SIZE)

BRILES REPAIR RIVET SHOWN INSTALLED
SEE APPLICABLE REPAIR FOR REPAIR FASTENER
DETAIL I

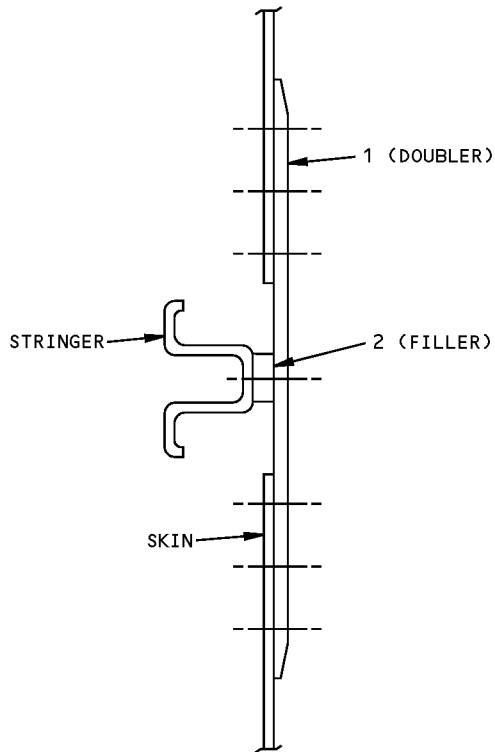
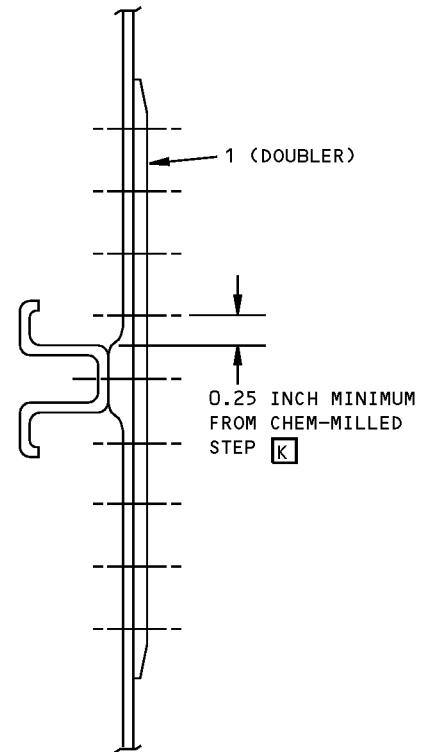
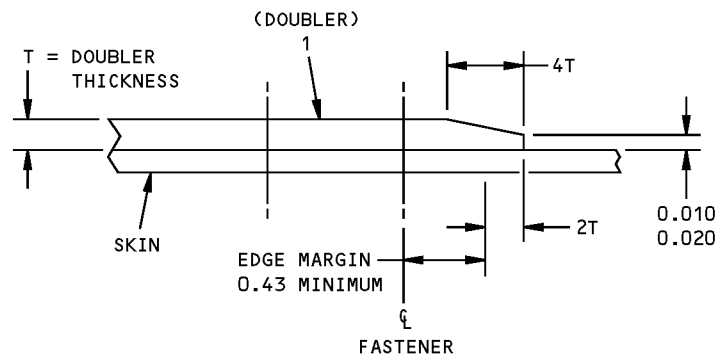
Fuselage Skin - External Repair for Damage at a Stringer with Solid Fasteners
Figure 201 (Sheet 5 of 6)

SECTION A-A

SECTION C-C

SECTION B-B

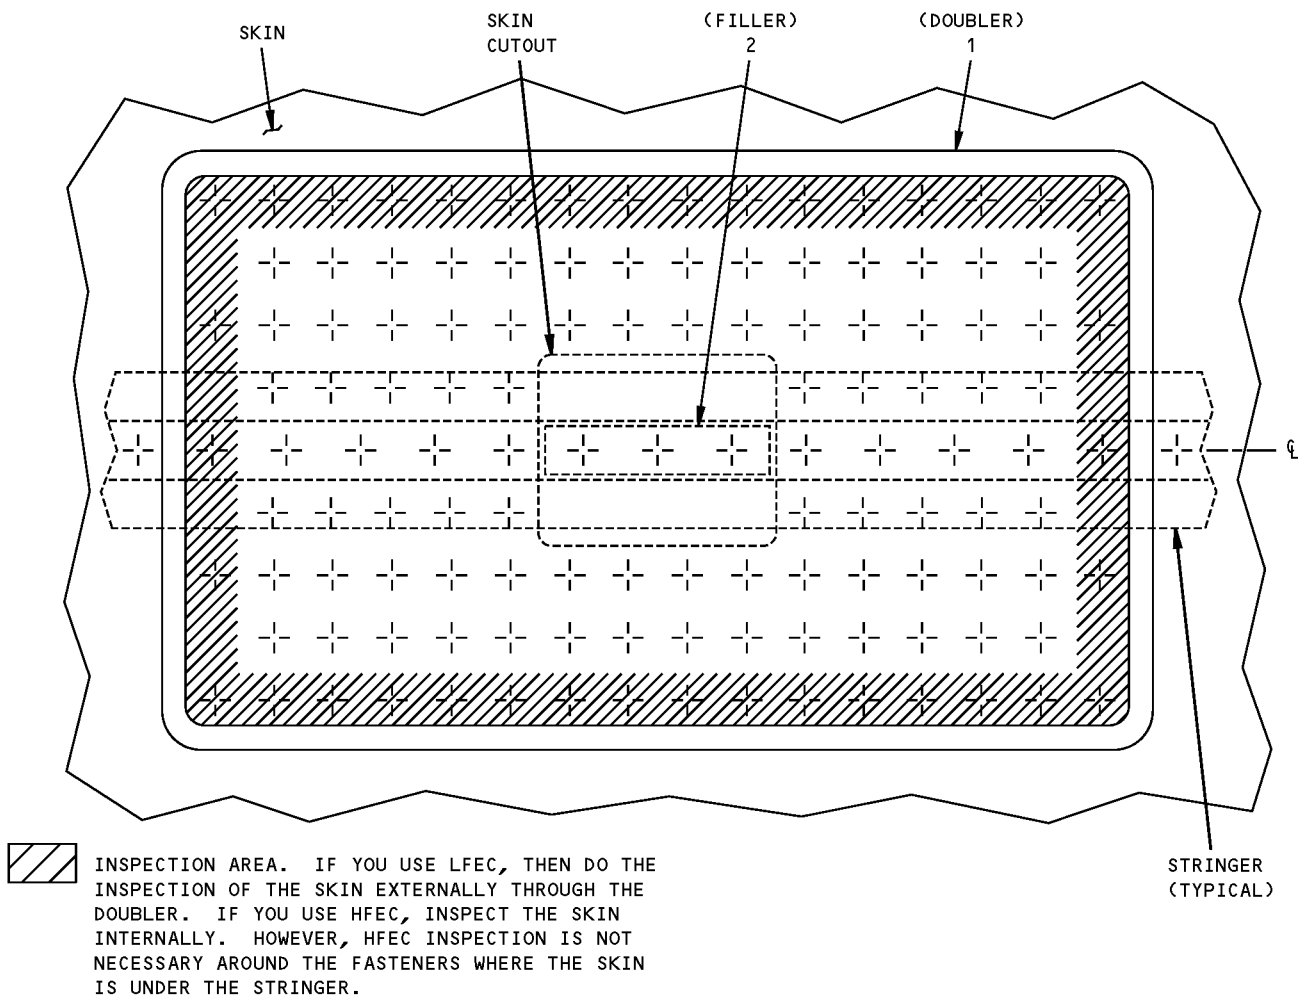
Fuselage Skin - External Repair for Damage at a Stringer with Solid Fasteners
Figure 201 (Sheet 6 of 6)

| CATEGORY B REPAIR INSPECTION REQUIREMENTS | | | | |
|---|---|--|---|---|
| NOTE: INSPECT THE SKIN AROUND THE FIRST ROW OF FASTENERS ALONG THE EDGE OF THE DOUBLER AS SHOWN IN DETAIL II. USE ONE OF THE TWO INSPECTION METHODS. | | | | |

DETAIL II

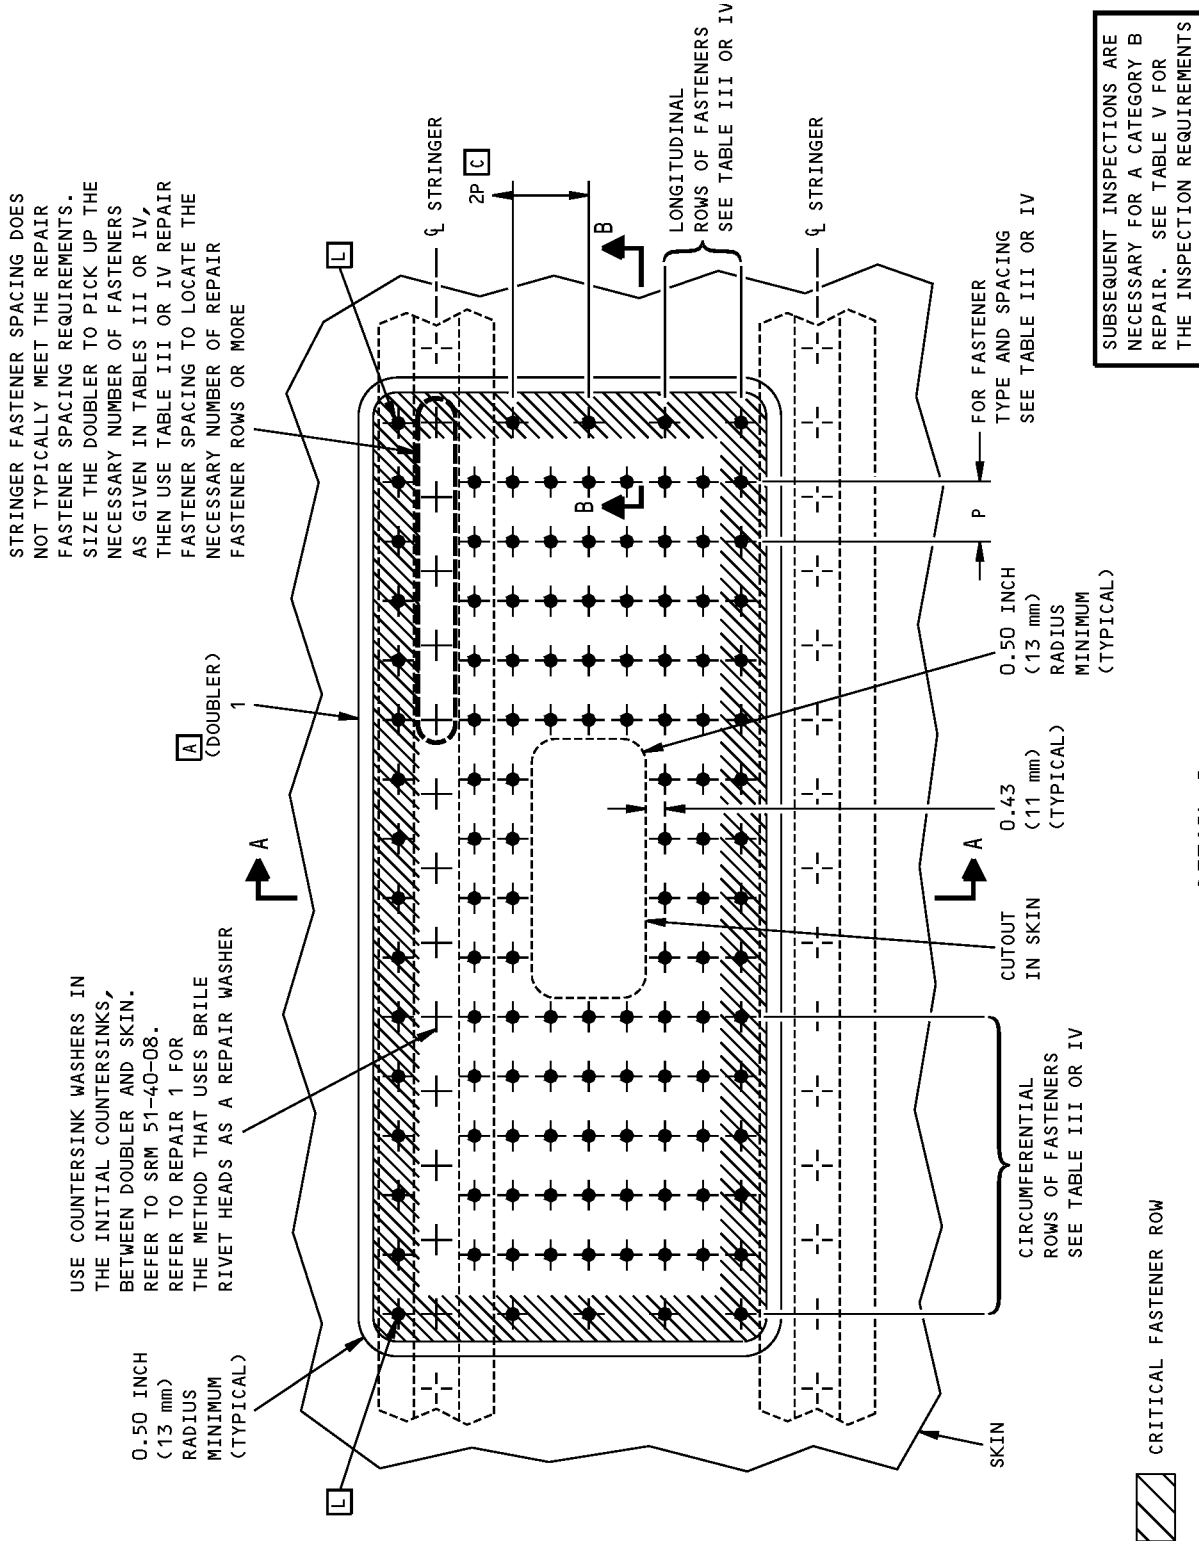
**Fuselage Skin - External Repair for Damage Between Stringers with Solid Fasteners
Figure 201 (Sheet 4 of 6)**

DETAIL I

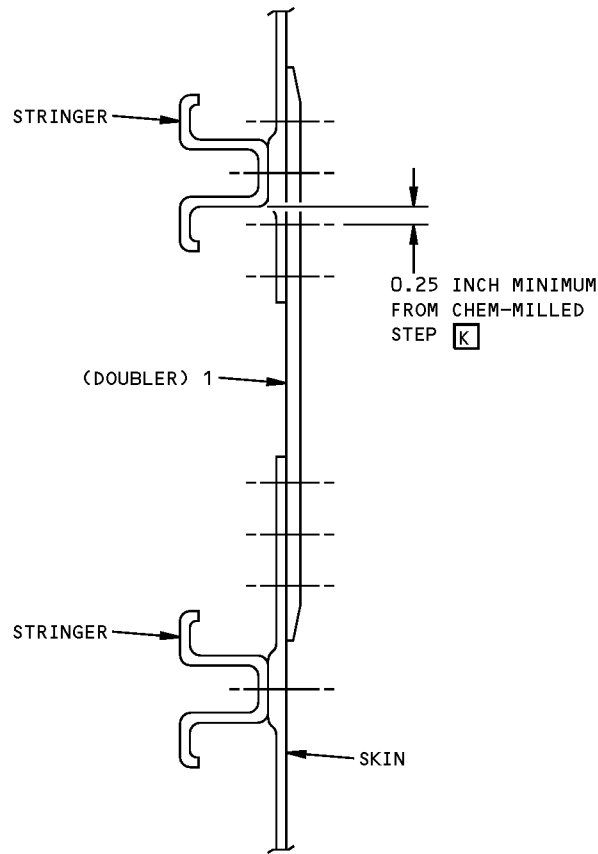
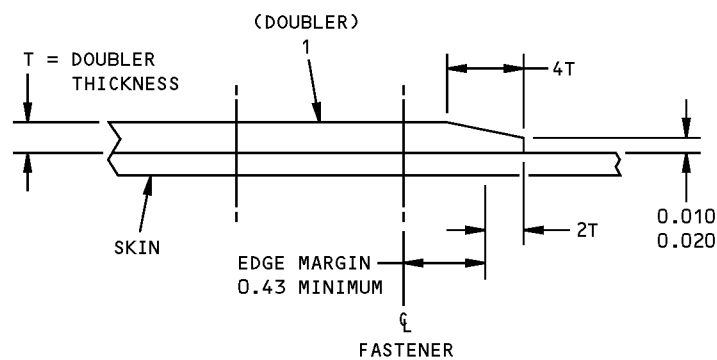
Fuselage Skin - External Repair for Damage Between Stringers with Solid Fasteners
Figure 201 (Sheet 5 of 6)

SECTION A-A

SECTION B-B

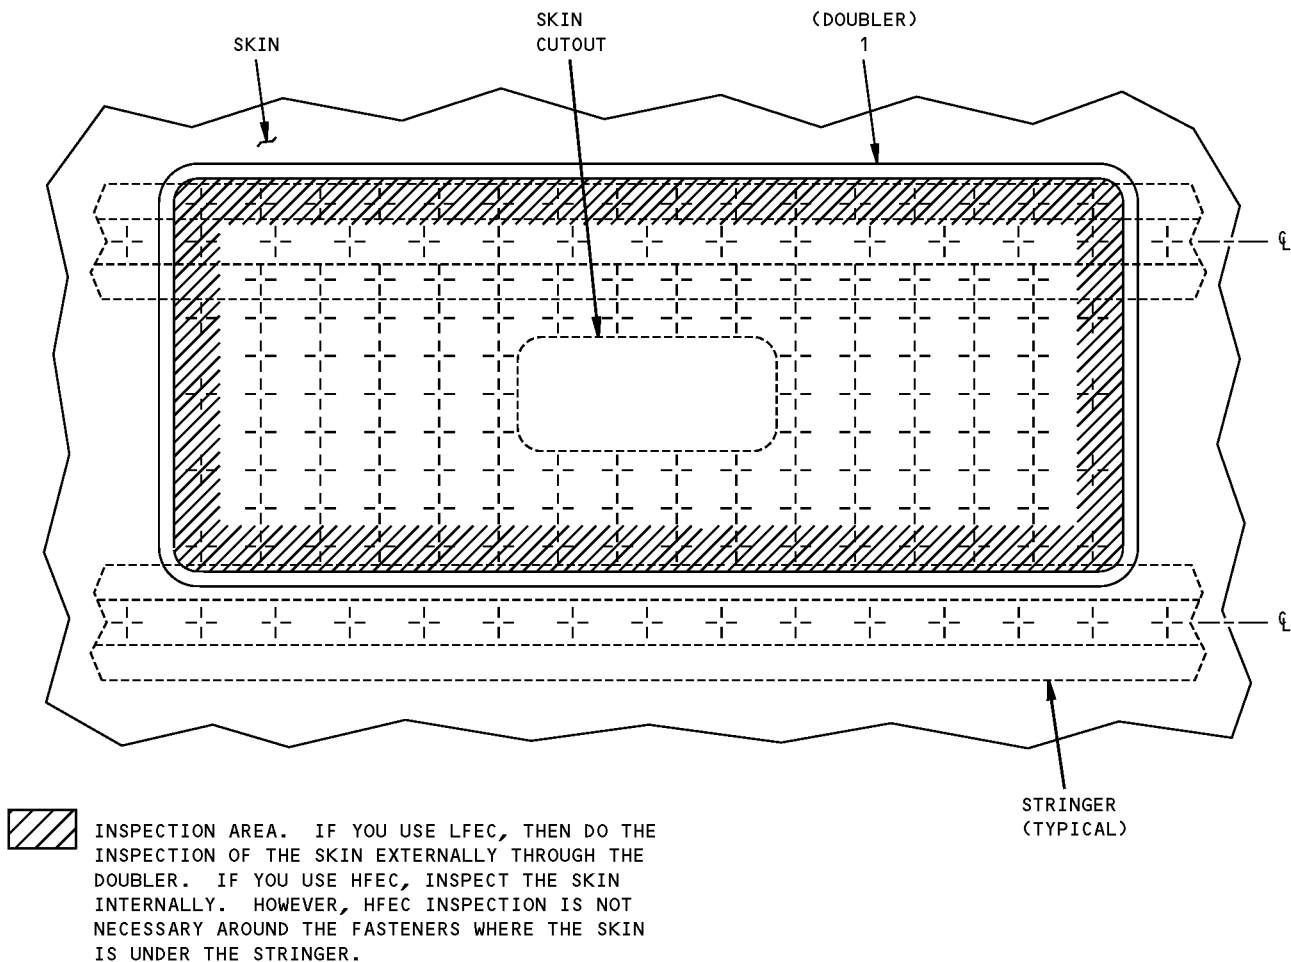
Fuselage Skin - External Repair for Damage Between Stringers with Solid Fasteners
Figure 201 (Sheet 6 of 6)

| CATEGORY B REPAIR INSPECTION REQUIREMENTS | | | | |
|---|---|--|---|---|
| NOTE: INSPECT THE SKIN AROUND THE FIRST ROW OF FASTENERS ALONG THE EDGE OF THE DOUBLER AS SHOWN IN DETAIL II. USE ONE OF THE TWO INSPECTION METHODS. | | | | |

DETAIL II

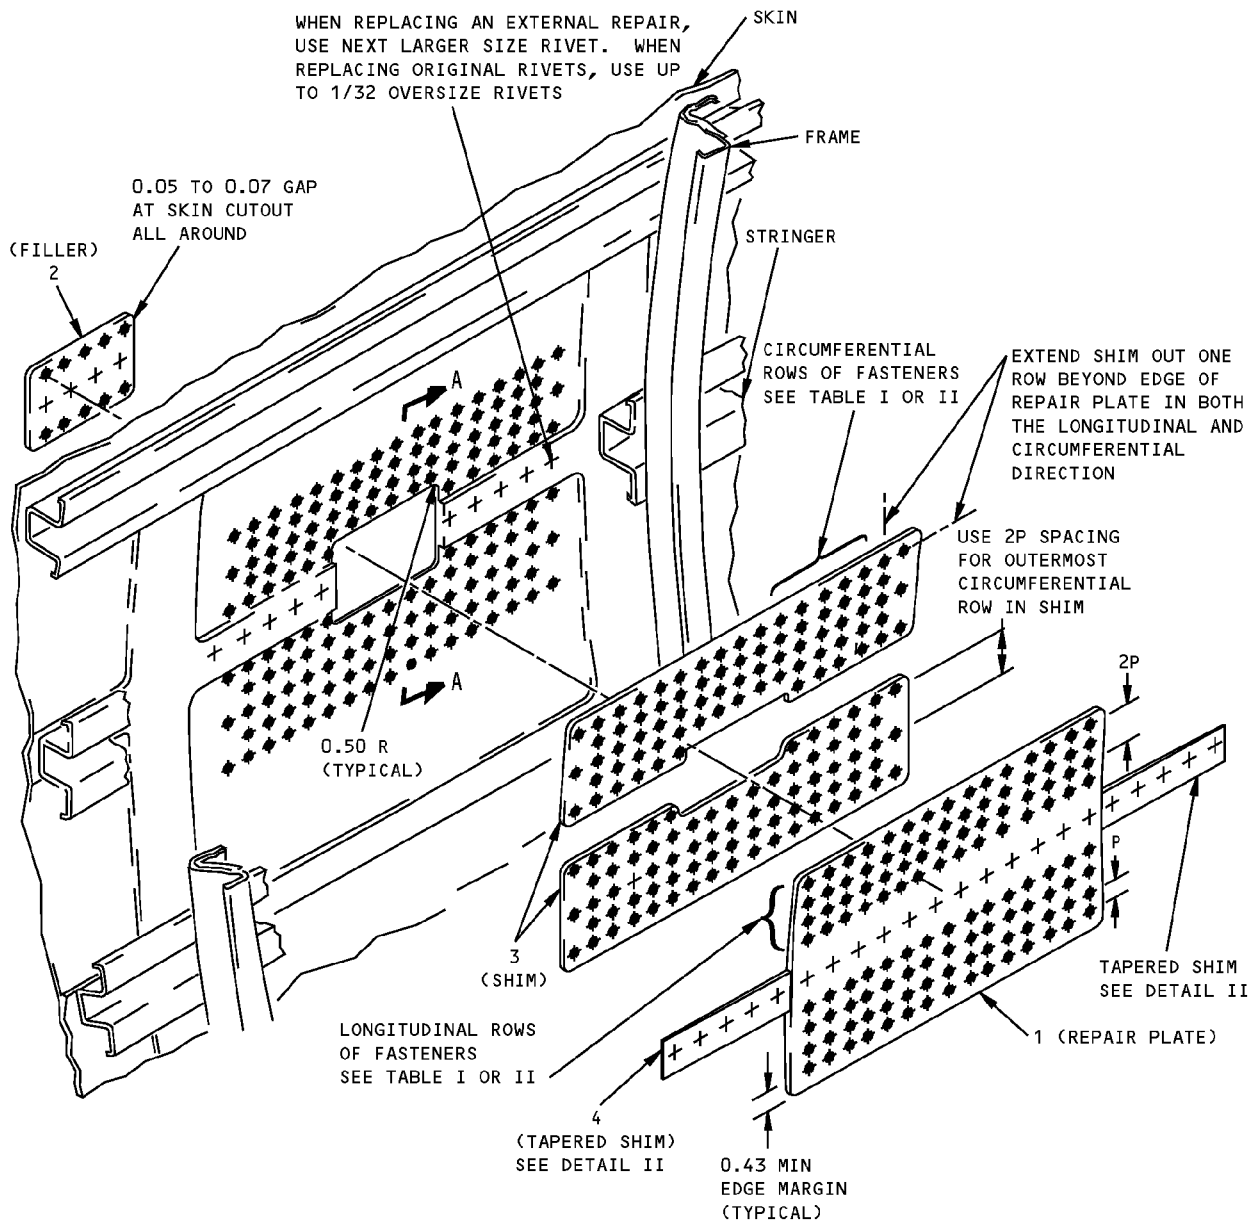
Fuselage Skin - Flush Repair at a Stringer
Figure 201 (Sheet 3 of 4)

DETAIL I

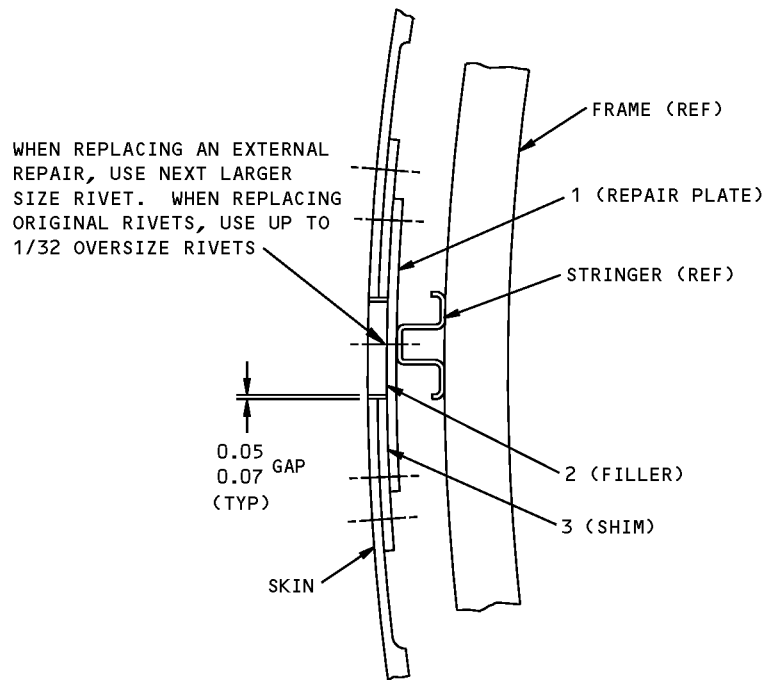
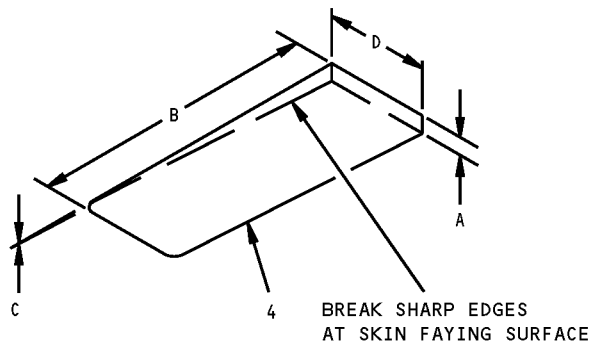
SECTION A-A

DETAIL II

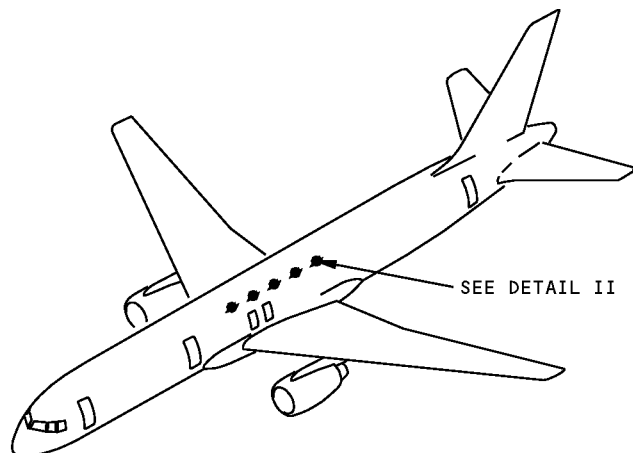
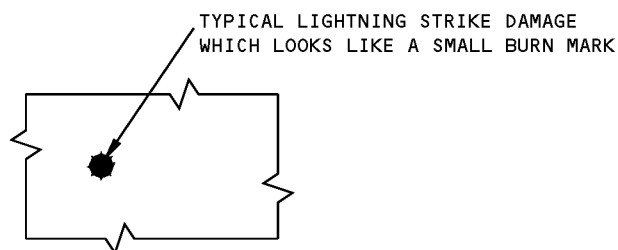
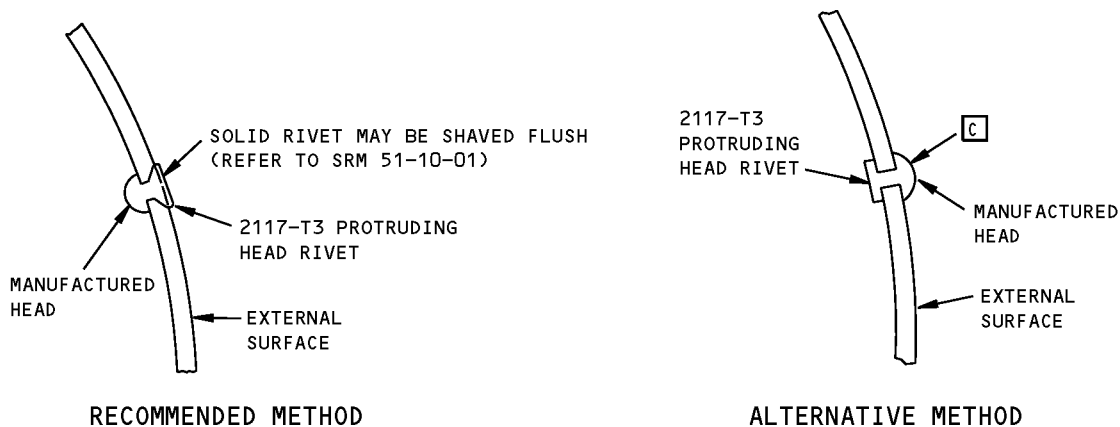
Repair of Lightning Strike Damage on Pressurized Fuselage Skin
Figure 201 (Sheet 7 of 8)

DETAIL II

DETAIL III

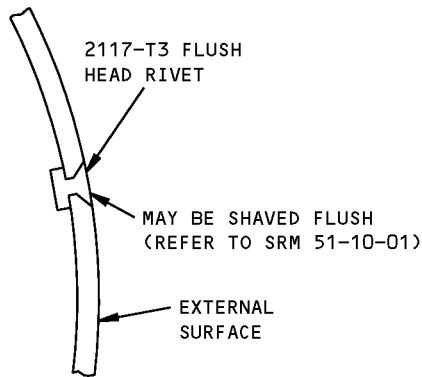
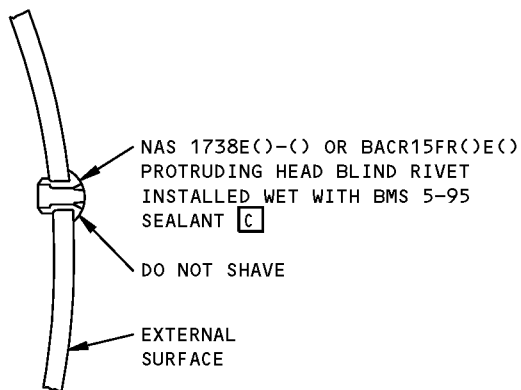
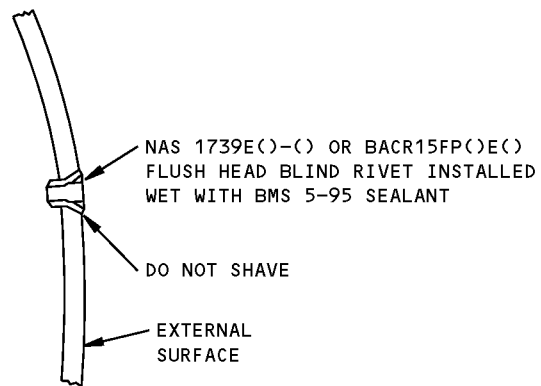
DETAIL IV

FOR USE IN AREAS WITHOUT EASY ACCESS
FOR INTERNAL INSTALLATION

DETAIL V D

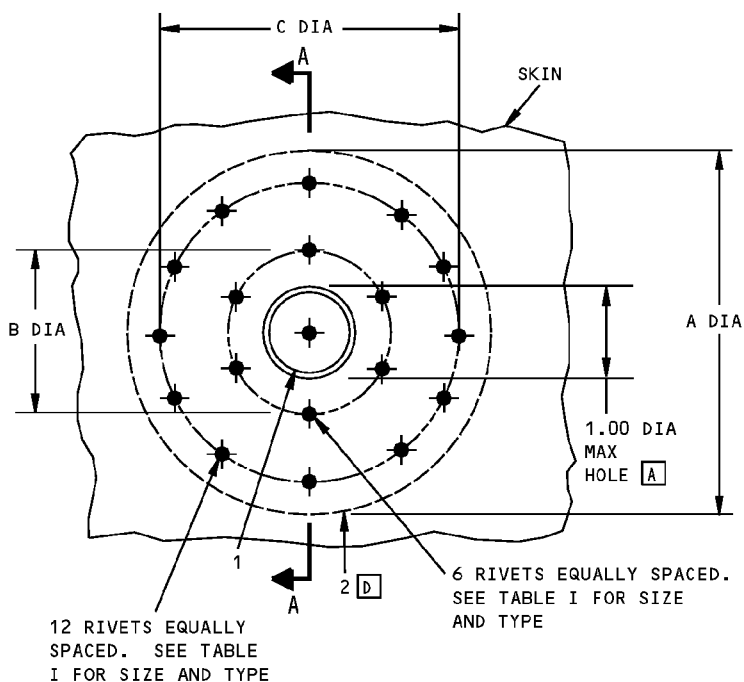
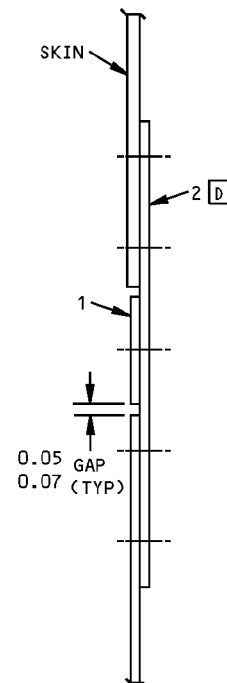
Fuselage Skin - Small Hole Flush Repair
Figure 201 (Sheet 2 of 2)

SECTION A-A

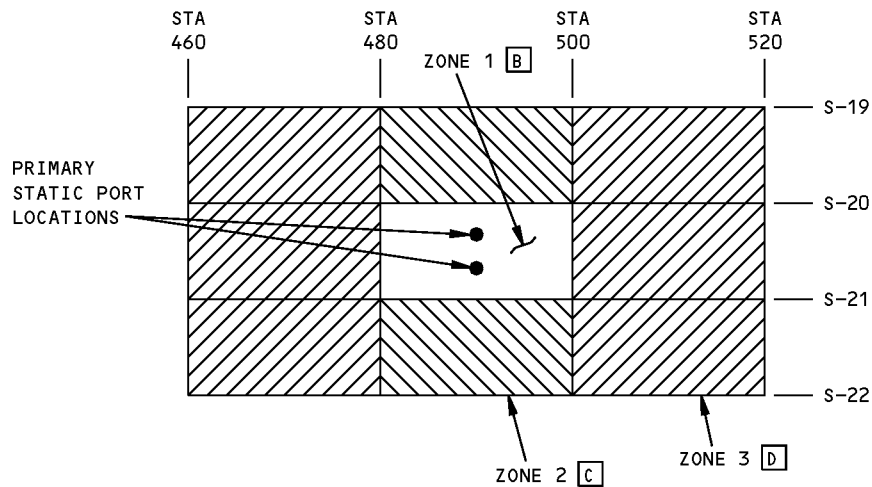
Fuselage Skin Repair Near the Primary Static Ports
Figure 201 (Sheet 3 of 6)

REPAIR ZONES [F] [G]
DETAIL I

| | REPAIR ZONE 1 [B] [E] |
| | REPAIR ZONE 2 [C] |
| | REPAIR ZONE 3 [D] |

- REPAIRS DIFFER DEPENDING ON LOCATION OF DAMAGE. SEE DETAIL I FOR DEFINITIONS OF REPAIR ZONES.
- FOR SKIN REPAIRS NEAR AIR DATA SENSORS (OTHER THAN THE PRIMARY STATIC PORTS), REFER TO SRM 51-10-01, REPAIR 6.
- WHEN YOU USE THIS REPAIR REFER TO:
 - AMM 11-21-21 FOR PLACARDS AND MARKINGS
 - AMM 34-11-03 FOR REMOVAL AND INSTALLATION OF STATIC PORTS
 - AMM 51-21 FOR INTERIOR AND EXTERIOR FINISHES
 - SOPM 20-20-02 FOR PENETRANT INSPECTION METHODS
 - SRM 51-10-01 FOR AERODYNAMIC SMOOTHNESS REQUIREMENTS
 - SRM 51-10-02 FOR INSPECTION AND REMOVAL OF DAMAGE
 - SRM 51-20-01 FOR PROTECTIVE TREATMENT OF METAL
 - SRM 51-20-05 FOR SEALING OF FUSELAGE SKIN REPAIRS
 - SRM 51-40 FOR FASTENER CODE, INSTALLATION AND REMOVAL, HOLE SIZES AND EDGE MARGINS
 - SRM 51-40-08 FOR COUNTERSINK WASHERS.

1. EXTERNAL REPAIRS ONLY
2. NO REPAIR EDGES WITHIN THIS ZONE (I.E. ANY REPAIR WHICH ENTERS THE ZONE MUST COVER AT LEAST THE ENTIRE ZONE)
3. REPAIRS COVERING THIS ZONE MUST HAVE $L \geq 2.2W$
4. NO TAPERED SHIMS MAY ENTER THIS ZONE.
5. IN ADDITION TO THE ABOVE LIMITS, THE FOLLOWING NOTE APPLIES:

1. ANY REPAIR WHICH ENTERS ZONE 2 MUST SPAN THE ENTIRE LENGTH OF THE ZONE
2. REPAIRS ENTERING THE ZONE MUST HAVE $L > W$
3. EXTERNAL REPAIRS ARE PERMITTED
4. FLUSH REPAIRS ARE PERMITTED IF THE TAPERED SHIMS END AT LEAST 2 INCHES AWAY FROM THE BORDER WITH ZONE 1. TAPERED SHIMS MUST HAVE AT LEAST A 50:1 TAPER RATIO
5. USE FLUSH FASTENERS ONLY.

1. EXTERNAL REPAIRS ARE PERMITTED
2. FLUSH REPAIRS ARE PERMITTED IF THE TAPERED SHIMS END AT LEAST 2 INCHES AWAY FROM ZONE 1. TAPERED SHIMS MUST HAVE AT LEAST A 50:1 TAPER RATIO
3. USE FLUSH FASTENERS ONLY.

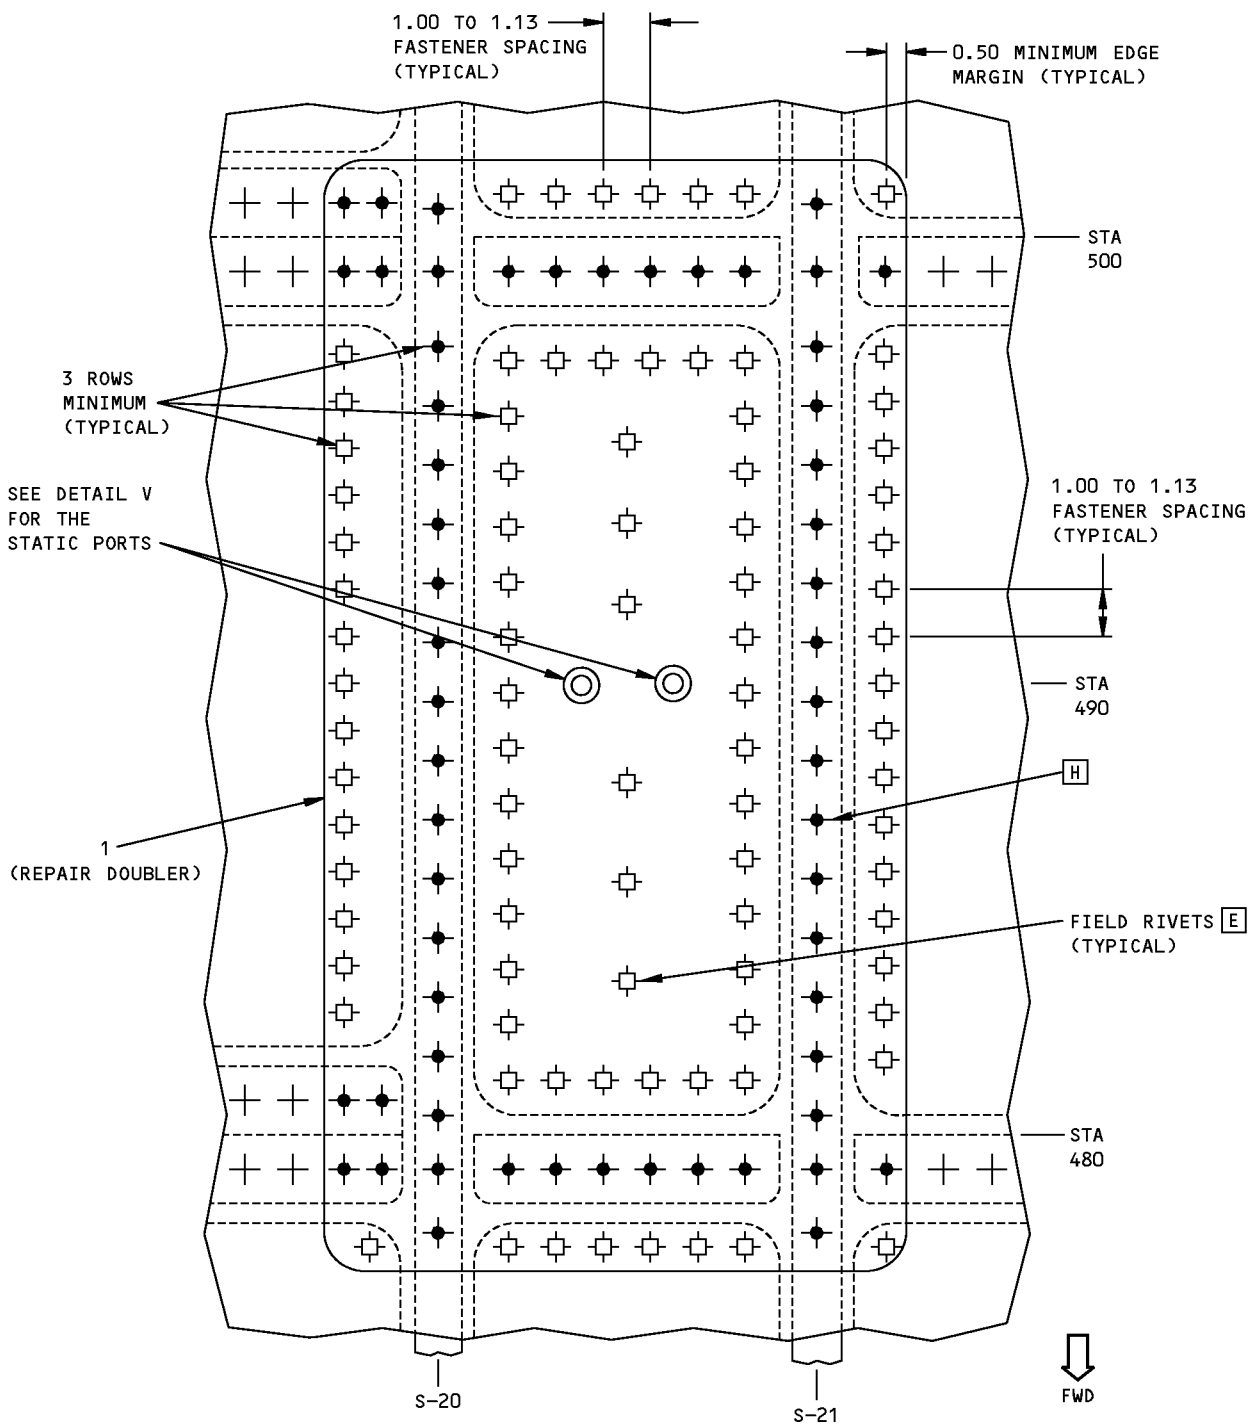
Fuselage Skin Repair Near the Primary Static Ports
Figure 201 (Sheet 4 of 6)

EXTERNAL SKIN REPAIR NEAR THE PRIMARY STATIC PORTS ZONE 1 REPAIR IS SHOWN
DETAIL II

1. Return all indented or projecting skin to contour.
2. Penetrant inspect surface for cracks. If cracks are found, stop drill to a diameter of 0.25 inch (6 mm), or remove damaged skin using a 0.50 inch (13 mm) minimum corner radius. A filler is necessary if damage is at a stringer location. See Repair 2 for filler and surface treatment. **[A]**

3. For Zone 1 repairs, do the steps that follow:
 - A. Remove and discard static ports.
 - B. Increase the diameter of the initial static port hole for a 232N9104-1 washer.

- C. Make the repair doubler and drill the fastener holes. See Detail VI for the countersink in the repair doubler at the static port.
4. Apply a chemical conversion coating to the repair parts and to the bare surfaces of the remaining skin. Refer to SRM 51-20-01.
