FUSELAGE

757-200 STRUCTURAL REPAIR MANUAL

CHAPTER 53 FUSELAGE

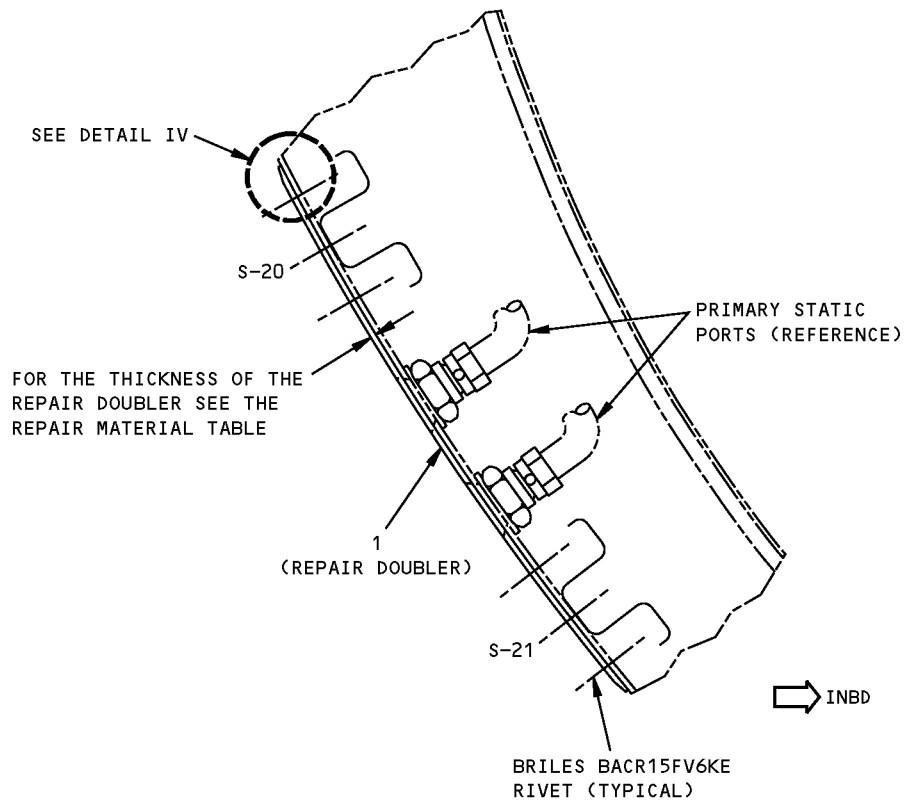
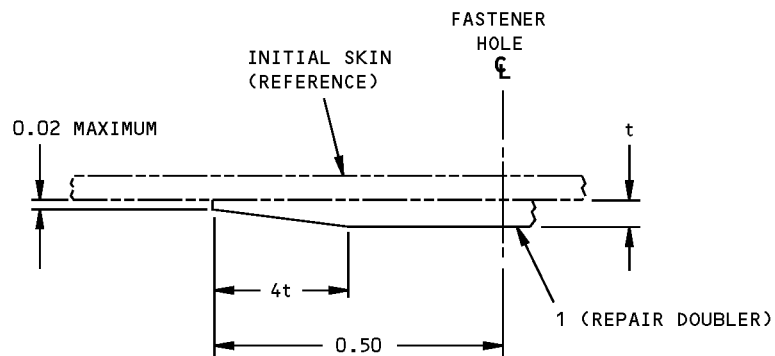
Fuselage Skin Repair Near the Primary Static Ports
Figure 201 (Sheet 5 of 6)

DETAIL III

TYPICAL ALL EDGES
DETAIL IV

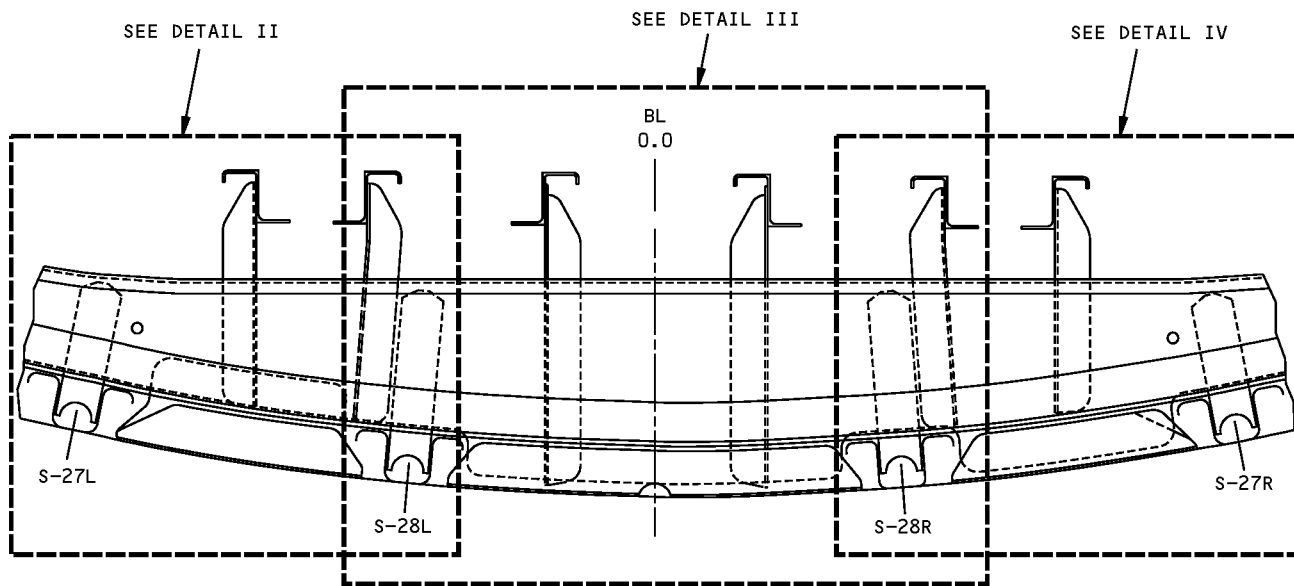
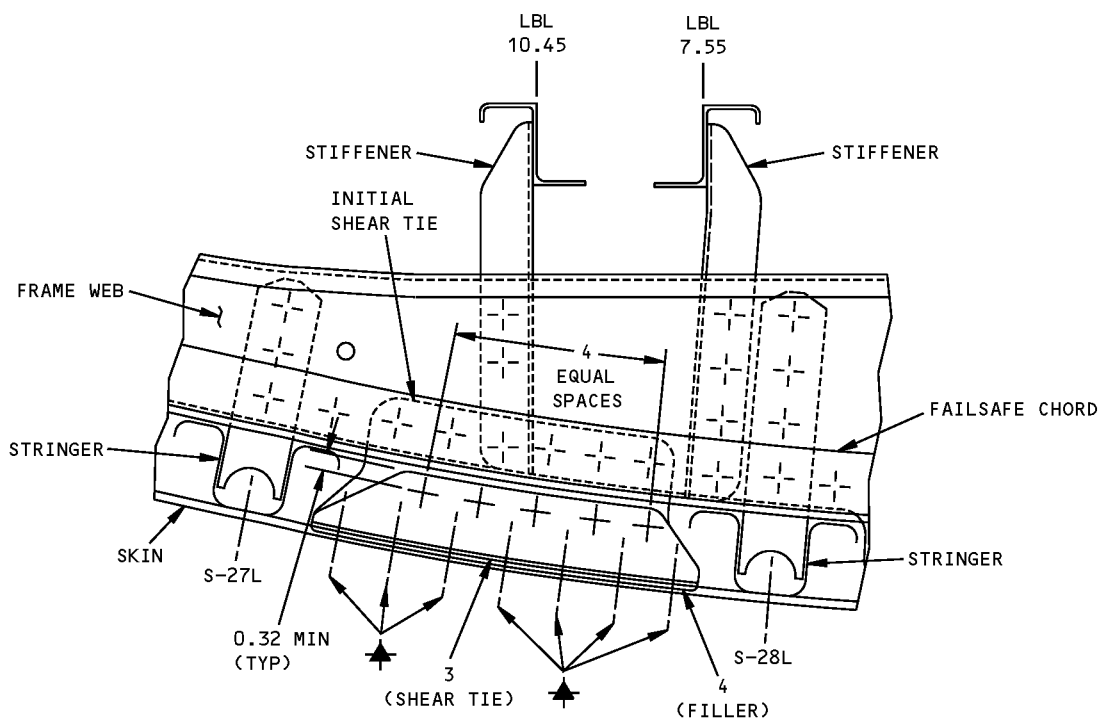
Fuselage Skin Crease Repair at BS 600 Between Stringers 27L and 27R
Figure 201 (Sheet 4 of 6)

SECTION A-A

DETAIL II

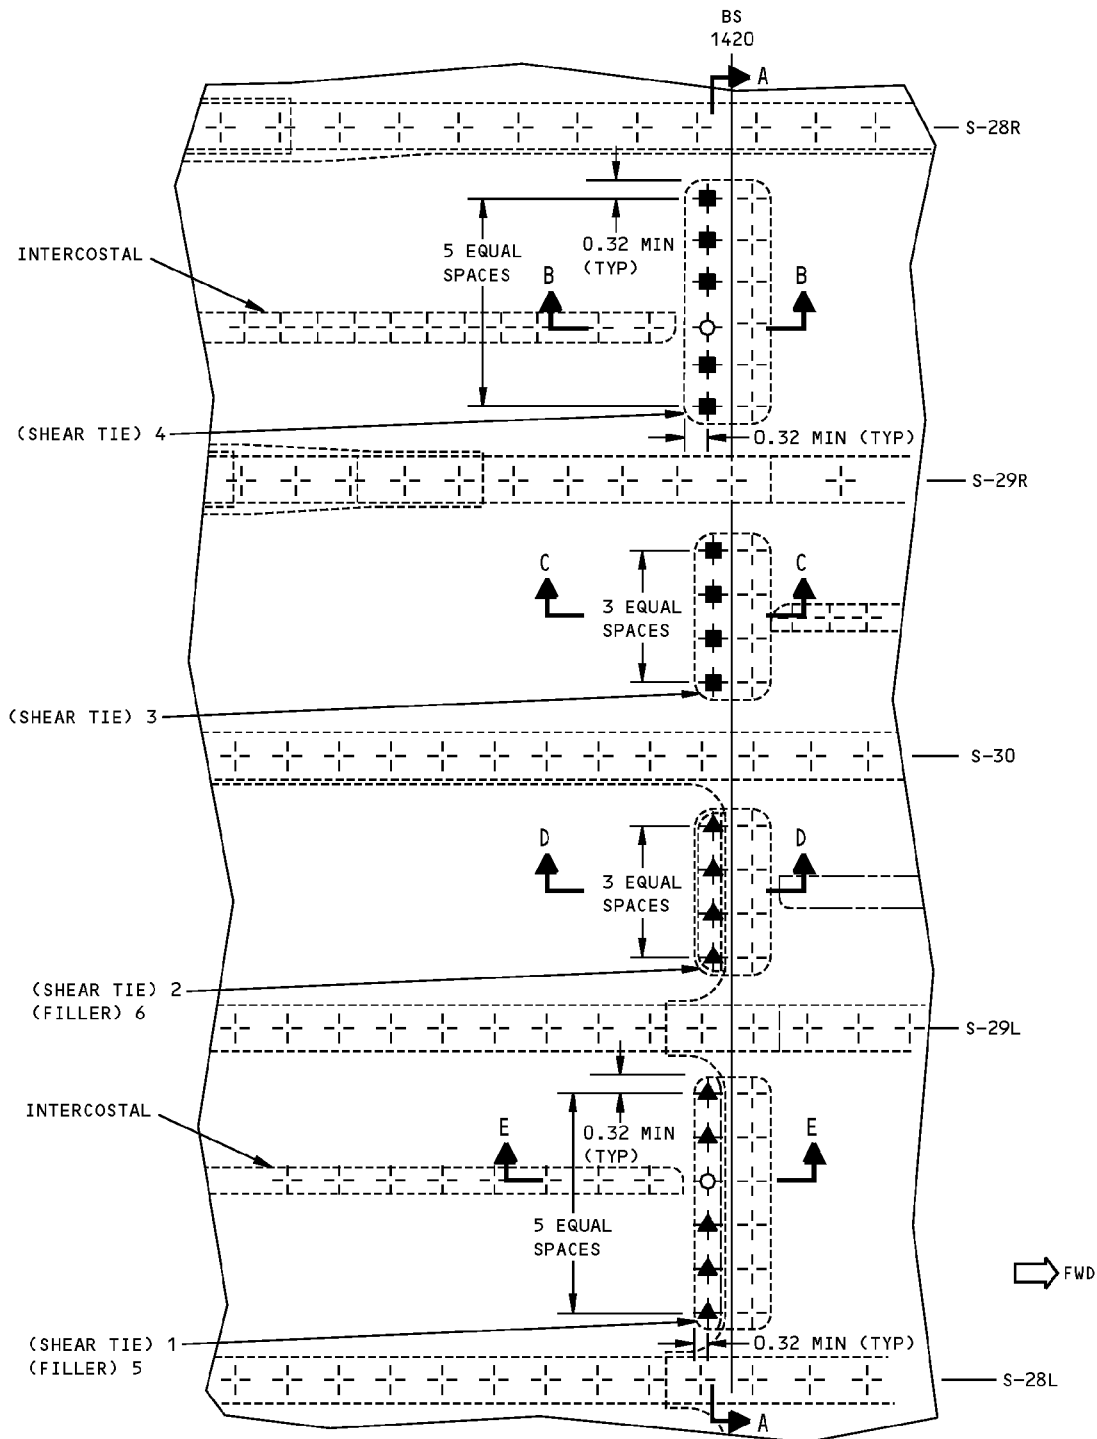
Fuselage Skin Crease Repair at BS 1420 Between Stringers 28L and 28R
Figure 201 (Sheet 3 of 6)

DETAIL I

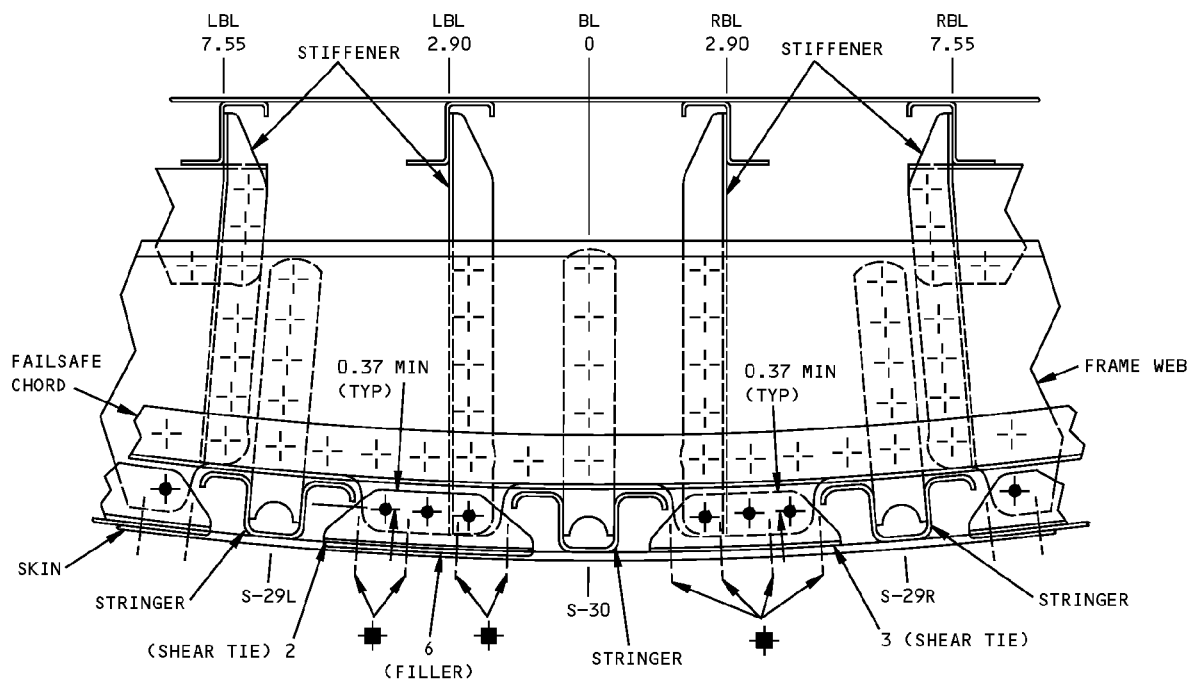
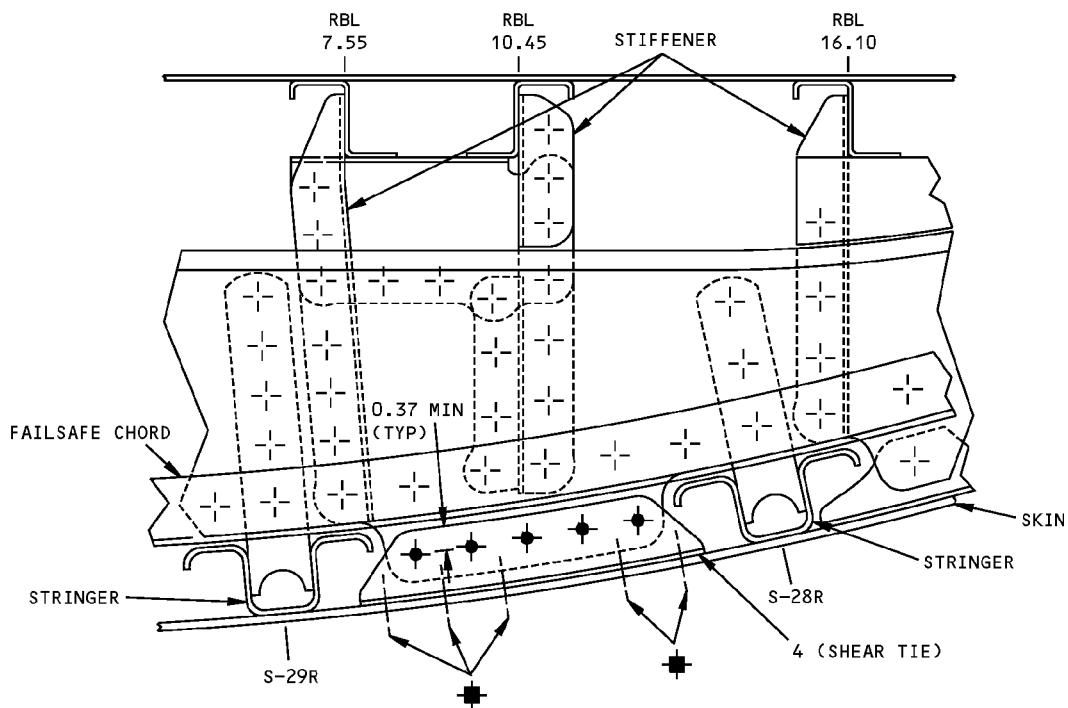
Fuselage Skin Crease Repair at BS 1420 Between Stringers 28L and 28R
Figure 201 (Sheet 5 of 6)

DETAIL III

DETAIL IV

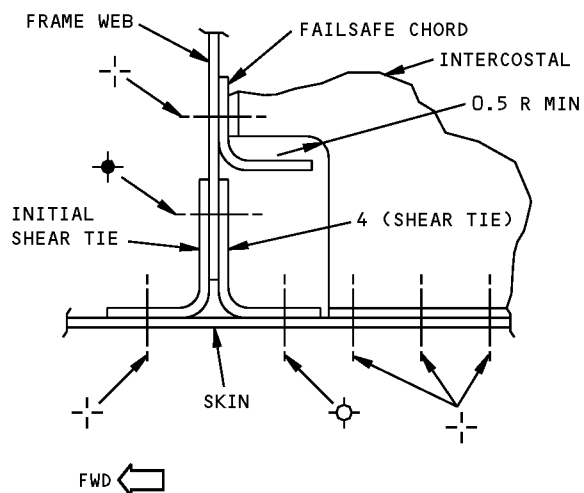
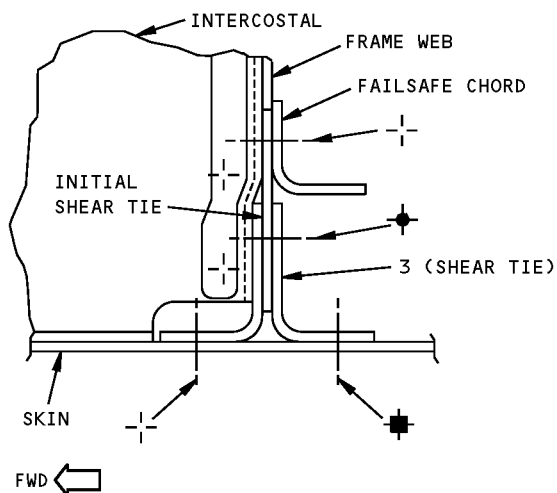
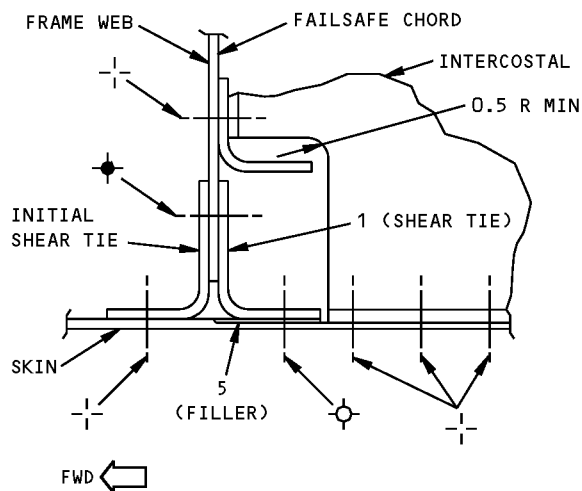
Fuselage Skin Crease Repair at BS 1420 Between Stringers 28L and 28R
Figure 201 (Sheet 6 of 6)

SECTION B-B

SECTION C-C

SECTION D-D

SECTION E-E

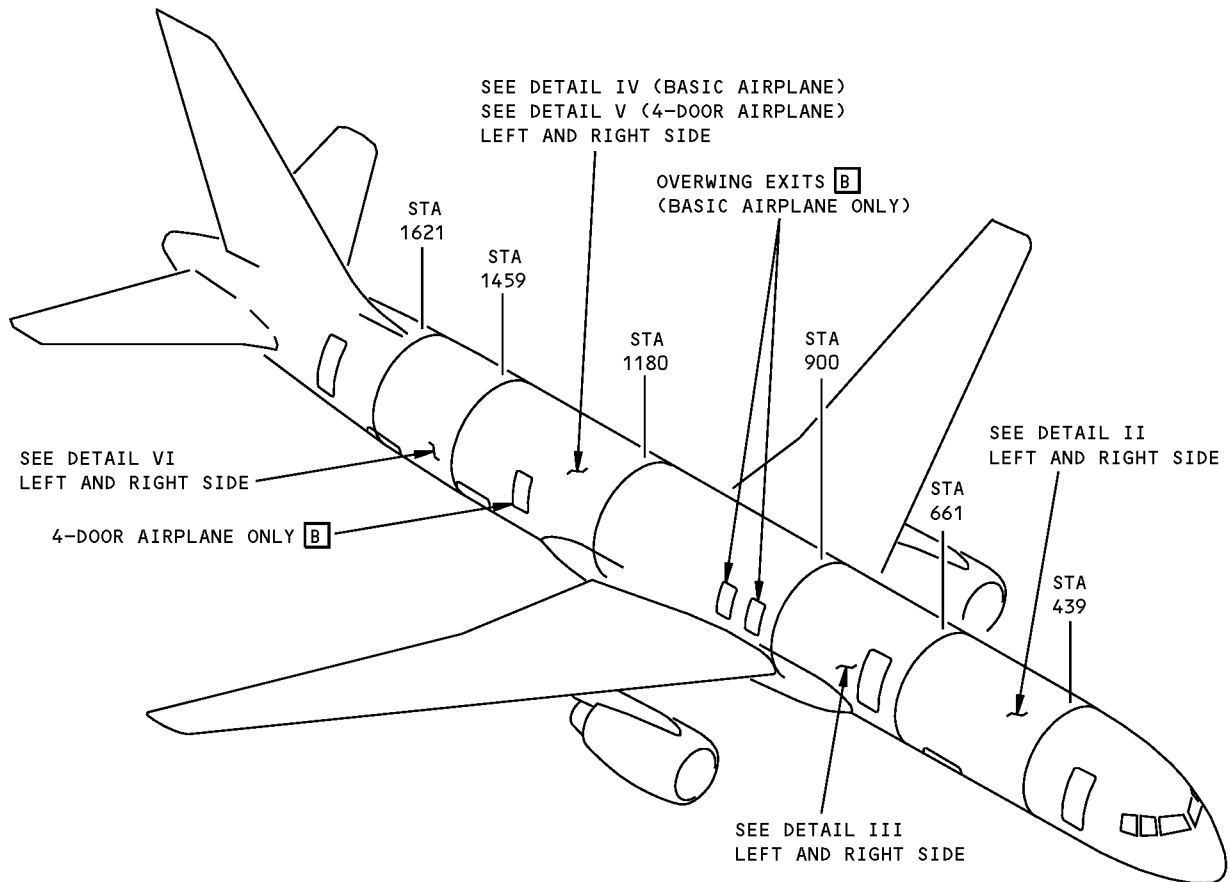
Repair of Skin Tear Strap Disbond Between Stringers 10L and 10R - Section 43 and 46
Figure 201 (Sheet 3 of 7)

DETAIL I

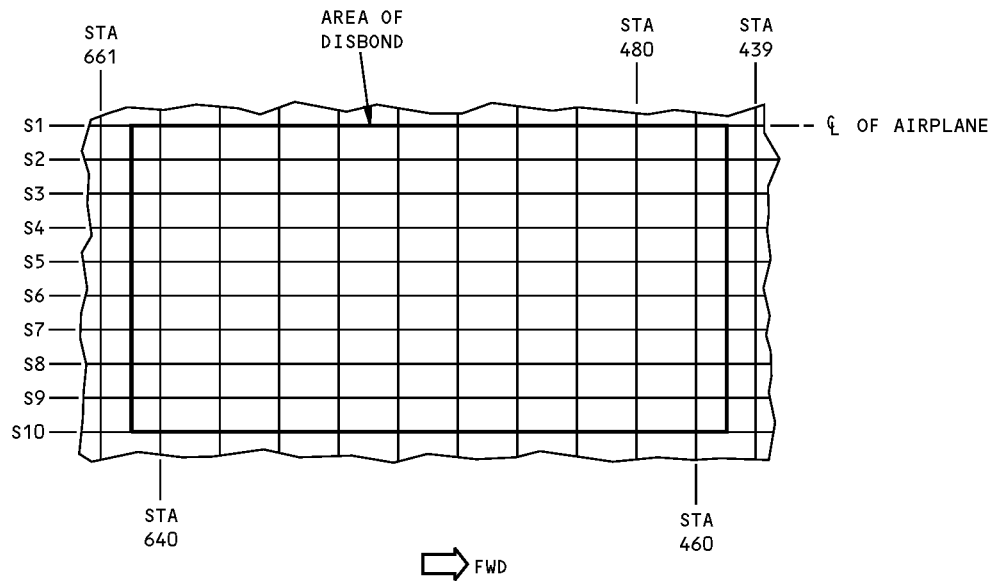
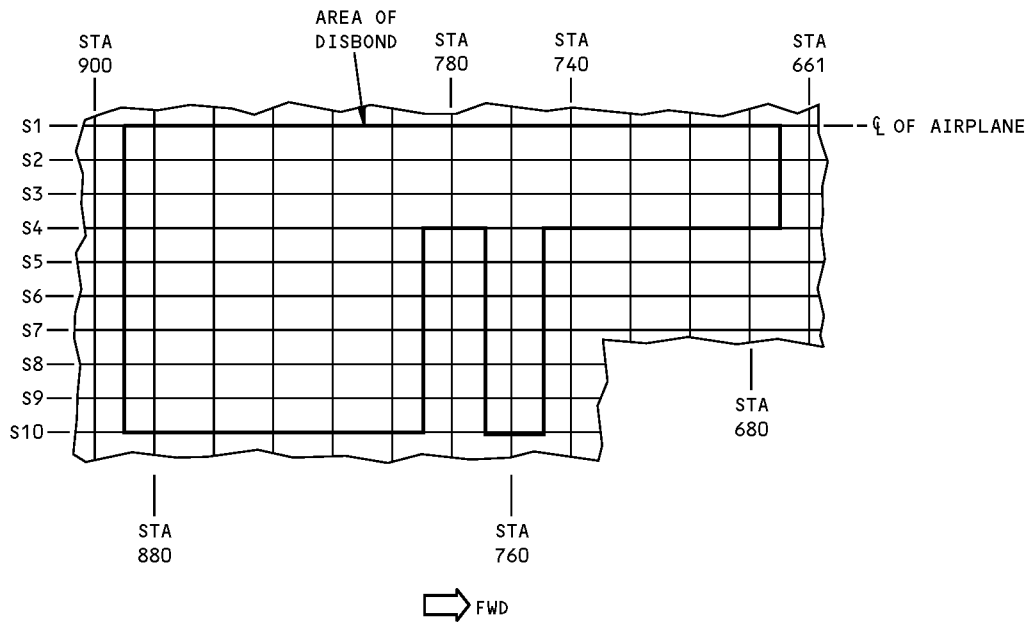
Repair of Skin Tear Strap Disbond Between Stringers 10L and 10R - Section 43 and 46
Figure 201 (Sheet 4 of 7)

DETAIL II A

DETAIL III A

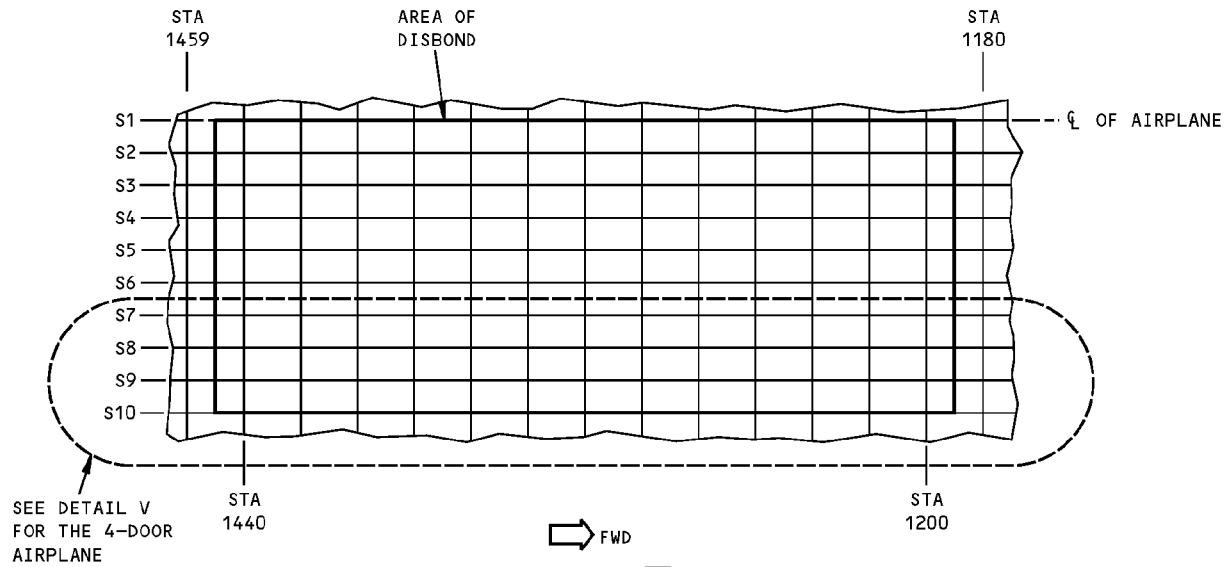
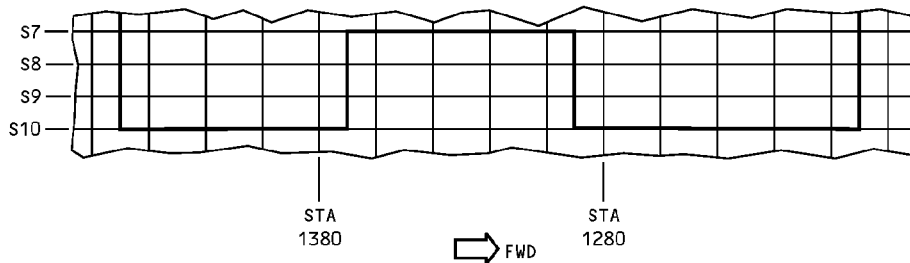
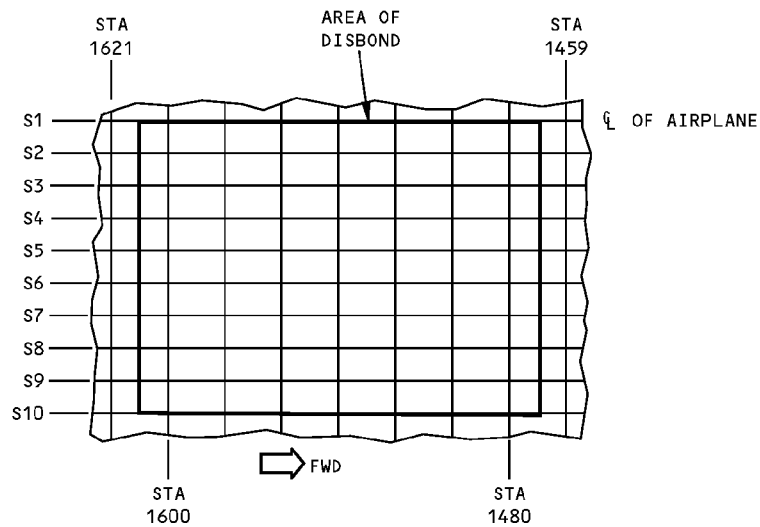
Repair of Skin Tear Strap Disbond Between Stringers 10L and 10R - Section 43 and 46
Figure 201 (Sheet 5 of 7)

DETAIL IV **A**

DETAIL V **A**

DETAIL VI **A**

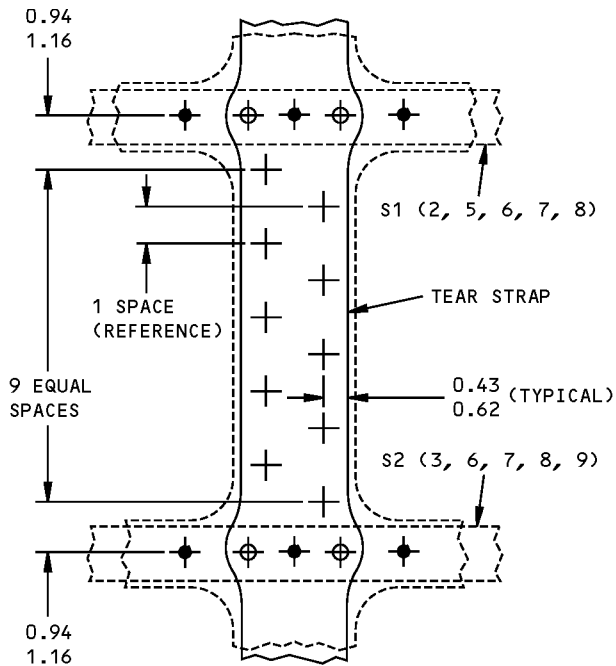
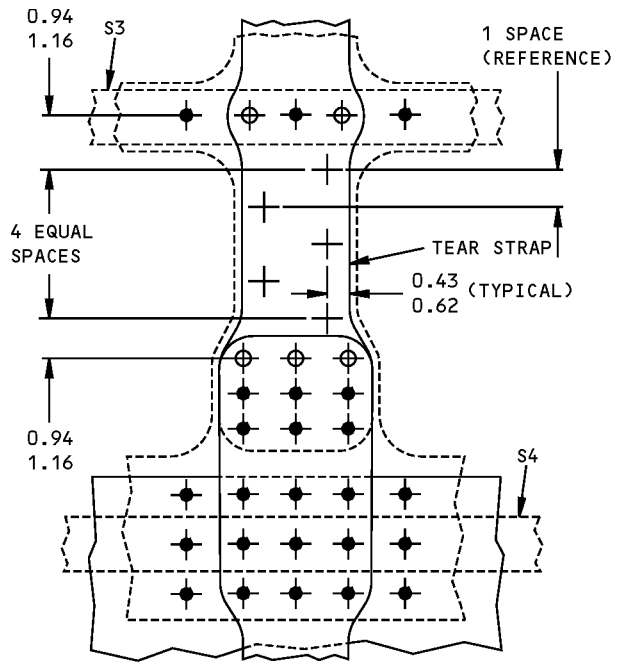
DETAIL VII

DETAIL VIII

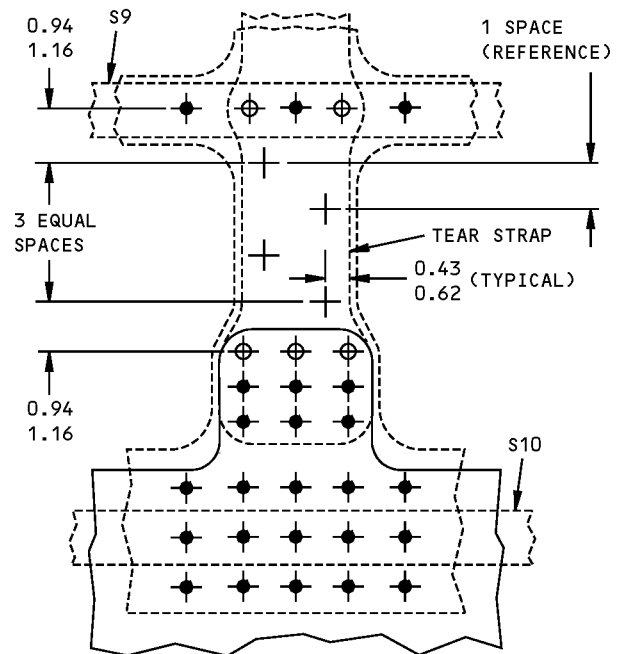
DETAIL X

Repair of Skin Tear Strap Disbond Between Stringers 10L and 10R - Section 43 and 46
Figure 201 (Sheet 6 of 7)

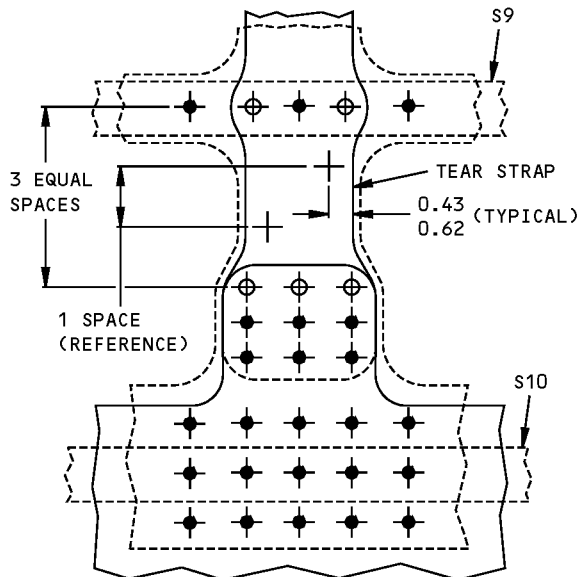
DETAIL XIII

STA 1380 SHOWN, STA 1400 SIMILAR

Repair of Skin Tear Strap Disbond Between Stringers 10L and 10R - Section 43 and 46
Figure 201 (Sheet 7 of 7)

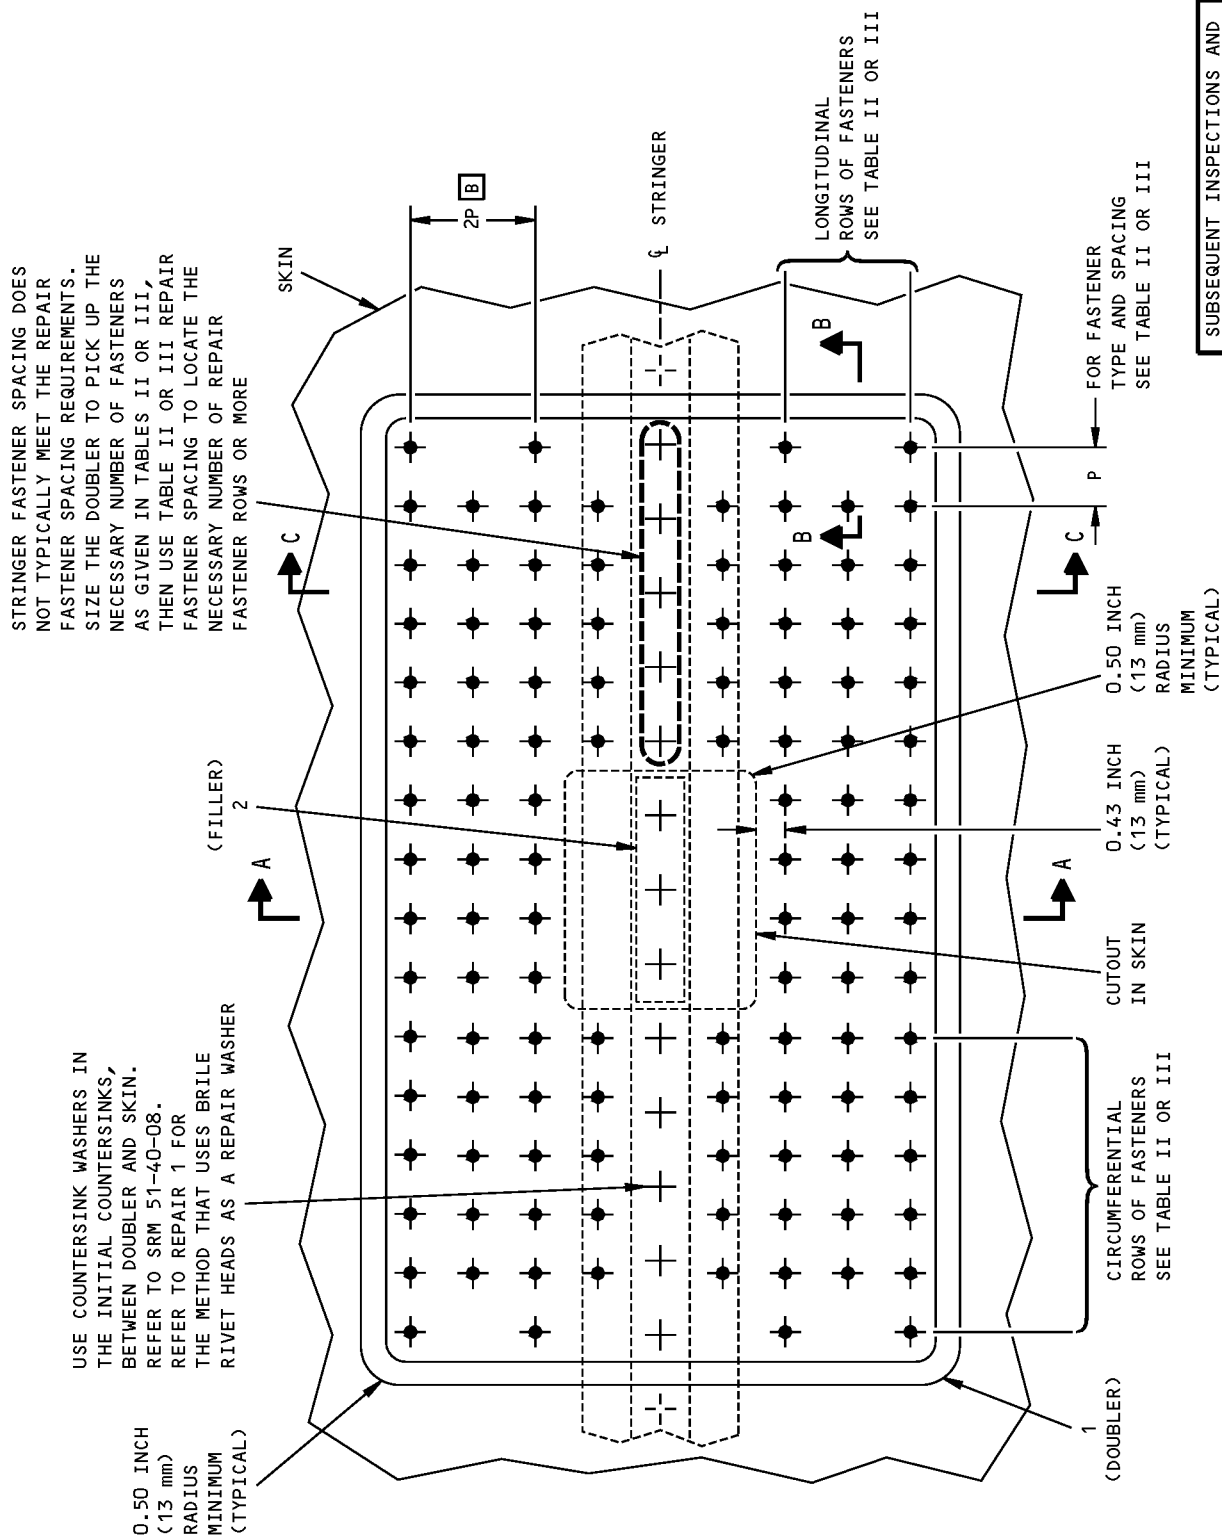
DETAIL I

**SUBSEQUENT INSPECTIONS AND
A TIME LIMIT ARE NECESSARY
FOR A CATEGORY C REPAIR.
SEE TABLE IV.**

Fuselage Skin - External Repair for Damage at a Stringer with Blind Fasteners
Figure 201 (Sheet 4 of 6)

1. Cut out damage to skin to a rectangular shape parallel to the stringer with a minimum corner radius of 0.50 inch.
2. Drill out existing fasteners in the skin to stringer attachment as required.
3. Return all indented or projecting skin to contour. Remove all burrs, nicks, scratches, sharp edges or corners from the damaged area. Make the surface finish of 63 microinches Ra or better.

5. Make the repair parts as given in Table I. Pre-form the repair doubler to the fuselage contour. Drill the appropriate fastener holes. Use a drill stop to restrict penetration through skin to 0.06 maximum.

8. Install the repair parts with BMS 5-95 sealant making faying surface seals between all parts in accordance with SRM 51-20-05. A bead of sealant should be apparent all around repair parts after installation. Where there is sufficient sealant squeezed out, it may be formed into a fillet, otherwise an additional fillet seal should be applied.

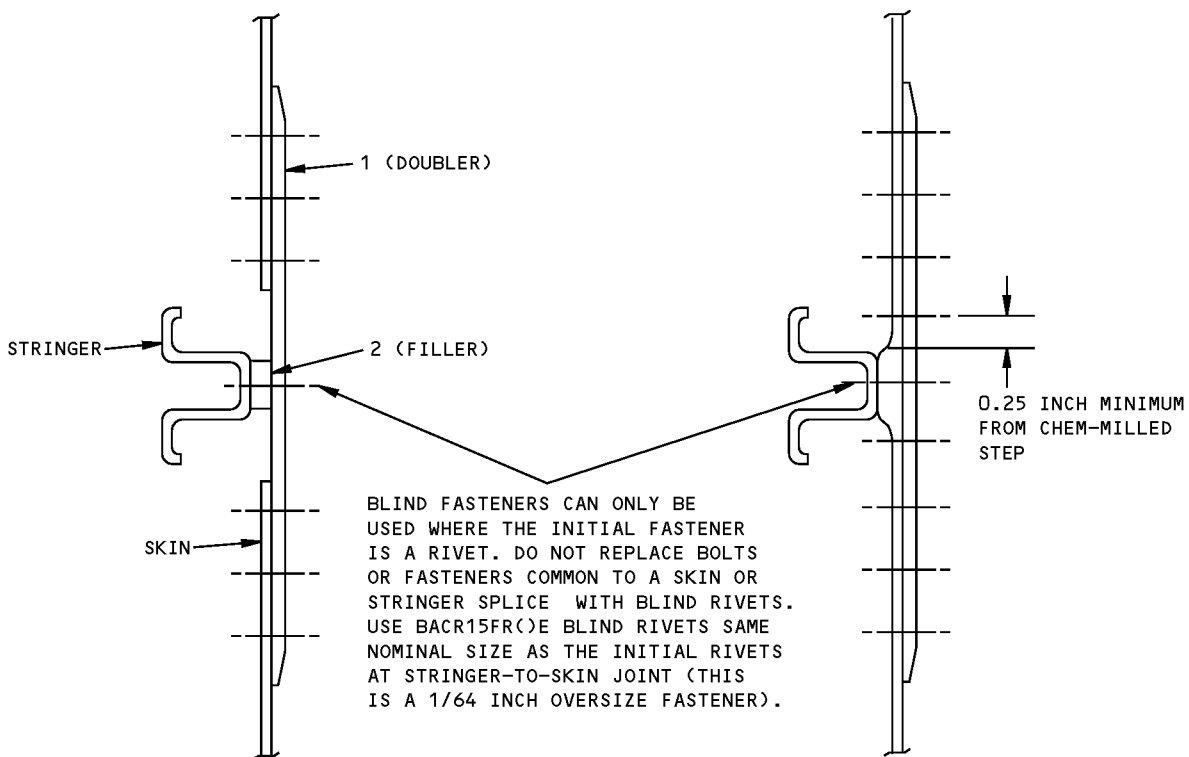
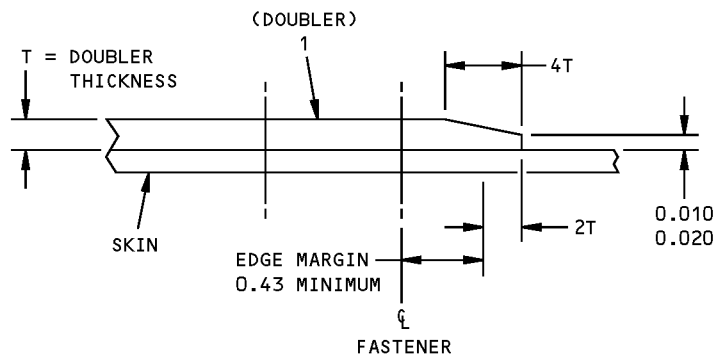
Fuselage Skin - External Repair for Damage at a Stringer with Blind Fasteners
Figure 201 (Sheet 5 of 6)

SECTION A-A

SECTION C-C

SECTION B-B

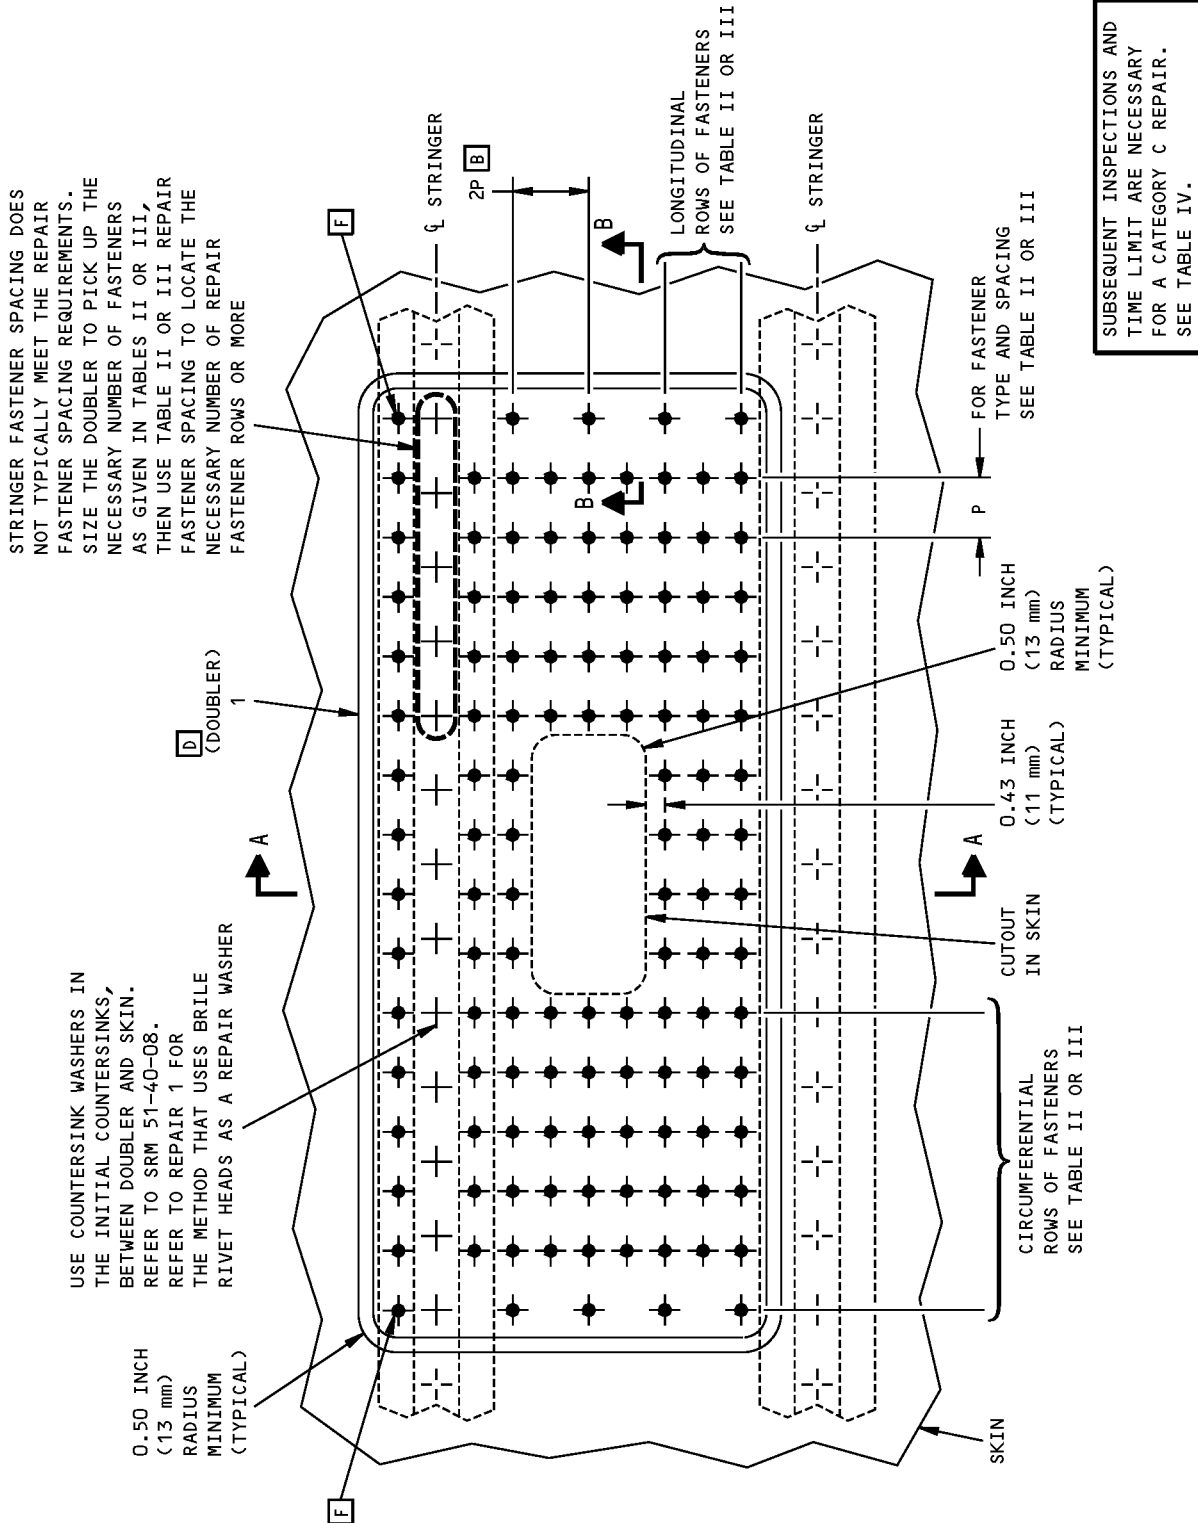
DETAIL I

**Fuselage Skin - External Repair for Damage Between Stringers with Blind Fasteners
Figure 201 (Sheet 4 of 6)**

1. Cut out damage to skin to a rectangular shape parallel to the stringer with a minimum corner radius of 0.50 inch.
2. Return all indented or projecting skin to contour. Remove all burrs, nicks, scratches, sharp edges or corners from the damaged area. Make the surface finish of 63 microinches Ra or better.
3. Do a High Frequency Eddy Current (HFEC) inspection along the edge of the cutout. Make sure there are no cracks. If there is no more damage, make the cutout larger by 0.04 inch. All cutout edges must have a finish of 63 microinches Ra or better. Refer to 757 NDT part 6, 51-00-01 for the HFEC procedure.

4. Make the repair parts as given in Table I. Pre-form the repair doubler to the fuselage contour. Drill the appropriate fastener holes. Use a drill stop to restrict penetration through skin to 0.06 maximum. **D**

7. Install the repair parts with BMS 5-95 sealant making faying surface seals between all parts in accordance with SRM 51-20-05. A bead of sealant should be apparent all around repair parts after installation. Where there is sufficient sealant squeezed out, it may be formed into a fillet, otherwise an additional fillet seal should be applied.

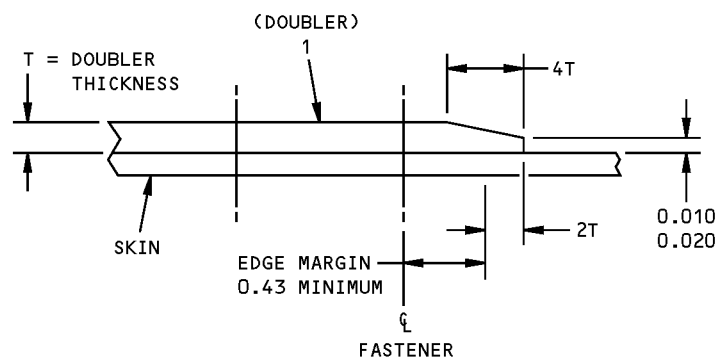
Fuselage Skin - External Repair for Damage Between Stringers with Blind Fasteners
Figure 201 (Sheet 5 of 6)

SECTION A-A

SECTION B-B

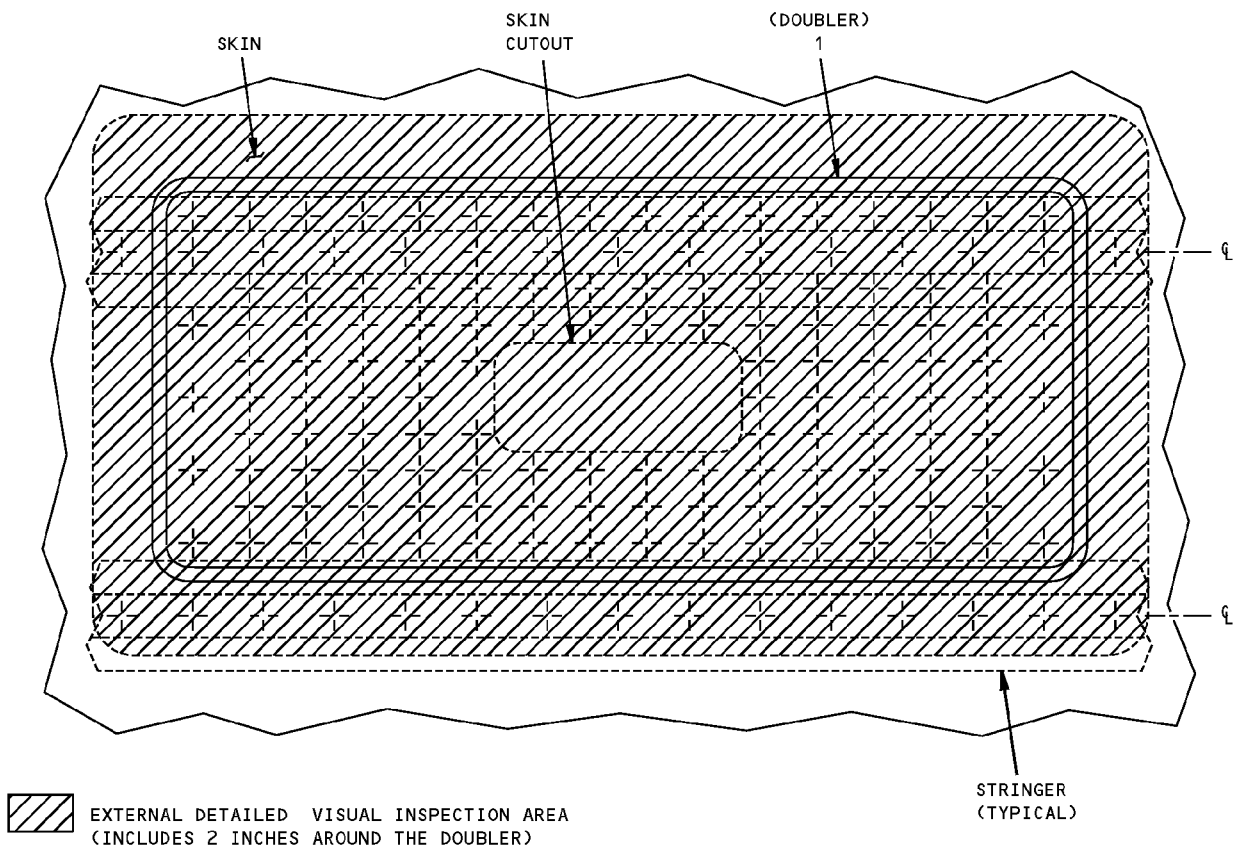
Fuselage Skin - External Repair for Damage Between Stringers with Blind Fasteners
Figure 201 (Sheet 6 of 6)

| CATEGORY C REPAIR INSPECTION AND REPLACEMENT REQUIREMENTS | | | |
|--|---|---|---|
| NOTE: INSPECT THE 2 INCH WIDE ZONE AROUND THE DOUBLER FOR SKIN DAMAGE AND INSPECT THE DOUBLER FOR MISSING OR LOOSE FASTENERS. IF FOUND, REPLACE THE FASTENER. REFER TO DETAIL II FOR THE AREA WHERE THE EXTERNAL DETAILED VISUAL INSPECTION IS NECESSARY. | | | |

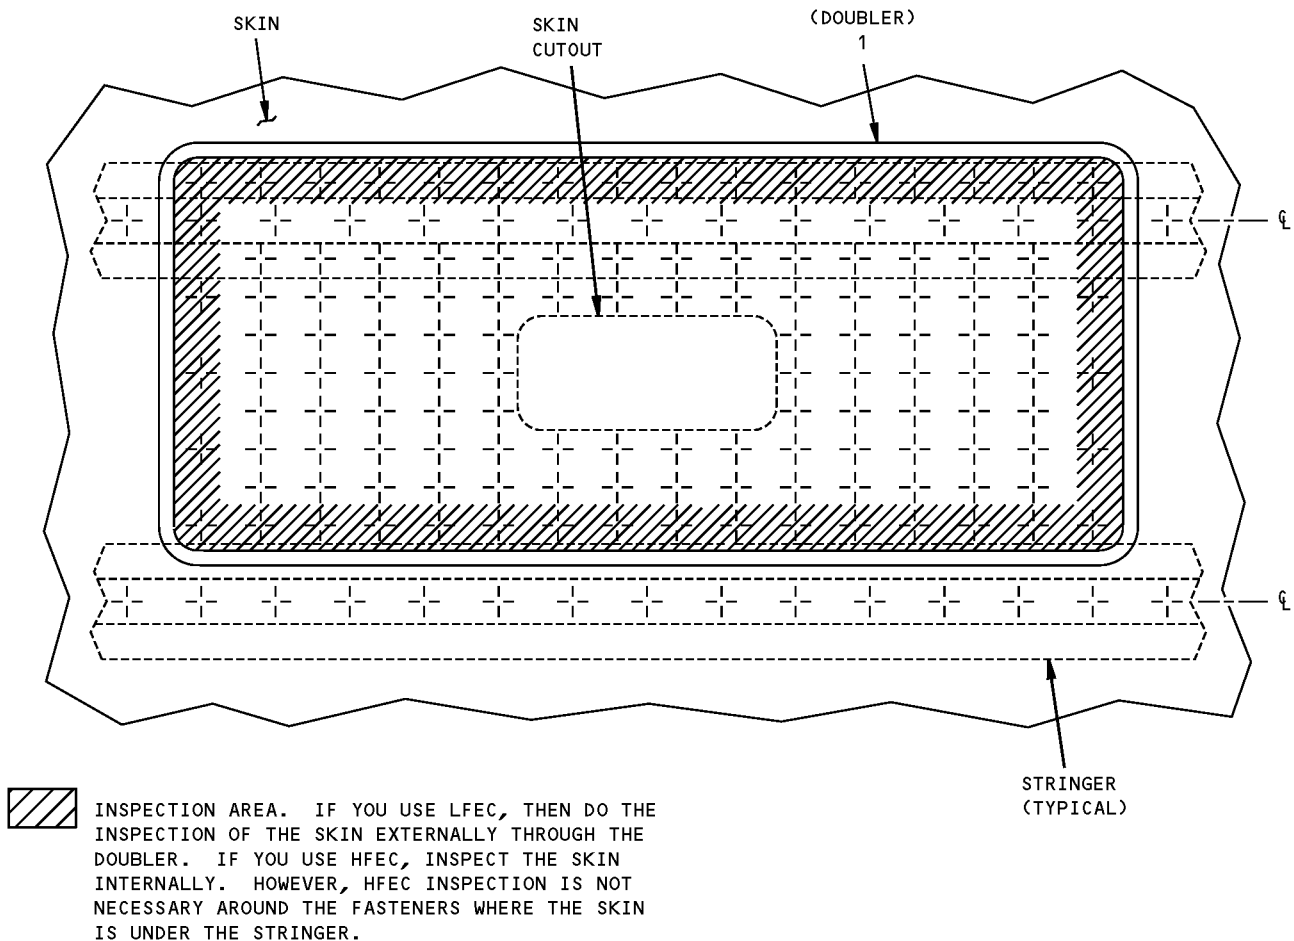
DETAIL II

**Fuselage Skin - External Repair for Damage Between Stringers with Solid Fasteners - 757-SF
Figure 201 (Sheet 6 of 6)**

| CATEGORY B REPAIR INSPECTION REQUIREMENTS | | | | | |
|---|---|---|---|---|---|
| NOTE: INSPECT THE SKIN AROUND THE FIRST ROW OF FASTENERS ALONG THE EDGE OF THE DOUBLER AS SHOWN IN DETAIL II. USE ONE OF THE TWO INSPECTION METHODS. | | | | | |

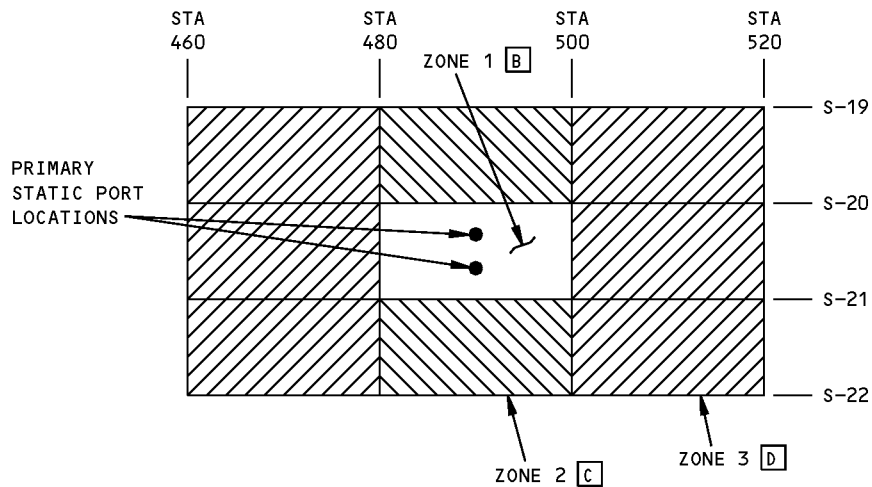
REPAIR ZONES [F] [G]
DETAIL I

| | REPAIR ZONE 1 [B] [E] |

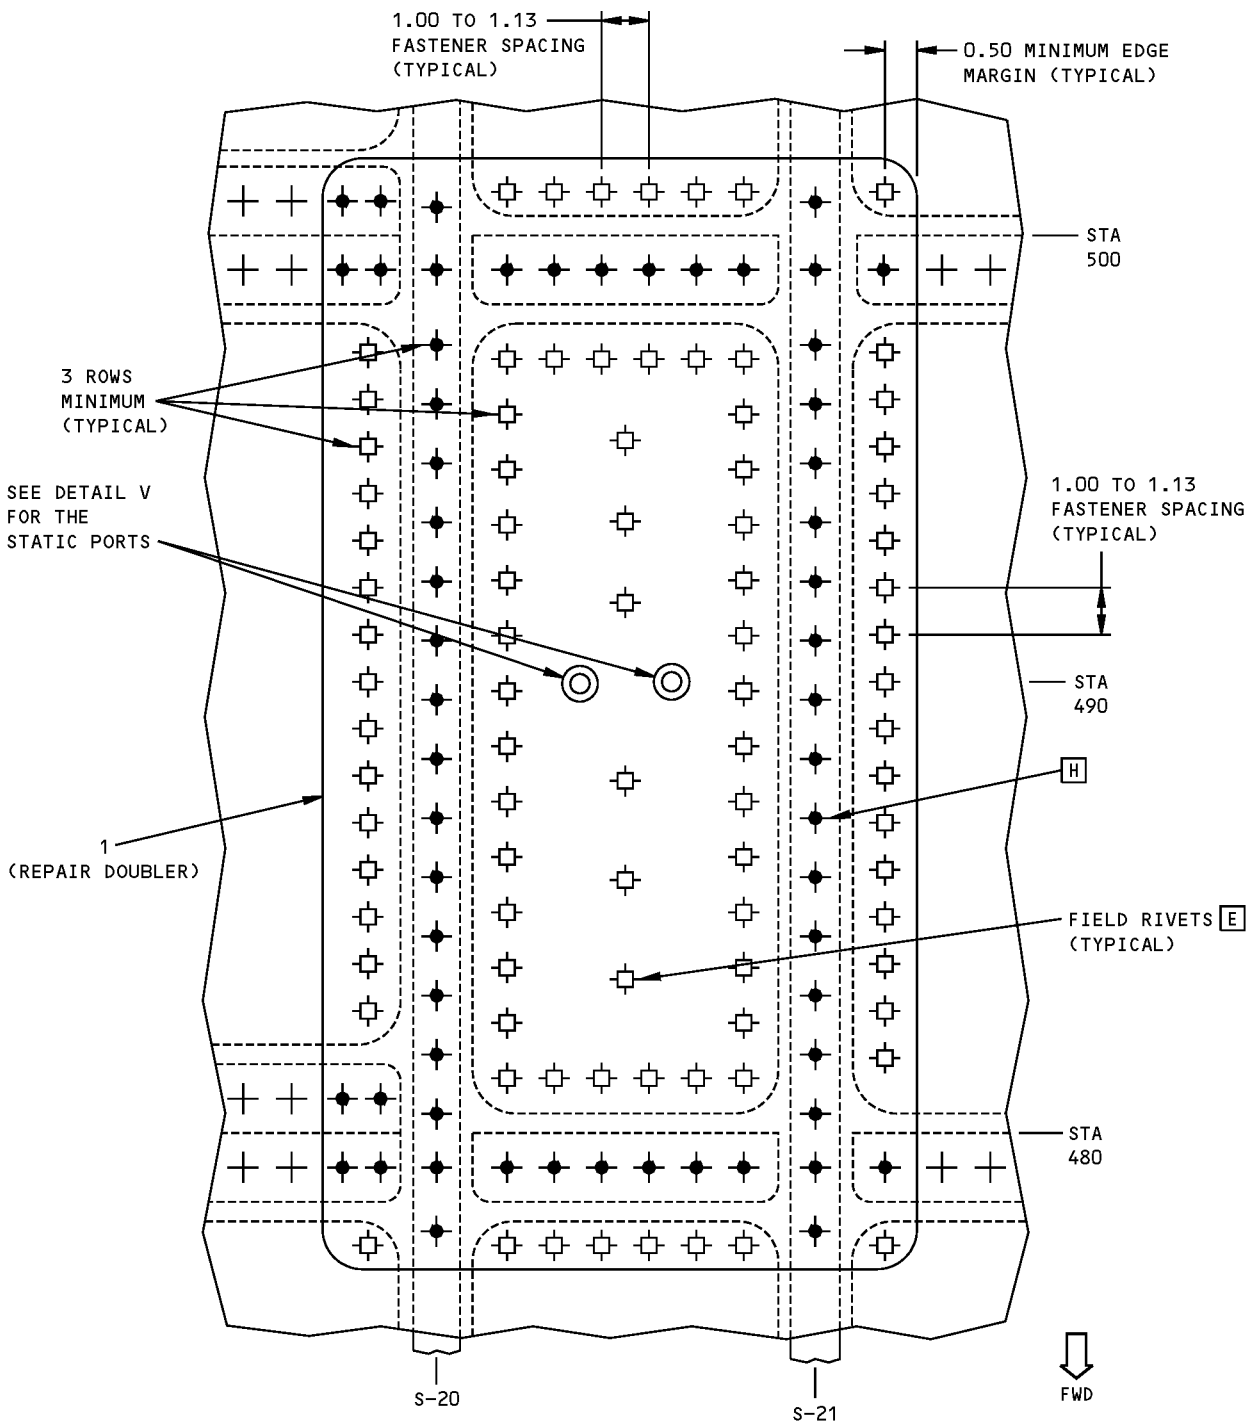
EXTERNAL SKIN REPAIR NEAR THE PRIMARY STATIC PORTS
ZONE 1 REPAIR IS SHOWN
DETAIL II
