FUSELAGE

757-200 STRUCTURAL REPAIR MANUAL

CHAPTER 53 FUSELAGE

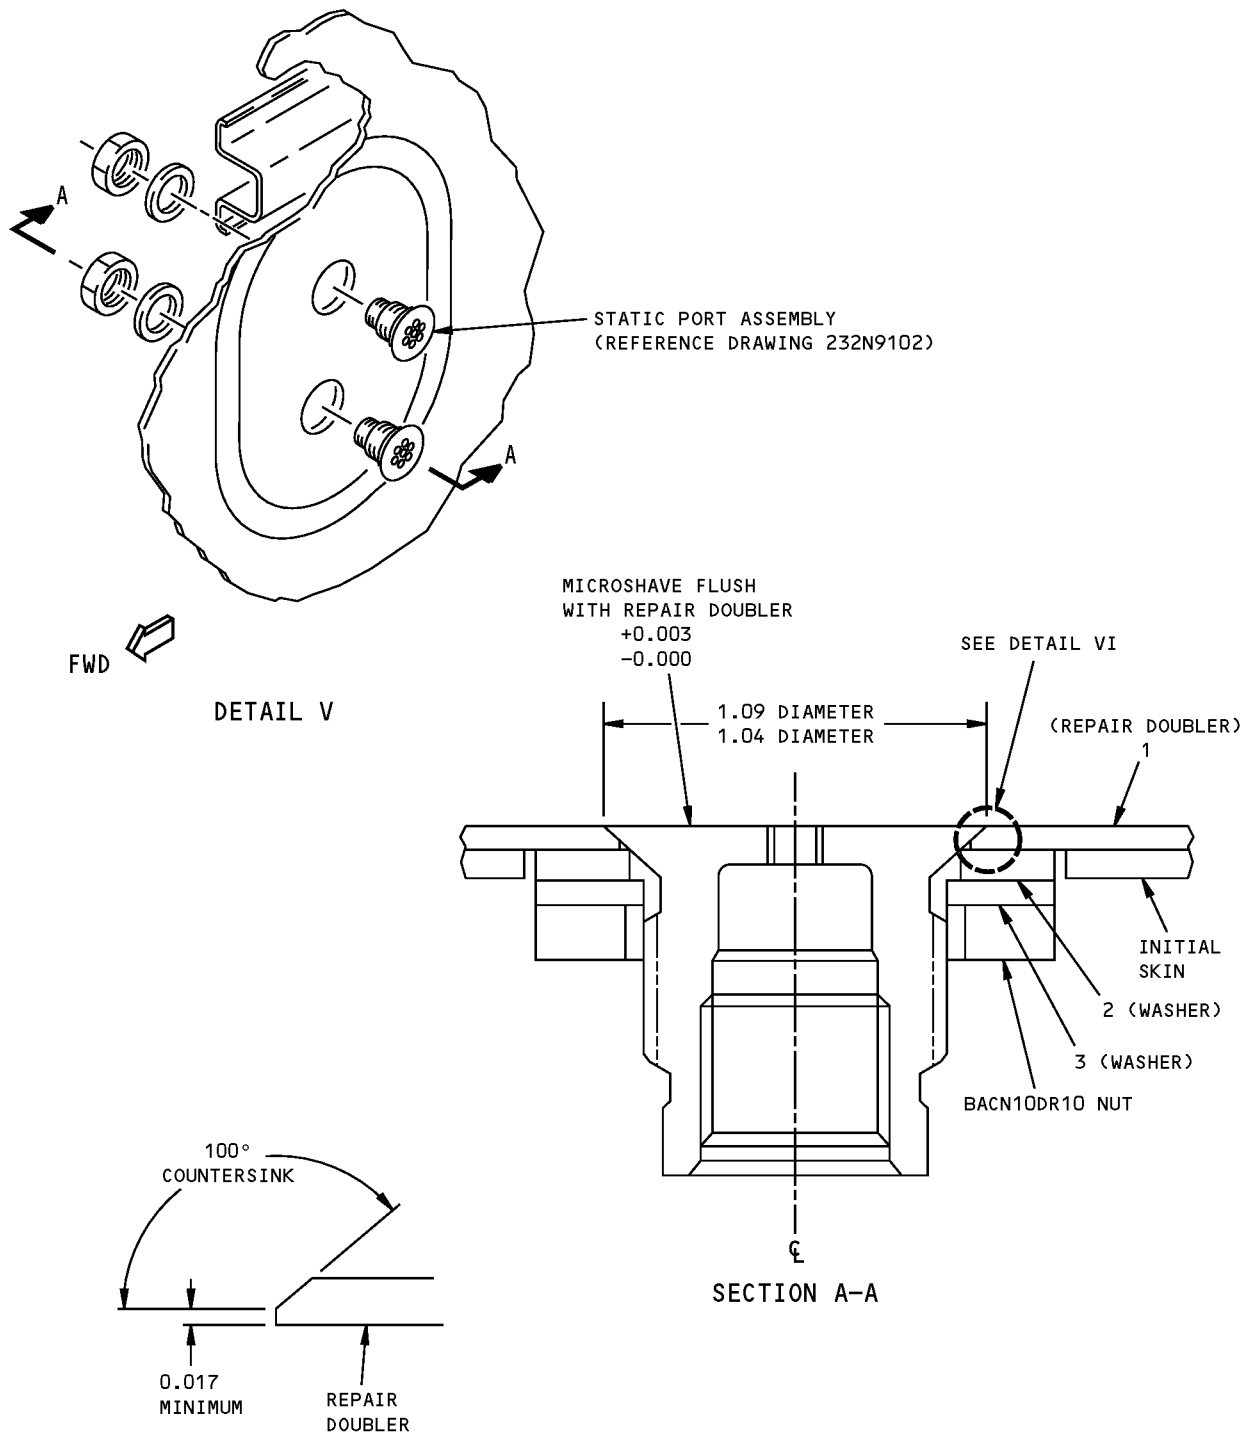
(ONLY THE REPAIR DOUBLER IS SHOWN)
DETAIL VI

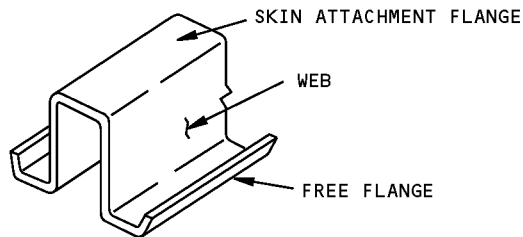
TYPICAL STRINGER SECTION

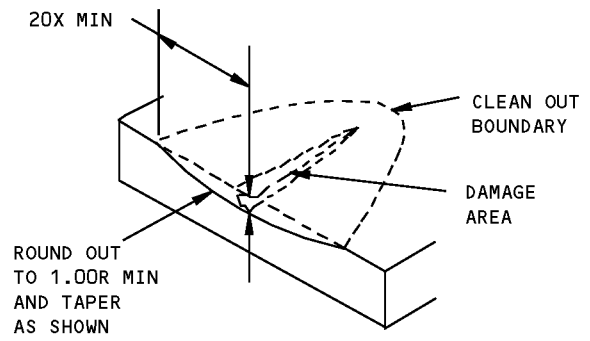
DETAIL II

X = DEPTH OF CLEANUP MUST NOT EXCEED 20% OF GAGE

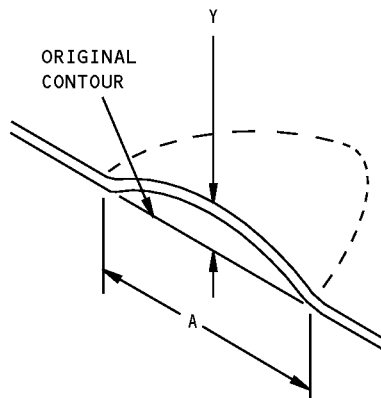
$\frac{A}{Y}$ MUST NOT BE LESS THAN 30

A = WIDTH OF MINOR AXIS OF DENT

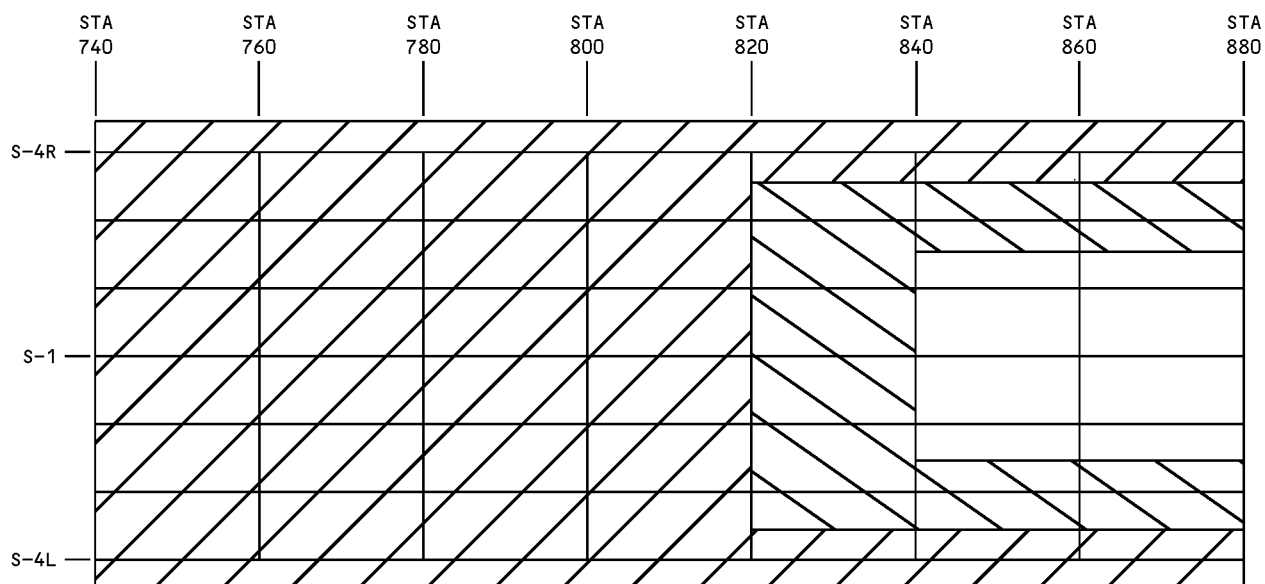
RESTRICTIONS ON STRINGER SPLICE USE DETAIL I

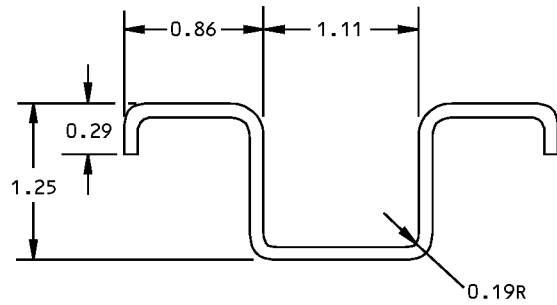
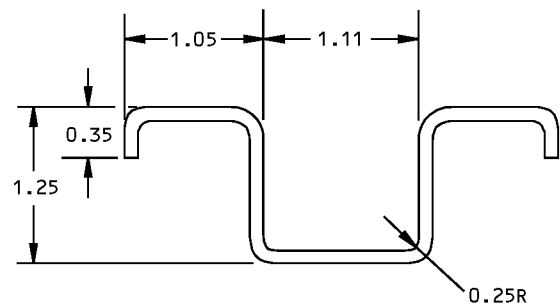
TYPE I

TYPE II

Fuselage Stringer Repair S-1 thru S-30
Figure 201 (Sheet 6 of 9)

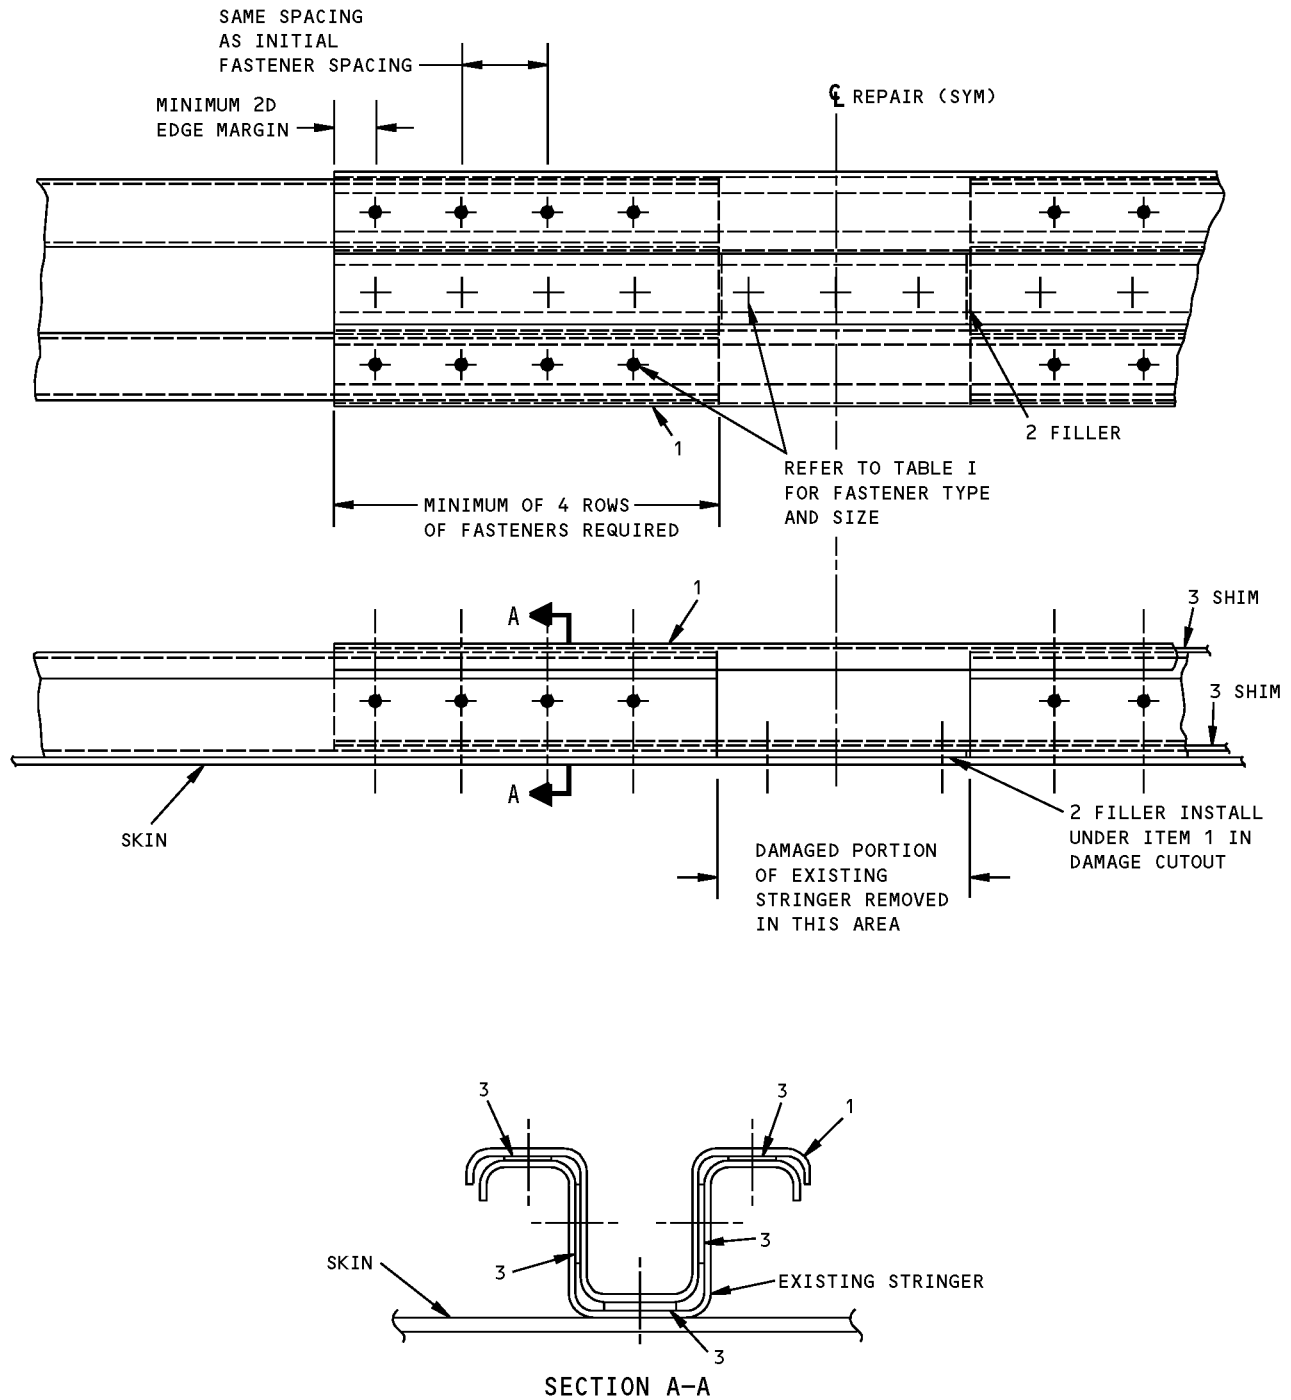
FOR TYPE I STRINGERS WITH A GAGE OF 0.090 OR OR LESS
AND FOR TYPE II STRINGERS WITH A GAGE OF 0.063 OR LESS
DETAIL II

Fuselage Stringer Repair S-1 thru S-30
Figure 201 (Sheet 7 of 9)

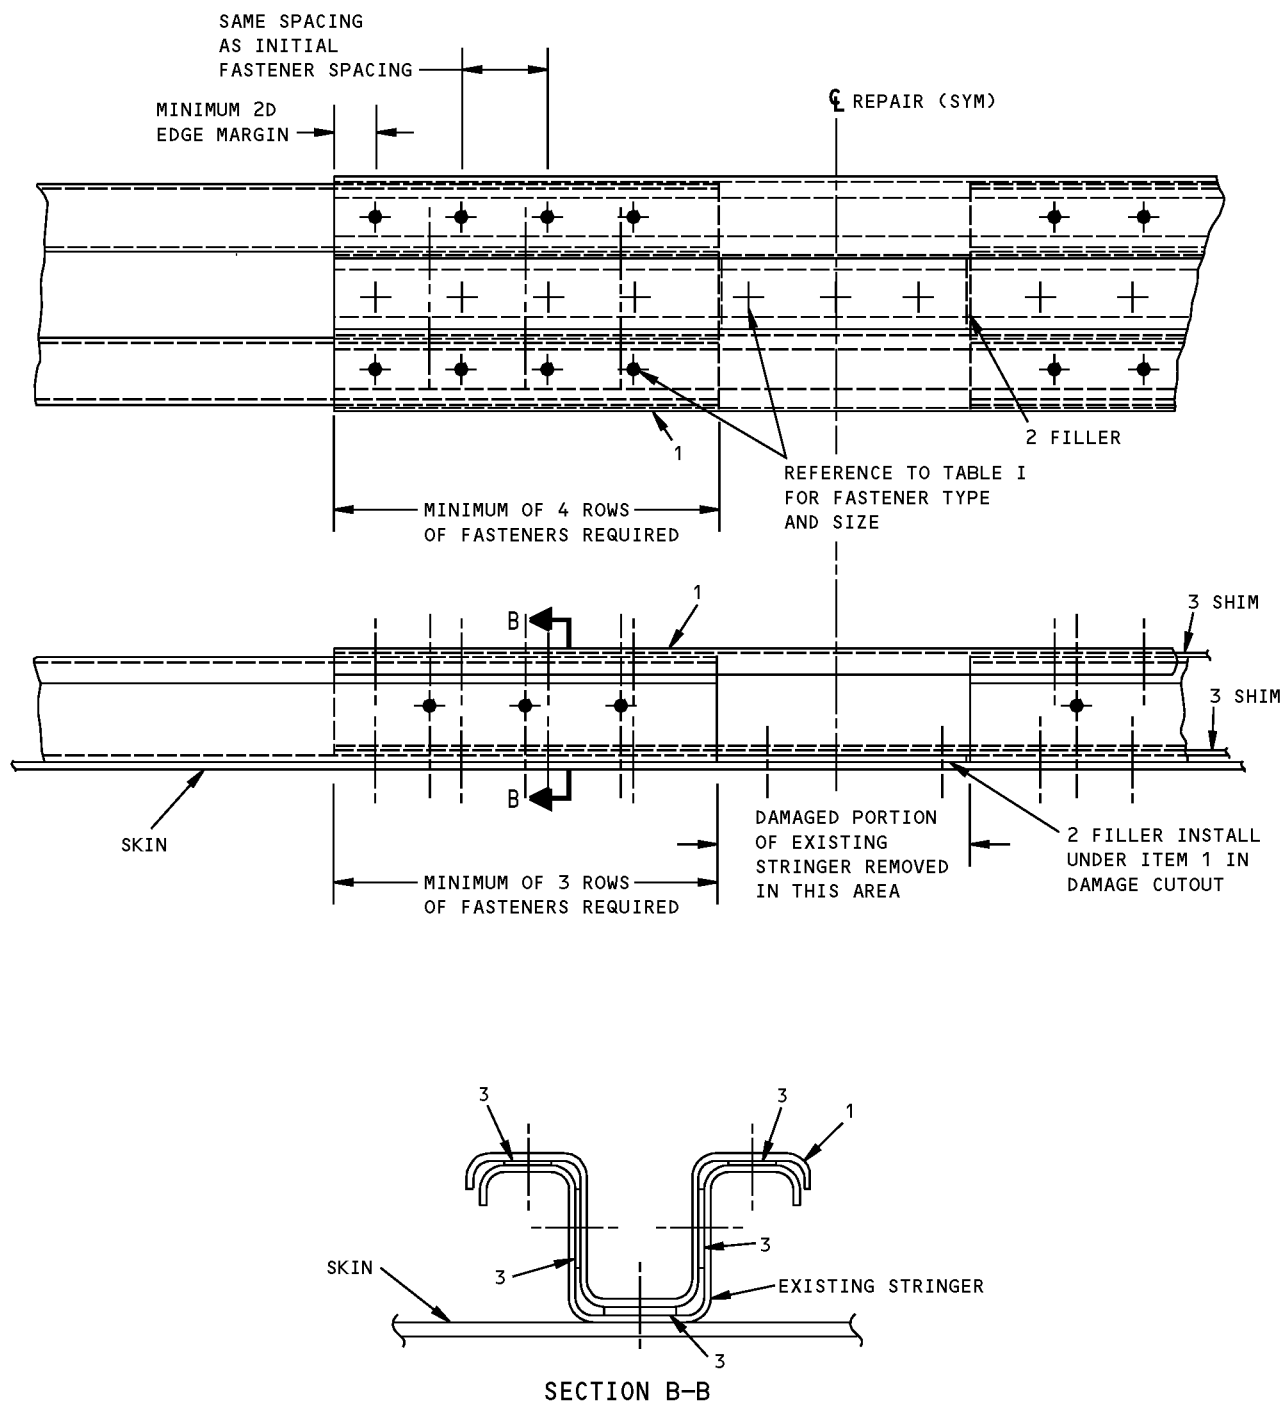
FOR TYPE II STRINGERS WITH A GAGE BETWEEN 0.064 TO 0.090
DETAIL III

Fuselage Stringer Repair S-1 thru S-30
Figure 201 (Sheet 8 of 9)

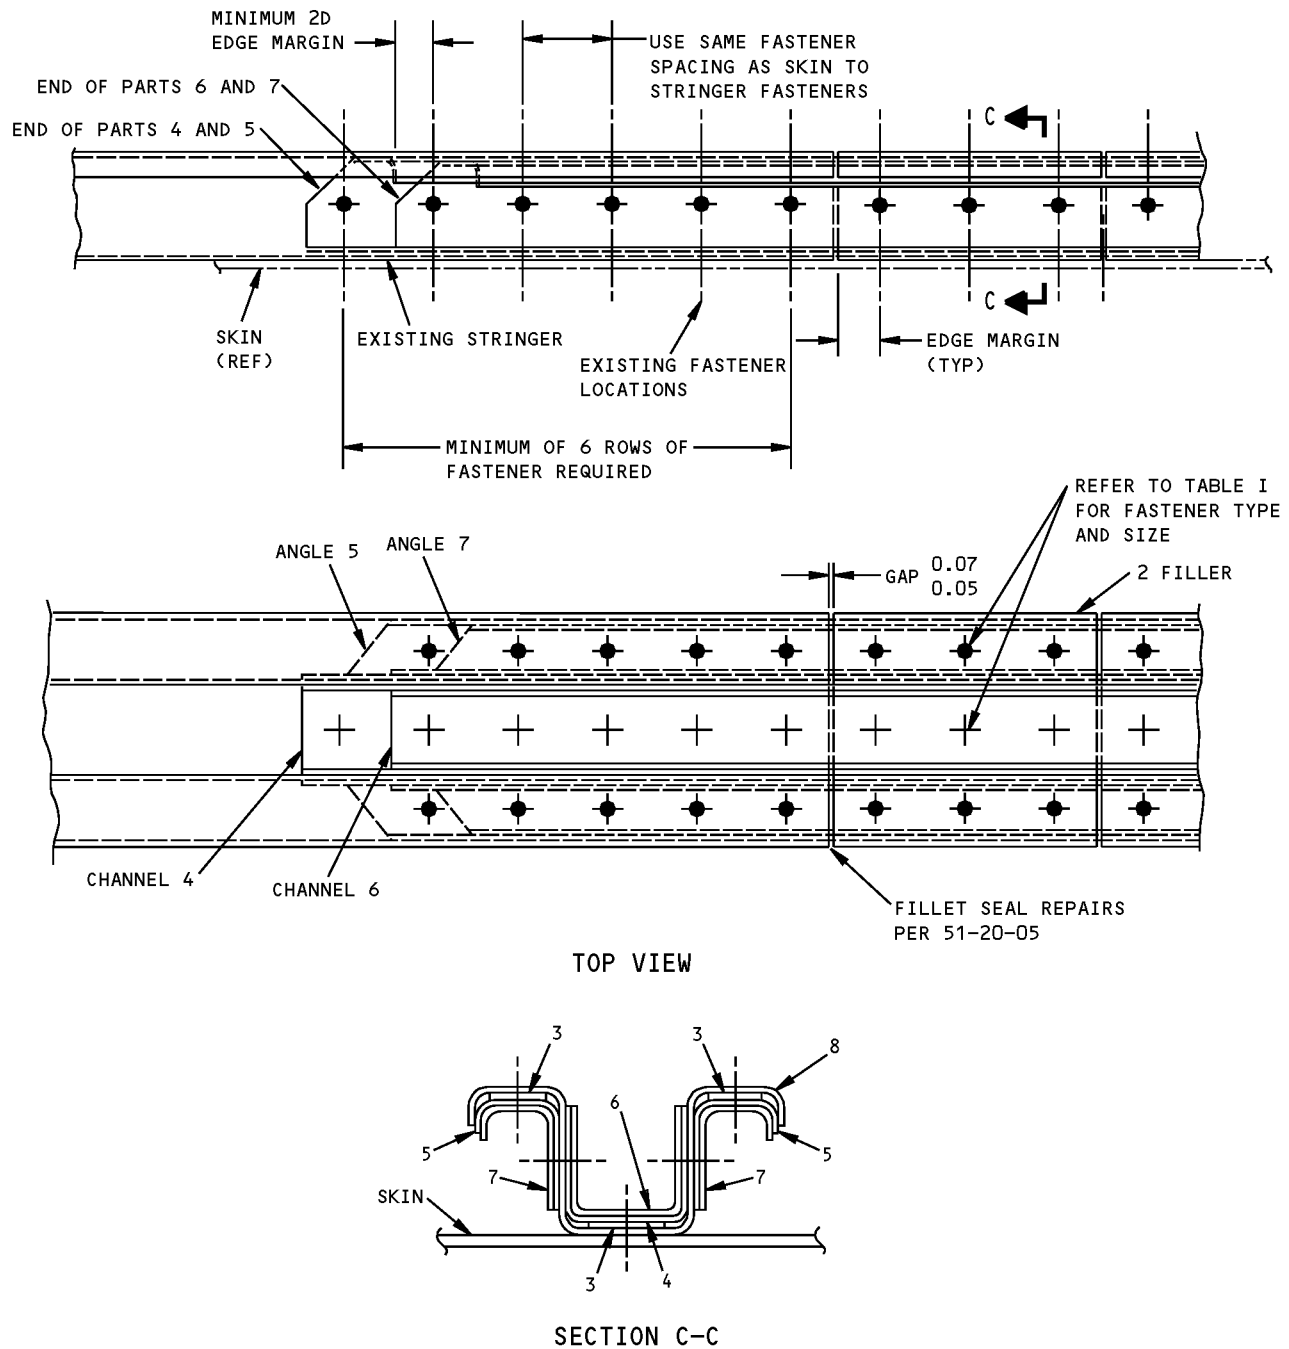
FOR TYPE I OR II STRINGERS WITH GAGE GREATER THAN 0.090
DETAIL IV

Fuselage Stringer Repair S-1 thru S-30
Figure 201 (Sheet 9 of 9)

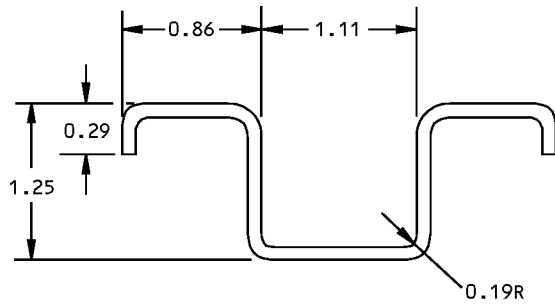
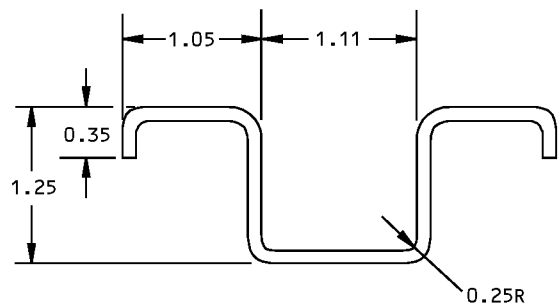
TYPE I

TYPE II

Fuselage Stringer Repair S-1 thru S-30 - 757-SF
Figure 201 (Sheet 5 of 8)

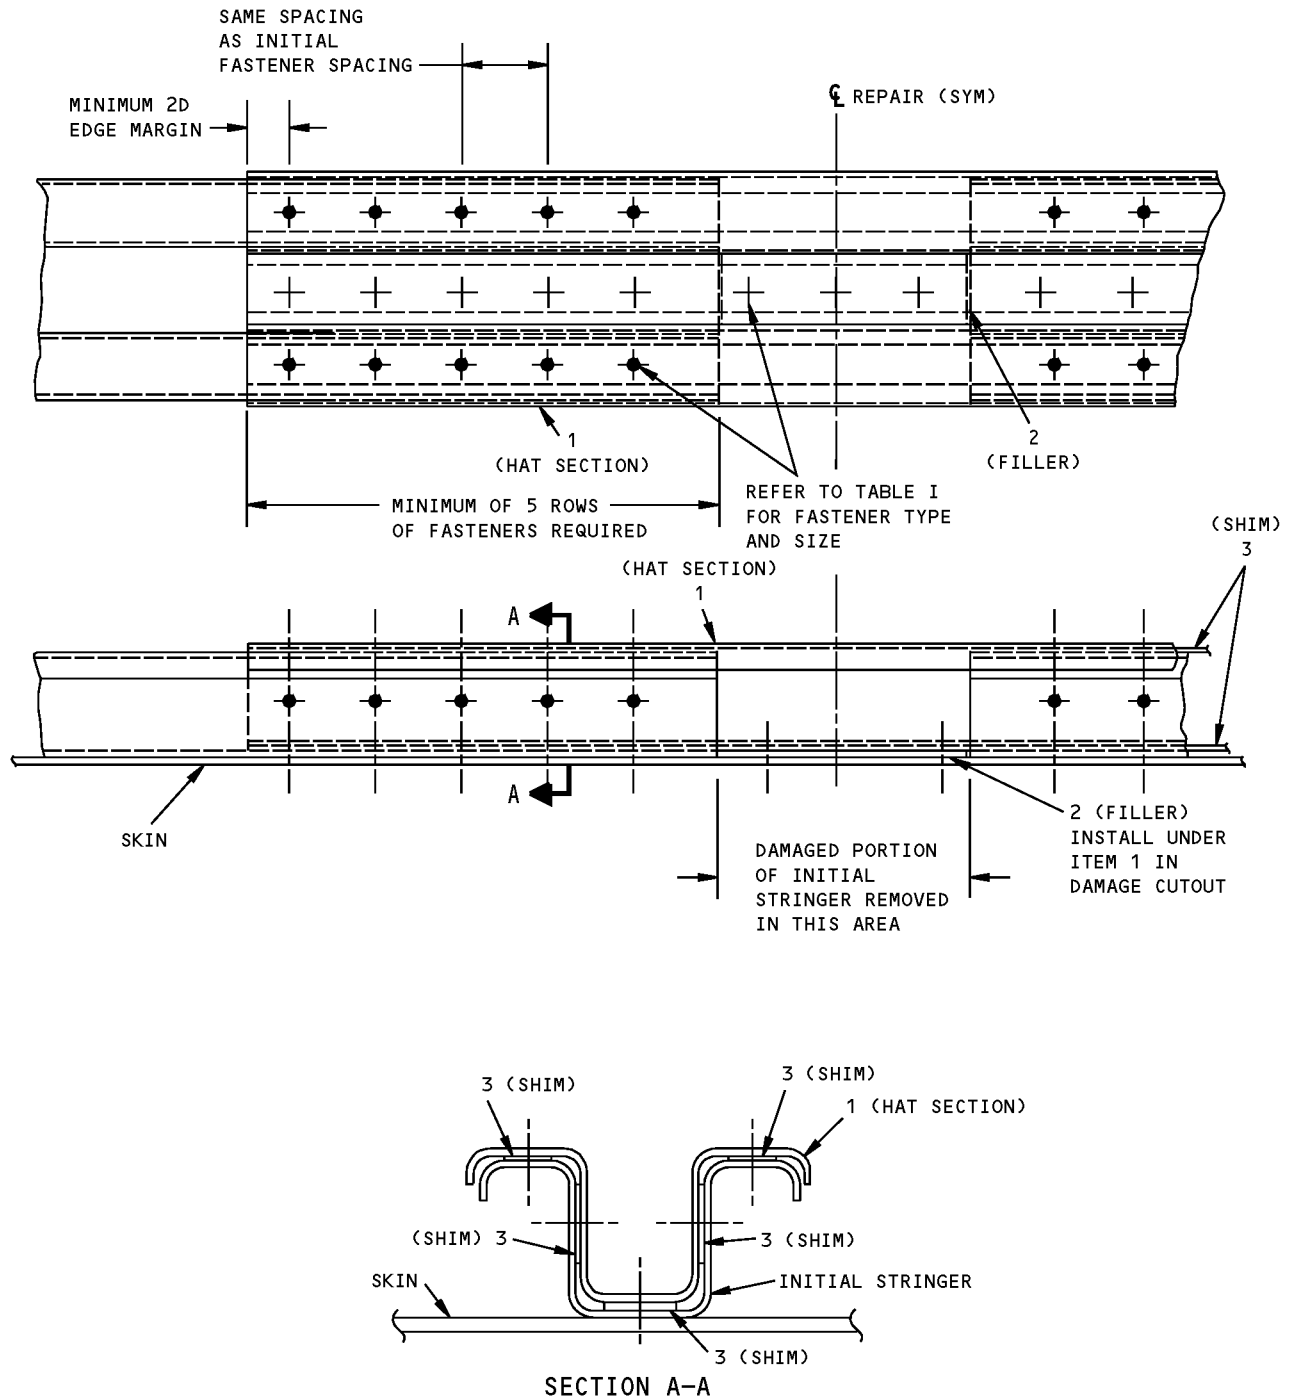
FOR TYPE I STRINGERS WITH A GAGE OF 0.090 OR LESS
AND FOR TYPE II STRINGERS WITH A GAGE OF 0.063 OR LESS
DETAIL I

Fuselage Stringer Repair S-1 thru S-30 - 757-SF
Figure 201 (Sheet 6 of 8)

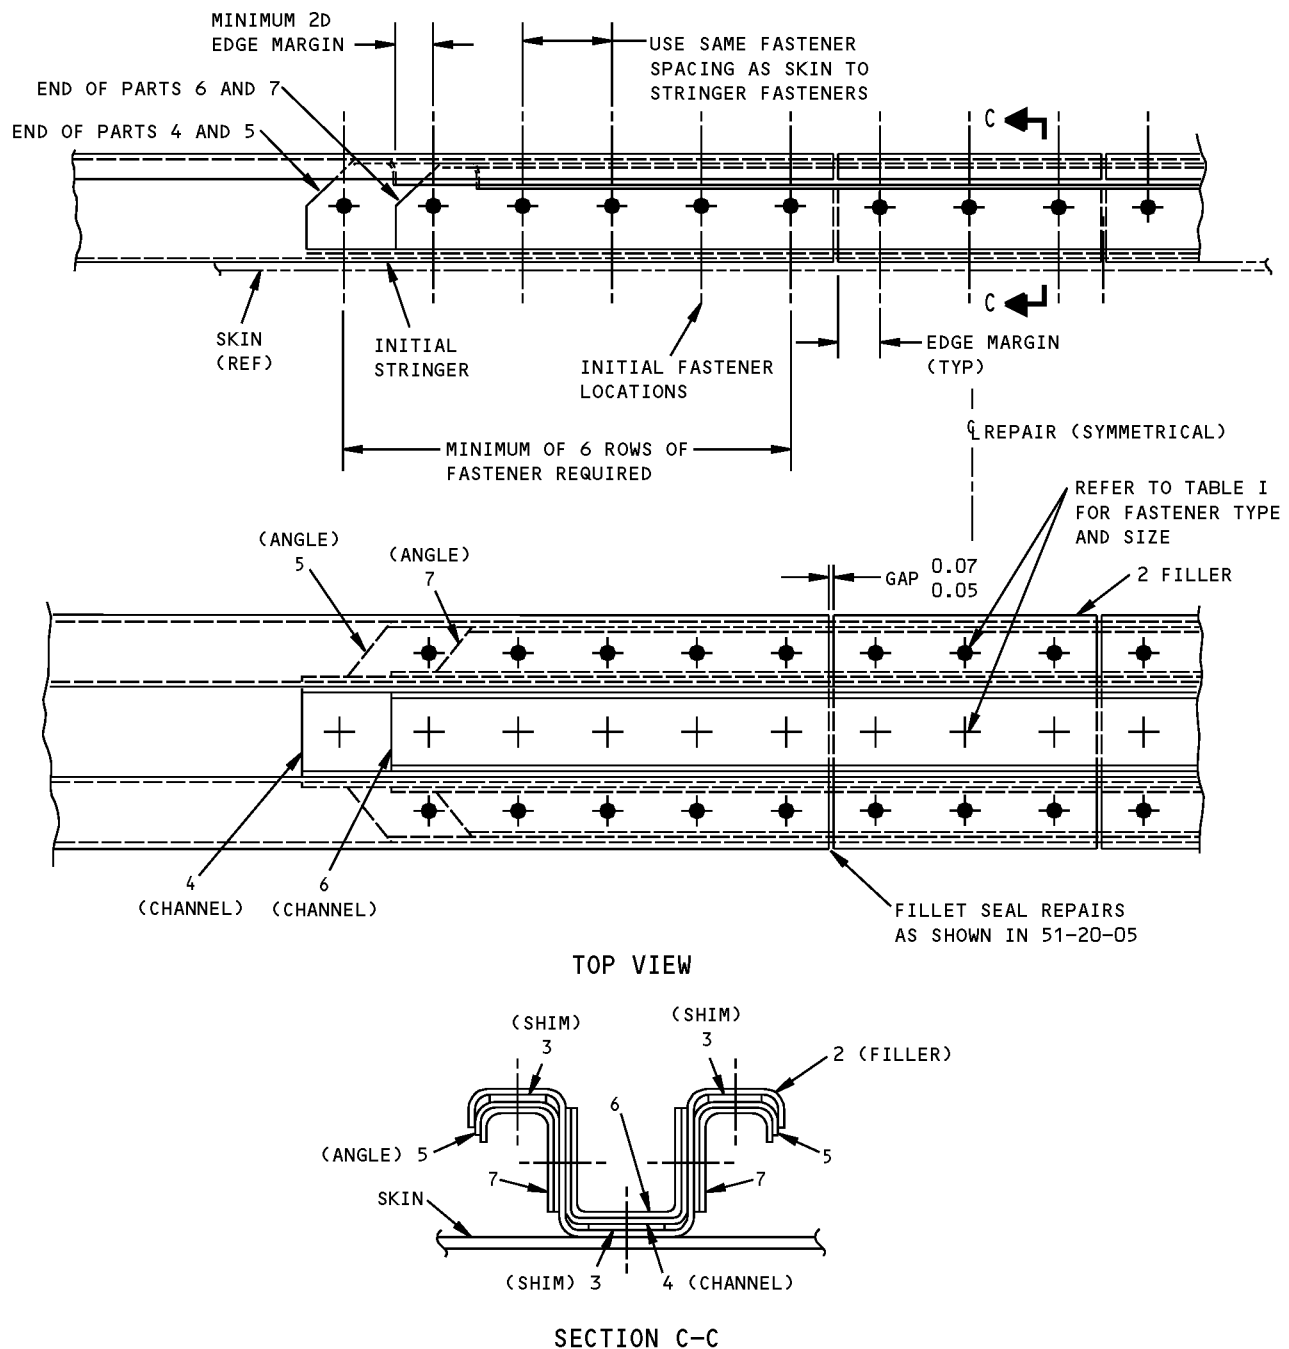
FOR TYPE I OR II STRINGERS WITH GAGE GREATER THAN 0.090
DETAIL III

**Fuselage Stringer Repair S-1 thru S-30 - 757-SF
Figure 201 (Sheet 8 of 8)**

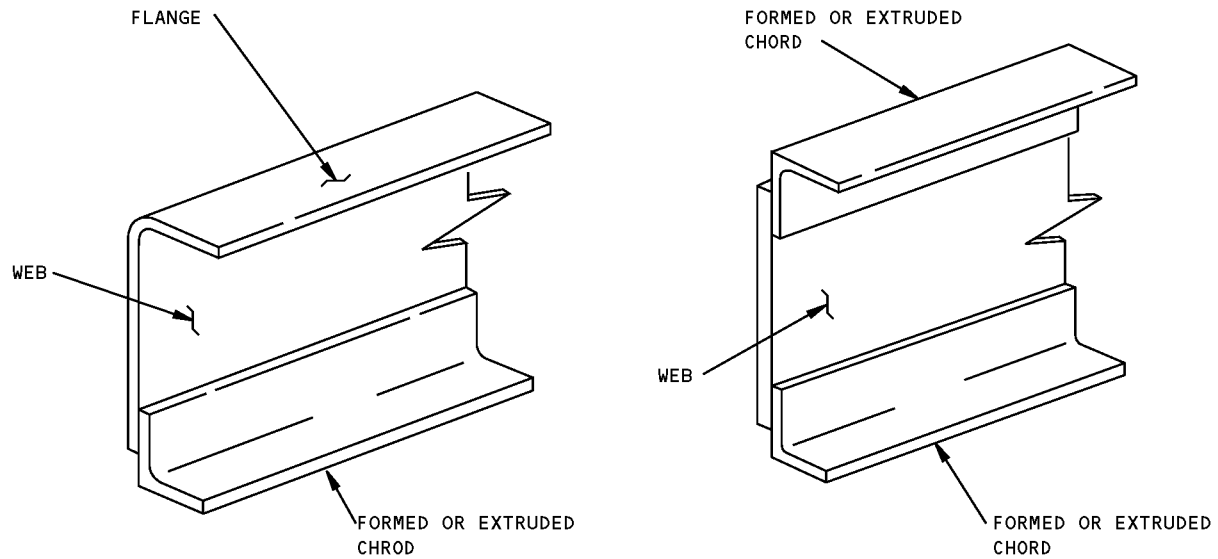
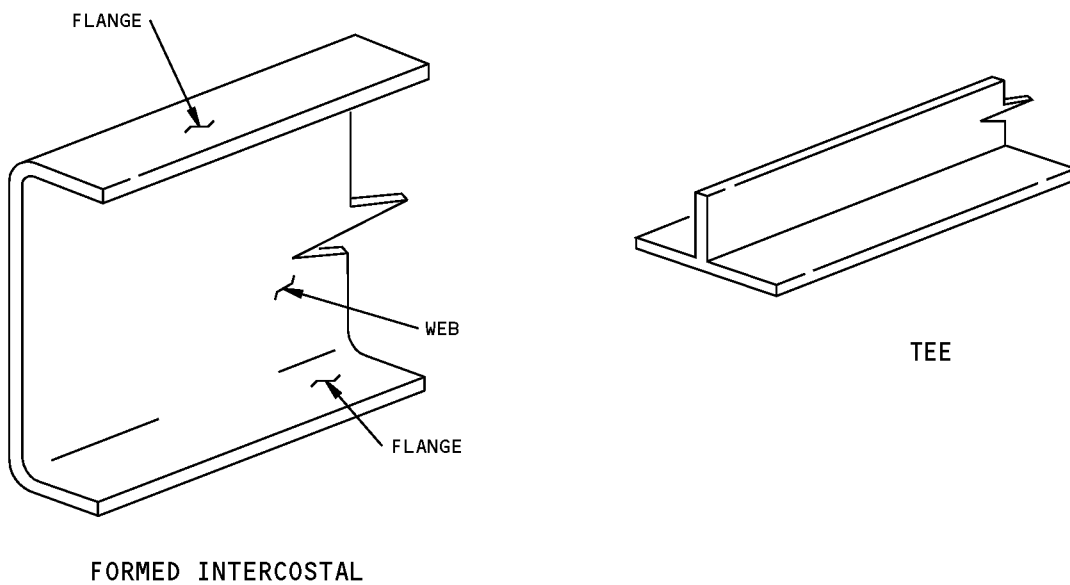
**Intercostals Allowable Damage
Figure 101 (Sheet 1 of 3)**

BUILT-UP INTERCOSTALS

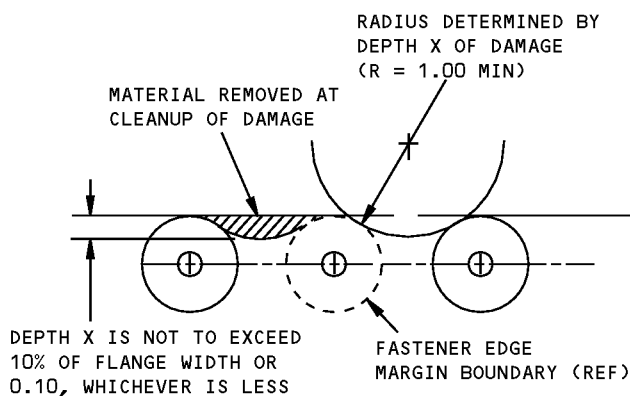
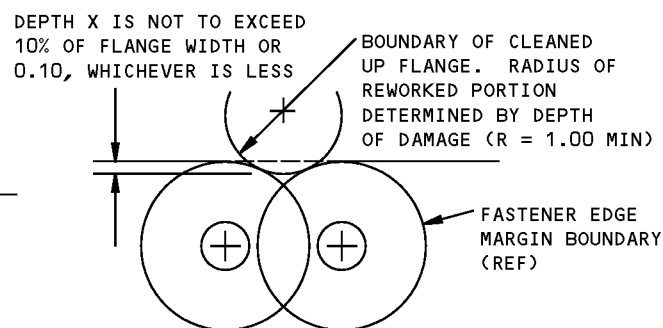
DETAIL I

DAMAGE CLEANUP OF EDGES WHERE FASTENER EDGE MARGINS DO NOT OVERLAP

DAMAGE CLEANUP OF EDGES WHERE FASTENER EDGE MARGINS OVERLAP

F REMOVE DAMAGE PER DETAILS I, II AND IV

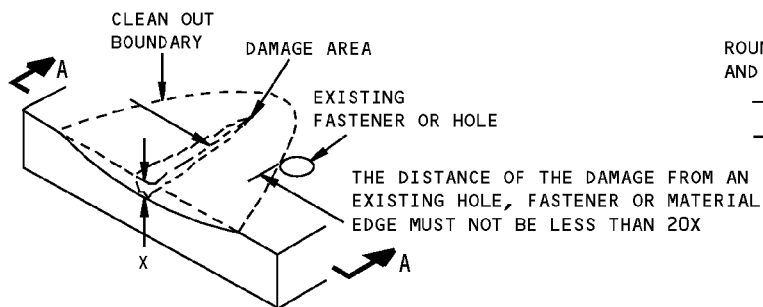
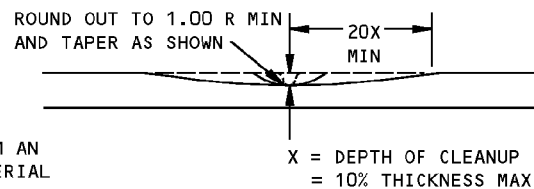
SECTION A-A

REMOVAL OF NICK, GOUGE AND SCRATCH DAMAGE ON A SURFACE
DETAIL II

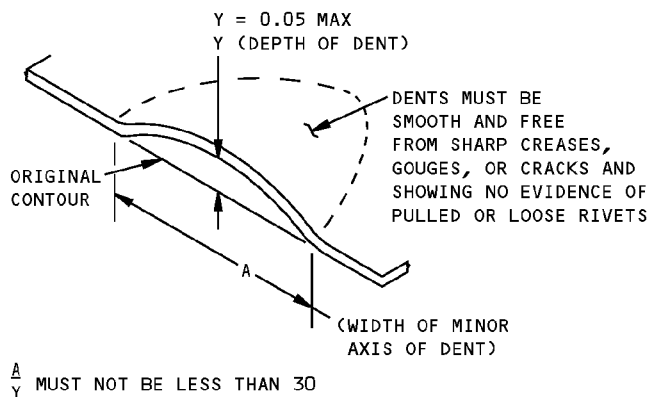
ALLOWABLE DAMAGE FOR DENT
DETAIL III

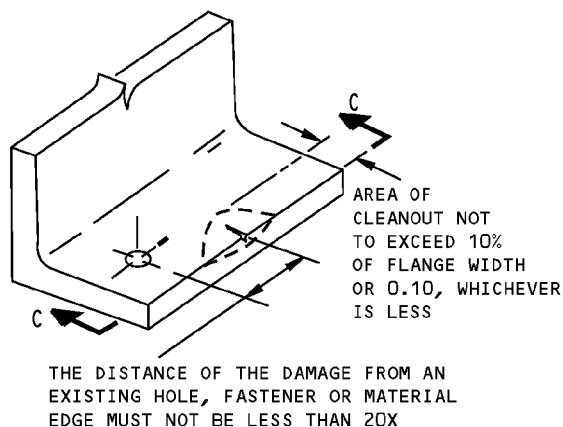
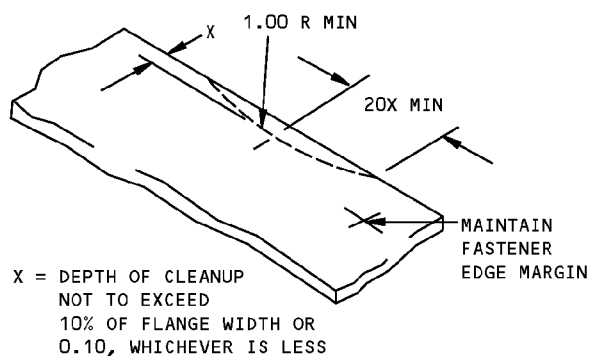
REMOVAL OF NICK OR CRACK
DAMAGE ON AN EDGE
DETAIL IV

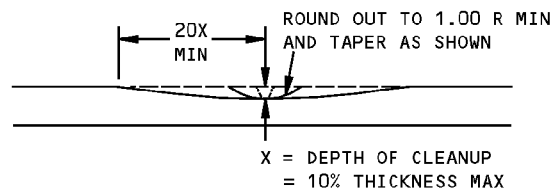
REMOVAL OF NICK OR CRACK
DAMAGE ON AN EDGE
DETAIL V

Intercostals Allowable Damage
Figure 101 (Sheet 3 of 3)

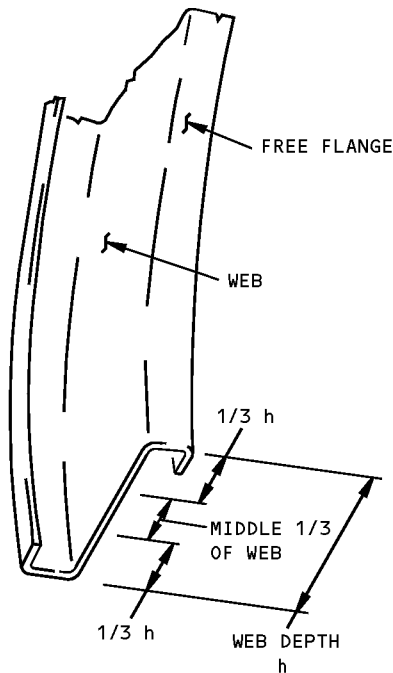
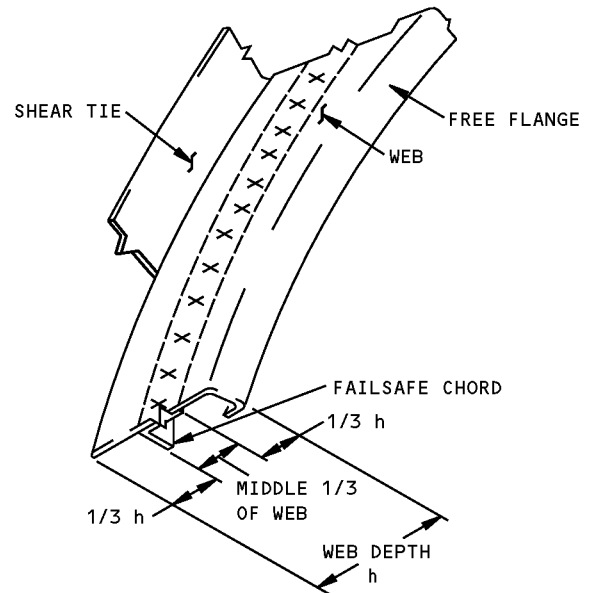
ZEE FRAME

BUILT-UP FRAME

TYPICAL FRAME SECTIONS

Fuselage Frames Allowable Damage
Figure 101 (Sheet 1 of 4)

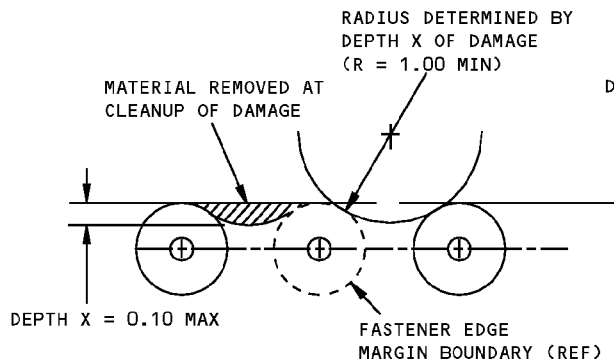
DETAIL I

DAMAGE CLEANUP OF EDGES WHERE
FASTENER EDGE MARGINS DO NOT OVERLAP

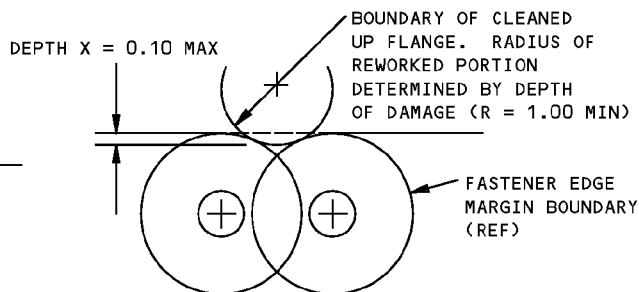
DAMAGE CLEANUP OF EDGES WHERE
FASTENER EDGE MARGINS OVERLAP

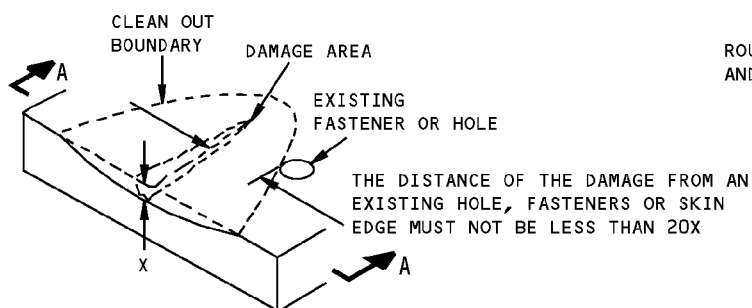
REMOVAL OF NICK, GOUGE AND SCRATCH DAMAGE ON A SURFACE
DETAIL II

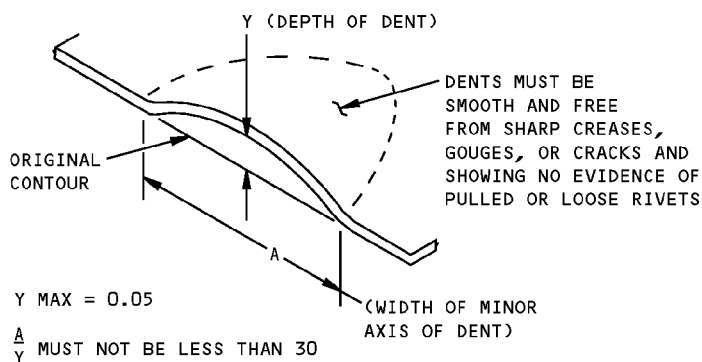
ALLOWABLE DAMAGE FOR DENT
DETAIL III

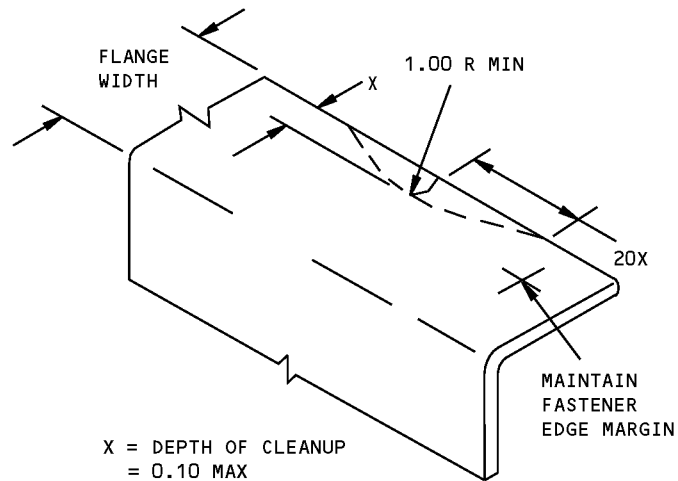
REMOVAL OF NICK OR CRACK DAMAGE ON AN EDGE DETAIL IV

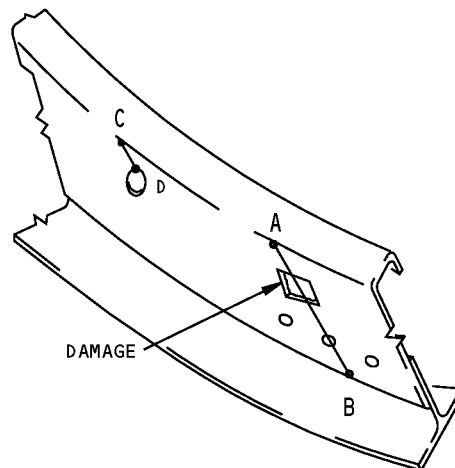
DETAIL V

LOSS IN CROSS-SECTIONAL AREA ALONG ANY LINE A-B OR C-D DUE TO REMOVAL OF ANY TYPE OF DAMAGE MUST NOT EXCEED 10% OF ORIGINAL NET CROSS-SECTIONAL AREA

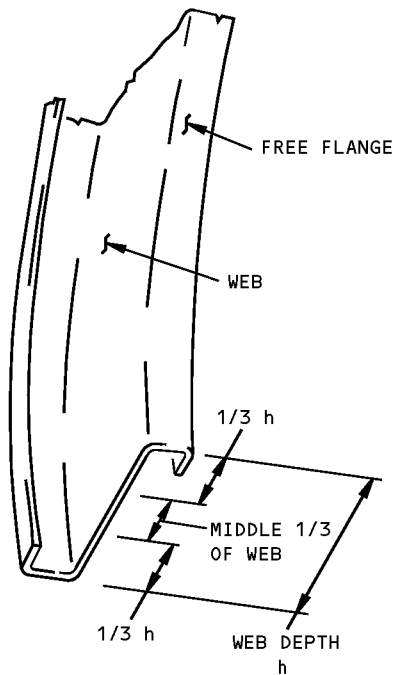
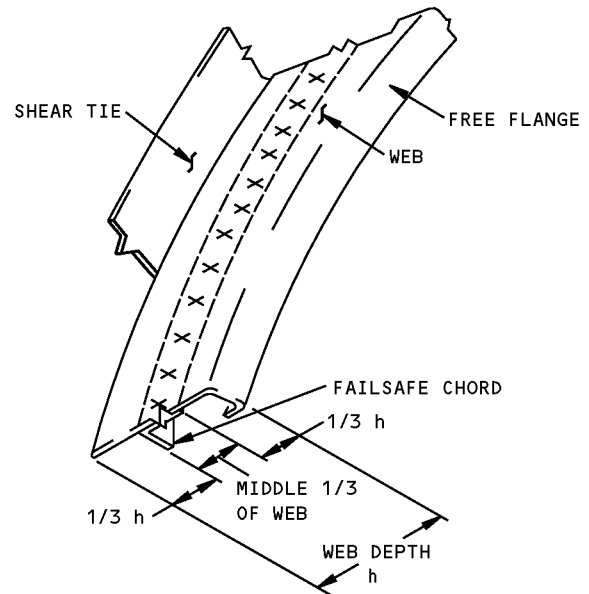
ZEE FRAME

BUILT-UP FRAME

TYPICAL FRAME SECTIONS

Fuselage Frames Allowable Damage - 757-SF
Figure 101 (Sheet 1 of 4)

- ALL DIMENSIONS ARE IN INCHES.
 - D = THE FASTENER DIAMETER.
 - REFER TO AMM 51-21 FOR FINISHES IN THE REWORK AREA
 - THE TOTAL CROSS-SECTIONAL AREA REMOVED BY ANY TYPE OF DAMAGE CLEANUP MUST NOT EXCEED 10 PERCENT OF THE INITIAL NET CROSS-SECTIONAL AREA OF THE WEB OR FLANGE AS APPROPRIATE. THE NET CROSS-SECTIONAL AREA IS THE INITIAL CROSS-SECTIONAL AREA LESS LIGHTENING OR FASTENER HOLES PROVIDED AT MANUFACTURER. SEE DETAIL V

- A** CRACKS NOT PERMITTED EXCEPT FOR EDGE CRACKS WHICH MUST BE REMOVED AS SHOWN IN DETAILS I AND IV.
- B** REMOVE DAMAGE AS SHOWN IN DETAILS I, II AND IV.

- C** CLEAN OUT DAMAGE UP TO 0.18 DIA MAXIMUM AND NOT CLOSER THAN 3D TO FASTENER HOLE, MATERIAL EDGE OR OTHER DAMAGE WITH A MAXIMUM OF 4 HOLES IN 6 INCHES. SEE DETAIL II. FILL HOLE WITH 2117-T3 ALUMINUM RIVET INSTALLED WET WITH BMS 5-95 SEALANT. ALL OTHER HOLES TO BE REPAIRED.

- D** NO DAMAGE IS PERMITTED FOR SECTION 46 BUILT-UP FRAMES BETWEEN S-17 AND S-22 (L/R).
- E** FOR SECTION 46 BUILT-UP FRAMES BETWEEN S-13 AND S-17 (L/R), THE MAXIMUM DEPTH OF CLEANUP TO THE WEB IS 5 PERCENT OF THICKNESS.

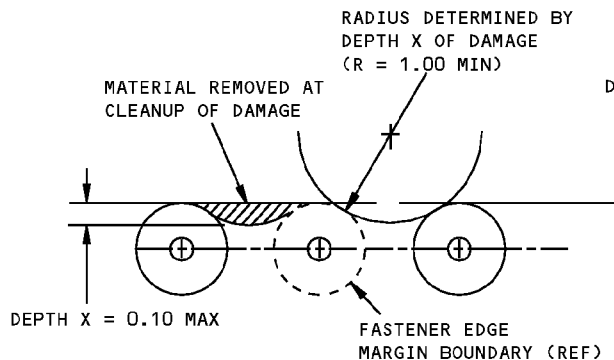
DETAIL I

DAMAGE CLEANUP OF EDGES WHERE
FASTENER EDGE MARGINS DO NOT OVERLAP

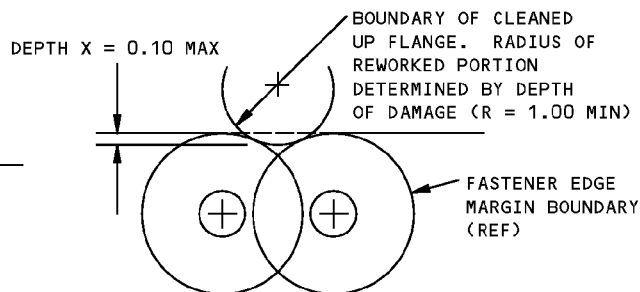
DAMAGE CLEANUP OF EDGES WHERE
FASTENER EDGE MARGINS OVERLAP

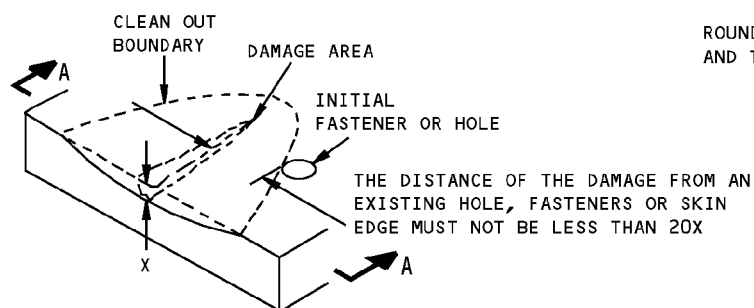
REMOVAL OF NICK, GOUGE AND SCRATCH DAMAGE ON A SURFACE
DETAIL II

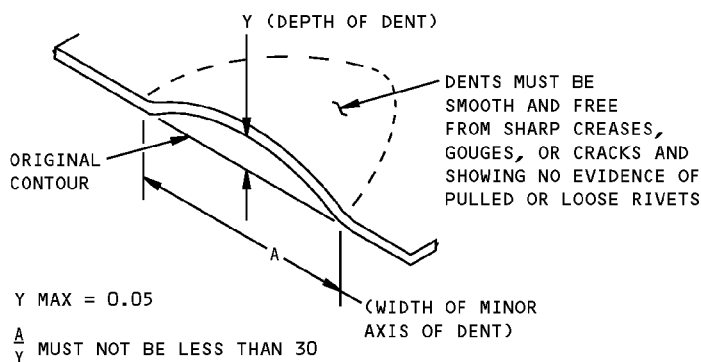
ALLOWABLE DAMAGE FOR DENT
DETAIL III

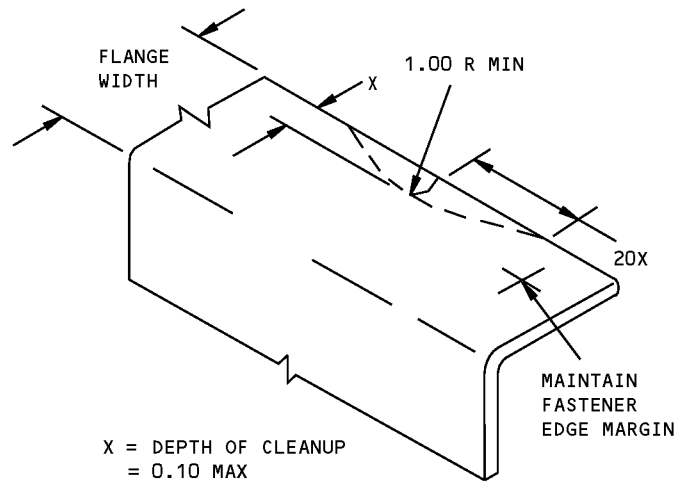
REMOVAL OF NICK OR CRACK DAMAGE ON AN EDGE DETAIL IV

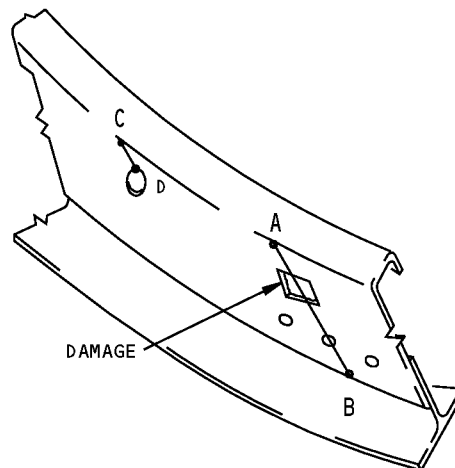
DETAIL V

LOSS IN CROSS-SECTIONAL AREA ALONG ANY LINE A-B OR C-D DUE TO REMOVAL OF ANY TYPE OF DAMAGE MUST NOT EXCEED 10% OF INITIAL NET CROSS-SECTIONAL AREA

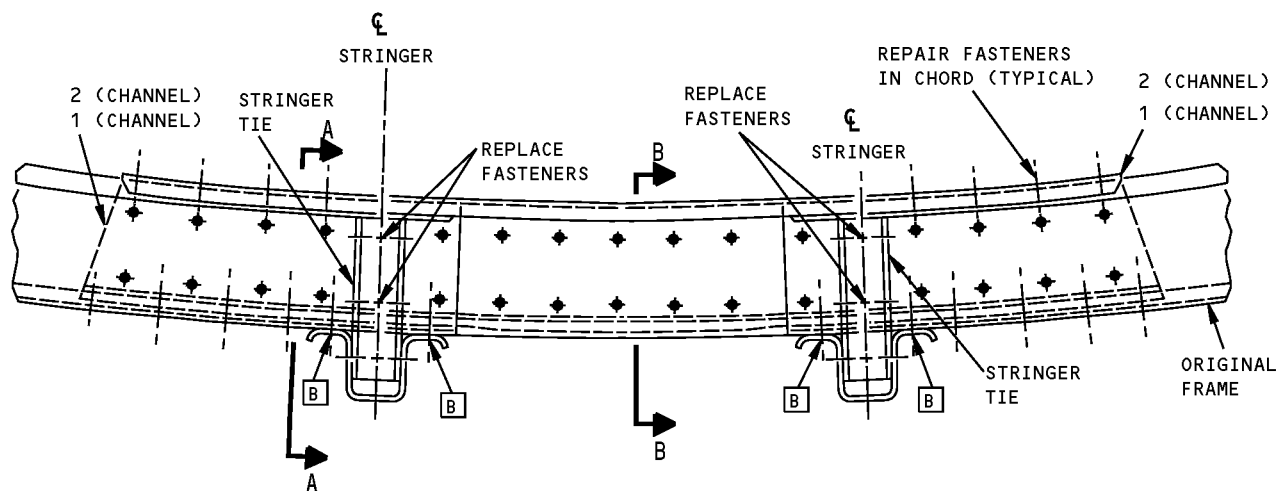
**REPAIR FOR FRAME DAMAGE BETWEEN TWO STRINGERS
DETAIL I**

**Fuselage Formed Zee Frame Repair
Figure 201 (Sheet 2 of 3)**

- Trim out the body frames as required.
- Drill out fasteners joining stringer tie and frame to facilitate removal of damaged portion of frame. Drill out fasteners joining stringer tie and stringer only when needed to complete the repair, or when stringer tie is damaged. See Details I and II.
- Make repair parts.
- Assemble the repair parts and drill fastener holes.
- Remove the repair parts and alodize all cut edges on original and repair parts.
- Install repair parts with BMS 5-95 faying surface sealant as given in SRM 51-20-05. Install fasteners wet with BMS 5-95 sealant.
- Restore original finish as given in AMM 51-21.

- A** SAME GAGE AS ORIGINAL FRAME
- B** SHIM GAP BETWEEN STRINGER AND FRAME. INSTALL FASTENER COMMON TO STRINGER AT CENTER OF STRINGER FLANGE WIDTH.
- C** YOU CAN ORDER REPAIR CHANNEL PARTS AS SHOWN IN DRAWING NUMBER 691N0006 (SHEET 2) FROM BOEING SPARES.

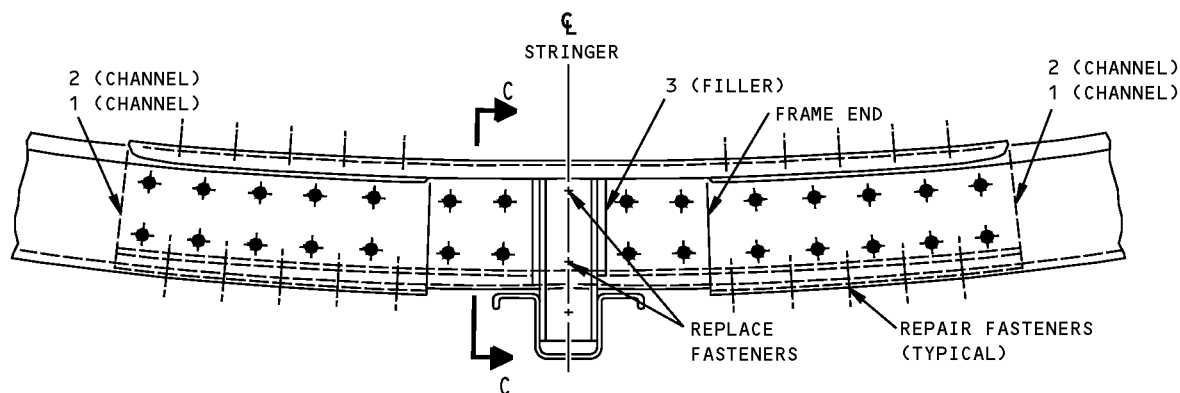
**REPAIR FOR DAMAGE AT A STRINGER
DETAIL II**

**Fuselage Formed Zee Frame Repair
Figure 201 (Sheet 3 of 3)**
