FUSELAGE

757-200 STRUCTURAL REPAIR MANUAL

CHAPTER 53 FUSELAGE

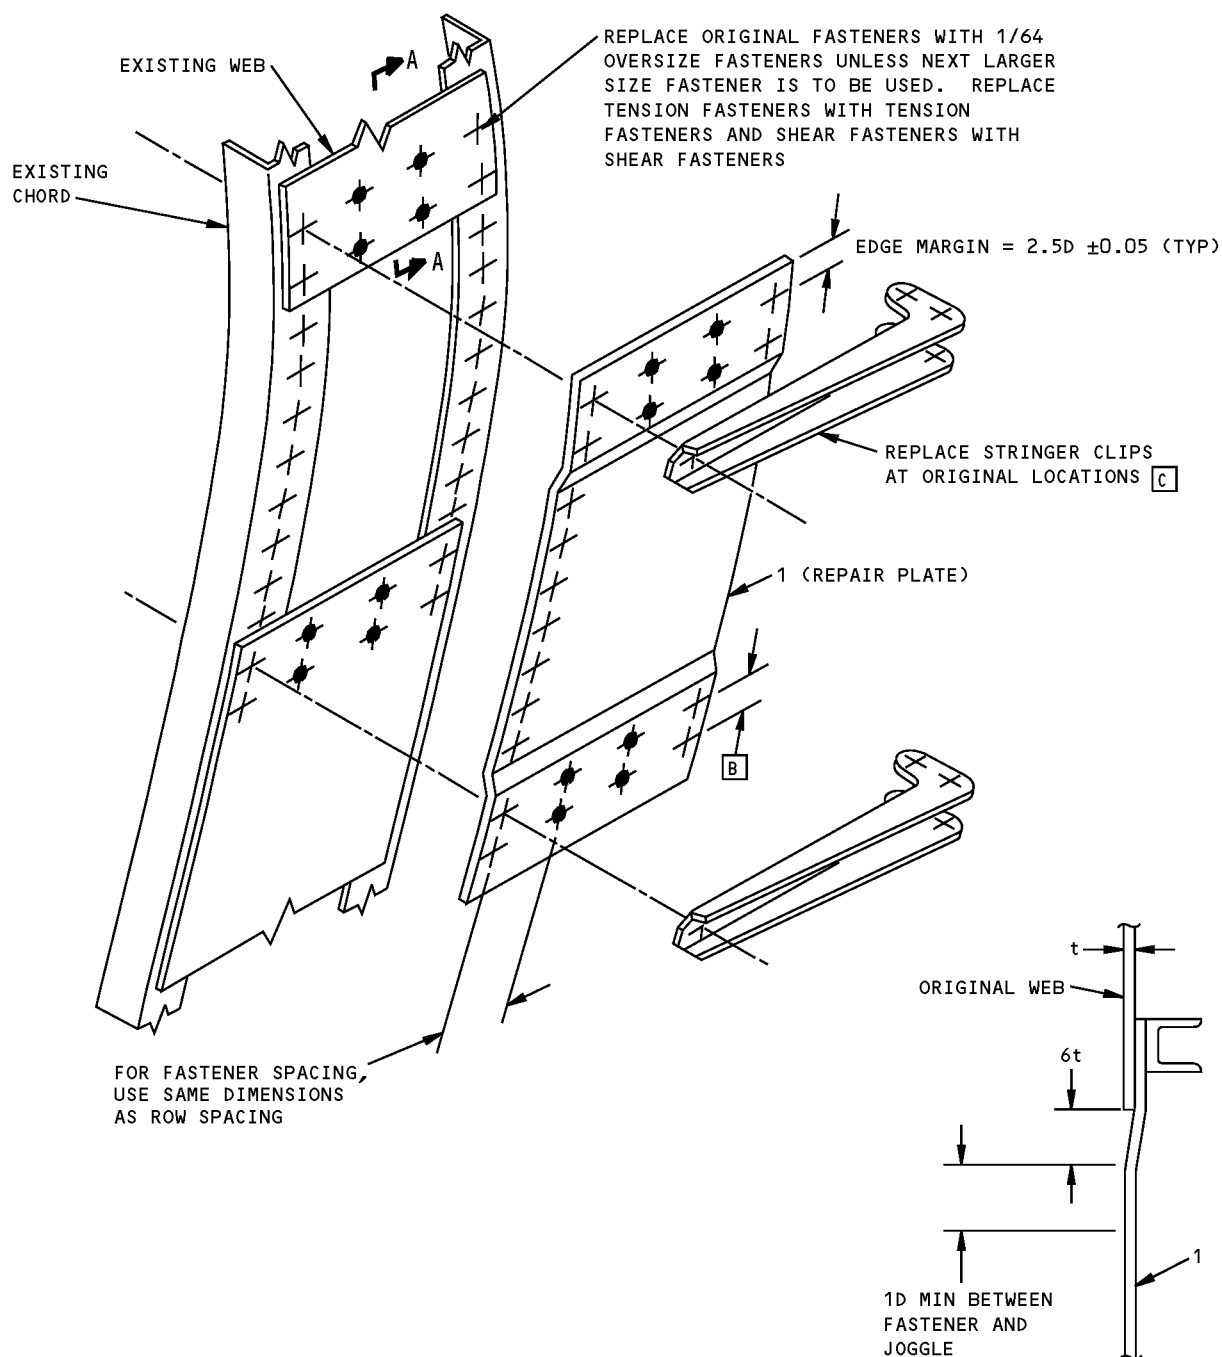
SECTION A-A

WEB GAGE 0.071 OR LESS

Fuselage Built-Up Frame Web Repair
Figure 201 (Sheet 2 of 3)

1. Cut and remove damaged portion of web. Do not cut into any surrounding structure.
2. Fabricate repair parts per Detail I or II.
3. Assemble the repair parts and drill the fastener holes. See Table II for rows of rivets required and rivet spacing.
4. Remove repair parts.
5. Break sharp edges of original and repair parts 0.015 to 0.030.
6. Remove all nicks, scratches, burrs, sharp edges and corners from original and repair parts.
7. Alodize the repair parts and the raw edges of the original parts per 51-20-01.
8. Apply one coat of BMS 10-11, Type 1 primer to all repair parts in accordance with 51-24 of the 757 Maintenance Manual.
9. Install the repair parts. Install rivets wet with BMS 5-95.
10. Restore original finish per 51-21 of the 757 Maintenance Manual.

- FOR CHEM-MILLED WEBS INSTALL REPAIR PART ON SIDE OF WEB WHICH IS NOT CHEM-MILLED IF POSSIBLE. WHERE NOT POSSIBLE, SHIMS MAY BE USED TO MAKE UP FOR VARIATIONS IN THICKNESS
- REFER TO THE FOLLOWING WHEN USING THIS REPAIR.

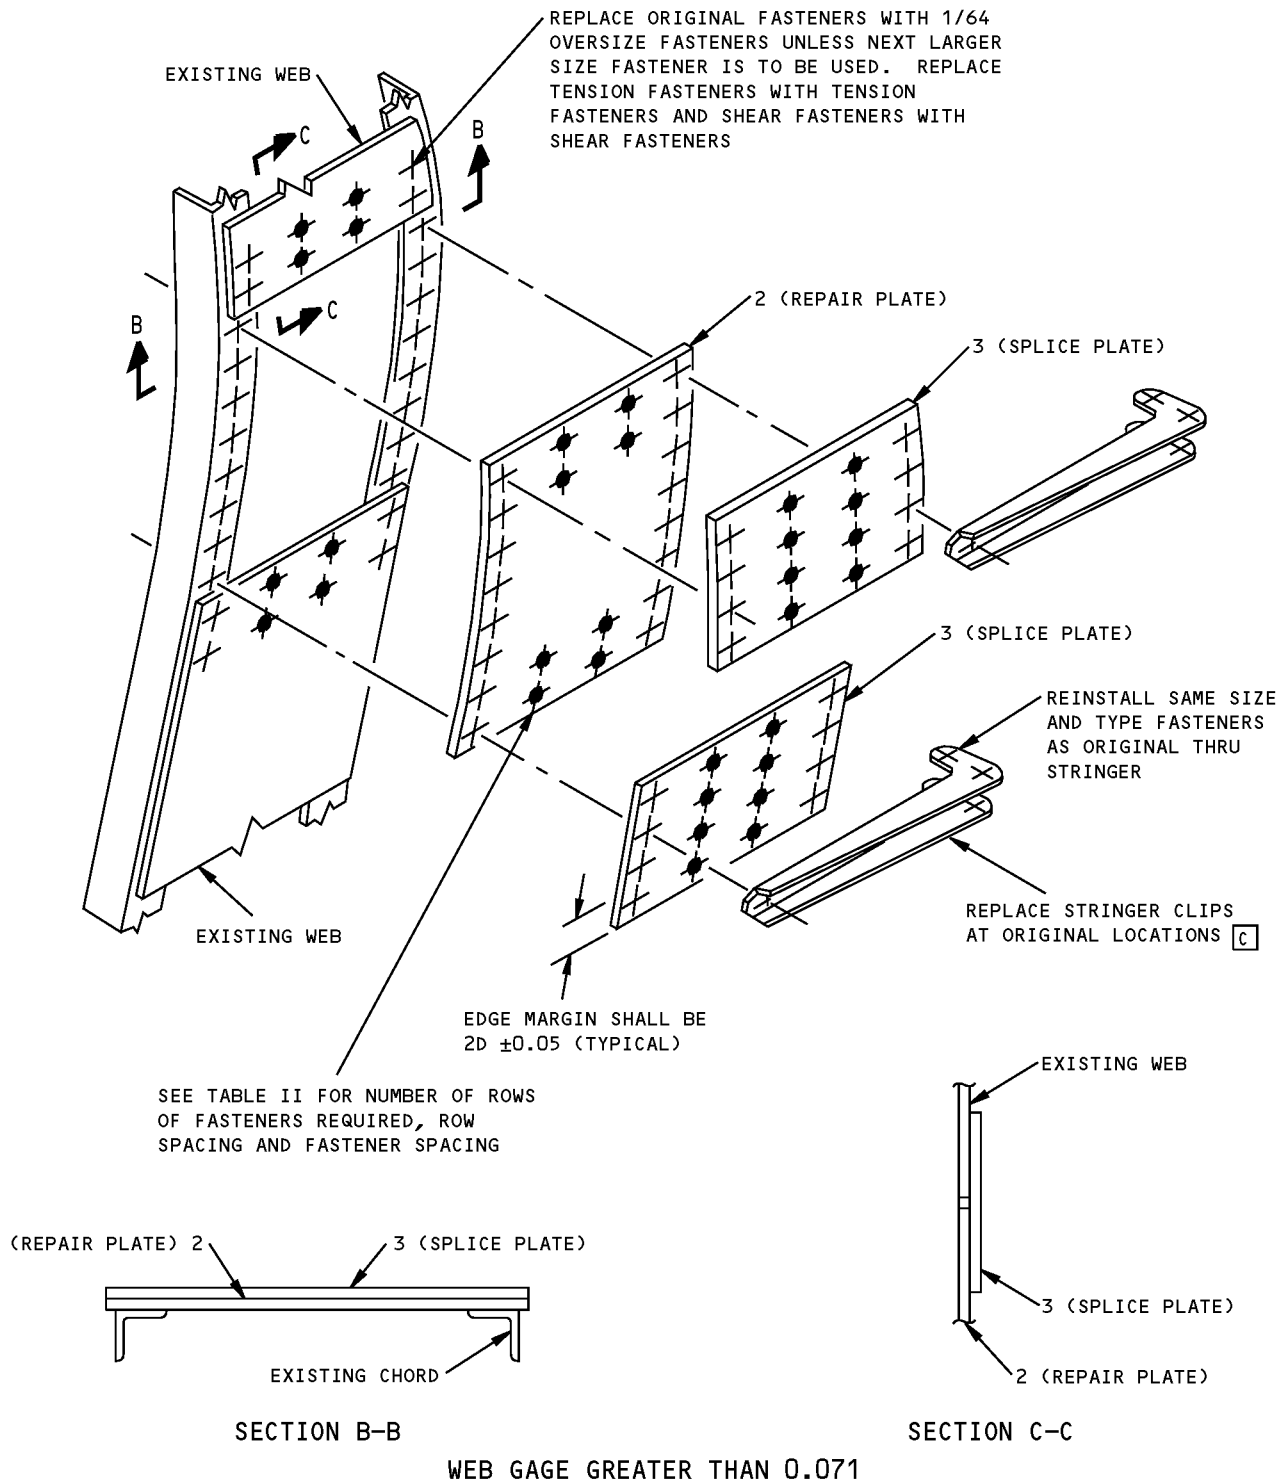
DETAIL II

Fuselage Built-Up Frame Web Repair Figure 201 (Sheet 3 of 3)

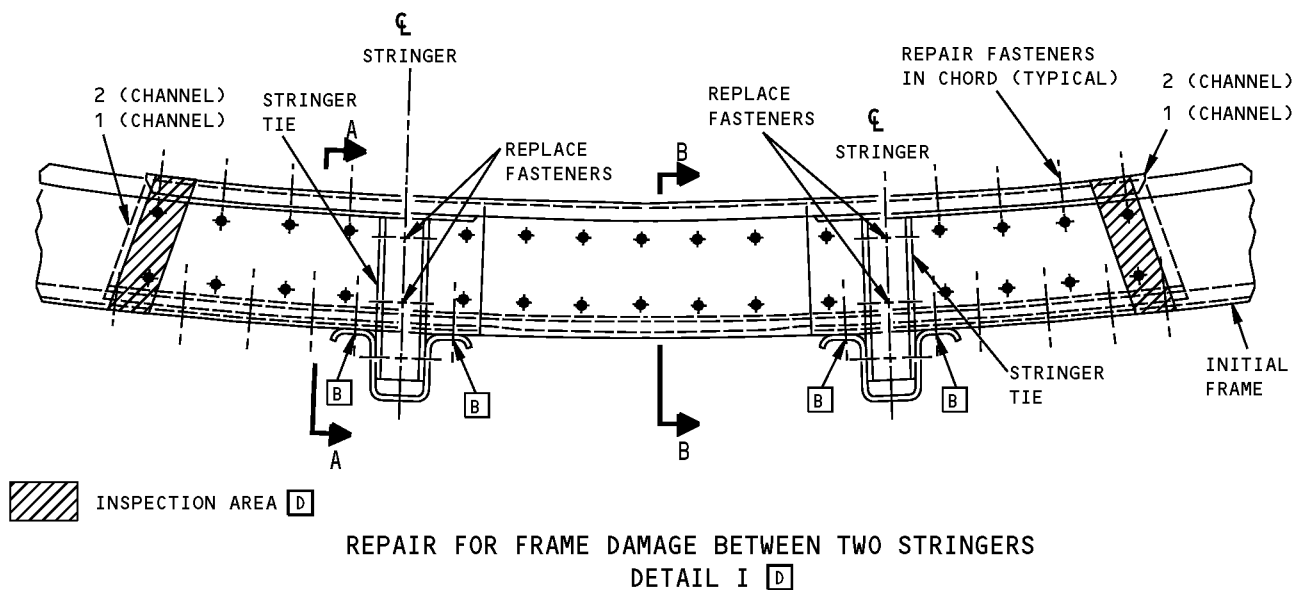
Fuselage Formed Zee Frame Repair - 757-SF
Figure 201 (Sheet 2 of 3)

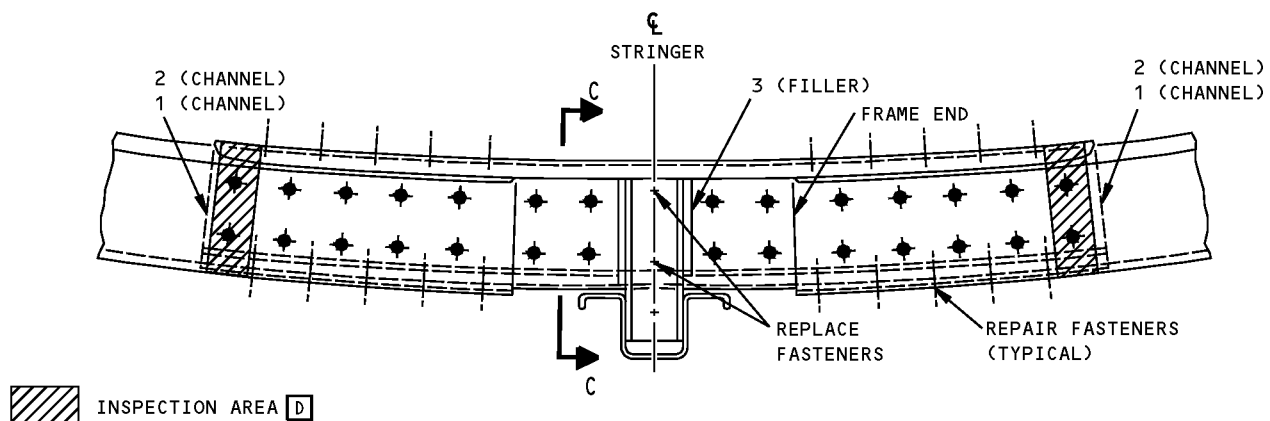
**REPAIR FOR DAMAGE AT A STRINGER
DETAIL II D**

**Fuselage Formed Zee Frame Repair - 757-SF
Figure 201 (Sheet 3 of 3)**

D INSPECT FOR CRACKS IN THE INITIAL FRAME AROUND THE HEAD OF THE FASTENERS WHERE INDICATED.

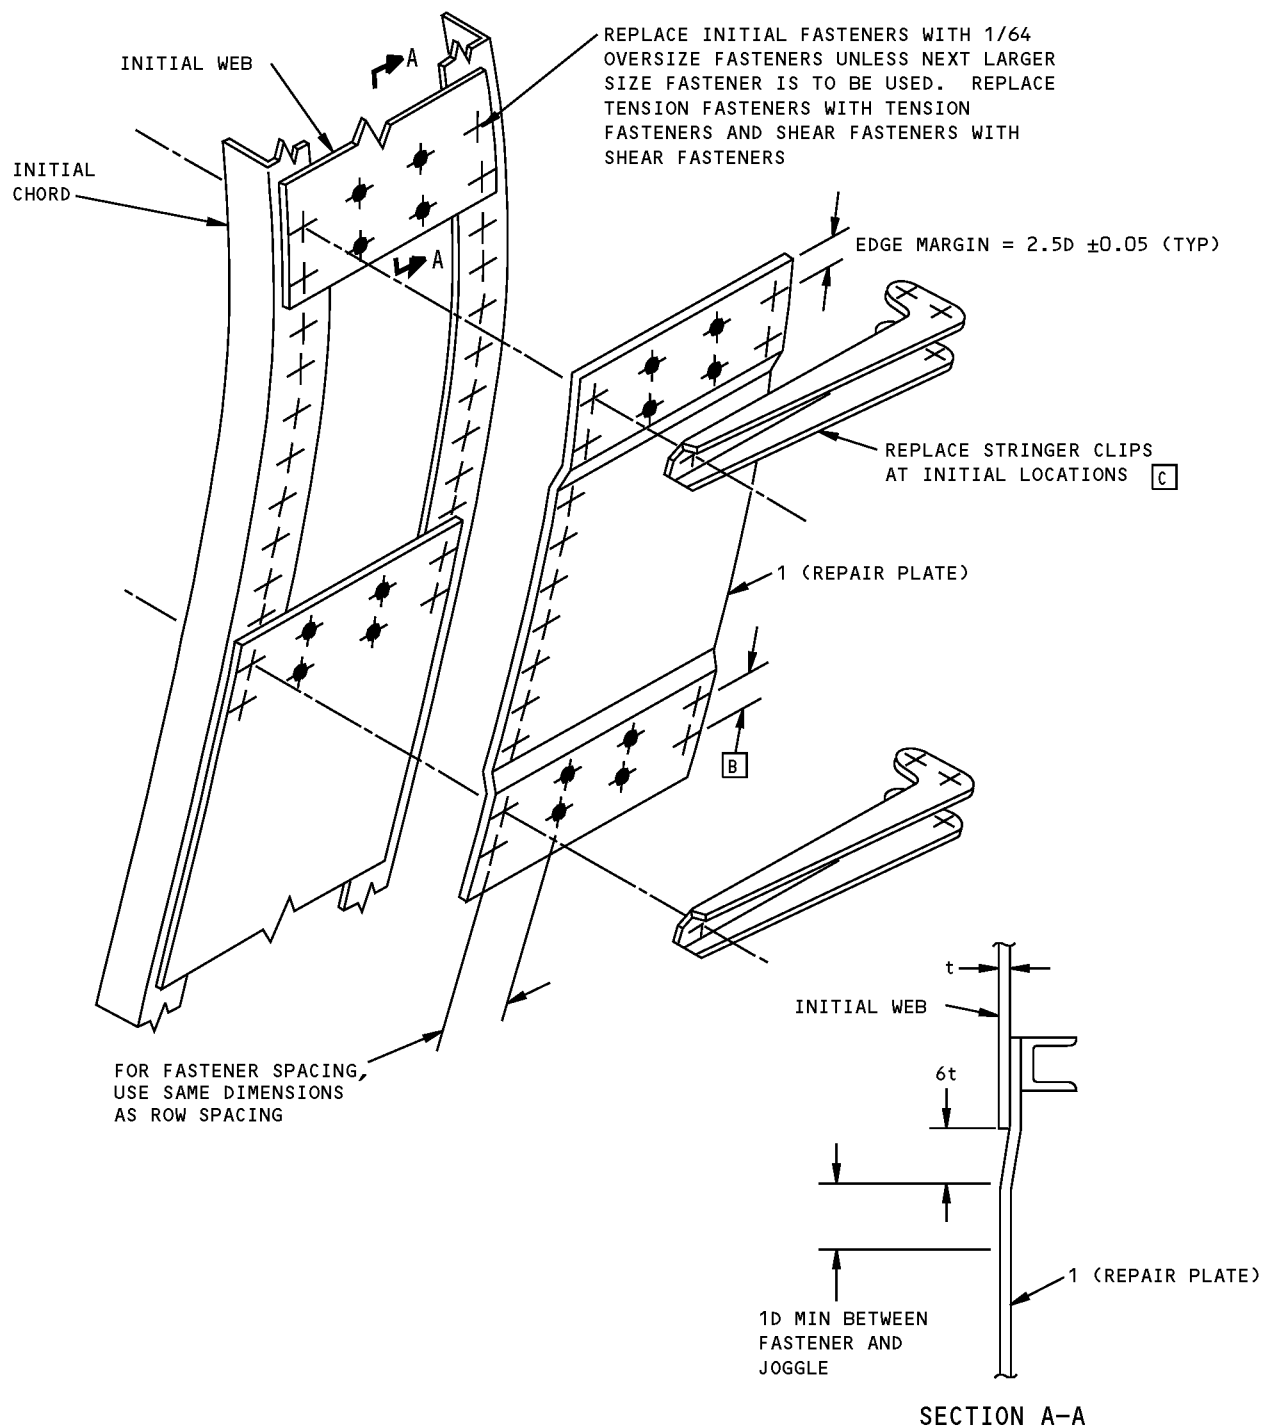
DETAIL I

WEB GAGE 0.071 INCH OR LESS

Fuselage Built-Up Frame Web Repair - 757-SF
Figure 201 (Sheet 2 of 3)

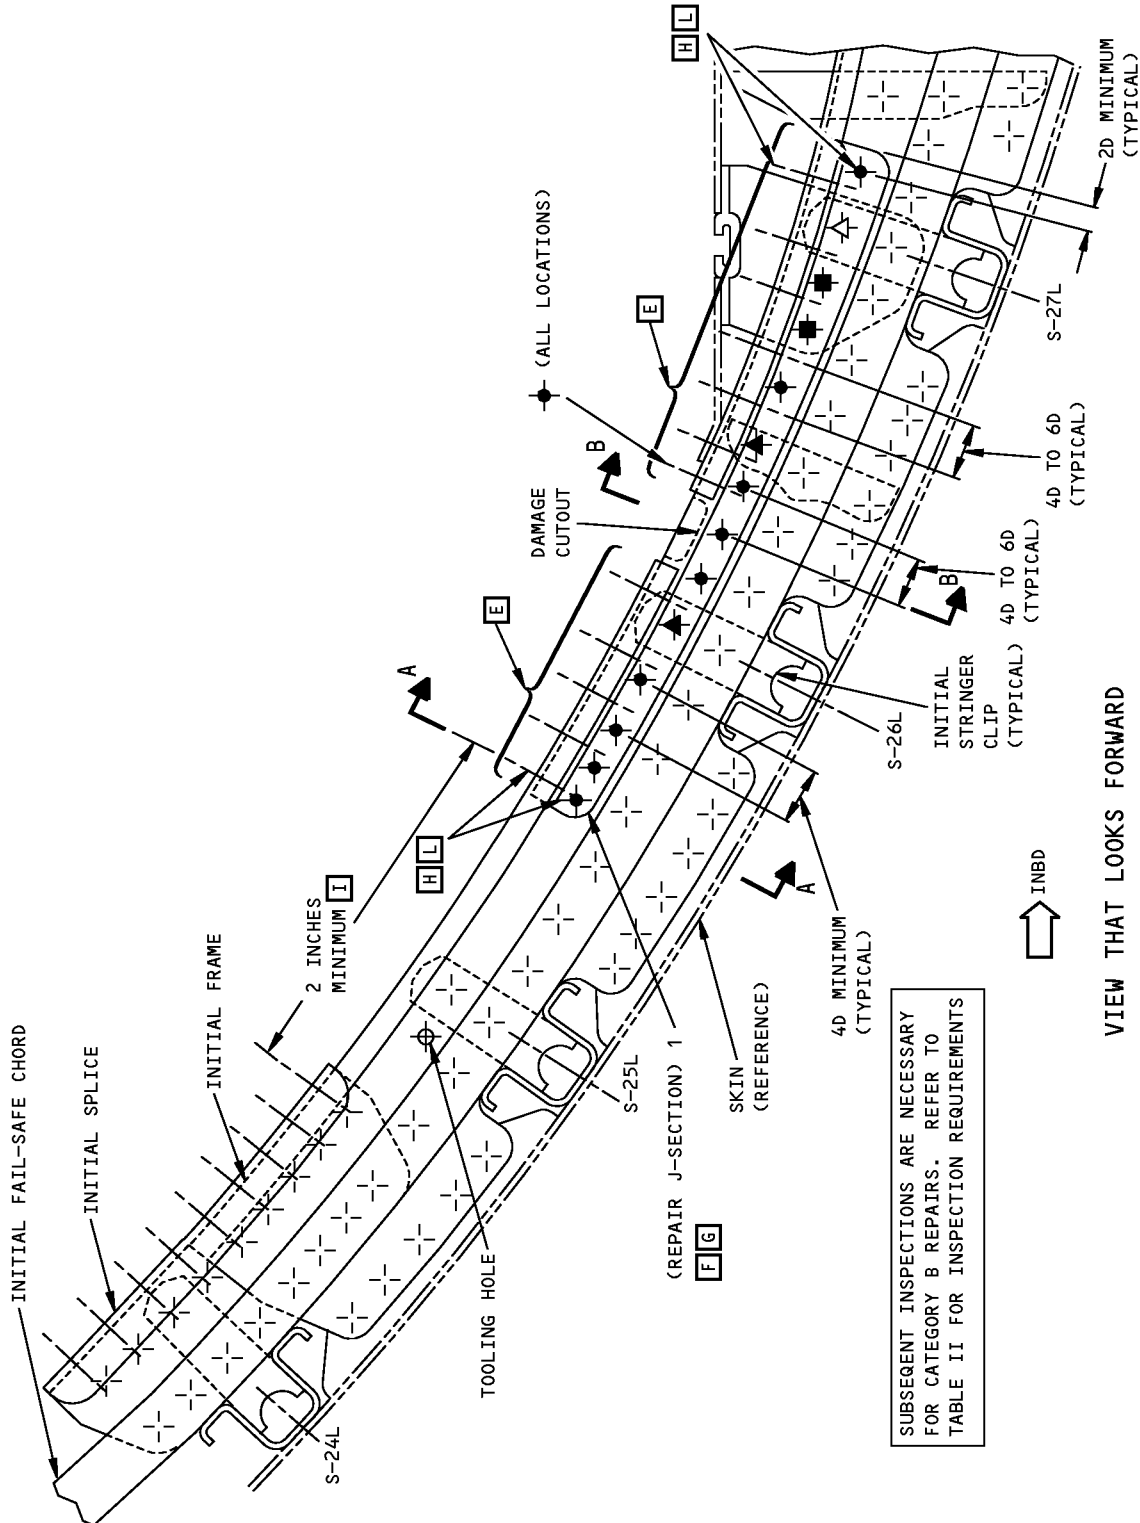
(STATION 1380 FRAME IS SHOWN, ALMOST THE SAME AT OTHER CARGO FRAMES)
REPAIR FOR DAMAGE AT THE INNER CHORD AND AWAY FROM THE PRODUCTION SPLICE
DETAIL 1

**Fuselage Lower Lobe Frame Repairs in the Forward and Aft Cargo Compartments
Figure 201 (Sheet 4 of 15)**

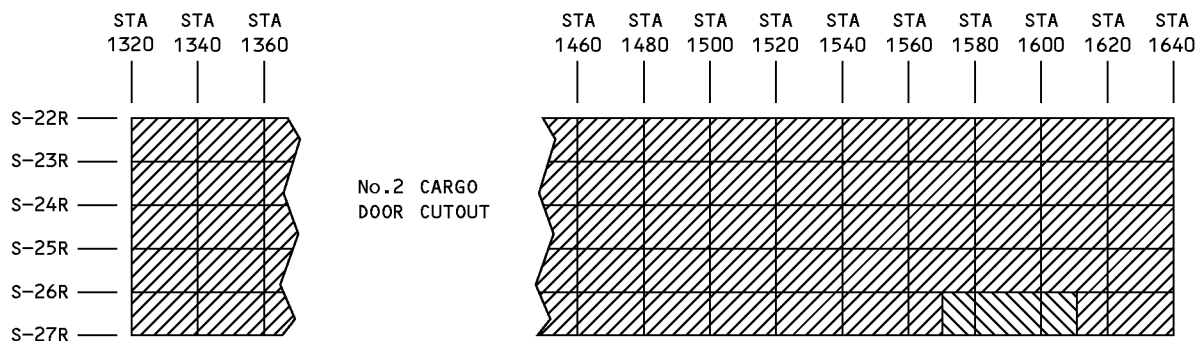
RIGHT SIDE

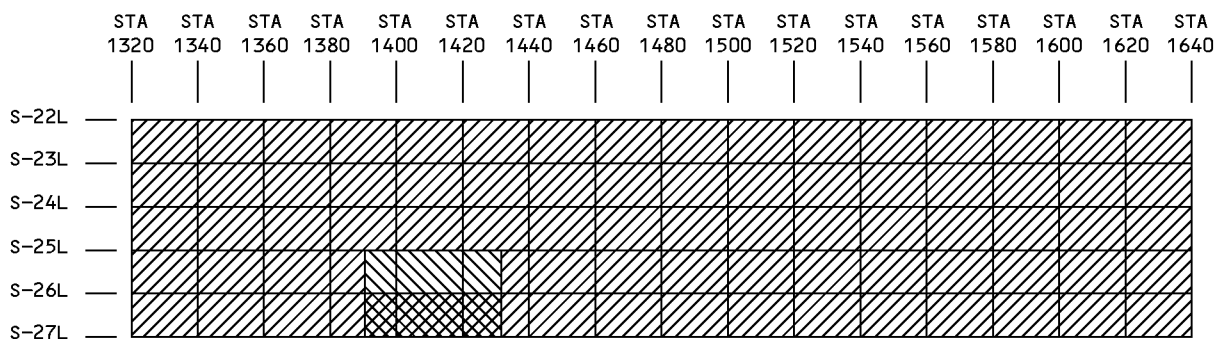
LEFT SIDE

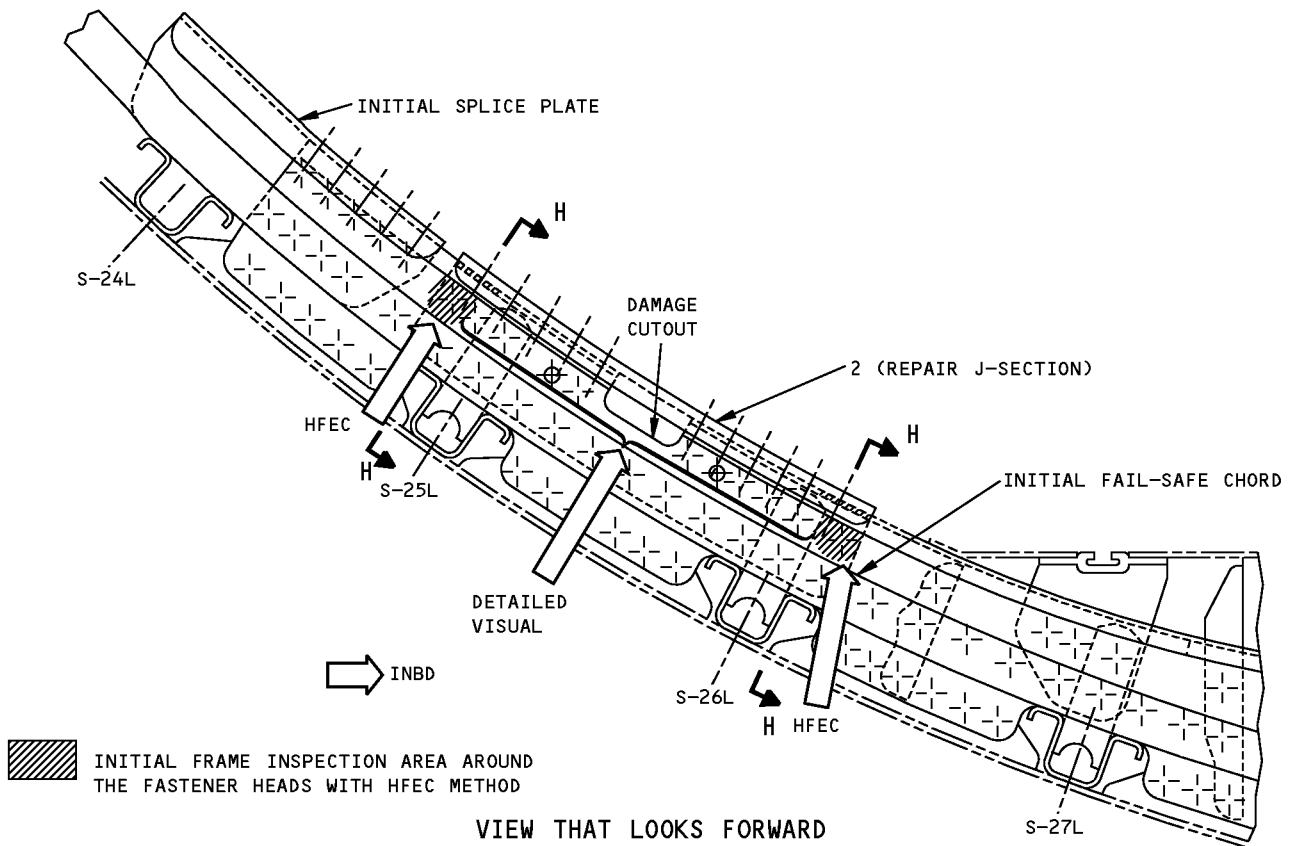
Fuselage Lower Lobe Frame Repairs in the Forward and Aft Cargo Compartments
Figure 201 (Sheet 13 of 15)

VIEW THAT LOOKS FORWARD
INSPECTION AREAS FOR DETAIL II
DETAIL VII

| CATEGORY B INSPECTION REQUIREMENTS | | | |
|---|---|---|---|
| NOTE: - INSPECT THE INITIAL FRAME IN THE REPAIRED AREA WITH HFEC METHOD AS SHOWN IN DETAILS VI, VII AND VIII AS APPLICABLE. - DO A DETAILED INSPECTION OF THE INITIAL FRAME COMMON TO THE REPAIR SECTION AS SHOWN IN DETAILS VI, VII, AND VIII. ALSO DO A DETAILED INSPECTION OF THE TWO ADJACENT FRAMES ON EACH SIDE (TOTAL OF FOUR FRAMES) OF THE REPAIRED FRAME (FROM ONE STRINGER ABOVE TO ONE STRINGER BELOW THE REPAIR SECTION). - CONTINUE WITH THE MPD ITEM 53-372-00 INSPECTIONS IN ALL AREAS BEYOND THE REPAIR. | | | |

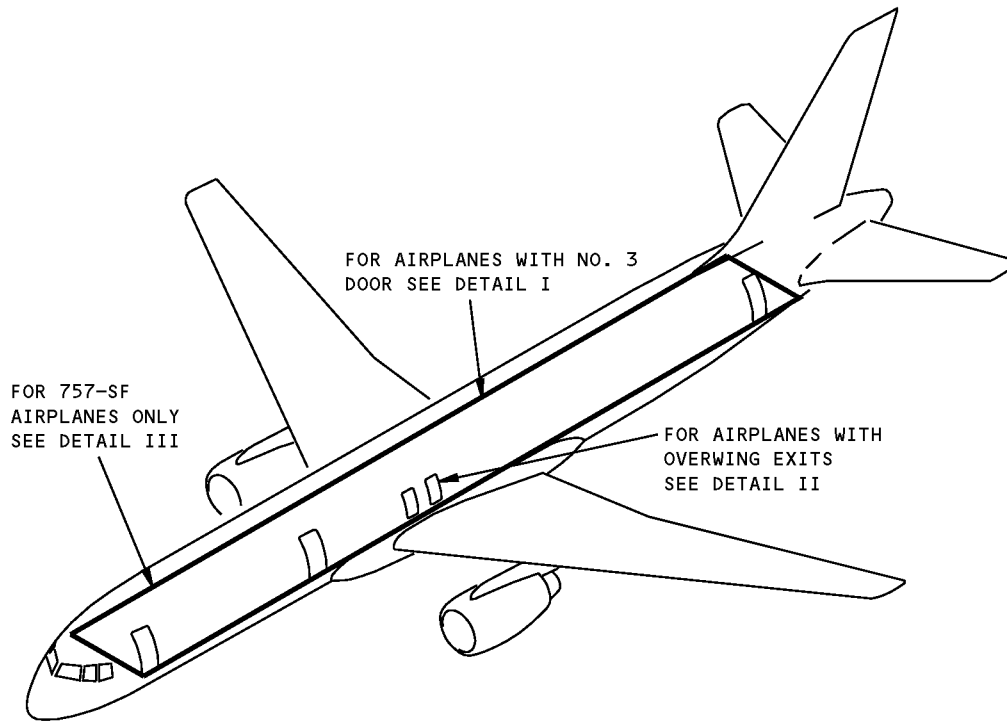
IDENTIFICATION 1 - MAIN DECK FLOOR PANEL

- THE FOLLOWING GROUND RULES HAVE BEEN USED FOR THE SELECTION OF FLOOR PANELS IN DESIGN. THE FLOOR PANEL ARRANGEMENT AND MATERIAL SELECTION, HOWEVER, REMAINS AS OPERATOR OPTIONS.

- 2. MEDIUM DENSITY ALUMINUM HONEYCOMB CORES ARE USED IN SPECIAL CASES OF AREAS WITH HIGH LOADS NOT SUBJECT TO MOISTURE.
- 3. MEDIUM AND DUAL DENSITY HONEYCOMB CORES (BOTH NOMEX AND ALUMINUM CORES) ARE USED IN HIGH TRAFFIC AREA SUCH AS IN AISLES.

- 4. HIGH DENSITY NOMEX HONEYCOMB CORES ARE USED IN AREA OF HIGH LOADS SUBJECT TO MOISTURE SUCH AS IN GALLEYS AND IN THE VICINITY OF ENTRANCE DOORS.
- LAVATORY FLOOR INTEGRAL WITH MODULE

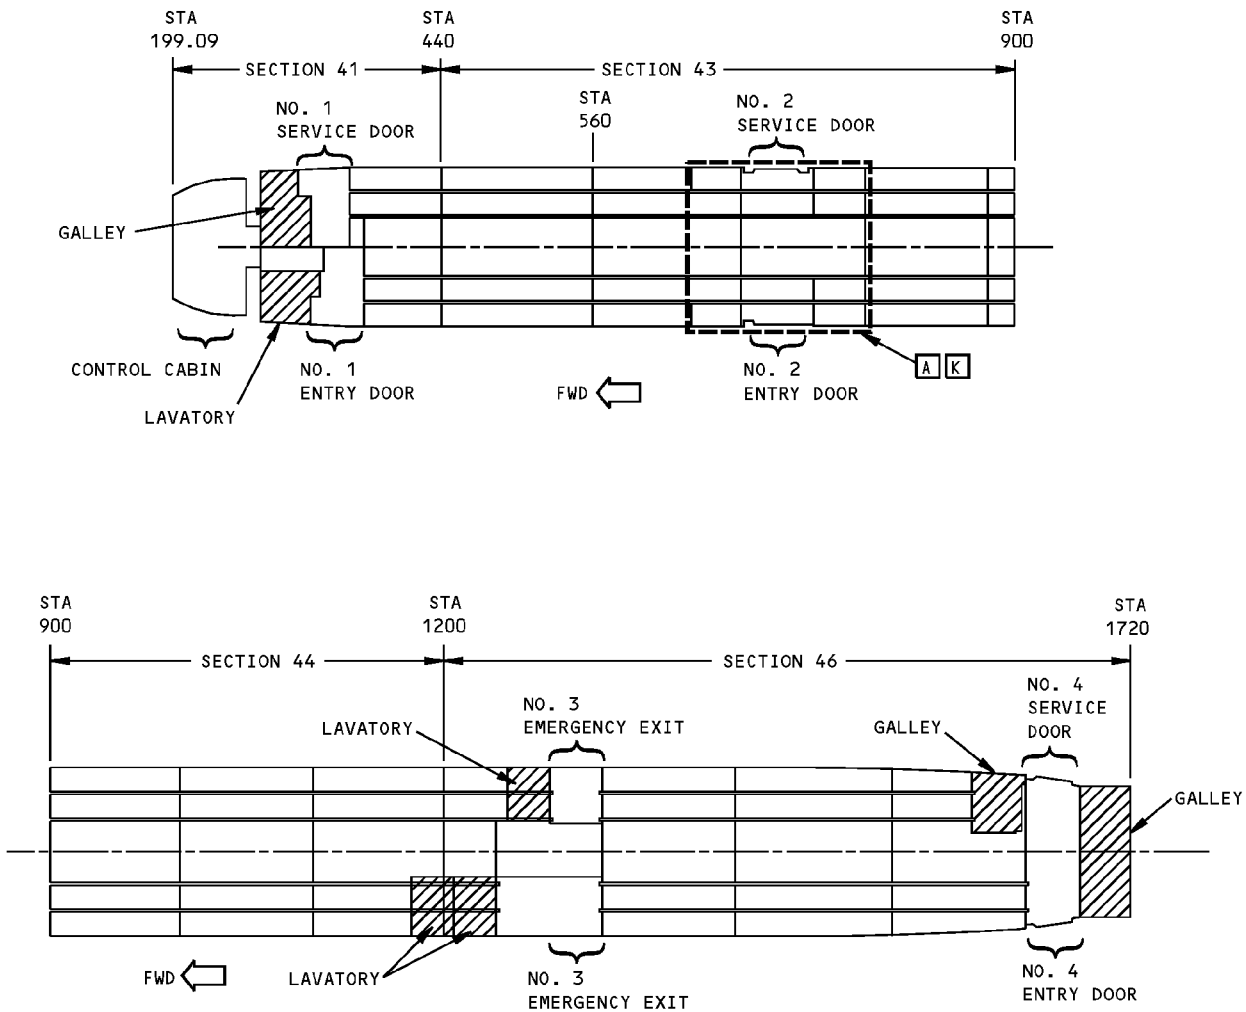
DETAIL I

BASIC 4-DOOR CONFIGURATION
AIRPLANES WITH NO. 3 DOOR EMERGENCY EXITS
TYPICAL FLOOR PANEL ARRANGEMENT

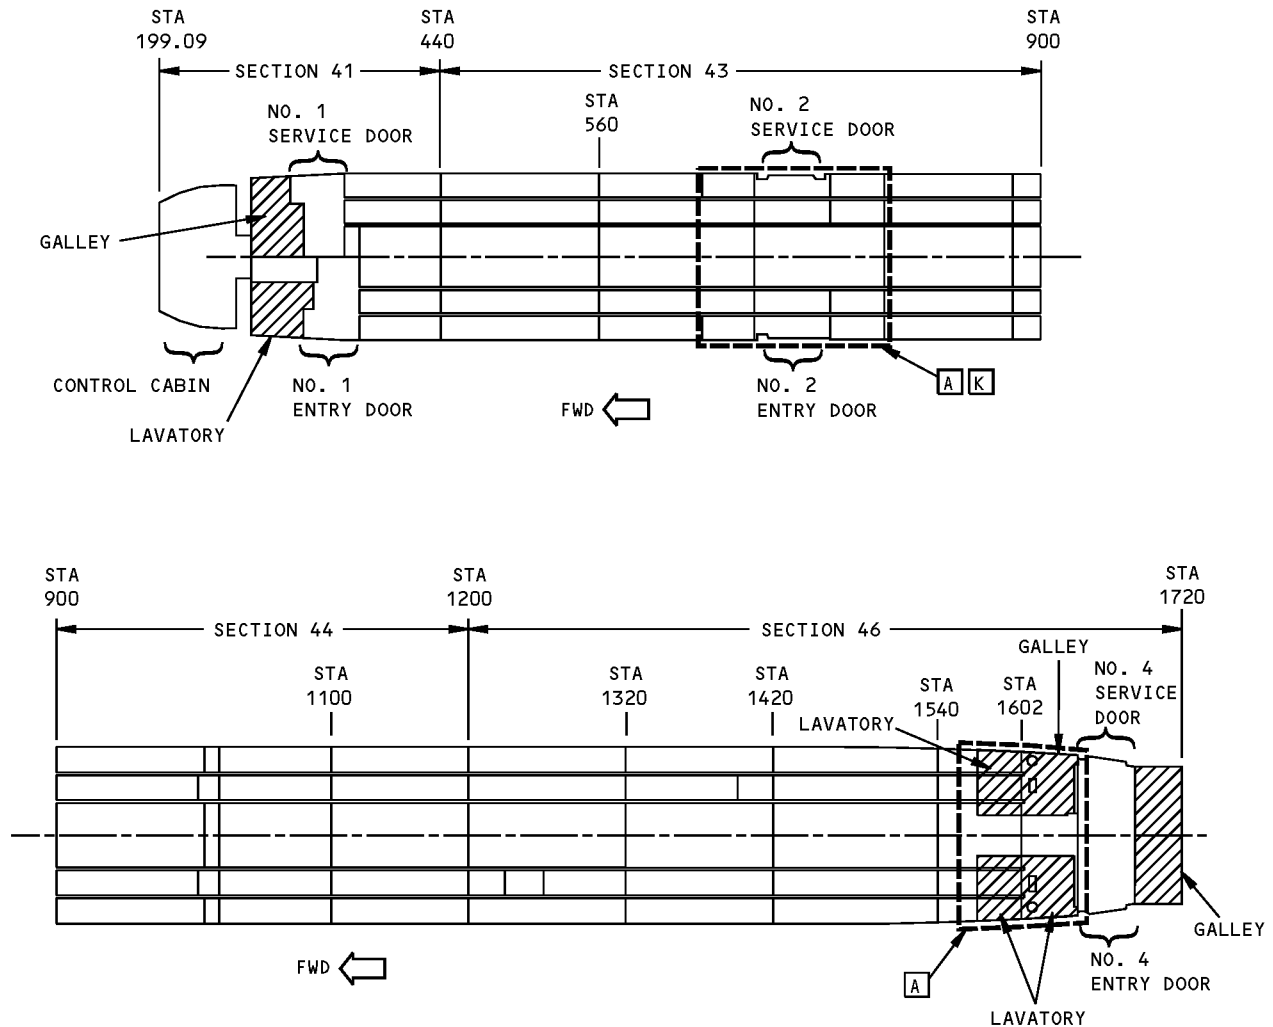
DETAIL II

BASIC 3-DOOR CONFIGURATION
AIRPLANES WITH OVERWING EMERGENCY EXITS
TYPICAL FLOOR PANEL ARRANGEMENT

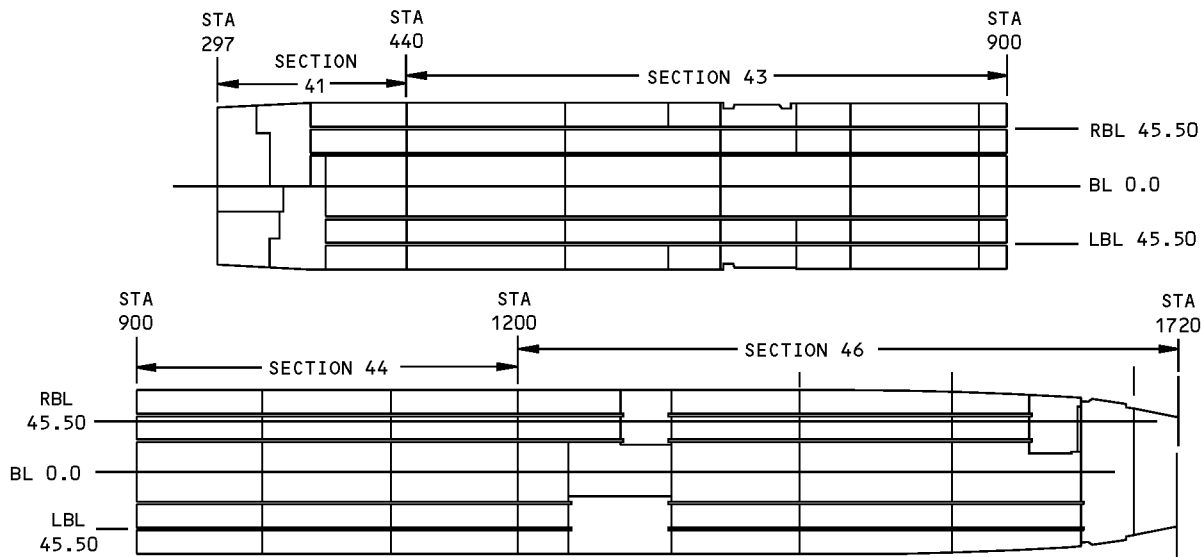
BASIC FLOOR PANEL ARRANGEMENT SHOWN
FLOOR PANEL ARRANGEMENT MAY VARY WITH OPERATOR'S OPTION
DETAIL I

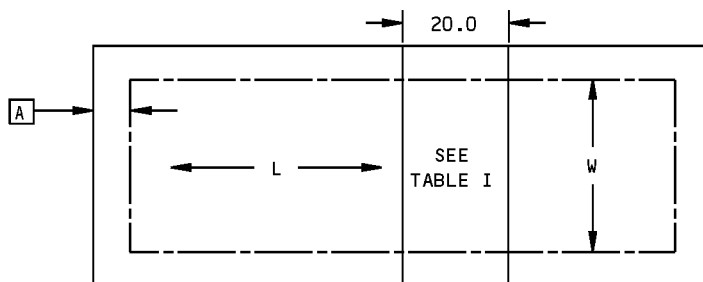
TYPICAL FLOOR PANEL
PLAN VIEW

| ALLOWABLE DAMAGE FOR ANY 20.0 INCH LENGTH (FORE AND AFT) | | | |
| 2.0 MAX LENGTH SINGLE CRACK OR MULTIPLE CRACKS TOTALING NO MORE THAN 2.0 INCHES | UP TO 4 SQUARE INCHES | UP TO 4 SQUARE INCHES | UP TO 4 SQUARE INCHES |

A NO DAMAGE ALLOWED WITHIN 3.00 INCHES OF THE EDGE OR PANEL CUTOUT

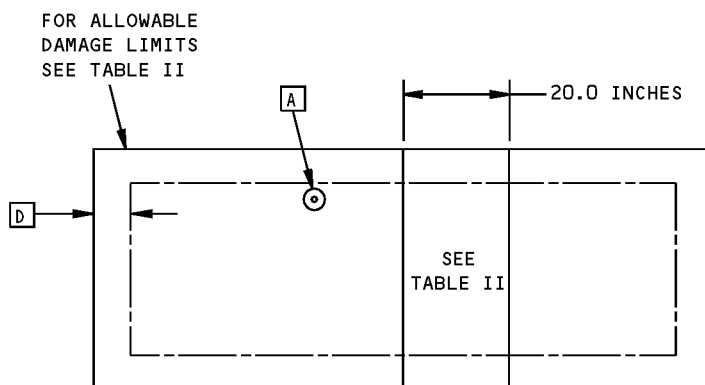
TYPICAL FLOOR PANEL FOR FIBERGLASS FACED NOMEX CORE PANELS
DETAIL II

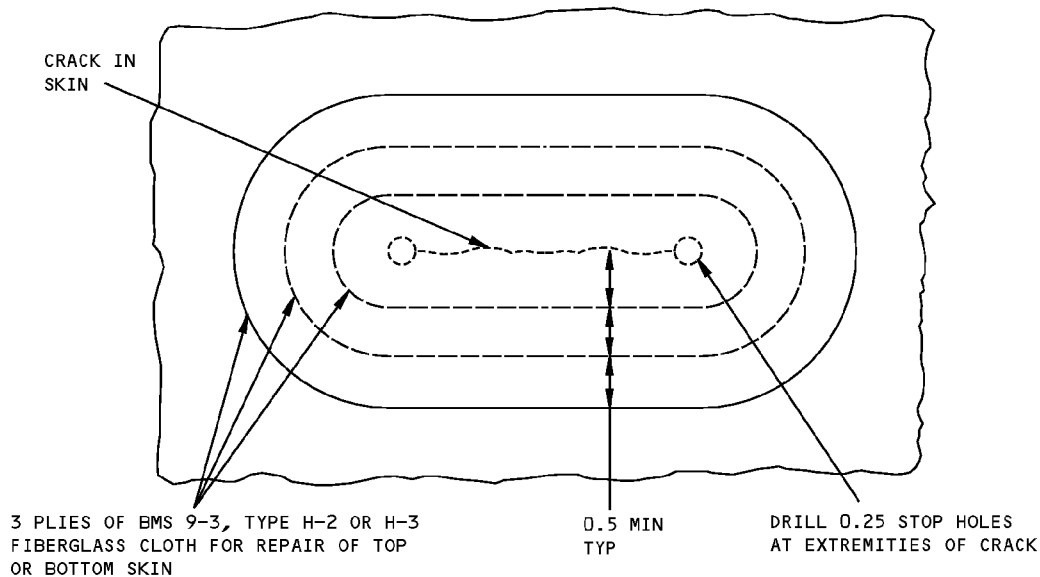
TYPICAL REPAIR TO CRACK IN SKIN USING FIBERGLASS CLOTH REPAIR PLIES

- (2) Carefully cut the damaged skin with a circular hole saw and remove the damaged portion, or if the skin is cracked, drill stop holes at the extremities as shown in Figure 201/REPAIR 1, Details I and II.

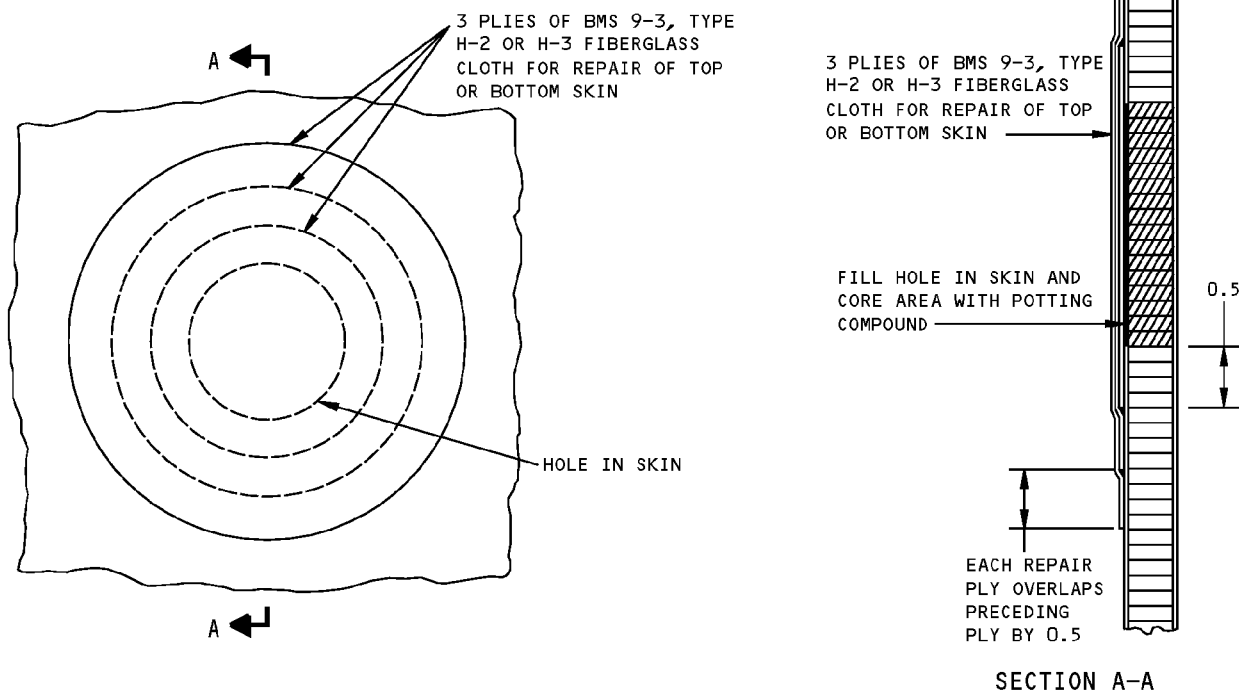
**TYPICAL REPAIR TO HOLE OR CRACK IN SKIN USING FIBERGLASS CLOTH REPAIR PLIES
DETAIL I**

- (5) Apply either of the following:
 - (a) Three plies of BMS 9-3, Type H-2 or H-3 fiberglass cloth impregnated with Resin Mix 1 to a damaged top skin or bottom skin as shown in Figure 201/REPAIR 1, Detail I. Refer to Paragraph 4./REPAIR 1 for cleaning of the damaged area, and preparation and application of fiberglass repair plies.

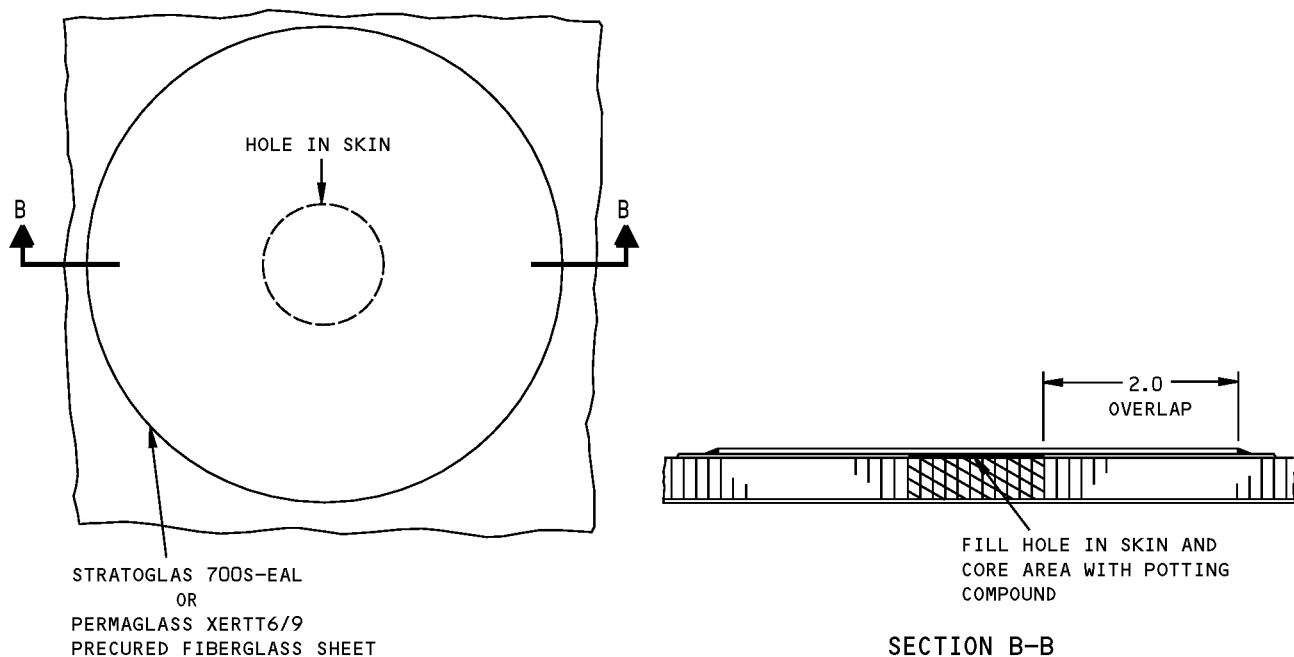
REPAIR FOR HOLE

TYPICAL REPAIR TO HOLE OR CRACK IN SKIN USING PRECURED FIBERGLASS SHEET
DETAIL II

- (b) One ply of precured fiberglass sheet (Stratoglas 700S-EAL or Permaglass XERTT6/9) as shown in Figure 201/REPAIR 1, Detail II. Refer to Paragraph 5./REPAIR 1 for cleaning of the damaged area, and preparation and application of the fiberglass sheet.

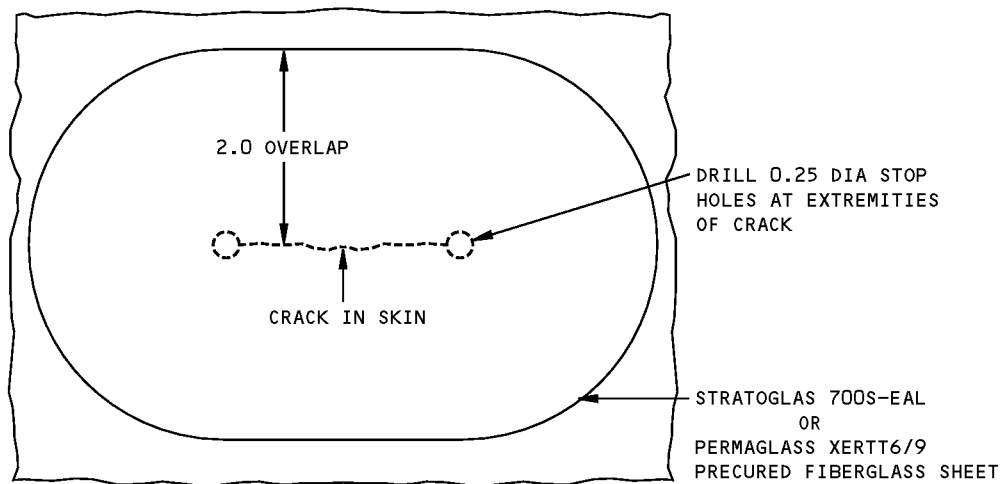
REPAIR FOR CRACK

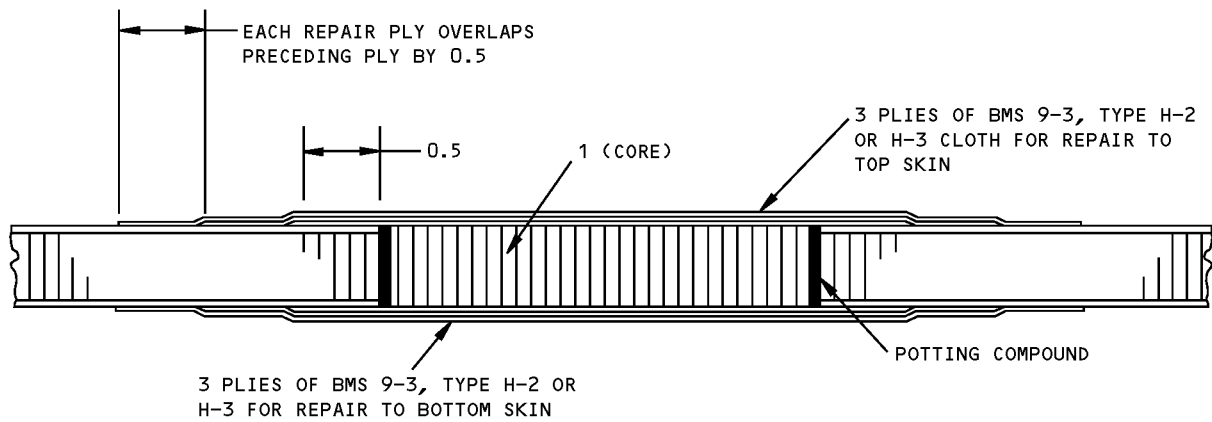
TYPICAL REPAIR TO SKIN AND CORE USING FIBERGLASS CLOTH REPAIR PLIES
DETAIL III

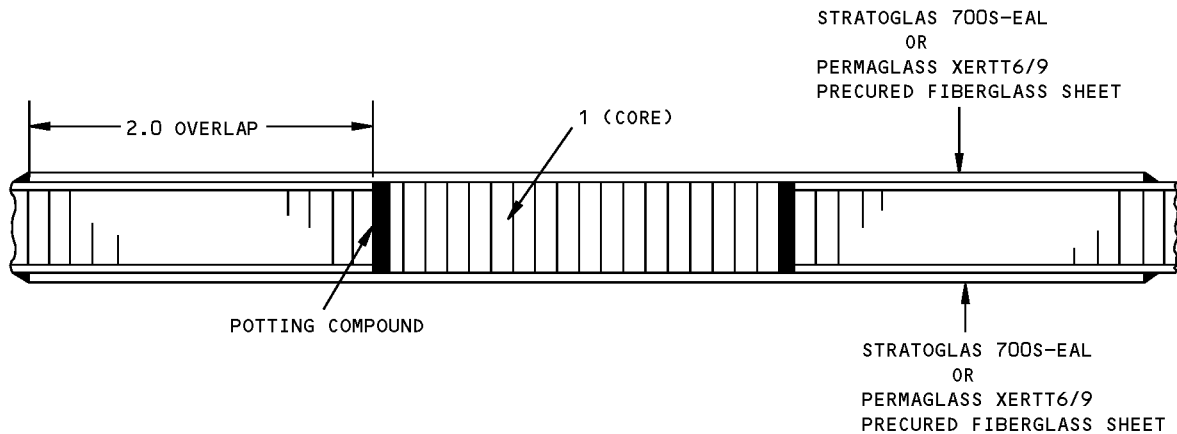
TYPICAL REPAIR TO SKIN AND CORE USING PRECURED FIBERGLASS SHEET
DETAIL IV

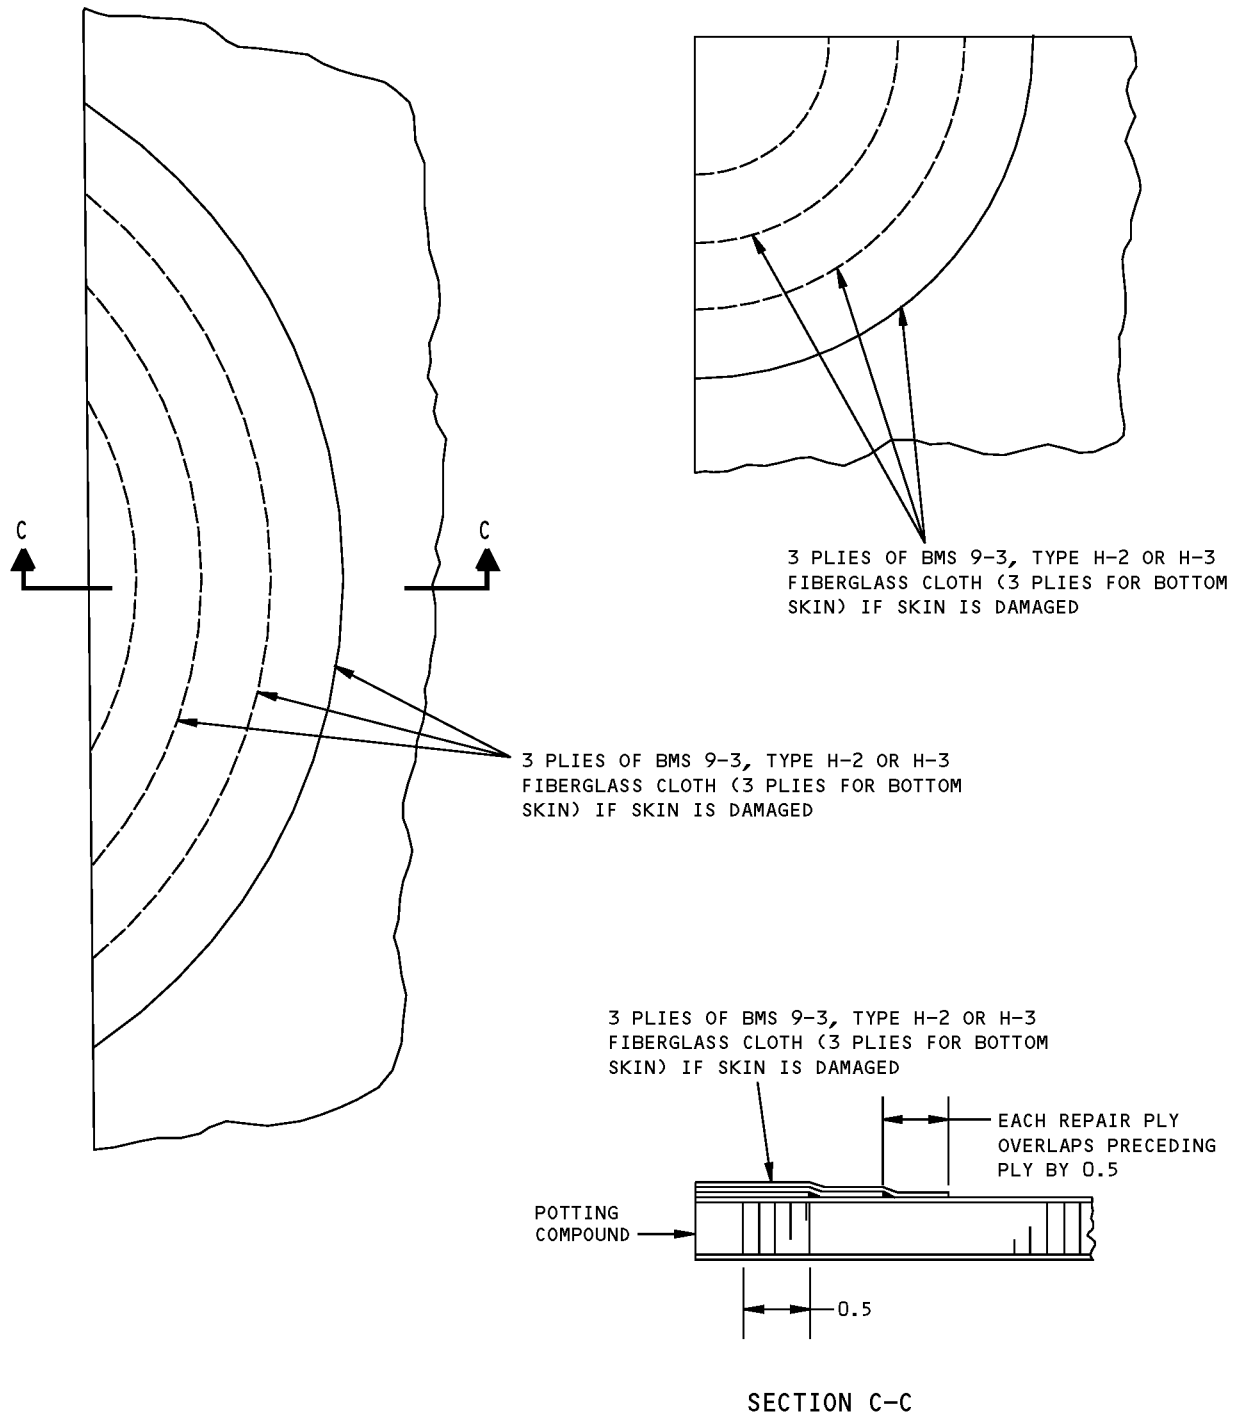
TYPICAL REPAIR TO CORE AT EDGE OF PANEL USING FIBERGLASS CLOTH REPAIR PLIES
DETAIL V
