FUSELAGE

757-200 STRUCTURAL REPAIR MANUAL

CHAPTER 53 FUSELAGE

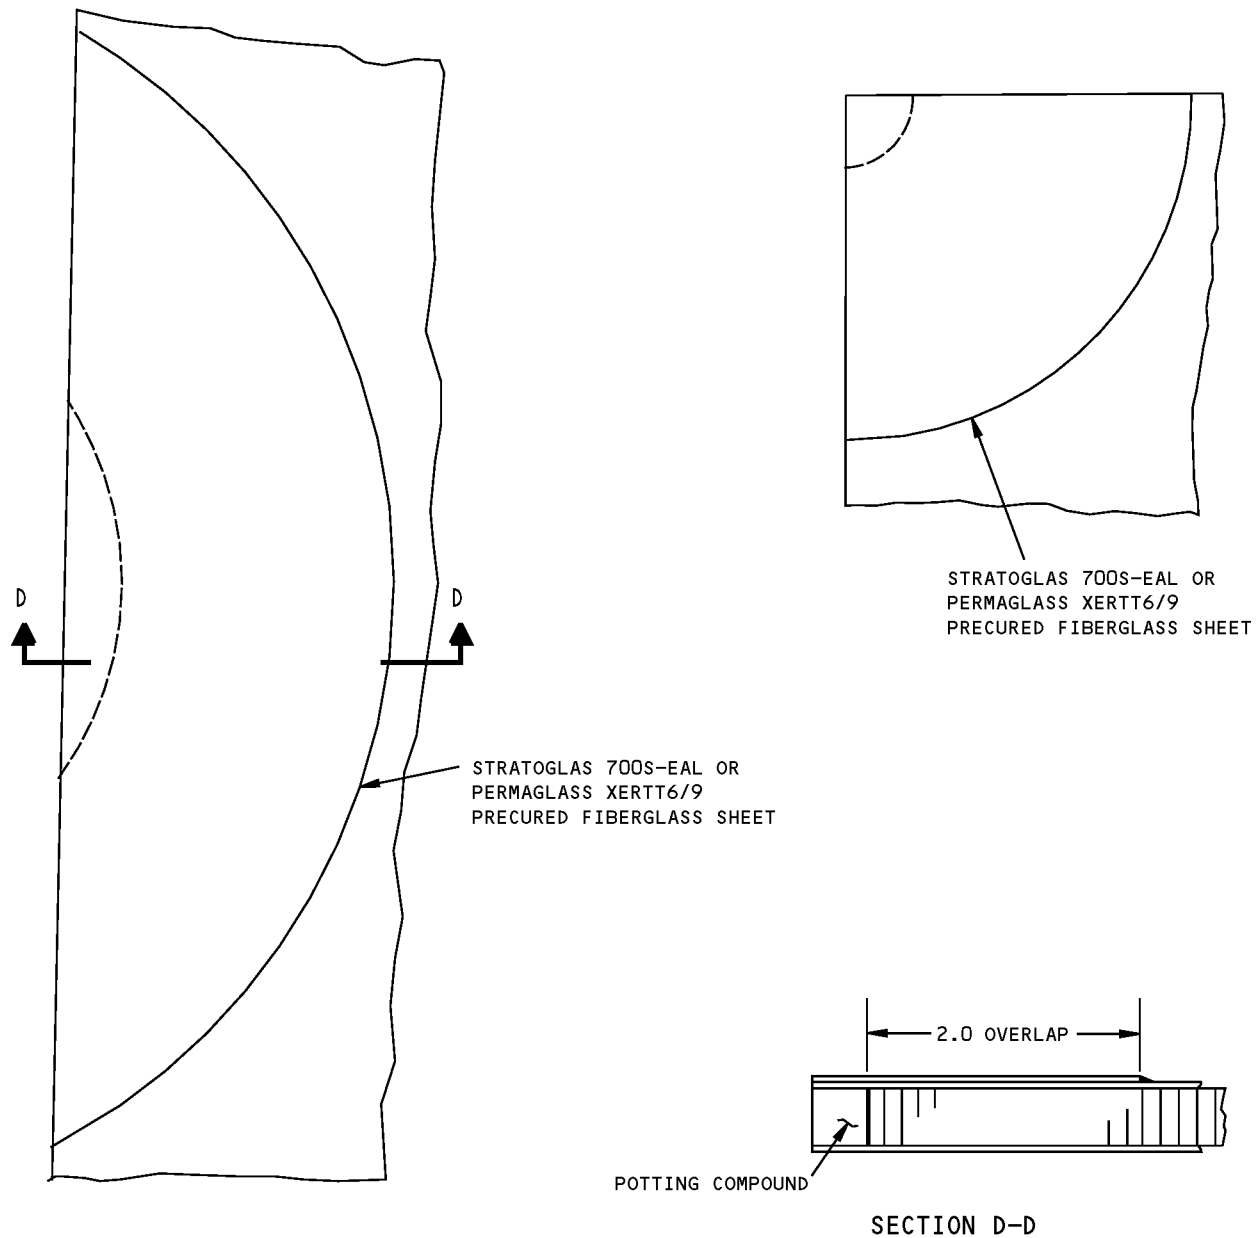
TYPICAL REPAIR TO CORE AT EDGE OF PANEL USING PRECURED FIBERGLASS SHEET
DETAIL VI

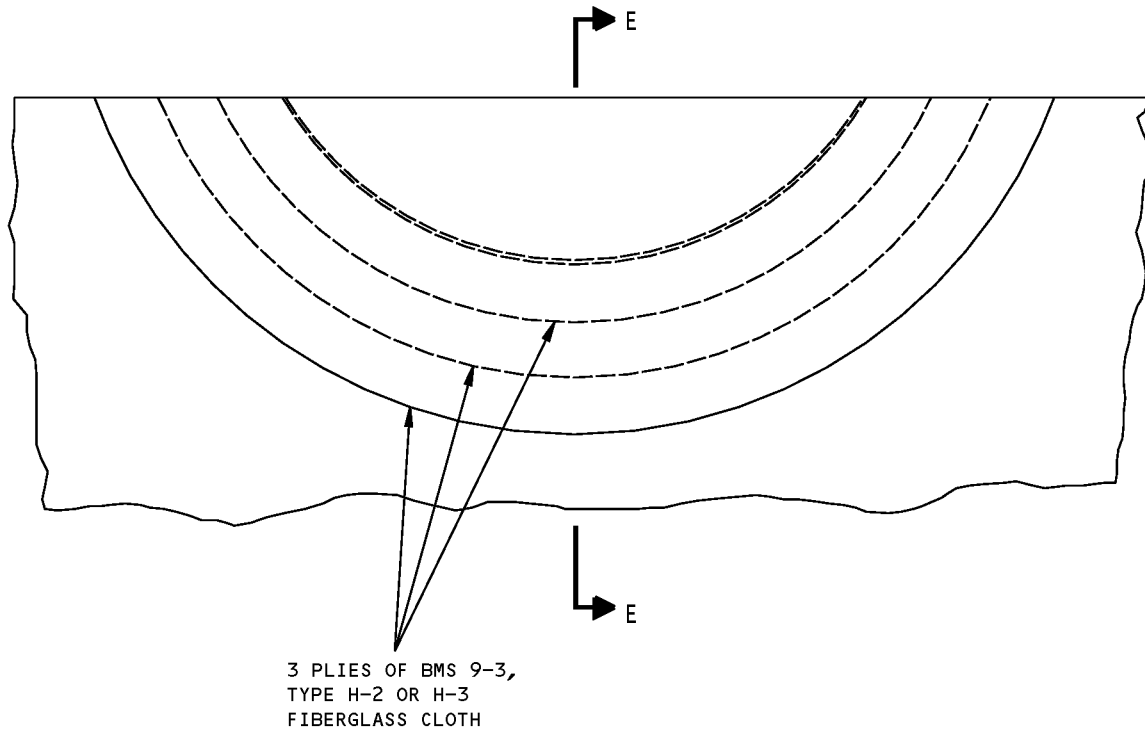
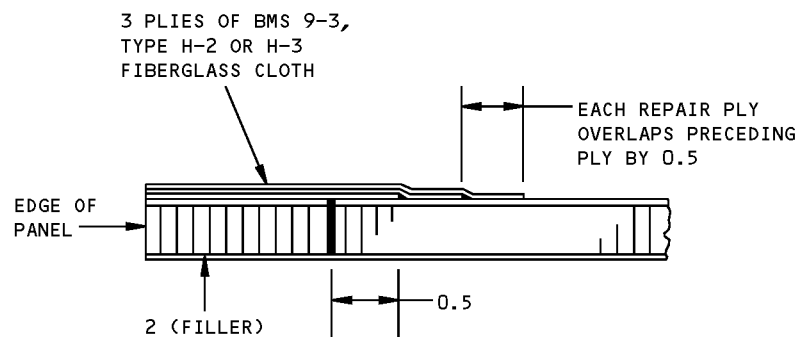
SECTION E-E

**TYPICAL REPAIR TO SKIN AND CORE AT EDGE OF PANEL USING FIBERGLASS CLOTH REPAIR PLIES
DETAIL VII**

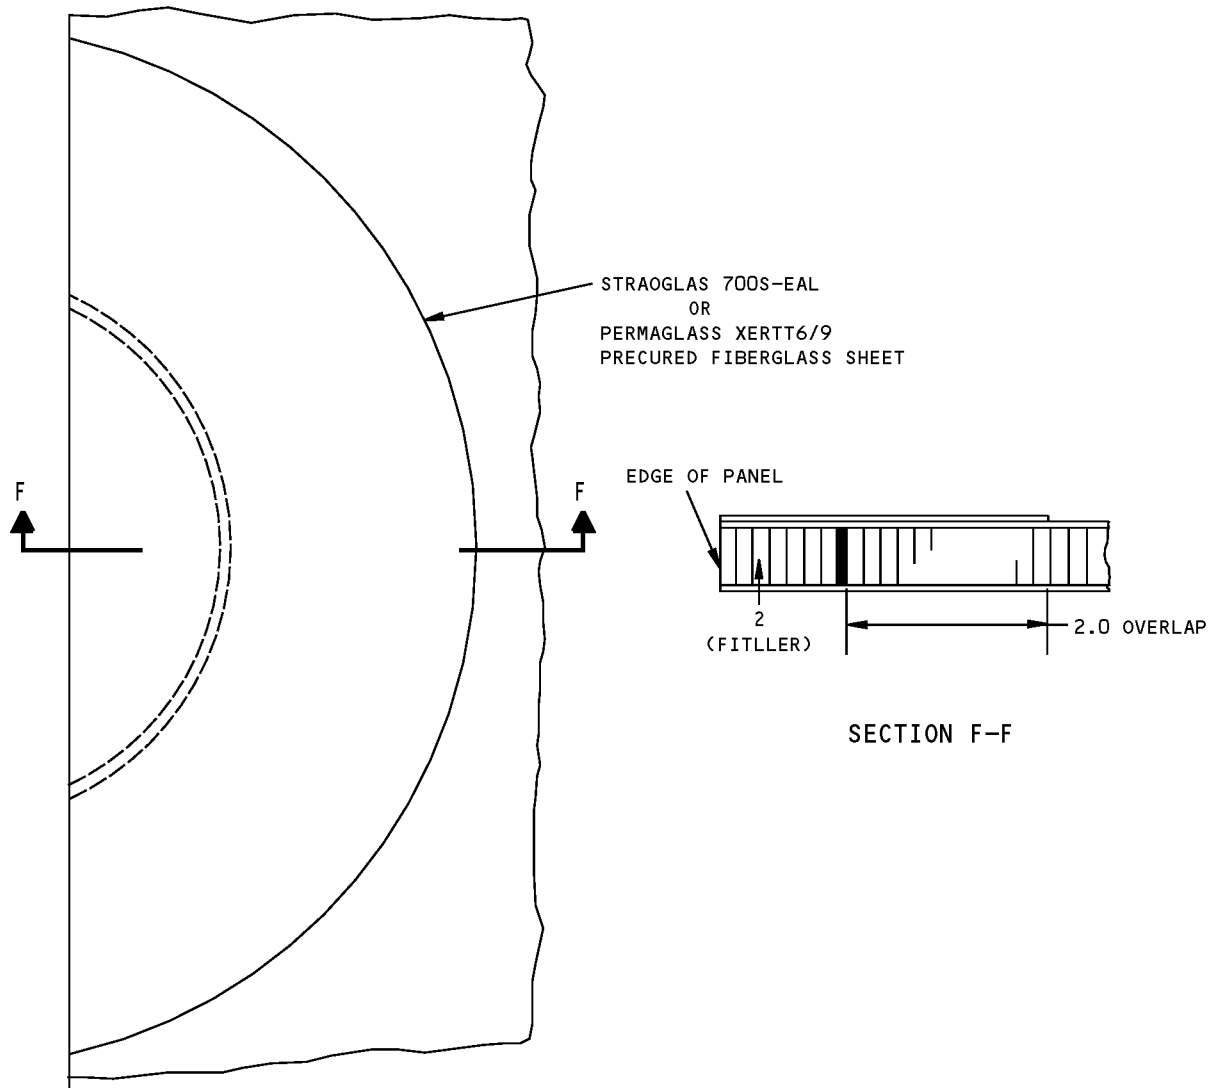
DETAIL VIII

TYPICAL REPAIR TO SKIN AND CORE AT EDGE OF PANEL
USING PRECURED FIBERGLASS SHEET

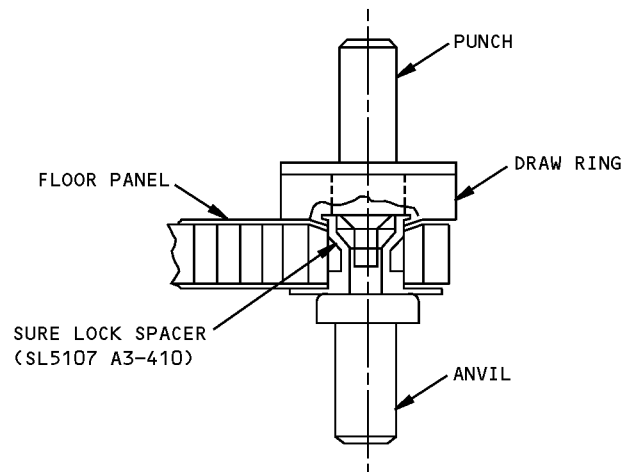
INSTALLATION TOOL [E] FOR SURE LOCK SPACER SL5107 A3-410
DETAIL IX

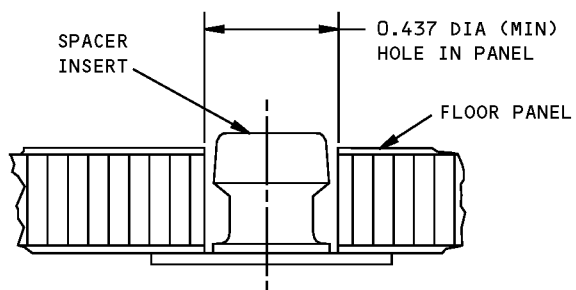
BEFORE SWAGING

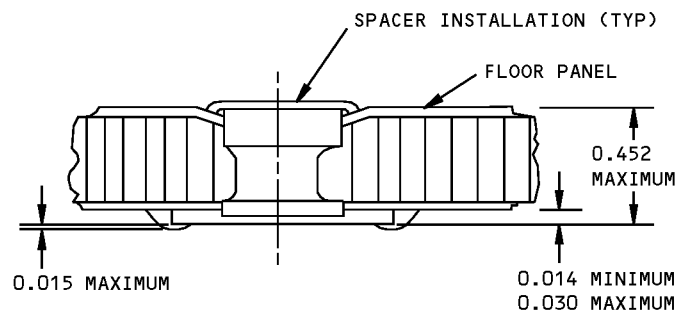
DETAIL X

AFTER SWAGING

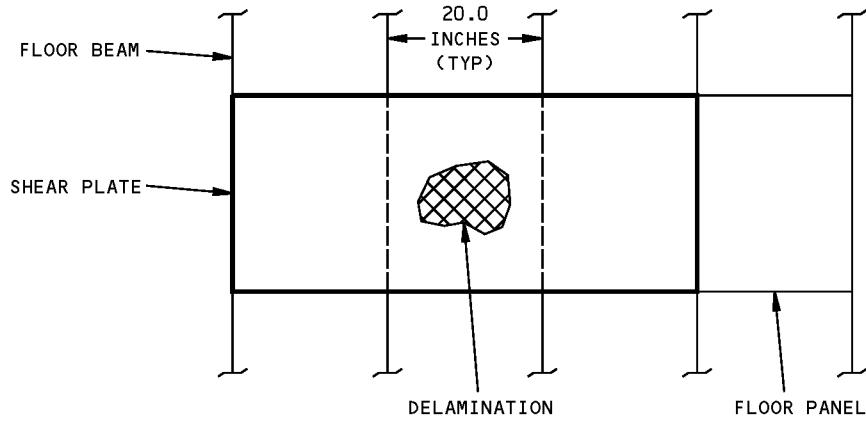
**DELAMINATION IN CENTER OF PANEL
DETAIL I**

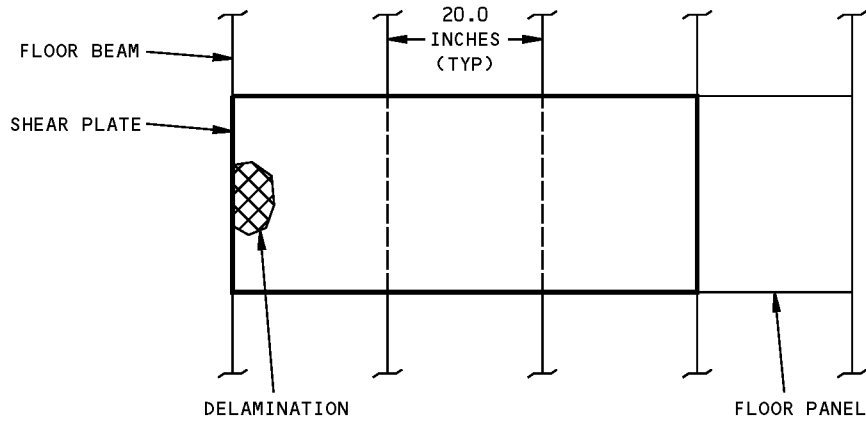
**DELAMINATION NEAR EDGE OF PANEL
DETAIL II**

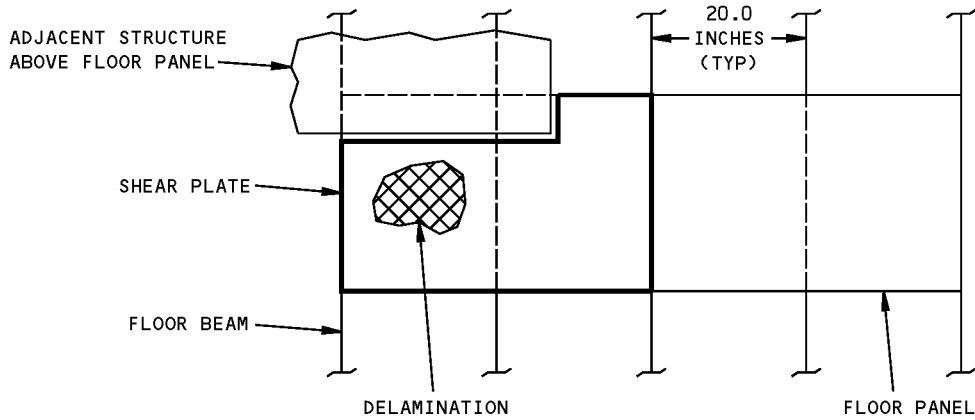
**Floor Panel Repair Limits - Time Limited Repairs
Figure 202**

**DELAMINATION NEAR ADJACENT STRUCTURE
DETAIL III**

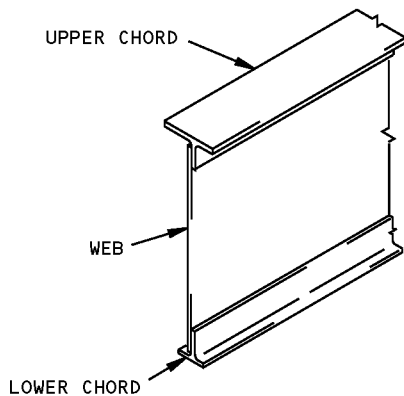
LONGITUDINAL AND TRANSVERSE FLOOR
BEAMS IN SECTIONS 41 AND 44
BUILT UP

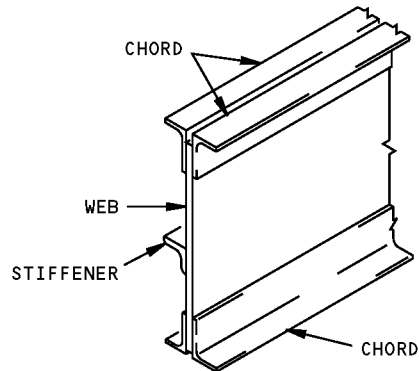
TYPICAL STUB BEAM
BUILT UP

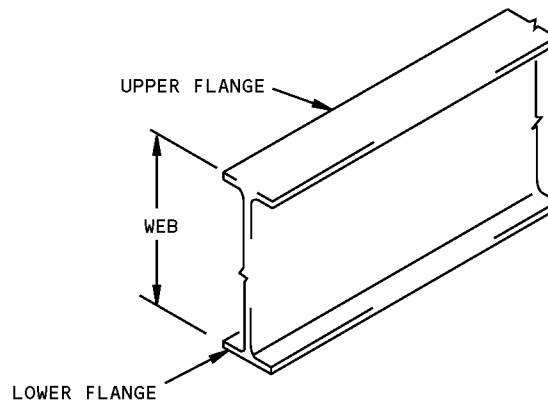
TRANSVERSE FLOOR BEAM
EXTRUDED OR MACHINED

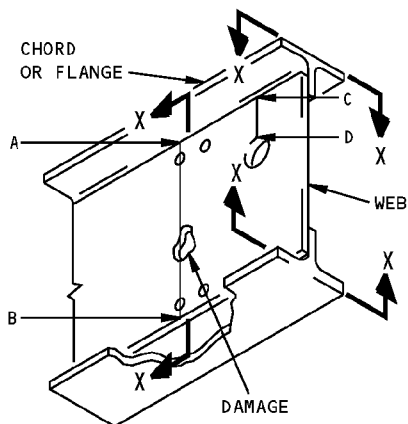
LOSS IN CROSS-SECTIONAL AREA ALONG ANY LINE A-B OR C-D DUE TO REMOVAL OF NICKS, GOUGES OR CORROSION PER DETAIL II OR DETAIL III MUST NOT EXCEED 5% OF ORIGINAL NET CROSS-SECTIONAL AREA (SEE SECTION X-X)

A_2 = AREA REMOVED FOR NICKS, GOUGES, OR CORROSION

(CHORD OR FLANGE, ROTATED 90° FOR THE WEB)

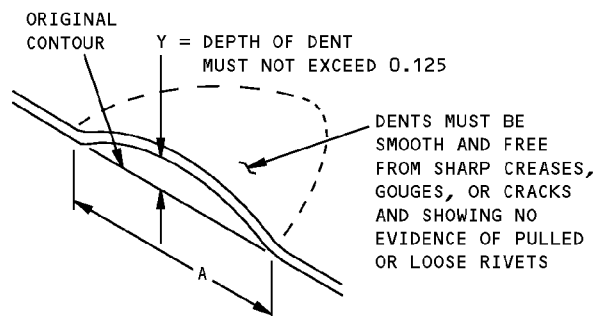
DETAIL V

A = WIDTH OF MINOR AXIS OF DENT

- [C] SMOOTH DENTS THAT ARE FREE FROM CRACKS, GOUGES AND ABRASIONS, AND SHOWING NO EVIDENCE OF PULLED OR LOOSE RIVETS, ARE ALLOWED UP TO 0.125 INCH DEEP PROVIDED THAT A/Y IS NOT LESS THAN 20. SEE DETAIL V.

- [E] REMOVE EDGE DAMAGE AS SHOWN IN DETAIL II. ELSEWHERE, REMOVE DAMAGE AS SHOWN IN DETAIL III.
- [F] SMOOTH DENTS THAT ARE FREE FROM CRACKS, GOUGES AND ABRASIONS, AND SHOWING NO EVIDENCE OF PULLED OR LOOSE RIVETS, ARE ALLOWED UP TO 0.125 INCH DEEP PROVIDED THAT A/Y IS NOT LESS THAN 30. SEE DETAIL V.

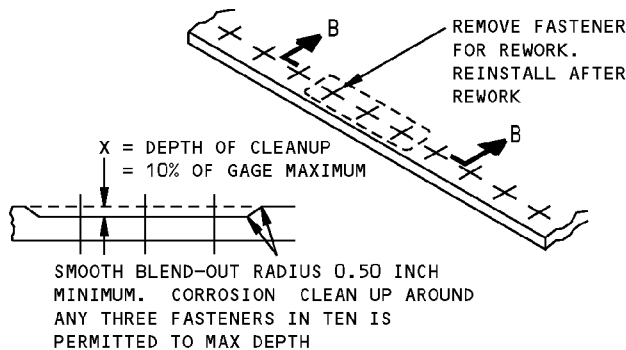
DETAIL VI

SECTION B-B CORROSION CLEANUP

- [B] EDGE DAMAGE MUST BE REMOVED AS SHOWN IN DETAILS II AND VI. ELSEWHERE DAMAGE MUST BE REMOVED AS SHOWN IN DETAIL III. FASTENER EDGE MARGINS MUST BE MAINTAINED. THE TOTAL CROSS-SECTIONAL AREA REMOVED AS SHOWN IN DETAILS II OR III TO REMOVE NICKS, GOUGES OR CORROSION MUST NOT EXCEED 5 PERCENT OF THE INITIAL CROSS-SECTIONAL AREA OF THE FLANGE OR WEB AS APPROPRIATE. SEE DETAIL IV. THE LIMITATION ON CROSS-SECTIONAL AREA REMOVAL AND THE LIMITATION TO THE DEPTH OF CLEANUP (AS SHOWN IN DETAILS II AND III) MUST BOTH BE SATISFIED.

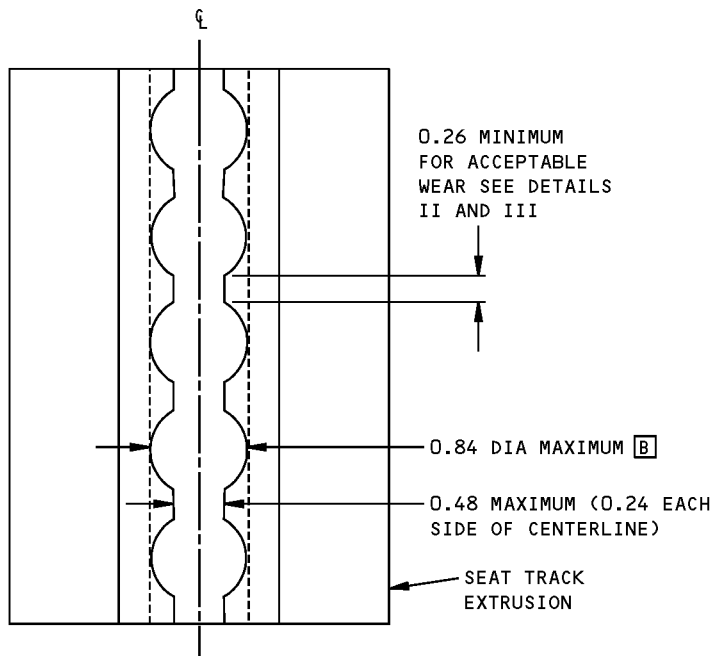
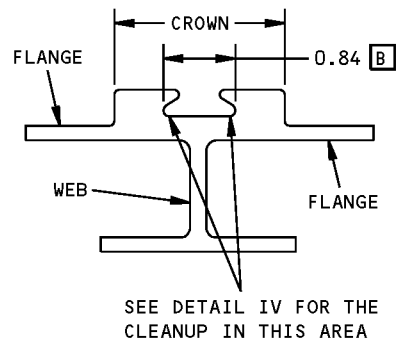
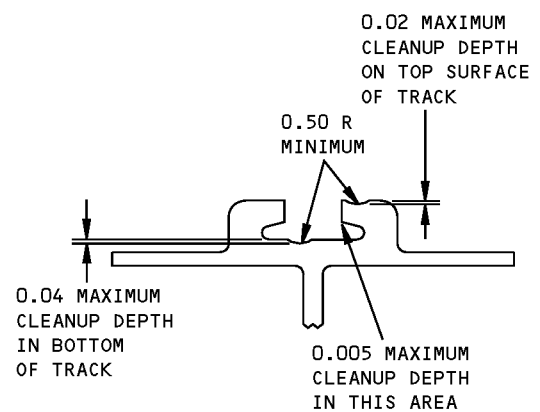
REMOVAL OF DAMAGE AT THE CROWN AREA (DIMENSIONS SHOWN ARE THE SAME FOR SEAT TRACKS OVER THE WING) DETAIL I

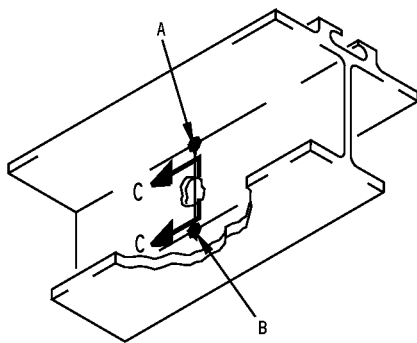
DETAIL VI

LOSS IN CROSS-SECTIONAL AREA ALONG ANY
LINE A-B DUE TO REMOVAL OF NICKS, SCRATCHES,
GOUGES OR CORROSION PER DETAIL V AND DUE
TO PUNCTURE CLEANUP PER NOTE [6] MUST NOT EXCEED
10% OF ORIGINAL WEB NET CROSS-SECTIONAL AREA
(SEE SECTION C-C)

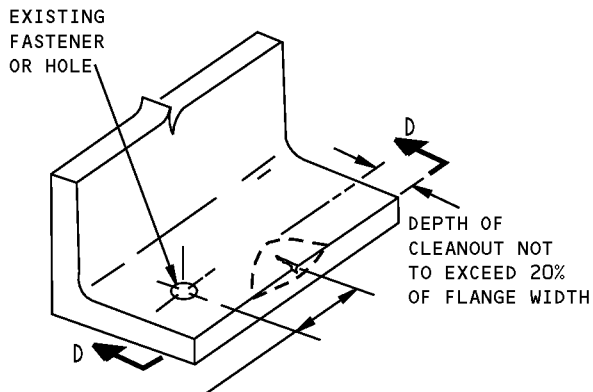
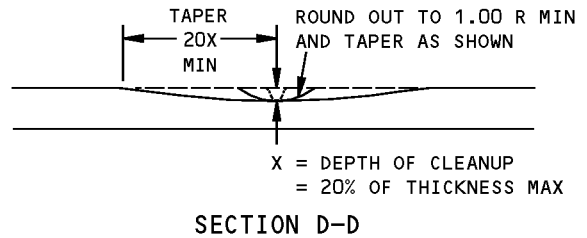
THE DISTANCE OF THE DAMAGE FROM AN EXISTING HOLE, FASTENER OR MATERIAL EDGE MUST NOT BE LESS THAN 20X

REMOVAL OF NICK, GOUGE, CORROSION, AND SCRATCH DAMAGE ON A SURFACE DETAIL VII

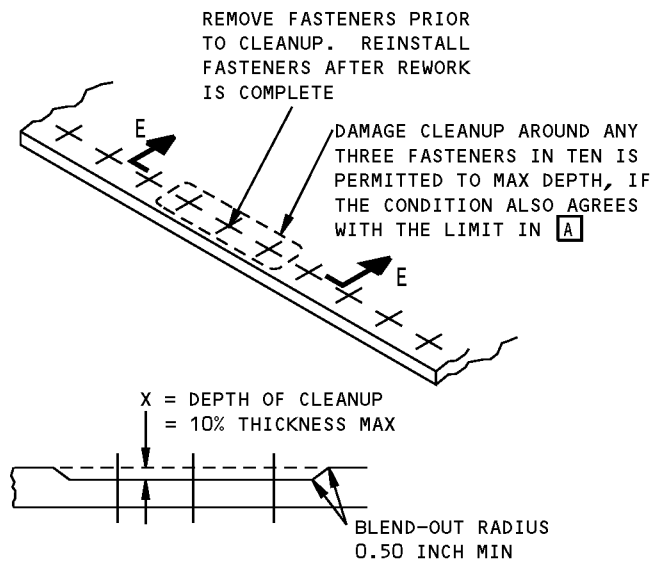
SECTION E-E DAMAGE CLEANUP DETAIL VIII

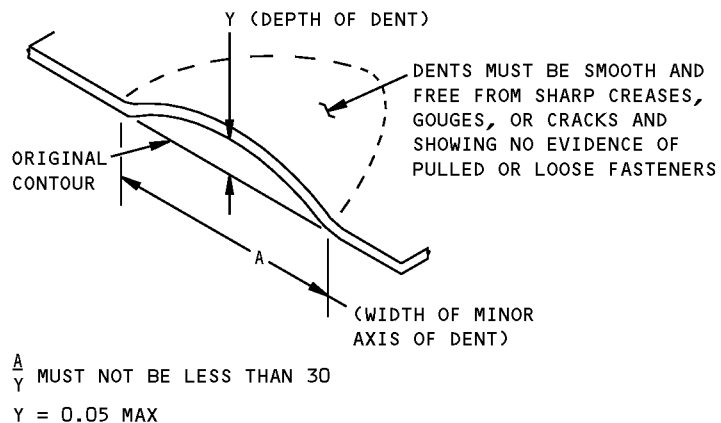
DETAIL X

ALLOWABLE DAMAGE FOR DENT DETAIL IX

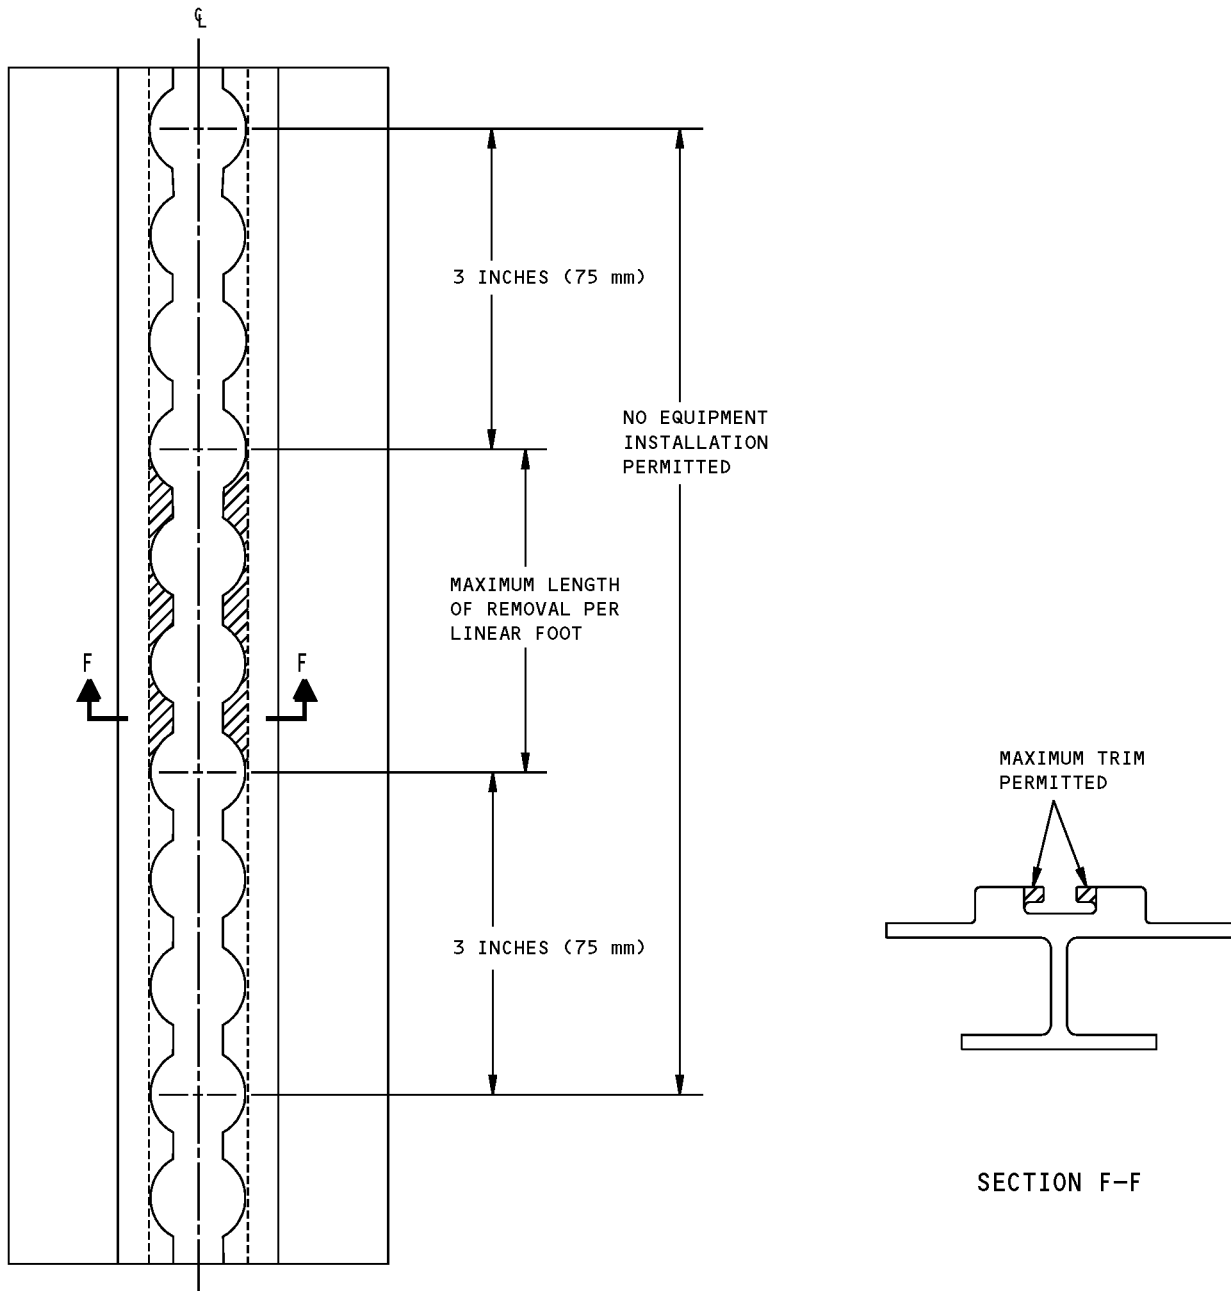
DETAIL XI

REMOVAL OF DAMAGE AT THE CROWN LIP AREA
WHERE NO EQUIPMENT IS INSTALLED

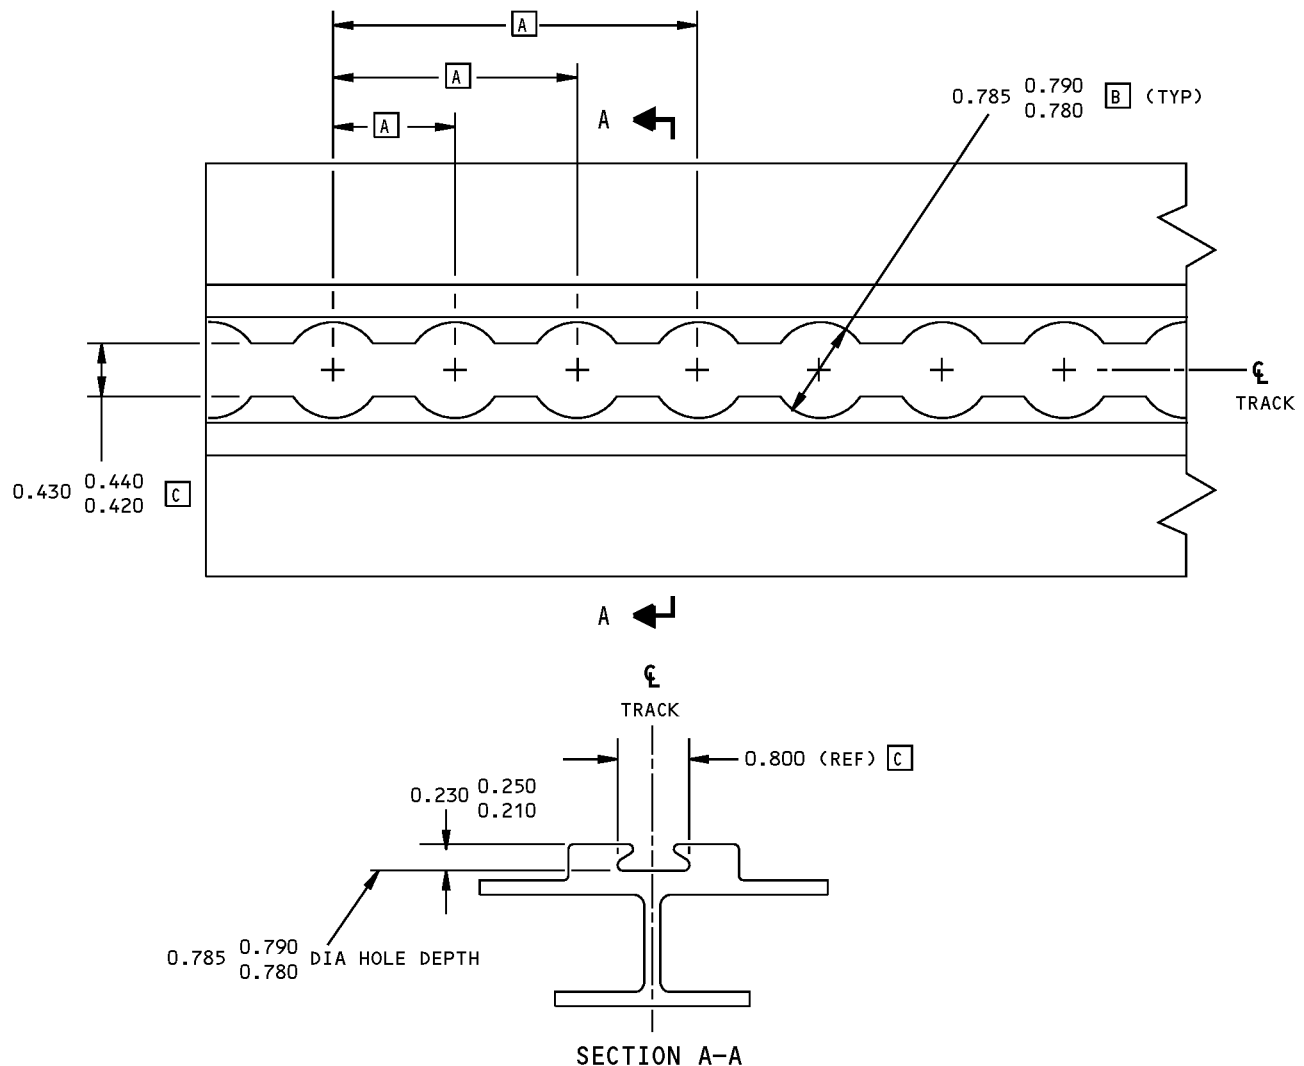
Hole Pattern for Seat Track Repairs
Figure 201

REPAIR 2 - HOLE PATTERN FOR SEAT TRACK REPAIRS

- THIS IS A CATEGORY A REPAIR FOR 757-SF AIRPLANES. THE INSPECTIONS GIVEN IN THE MAINTENANCE PLANNING DATA (MPD) ARE SUFFICIENT TO MAINTAIN THE DAMAGE TOLERANCE OF THE INITIAL STRUCTURE WITH THIS REPAIR INSTALLED. REFER TO SRM 51-00-06 FOR REPAIR CATEGORIES AND DEFINITIONS.
- MACHINE FINISH TO 125 MICROINCHES AA

[G] REFER TO REPAIR 2 FOR HOLE PATTERN FOR REPAIR PART 1.

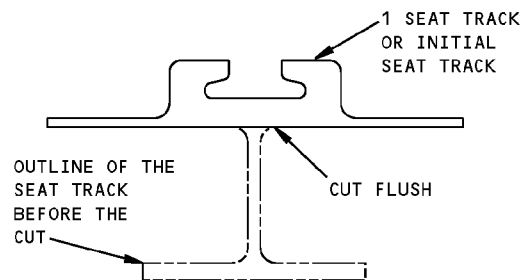
REMOVAL OF THE WEB AND LOWER
HORIZONTAL FLANGES OF REPAIR
PART 1 AND THE INITIAL SEAT TRACK
DETAIL I

- (3) Refer to repair 2 and make the seat track hole pattern.
 - B. For repair part 2, refer to Sections A-A and B-B and cut to the contour shown.
4. Cut off the web and the lower horizontal flanges of the initial seat track section between the floor beams where the splice will be made. Refer to Detail I.

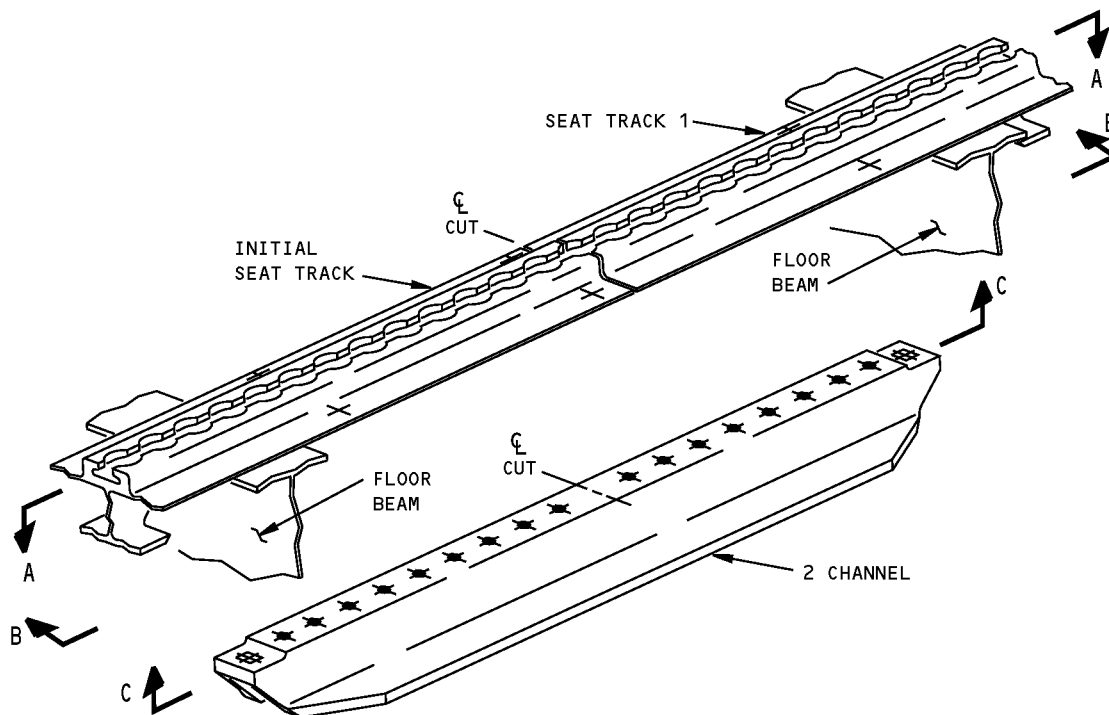
ALTERNATIVE BAC1520-792 SEAT TRACK REPAIR
(REPAIR PART 2 EXPLODED AWAY)
DETAIL II

1. Remove the floor panels as necessary.
2. Remove the damaged seat track section.
Refer to Detail II.
 - A. Make a cut at the center of the seat track hole which is 9.45 (240 mm) or 10.45 inches (265 mm) from a floor beam centerline. Refer to Section A-A.

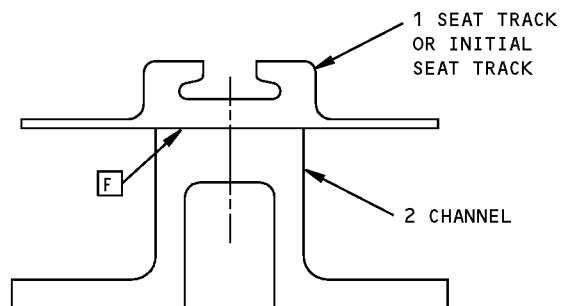
TYPICAL SECTION CUT OF THE
SEAT TRACK SPLICE BETWEEN FLOOR BEAMS
DETAIL III

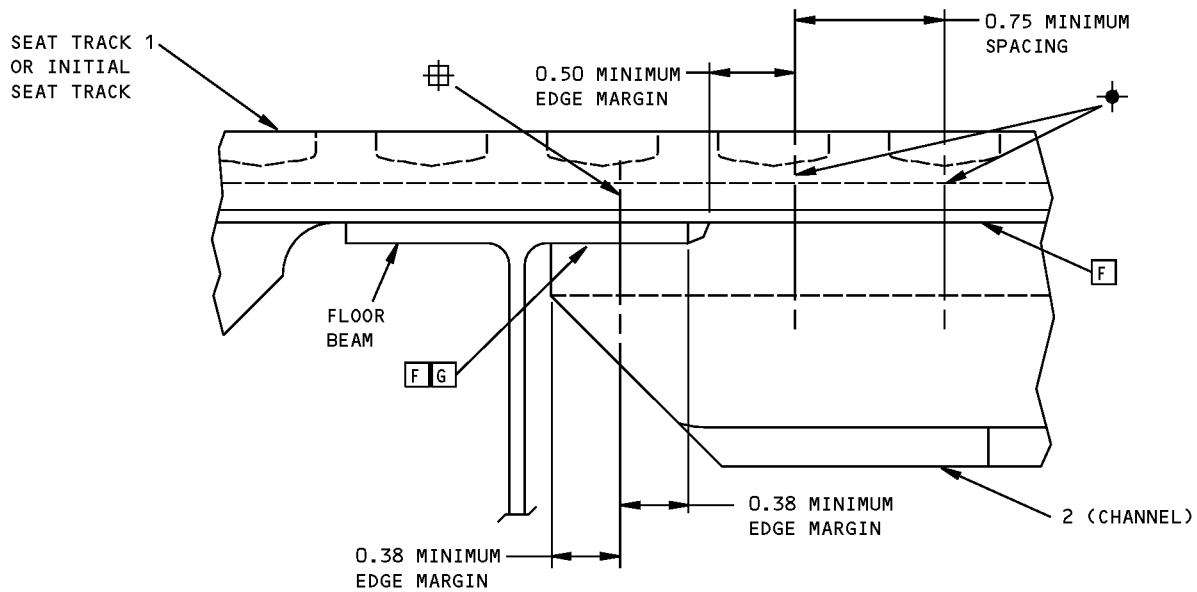
**FASTENER LOCATIONS AND GAP LIMITATIONS AT A FLOOR BEAM
DETAIL IV**

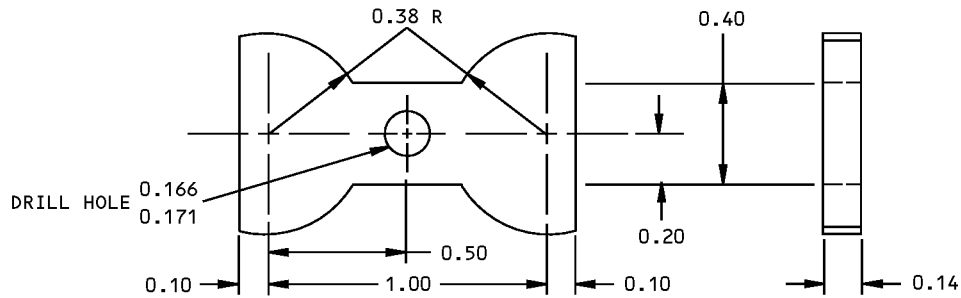
REPAIR PART 2
DETAIL III

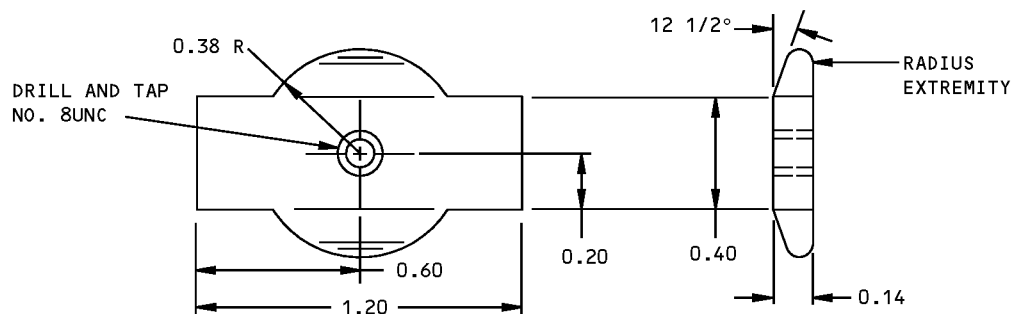
REPAIR PART 3
DETAIL IV

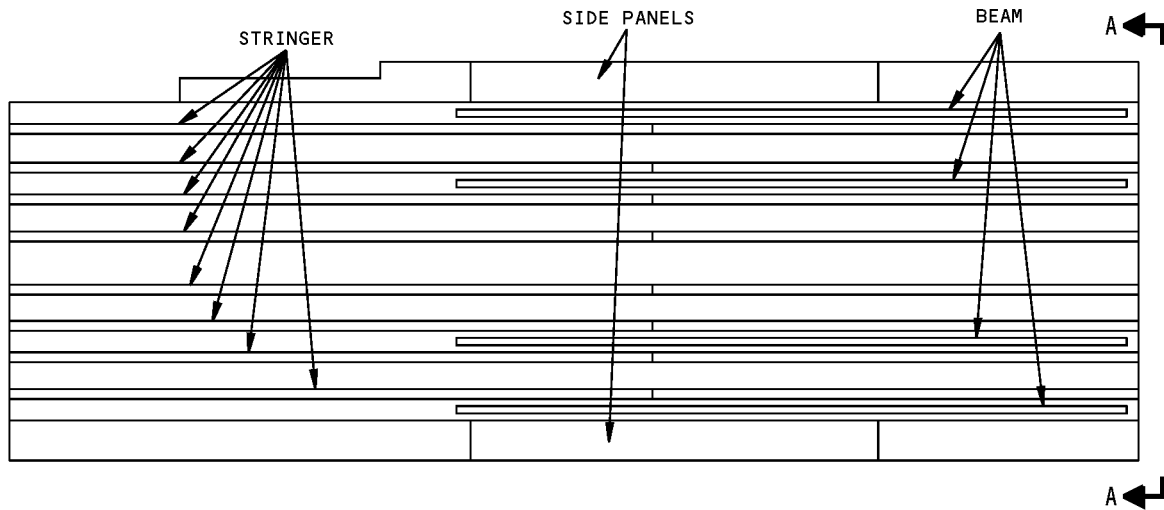
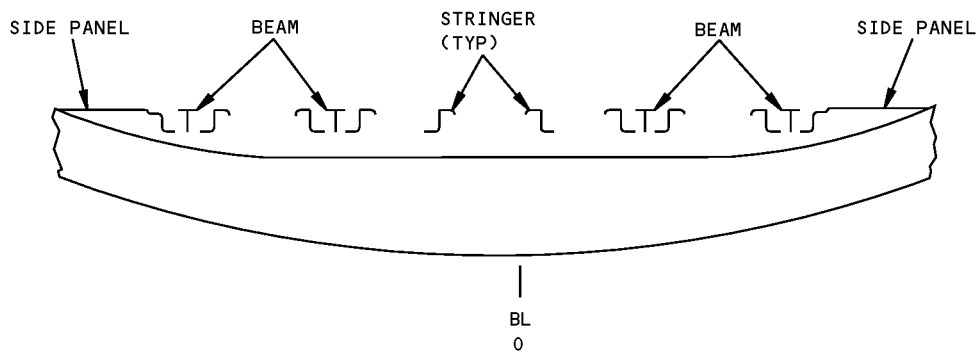
SECTION A-A (ROTATED 90°)
TYPICAL CARGO FLOOR STRUCTURE
DETAIL I

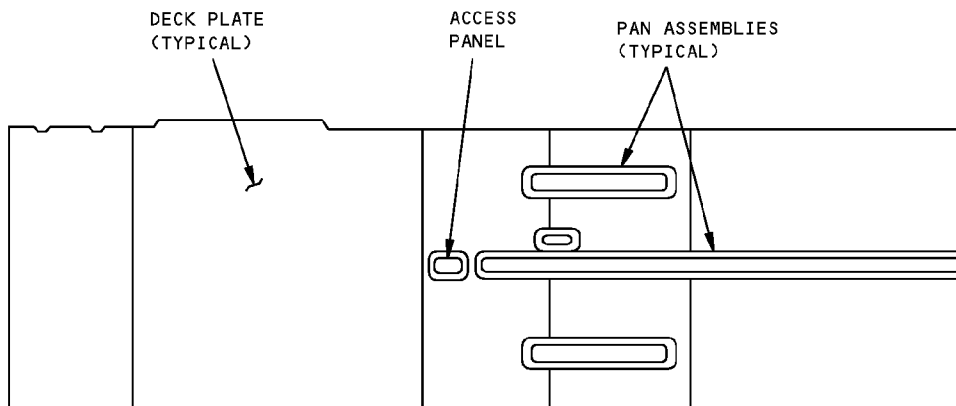
TYPICAL CARGO DECK
DETAIL II

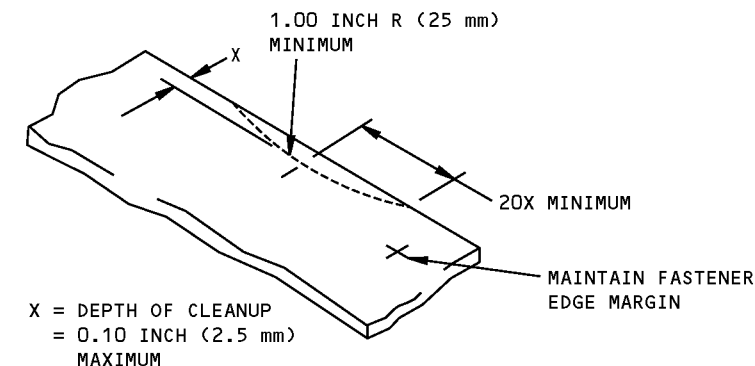
DETAIL III

REMOVAL OF NICK OR CRACK DAMAGE ON AN EDGE

- [H]** THESE ALLOWABLE DAMAGE LIMITS HAVE FAA APPROVAL CONTINGENT ON ACCOMPLISHMENT OF THE INSPECTIONS CONTAINED HEREIN
- [I]** 2.0 INCH (50 mm) MAX DIMENSION ALLOWED NOT CLOSER THAN 1.0 INCH (25 mm) TO FASTENER HOLE OR OTHER DAMAGE. CLEAN UP EDGE DAMAGE PER DETAILS III AND IV **[A]**

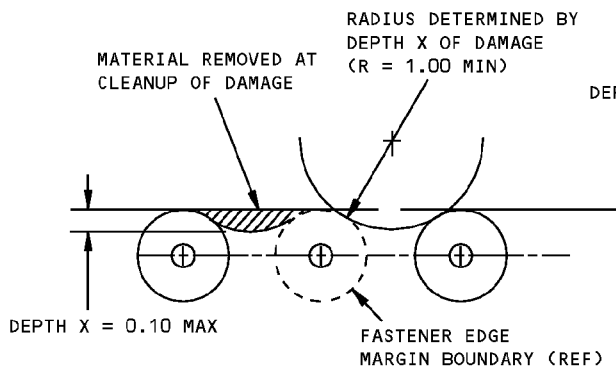
DETAIL IV

DAMAGE CLEANUP OF EDGES WHERE FASTENER EDGE MARGINS DO NOT OVERLAP

DAMAGE CLEANUP OF EDGES WHERE FASTENER EDGE MARGINS OVERLAP

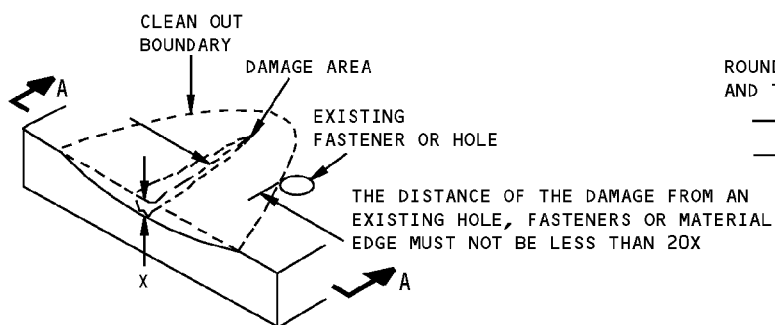
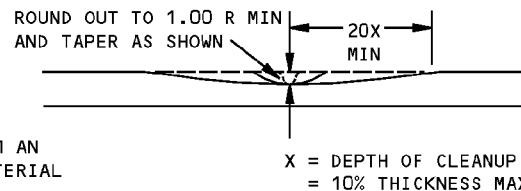
SECTION A-A

REMOVAL OF NICK, GOUGE AND SCRATCH DAMAGE ON A SURFACE
DETAIL V

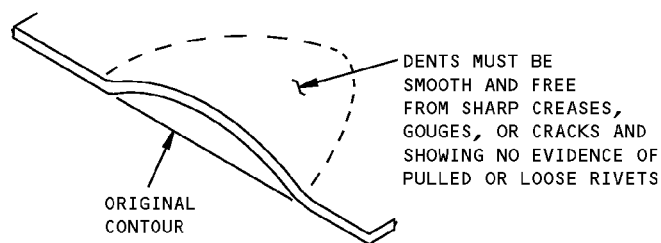
ALLOWABLE DAMAGE FOR DENT
DETAIL VI

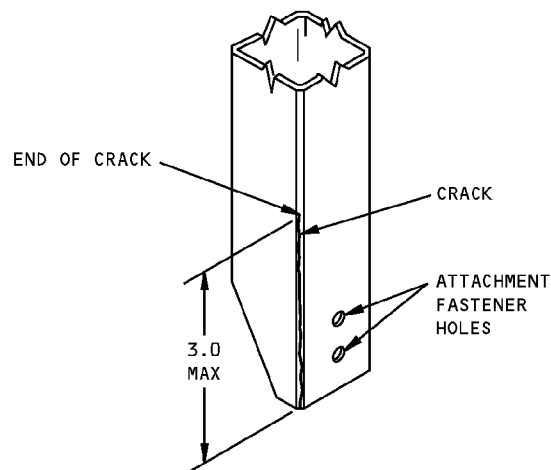
GRAPHITE STANCHION CRACK
DETAIL VII

- [J]** A CRACK IS PERMITTED IN A CORNER OF A GRAPHITE STANCHION IF THE CRACK DOES NOT EXCEED A MAXIMUM OF 3.00 INCHES (75 mm) IN LENGTH, REFER TO DETAIL VII.

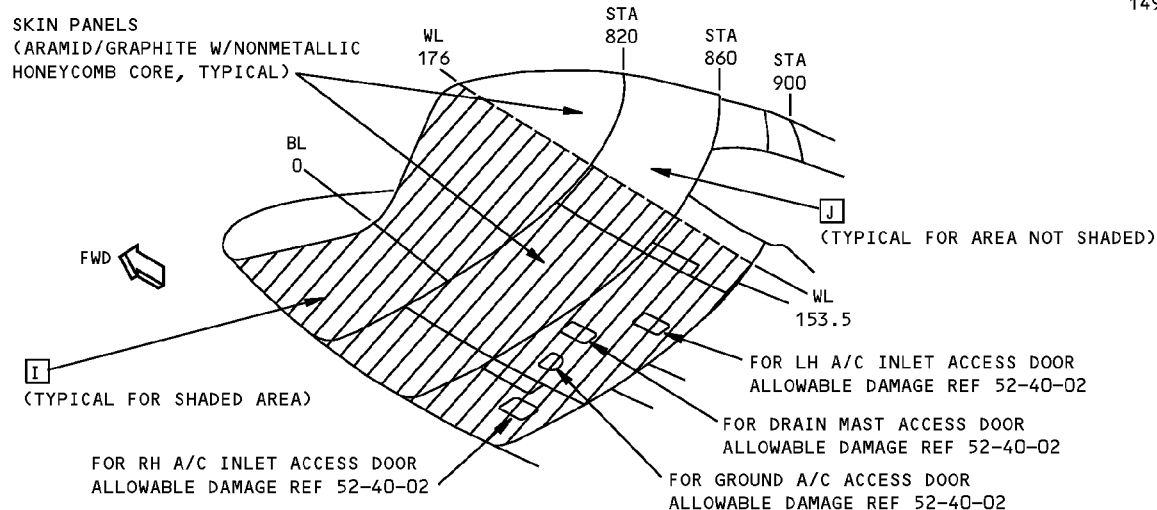
LEFT SIDE SHOWN
RIGHT SIDE OPPOSITE
WING-TO-BODY FAIRING - SECTION 43
DETAIL I

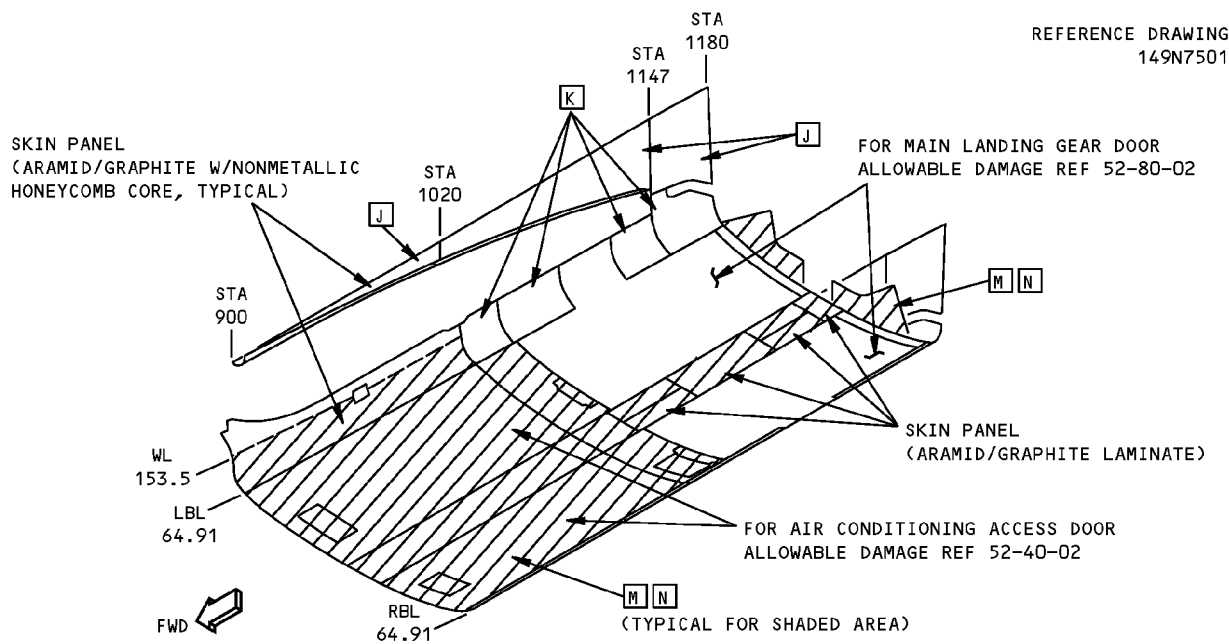
LEFT SIDE SHOWN
RIGHT SIDE OPPOSITE
WING-TO-BODY FAIRING - SECTION 44
DETAIL II

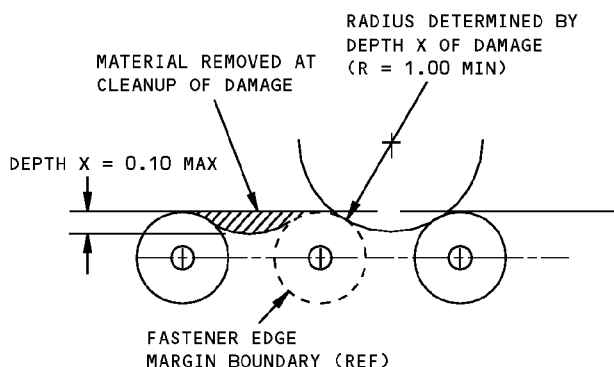
DETAIL IV

DAMAGE CLEANUP OF EDGES WHERE FASTENER EDGE MARGINS DO NOT OVERLAP

DAMAGE CLEANUP OF EDGES WHERE FASTENER EDGE MARGINS OVERLAP

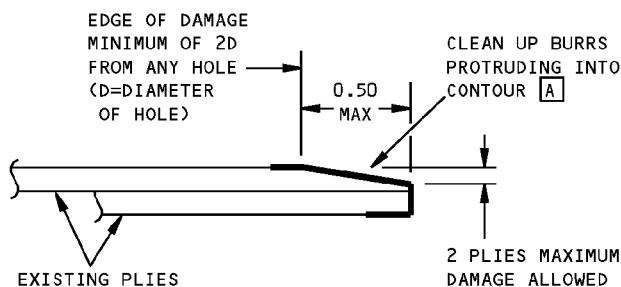
DAMAGE CLEANUP AND SEALING OF EDGE EROSION

| DESCRIPTION | CRACKS | NICKS, GOUGES AND CORROSION | DENTS | HOLES AND PUNCTURES | DELAMINATION | EDGE EROSION |
|--|---|---|---|---|---|---|
| SKIN PANEL (ARAMID/GRAPHITE W/HONEYCOMB CORE) | [B] | [C] | [D] | [E] | [F] | SEE DETAIL V |

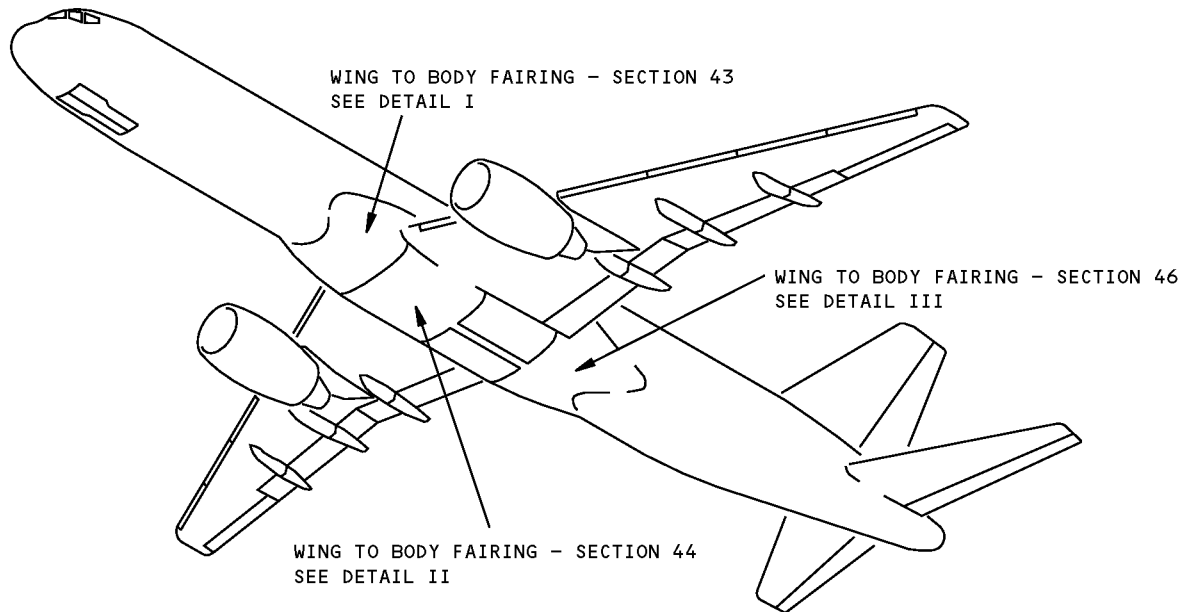
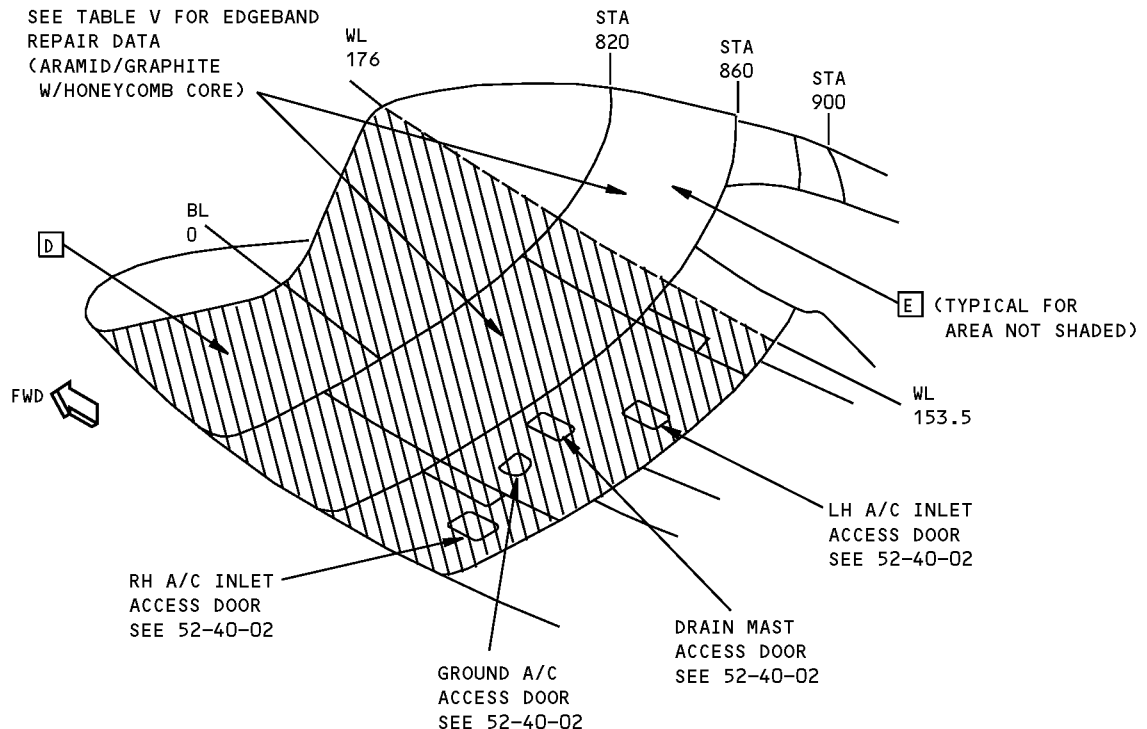
Wing To Body Fairing Skin Repairs
Figure 201 (Sheet 1 of 12)

SKIN PANELS (TYP) -
SEE TABLE II FOR HONEYCOMB
AREA REPAIR DATA
SEE TABLE V FOR EDGE BAND
REPAIR DATA
(ARAMID/GRAPHITE
W/HONEYCOMB CORE)

LEFT SIDE SHOWN
RIGHT SIDE OPPOSITE

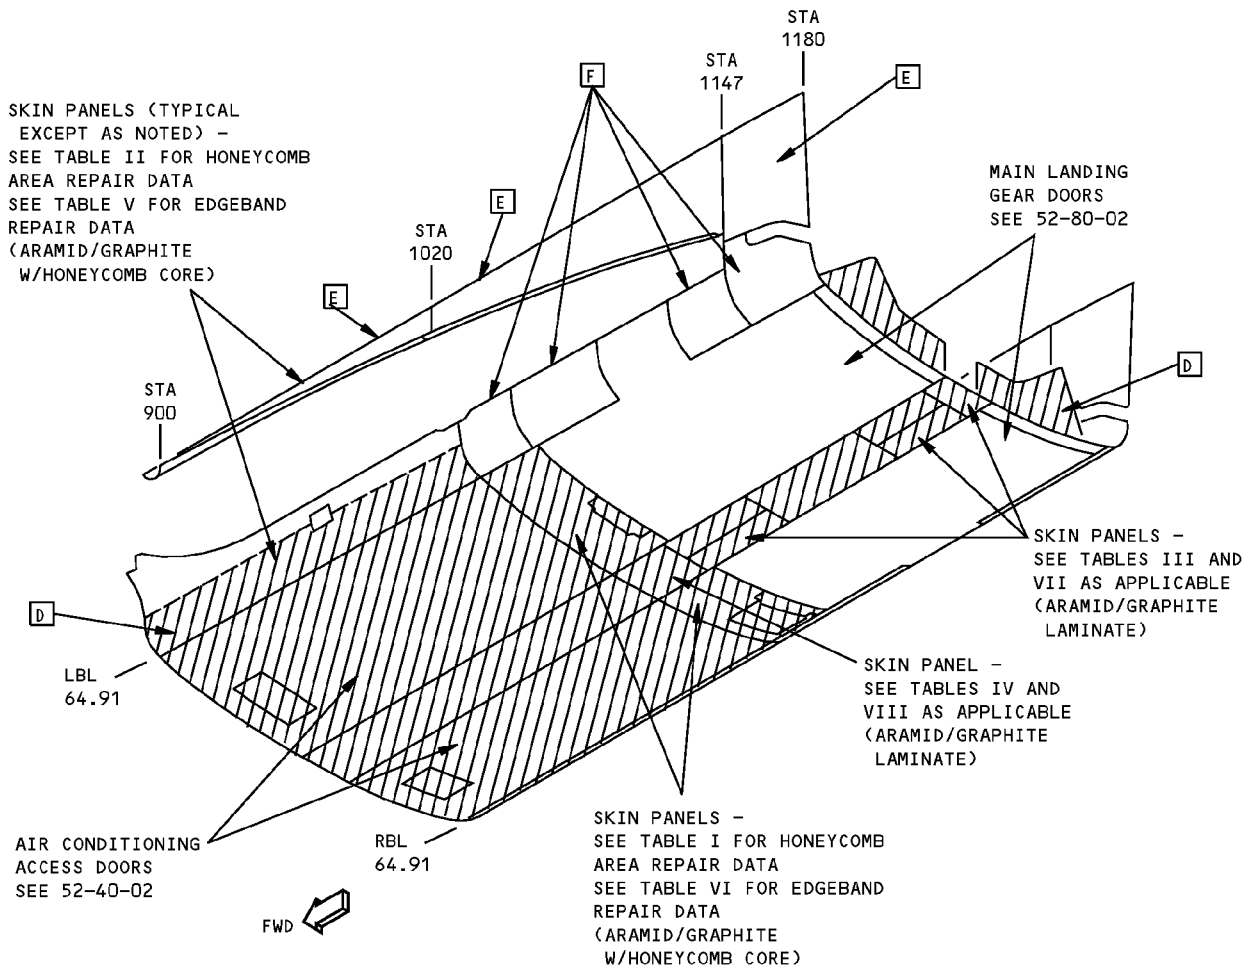
**Wing To Body Fairing Skin Repairs
Figure 201 (Sheet 2 of 12)**

LEFT SIDE SHOWN
RIGHT SIDE OPPOSITE
WING TO BODY FAIRING - SECTION 44
DETAIL II
