FUSELAGE

757-200 STRUCTURAL REPAIR MANUAL

CHAPTER 53 FUSELAGE

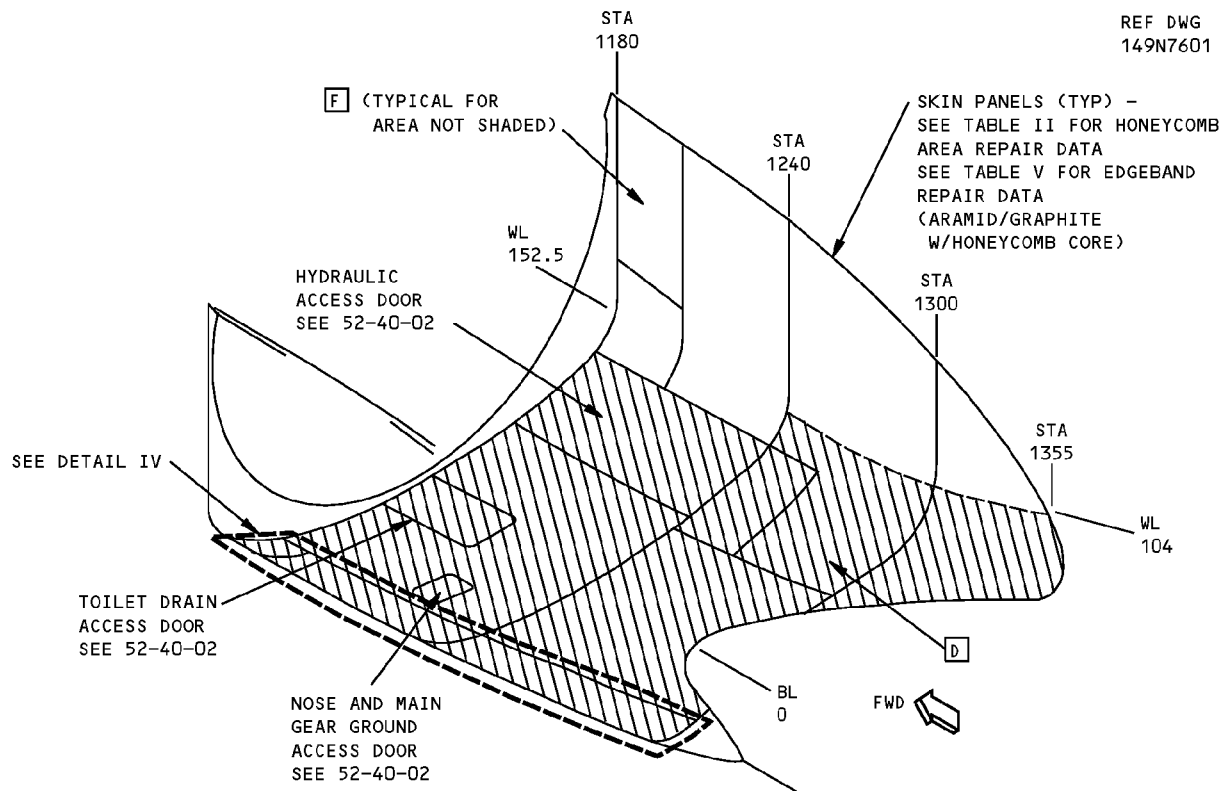
**Wing To Body Fairing Skin Repairs
Figure 201 (Sheet 3 of 12)**

LEFT SIDE SHOWN
RIGHT SIDE OPPOSITE EXCEPT AS NOTED
WING TO BODY FAIRING - SECTION 46
DETAIL III

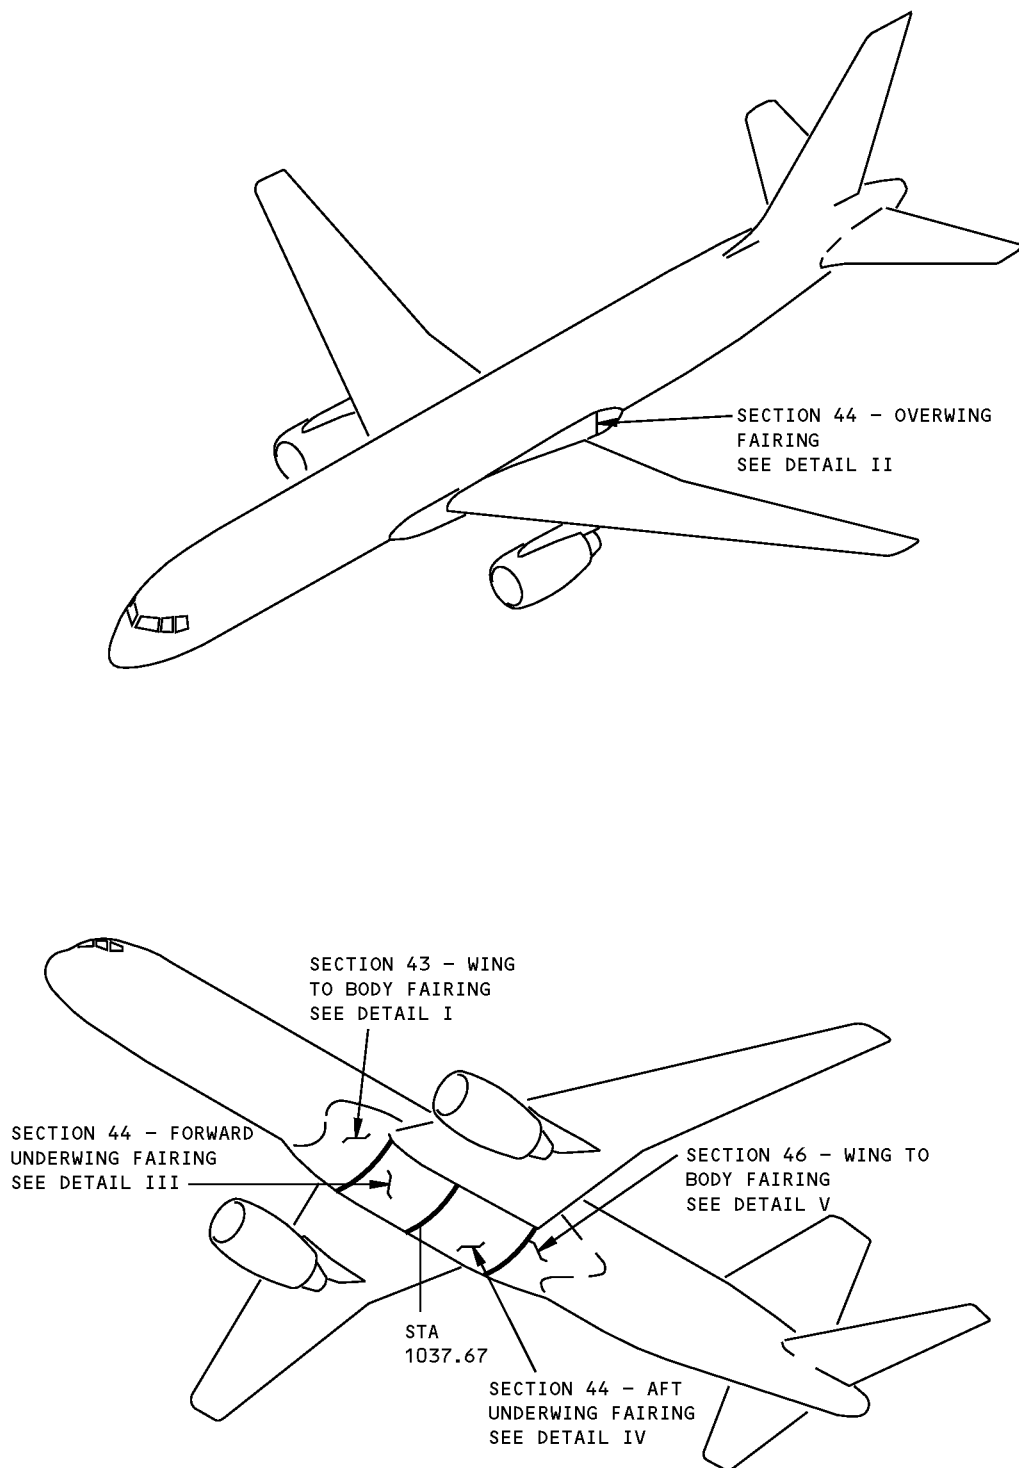
Wing to Body Fairing Structure Allowable Damage
Figure 101 (Sheet 1 of 10)

ALLOWABLE DAMAGE 1 - WING TO BODY FAIRING STRUCTURE

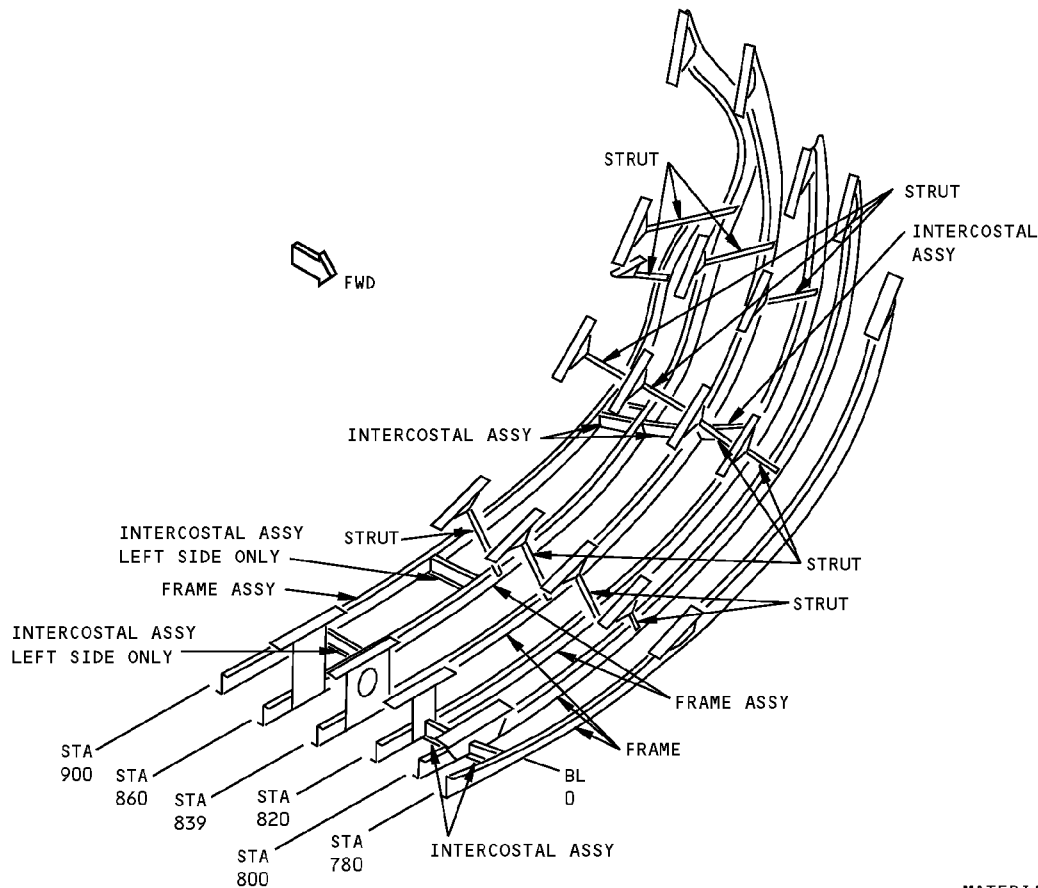
MATERIAL:
ALUMINUM

LEFT SIDE SHOWN
RIGHT SIDE OPPOSITE EXCEPT AS NOTED
SECTION 43 - WING TO BODY FAIRING
DETAIL I

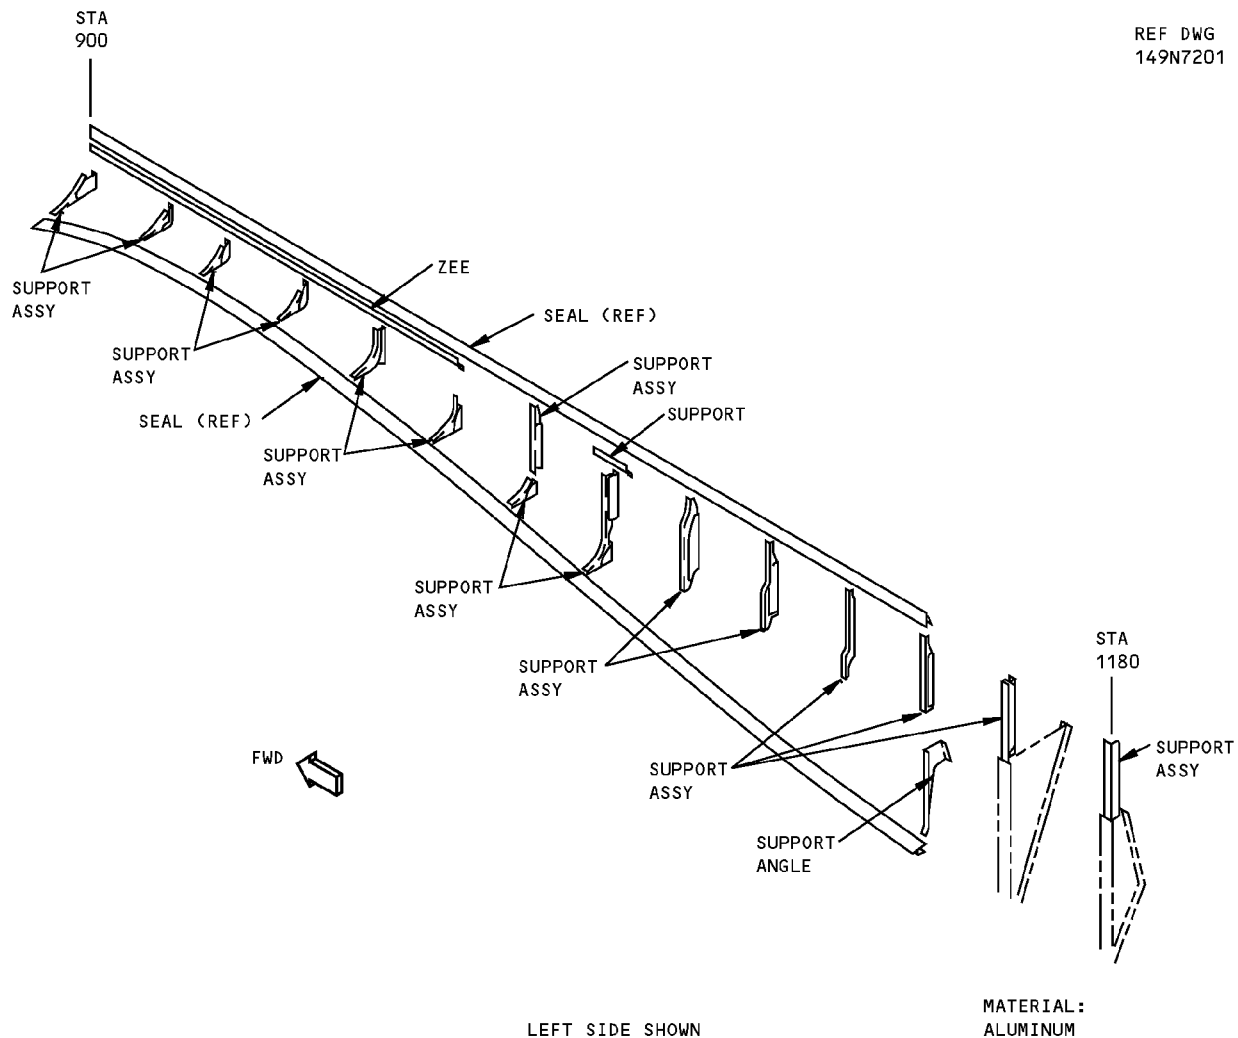
**Wing to Body Fairing Structure Allowable Damage
Figure 101 (Sheet 3 of 10)**

SECTION 44 - OVERWING FAIRING DETAIL II

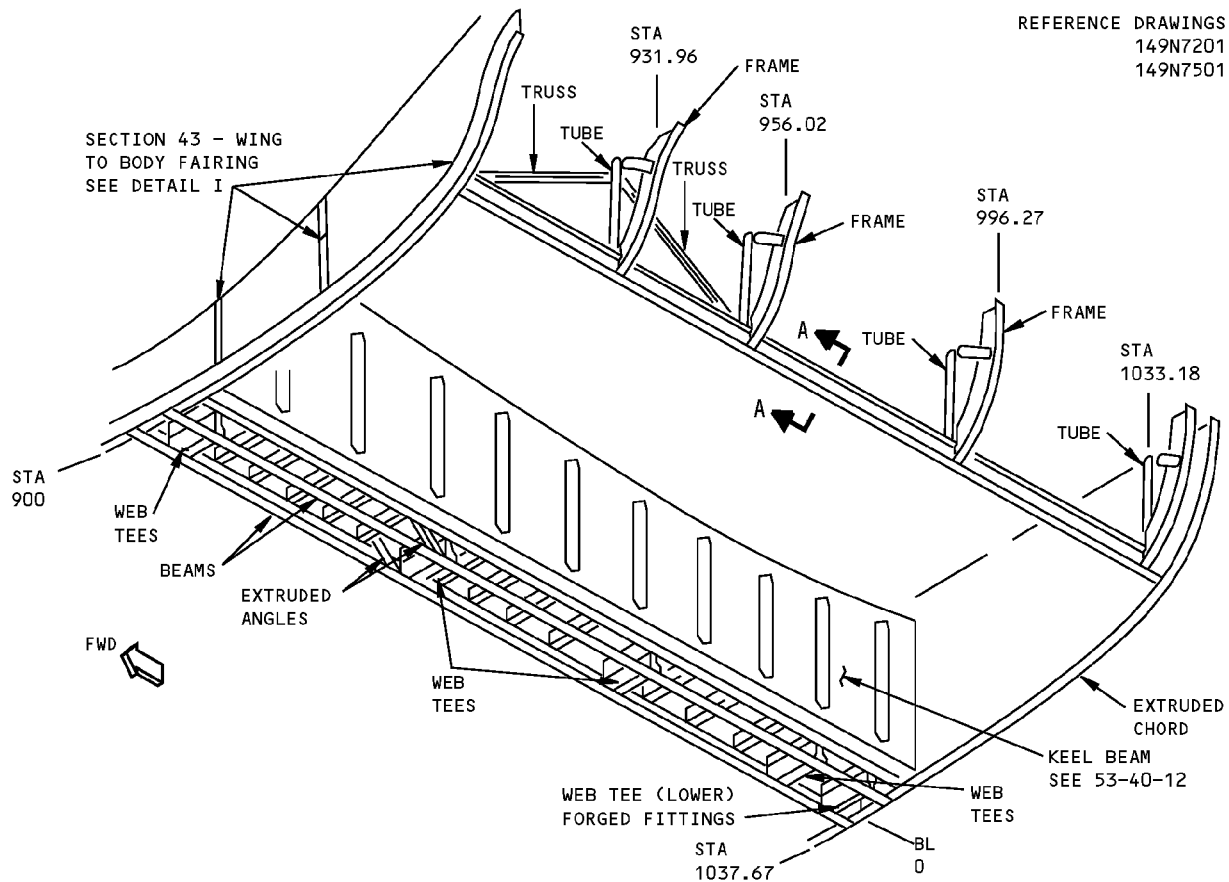
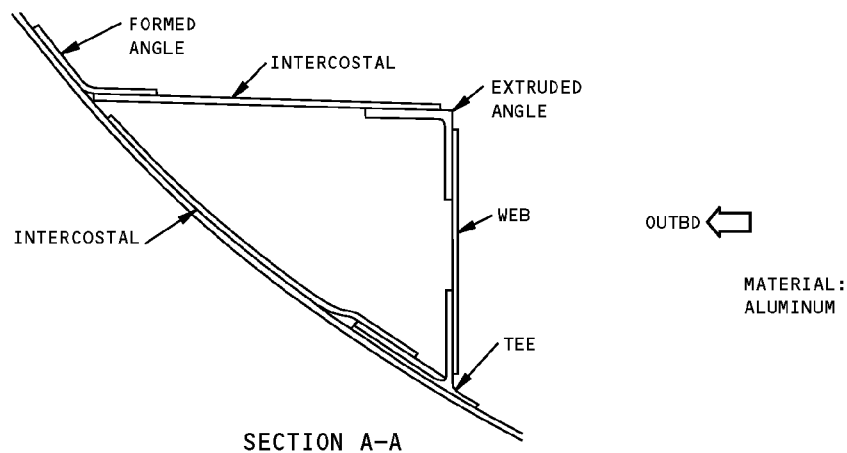
Wing to Body Fairing Structure Allowable Damage
Figure 101 (Sheet 4 of 10)

LEFT SIDE IS SHOWN, RIGHT SIDE IS OPPOSITE
SECTION 44 - FORWARD UNDERWING FAIRING
DETAIL III

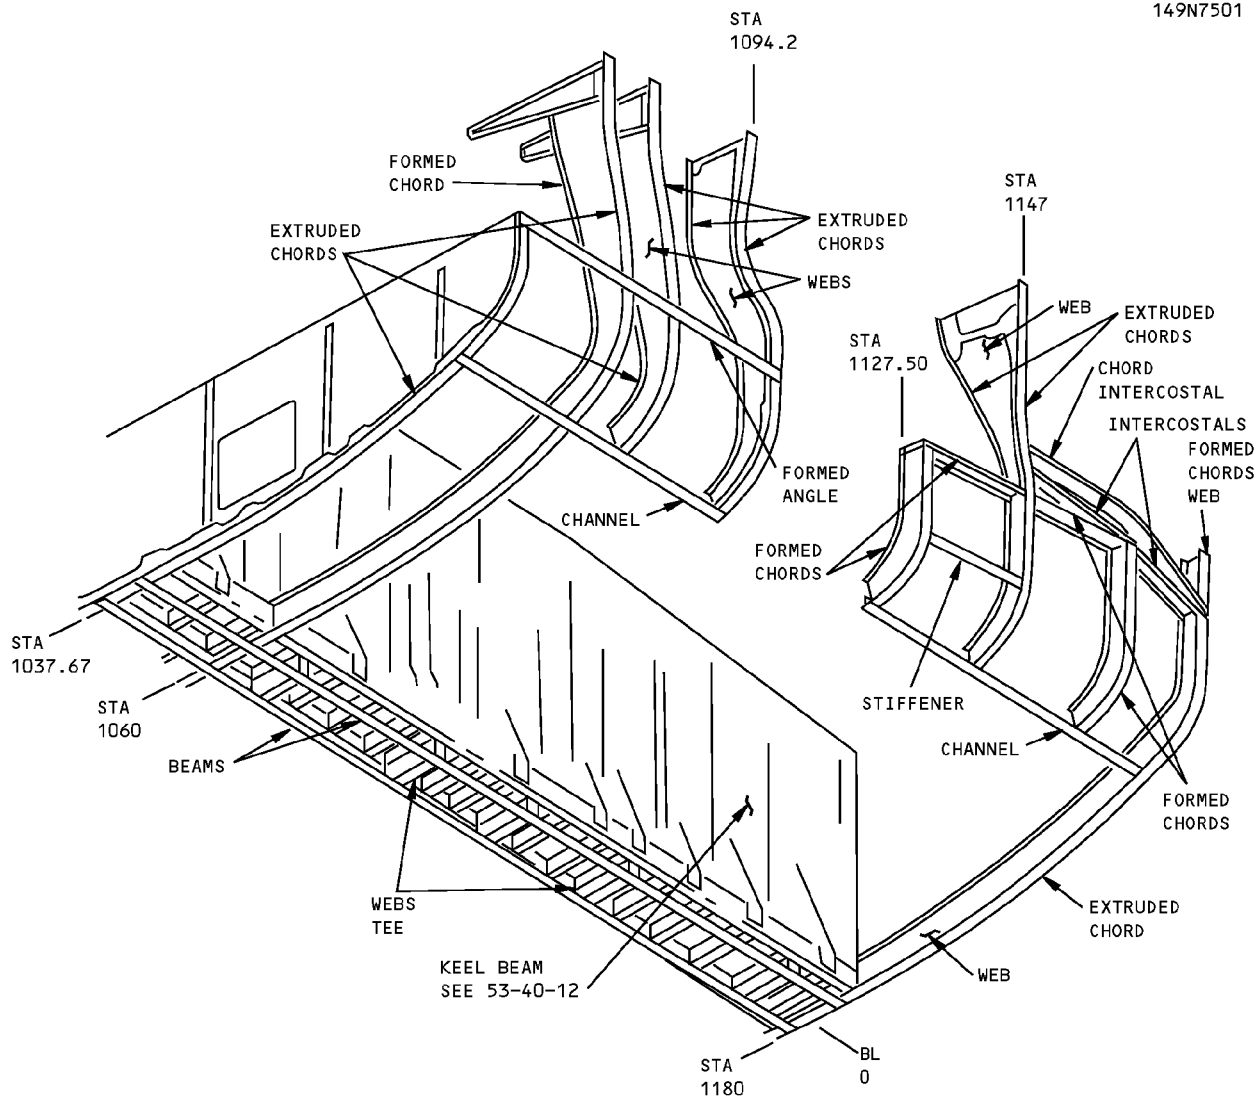
LEFT SIDE SHOWN
RIGHT SIDE OPPOSITE

MATERIAL:
ALUMINUM

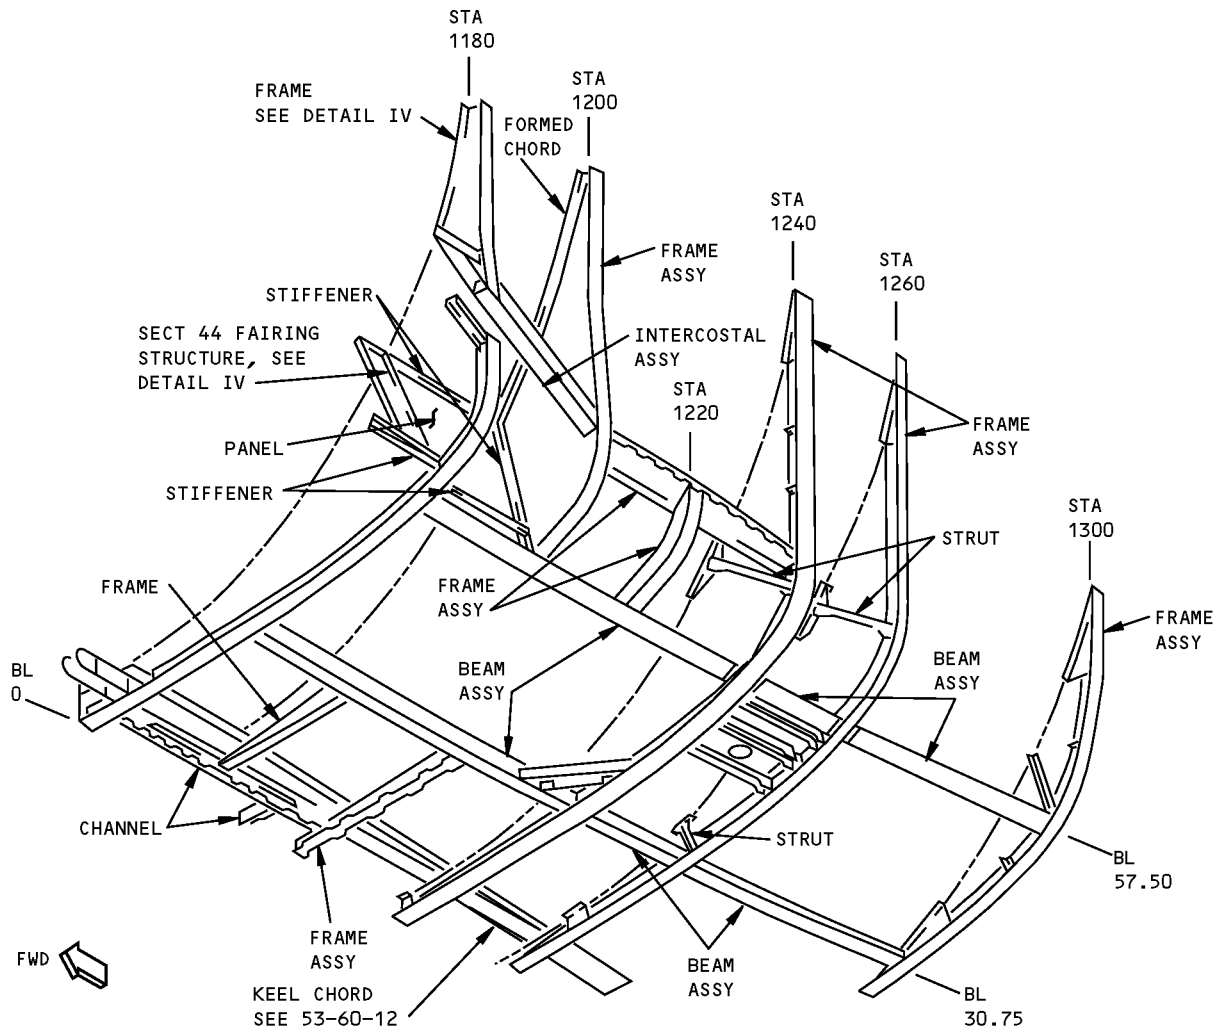
LEFT SIDE SHOWN
RIGHT SIDE OPPOSITE
SECTION 46 - WING TO BODY FAIRING
DETAIL V

MATERIAL:
ALUMINUM

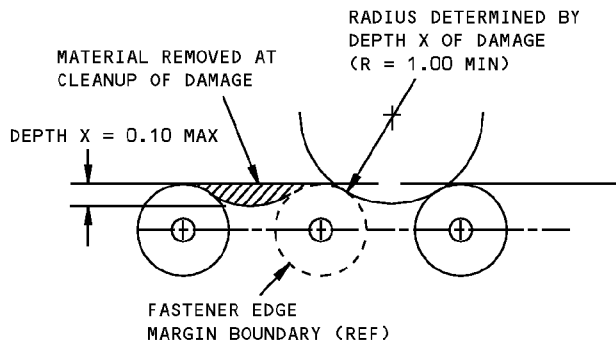
DAMAGE CLEAN UP OF EDGES WHERE
FASTENER EDGE MARGINS DO NOT OVERLAP

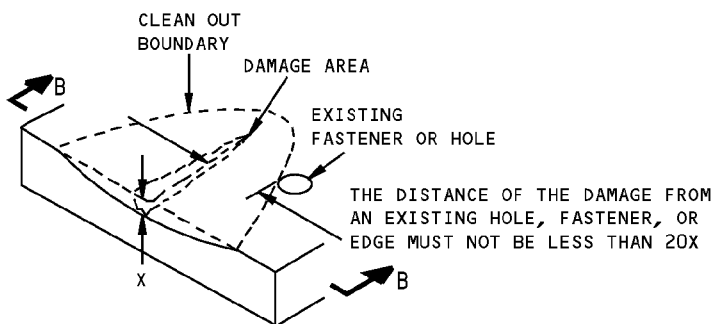
REMOVAL OF NICK, GOUGE AND SCRATCH DAMAGE ON A SURFACE
DETAIL VII

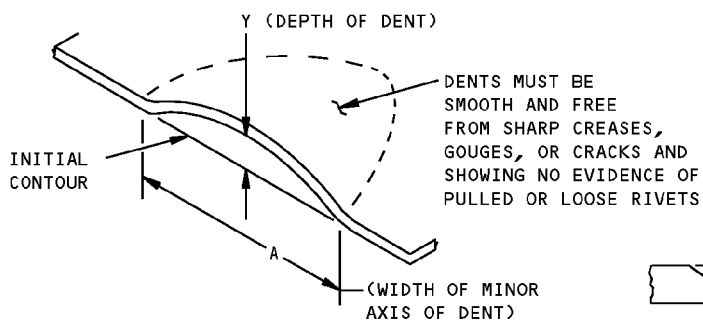
$\frac{A}{Y}$ MUST NOT BE LESS THAN 30

ALLOWABLE DAMAGE FOR DENT
DETAIL VIII

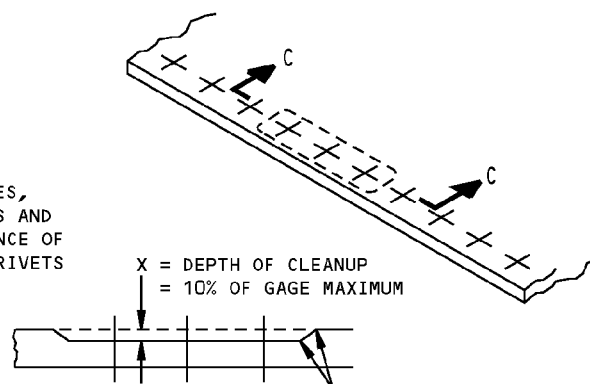
SMOOTH BLEND-OUT RADIUS 0.50 INCH MINIMUM.
CORROSION CLEANUP AROUND ANY THREE FASTENERS
IN TEN IS PERMITTED TO MAXIMUM DEPTH

SECTION C-C
CORROSION CLEANUP
DETAIL IX

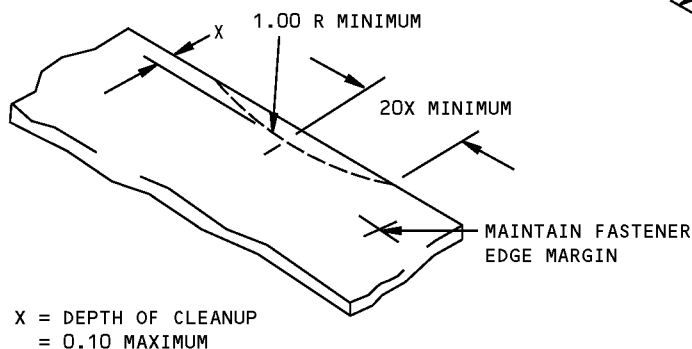
REMOVAL OF NICK OR CRACK
DAMAGE ON AN EDGE
DETAIL X

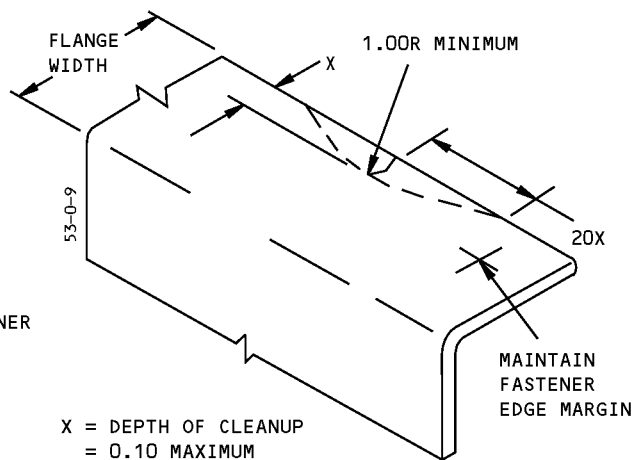
REMOVAL OF NICK OR CRACK
DAMAGE ON AN EDGE
DETAIL XI

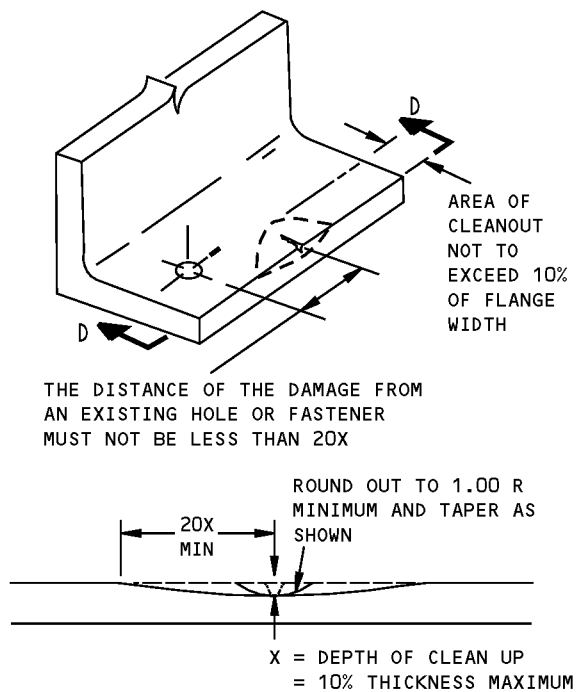
SECTION D-D
REMOVAL OF NICK OR CRACK
DAMAGE ON AN EDGE
DETAIL XII

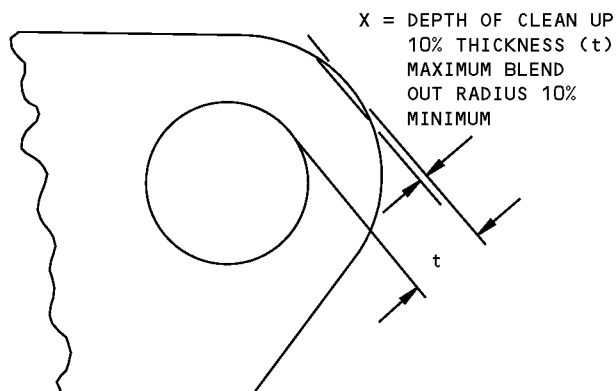
DAMAGE CLEAN UP FOR EDGES OF LUG
DETAIL XIII

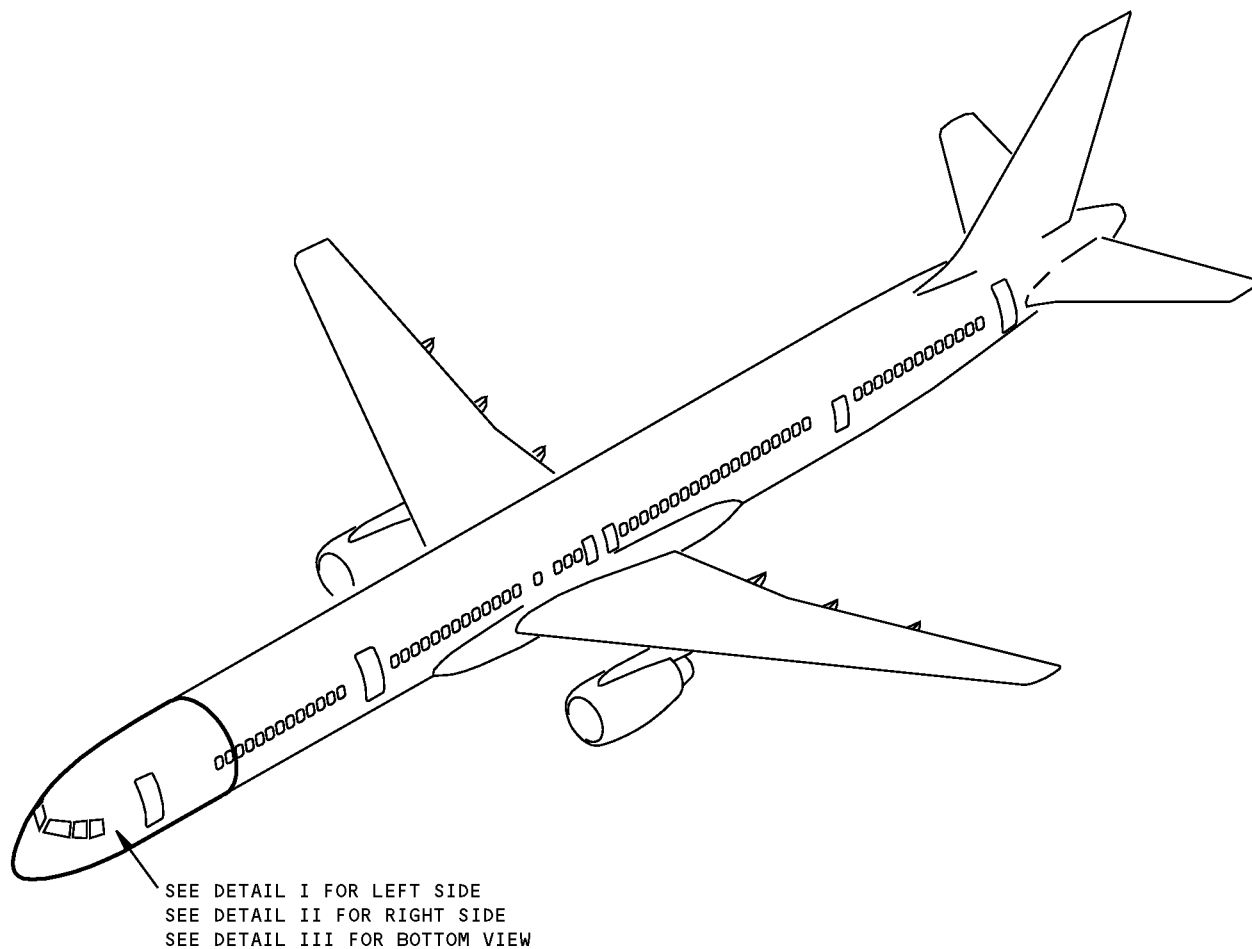
Section 41 Skin Identification
Figure 1 (Sheet 1 of 3)

IDENTIFICATION 1 - SECTION 41 - SKINS

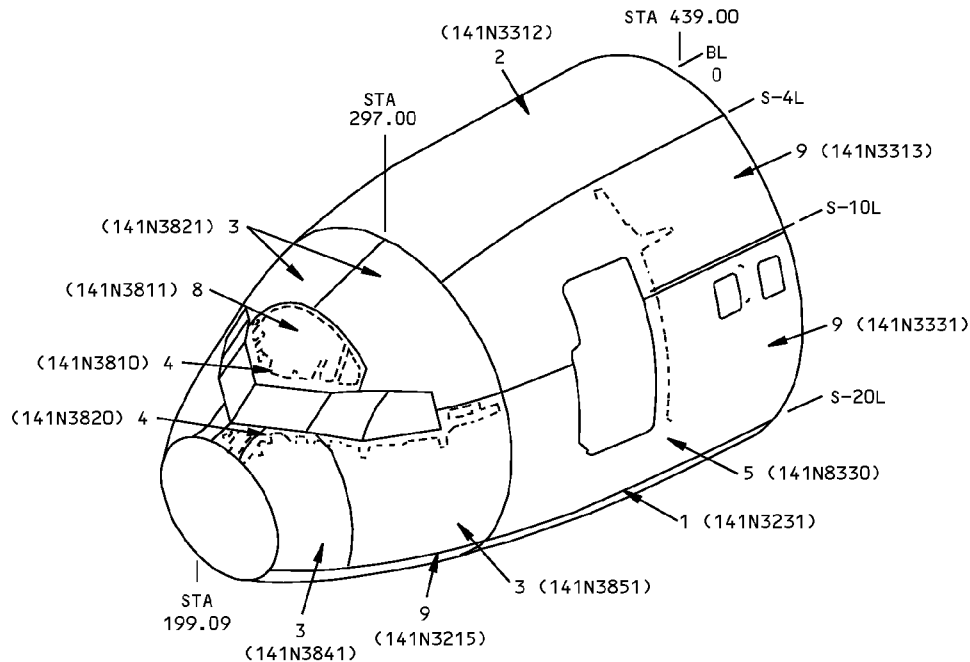
LEFT SIDE
DETAIL I

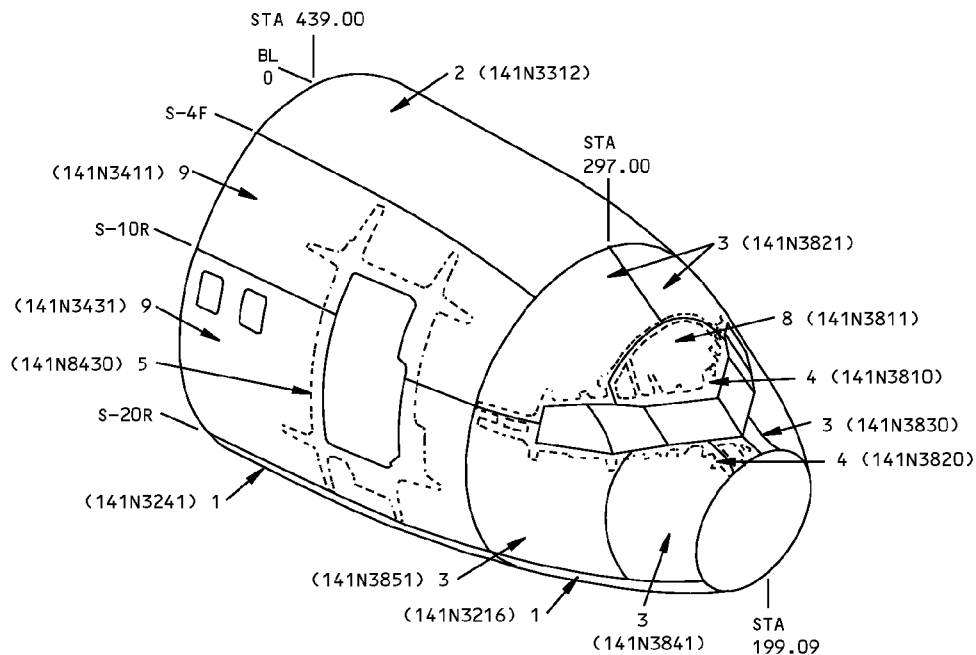
RIGHT SIDE
DETAIL II

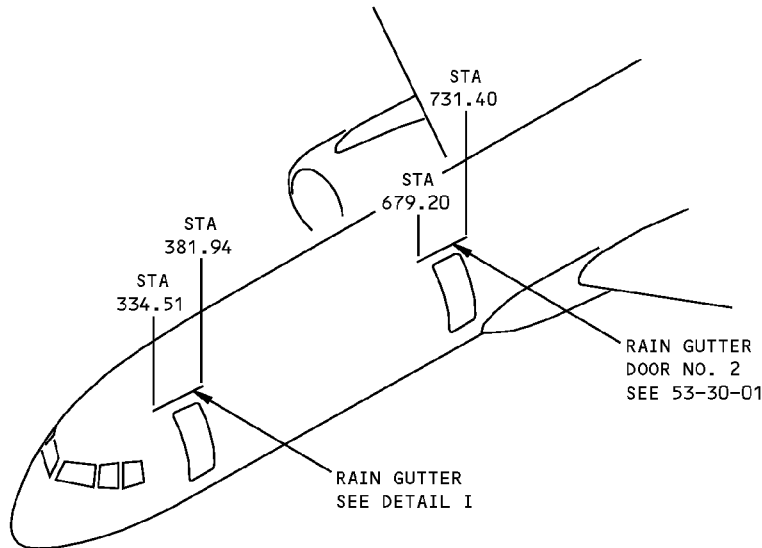
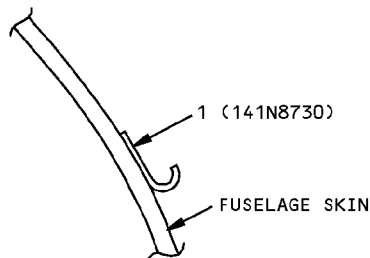
IDENTIFICATION 2 - SECTION 41 - RAIN GUTTER

SECTION THRU RAIN GUTTER
DETAIL I

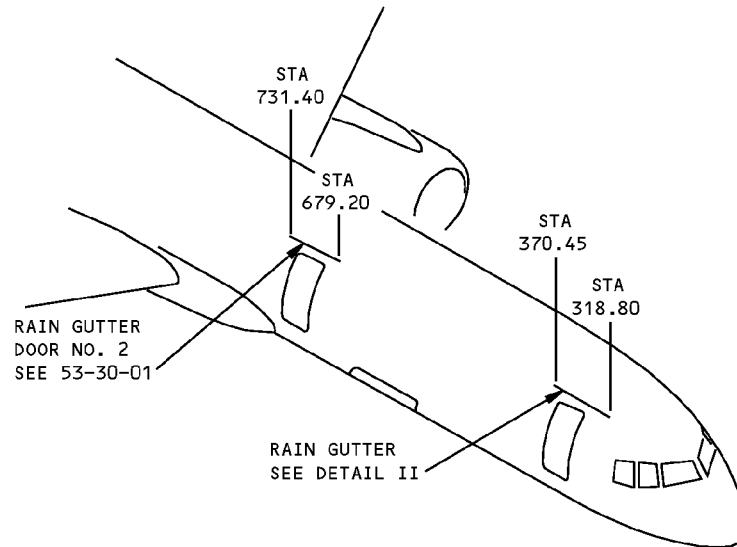
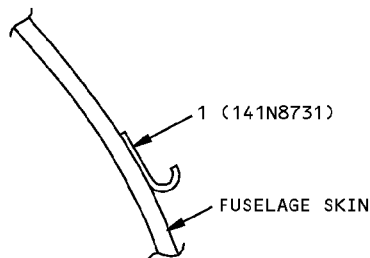
SECTION THRU RAIN GUTTER
DETAIL II

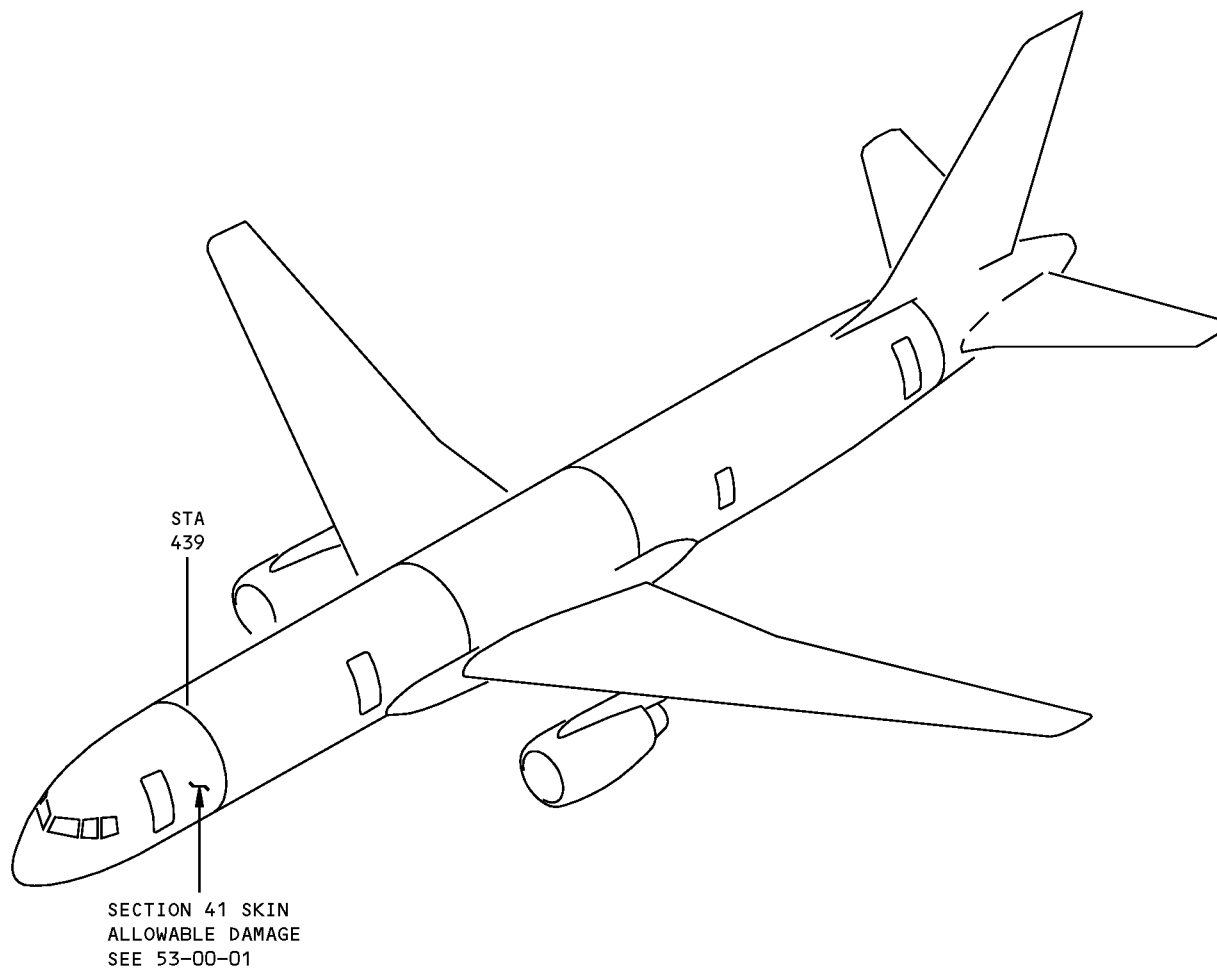
Section 41 Skin Allowable Damage
Figure 101

ALLOWABLE DAMAGE GENERAL - SECTION 41 - SKINS

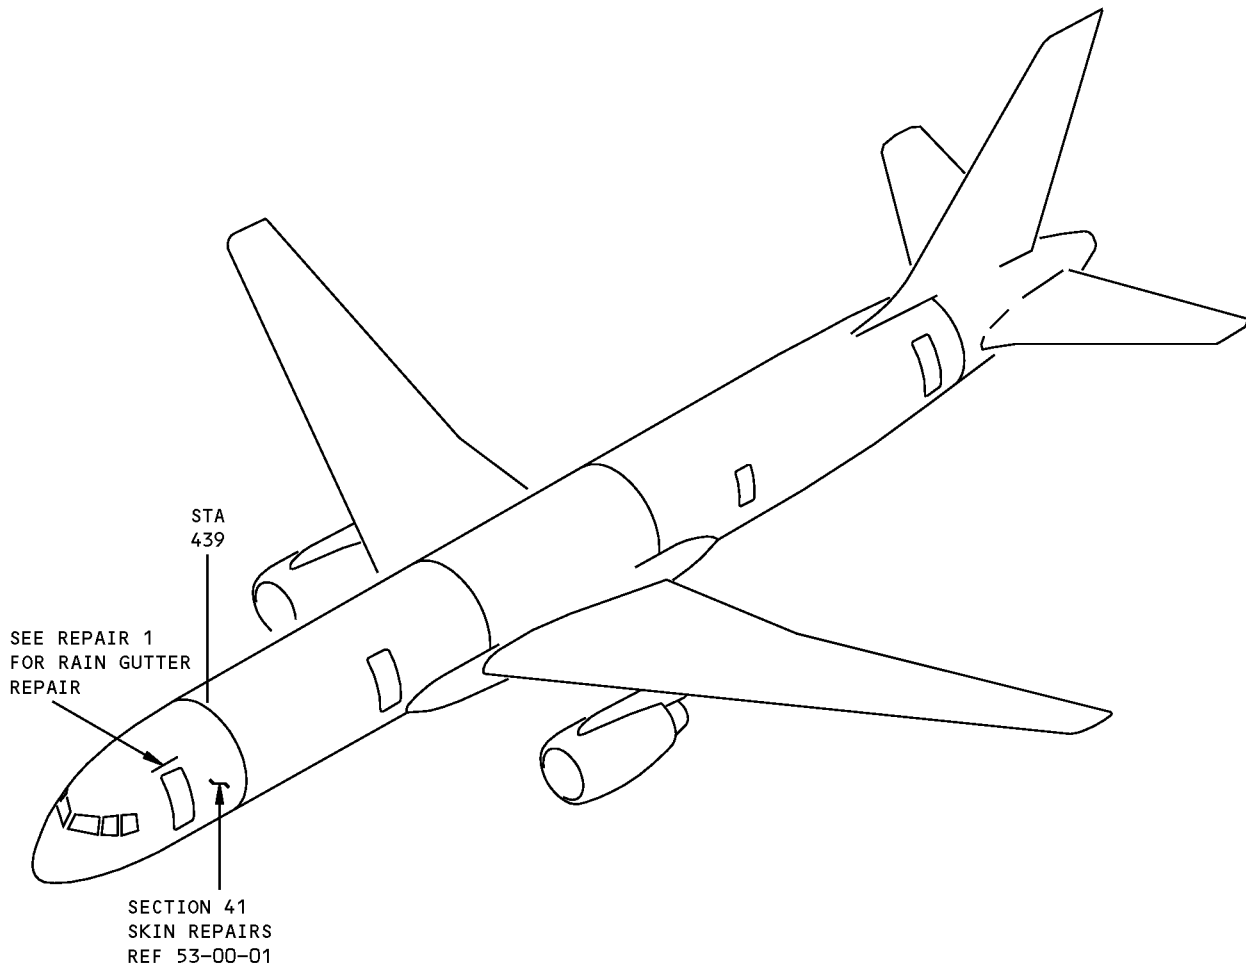
Section 41 Fuselage Skins
Figure 201

REPAIR GENERAL - SECTION 41 - FUSELAGE SKINS

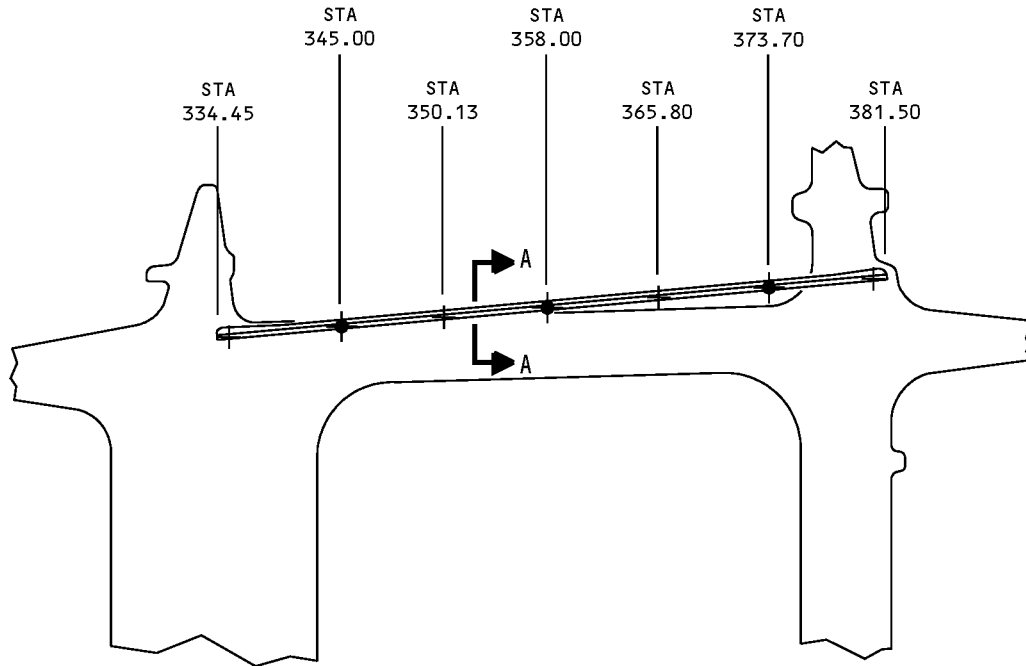
NO. 1 PASSENGER ENTRY DOOR (LEFT SIDE)
DETAIL I

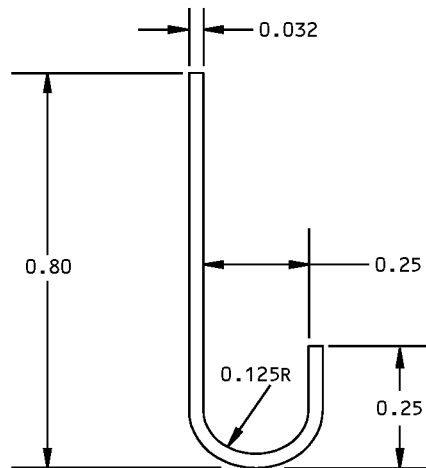
RAIN GUTTER SHOWN ONLY
SECTION A-A

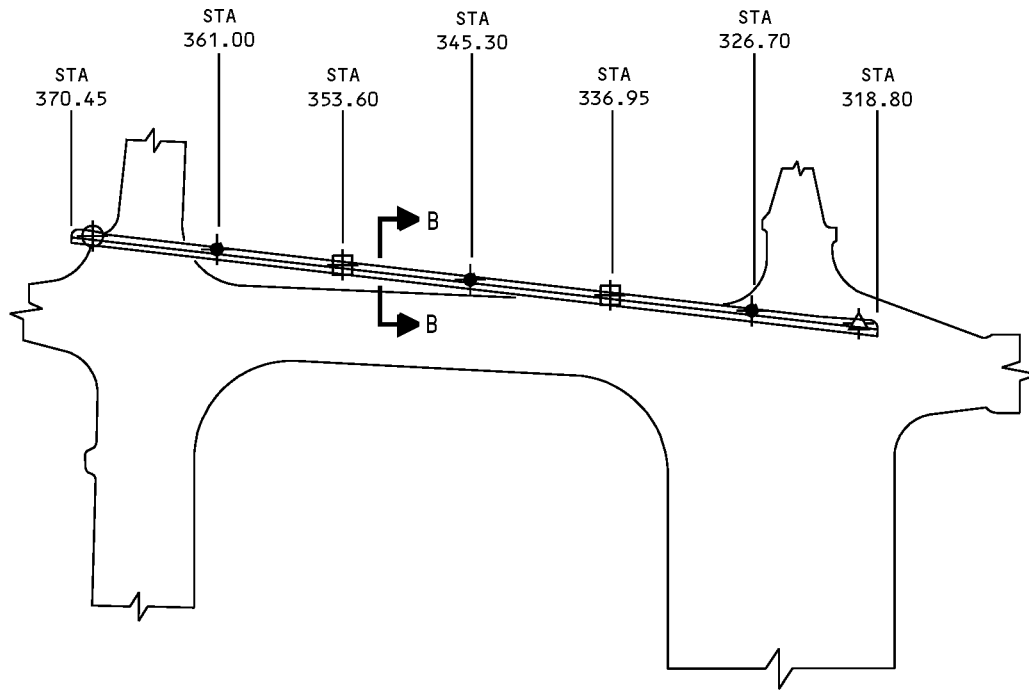
NO. 1 SERVICE DOOR (RIGHT SIDE)
DETAIL II

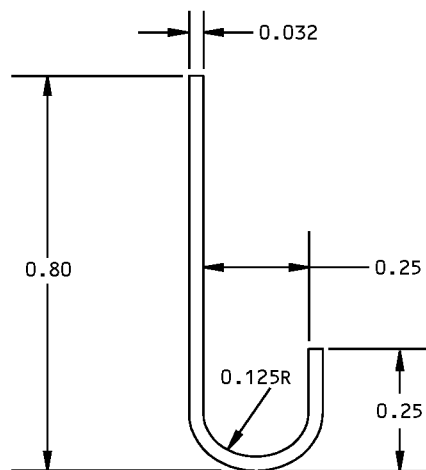
RAIN GUTTER SHOWN ONLY
SECTION B-B

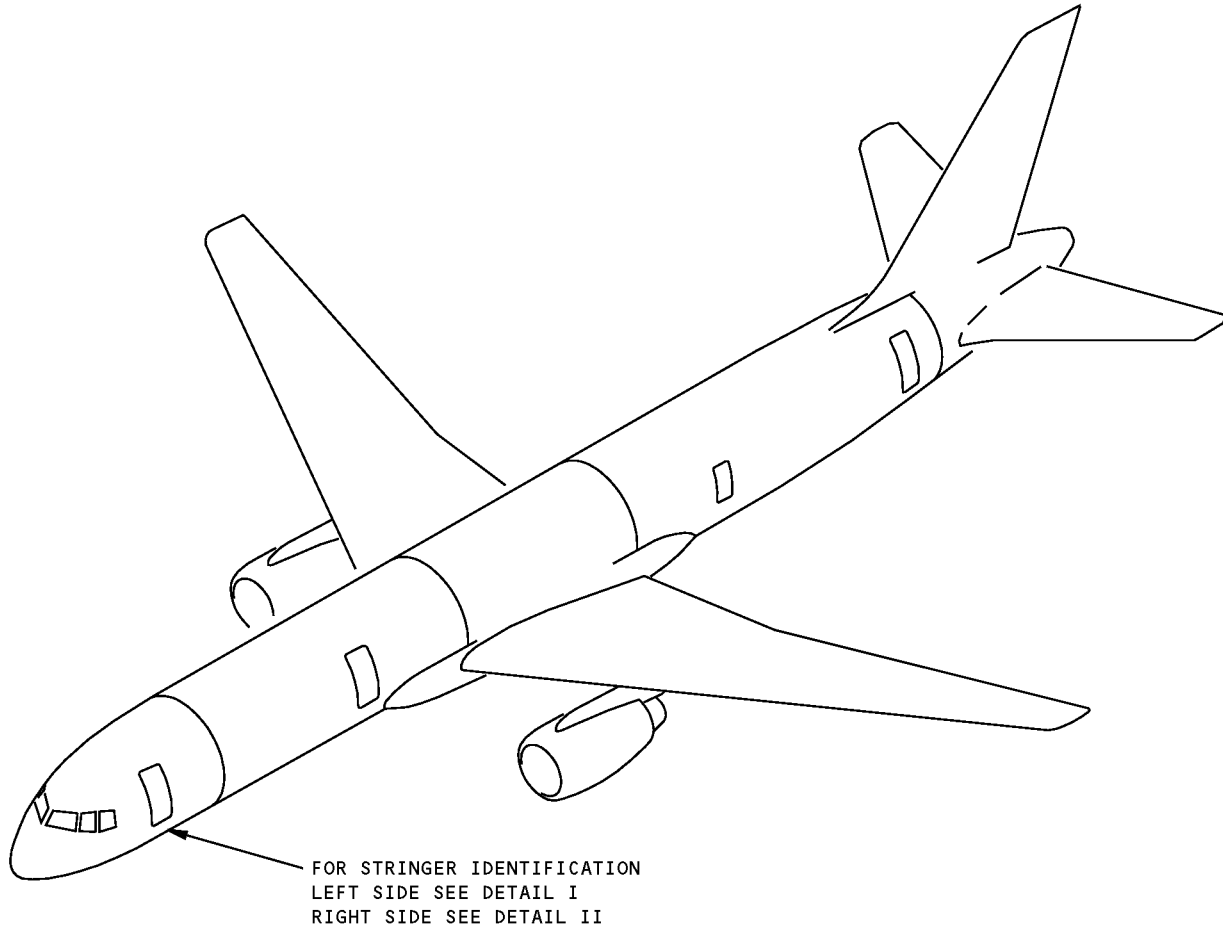
Section 41 Stringer Identification
Figure 1 (Sheet 1 of 5)

IDENTIFICATION 1 - SECTION 41 - STRINGERS

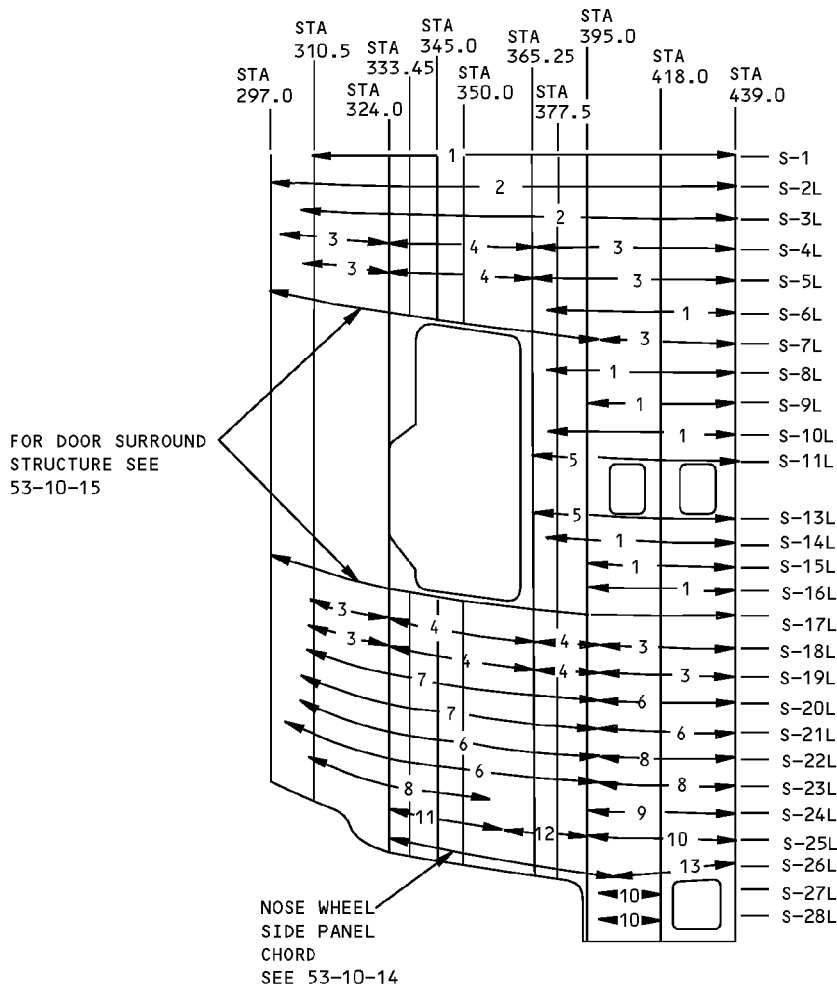
LEFT SIDE
DETAIL I

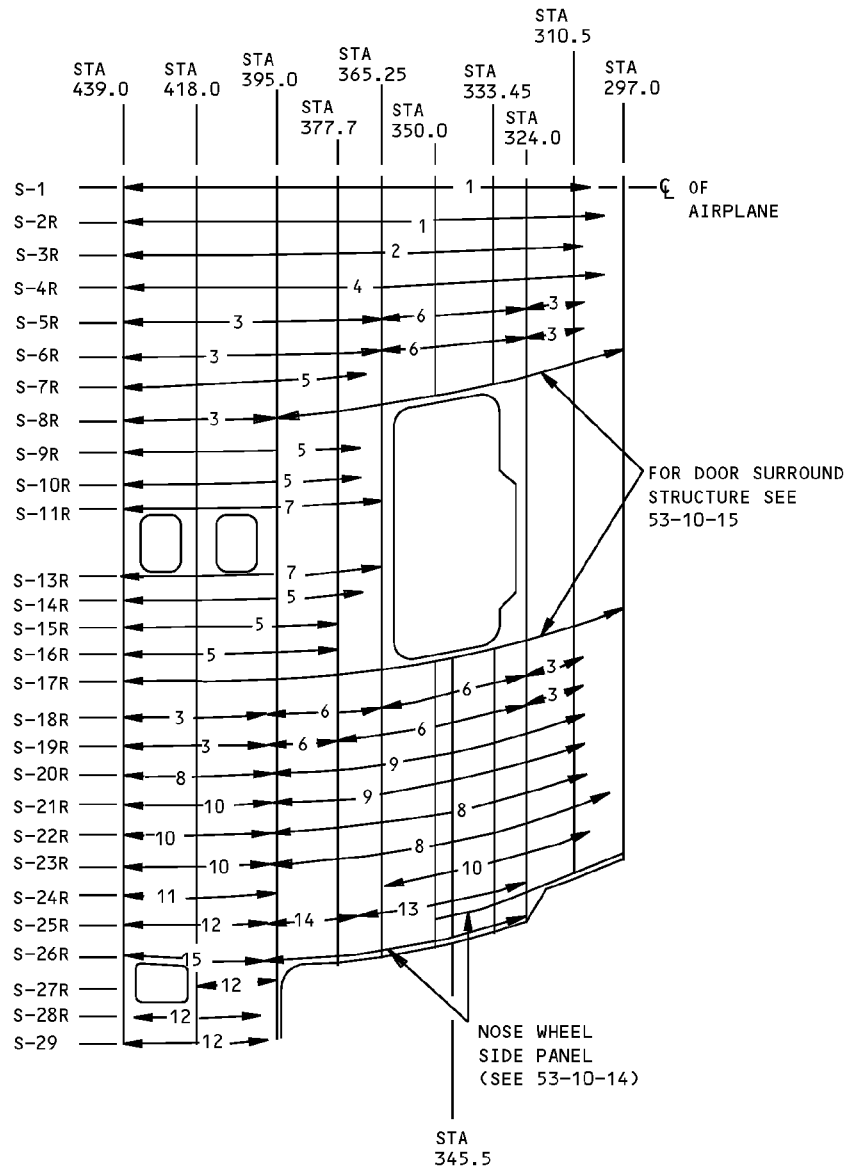
**RIGHT SIDE
DETAIL II**

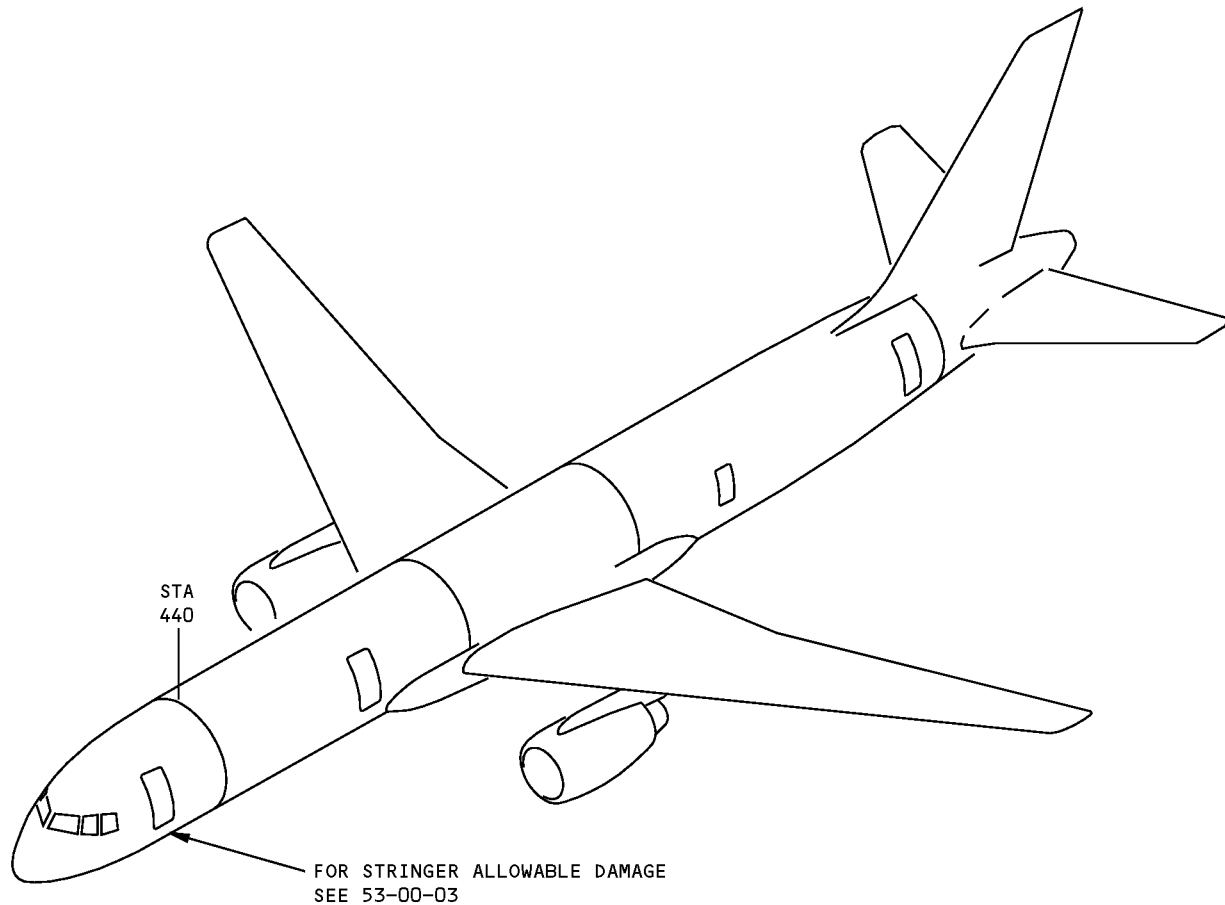
Section 41 Stringer Allowable Damage
Figure 101

ALLOWABLE DAMAGE GENERAL - SECTION 41 - STRINGERS
