FUSELAGE

757-200 STRUCTURAL REPAIR MANUAL

CHAPTER 53 FUSELAGE

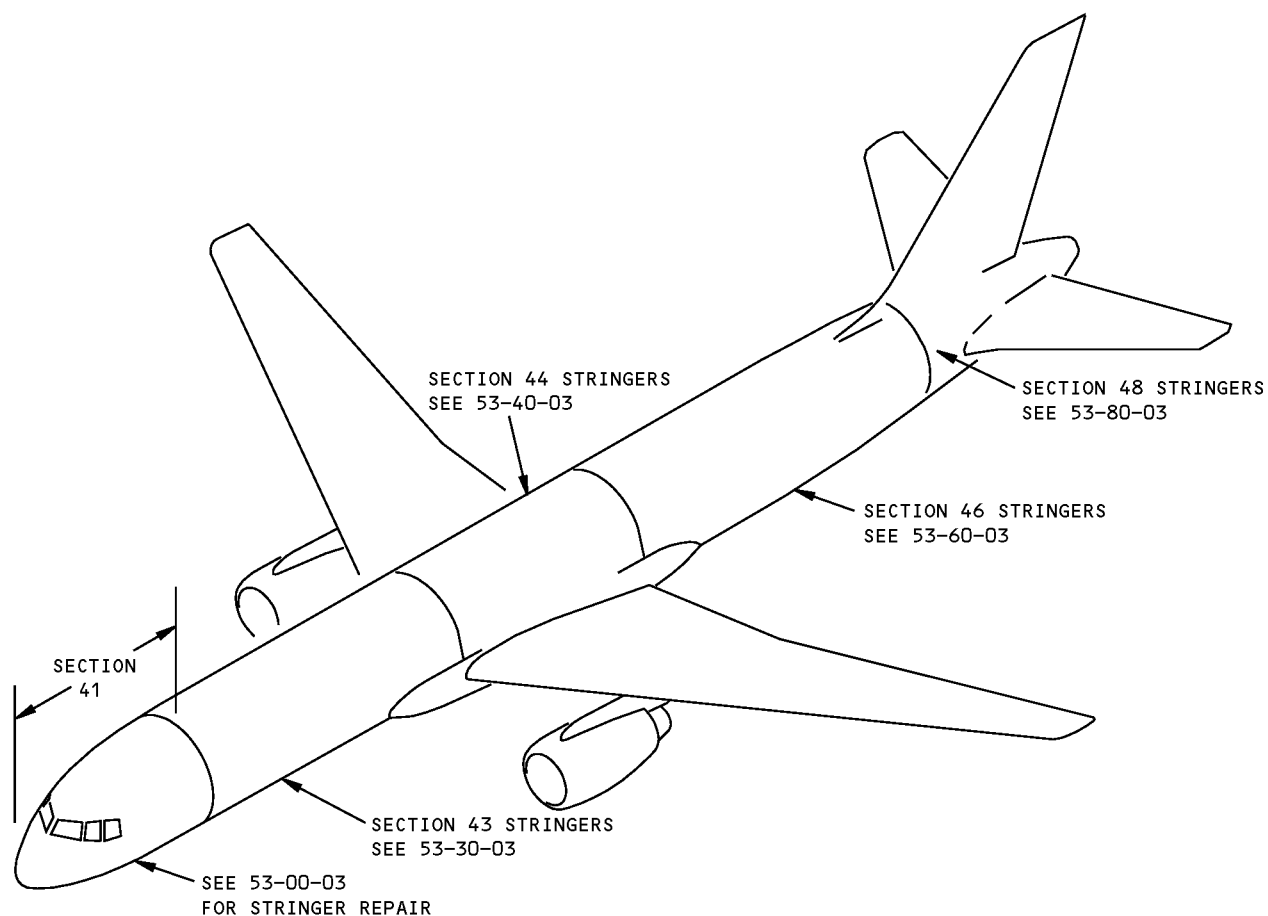
Section 41 Stringer Repair
Figure 201

REPAIR GENERAL - SECTION 41 - STRINGERS

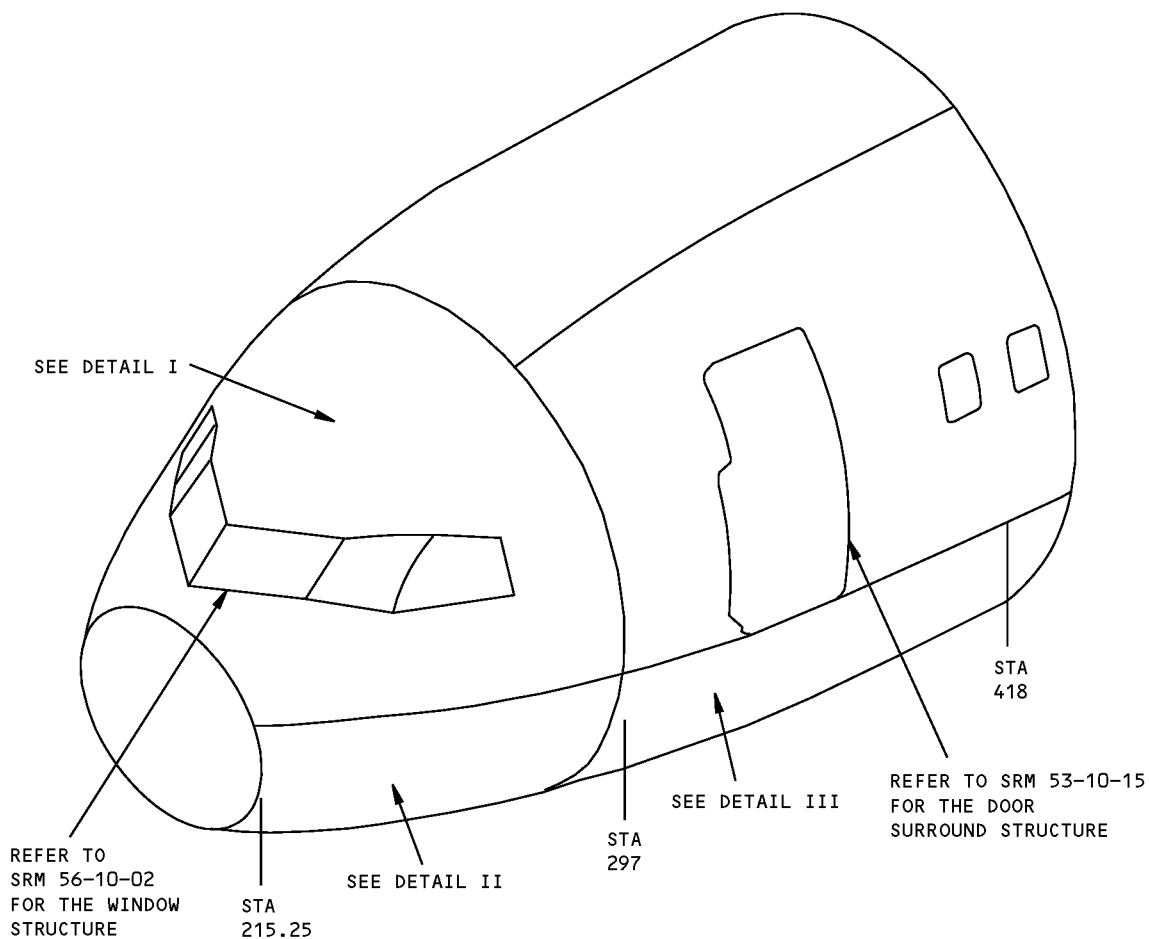
IDENTIFICATION 1 - SECTION 41 - INTERCOSTALS

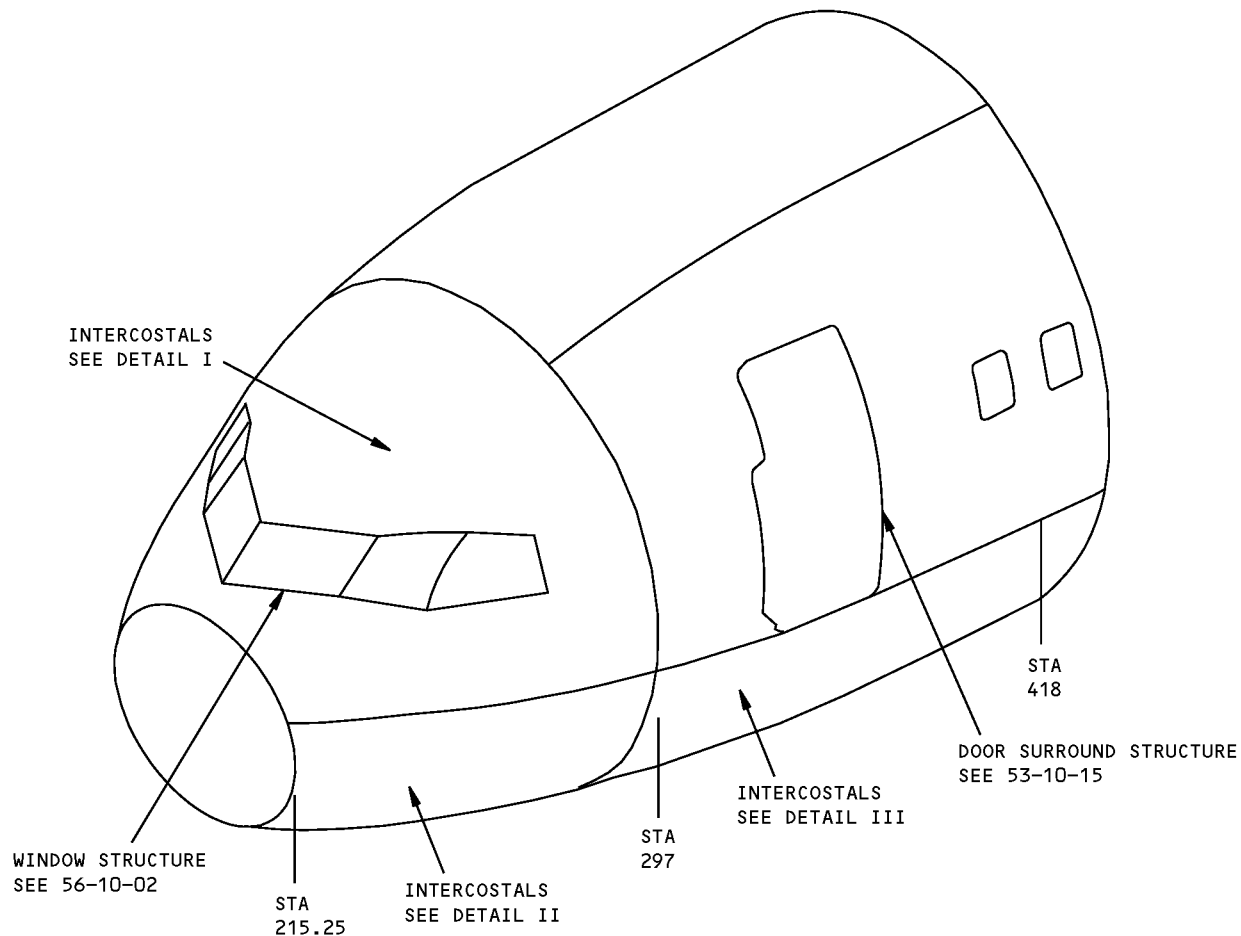
Section 41 Intercostal Allowable Damage
Figure 101 (Sheet 1 of 3)

- REFER TO 53-00-04 FOR INTERCOSTAL ALLOWABLE DAMAGE DATA

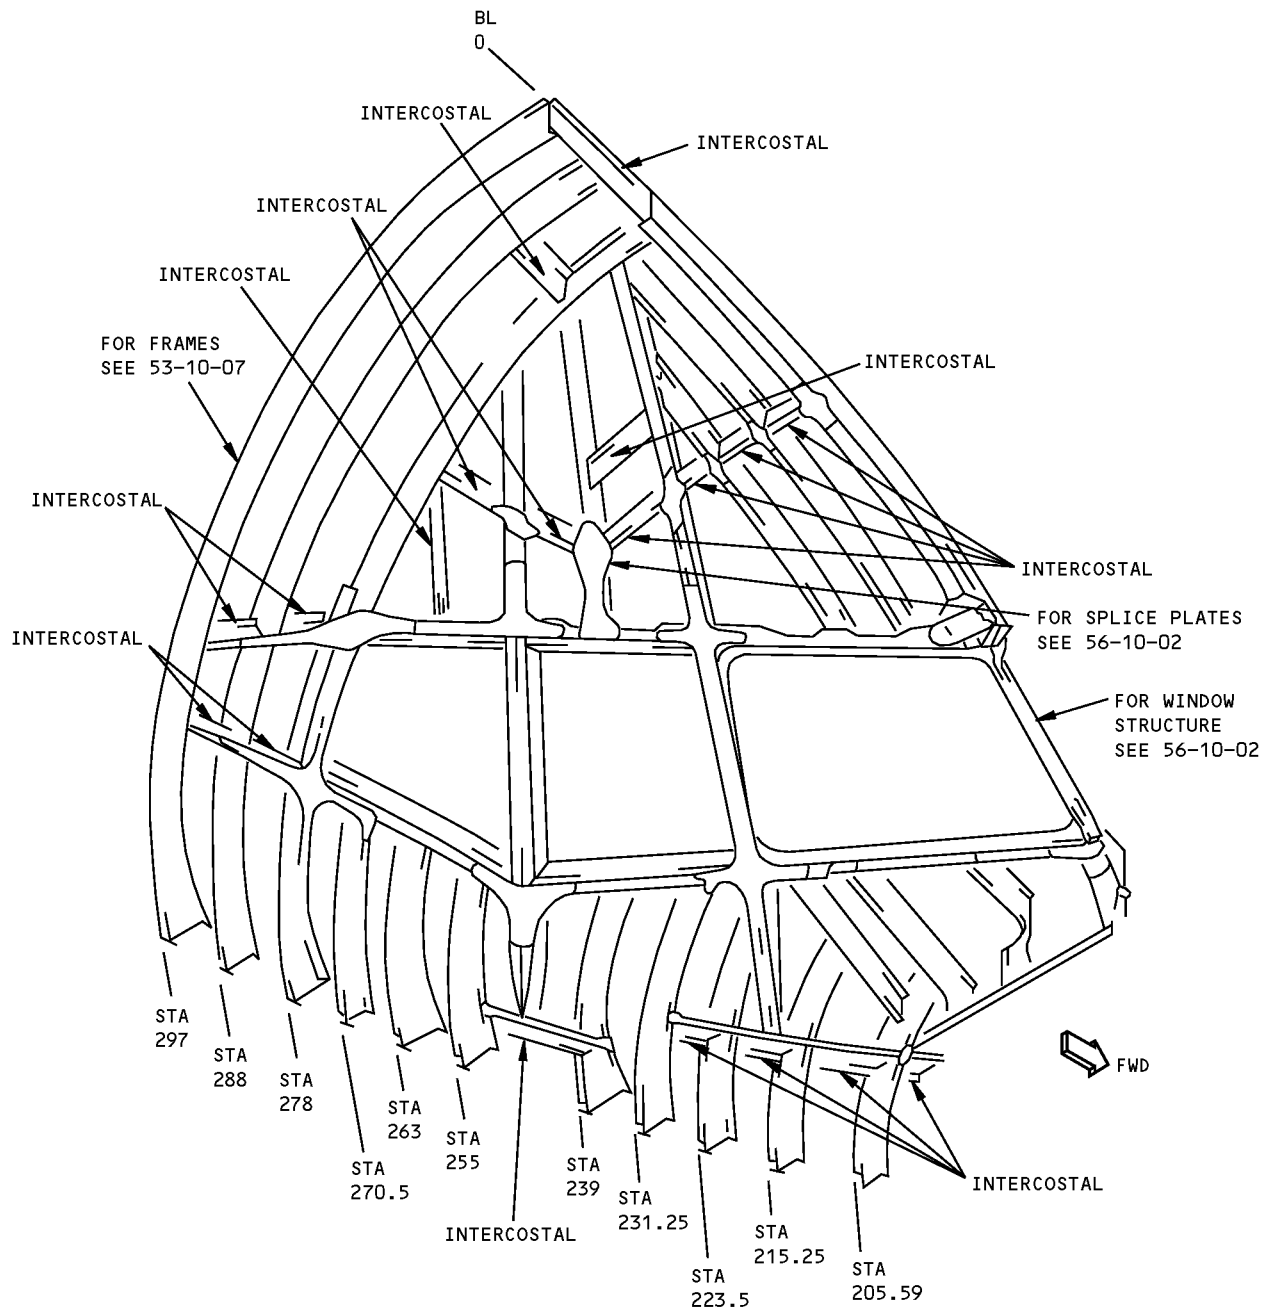
Section 41 Intercostal Allowable Damage
Figure 101 (Sheet 2 of 3)

LEFT SIDE SHOWN
RIGHT SIDE OPPOSITE
DETAIL I

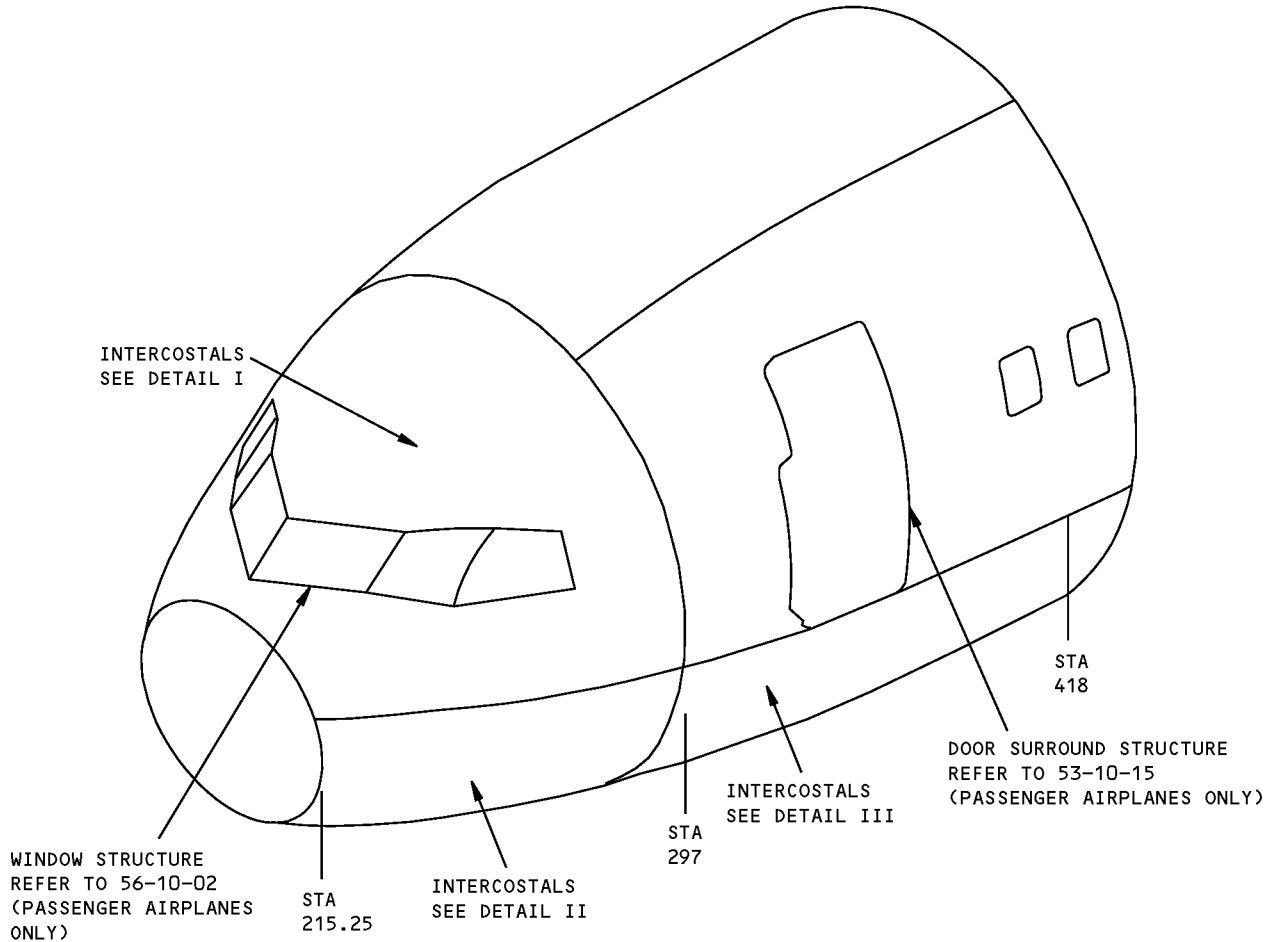
**Section 41 Intercostal Repair
Figure 201 (Sheet 1 of 3)**

- DAMAGED COMPONENTS MAY BE REPLACED OR REPAIRED. IF REPAIRS ARE TO BE MADE, SEE 51-70 FOR TYPICAL WEB, FORMED SECTION, OR EXTRUDED SECTION REPAIRS

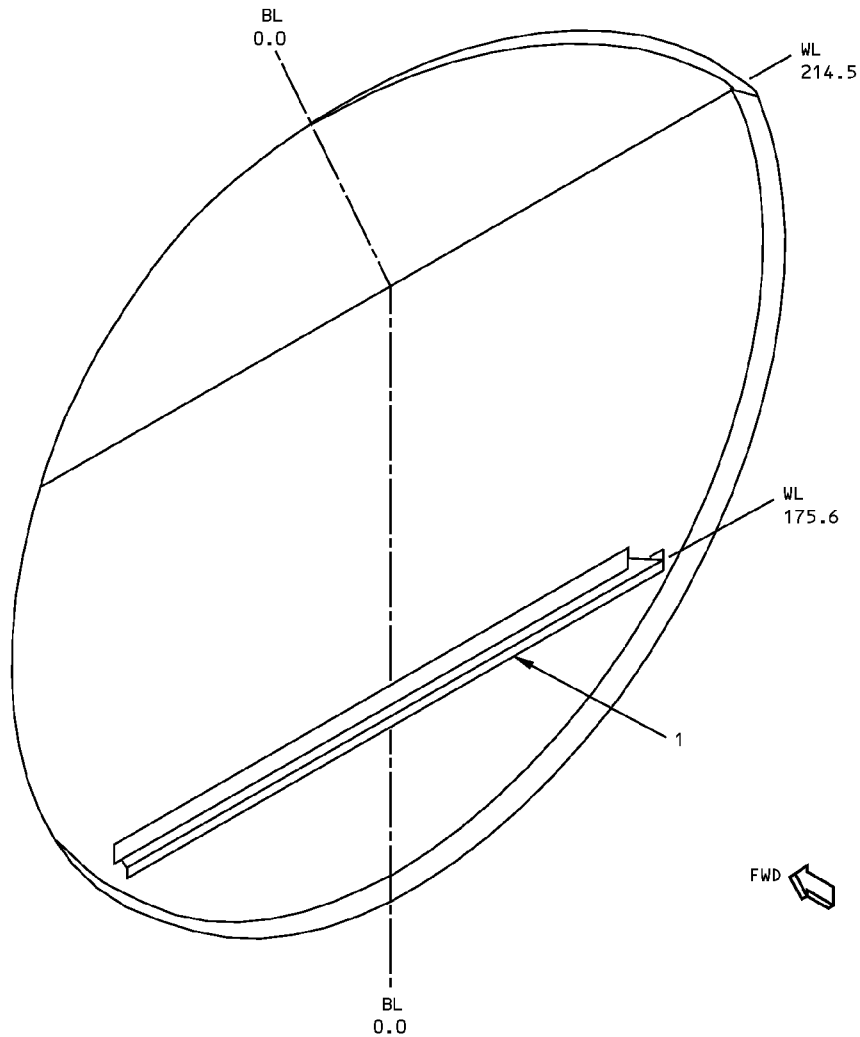
BULKHEAD STA 200.37
FORWARD VIEW
DETAIL II [E]

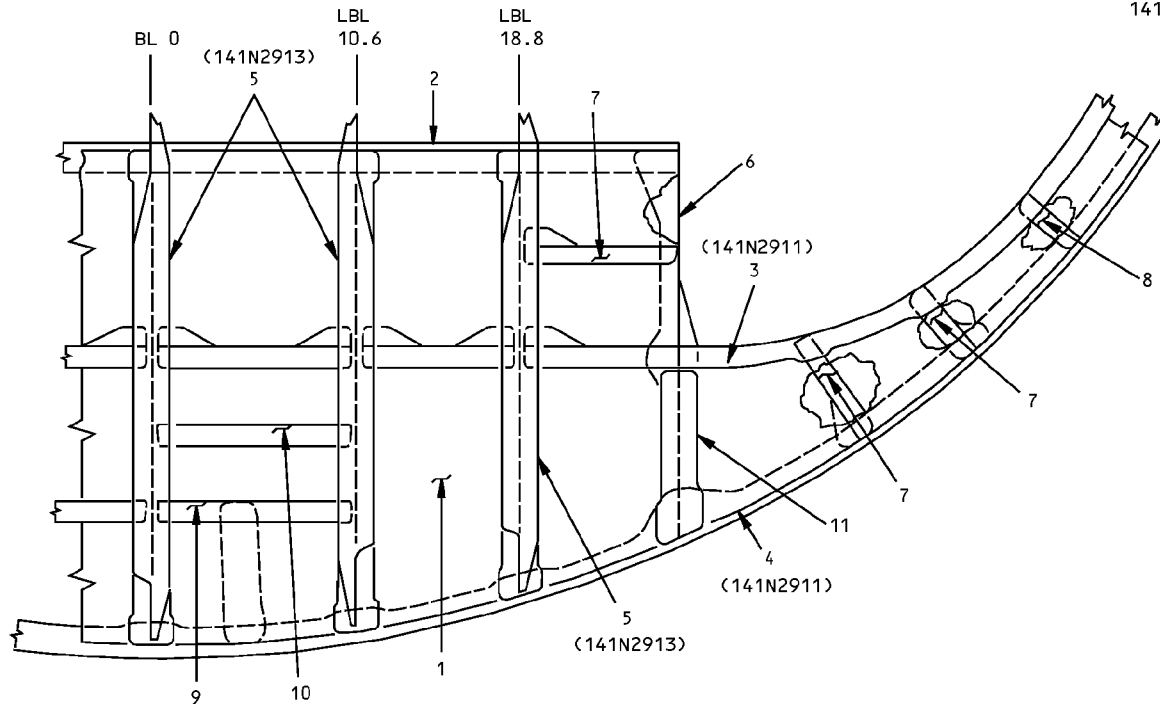
BULKHEAD STA 263
FRONT VIEW
DETAIL III

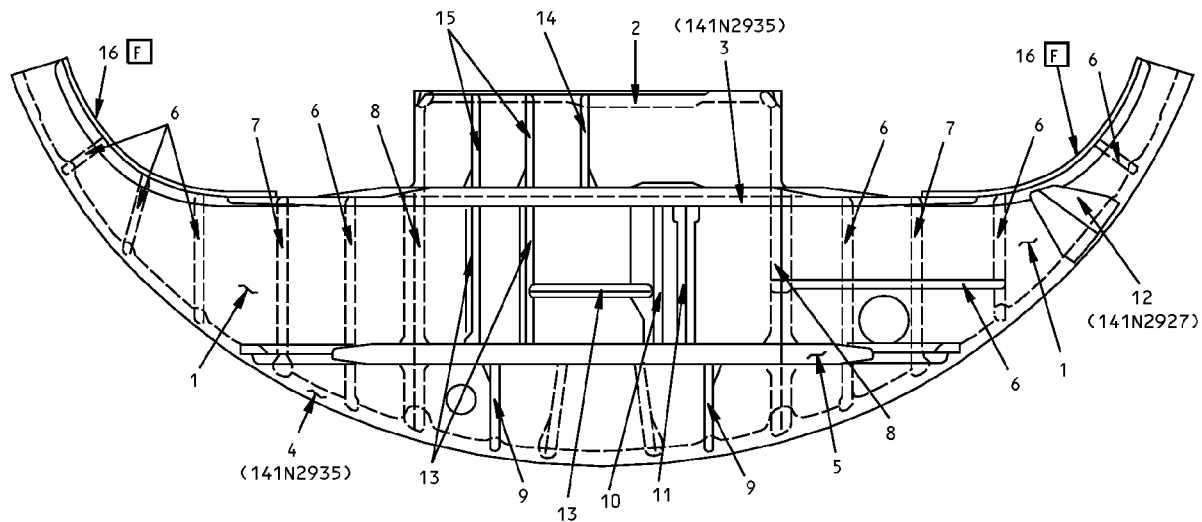
**BULKHEAD STA 395
REAR VIEW
DETAIL V**

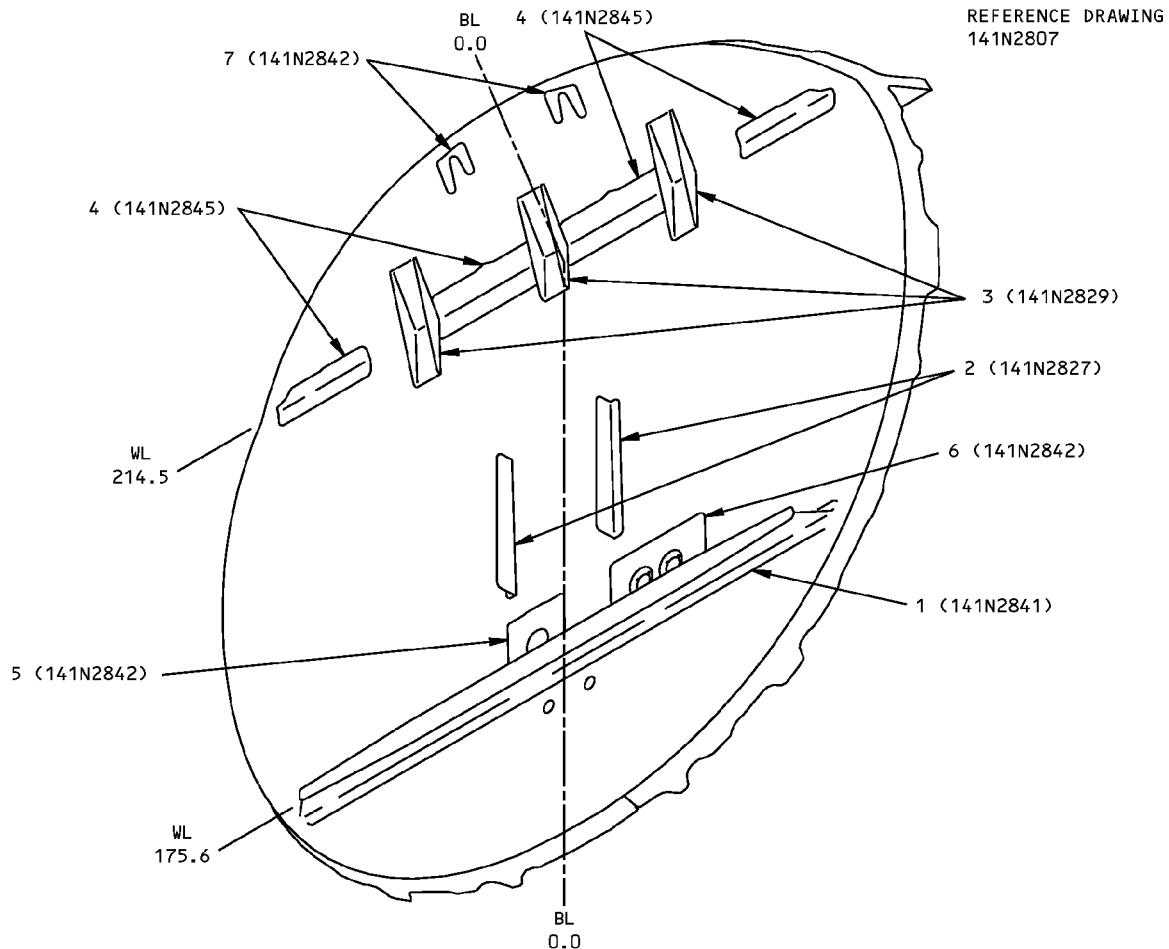
BULKHEAD STA 200.37
FORWARD VIEW
DETAIL VII **F**

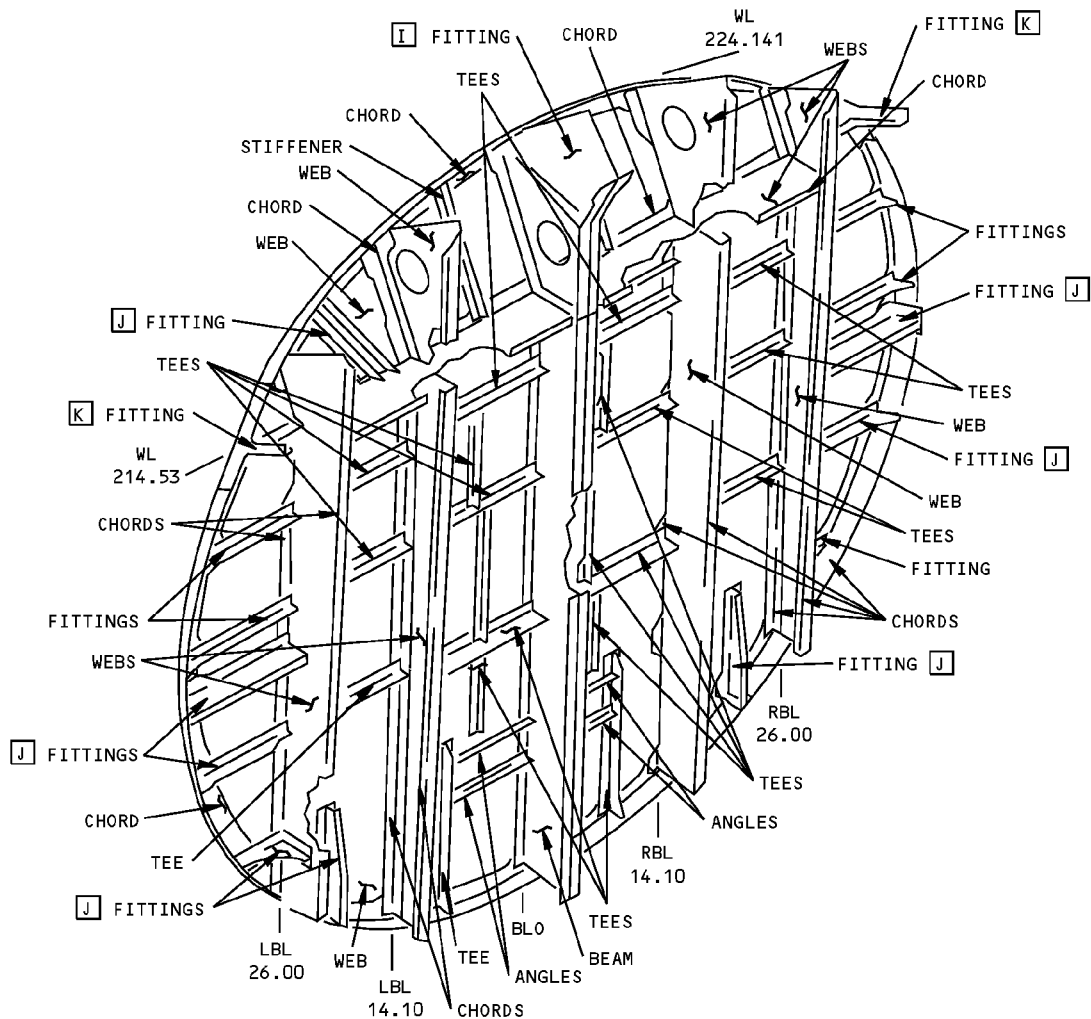
**Section 41 Bulkhead Allowable Damage
Figure 101 (Sheet 2 of 10)**

**BULKHEAD STA 200.37
REAR VIEW
DETAIL I M**

MATERIAL: ALUMINUM

- F** REMOVE THE DAMAGE AS GIVEN IN DETAILS VIII, IX, AND XI. SEE DETAILS IV AND V FOR THE SHOT PEENING THAT IS NECESSARY.
- G** CRACKS ARE NOT PERMITTED EXCEPT FOR EDGE CRACKS WHICH MUST BE REMOVED AS GIVEN IN DETAILS VIII AND XIII. SEE DETAILS I, V, AND VI FOR THE SHOT PEENING THAT IS NECESSARY.

- H** FOR EDGE DAMAGE, SEE DETAIL XVI. FOR LUG DAMAGE, SEE DETAIL XV. FOR OTHER DAMAGE, SEE DETAIL IX. DAMAGE IS NOT PERMITTED IN THE VICINITY OF BUSHINGS. SEE DETAILS I, V, AND VI FOR THE SHOT PEENING THAT IS NECESSARY.

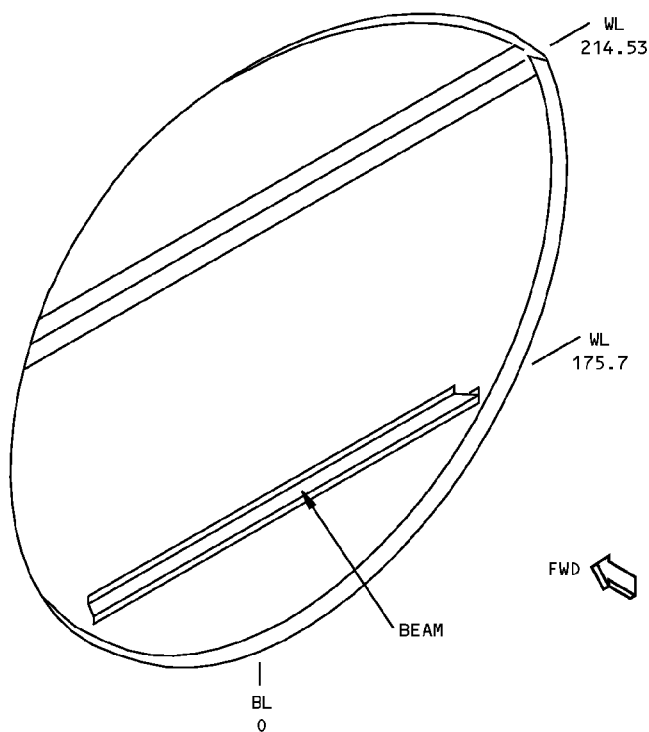
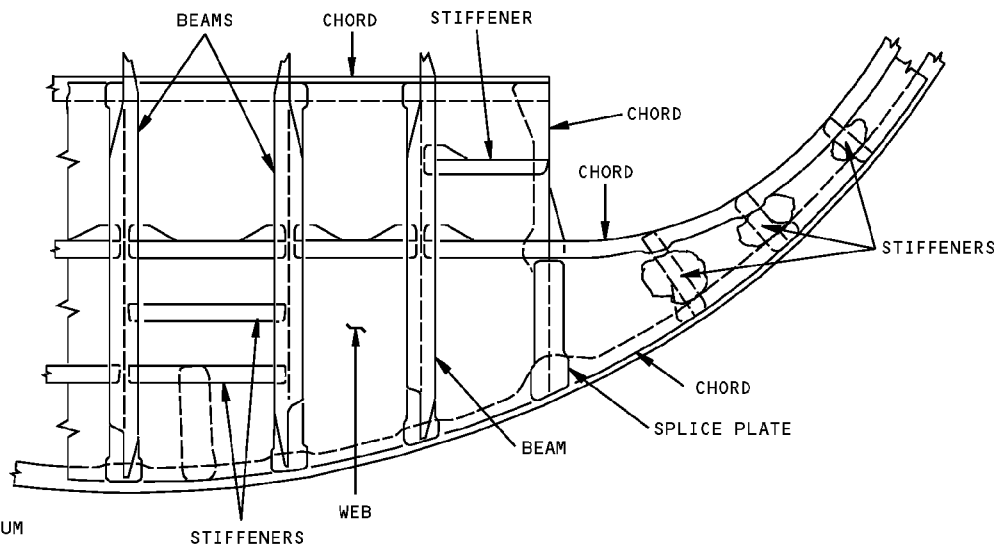
**Section 41 Bulkhead Allowable Damage
Figure 101 (Sheet 3 of 10)**

BULKHEAD STA 200.37
FRONT VIEW
DETAIL II M

BULKHEAD STA 263
FRONT VIEW
DETAIL III

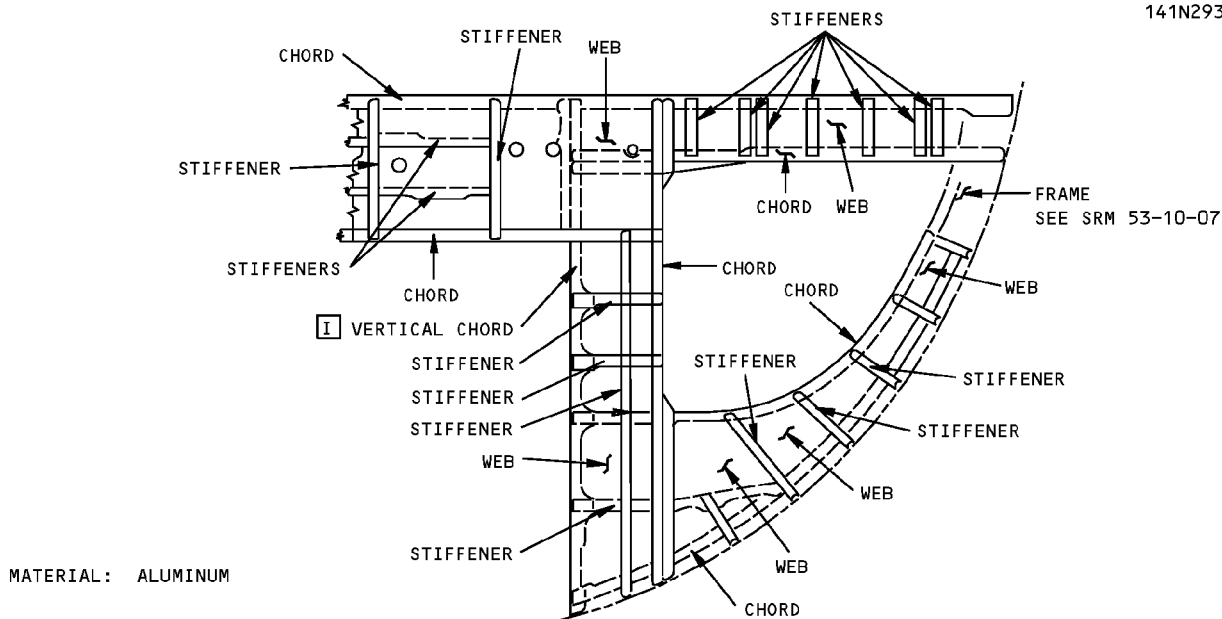
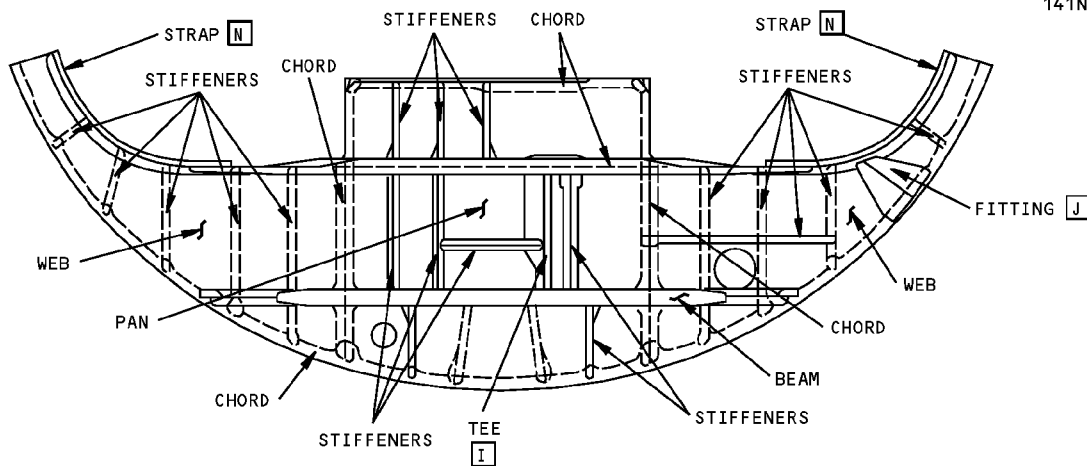
**Section 41 Bulkhead Allowable Damage
Figure 101 (Sheet 4 of 10)**

LEFT SIDE SHOWN
RIGHT SIDE SIMILAR
BULKHEAD STA 324
DETAIL IV

BULKHEAD STA 395
REAR VIEW
DETAIL V

- E** CRACKS ARE NOT PERMITTED EXCEPT FOR EDGE CRACKS WHICH MUST BE REMOVED AS GIVEN IN DETAILS VIII AND XIII. SEE DETAILS IV AND V FOR THE SHOT PEENING THAT IS NECESSARY.

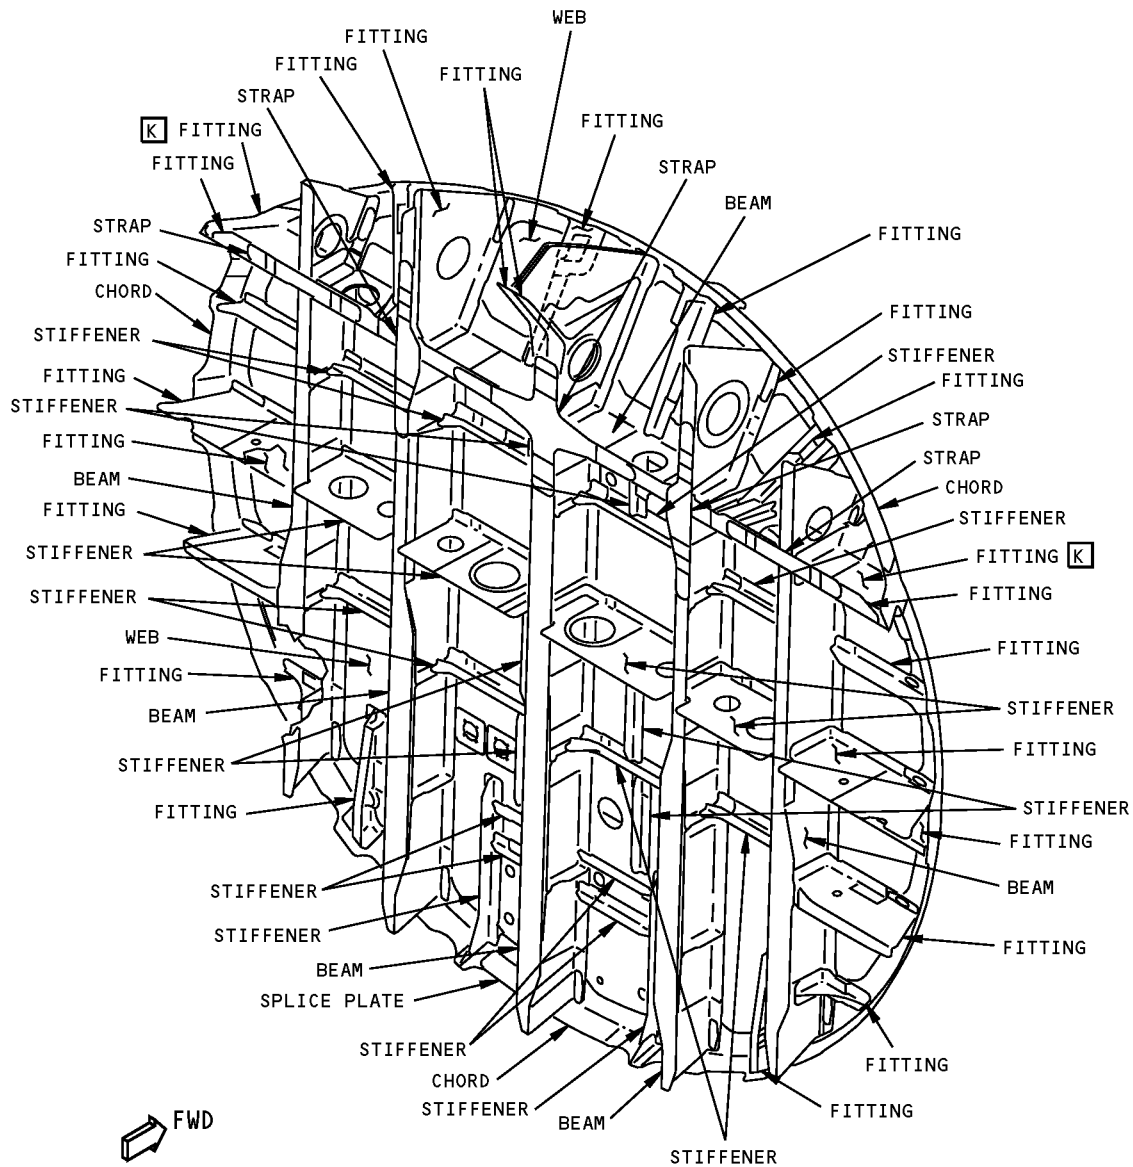
Section 41 Bulkhead Allowable Damage
Figure 101 (Sheet 5 of 10)

BULKHEAD STATION 200.37
REAR VIEW
DETAIL VI N

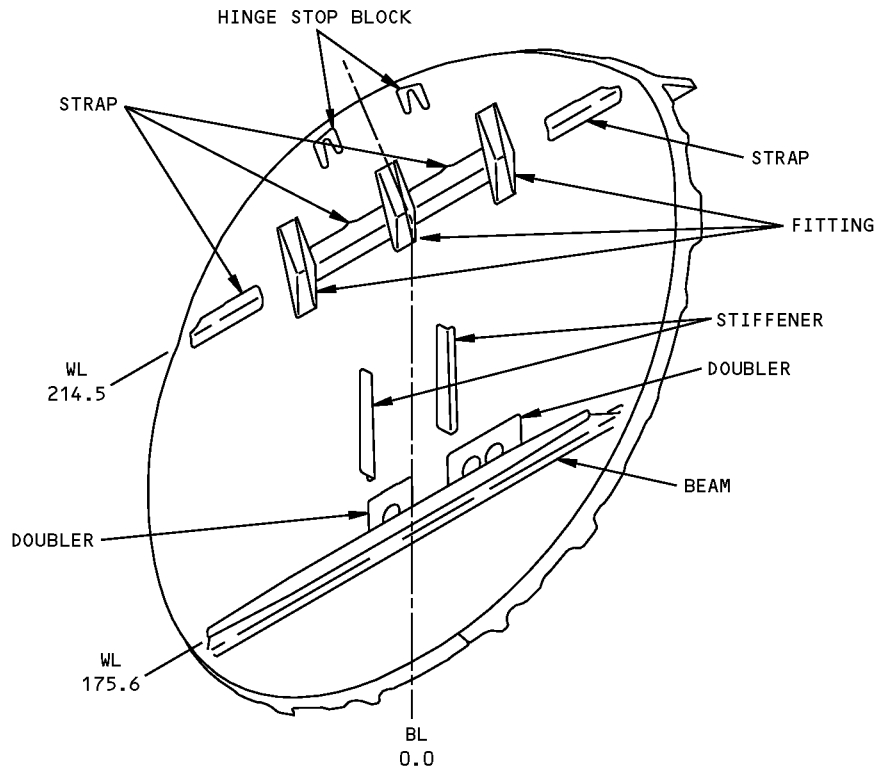
**Section 41 Bulkhead Allowable Damage
Figure 101 (Sheet 6 of 10)**

**BULKHEAD STA 200.37
FORWARD VIEW
DETAIL VII N**

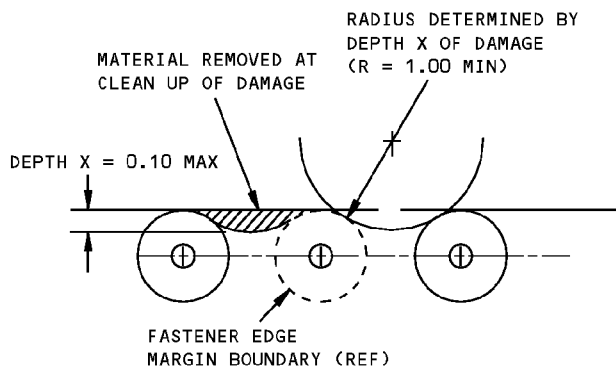
DETAIL VIII

DAMAGE CLEAN UP OF EDGES WHERE
FASTENER EDGE MARGINS DO NOT OVERLAP

DAMAGE CLEAN UP OF EDGES WHERE
FASTENER EDGE MARGINS OVERLAP

- REFINISH REWORKED AREAS AS GIVEN IN AMM 51-20.
- A** CRACKS ARE NOT PERMITTED EXCEPT FOR EDGE CRACKS WHICH MUST BE REMOVED AS GIVEN IN DETAILS VIII AND XIII

- B** REMOVE THE DAMAGE AS GIVEN IN DETAILS VIII, IX, AND XI
- C** CRACKS ARE NOT PERMITTED EXCEPT FOR EDGE CRACKS WHICH MUST BE REMOVED AS GIVEN IN DETAILS VIII AND XII

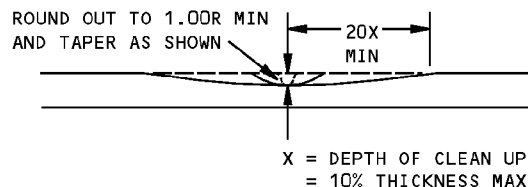
REMOVAL OF NICK, GOUGE AND SCRATCH DAMAGE ON A SURFACE
DETAIL IX

SECTION A-A

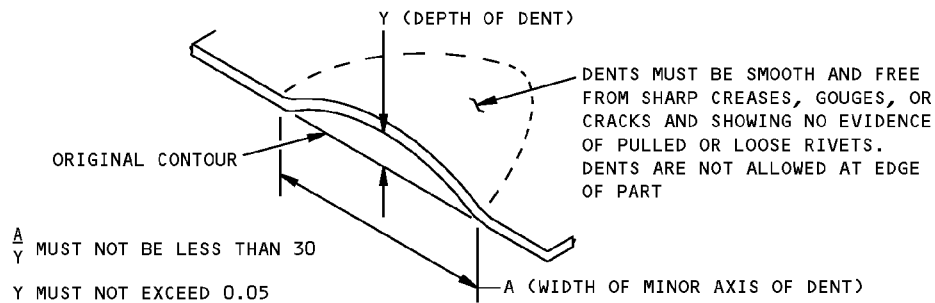
ALLOWABLE DAMAGE FOR DENT
DETAIL X

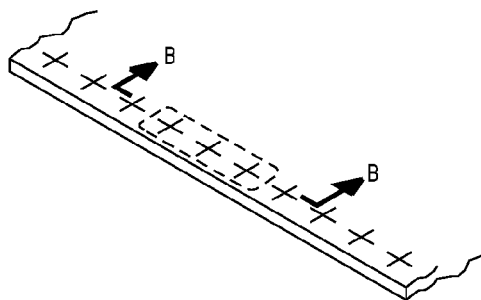
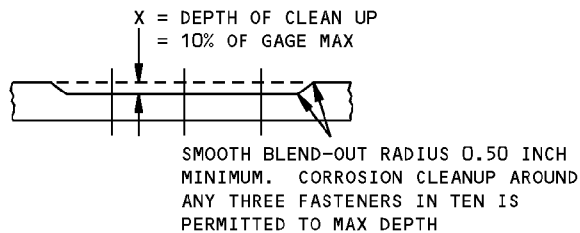
SECTION B-B

CORROSION CLEANUP
DETAIL XI

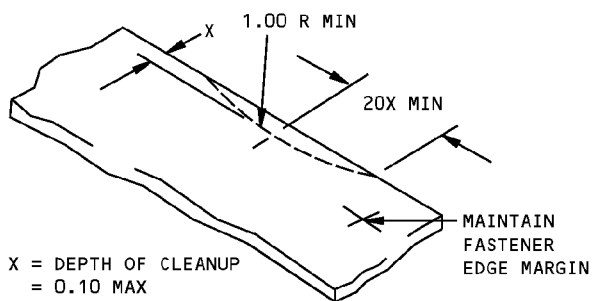
REMOVAL OF NICK OR CRACK
DAMAGE ON AN EDGE
DETAIL XII

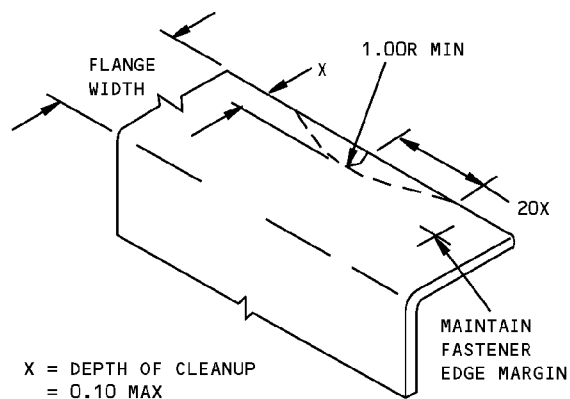
REMOVAL OF NICK OR CRACK
DAMAGE ON AN EDGE
DETAIL XIII

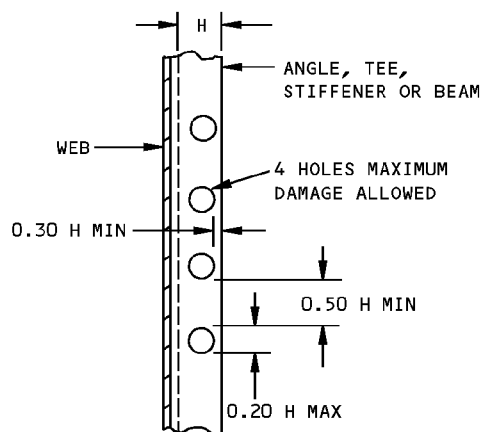
NO HOLE DAMAGE ALLOWED IN FLANGES FASTENED TO WEB.
HOLE DAMAGE NOT TO EXCEED 4 PLACES. FILL ALL HOLES
WITH 2117-T4 OR 2017-T3 ALUMINUM PROTRUDING HEAD
RIVETS INSTALLED WET WITH BMS 5-95. NO HOLE DAMAGE
ALLOWED CLOSER THAN 3.5 D TO EXISTING FASTENER.
NO HOLE DAMAGE ALLOWED IN SPLICES

H = WIDTH OF STIFFENER FLANGE

ALLOWABLE DAMAGE LIMITS FOR HOLES IN ANGLES, TEES, STIFFENERS OR BEAMS
DETAIL XIV

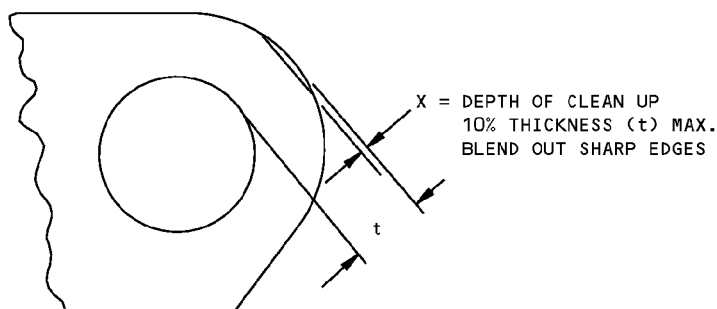
DAMAGE CLEAN UP FOR EDGES OF LUG
DETAIL XV

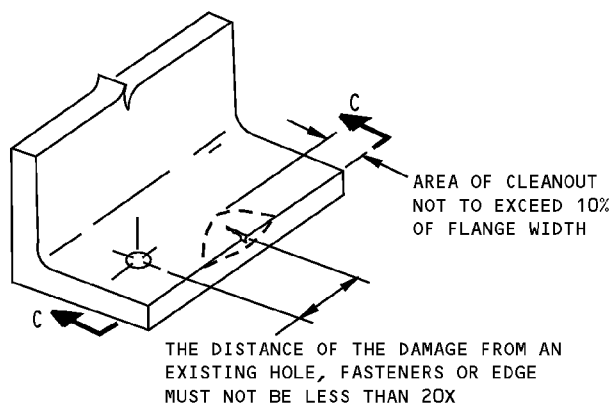
REMOVAL OF NICK OR CRACK DAMAGE ON AN EDGE
DETAIL XVI

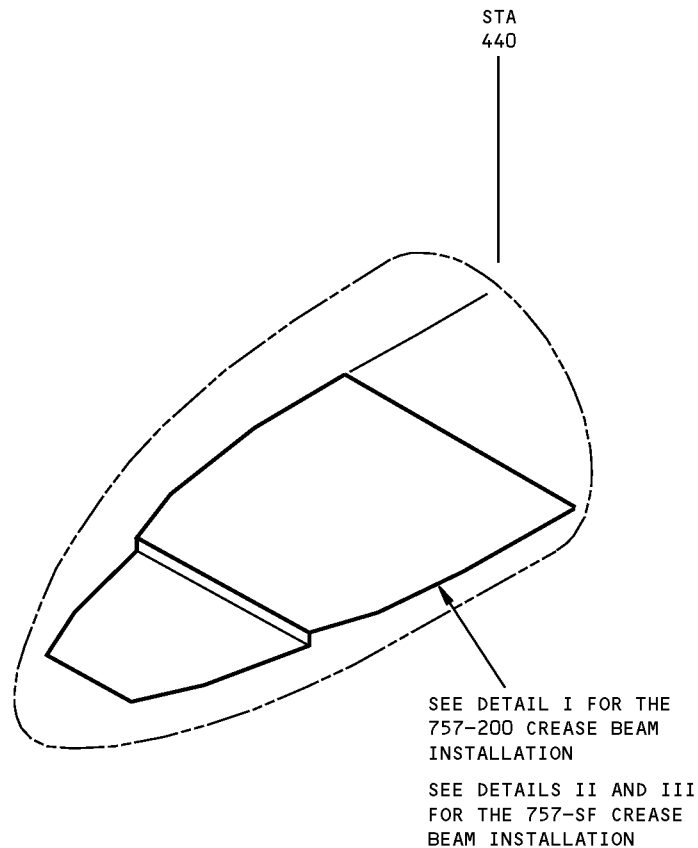
IDENTIFICATION 1 - SECTION 41 - CREASE BEAM

Section 41 Crease Beam Identification
Figure 1 (Sheet 1 of 5)

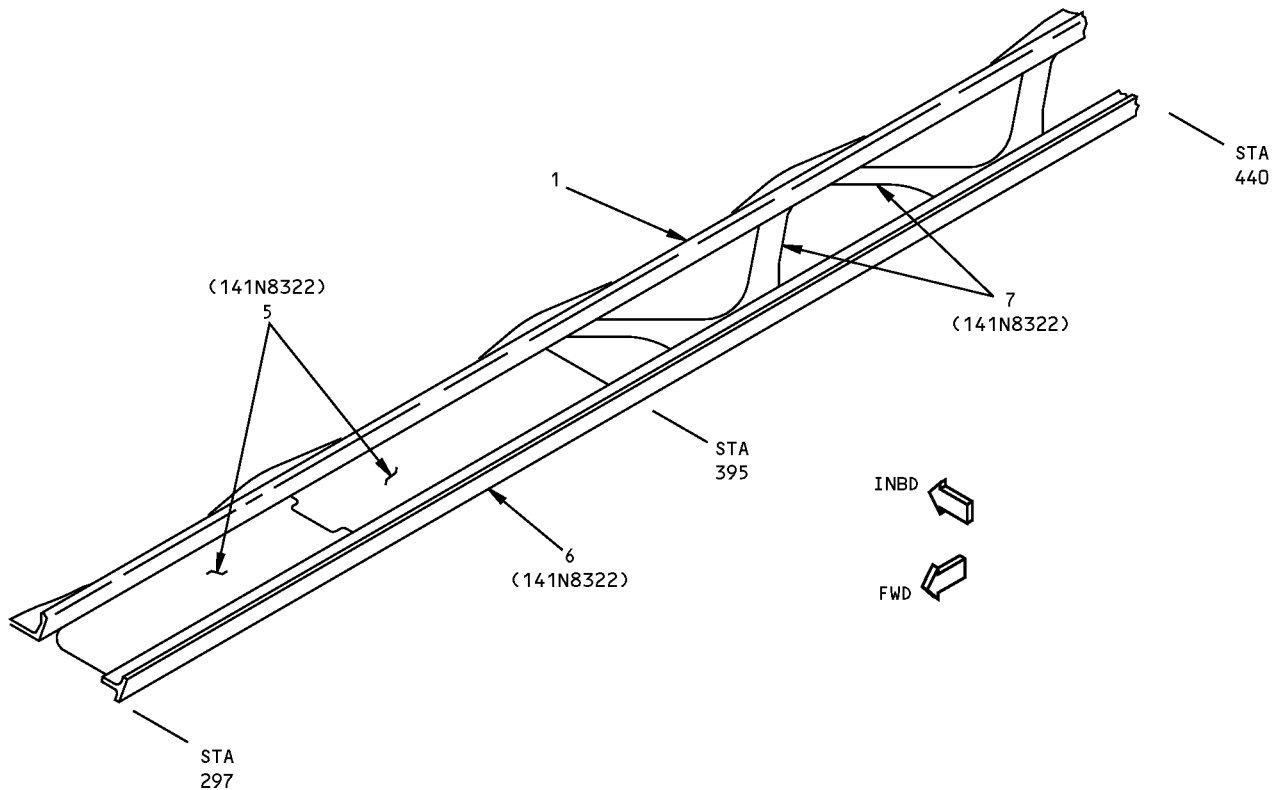
REFERENCE DRAWING
141N8322

LEFT SIDE IS SHOWN, RIGHT SIDE IS OPPOSITE
DETAIL I

Section 41 Crease Beam Identification
Figure 1 (Sheet 2 of 5)

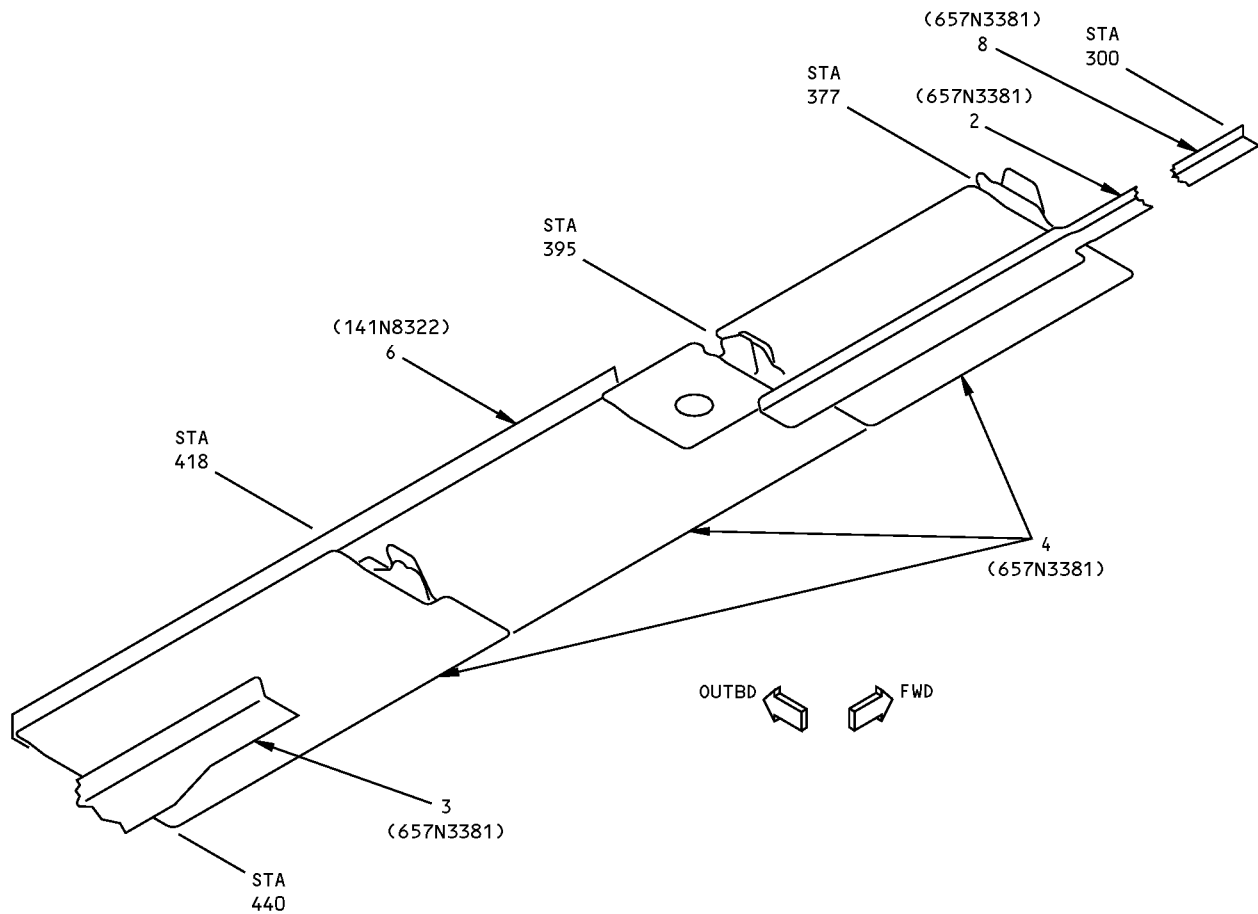
REFERENCE DRAWING
657N3381

LEFT SIDE
MODIFIED CREASE BEAM FOR 757-SF AIRPLANES ONLY
DETAIL II

NOTE: FOR CREASE BEAM CONTINUATION
FOR SECTION 43 SEE 53-30-13

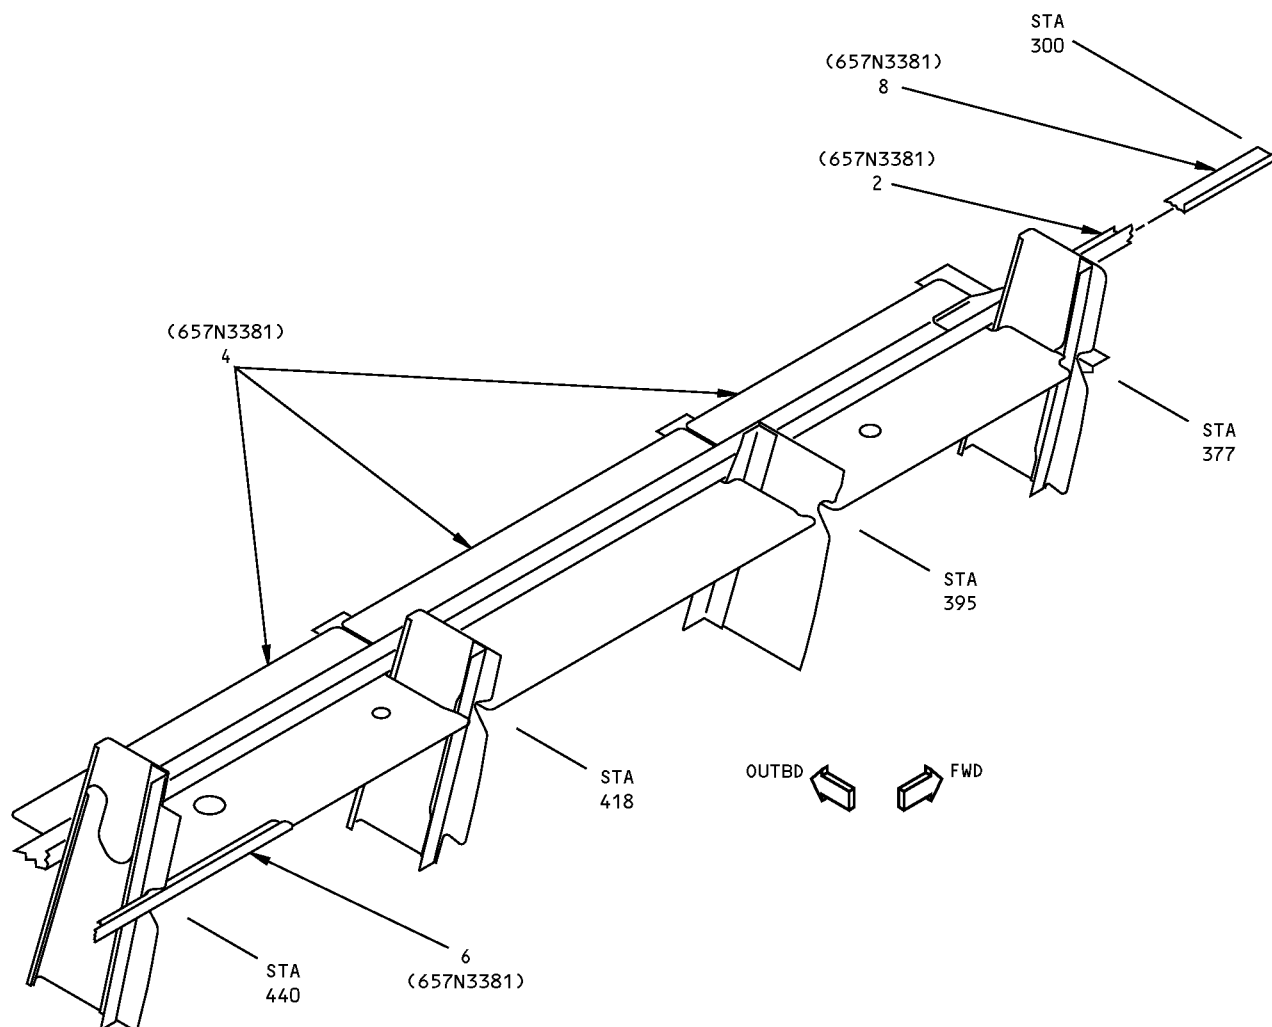
RIGHT SIDE

MODIFIED CREASE BEAM FOR 757-SF AIRPLANES ONLY
DETAIL III
